Missouri DOT's 2018 Poplar Street Bridge Lateral Slide

Gregory Kuntz & Dennis Heckman

Monthly Webinar
July 18, 2019

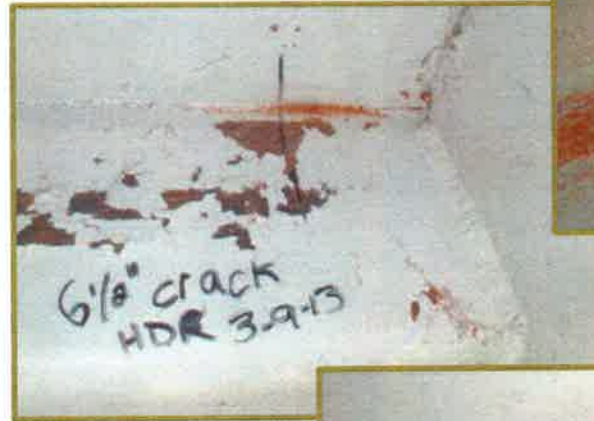
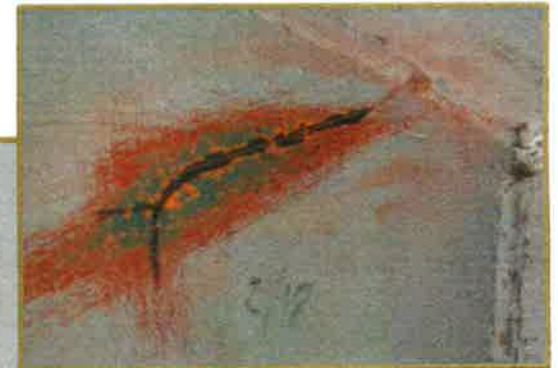
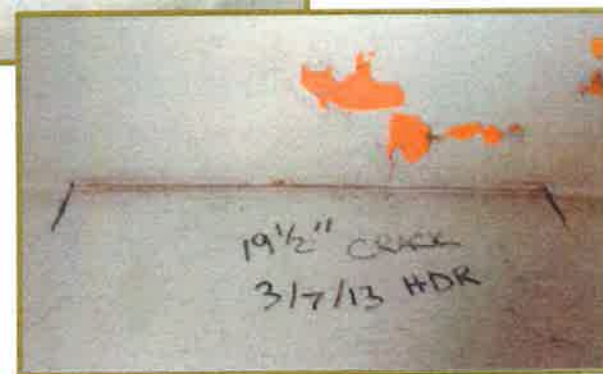
Rehabilitation – Orthotropic Steel Deck

- Numerous rib web to deck weld cracks (>100 locations)
- Some have propagated into web of rib
- Most near floor beam, some large at mid-bay up to 60" maximum observed
- Recommend bolted repair
- Cause?!?!

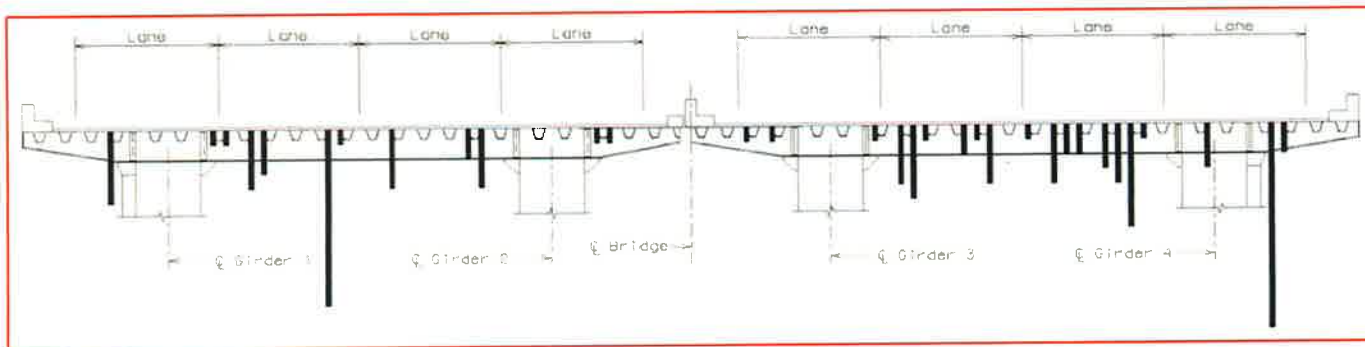
Rehabilitation – Orthotropic Steel Deck

- Plot below shows number of cracks transversely along bridge
- Cracks generally correspond to wheel lines
- Flexibility of deck contributing to cracking
Thin, de-bonded overlay contributing no stiffness to deck
- Cracks will continue to progress & develop unless deck is stiffened
- Solution: Thicker & Stiffer Overlay!

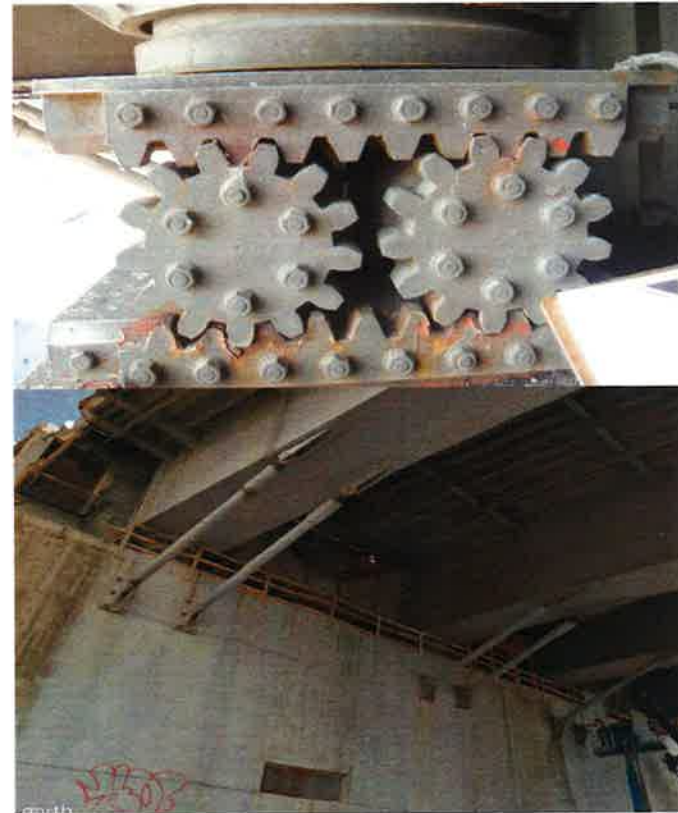
Rehabilitation - Bearings

- Evidence existing bearings not performing as intended (no thermal movement)
- Shock transmission units (STU) previously installed as part of seismic retrofit
- Concern of poor performance, sent 4 STU's to lab for testing

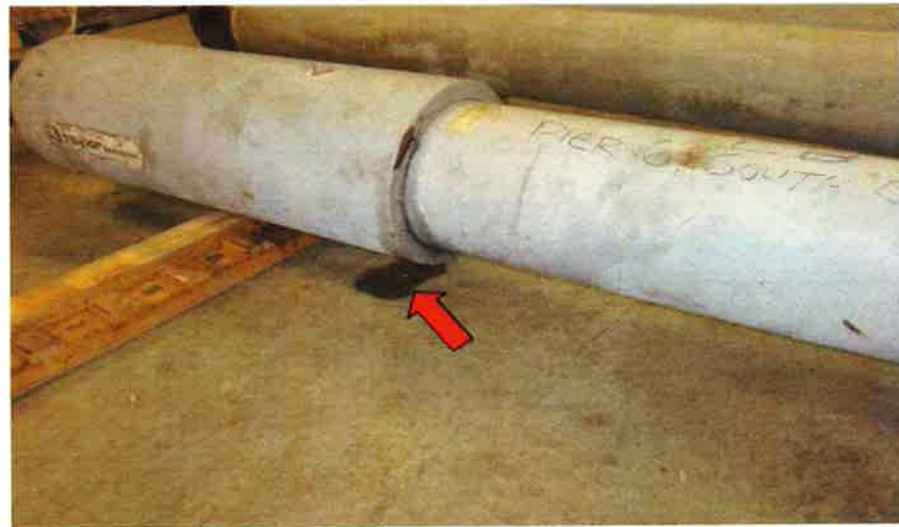
Rehabilitation - Bearings

- Confirmed 1 of the 4 STU's fluid had leaked out and did not pass verification testing
- Potential for lack of response under seismic loading
- Remove existing STU's & replace existing bearings with lead core seismic isolation bearings

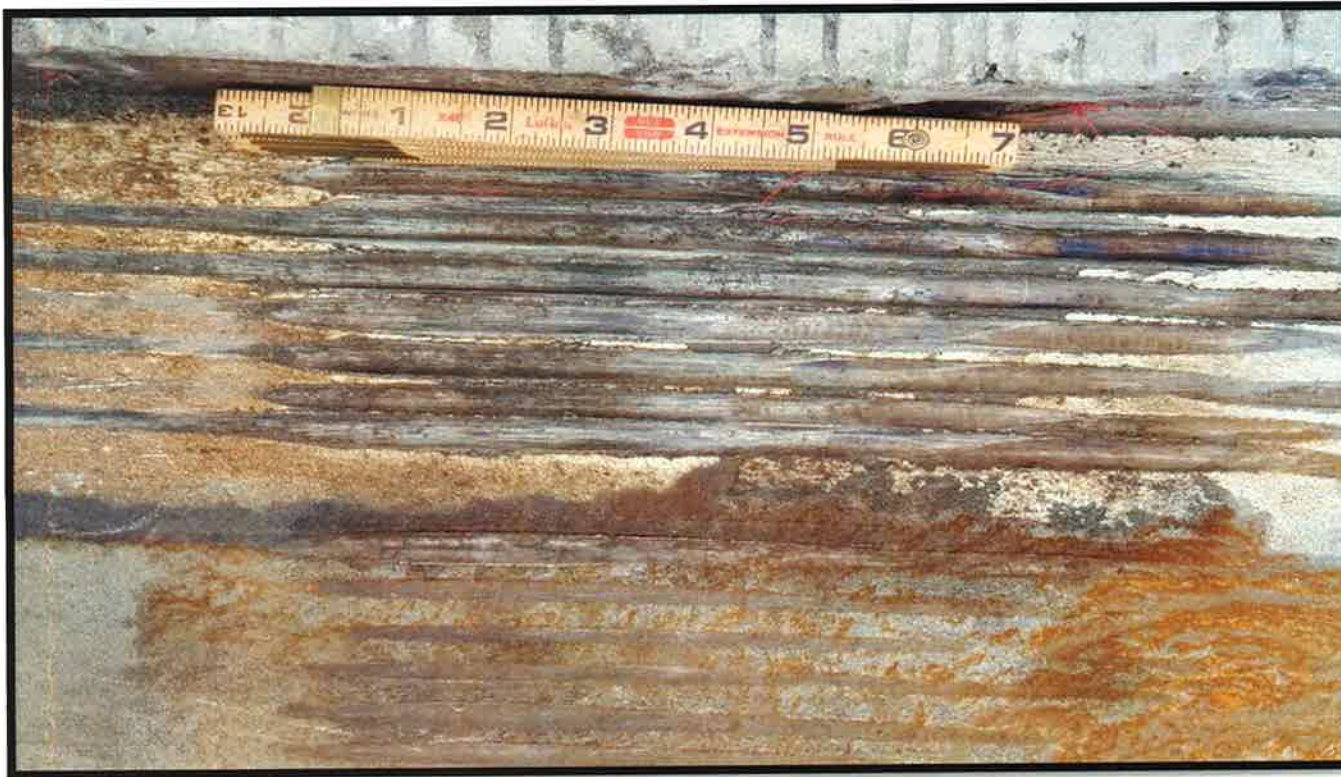
Gouges From Previous Overlay Removals
