DURABILITY OF GFRP BARS IN BRIDGES WITH 15 TO 20 YEARS OF SERVICE

Vanessa Benzecri, E.I., University of Miami, (786) 469-0327, v.benzecri@umiami.edu
Antonio Nanni, Ph.D., P.E., University of Miami, (305) 284-2404, nanni@miami.edu

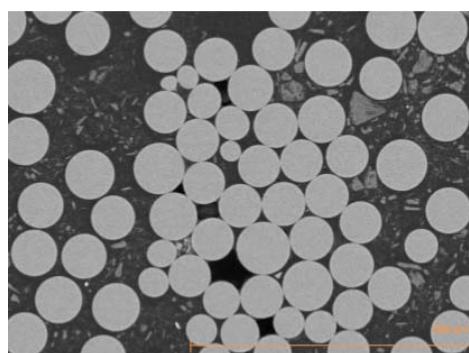
Evidence of GFRP rebar fibers being negatively affected by the concrete environment after 15 years in service is minimal and less than expected or predicted by accelerated test methods. Physical damage on fibers was observed on the outer edge of some bars, typically near a void in the resin matrix. At times, damage is likely due to the specimen preparation procedure (saw cutting and polishing). Overall, it was estimated that approximately 0.05 to 0.12% of the total number of fibers was damaged.

Figure 2. Cuyahoga Bridge. No visually affected fibers

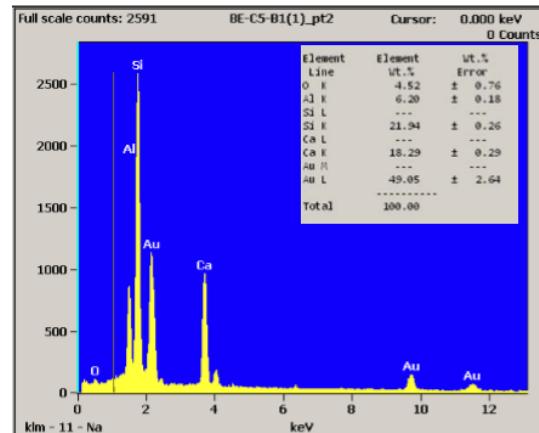
The result of EDS analysis shows Si and Al (from glass fibers) and C (from the matrix) as the predominant chemical elements. An example of SEM image and EDS are shown in Figures 2 and 3.

Figure 3. Bettendorf Bridge EDS

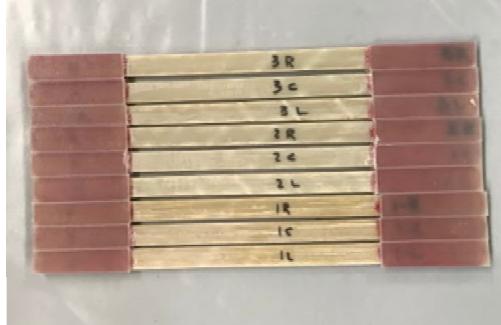
Figure 4. Extracted bars cut into laminates

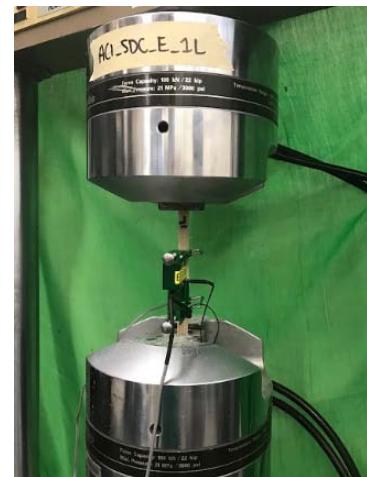
The results from the new generation virgin full-size rebars were compared to data from tensile tests performed in 2000 on bars used in Sierrita de la Cruz Creek. Consequently, a correlation factor between the coupon ultimate tensile strength and the full-sized ultimate tensile strength was calculated and used to interpret results. It was found that the extracted GFRP bars had a reduction in strength of 2.1% over 17 years of service, as shown in Table 7.

Figure 5. Extracted bar from the left being tested in tension
