## ACCELERATED AND RESILIENT REPAIR OF BRIDGE COLUMNS

Shamim A. Sheikh, Ph.D., FCAE, University of Toronto, (416) 978-3671, [sheikh@ecf.utoronto.ca](mailto:sheikh@ecf.utoronto.ca)

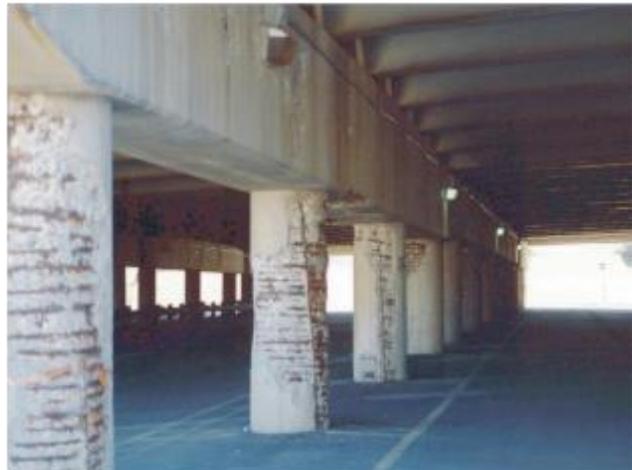
There is a large inventory of existing bridges that have become deficient as a result of corrosion of reinforcing steel. Upgrade and repair of these structures is an expensive and time consuming exercise in most cases. For structures such as bridges, it is especially serious considering the disruptions in traffic and related costs. Corrosion of steel is accelerated in regions where de-icing salts are used to clear the roads of the snow and ice. The chloride from these salts contaminates the concrete and is very corrosive for the reinforcing steel. Expansion of steel caused by corrosion results in expansive forces that causes delamination and removal of concrete cover further exacerbating the process and reducing load carrying capacity of structures. Figure 1 shows such a bridge with damaged corroded columns and girders. The concrete cover was completely spalled off in a number of columns and the effectiveness of spiral steel was almost completely lost.

*Fig. 1. Highway Bridge damaged by steel corrosion*

Traditional methods of repairing such a structure would require a number of steps such as providing temporary supports for the structure, removal of contaminated and damaged concrete from the columns, replacement of corroded steel with new steel, and building of columns to their original shapes with new concrete. Each of these steps involves costly operation that takes time to complete. The costs associated with the disruptions in traffic and the resulting chaos are enormous and difficult to quantify.

In the research presented here, an accelerated procedure was developed for the repair of columns such as those shown in Figure 1. It was stipulated that if the access of water and oxygen into the retrofitted columns could be stopped or at the very least minimized, the corrosion process can be slowed down if not completely stopped. This required providing an impervious layer on the outside and effectively sealing the columns from the environment as far as the water and oxygen ingress was considered. The contaminated concrete could thus be left inside the members as long as it is reasonably sound. It was also felt that the corroded steel can also stay in place and additional reinforcement can be provided to compensate for the reduction due to corrosion. Only the spiral steel was observed to have been corroded in all the columns. The materials selected for replacement of concrete to build the columns included different types of grouts including one based on the expansive cement especially developed for such applications. Reinforcement provided consisted of glass fiber reinforced polymer wraps.

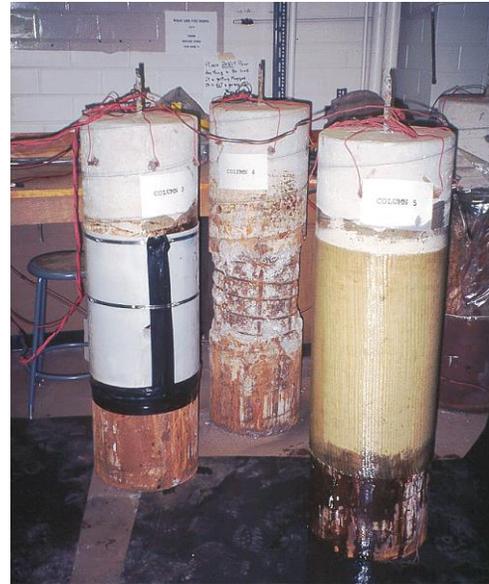
Figure 2 shows three of these columns at different stages of investigation. One column shows the damage due to corrosion of steel which resulted in complete loss of concrete cover as was observed in the field columns. It was observed that as in the field columns, corrosion was mainly limited to spiral. Of the four columns in this test series, one column was not subjected to the corrosion process and one corroded column was not repaired. These two columns acted as control specimens against which the performance of the repaired columns could be evaluated to judge various repair techniques for their abilities to upgrade the columns. The two control columns also provided a direct comparison to evaluate the loss of a column's load carrying capacity and the deformation capacity.

*Fig. 2. Columns at various repair stages*

Two corroded columns were repaired using two different accelerated retrofit techniques with the aim of minimizing the time required to complete the field work and the total cost (Figure 2). In each of the procedures investigated, the corroded steel and the contaminated concrete were not removed from the damaged column. Only loose concrete and debris were cleaned with a steel brush. The columns were built

One column was repaired with grout based on the expansive cement especially developed for such applications (exp-repaired) by Sheikh et al (2). A 3 mm thick polymer sheet was bent around the damaged area of the column and held in place with five clamps so as to act as formwork for the column repair. The expansive cement grout was then poured in place. Four hours after grouting, the column was wrapped with two layers of GFRP on top of the 3 mm thick polymer formwork sheet.

A commercially available rheoplastic, shrinkage-compensated grout containing non-ferrous fibers named Emaco was used to build the second column to its original shape. The repair patch was covered with epoxy coating to avoid direct contact of GFRP with the new cementitious material. After 24 hours of curing, the column was wrapped with two layers of GFRP. All the columns were stored in the laboratory at room conditions with temperature of about 23°C and 50% relative humidity until testing.

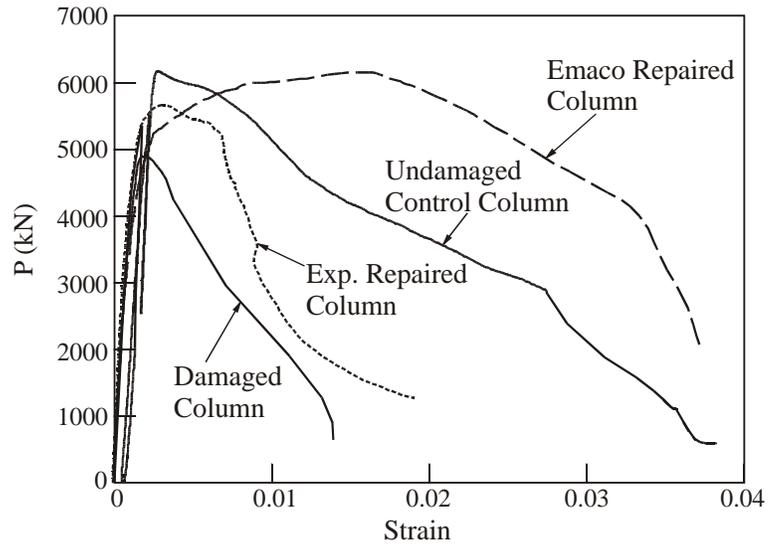
Figure 3 shows the results from the tests on columns under axial load. It can be seen in the figure that damage caused by corrosion of the spiral and the loss of concrete cover resulted in about 20% reduction of the axial load carrying capacity of the column compared with the healthy undamaged column. Reductions in ductility and energy dissipating capacity were even more significant. Figure 4 shows the columns after their tests. While the undamaged healthy column displays the role of spiral reinforcement in keeping the integrity of the column core intact, the corrosion in the damaged column rendered the spiral steel completely ineffective. Pitting corrosion created weak spots where the spiral ruptured at relatively small axial strain in the column. The ruptured pieces of the spiral that flew off the column during testing are shown in Figure 5. The pitted corrosion can be clearly seen at several locations including points of rupture. Confinement that is needed at large strains is obviously not available in the corroded columns.

Fig. 3. Behavior of columns under axial load

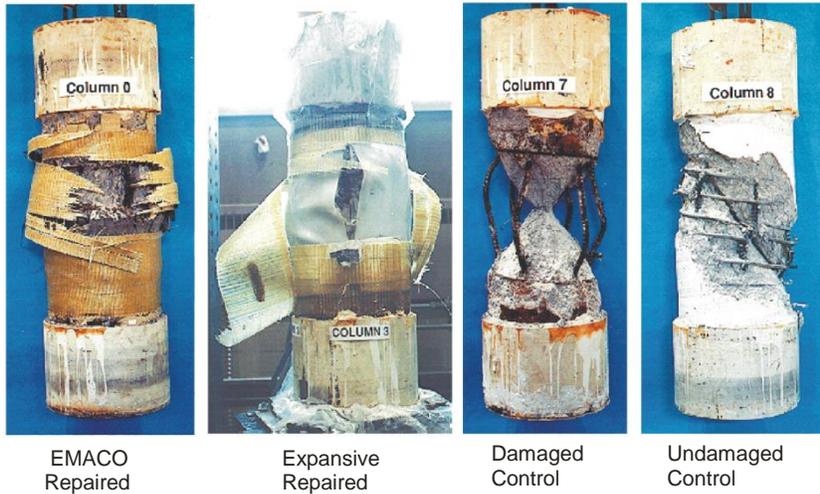
Fig. 4: Columns after testing

The two repaired columns displayed improved behavior compared with the damaged column. The Emaco-repaired column showed better behavior than the original healthy column with substantially higher ductility and energy dissipation capacity. The axial load capacities of the two columns were similar. The exp-repaired column, however, did not perform as well as the Emaco-repaired column. The main reason was the premature failure of GFRP wrap. As the load on the column increased, the plastic sheet of the formwork opened out and engaged the GFRP wrap creating large local strain and rupture of the wrap, and hence failure of the column. Figure 4 clearly shows the localized failure of GFRP wrap due to the opening of the formwork sheet in the Exp-repaired column.

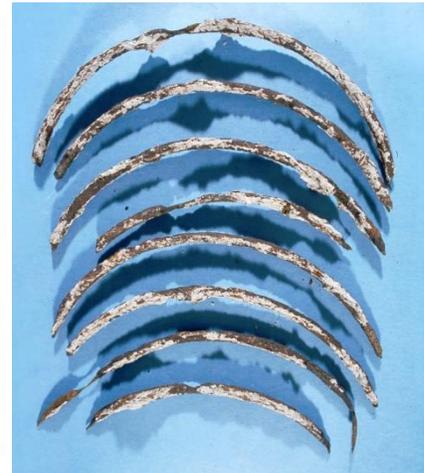
Fig. 5. Ruptured pieces of spiral

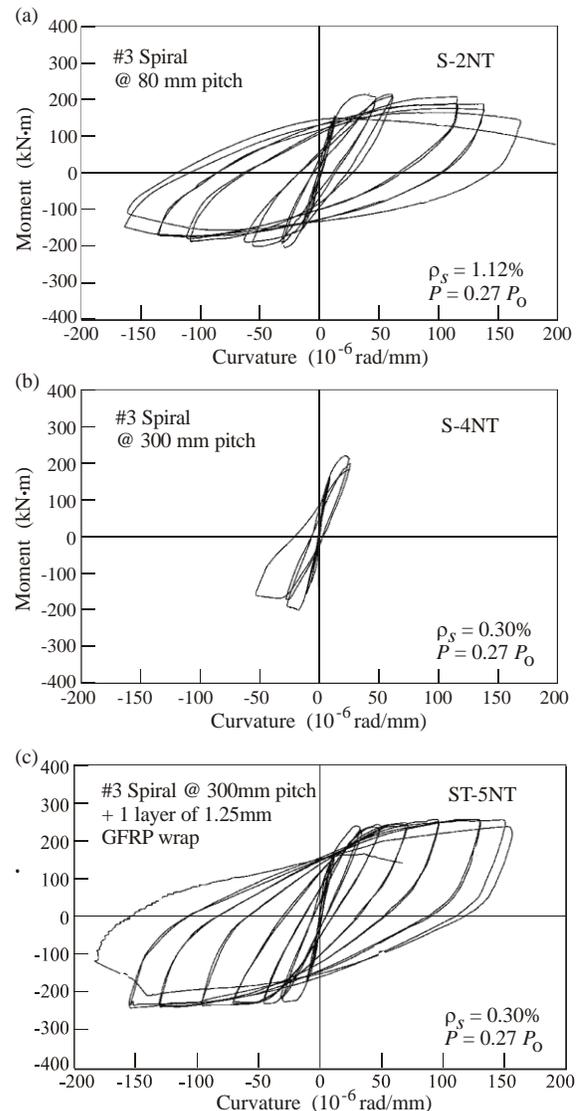
A comparison of the moment-curvature responses of Specimens S-2NT and S-4NT underlines the importance of the spiral steel and its spacing on the seismic resistance of columns. Strength, ductility, energy dissipation capacity and the number of cycles of inelastic excursions that a column can sustain depend on the effectiveness of the spiral steel and the confinement it provides. The deficiency of the column caused by the reduced amount of spiral steel and its larger than required spacing could be easily overcome by the addition of only one layer of GFRP wrap as shown by the

Fig. 7 Moment-curvature behavior of columns

response of Specimen ST-5NT. Strength, ductility and energy dissipation capacity of the GFRP-retrofitted column ST-5NT are similar or superior to those of the control column S-4NT that met the code requirements.

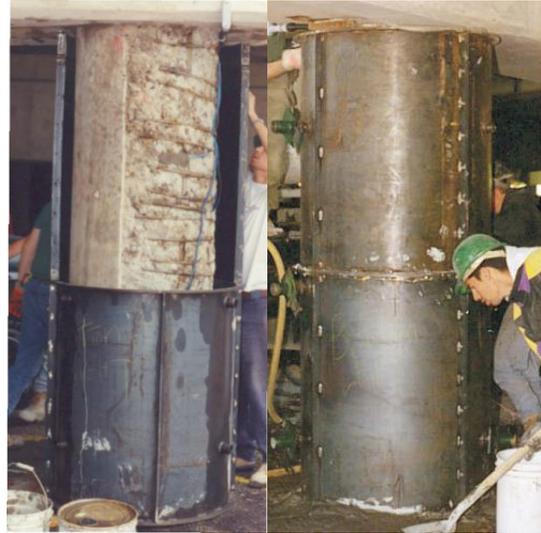
*Fig. 8. Formwork used for expansive cement grout*

Emaco-based mortar is rheoplastic which did not require any formwork for the repair of columns. For expansive cement based grout and the non-shrink grout, steel formwork was used instead of the plastic sheet formwork that caused premature failure observed in the specimen tested in the lab. The grout was pumped in place to build the columns as shown in Figure 8.

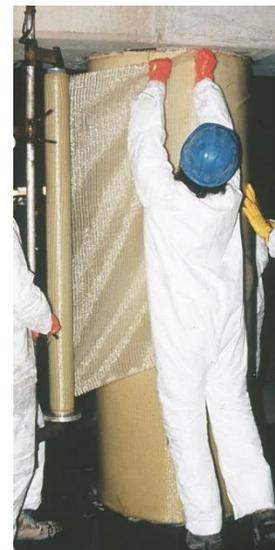
*Fig 9. GFRP wrapping of field columns*

Three days after the grout application, the column was instrumented with six strain gauges on the FRP in the circumferential direction, two each, 180° apart, at mid-height, 750 mm above and 750 mm below the mid-point. The column repaired with non-shrink grout was treated the same way as the one repaired with expansive cement except that the formwork was removed four days after grouting. In the Emaco-repaired column, a protective epoxy coating was applied before the FRP wrapping and instrumentation.

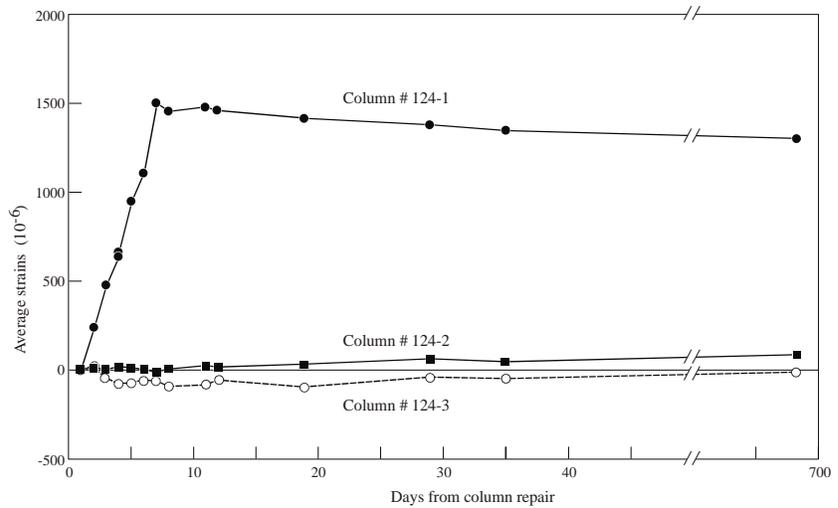
lateral strain measured on three columns over a period of about two years. The strain values were observed to be as expected. Column 124-1 containing expansive cement showed substantial expansion while no significant lateral strain was measured in FRP in the other two columns, 124-2 and 124-3 that were repaired with non-shrink and Emaco grout, respectively. The maximum expansion of about 0.16% was observed in Column 124-1 at ten days after grouting which settled at about 0.14% at later age. Lateral GFRP strain in all columns remained fairly constant for about two years indicating stable expansive cement behavior and no significant creep of GFRP.

Fig. 10. Transverse GFRP strain in repaired columns

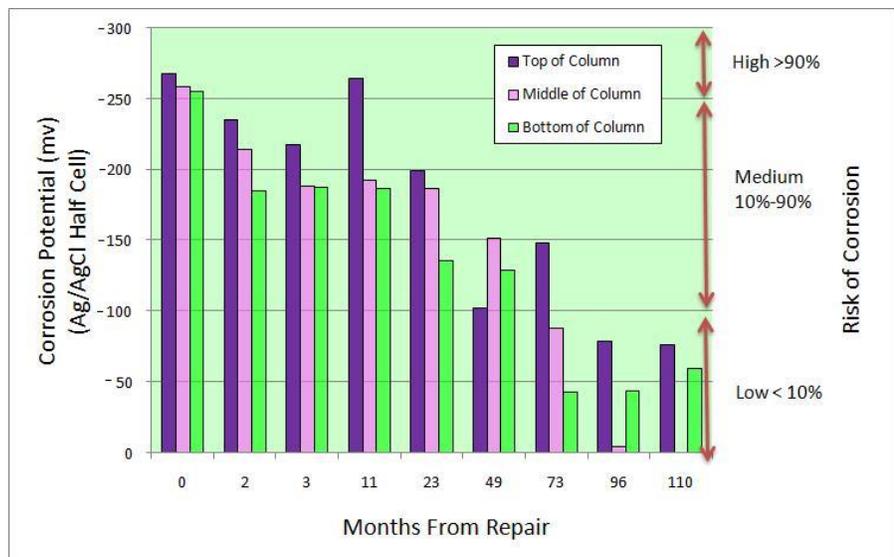
Corrosion activity recorded by half cells is shown in a graphical form in Figure 11 which displays the average corrosion potential in three columns at different locations along their height. The corrosion potentials can be used to provide some indication of the probability of corrosion activity in the columns at the time of the measurement (Broomfield 1997). The risk of corrosion thus determined is shown along Y-axis on the right side of the figure. Reduction in the corrosion activity and the reduced risk of corrosion over the years can be clearly seen in the figure. The average risk of corrosion in three columns at different locations along their height has reduced from high to low in about six years and remained low afterward. Monitoring of the corrosion activity was terminated at 100 months.

Fig. 11. Corrosion activity in repaired field columns

The average risk of corrosion in three columns at different locations along their height has reduced from high to low in about six years and remained low afterward. Monitoring of the corrosion activity was terminated at 100 months.

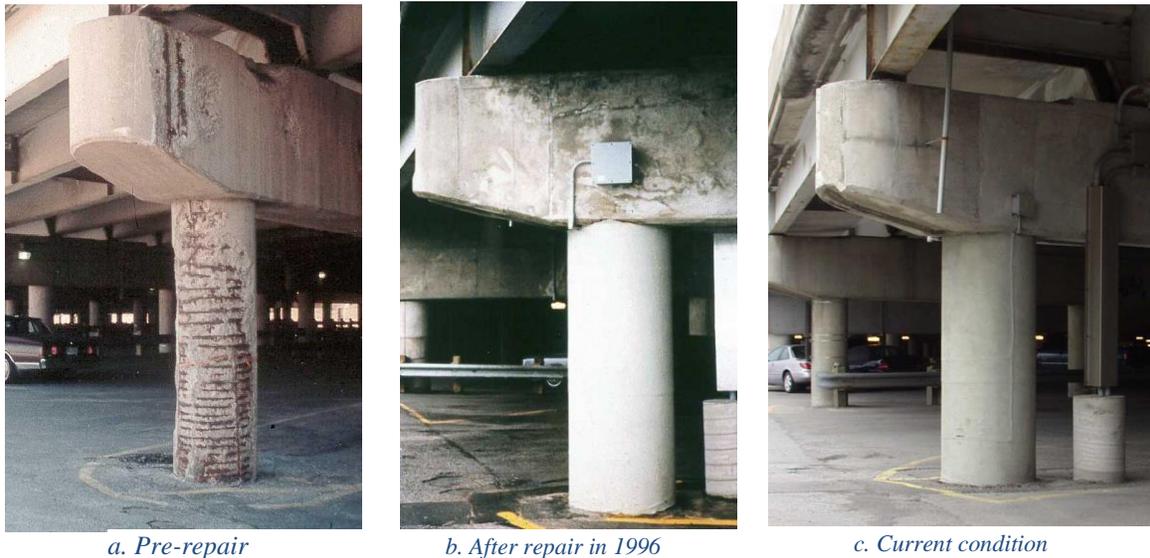
Figure 12 shows one of the columns before and just after the repair. The same column in its current condition is also shown in the figure. It is clear that after more than 22 years of service, the repair technique

has stood the test of the time and performed flawlessly in an excellent manner. Traditional repair techniques have generally required a repeat of repair procedure every 8 years or so in similar cases.

*Fig. 12. Sustainability of the repair techniques*
