# Fiber Reinforced Polymer (FRP) Composite Bridges in West Virginia

Compiled by  
West Virginia University  
Constructed Facilities Center

June 2015

Data provided herein is compiled from Inspection Records provided by the West Virginia Department of Transportation – Division of Highways, personal correspondence from WVDOT-DOH officials and reports completed by the West Virginia University – Constructed Facilities Center. Data on the current condition and maintenance issues of the bridge is paraphrased from the WVDOT-DOH Inspection Reports.

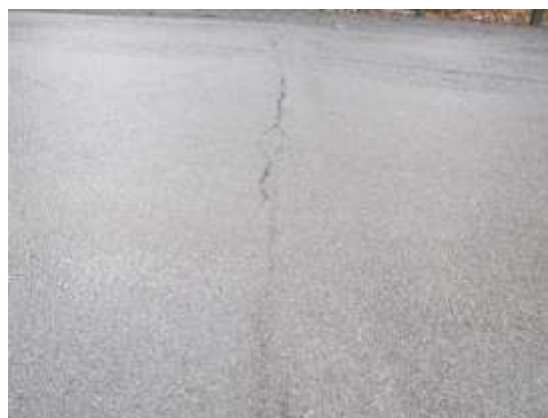
The wearing surface is in place and provides a smooth ride. Slight transverse cracking exists along both ends of the deck.

TYPICAL TRANSVERSE CRACKING

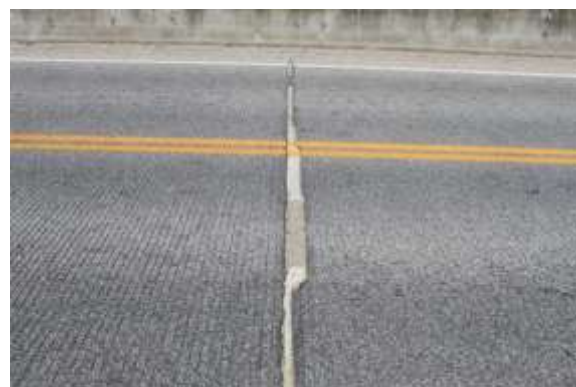
**Current FRP Condition:** The deck is in good condition. The decking appears to be loose in the area over the pier. The decking here rattles occasionally under live loads. The top of the deck is exposed in scattered locations due to missing asphalt. This break up is located at the junctures of the deck panels with the appearance of solar decomposition. The wearing surface is in fair condition. The wearing surface is cracking and breaking up over several of the joints exposing the top of the deck. During periods of hot weather the asphalt loses bond with the deck surface. This condition is visible in the form of large blisters.

BREAKUP OF DECK PANEL JOINT

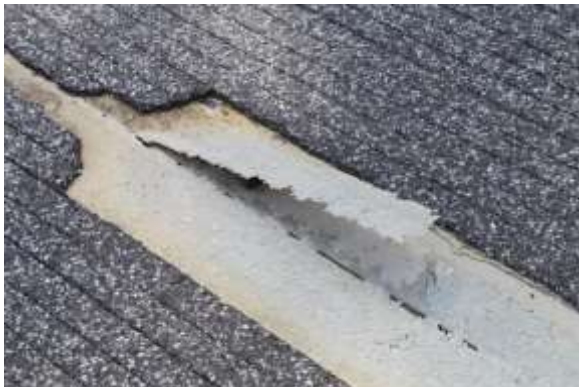
BREAK UP OF WEARING SURFACE AND DETERIORATION  
OF DECK PANEL JOINT REINFORCEMENT

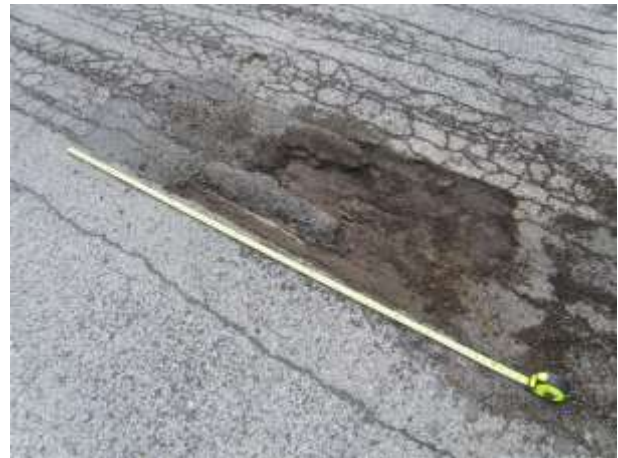
MISSING ASPHALT AT ABUTMENT 2

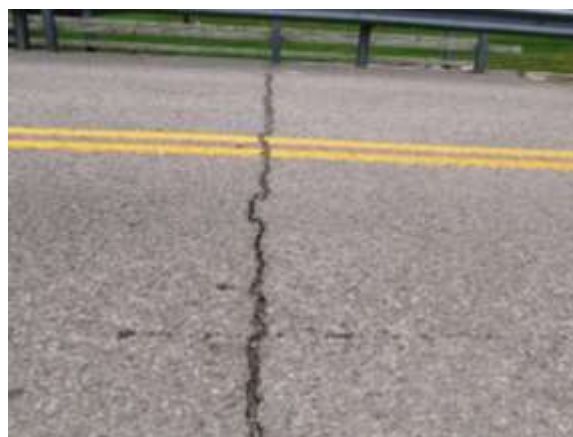
**Current FRP Condition:** The deck is in good condition. There were no deck clips broken or loose but there is deck movement under live load. The deck clips at Abutment 2 are bent due to over tightening. The wearing surface is in poor condition, due to cracks at all deck panel joints, with minor advancement since 2011. There is some minor leakage visible near Abutment 1. There are short longitudinal cracks at both abutments. The cracks are  $\pm 1/16''$  to  $5/16''$  wide. The sidewalk is in good condition.

WEARING SURFACE CRACK

**Applicable Maintenance Issues:** The original  $3/8''$  thick epoxy wearing surface distintegrated following a very short service life. A new 2.25" (average) asphalt surface was applied in 2002.

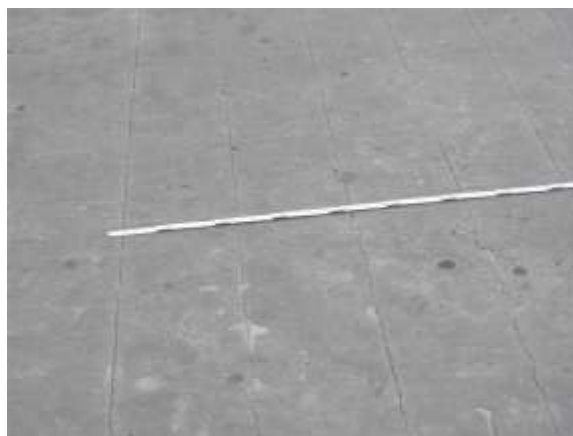
**Current FRP Condition:** The deck is in good condition. A few of the fasteners are loose. The wearing surface is in fair condition. Transverse cracks have developed in the wearing surface at the joints between the four pre-constructed deck panels. Corresponding cracks have developed in the concrete curbs. Cracks are also present over the joint between individual FRP planks and delaminations and map cracking exist. A few areas of missing wearing surface are also present. Water tends to stand on the deck near Abutment 2.

CRACKS IN WEARING SURFACE

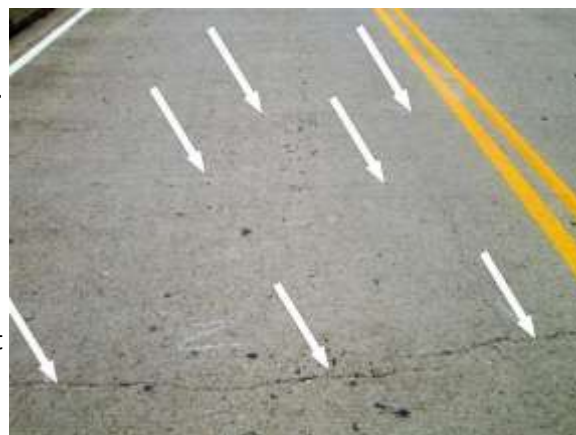
**Current Deck Condition:** The deck is in good condition. The underside continues to display numerous hairline transverse cracks with efflorescence stains in each span. There are small random isolated minor spalls in the deck haunches. The deck edge has random hairline cracks, there are transverse cracks with efflorescence in the overhangs. The textured concrete surface remains in good condition. There are still numerous hairline to 1/16" wide transverse, longitudinal and random cracks in each span. There are now small shallow edge spalls at the deck ends.

CRACKS IN THE WEARING SURFACE

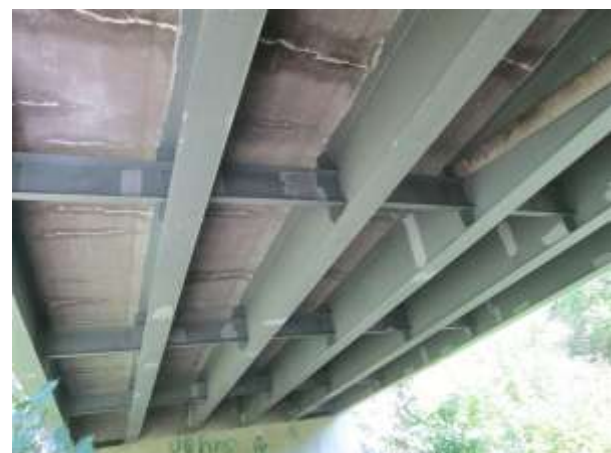
UNDERSIDE OF DECK WITH CRACKS/EFFLORESCENCE

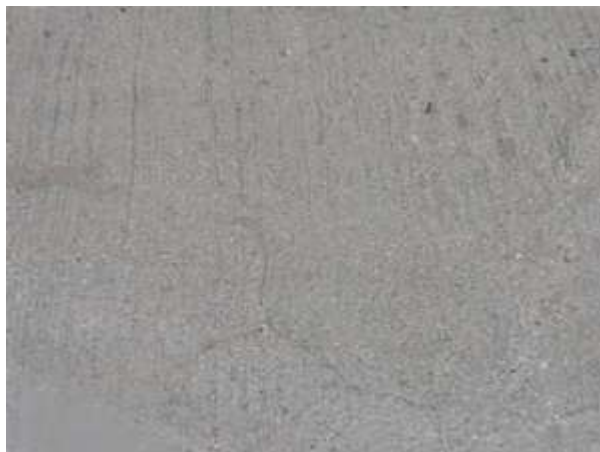
MAP CRACKING IN DECK

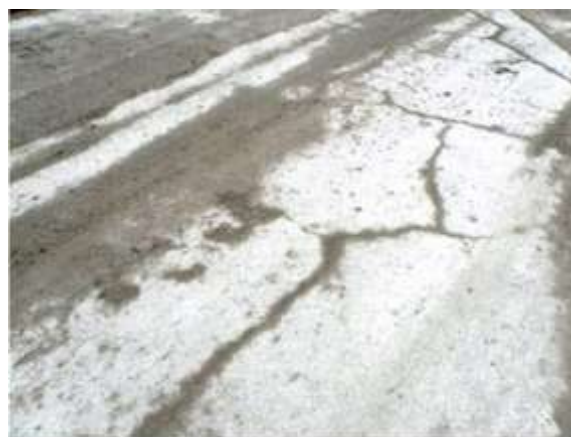
**Current Deck Condition:** The deck remains in fair condition, with hairline to 1/32" map cracking near Abutment One, longitudinal hairline to 1/32" cracking extending from the map cracking towards Abutment Two over Beam Four, a transverse/diagonal hairline crack over Beam Two at Abutment Two and exposed aggregate and a roughened deck surface in the wheel paths. A vertical hairline to 1/16" crack was also observed in the exterior upstream side just forward of the first guardrail post. Despite these deficiencies a relatively smooth ride is provided across the structure.

MAP CRACKING IN DECK

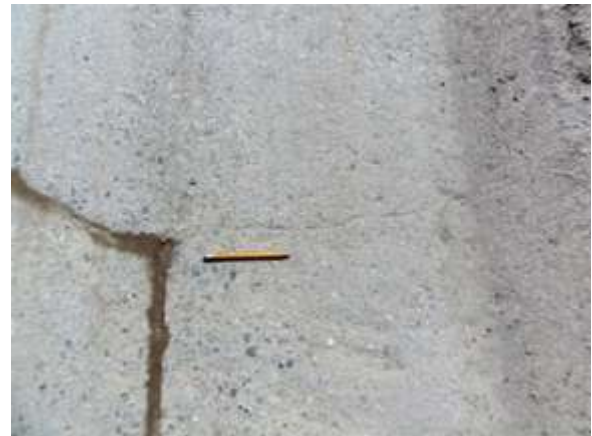
HAIRLINE CRACKS IN DECK

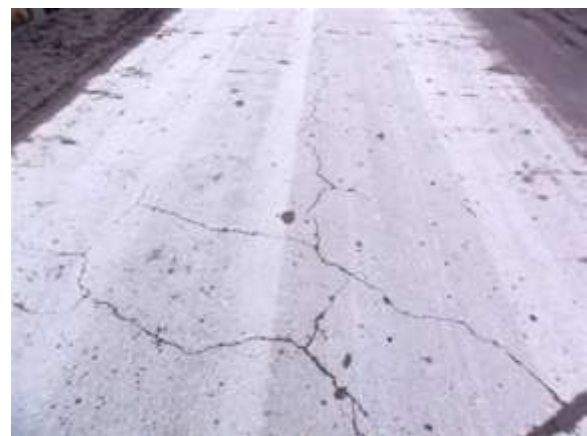
The deck remains in fair condition exhibiting the same map, diagonal, and longitudinal cracking as noted in 2009 and 2011 . Due to the staining between the beam undersides, we believe the 6" deck is leaking.

DECK CRACKING

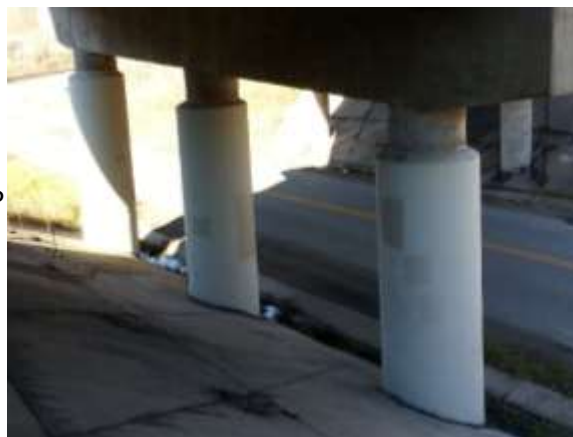
The FRP repairs remain in good condition.

COLUMNS WRAPPED WITH FRP

**Applicable Maintenance Issues:** The columns in Pier 1 were encased in concrete in 1990 to repair damage due to a fire. In 1998, these columns were repaired with FRP wraps and shells to provide confinement to the concrete to address cracking in the original repair. Three of the columns were repaired again in 2008 following another fire that damaged the 1998 FRP repair.

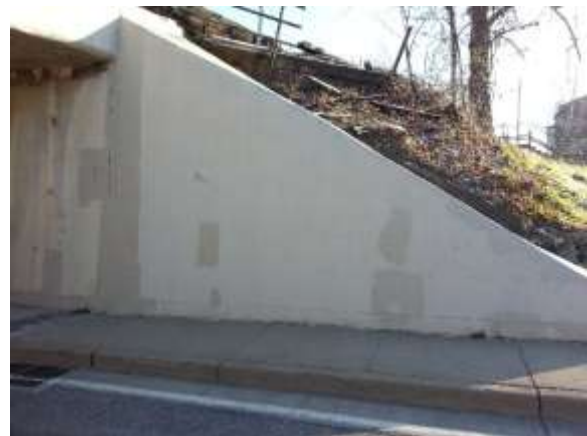
WINGWALL REPAIRED WITH FRP WRAPS

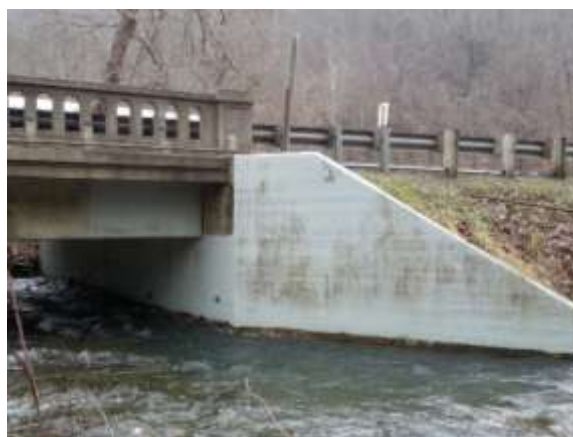
**Current FRP Condition:** The abutments are in fair condition. Minor spalling and scaling exists at the base of the breastwall and upstream wingwall beneath the carbon fiber wrap. There are a few localized spalls with exposed rebar in the backwall. The T-beams are in good condition.

FRP WRAP ON WINGWALL AND T-BEAM

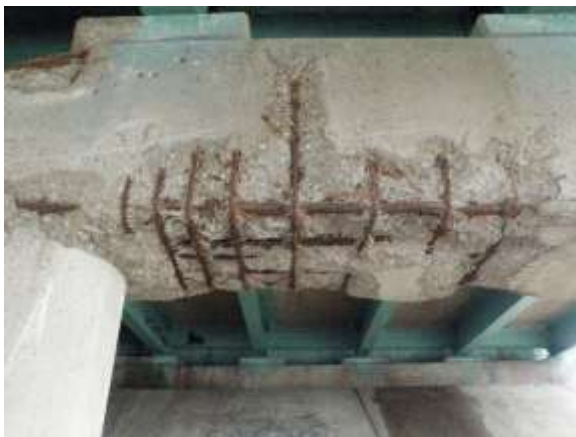
CONCRETE DETERIORATION PRIOR TO REPAIR

In 2014, FRP wraps used to rehabilitate piers 1 and 2 due to deterioration due to rebar corrosion leading to failure of concrete cover.

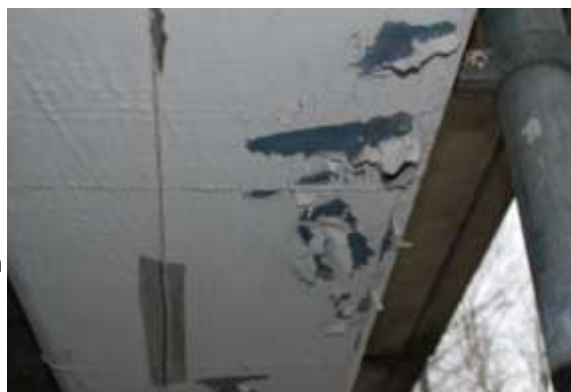
The T-beams are in good condition. Sporadic cracking and peeling is present in the epoxy coating over the carbon fiber wraps.

FAILED EPOXY COATING

In 2000, the T-beams 1 and 4 were strengthening with CFRP wraps in all spans due to general deterioration.

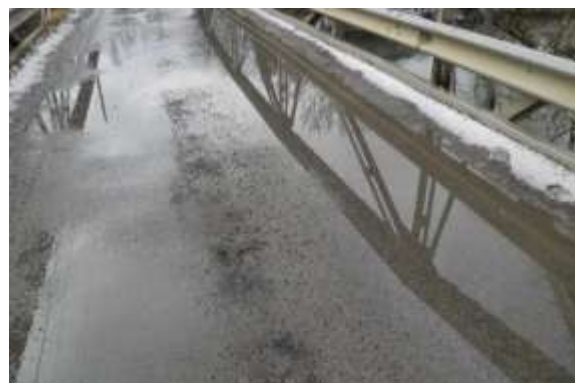
**Current FRP Condition:** The deck is in good condition. Water pools on the deck due to low spots in the FRP deck. The wearing surface is in good condition, with the only deficiency observed was the existence of transverse, hairline cracks over all the floorbeams.

WATER STANDING ON DECK

**Applicable Maintenance Issues:** Truss was completely renovated in 2001 when FRP deck was installed. Polymer concrete wearing surface reported loose and missing throughout the bridge in 2007 and was replaced with a epoxy urethane copolymer overlay by state forces in 2010.

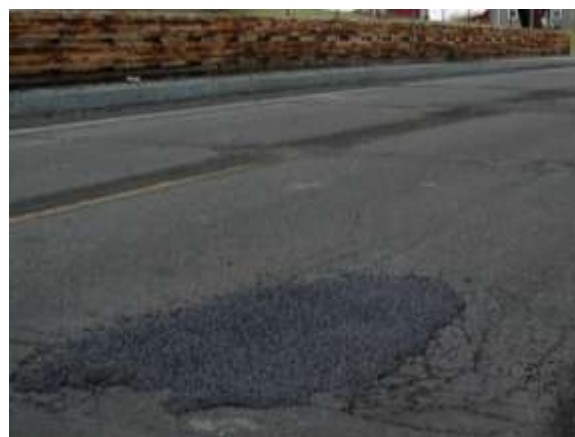
PATCHES IN WEARING SURFACE DUE TO FRP DECK FAILURE

**Applicable Maintenance Issues:** Steel plates were placed over failing deck panels in November 2006 and again in October 2007. FRP deck and sidewalk replaced by Orders Construction in May 2009 with Exodermic deck.

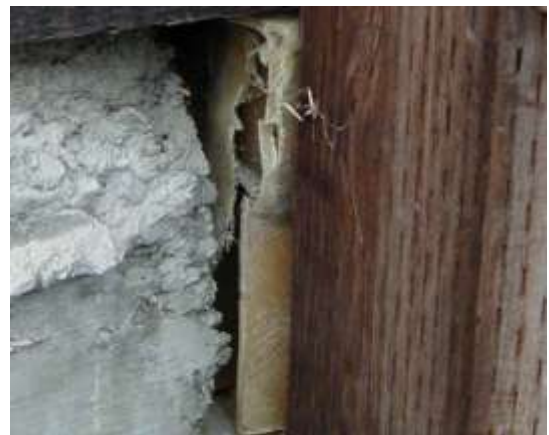
LOCALIZED FAILURE OF FRP DECK
