Development of Prefabricated Concrete Bridge Railings

QUARTERLY PROGRESS REPORT

Updated to include progress between September 1, 2016 to December 31, 2016
Period

December 2016

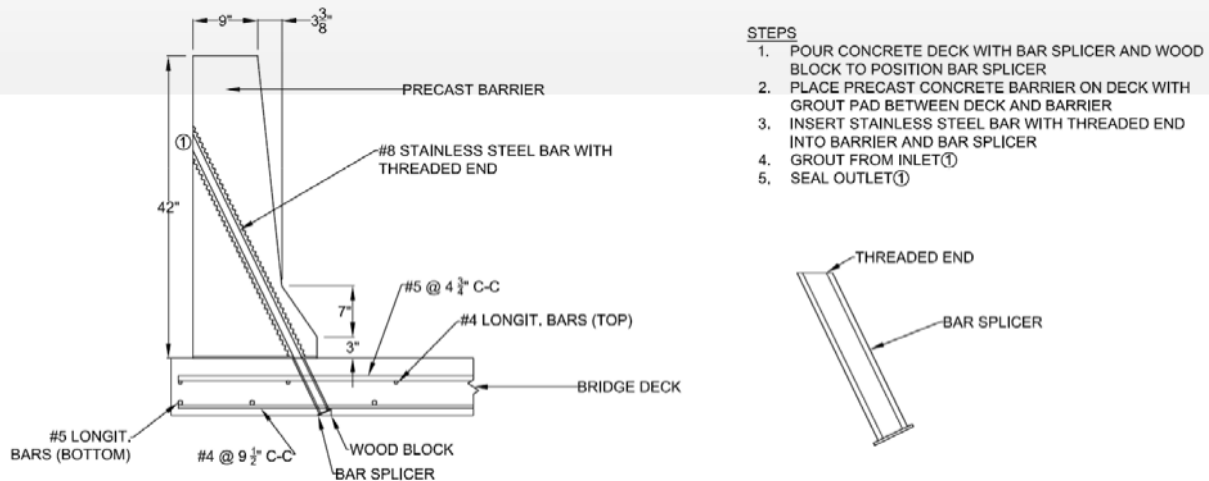
Figure 6 Details of Connection using Stainless Steel Bar with Threaded End and Bar Splicer

Another concept consists of an inclined stainless steel bar and bar splicer. The bar splicer will be precast into the bridge deck. Then the stainless steel bar will be inserted into the barrier segment and threaded into the bar splicer. This connection will also be sealed with grout and is shown in Figure 6. Figure 7 shows a photo of the bar splicer that will be used.

PRECAST CONCRETE BARRIER DETAILS OF CONNECTION USING STAINLESS STEEL BAR WITH THREADED END AND BAR SPLICER

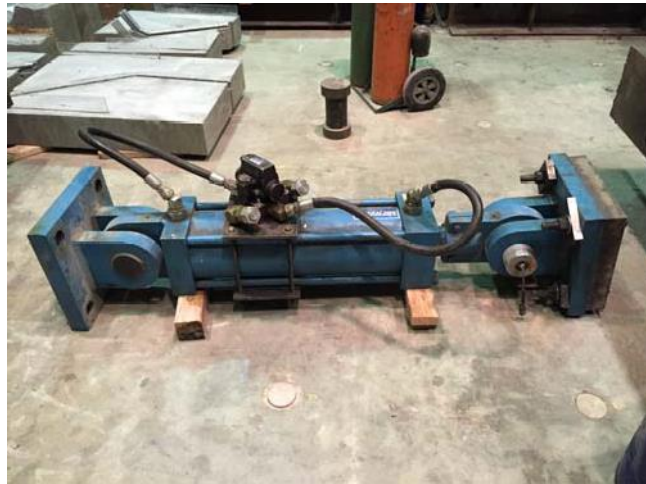
Figure 9 Hydraulic Actuator

Task 3: The two barrier connection systems shown above have been tested in the laboratory with quasi-static testing. The loads were applied cyclically using a hydraulic actuator. The systems will be evaluated based upon how they impact their individual strengths and how they impacted the

performance of the deck overhangs used to support the railing. The actuator that will be used in shown in Figure 9.

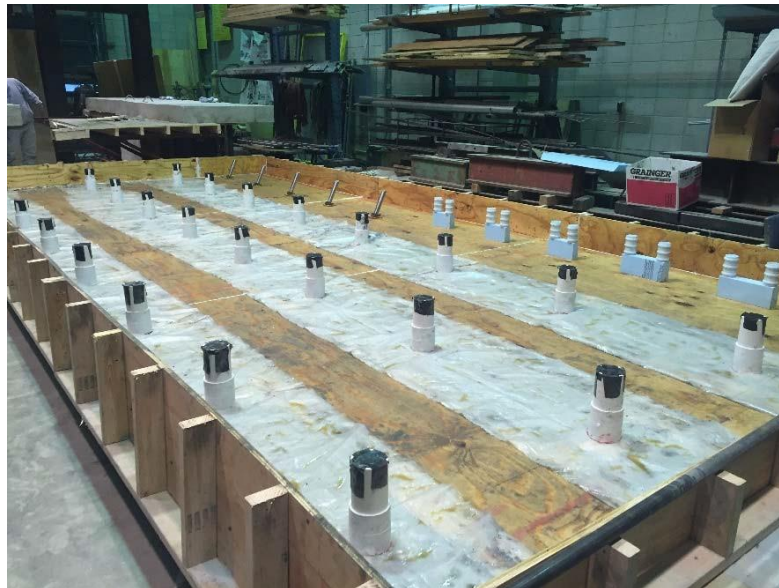
Three concrete beams support the deck slab. The deck slab will have an overhang of 3.5 feet. The hydraulic actuator was mounted onto the concrete block to apply load along the precast barrier segments. The concrete blocks are anchored into the lab floor. The concrete beams and the formwork for the suspended deck slab are shown in Figure 12.

Figure 11 Concrete Beams with Deck Slab Formwork

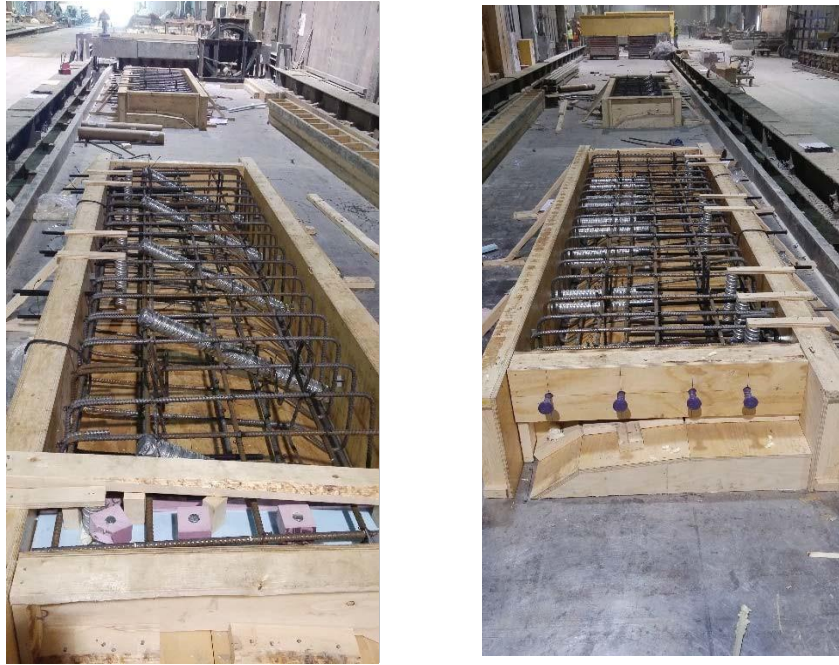
Figure 13 Precast Barrier Fabrication

The construction of the barrier rails was fabricated by a precast plant in Omaha. They were delivered to the Iowa State Lab February of 2016. Images of the precast construction are shown in Figure 13.

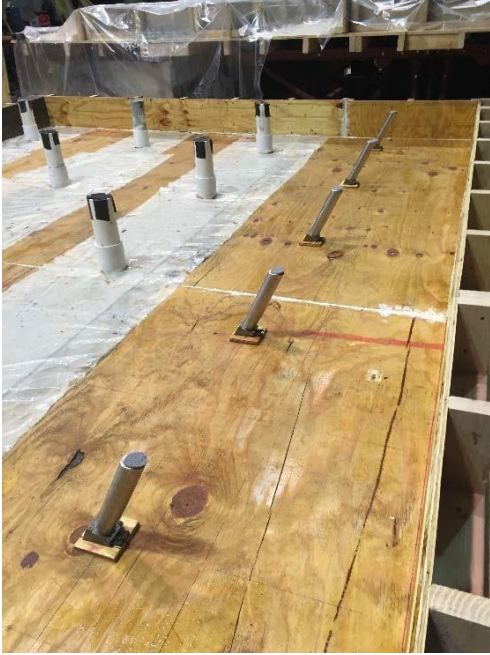
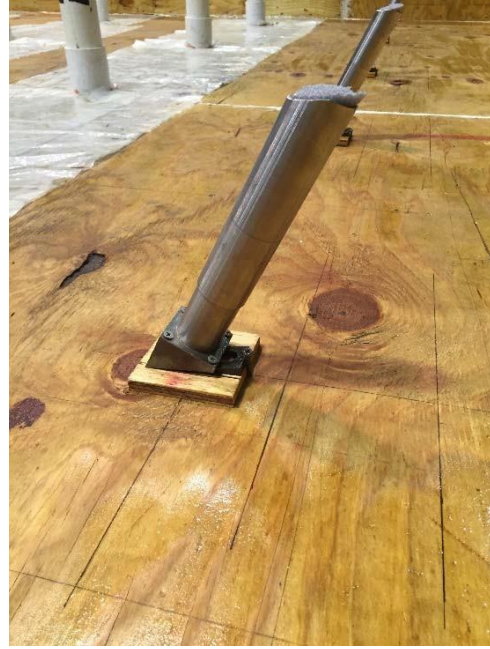
Figure 14 Inclined Bar Connection in Bridge Deck

The construction of the deck slab and the loading block were done in the Iowa State University Structures Lab. The following images (Figures 14-16) display the progress in the lab.

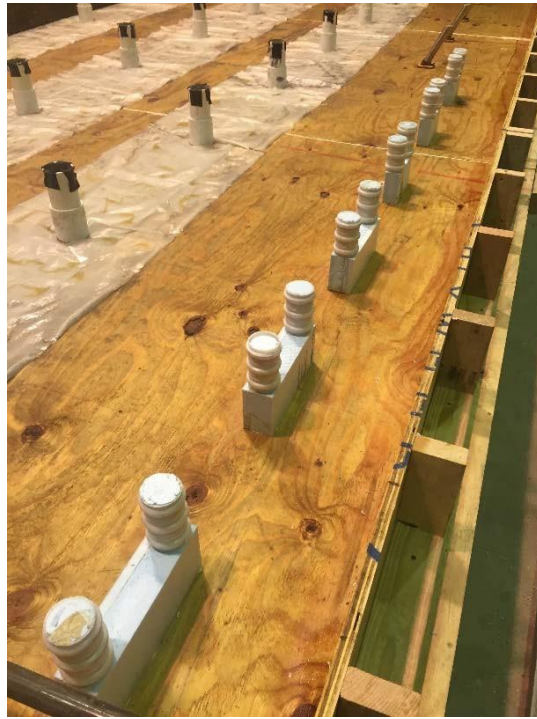
Figure 15 Pockets for U-bar Connection in Bridge Deck

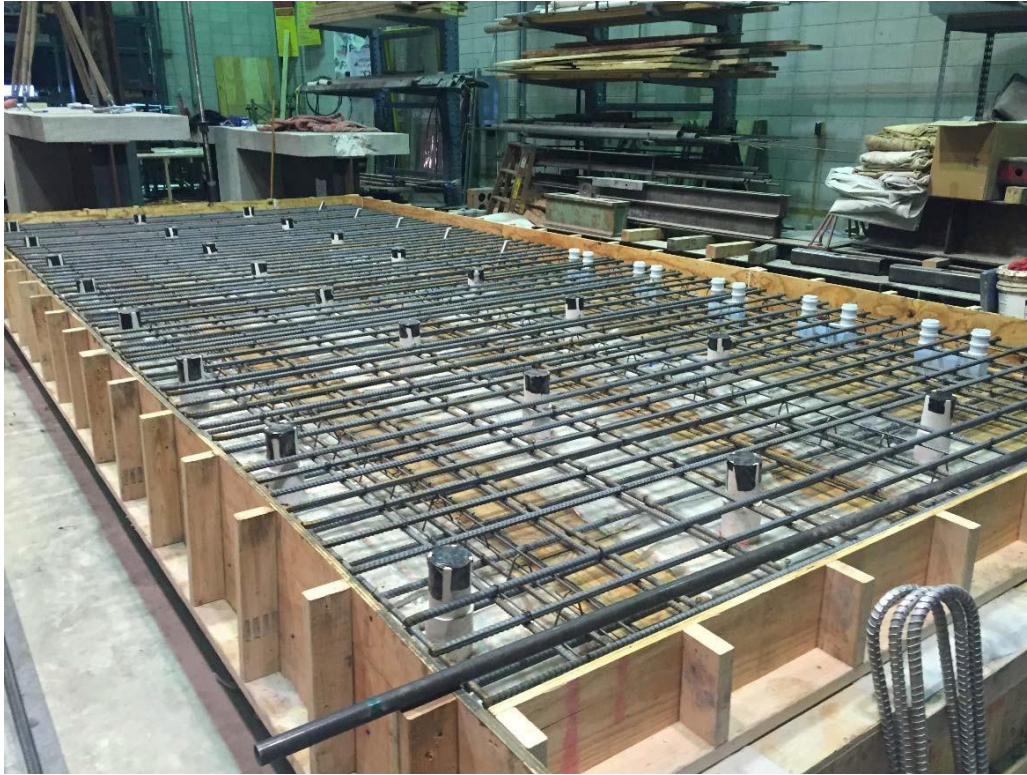
Figure 16 Bridge Deck Prior to Concrete Pour

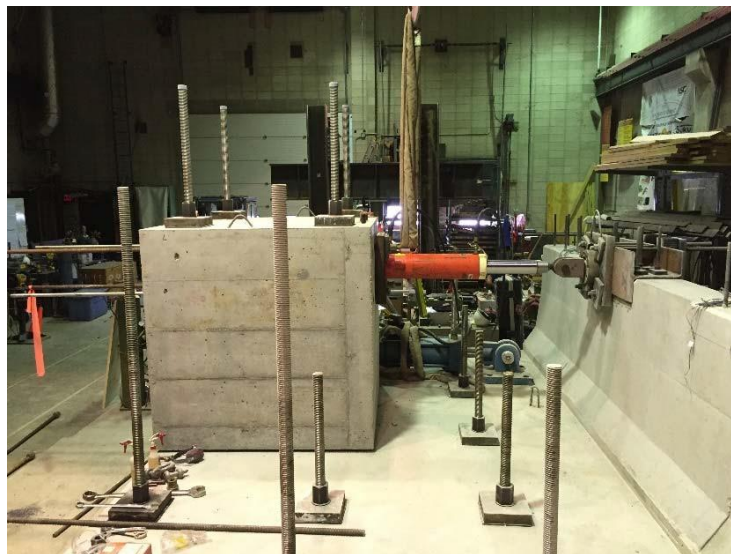
Laboratory testing began March of 2016. The first laboratory test was conducted on the precast barrier with the inclined rod connection, PBI. The loading block and actuator were set up to apply loads to the center of PBI. The test setup is shown in Figure 17. The push load was applied incrementally up to 54 kips. It was applied in six kip increments.

Figure 17 Test 1 (PBI Middle) Setup

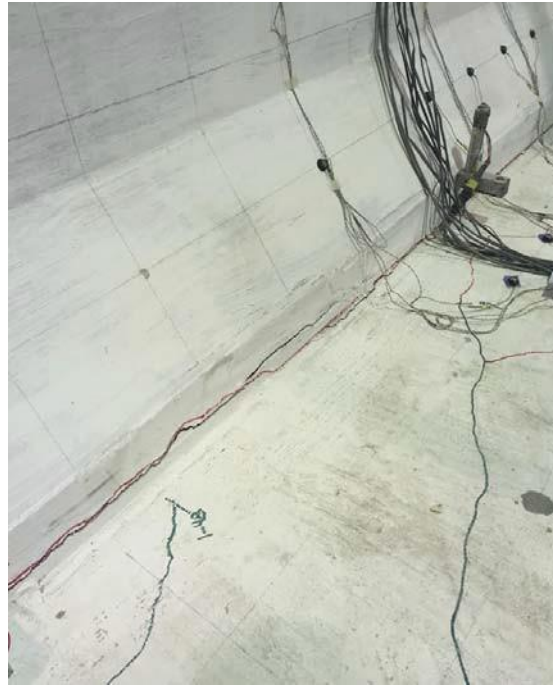
three intervals, up to 18 kips, performed very similar to Test 1. New deck cracking began around 18 kips. At this point the barrier was deflected 0.164 inches. At 24 kips, a crack became visible along the entire length of the grout pad between the barrier and the bridge deck, see Figure 21. The existing cracks continued to widen up until about 36 kips. Around 36 kips some softening was observed and the barrier was no longer holding the load. The barrier deflection reading after the maximum load was 0.8 inches.

Figure 21 Crack at barrier and deck interface during Test 2

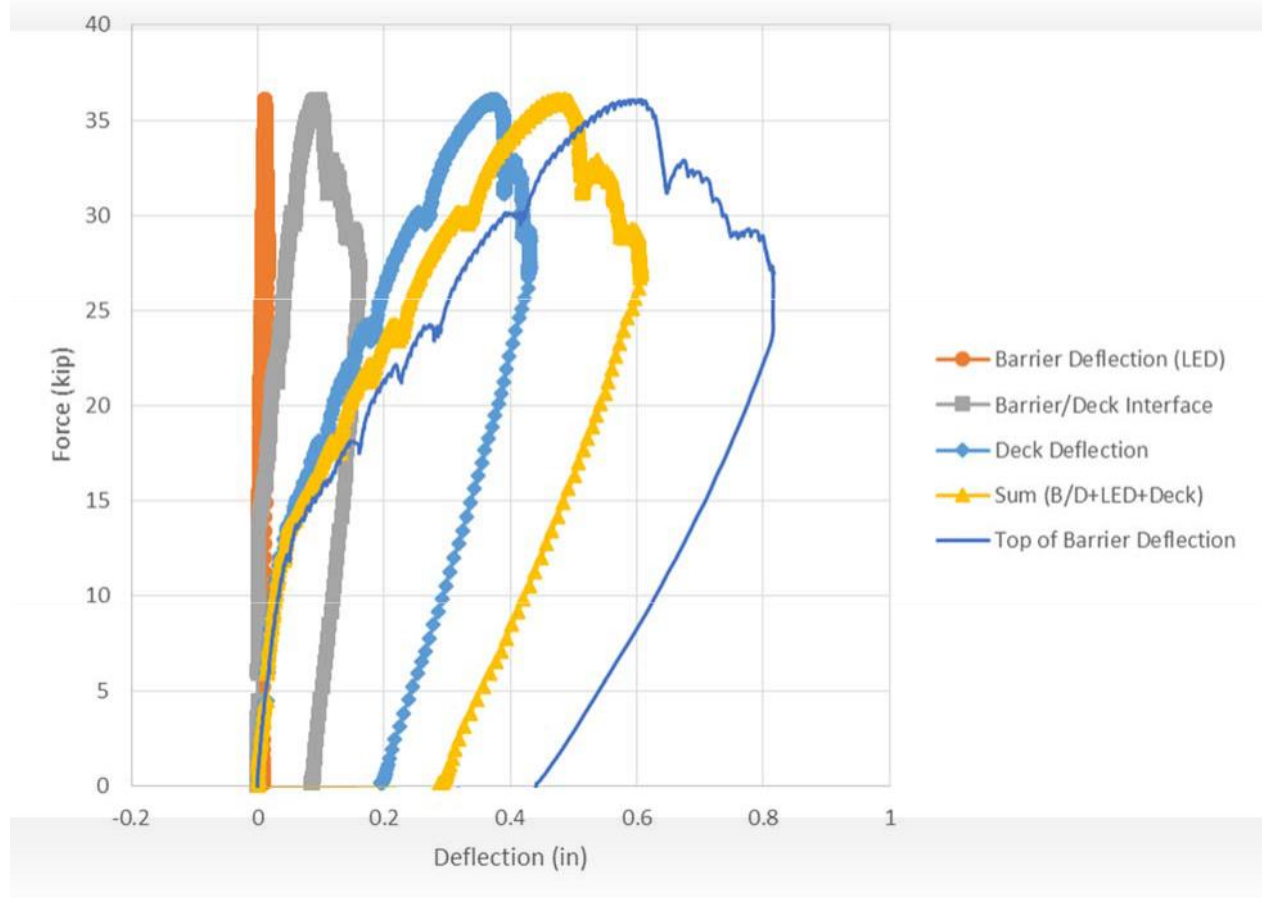
Figure 22 Test 2 Deflections

Although the total top of barrier deflection was recorded at 0.8 inches, the barrier's deflection accounted for 2.1% of the deflection at 0.017 inches and the deflection at the barrier and deck interface accounted for 20.3% at 0.162 inches. The various deflections of the specimen during Test 2 is summarized in Figure 22.

During the isolated testing of the u-bar connection, Test 2, the barrier was able to resist 36 kips without experiencing significant rotations. Larger rotation occurred from this point onward with localized deformation concentrated at the bottom of the barrier. This was suspected to be due to insufficient development length of the top deck reinforcement.

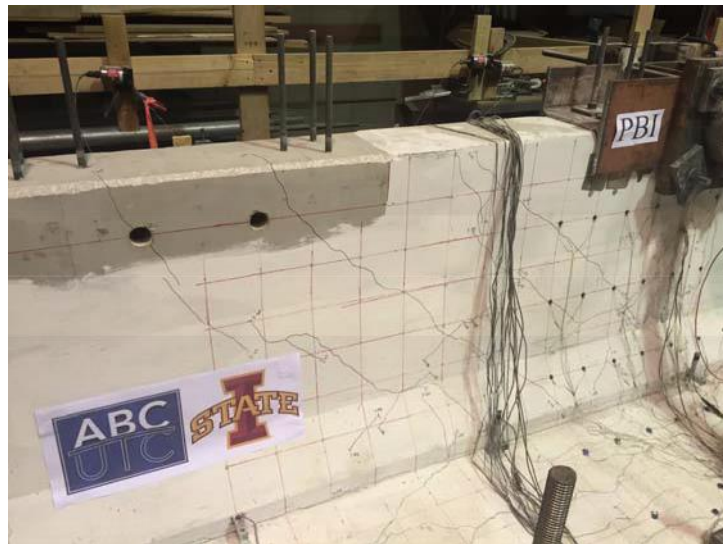
The third test was conducted on the precast barrier system between the two barriers. The loading block and actuator were set up to apply loads to 3.5 feet in the center of the entire test unit. The purpose of this test was to examine the connection between the precast barriers. Before testing could begin, the connection between the barriers was grouted. In the early stages of testing, no new cracks developed but old cracks began to open up. Around 30 kips a new crack appeared on the side of the bridge deck on the PBI side. It wasn't until 48 kips when cracks began to show on the barrier with the inclined connection. The cracks were diagonal cracks going in the opposite direction as the Test 1 cracks, see Figure 23. The center was able to hold a load up to 60 kips before it started dropping. The load was then released. The cracks along the grout between the

barriers and the deck remained. The crack on the inclined barrier side of the grout pad was measured at a width of 0.005 inches. The u-bar side was measure at a width of 0.07 inches. The majORITY of the cracks appeared on the inclined connection side, no cracks appeared on the u-bar connection barrier. The inclined connection barrier was most likely taking all the load.

Figure 23 Diagonal cracks during Test 3

The test conducted on the barrier-to-barrier connection, Test 3, also performed as expected. The barrier system was loaded up to 60 kips with the inclined connection supporting the majority of the load. The strain experienced in the inclined deck connections was significantly more than the strain experienced in the u-bar deck connections. Test 4 included loading on the inclined side of the barrier to barrier connection and demonstrated the force distribution about the barrier to barrier connection and the failure pattern of the connection.

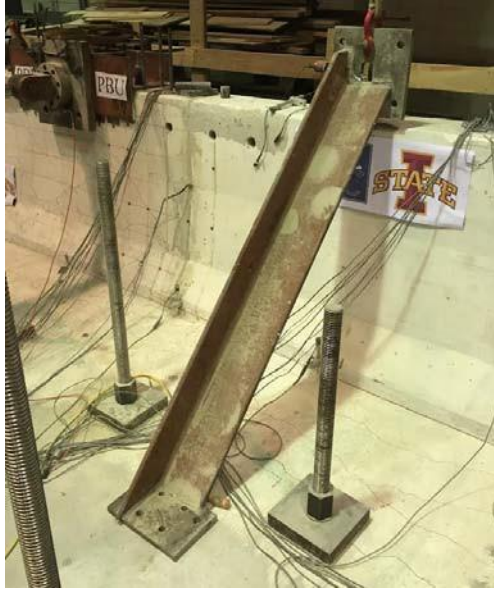
For Test 4, the loading beam was placed to the inclined connection side of the barrier-to-barrier connection. The center of the load was about three feet from the barrier-to-barrier connection. The purpose of the test was to observe the force distribution about the barrier-to-barrier connection and to fail the center connection. Before this test was performed, a beam was placed on the u-bar side to brace the barrier and keep it from deflecting. This brace beam can be seen in Figure 24.

Figure 24 Beam used to brace the u-bar connected barrier during Test 4

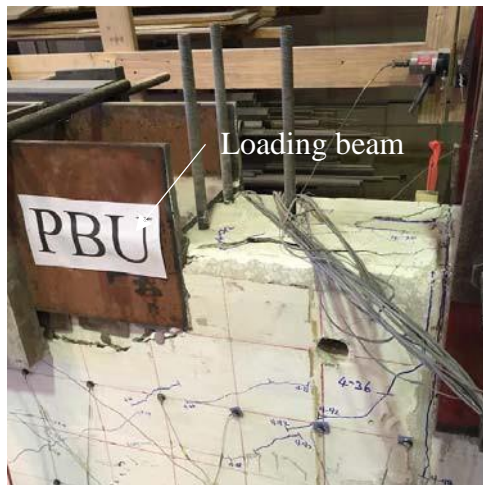
Hairline cracks didn't form on the grout between the barrier until 24 kips was applied. Other previous cracks just extended and opened up. At 48 kips, a crack developed on the front face of the grout between the barriers. A crack formed on the back of the barrier-to-barrier grout at 54 kips. This crack started at the bottom of the barrier. As the loads were increased, cracks continued to extend. At 72 kips, new cracks developed on the top of the barrier-to-barrier grout. The load was increased up to 81 kips before it started dropping. The test continued until the deflection was measured at 1.5 inches. Large cracks developed along the barrier under the loading beam, see Figure 25, and the barrier-to-barrier grout broke all the way along the top to the back, see Figure 26.

Figure 25 Cracking on barrier due to loading during Test 4
