Development of Prefabricated Concrete Bridge Railings

QUARTERLY PROGRESS REPORT

Updated to include progress between January 1, 2017 to March 31, 2017 Period

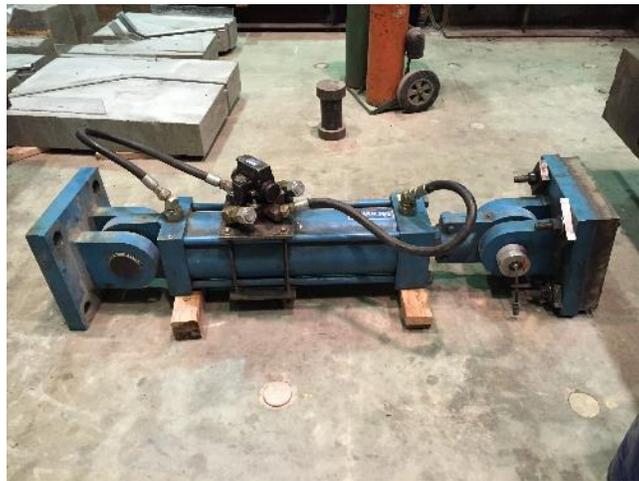
performance of the deck overhangs used to support the railing. The actuator that will be used in shown in Figure 9.

Figure 9 Hydraulic Actuator

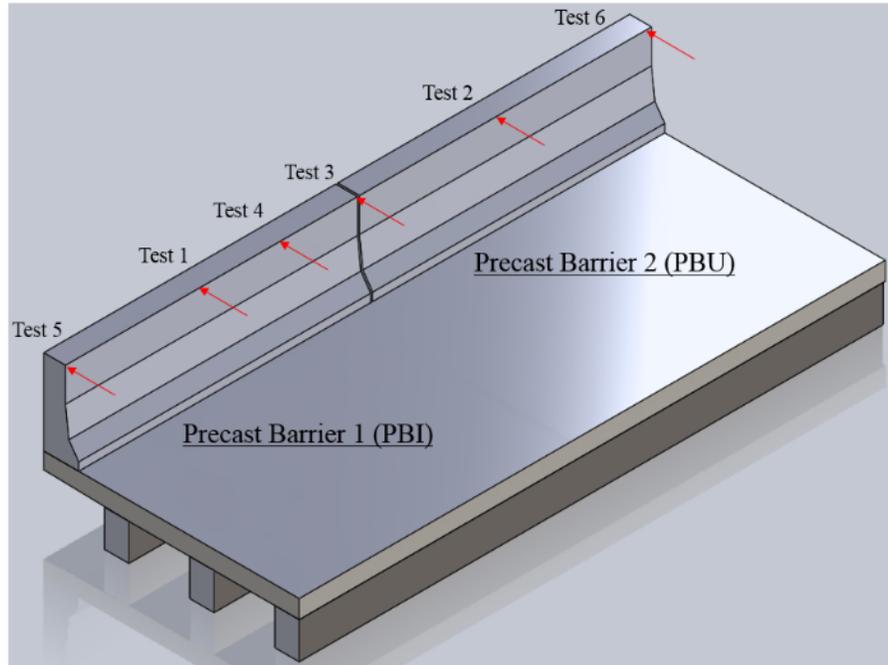
Figure 10 3D Model of Lab Set-up with Applied Load Locations

The barrier segments were tested individually to test the barrier to deck connection. Then they were connected and tested again. The force was applied at the joint to measure the force distribution. A ponding test will also be conducted on the connections to test for durability. A schematic drawing of the lab test set-up can be seen in Figures 10 and 11.

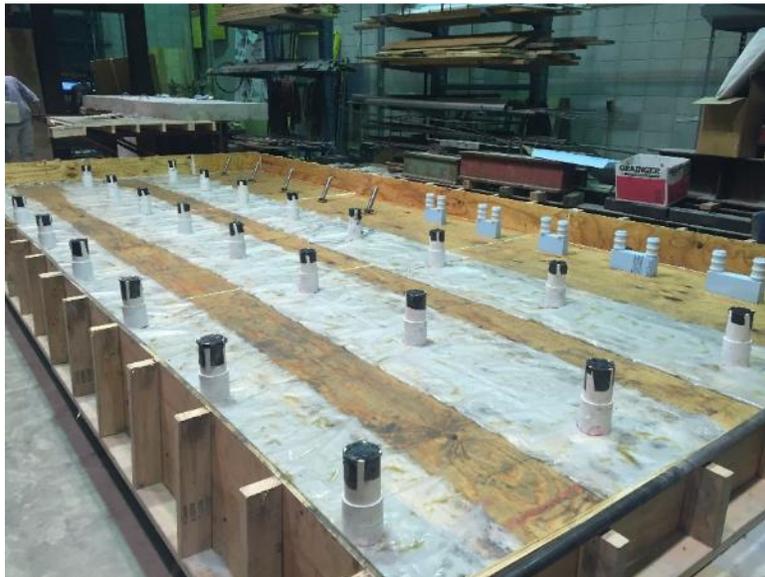
Three concrete beams support the deck slab. The deck slab will have an overhang of 3.5 feet. The hydraulic actuator was mounted onto the concrete block to apply load along the precast barrier segments. The concrete blocks are anchored into the lab floor. The concrete beams and the formwork for the suspended deck slab are shown in Figure 12.

Figure 11 Concrete Beams with Deck Slab Formwork

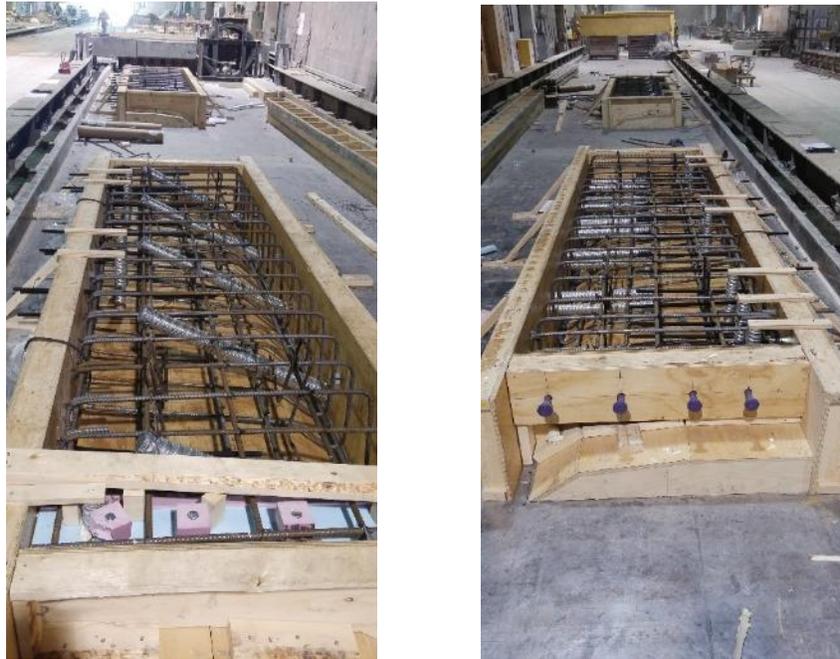
The construction of the barrier rails was fabricated by a precast plant in Omaha. They were delivered to the Iowa State Lab February of 2016. Images of the precast construction are shown in Figure 13.

Figure 13 Precast Barrier Fabrication

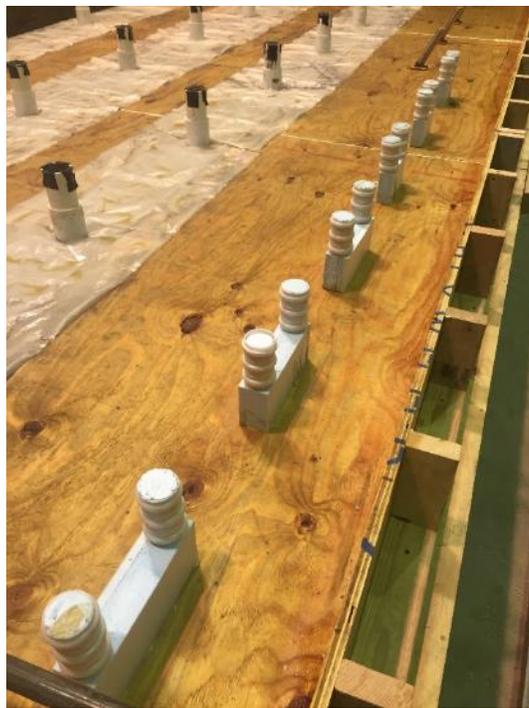
Figure 15 Pockets for U-bar Connection in Bridge Deck

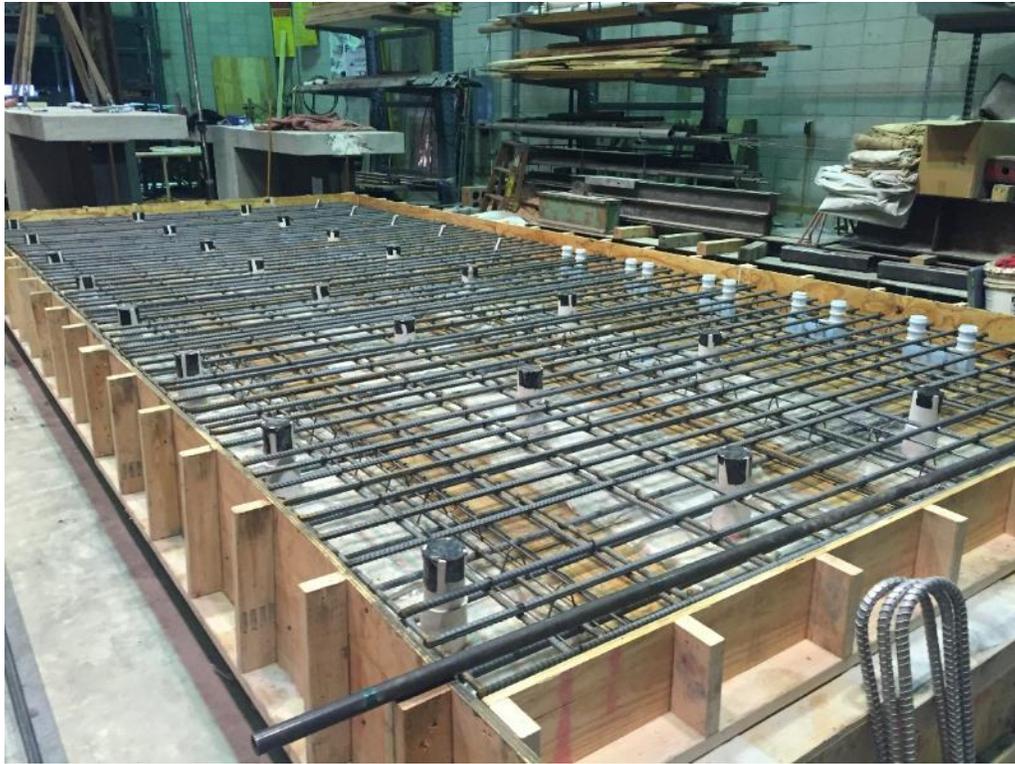
Figure 16 Bridge Deck Prior to Concrete Pour

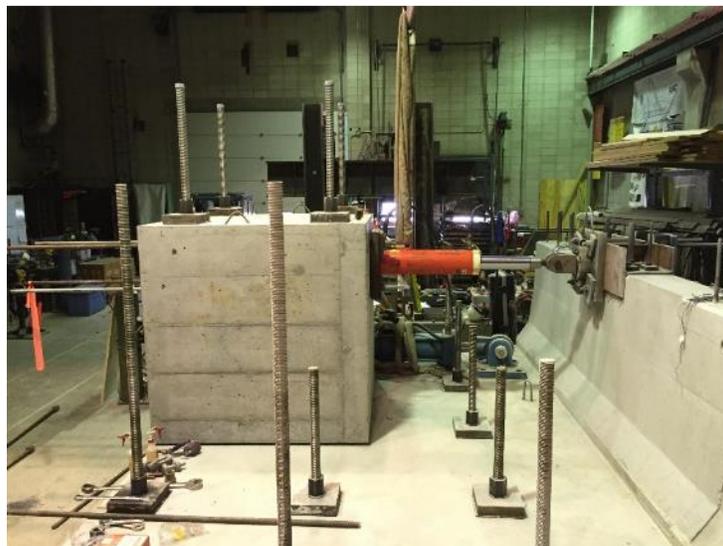
Laboratory testing began March of 2016. The first laboratory test was conducted on the precast barrier with the inclined rod connection, PBI. The loading block and actuator were set up to apply loads to the center of PBI. The test setup is shown in Figure 17. The push load was applied incrementally up to 54 kips. It was applied in six kip increments.

Figure 17 Test 1 (PBI Middle) Setup

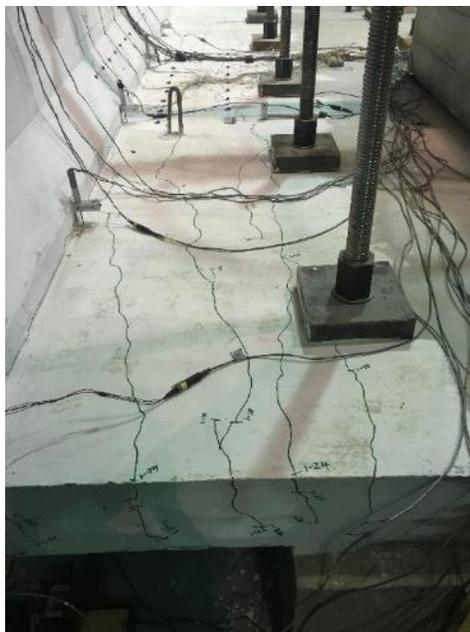
Figure 20 Test 1 (PBI Middle) Deck Cracks

The barrier performed as expected. Cracks developed along the deck around 18 kips. It wasn't until the loading reached 48 kips that diagonal, hairline cracks began to form on the barrier near the barrier-to-barrier interface. The maximum deflection of the barrier was measured at 0.807 inches. Although the total top of barrier deflection was recorded at 0.807 inches, the barrier's deflection accounted for 3.5% of the deflection at 0.028 inches and the deflection at the barrier and deck interface accounted for 17.3% at 0.140 inches. The various deflections throughout the test specimen during Test 1 are summarized in Figure 18.

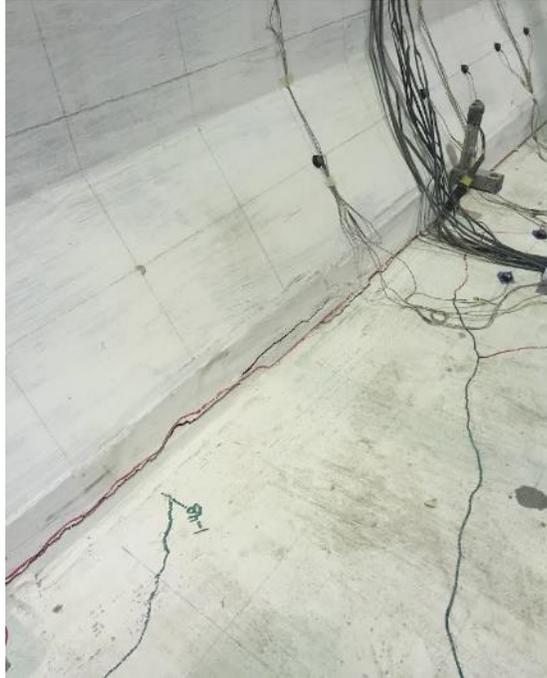
The second test was conducted on the precast barrier with the u-bar connections. The loading block and actuator were set up to apply loads to 3.5 feet in the center of the barrier. The purpose of this test was to examine the connection between the precast barrier and the bridge deck. The connection consisted of a u-shaped rebar inserted through the bridge deck into the barrier. The loading was planned to be applied up to 54 kips in 6 kip increments. After a few increments the barrier stopped holding the load. The barrier was loaded up to 36 kips in 6 kip intervals. The first three intervals, up to 18 kips, performed very similar to Test 1. New deck cracking began around 18 kips. At this point the barrier was deflected 0.164 inches. At 24 kips, a crack became visible along the entire length of the grout pad between the barrier and the bridge deck, see Figure 22. The existing cracks continued to widen up until about 36 kips. Around 36 kips some softening was observed and the barrier was no longer holding the load. The barrier deflection reading after the maximum load was 0.8 inches.

Figure 22 Crack at barrier and deck interface during Test 2

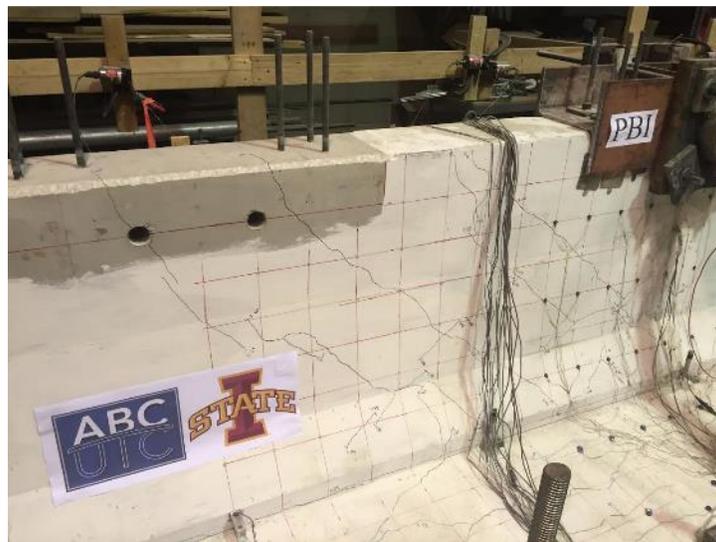
the barrier with the inclined connection. The cracks were diagonal cracks going in the opposite direction as the Test 1 cracks, see Figure 26. The center was able to hold a load up to 60 kips before it started dropping. The load was then released. The cracks along the grout between the barriers and the deck remained. The crack on the inclined barrier side of the grout pad was measured at a width of 0.005 inches. The u-bar side was measure at a width of 0.07 inches. The majority of the cracks appeared on the inclined connection side, no cracks appeared on the u-bar connection barrier. The inclined connection barrier was most likely taking all the load.

Figure 26 Diagonal cracks during Test 3

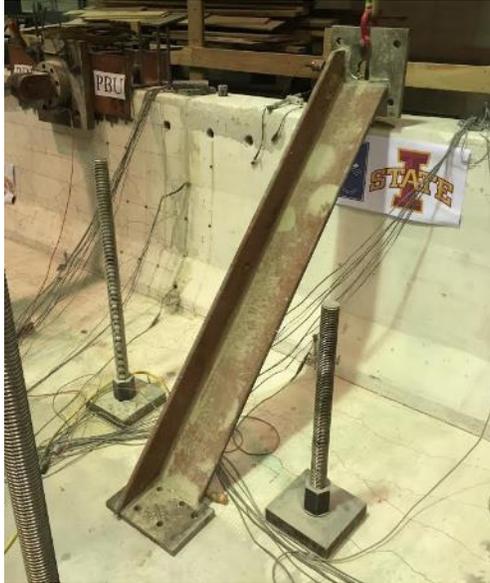
For Test 4, the loading beam was placed to the inclined connection side of the barrier-to-barrier connection. The center of the load was about three feet from the barrier-to-barrier connection. The purpose of the test was to observe the force distribution about the barrier-to-barrier connection and to fail the center connection. Before this test was performed, a beam was placed on the u-bar side to brace the barrier and keep it from deflecting. This brace beam can be seen in Figure 27.

Figure 27 Beam used to brace the u-bar connected barrier during Test 4

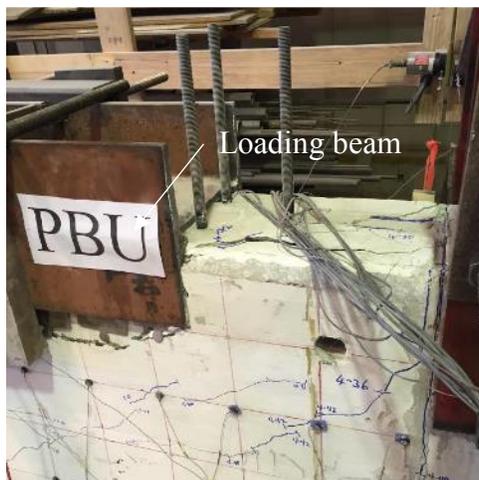
Hairline cracks didn't form on the grout between the barrier until 24 kips was applied. Other previous cracks just extended and opened up. At 48 kips, a crack developed on the front face of the grout between the barriers. A crack formed on the back of the barrier-to-barrier grout at 54 kips. This crack started at the bottom of the barrier. As the loads were increased, cracks continued to extend. At 72 kips, new cracks developed on the top of the barrier-to-barrier grout. The load was increased up to 81 kips before it started dropping. The test continued until the deflection was measured at 1.5 inches. Large cracks developed along the barrier under the loading beam, see Figure 28, and the barrier-to-barrier grout broke all the way along the top to the back, see Figure 29.

Figure 28 Cracking on barrier due to loading during Test 4

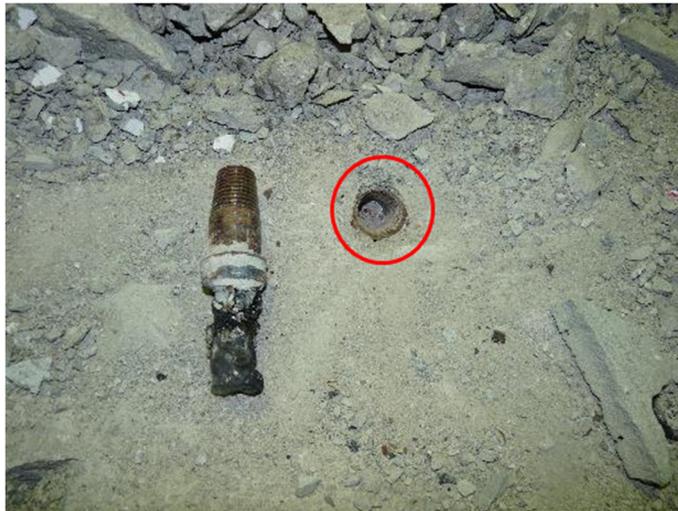
When an isolated unit of the inclined connection was subjected to test level 4 loading, it performed satisfactory, which was expected. The barrier, deck and barrier to deck connection performed well with no elastic strains developing in the deck reinforcement. The deck began to crack as the loading approached 18 kips. Hairline diagonal cracks were witnessed on the inclined connection barrier as the loading reached 48 kips. The cracking that developed on the deck was uniform and extended beyond the expected 45° force dispersion. As the applied load reached 54 kips, the top of the barrier experienced a total top lateral displacement of 0.81 inches. Removal of the system after testing proved that the threads in the embedded inclined deck piece remained intact. A replacement of this barrier segment and connection could be possible. Figure 30 shows the removed threaded bar and the intact deck receiving piece.

Figure 30 Removed Inclined Barrier Connection and Receiving Deck Piece

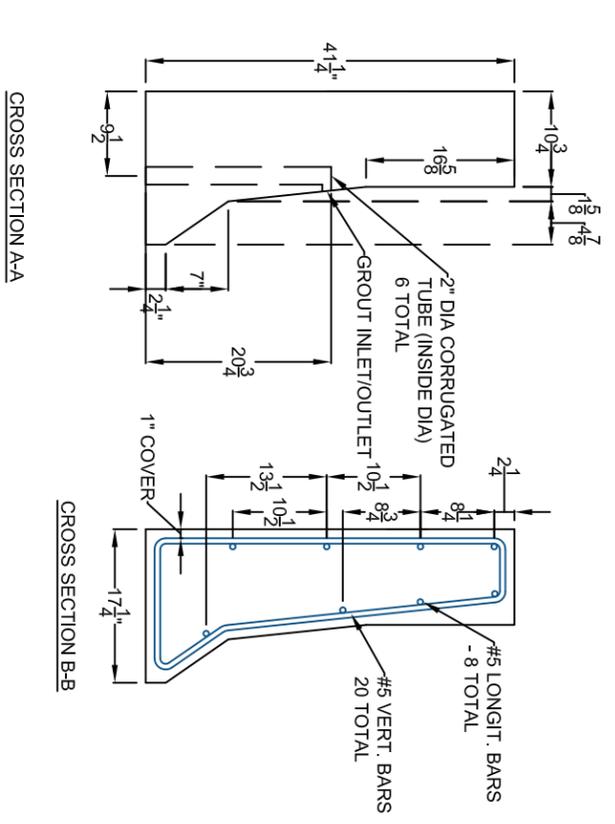
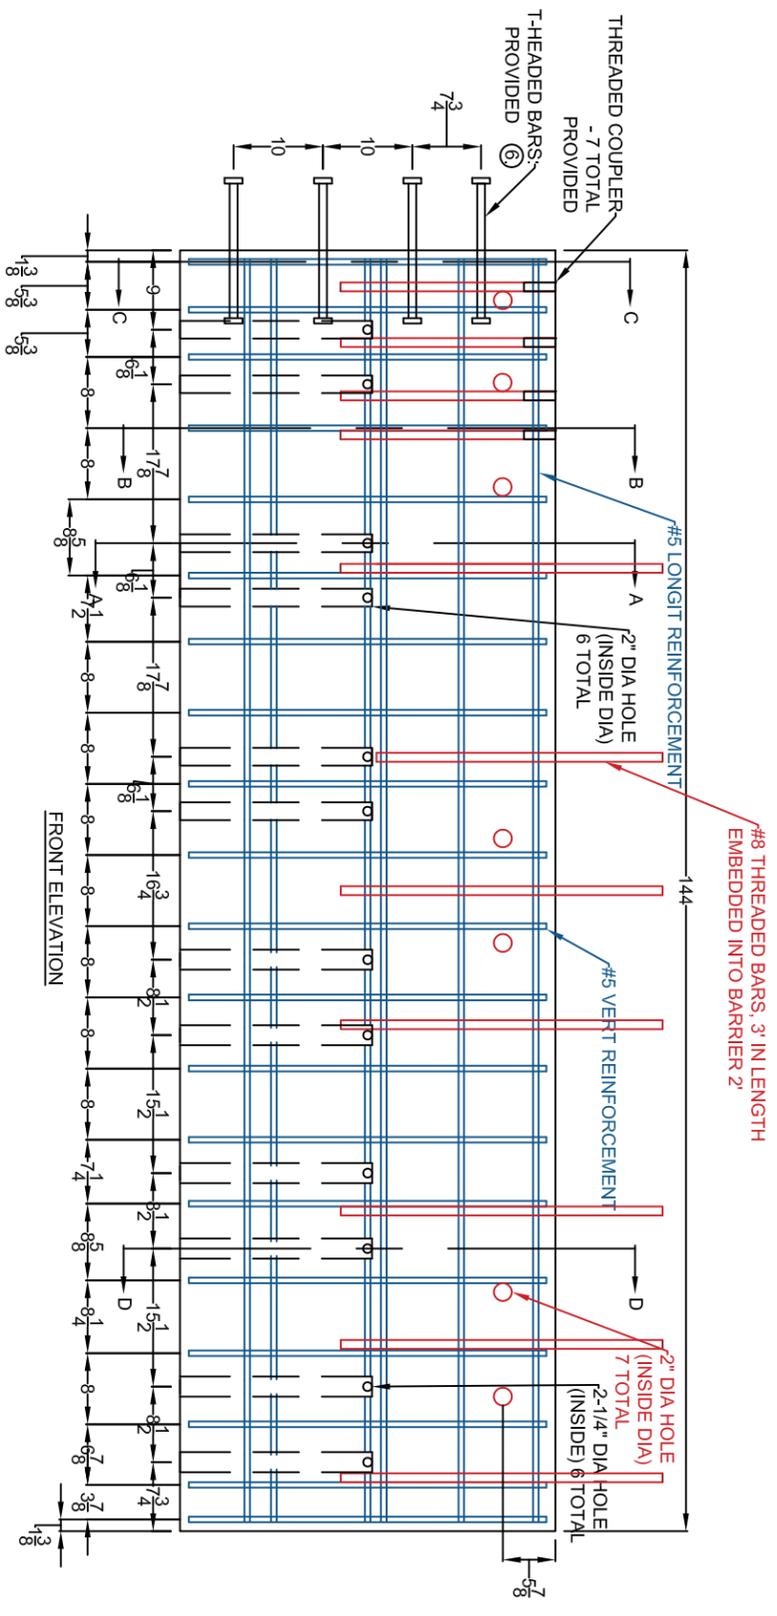
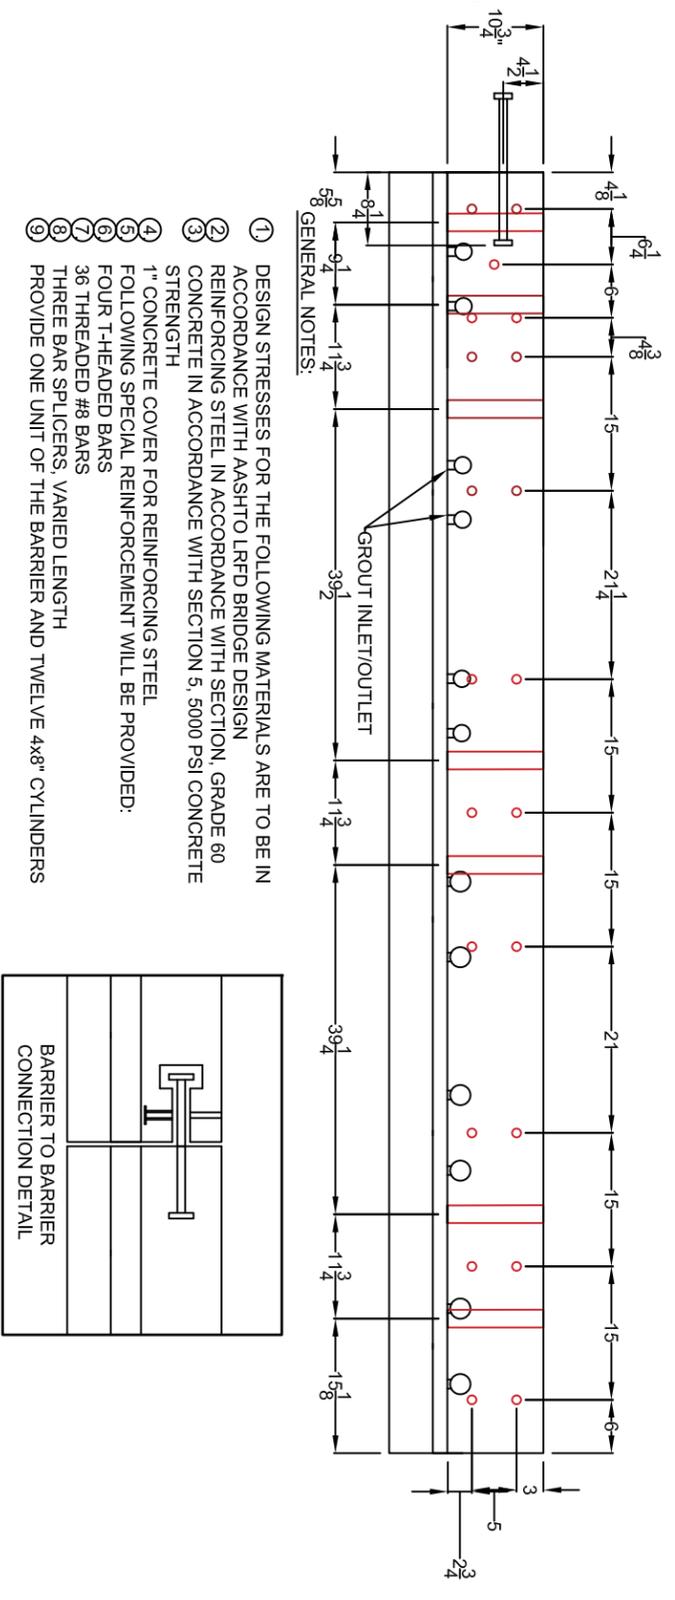
U-BAR CONNECTION

Detailed Prefabricated Concrete Barrier Drawings
