ACCELERATED BRIDGE CONSTRUCTION IN SEISMIC REGIONS: RESEARCH AT THE UW

John Stanton
Travis Thonstad

WSDOT ABC Workshop
1 April 2015

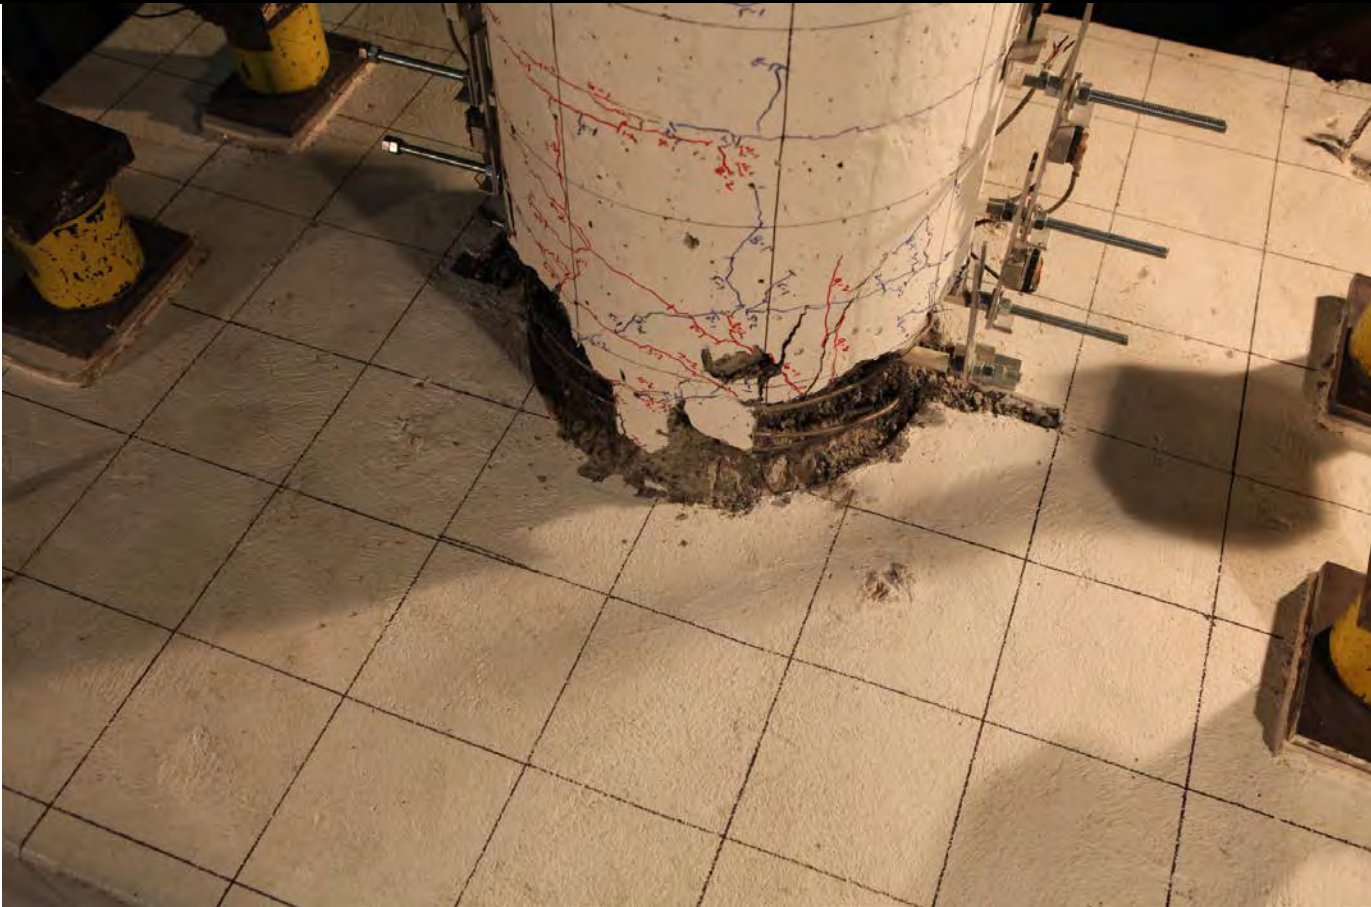
Spread Footing Connection

After lateral load testing. Foundation undamaged.

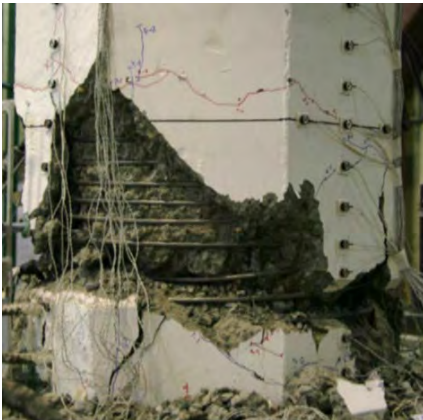
Conventional concrete only

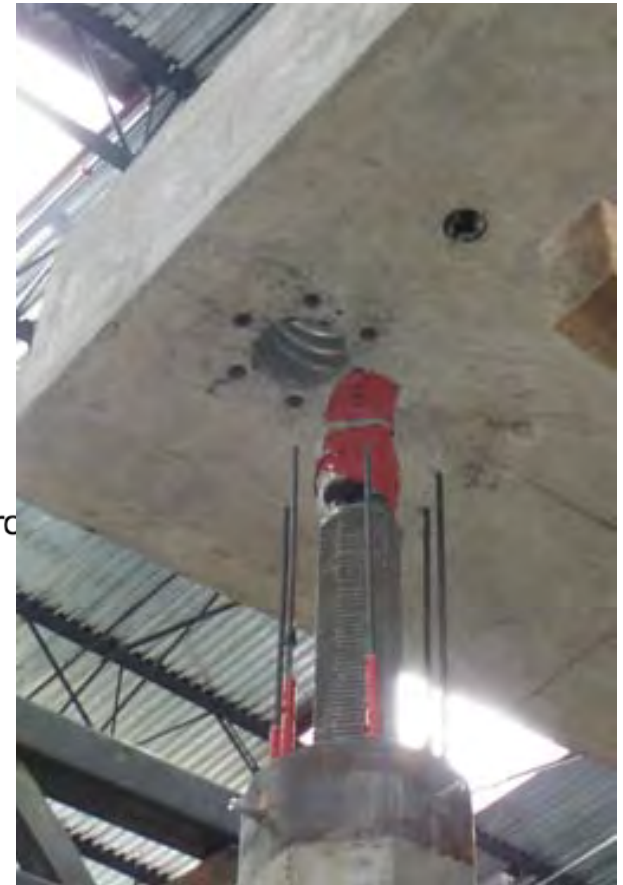
“Grouted-Bar-Socket” Cap Beam Connection

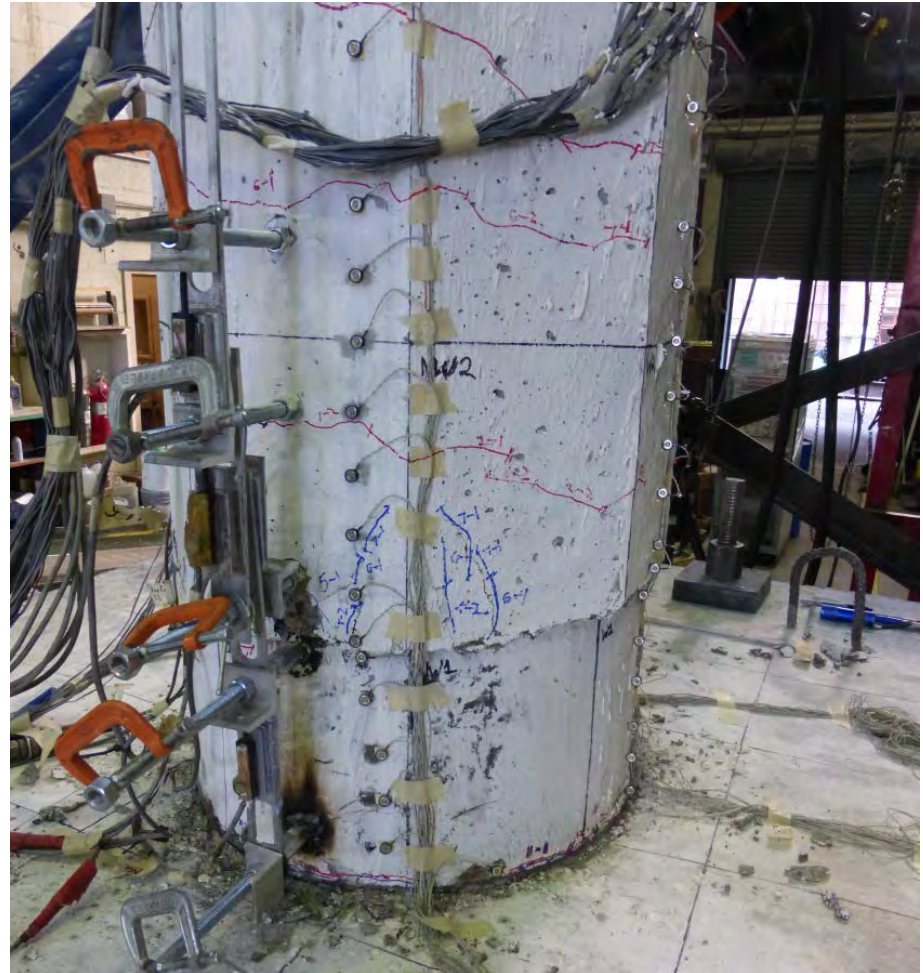
Observations

After 10% drift:

- No concrete damage,
- No footing damage,
- No cap beam damage.

- Rebars broken ($\theta = 6\%$)
- Strand yielded ($\theta = 3\%$)

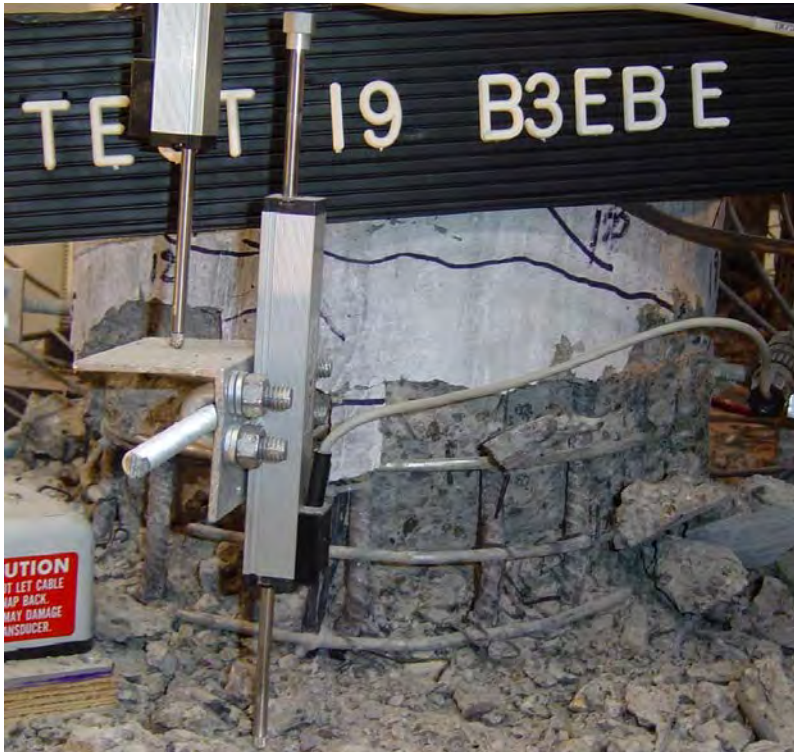
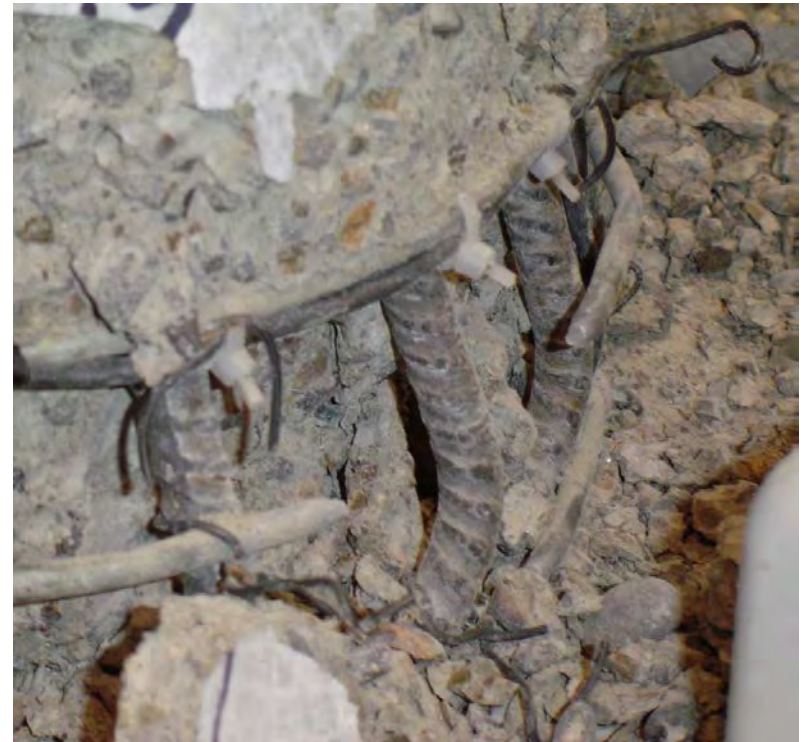
2005 RC Bridge Motion 19 (220% Design Level) 1994 Northridge - Century City CC North (PGA=1.66g)

- Bent 3 columns fully spalled, spiral fracture, bar buckling.
- Load over bent 3 was removed due to safety concerns.

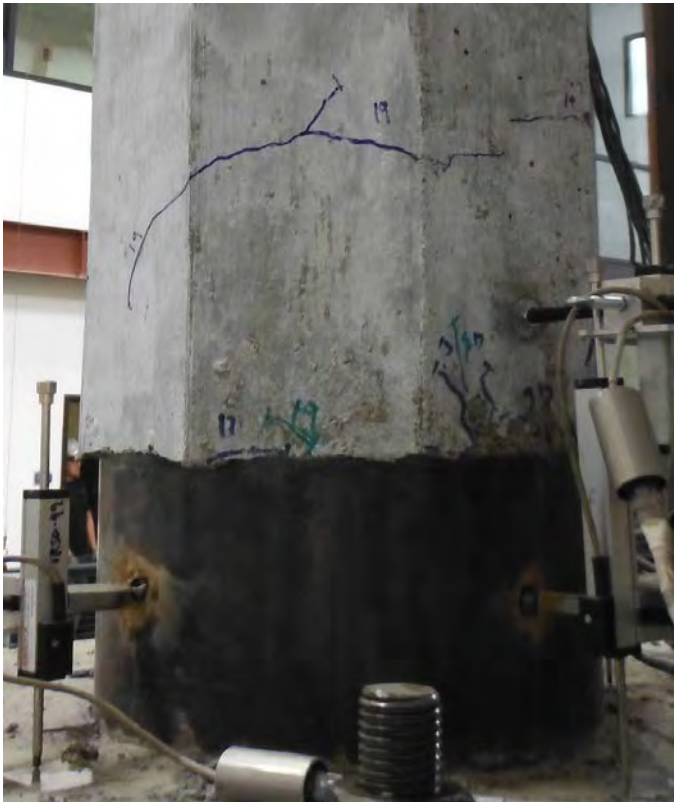
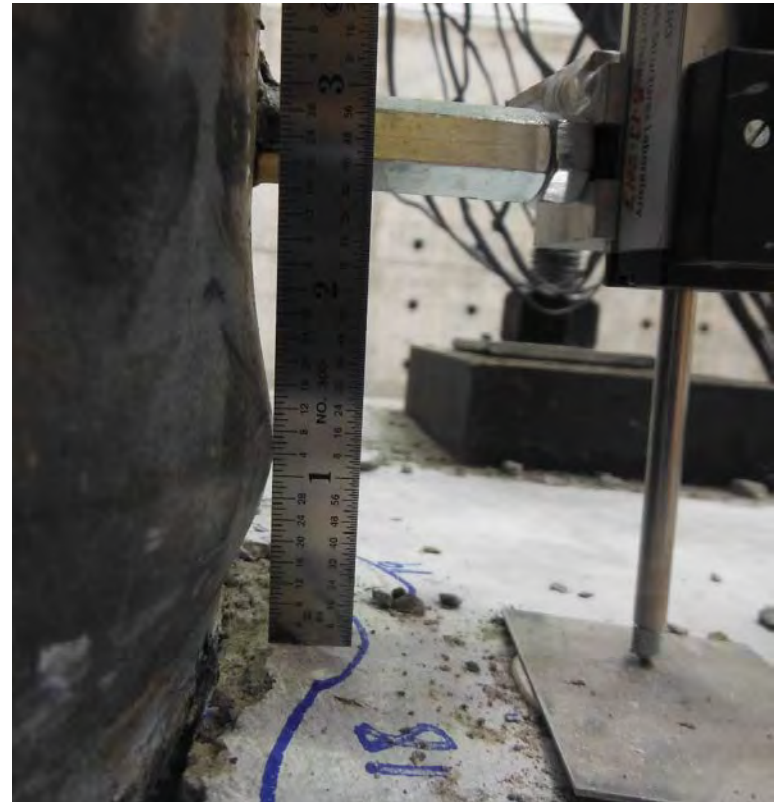
2005 RC Bridge Motion 19 (220% Design Level) 1994 Northridge - Century City CC North (PGA=1.66g)

- Hairline horizontal cracks (3 in total) minor flaking at steel tube,
- rebar fracture, bulging of steel confining jackets.

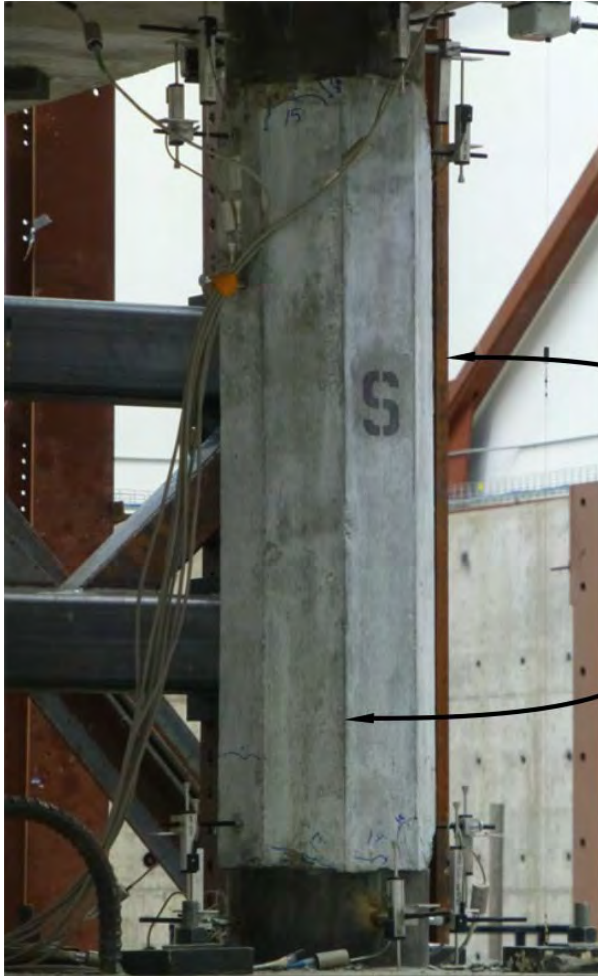
2014 PreT Bridge Motion 21C 1995 Kobe – Takatori Station (PGA=0.8g)

- Columns were vertical
 - Residual Drift < 0.2%
- Essentially no damage to concrete

Steel column
(lab safety frame)

Concrete
bridge
column
