Sliding Into History

Milton – Madison Bridge Project
Milton, KY – Madison, IN

Project Scope

Replacement of 80-Year Old Truss

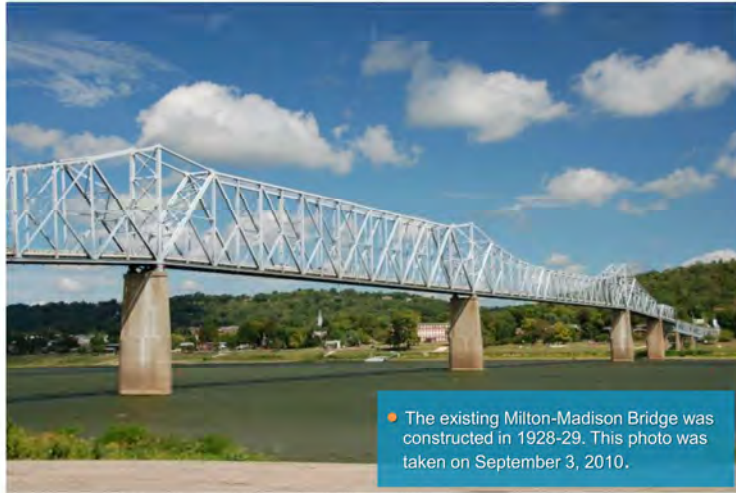
- The existing Milton-Madison Bridge was constructed in 1928-29. This photo was taken on September 3, 2010.

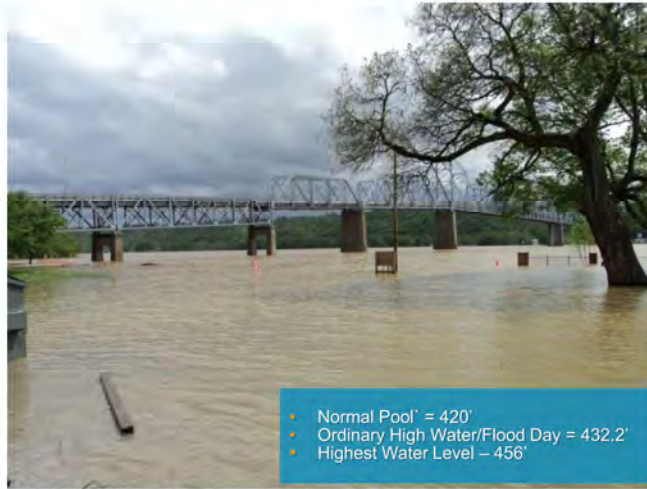
- Normal Pool = 420'
- Ordinary High Water/Flood Day = 432.2'
- Highest Water Level – 456'

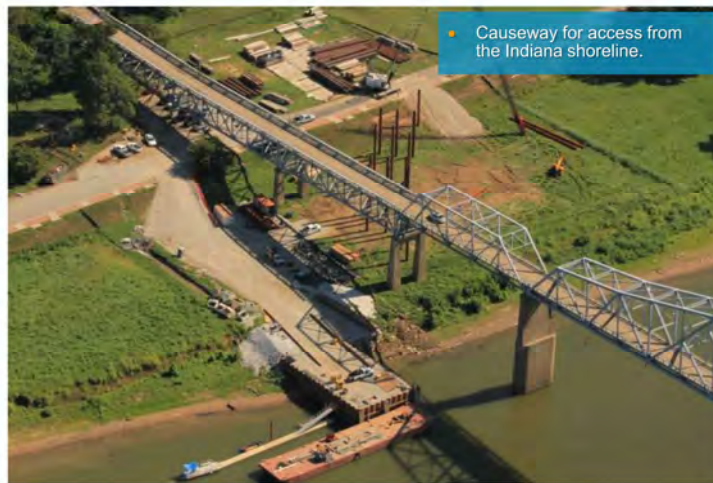
- Causeway for access from the Indiana shoreline.

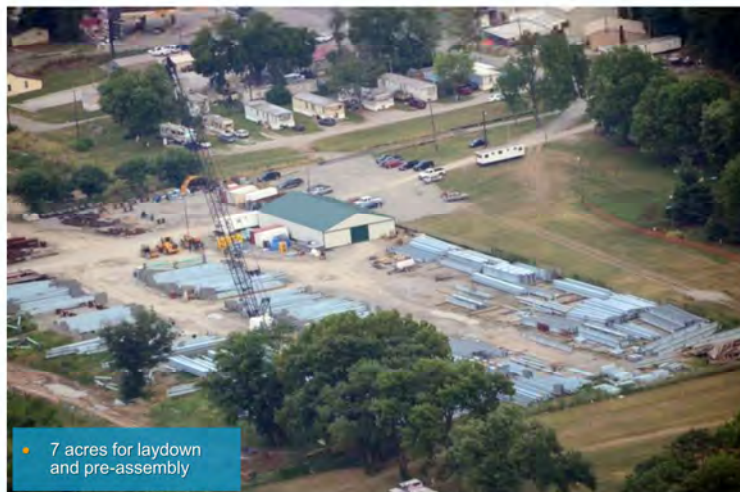
Kentucky Laydown Yard

- 7 acres for laydown and pre-assembly

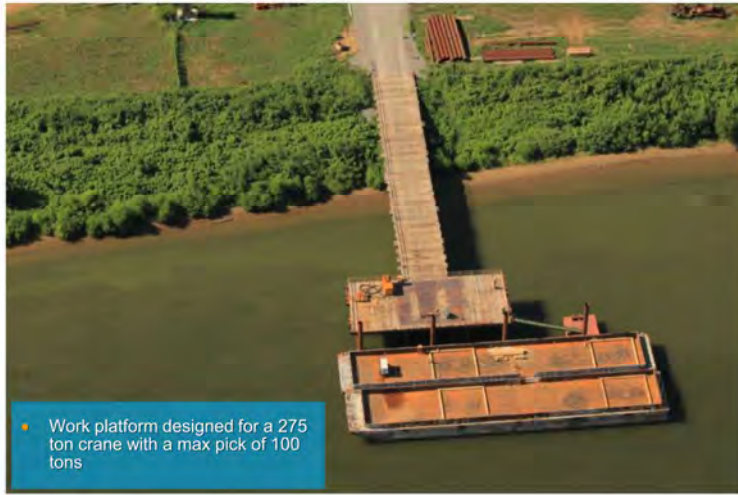
- Work platform designed for a 275 ton crane with a max pick of 100 tons

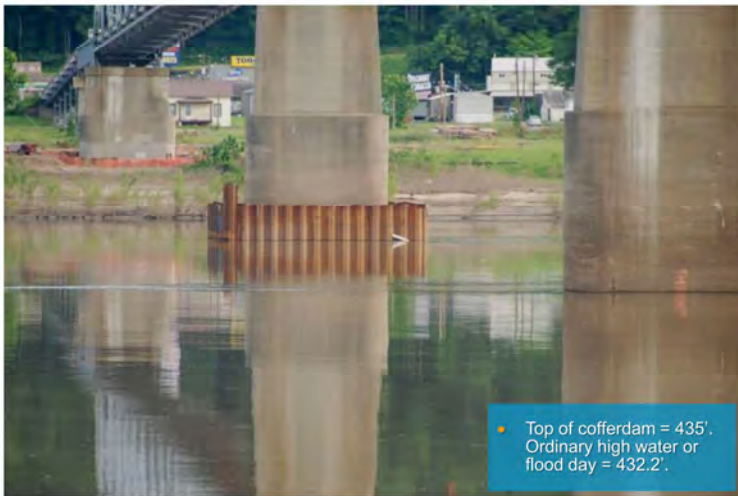
- Top of cofferdam = 435'. Ordinary high water or flood day = 432.2'.

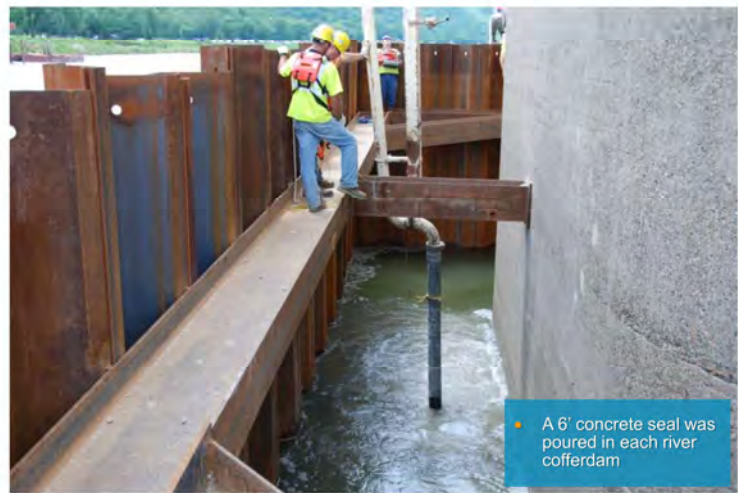
- A 6' concrete seal was poured in each river cofferdam

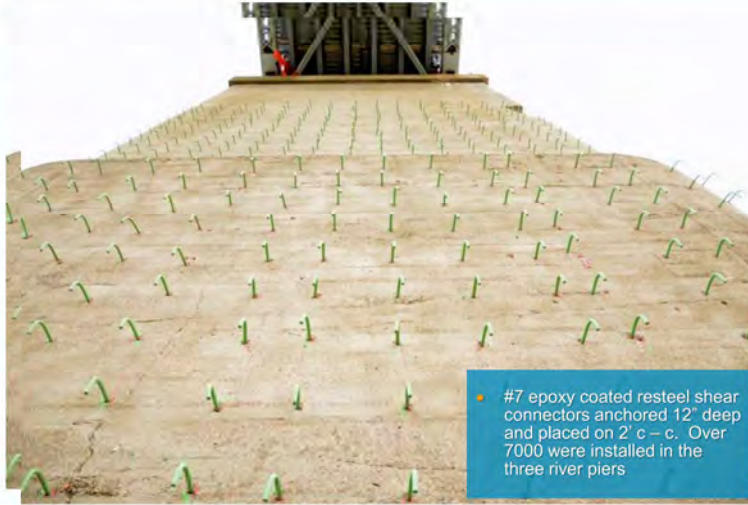
Pier 5 Shear Connectors

- #7 epoxy coated rebar shear connectors anchored 12" deep and placed on 2' c-c. Over 7000 were installed in the three river piers

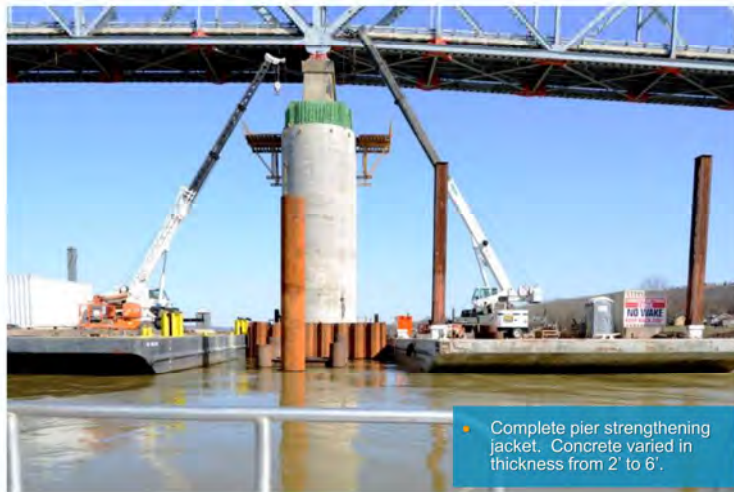
- Complete pier strengthening jacket. Concrete varied in thickness from 2' to 6'.

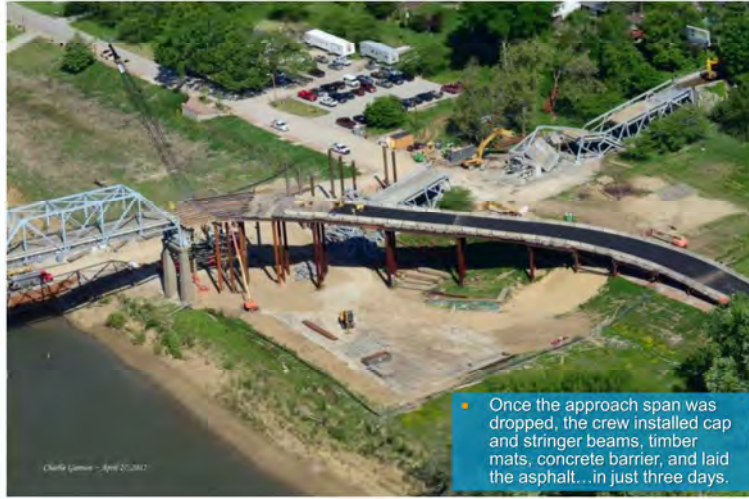
Connecting the IN Temp Ramp

- Once the approach span was dropped, the crew installed cap and stringer beams, timber mats, concrete barrier, and laid the asphalt...in just three days.

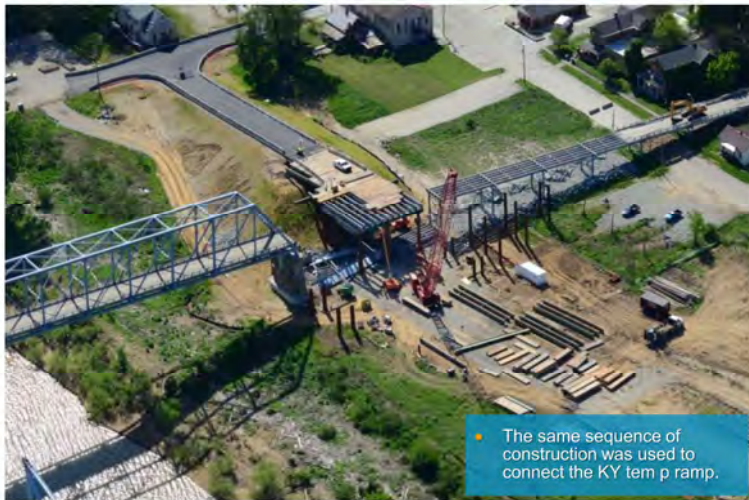
Connecting the KY Temp Ramp

- The same sequence of construction was used to connect the KY temp ramp.

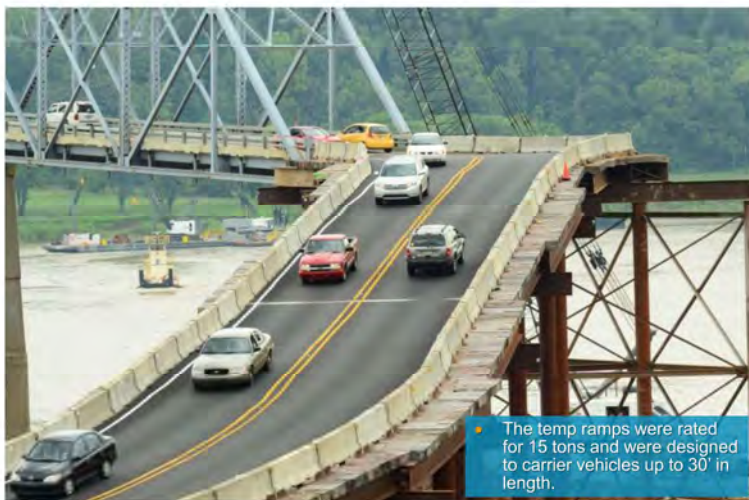
Indiana Temp Ramp Open

- The temp ramps were rated for 15 tons and were designed to carry vehicles up to 30' in length.

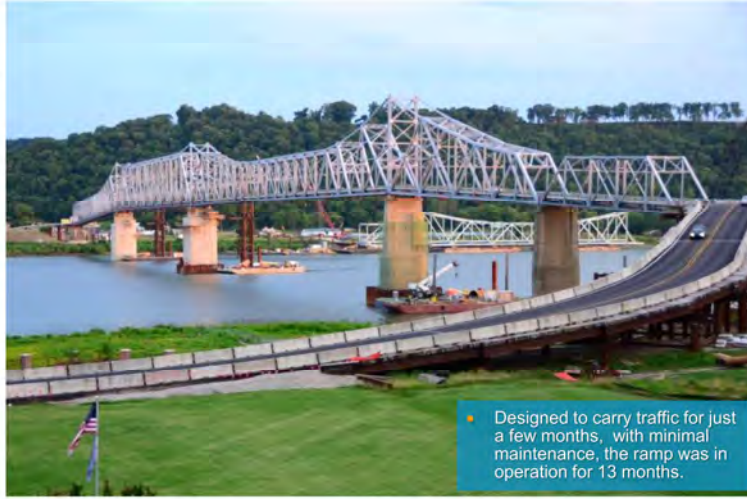
Indiana Temporary Ramp

- Designed to carry traffic for just a few months, with minimal maintenance, the ramp was in operation for 13 months.

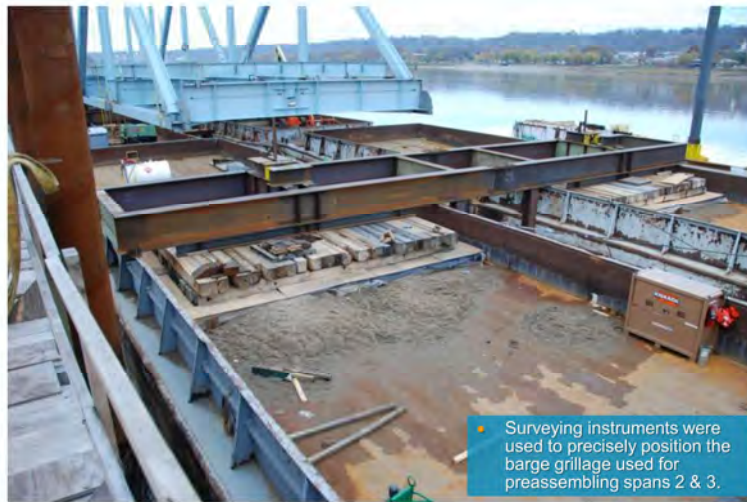
New Truss Barge Grillage

- Surveying instruments were used to precisely position the barge grillage used for preassembling spans 2 & 3.

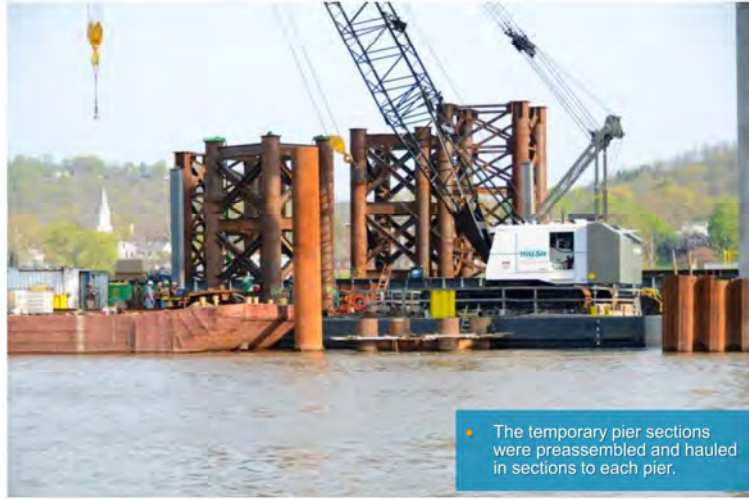
- The temporary pier sections were preassembled and hauled in sections to each pier.

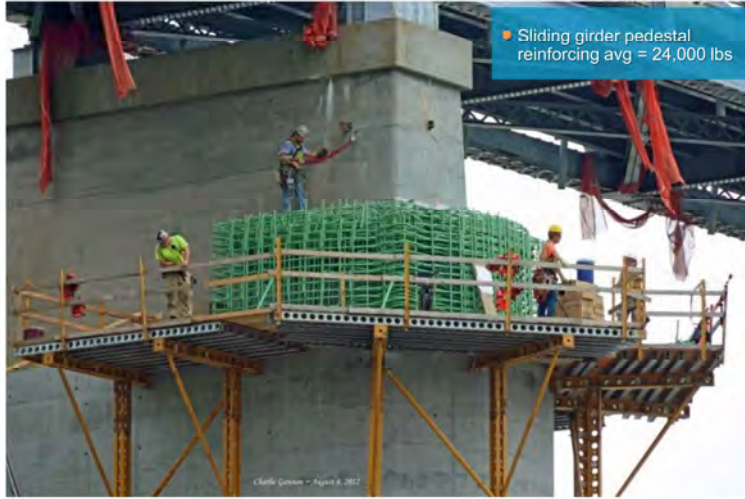
- Sliding girder pedestal reinforcing avg = 24,000 lbs

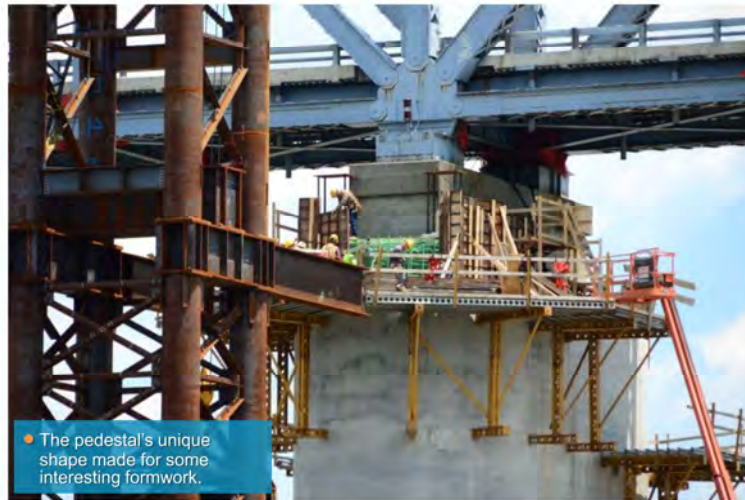
- The pedestal's unique shape made for some interesting formwork.

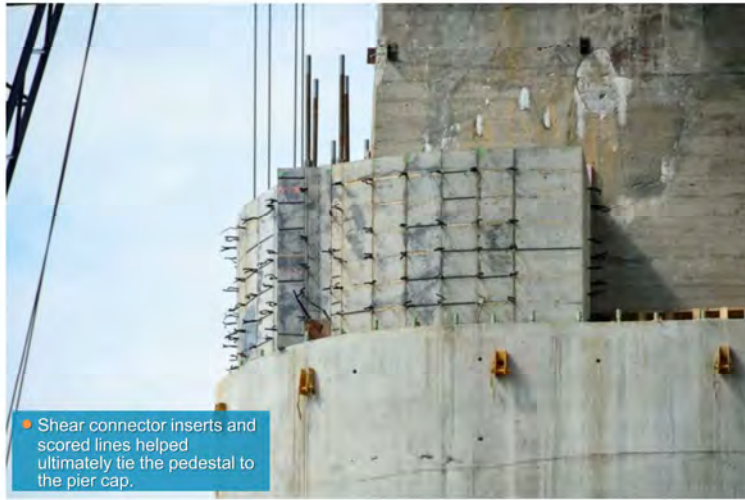
- Shear connector inserts and scored lines helped ultimately tie the pedestal to the pier cap.

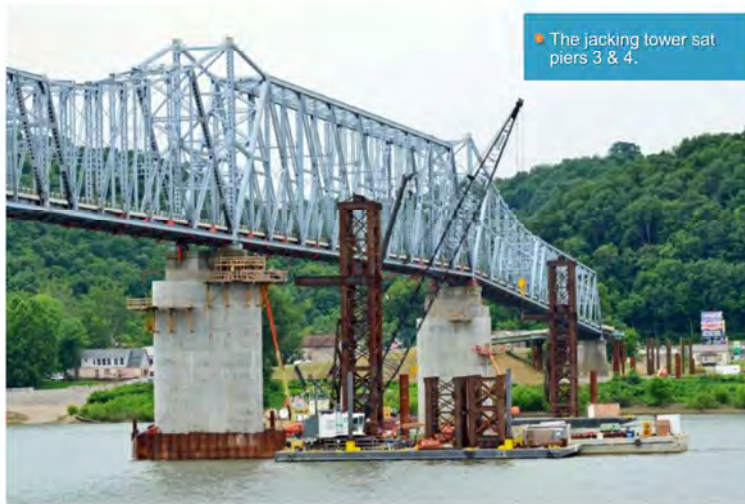
• The jacking tower sat piers 3 & 4.

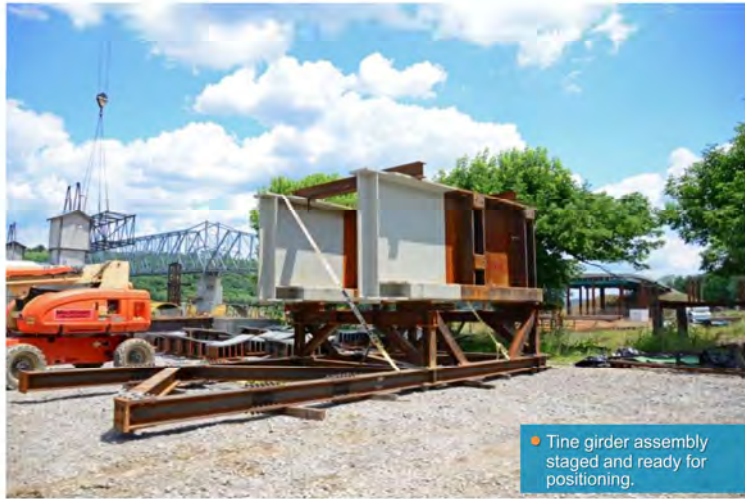
- Tine girder assembly staged and ready for positioning.

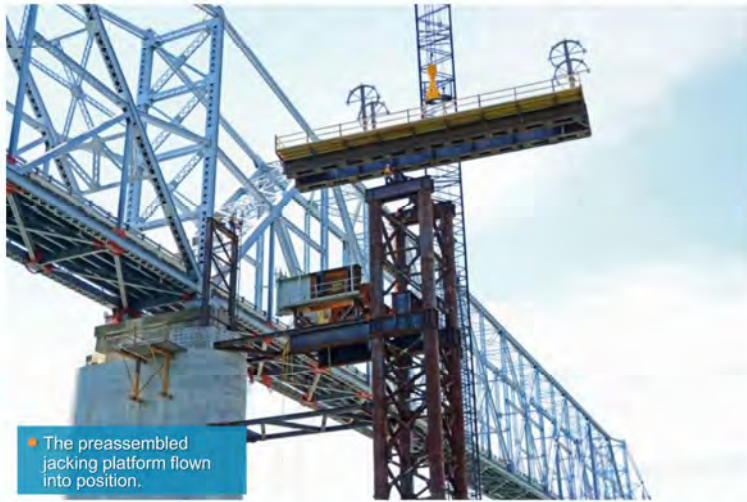
- The preassembled jacking platform flow into position.

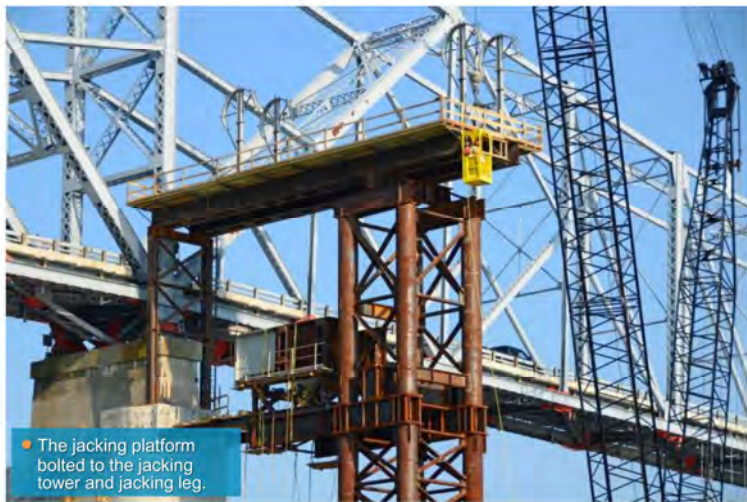
- The jacking platform bolted to the jacking tower and jacking leg.

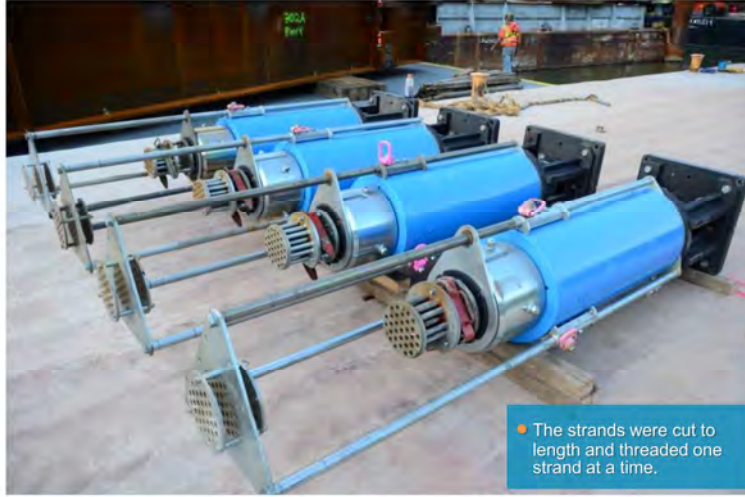
- The strands were cut to length and threaded one strand at a time.

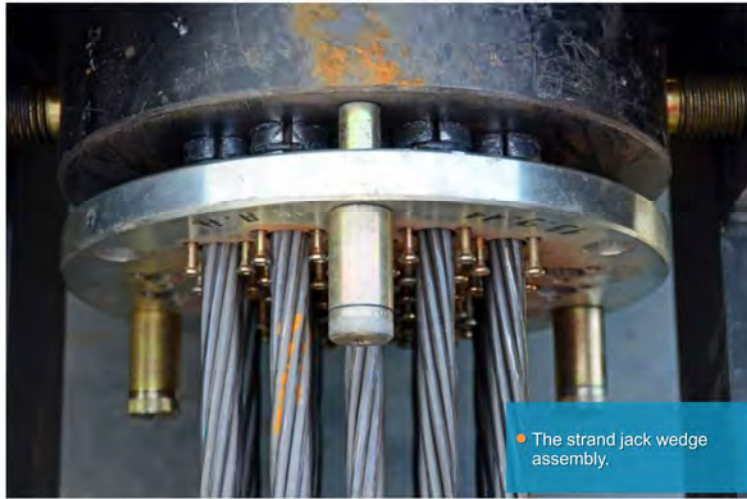
- The strand jack wedge assembly.

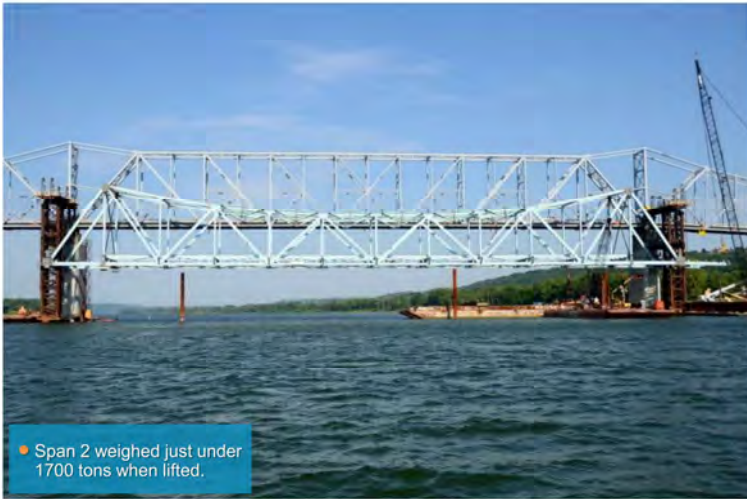
Strand Jacking Span 2

- Span 2 weighed just under 1700 tons when lifted.

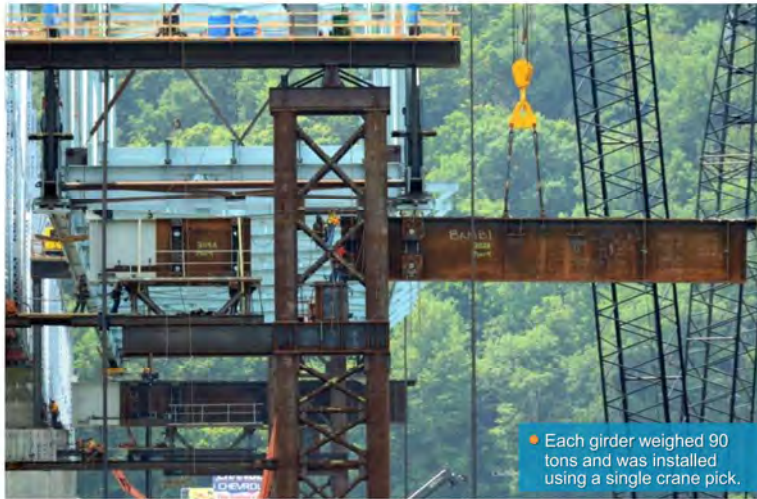
- Each girder weighed 90 tons and was installed using a single crane pick.

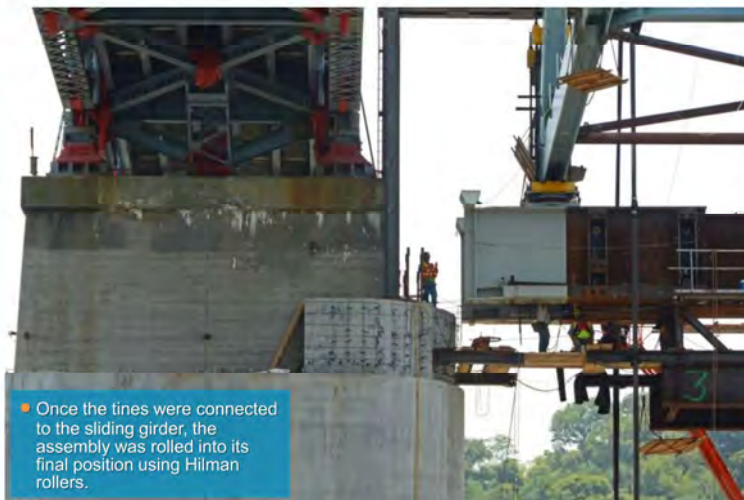
- Once the tines were connected to the sliding girder, the assembly was rolled into its final position using Hilman rollers.

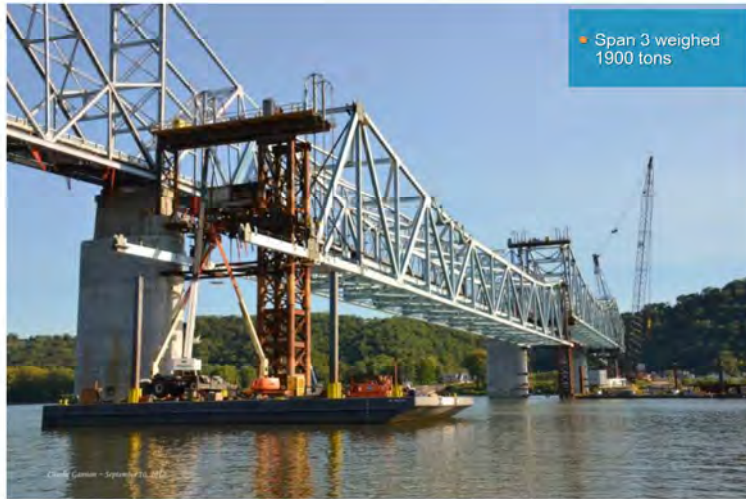
- Span 3 weighed 1900 tons

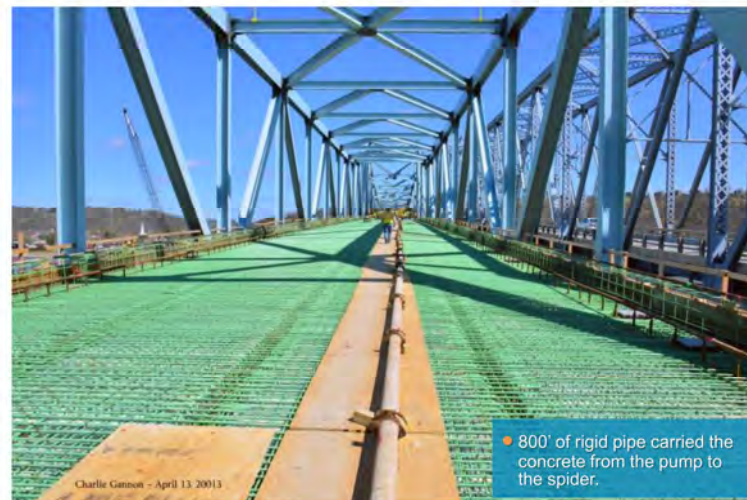
- 800' of rigid pipe carried the concrete from the pump to the spider.

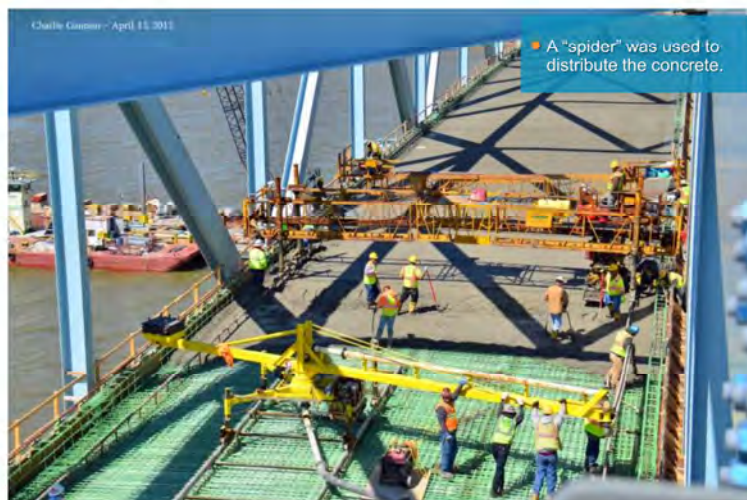
- A "spider" was used to distribute the concrete.

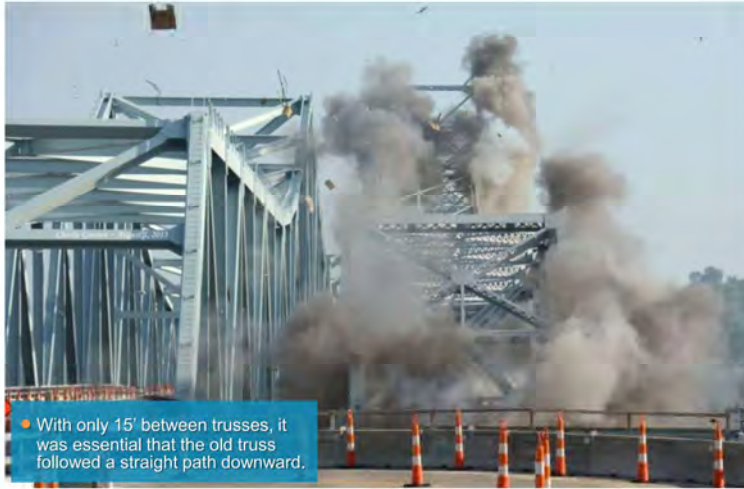
- With only 15' between trusses, it was essential that the old truss followed a straight path downward.

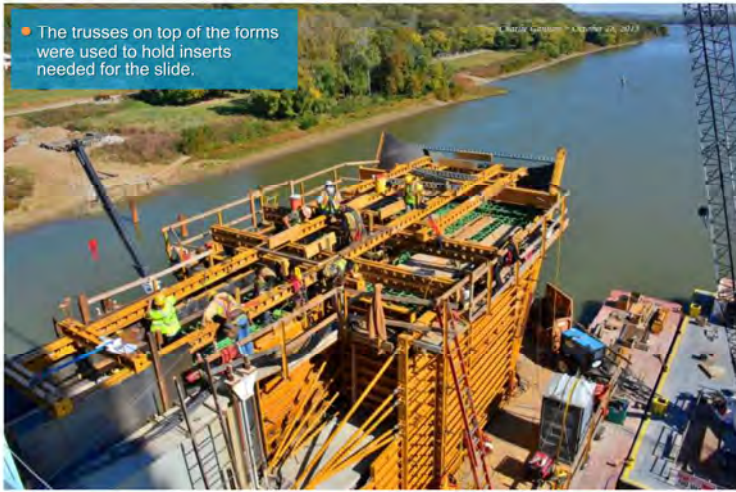
• The trusses on top of the forms were used to hold inserts needed for the slide.

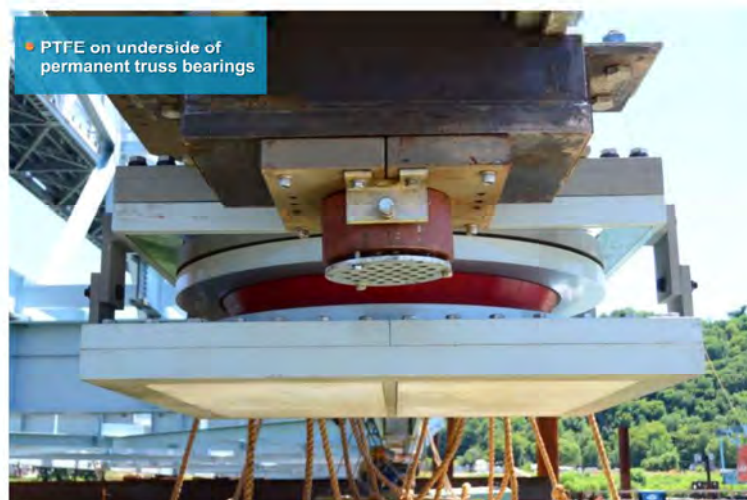
Truss Bearing Sliding Surface

• PTFE on underside of permanent truss bearings

- Dimpled PTFE on polished, greased, carbon steel
 - Permanent bearings utilized for sliding
- 1" thick slide plate, varied from 37" to 78" wide
 - Flatness of slide path critical
- Guided at only one pier (P4)
- BRAVO laser control system
- Bearing harness system
- Eight 350-ton strand jacks

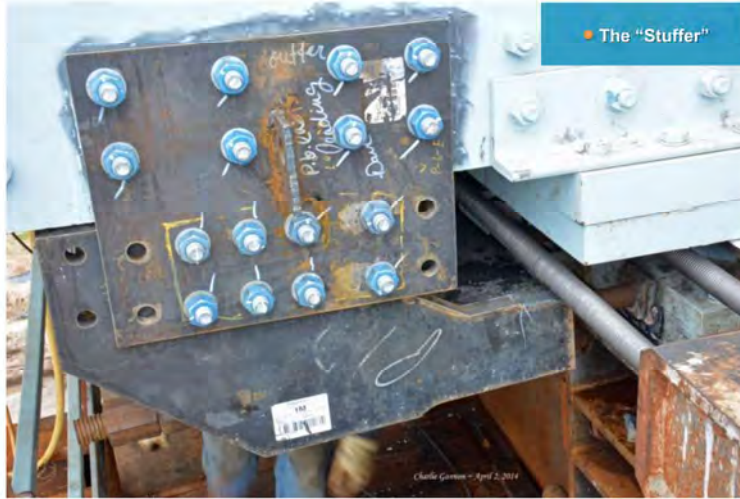
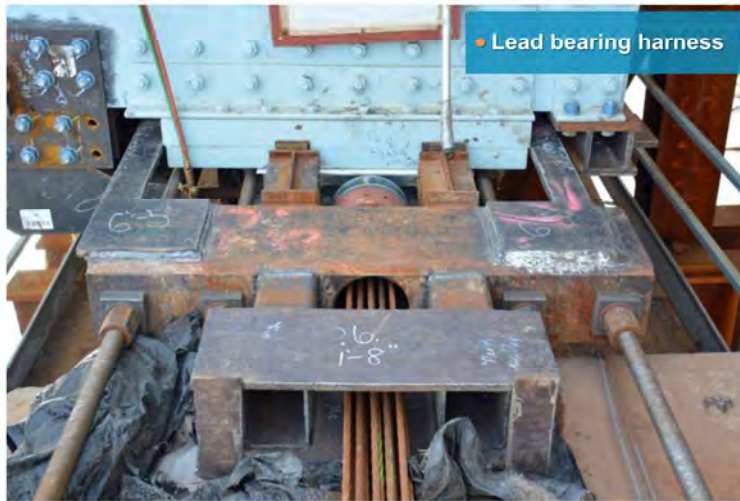
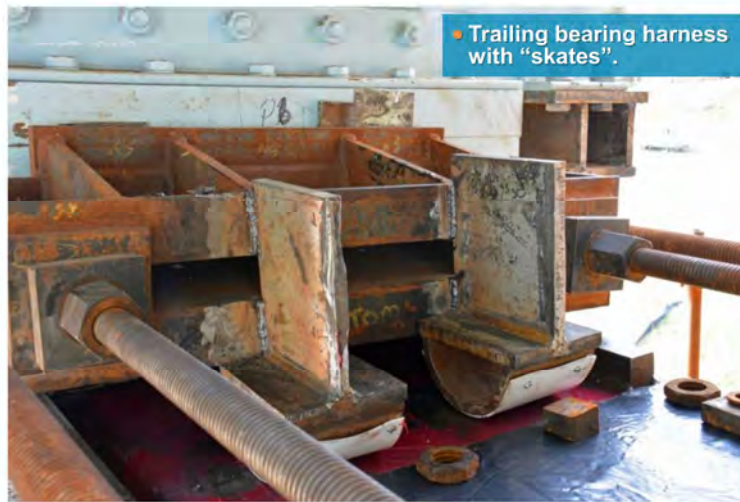
Piers 2 & 6 Truss Bearing

- Lead bearing harness
