WEST VIRGINIA'S ABC PROJECTS

Ahmed Mongi, M.S., P.E.
Engineering Division

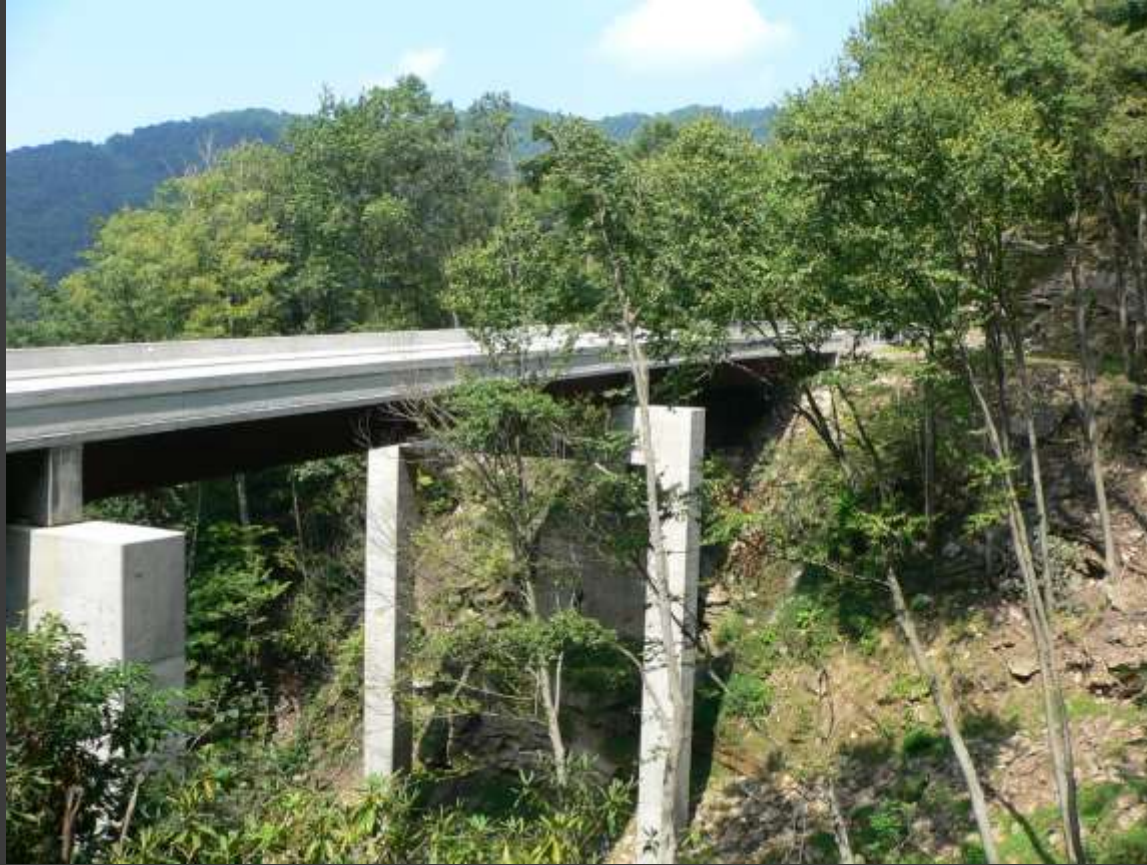
Honey Creek Bridge

- Completed in 2006 at a cost of \$2.6 Million
- Precast pier caps and abutments.

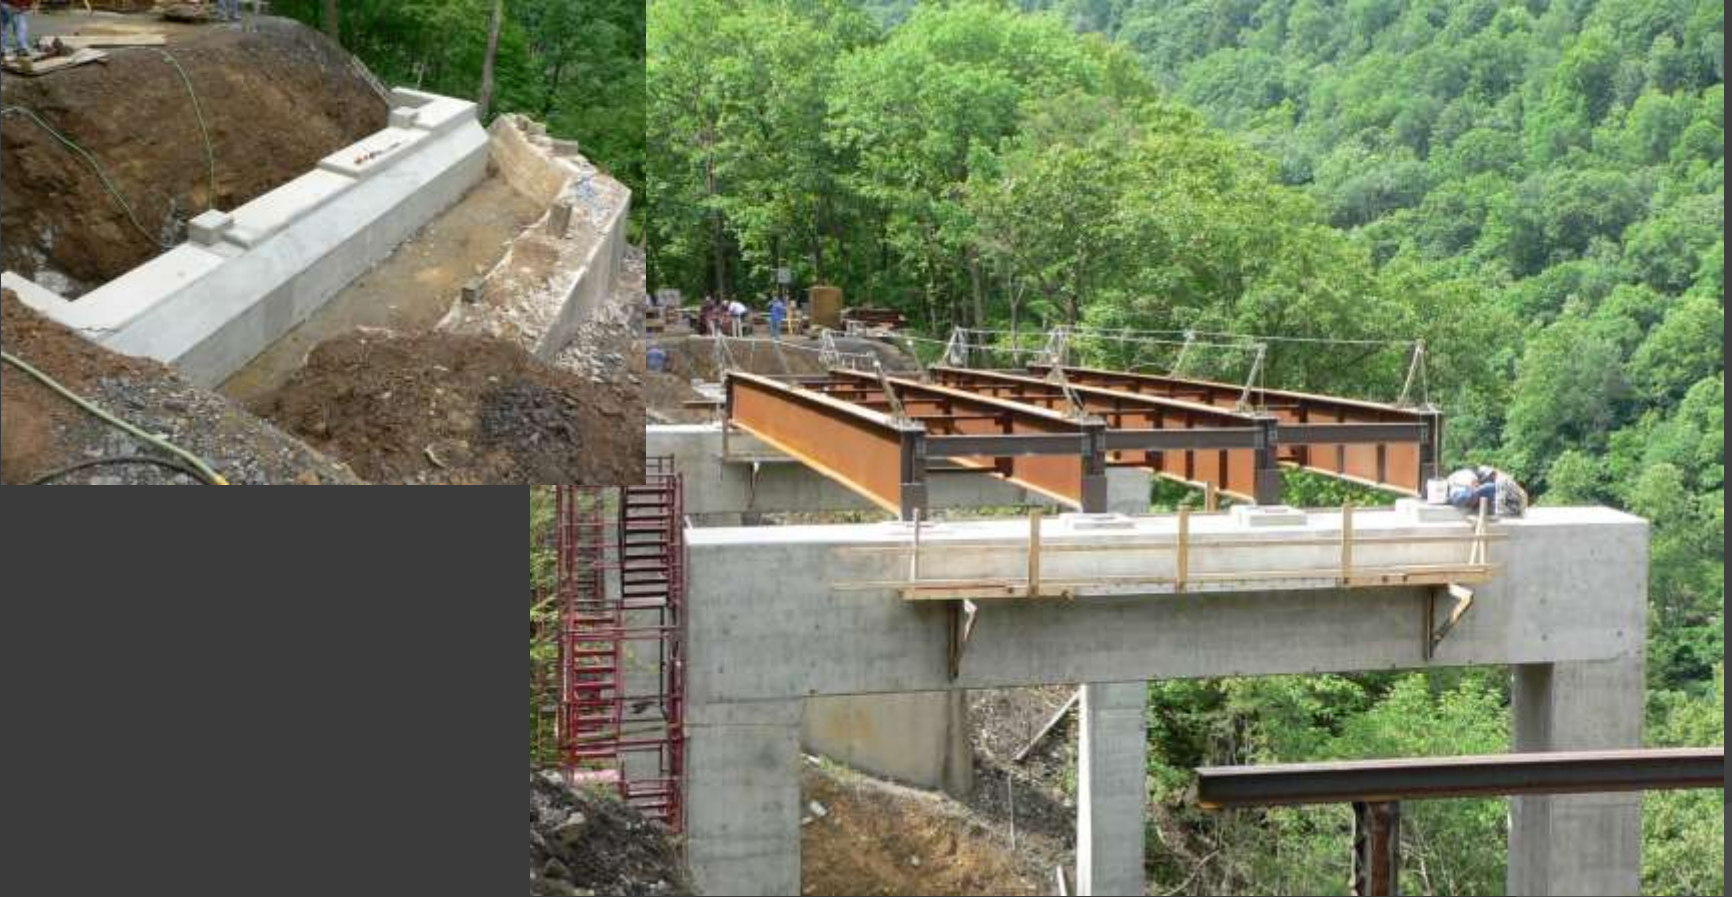
Honey Creek Bridge

- Bridge closed for 60 days
- Simple span for DL and continuous for LL

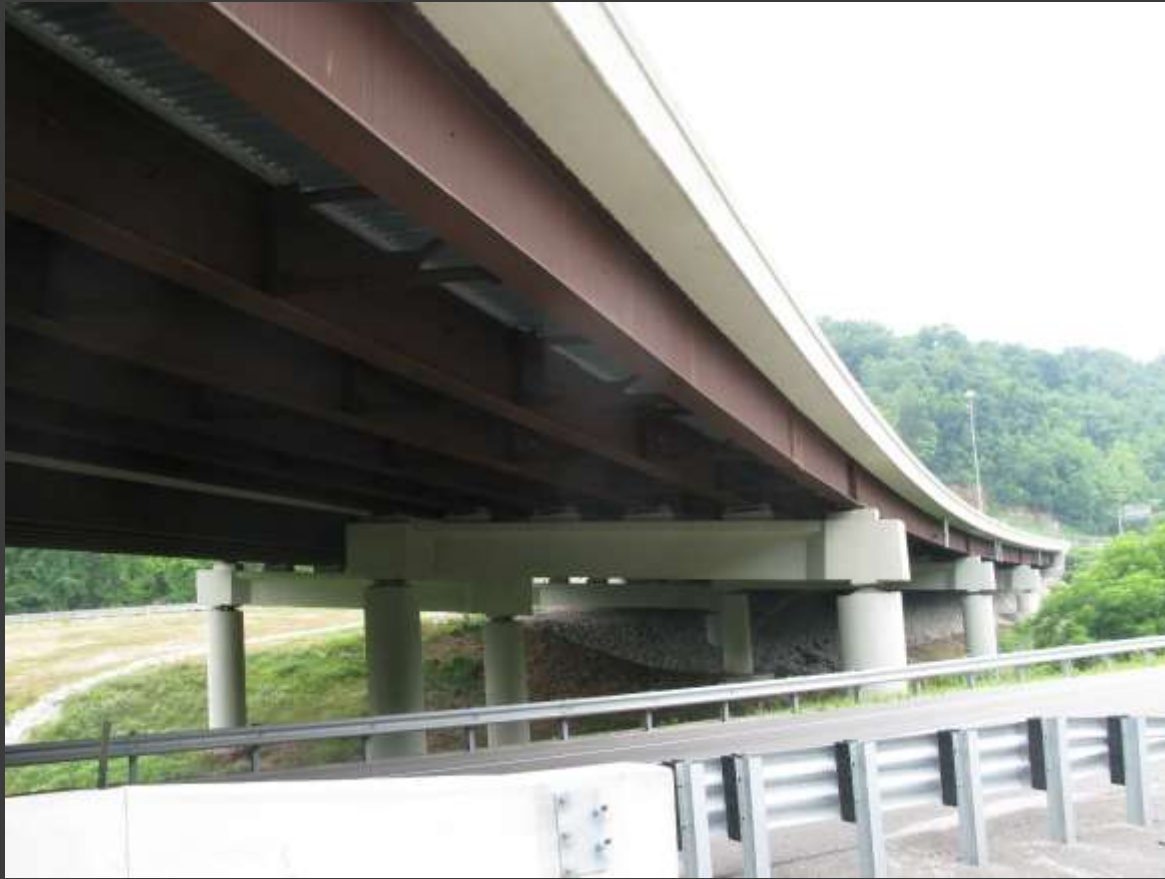
16th Street Interchange Bridge

- Completed in 2009 at a cost of \$26.0 Million
- Precast pier caps and abutments

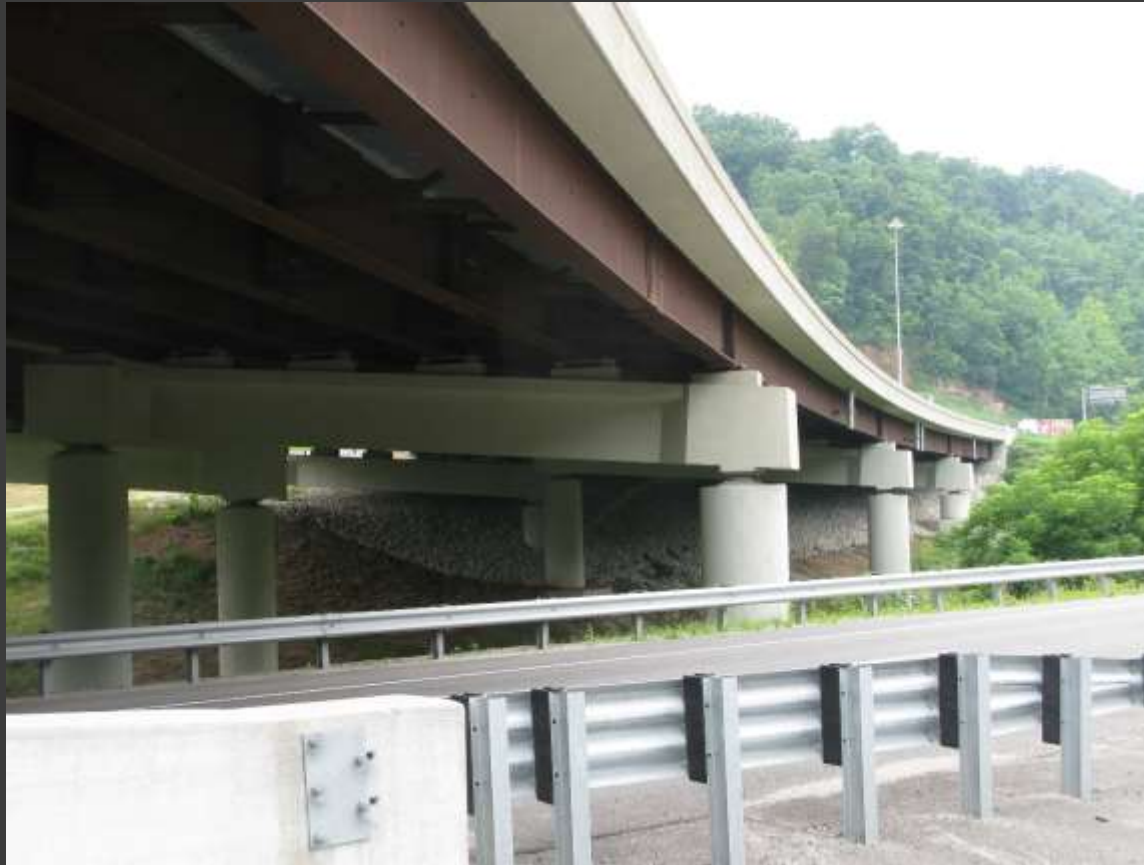
16th Street Interchange Bridge

- Staged construction using precast and CIP decks
- CIP deck was selected by the contractor

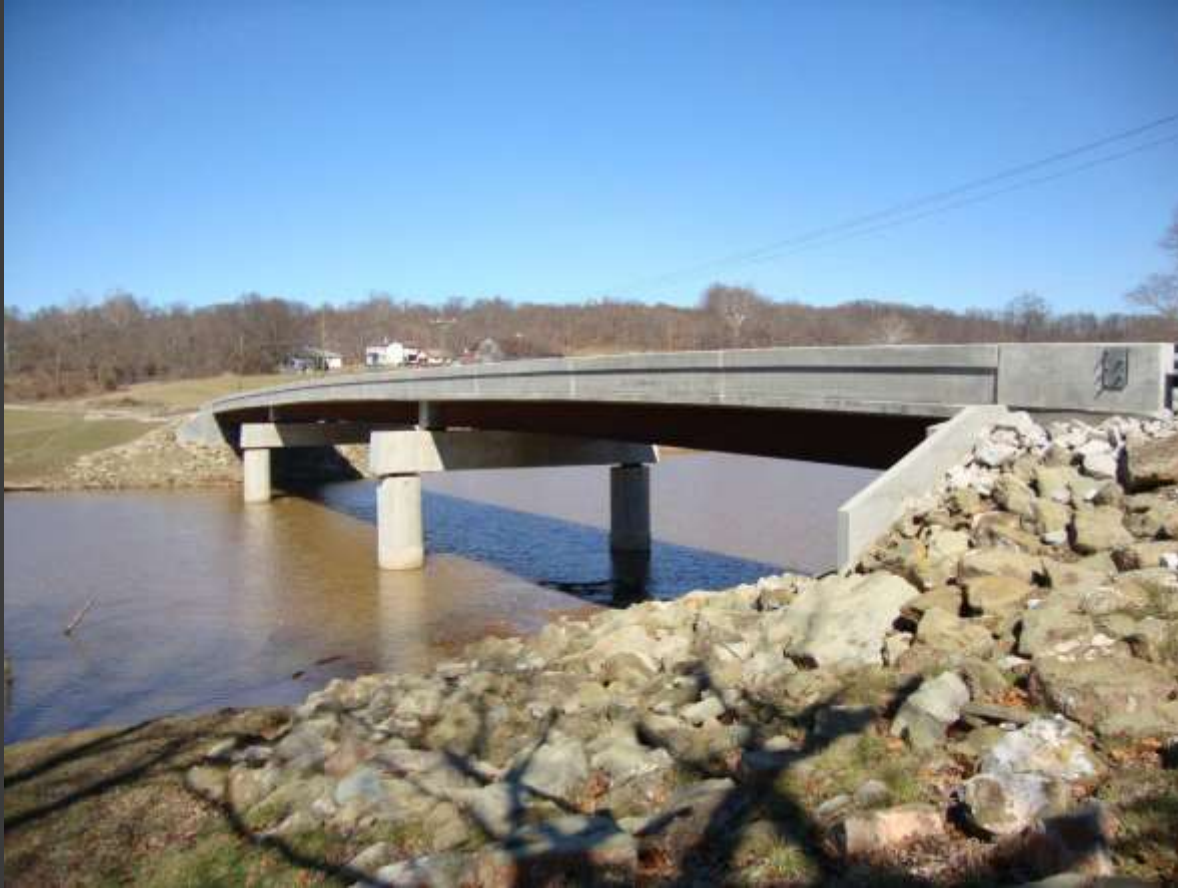
Robin Hood Bridge

- Completed in 2010 at a cost of \$2.5 Million
- Precast pier caps and abutments

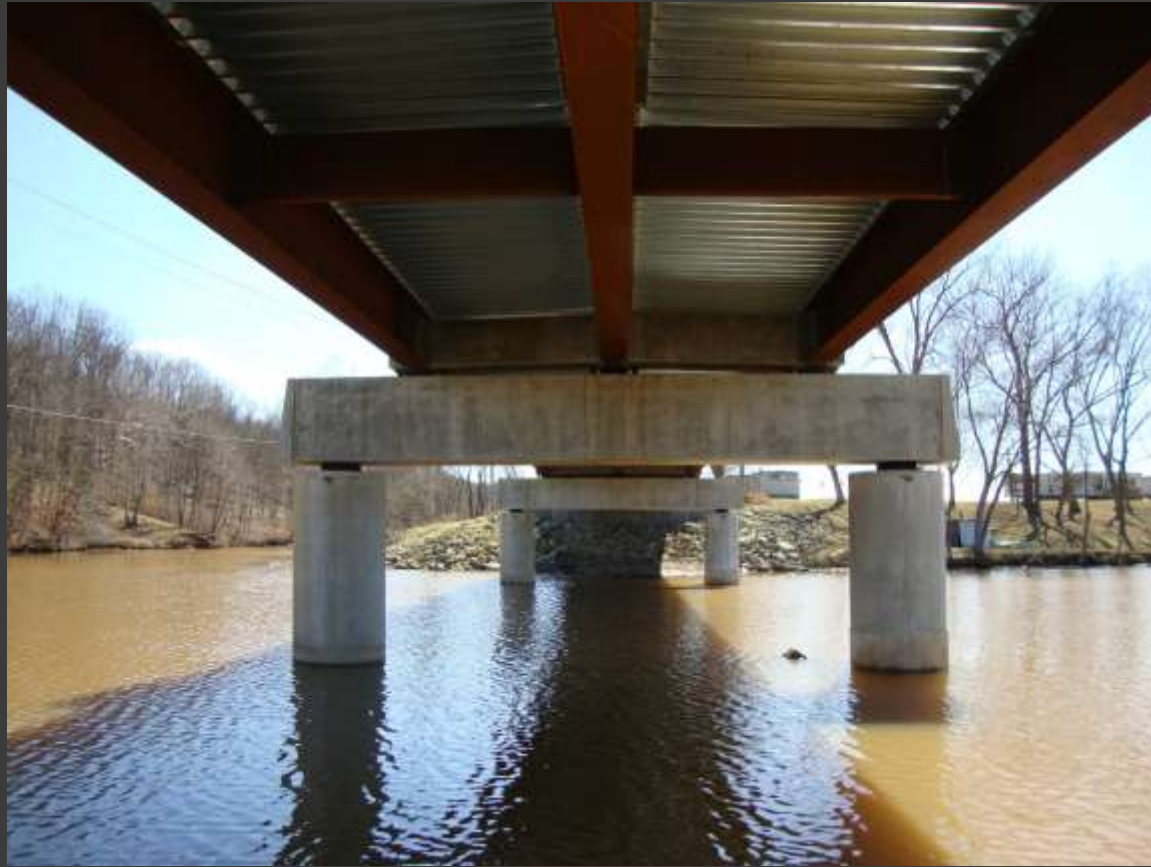
Robin Hood Bridge

- Bridge closed to traffic for 70 days
- Simple span for DL & continuous for LL

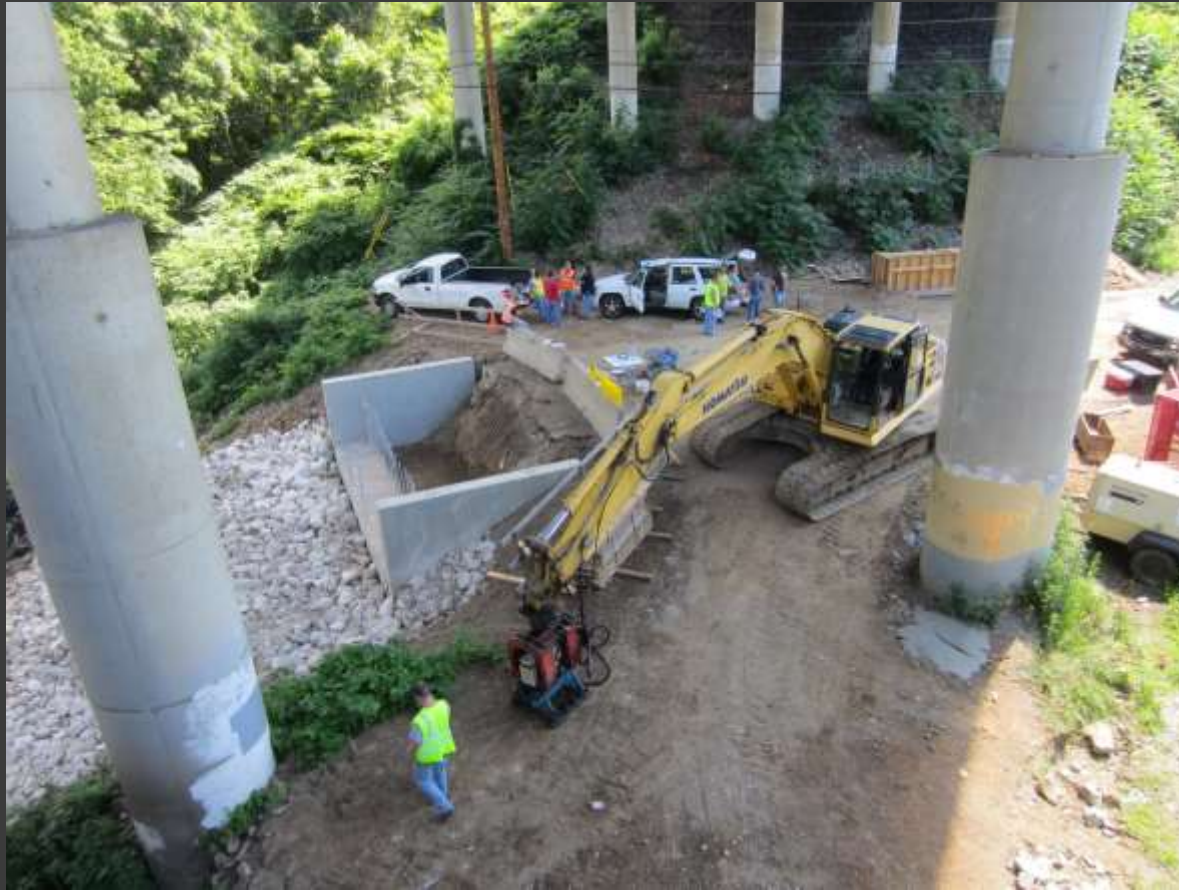
Dry Branch Bridge

- Completed in 2013 at a cost of \$1.7 Million
- Precast abutments

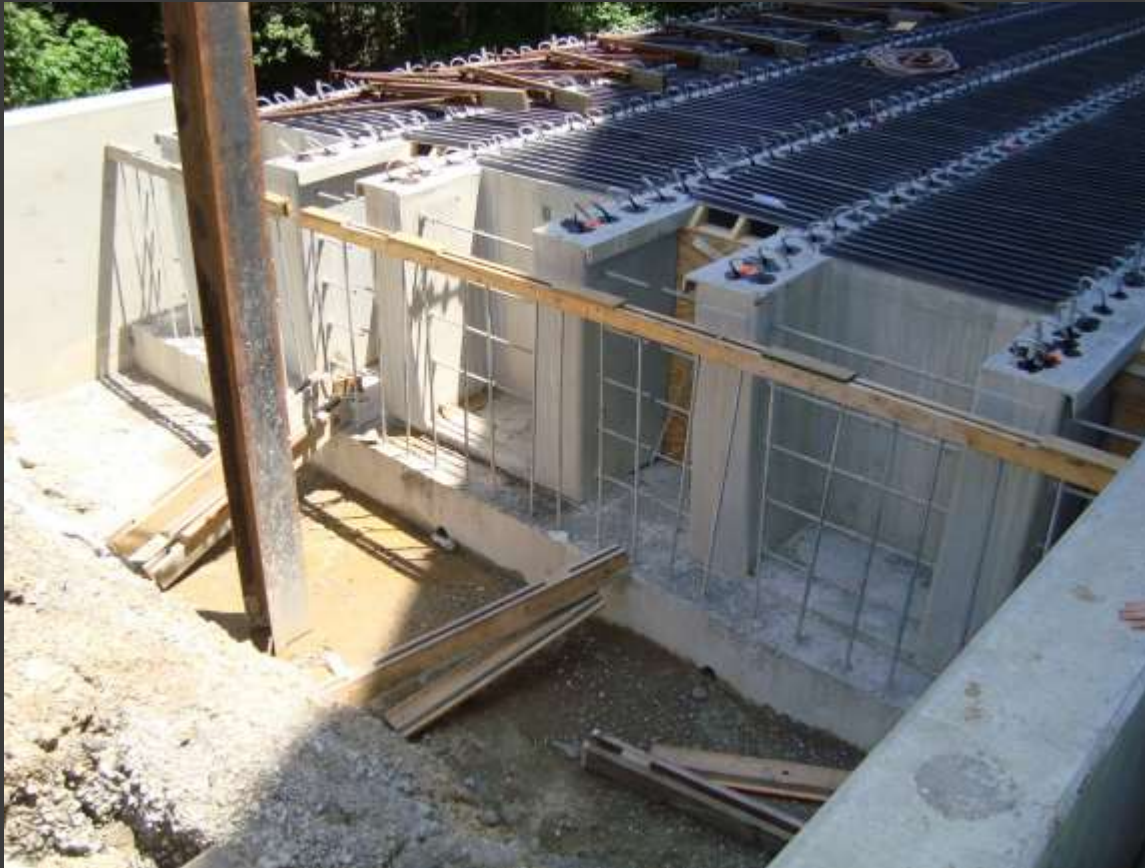
Dry Branch Bridge

- Bridge closed for 2.5 months during summer break
- Prefabricated beams (hybrid composite beams)

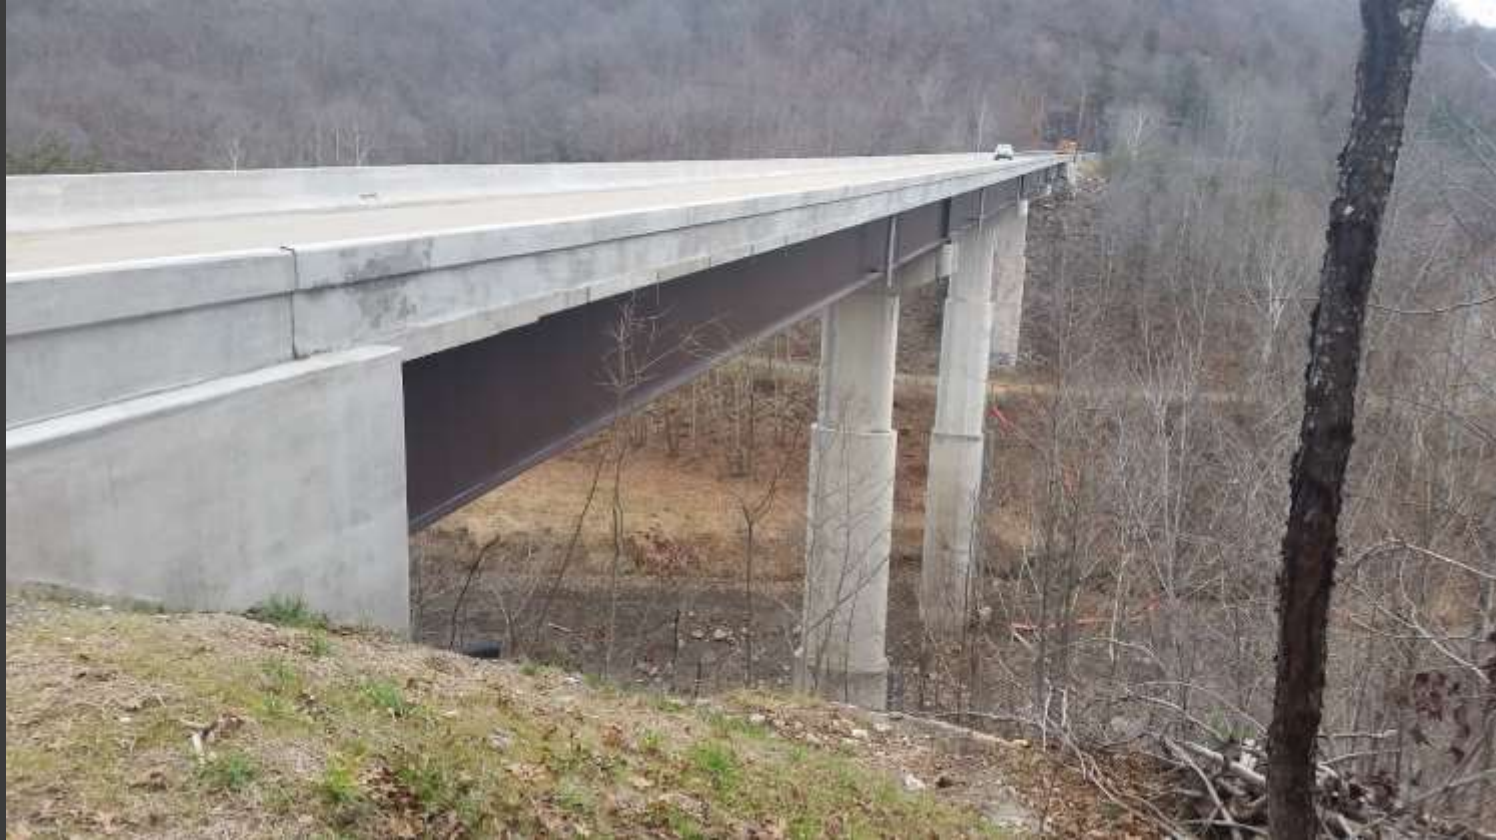
Rodney Staton Bridge

- Completed in 2015 at a cost of \$5.1 Million
- Precast deck panels

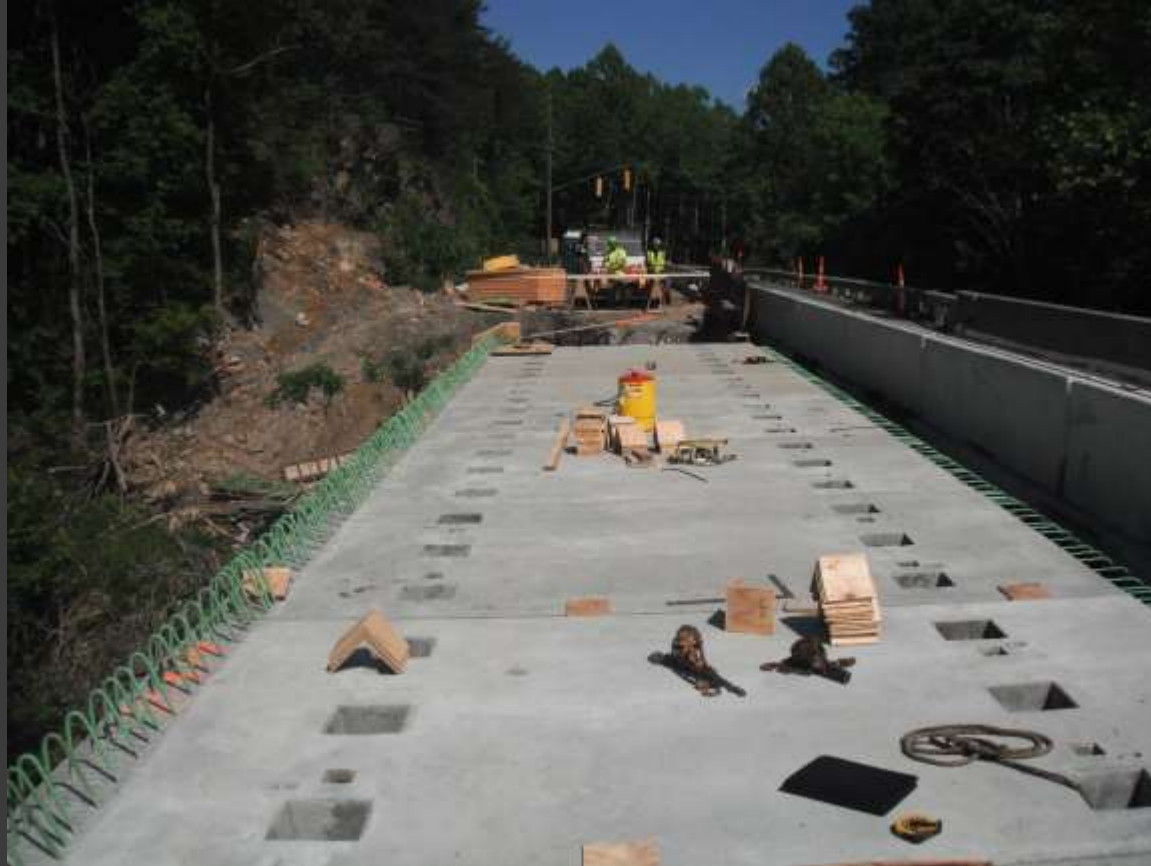
Rodney Staton Bridge

- Staged construction, longitudinal PT deck
- Integral abutments

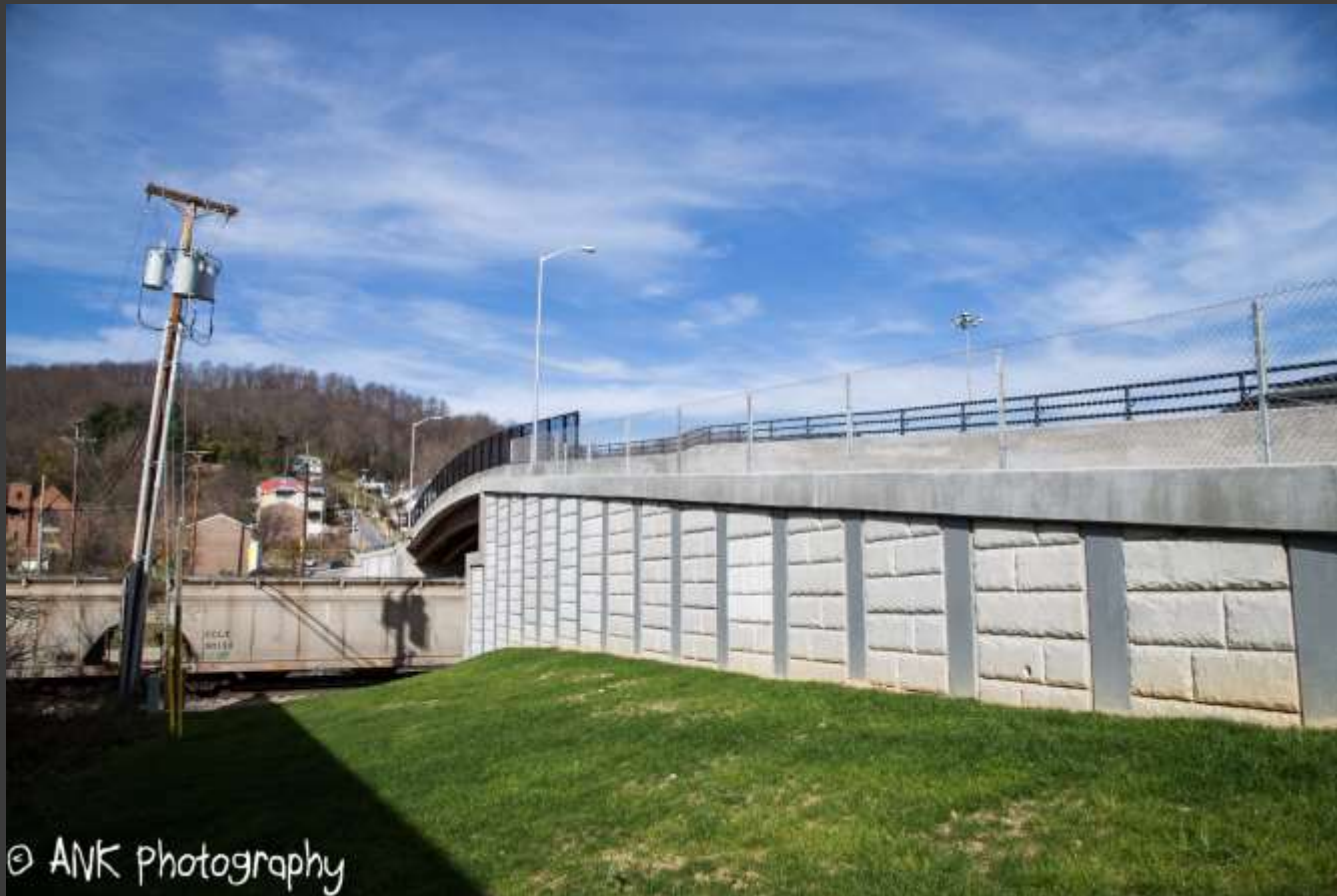
MLK Jr. Memorial Bridge

- Completed in 2015 at a cost of \$7.2 Million
- Precast deck panels, abutments & wingwalls

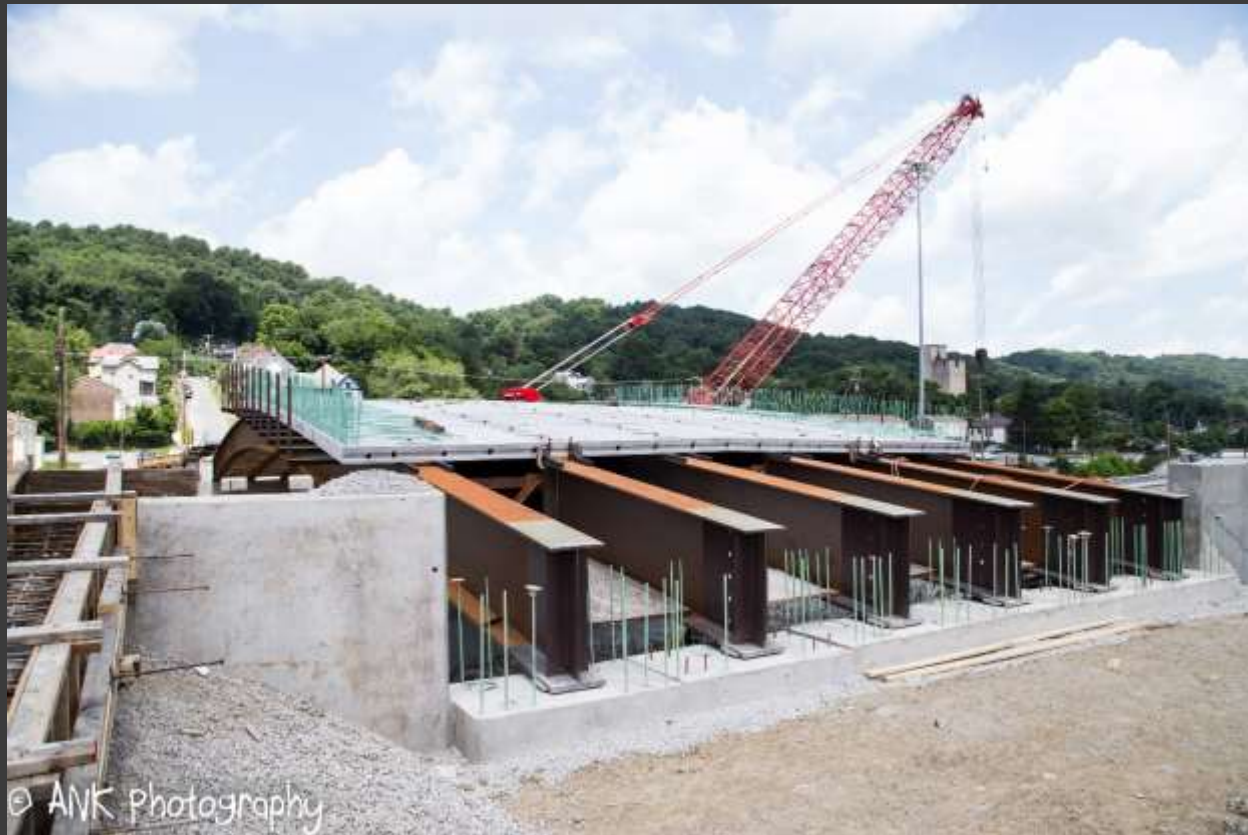
MLK Jr. Memorial Bridge

- Bridge closed to traffic for 2 months
- Longitudinal PT, integral abutments, 167 ft. span

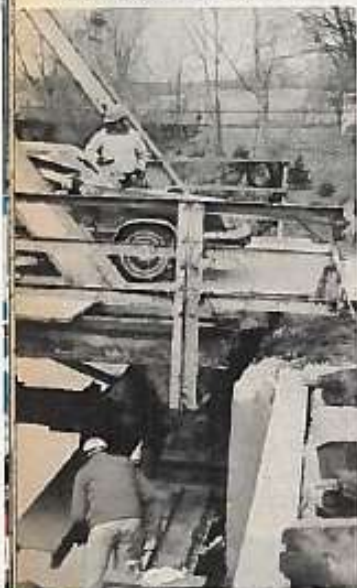
Jacking and bridge movement took place under traffic.

On the day of the move the 350-ton bridge was jacked vertically approximately 6 in. using a pair of 50-ton, 6-in. stroke jacks at each corner, with a maximum lift speed of 4 in./min. After raising, the structure anchor bolts were burned off flush with the masonry plate and the bearing and masonry plates were removed. Blocks were placed under the bearing seats, the jacks were blocked up and the process of jacking the bridge 6 in. was repeated.

Traffic, one car at a time, was allowed to cross the bridge, guided by a flagger at each end, during the lifts. Traffic was stopped during the time when jacks were relocated for the second lift.

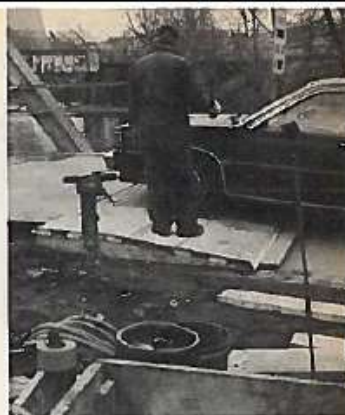
Temporary wooden ramps were used for traffic during the move.

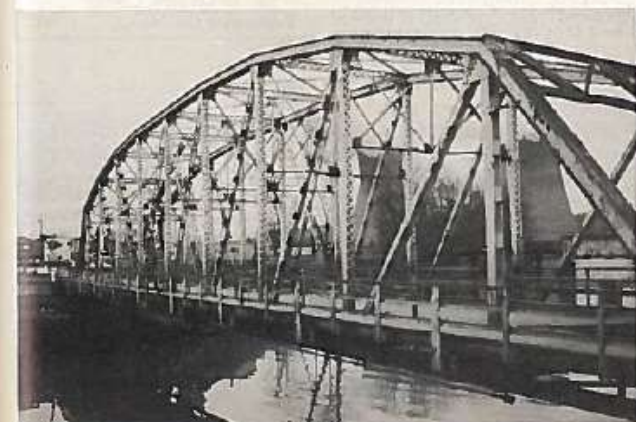
Existing jacked 39 ft upstream under traffic in 9 hours

The Pocahontas Bridge is a truss structure, built in 1922

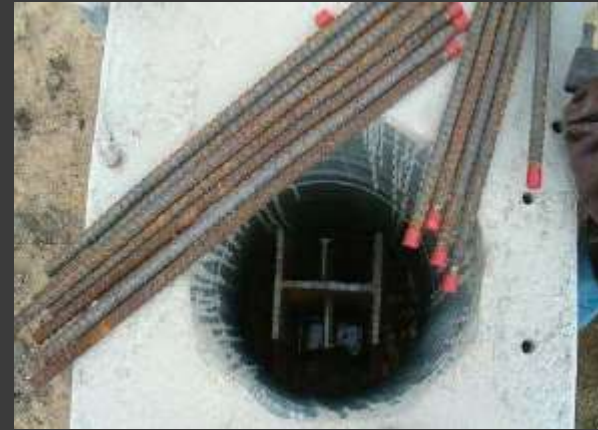
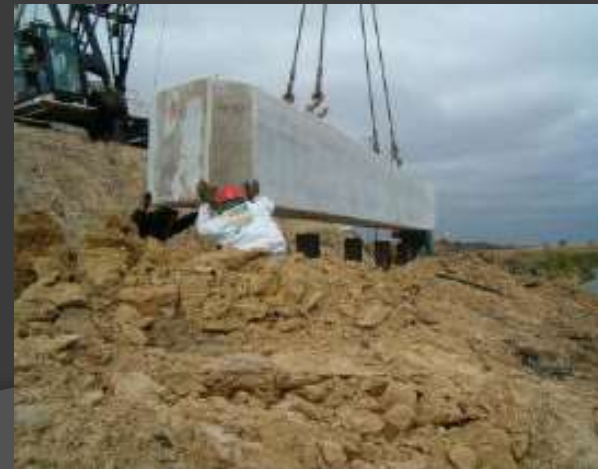
Accelerated Bridge Construction (ABC) Lateral Slide

- Prepare for existing bridge closure
 - Public meetings, media releases
 - Necessary traffic signs
 - Install and test slide equipment
 - Raise new structure , place slide/rollers
- Close existing bridge
 - Demolition
 - Excavation of pre-installed piles and abutments to grade
 - Set precast abutments
 - Fill abutment cavities with high-early strength concrete
 - Jack new structure into position
 - Replace slide/rollers with elastomeric bearings
