Development of Prefabricated Concrete Bridge Railings

QUARTERLY PROGRESS REPORT

Updated to include progress between January 1, 2018 to May 31, 2018 Period

Iowa State University

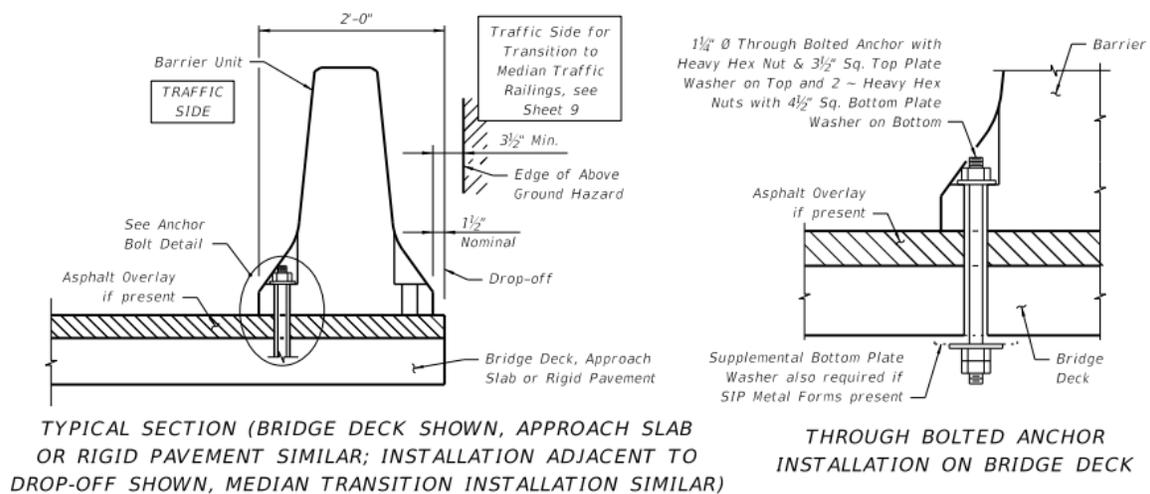
Figure 1 Through-Deck Bolting Detail (Source: FL DOT 414)

Common methods for anchoring precast concrete barriers to bridge decks include through-deck bolts and adhesive anchors. With the through-deck anchoring method, a hole is drilled through the entire bridge deck and a bolt is inserted through both the barrier and the deck. It is secured with heavy washers and nuts on both ends of the steel bolt. One issue with this design is getting access to the underside of the bridge to secure the nut. Another issue is weathering of the exposed connection. Figure 1 shows a typical anchoring detail for the through-deck configuration.

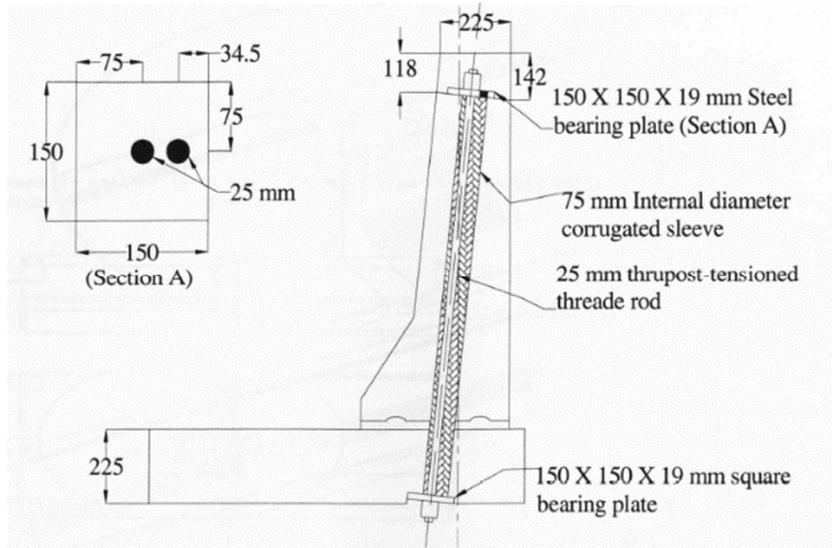
Figure 2 Barrier to deck Slab Connection (Source: Patel Dissertation, Fig 3.1)

A different way of connecting a barrier with the through-deck method is by pretensioned rods that are inserted all the way through the wall and the deck slab. They are then anchored to the bridge deck by end plates, washer, and nuts. An example of this can be seen in Figure 2.

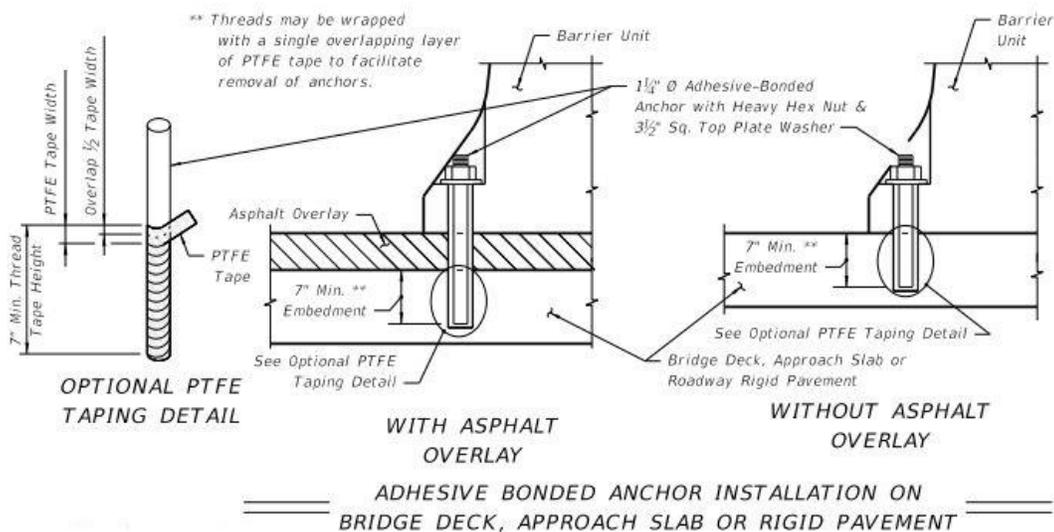
Figure 3 Adhesive-bonded Anchor Detail (Source: FL DOT 414)

Another precast concrete barrier anchoring technique that is used is an adhesive-bonded anchor. This method is completed by drilling a hole into the bridge deck and then inserted the threaded bolt through the barrier and into the deck. The bolt is then secured with an adhesive. This method can be seen in Figure 3. One issue with this anchoring method is the strength of the adhesive used.

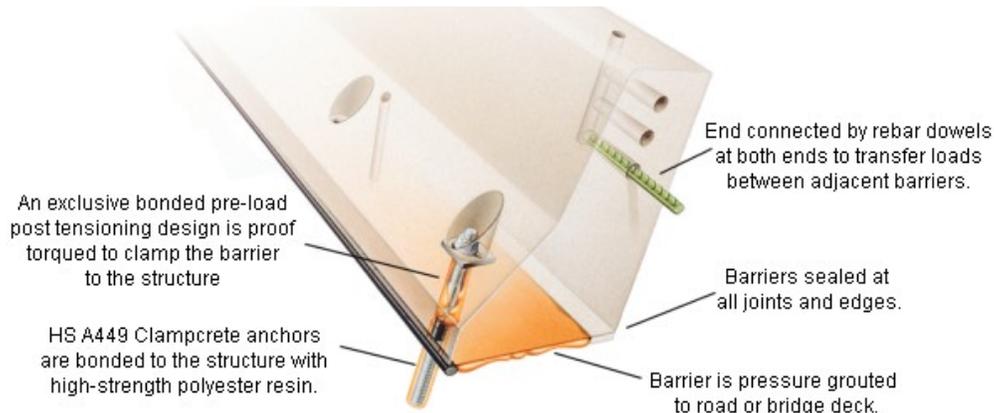
Figure 4 Clampcrete Barrier System (Source: clampcrete.com)

A precast barrier wall system similar to the adhesive anchored connection is engineering and patented by Clampcrete. It has been crash tested and approved for use. It is connected to the bridge deck by polyester resin anchors that are drilled into the bridge deck. This system is shown in Figure 4.

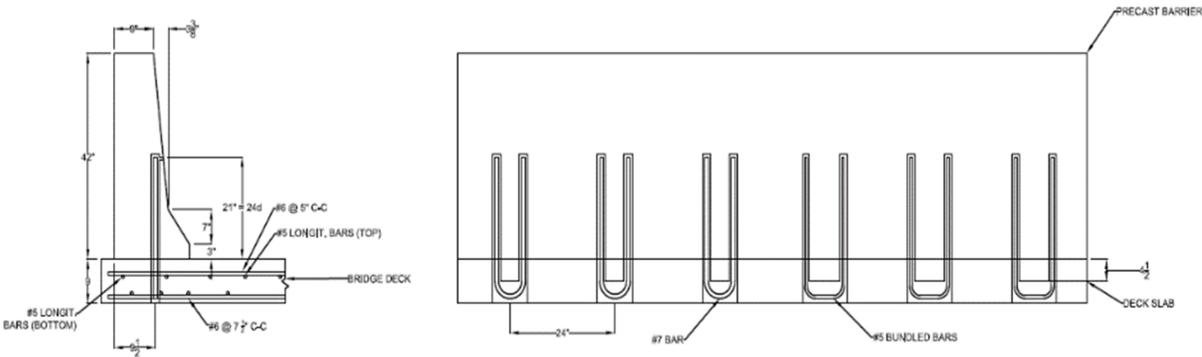
Figure 5 Details of Connection Using U-Bar

For this project, based on a nationally conducted survey, an F-shape profile was chosen. When connecting the precast concrete barrier to the bridge deck, two connection concepts were designed. The first design concept includes a u-shaped stainless steel bar that is inserted through the bottom of the bridge deck and into the barrier segment. The u-shaped rebar will then be secured with 10 ksi, non-shrink, fiber grout. This concept can be seen in Figure 5.

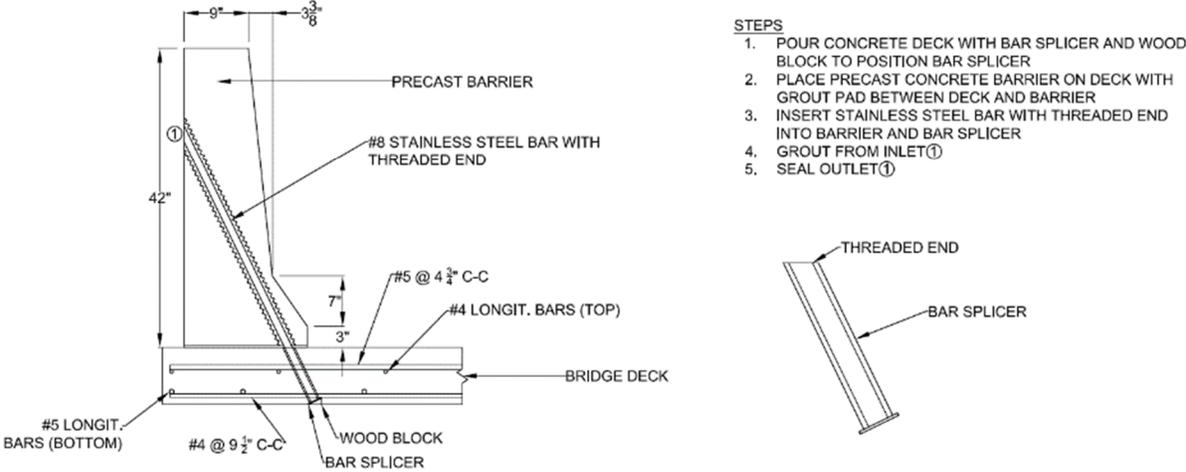
Figure 6 Details of Connection using Stainless Steel Bar with Threaded End and Bar Splicer

Another concept consists of an inclined stainless steel bar and bar splicer. The bar splicer will be precast into the bridge deck. Then the stainless steel bar will be inserted into the barrier segment and threaded into the bar splicer. This connection will also be sealed with grout and is shown in Figure 6. Figure 7 shows a photo of the bar splicer that will be used.

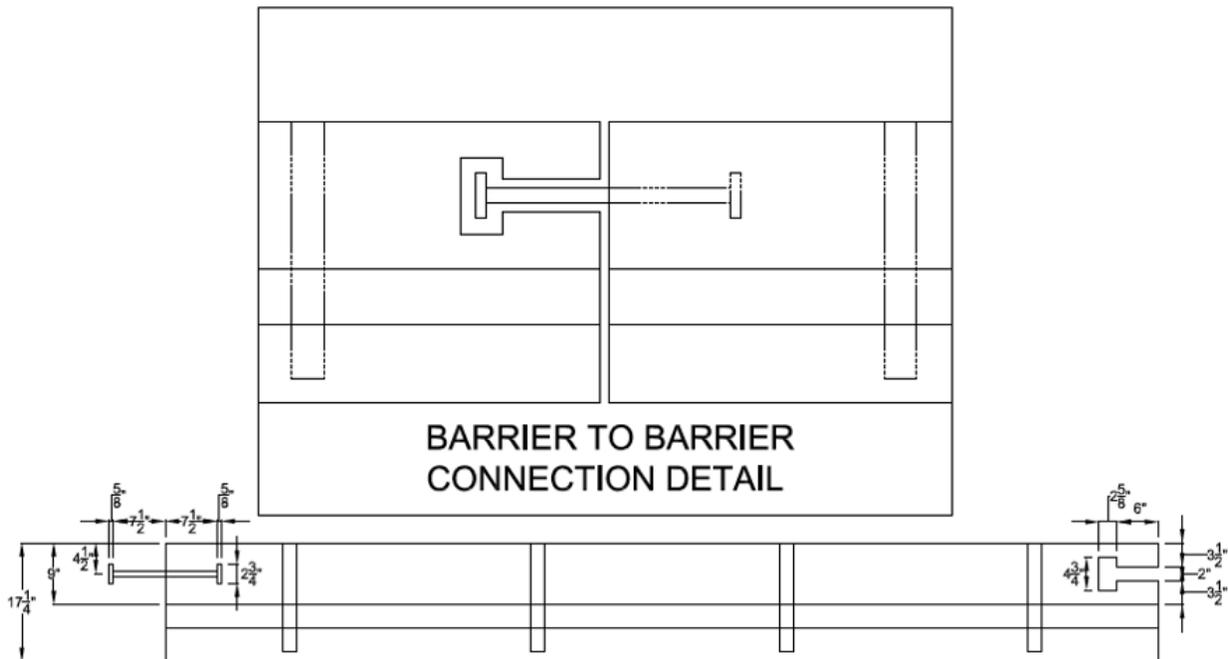
Figure 8 Barrier Connection Detail

The barrier-to-barrier connection detail includes four headed rods precast into the end of the barrier segment. The headed rods are inserted into a pocket in the adjacent barrier. Figure 8 shows this detail. Also, more detailed drawings of the barrier test concepts are included at the end of this report.

The test level 4 design load of 54 kips was used to design the connections. To limit the damage to the barrier and bridge deck, the connections were designed to allow the connections to fail instead of the barrier and bridge deck.

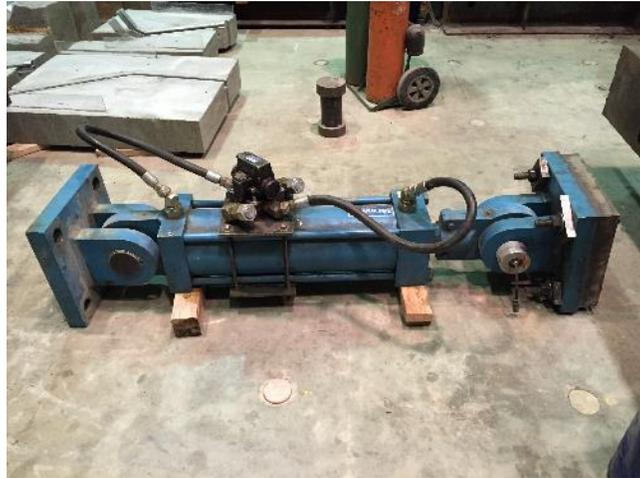
Figure 9 Hydraulic Actuator

Task 3: The two barrier connection systems shown above have been tested in the laboratory with quasi-static testing. The loads were applied cyclically using a hydraulic actuator. The systems will be evaluated based upon how they impact their individual strengths and how they impacted the

performance of the deck overhangs used to support the railing. The actuator that will be used in shown in Figure 9.

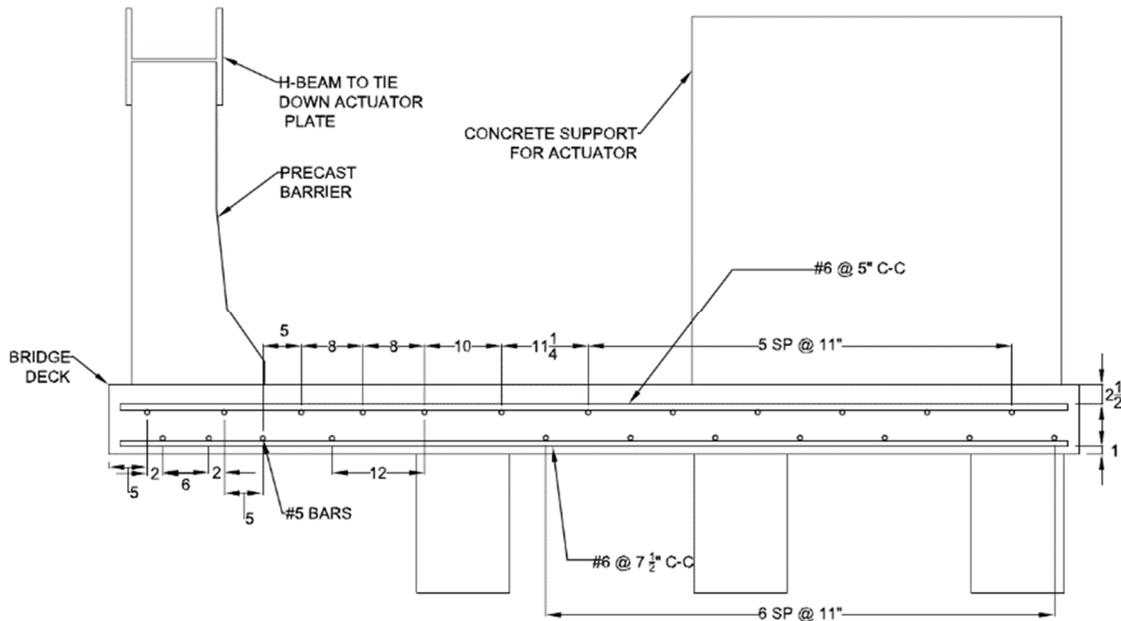
Figure 10 Lab Test Set-up

The barrier segments were tested individually to test the barrier to deck connection. Then they were connected and tested again. The force was applied at the joint to measure the force distribution. A ponding test will also be conducted on the connections to test for durability. A schematic drawing of the lab test set-up can be seen in Figures 10 and 11.

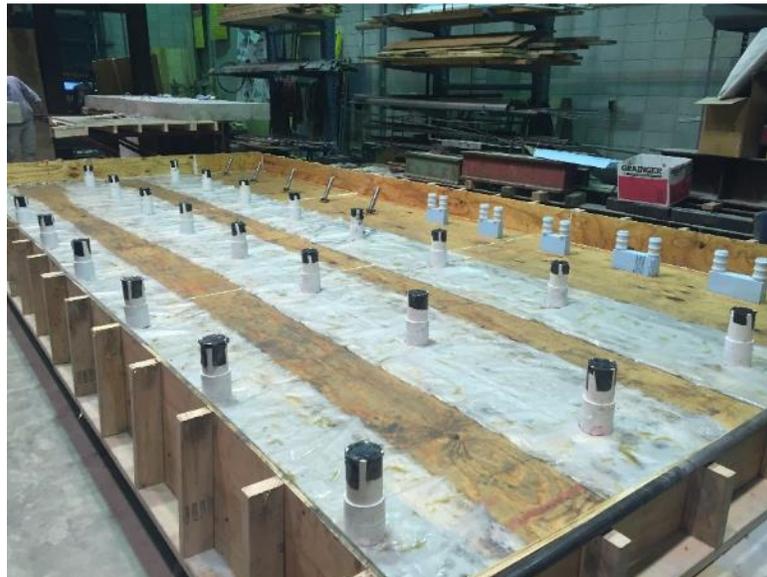
Figure 11 Concrete Beams with Deck Slab Formwork

Three concrete beams support the deck slab. The deck slab will have an overhang of 3.5 feet. The hydraulic actuator was mounted onto the concrete block to apply load along the precast barrier segments. The concrete blocks are anchored into the lab floor. The concrete beams and the formwork for the suspended deck slab are shown in Figure 12.

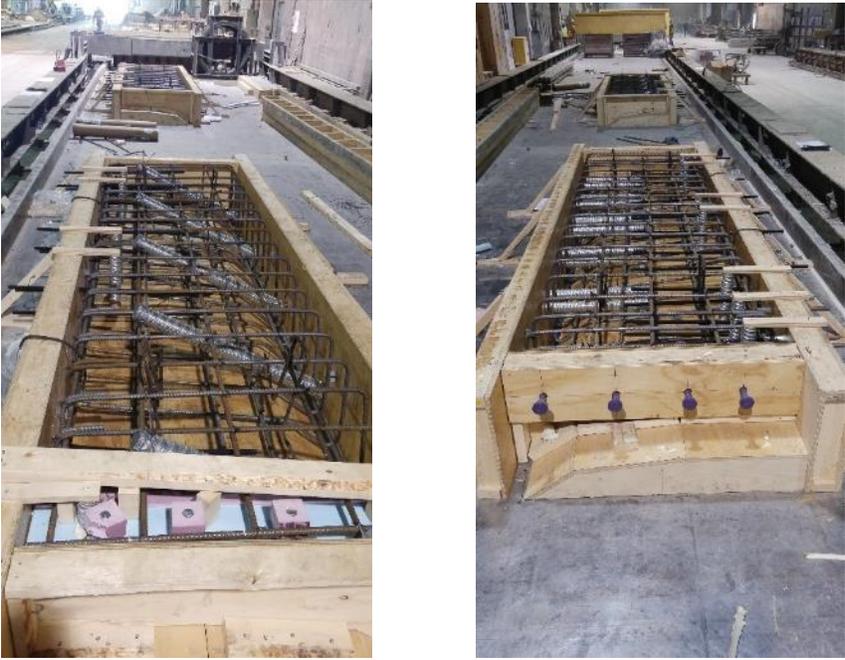
Figure 13 Precast Barrier Fabrication

The construction of the barrier rails was fabricated by a precast plant in Omaha. They were delivered to the Iowa State Lab February of 2016. Images of the precast construction are shown in Figure 13.

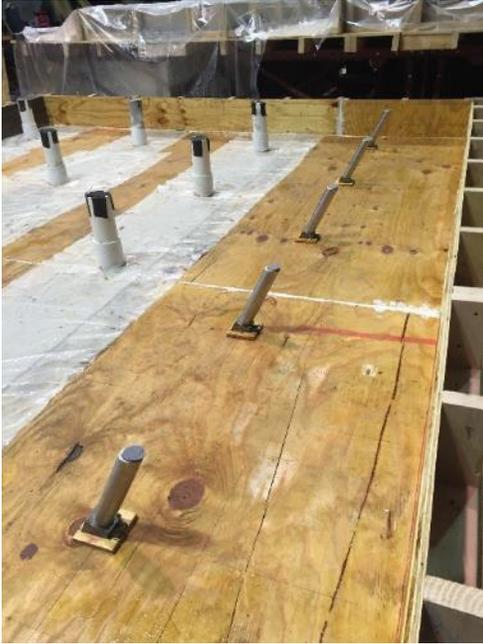
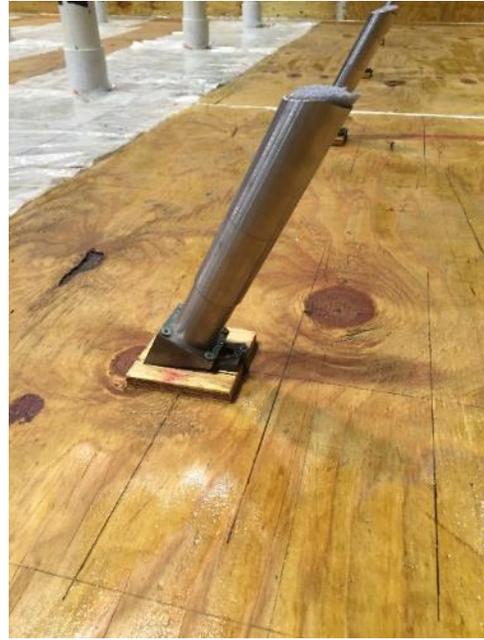
Figure 14 Inclined Bar Connection in Bridge Deck

The construction of the deck slab and the loading block were done in the Iowa State University Structures Lab. The following images (Figures 14-16) display the progress in the lab.

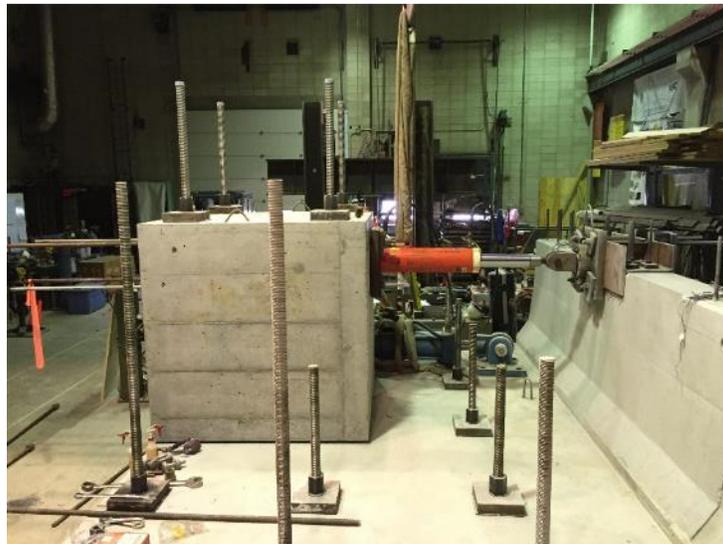
Figure 17 Test 1 (PBI Middle) Setup

Laboratory testing began March of 2016. The first laboratory test was conducted on the precast barrier with the inclined rod connection, PBI. The loading block and actuator were set up to apply loads to the center of PBI. The test setup is shown in Figure 17. The push load was applied incrementally up to 54 kips. It was applied in six kip increments.

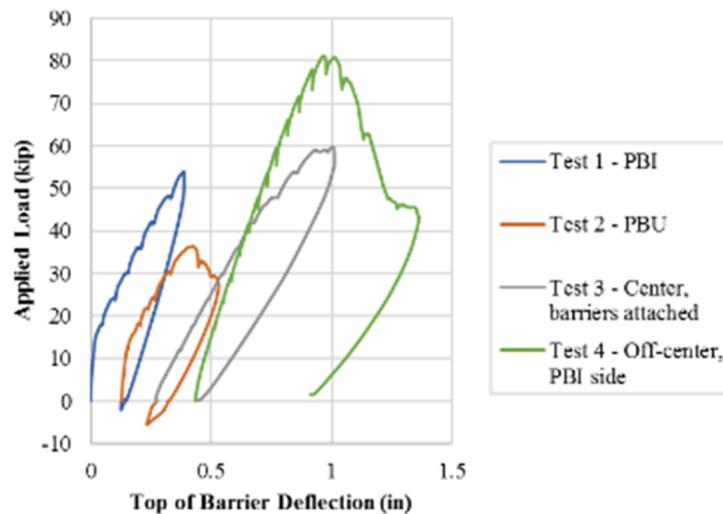
Figure 18 Continuous test plot of top of barrier deflection for Tests 1-4

For the first two tests performed, the barrier to barrier connection was left ungrouted and disconnected. The inclined connection was tested first with the center not grouted and not connected. This allowed for an individual test of the inclined barrier itself. The u-bar connection was then tested second. After this test was completed, the bar splicers were threaded in and the center connection was grouted. Once the connection between the two barrier segments was established, the third test was conducted directly to the center of the two barriers. For the fourth test, the load was applied just off-center of the barrier to barrier connection. It was tested on the PBI side of the test specimen to ensure that we achieve the selected failure mechanism. The last two experiments included load application to the free ends of both PBI and PBU. The chart below, Figure 18, illustrates the top of the barrier’s deflection throughout the course of the first four tests. Even though the actuator was moved for each test, a single reference point was used at the center of the entire test specimen and was used to create the continuous plot.

Test 1 of PBI was taken to the desired target force of 54 kips. Test 2 of PBU experienced premature failure and was terminated at 36 kips. Test 3 conducted at the center barrier-to-barrier connection was tested to the desired target force of 54 kips and then take one six kip increment farther to observe results. In order to protect any more damage to PBU during Test 4, which was conducted on the PBI side of the barrier-to-barrier connection, a brace beam was added to the test unit to limit the deflection of PBU. This explains the increased stiffness seen in Test 4 in the previous Figure.

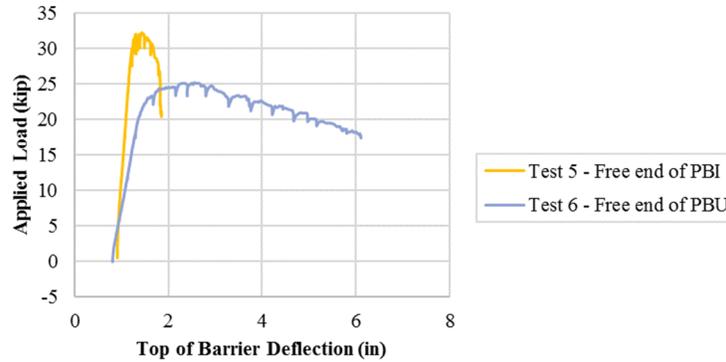
Figure 19 Top of barrier deflection for Tests 5 and 6

The top barrier deflection observed during Tests 5 and 6 are displayed in Figure 19. Test 5 was conducted on the free end of PBI and was taken to failure. Test 6 was conducted on the free end of PBU and was taken to failure. In both tests, the barriers were pushed to deflect the extent of the hydraulic actuator used to apply the force. They were also pulled in the opposite direction to observe damage.

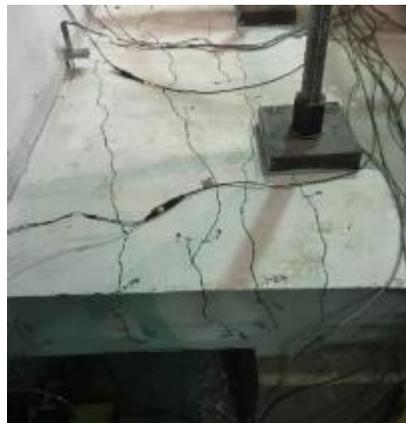
Figure 20 Test 1 (PBI Middle) deck cracks

The first barrier test performed as expected. The first two load increments produced no visible cracks on the test specimen. The deck began to crack as the applied load approached 18 kips. The initial cracks were noticed on the beginning of the bridge overhang, as seen in **Error! Reference source not found.** 20, three somewhat uniformly spaced flexural cracks were formed on the deck overhang. The deflection was 0.105 inches after 18 kips were applied to the barrier.

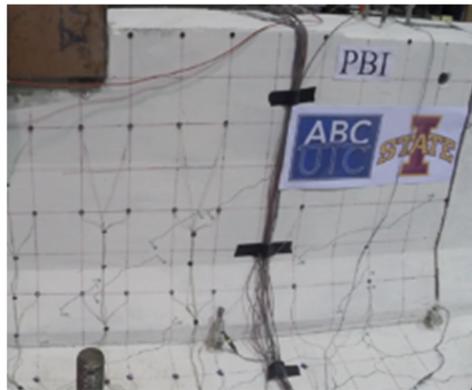
Figure 21 Test 1 (PBI Middle) barrier cracks

As load was increased, the flexural cracks extended along the overhang and over the side of the bridge deck. At 24 kips, cracks also began to develop along the grout pad that was placed between the barrier and top of the deck. At 24 kips, the deflection was measured at 0.215 inches. When the

load was increased to 30 kips, there were only minor crack extensions on the deck and on the side of the bridge deck. The measured deflection was 0.317 inches. It was at 36 kips when the crack on the deck extended over to the other side near the u-bar precast barrier, PBU. There was no crack extension on the side of the bridge but a new crack developed behind PBU near the barrier-to-barrier interface. At this point, deflection was 0.426 inches. The load was then increased to 42 kips, which led to small deck crack extensions and crack widening. The 42-kip deflection was 0.536 inches. It wasn't until the load reached 48 kips that diagonal, hairline cracks began to develop on the barrier near the barrier-to-barrier interface, see Figure 21. The deflection was 0.67 inches. Finally, the load was increased to the full 54 kips. The crack on the back of the deck behind PBU widened and the cracks on the side of the deck had small extensions. No new cracks were seen on the barrier. The deflection of PBI at this point was 0.81 inches, the majority of which was due to the deck rotation and the concentrated crack developed at the bottom of the barrier along the grout interface.

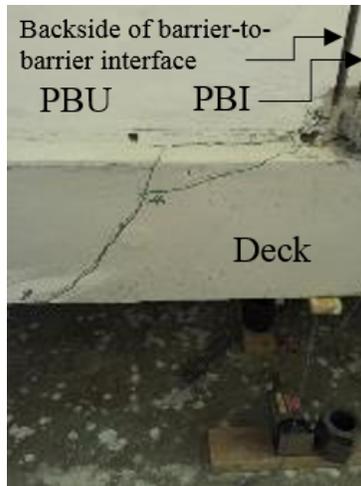
Figure 22 Formation of crack on back side of test unit during Test 1

After the loading was complete, the crack widths were measured. The thickest cracks appeared on the backside of the bridge deck behind PBU, see Figure 22. They were 0.083 inches. The thickest cracks measured on the bridge deck were 0.02 inches. The cracks that developed within the grout between the deck and the barrier on the front side of the barrier were 0.03 inches. On the side of the deck the cracks only thickened to about 0.007 inches.

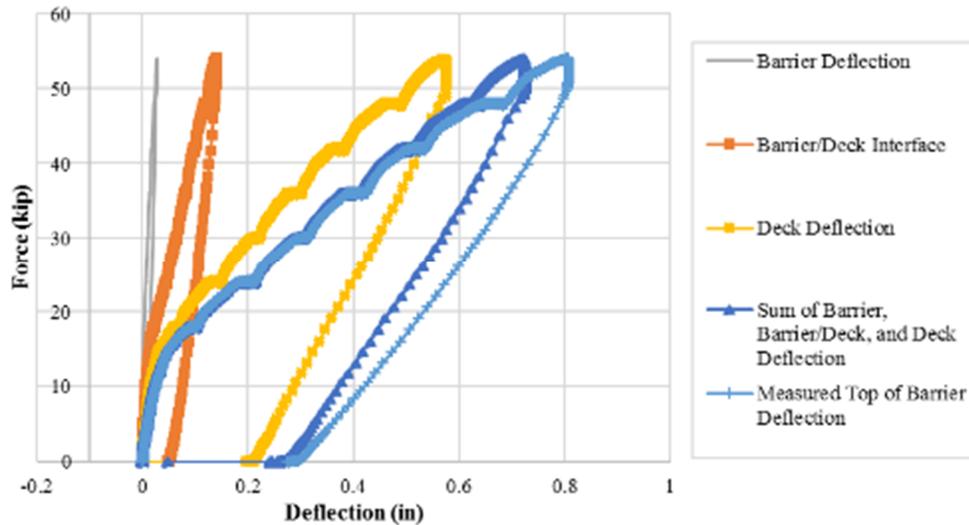
Figure 23 Test 1 Deformation of test components

The maximum measured barrier displacement during Test 1 was 0.81 inches, which included the flexural deflection of the barrier, the rotation of the barrier at the deck interface, and the barrier deflection resulting from the rotation that the deck overhang experienced. As shown in Figure 5.9, the barrier's flexural deflection was only about 3.5% of the total deflection at 0.028 inches and the deflection of the barrier due to formation of a crack at the barrier to deck interface accounted for 17.3% at 0.140 inches. This implies that the majority of the measured barrier deflection was largely due to the rotation of the deck. The deck's deformation was somewhat amplified by a large deck crack that developed on the backside of the deck behind PBI-PBU connection region, see Figure 23. This crack developed because during Test 1, the barriers were not connected, therefore not engaging PBU in resisting the applied load.

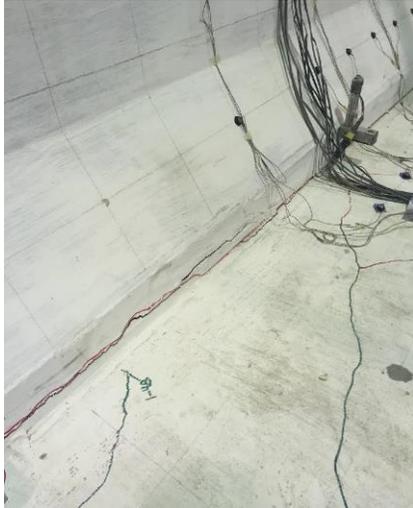
Figure 24 Crack at barrier and deck interface during Test 2

The first three intervals, up to 18 kips, performed very similar to response of PBI in Test 1. New deck cracking began around 18 kips. At this point, the barrier was deflected 0.164 inches. At 24 kips, a crack became visible along the entire length of the grout pad between the bottom of the barrier and the top of the bridge deck, see Figure 24. The existing cracks continued to widen up until about 36 kips. Some softening in the system was observed when the load was about 36 kips and the barrier began to experience large displacements. The test was paused and unloaded after the barrier deflection reached 0.8 inches.

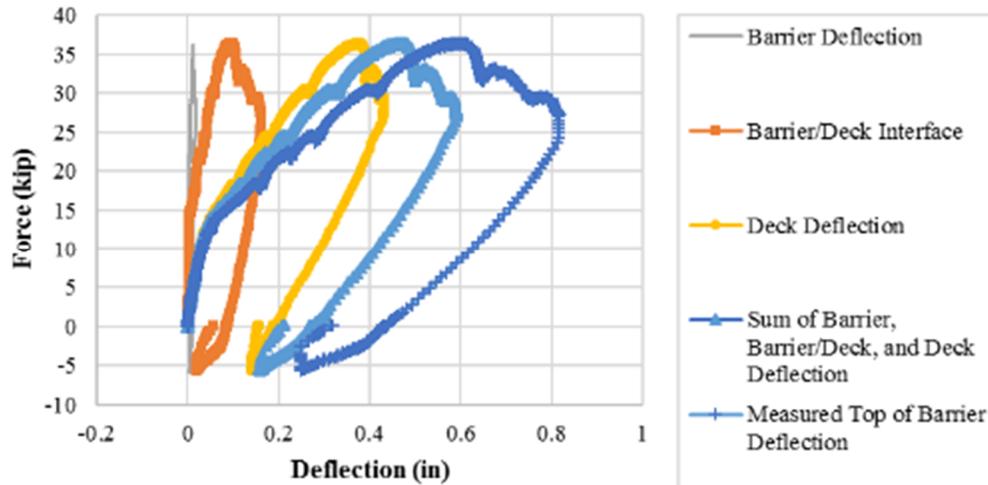
Figure 25 Test 2 deformation of test components

The various deflections of the specimen during Test 2 again included the flexural deflection of the barrier, the rotation of the barrier at the deck interface, and the barrier deflection resulting from the rotation that the deck overhang experienced and are shown in Figure 25. Although the maximum measured barrier deflection during Test 2 was recorded at 0.8 inches, the barrier's deflection accounted for 2.1% of the deflection at 0.017 inches and the deflection at the barrier and deck interface accounted for 20.3% at 0.162 inches. As with Test 1, the majority of the measured barrier deflection was mainly due to the rotation of the deck. The large deflection and rotation recorded were suspected to be due to insufficient development length of the deck overhang reinforcement.

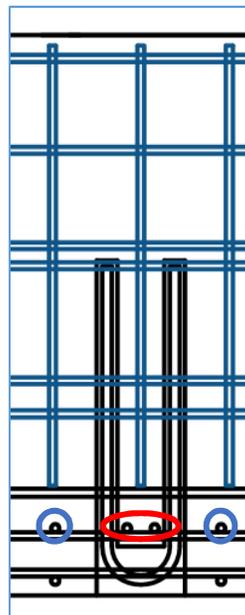
Figure 26 Schematic Drawing of Deck Reinforcement of U-bar

The larger deflection and larger rotation recorded during Test 2 was suspected to be due to insufficient development length of the deck overhang reinforcement. The construction of the u-bar reinforcement placed two bars from the top deck mat within the confines of the u-shaped bar, see the red circle in Figure 26. Figure 27 is a coordinating photo from the actual testing results. The two bars within the u-bar separated from the top reinforcement mat within the deck.

During the isolated testing of the u-bar connection, Test 2, the barrier was able to resist 36 kips without experiencing significant rotations. Larger rotation occurred from this point onward with localized deformation concentrated at the bottom of the barrier. This was suspected to be due to insufficient development length of the top deck reinforcement.

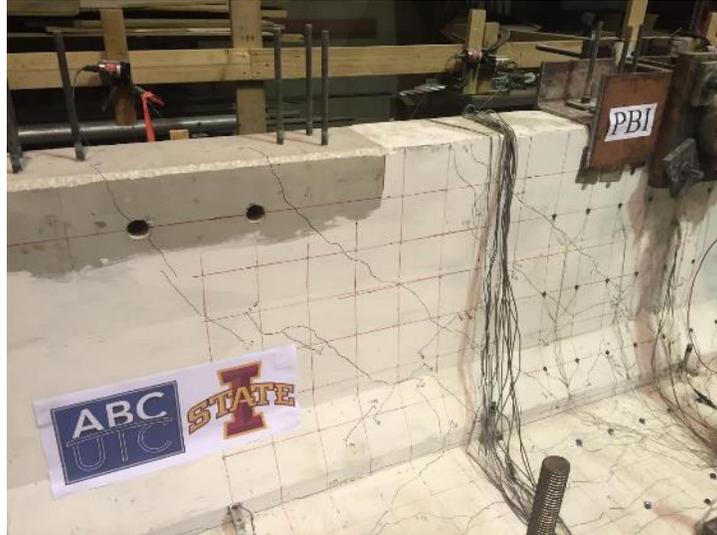
Figure 28 Diagonal cracks during Test 3

The third test was conducted on the precast barrier system between the two barriers. The loading block and actuator were set up to apply loads to 3.5 feet in the center of the entire test unit. The purpose of this test was to examine the connection between the precast barriers. Before testing could begin, the connection between the barriers was grouted. In the early stages of testing, no new cracks developed but old cracks began to open up. Around 30 kips a new crack appeared on the side of the bridge deck on the PBI side. It wasn't until 48 kips when cracks began to show on the barrier with the inclined connection. The cracks were diagonal cracks going in the opposite direction as the Test 1 cracks, see Figure 28. The center was able to hold a load up to 60 kips before it started dropping. The load was then released. The cracks along the grout between the barriers and the deck remained. The crack on the inclined barrier side of the grout pad was measured at a width of 0.005 inches. The u-bar side was measured at a width of 0.07 inches. The majority of the cracks appeared on the inclined connection side, no cracks appeared on the u-bar connection barrier. The inclined connection barrier was most likely taking all the load.

The test conducted on the barrier-to-barrier connection, Test 3, also performed as expected. The barrier system was loaded up to 60 kips with the inclined connection supporting the majority of the load. The strain experienced in the inclined deck connections was significantly more than the strain experienced in the u-bar deck connections. Test 4 included loading on the inclined side of the barrier to barrier connection and demonstrated the force distribution about the barrier to barrier connection and the failure pattern of the connection.

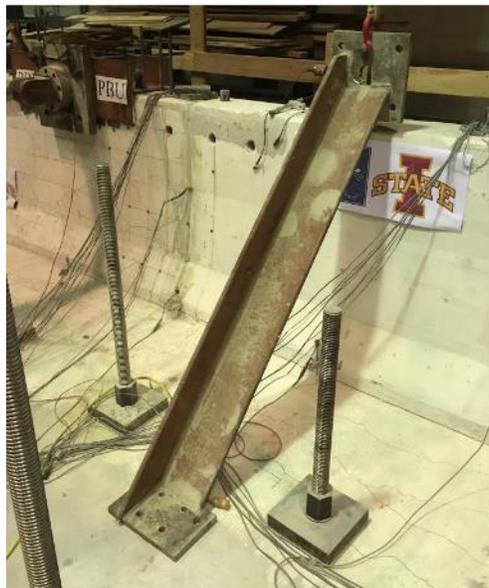
Figure 29 Beam used to brace the u-bar connected barrier during Test 4

For Test 4, the loading beam was placed to the inclined connection side of the barrier-to-barrier connection. The center of the load was about three feet from the barrier-to-barrier connection. The purpose of the test was to observe the force distribution about the barrier-to-barrier connection and to fail the center connection. Before this test was performed, a beam was placed on the u-bar side to brace the barrier and keep it from deflecting. This brace beam can be seen in Figure 29.

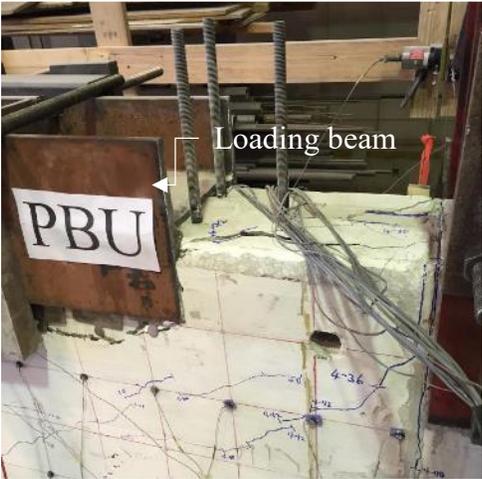
Figure 30 Cracking on barrier due to loading during Test 4

the grout between the barriers. A crack formed on the back of the barrier-to-barrier grout at 54 kips. This crack started at the bottom of the barrier. As the loads were increased, cracks continued to extend. At 72 kips, new cracks developed on the top of the barrier-to-barrier grout. The load was increased up to 81 kips before it started dropping. The test continued until the deflection was measured at 1.5 inches. Large cracks developed along the barrier under the loading beam, see Figure 30, and the barrier-to-barrier grout broke all the way along the top to the back, see Figure 31.

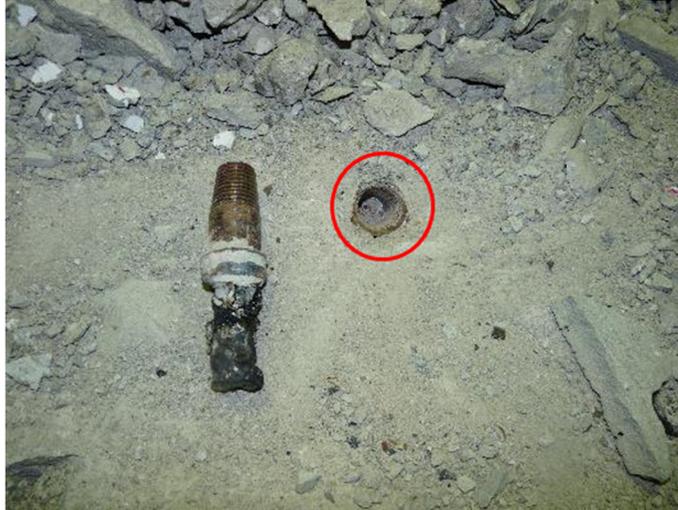
Figure 32 Removed Inclined Barrier Connection and Receiving Deck Piece

When an isolated unit of the inclined connection was subjected to test level 4 loading, it performed satisfactory, which was expected. The barrier, deck and barrier to deck connection performed well with no elastic strains developing in the deck reinforcement. The deck began to crack as the loading approached 18 kips. Hairline diagonal cracks were witnessed on the inclined connection barrier as the loading reached 48 kips. The cracking that developed on the deck was uniform and extended beyond the expected 45° force dispersion. As the applied load reached 54 kips, the top of the barrier experienced a total top lateral displacement of 0.81 inches. Removal of the system after testing proved that the threads in the embedded inclined deck piece remained intact. A replacement of this barrier segment and connection could be possible. Figure 32 shows the removed threaded bar and the intact deck receiving piece.
