Development of Manual for Enhanced Service Life of ABC Projects

QUARTERLY REPORT

Period ending August 31, 2018

Title: Development of Manual for Enhanced Service Life of ABC Projects

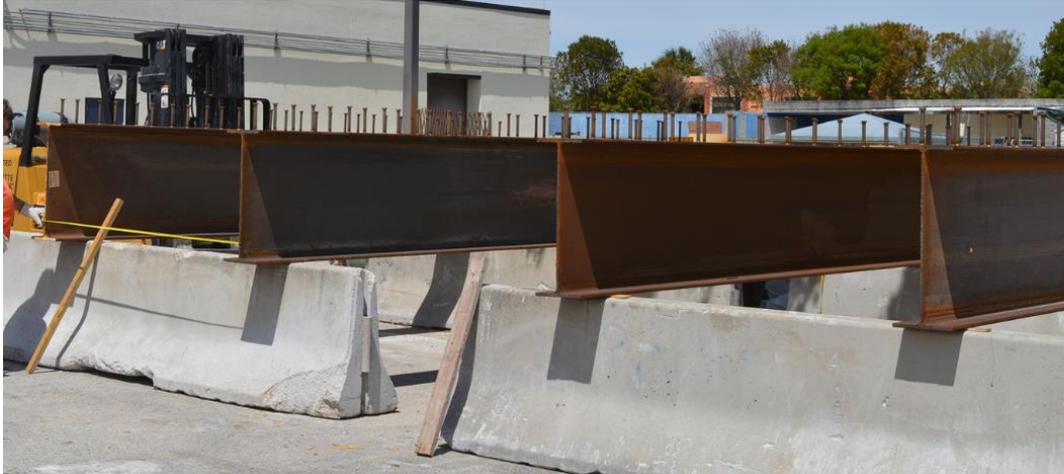
Fig. 2. Laboratory test specimens under construction, showing the girders and Nelson studs.

The second phase of the study includes construction of test specimens at the Structures Lab at FIU. Three (3) specimens have been constructed, each 15 feet long. The bridge girders are spaced 6 feet apart, and are WF 30 x 99 steel sections. Nelson studs are welded to the top flange. The girders are set on top of concrete jersey traffic barricades, and rest on elastomeric pads.

Each of the 3 specimens was constructed with a different closure pour detail. These include the 2 details discussed above, and the third will have a closure pour about 3 feet wide. This third detail is modeled after closure pour details implemented in the MASS 14 projects. The test specimens are complete. IR testing of the specimens has commenced.

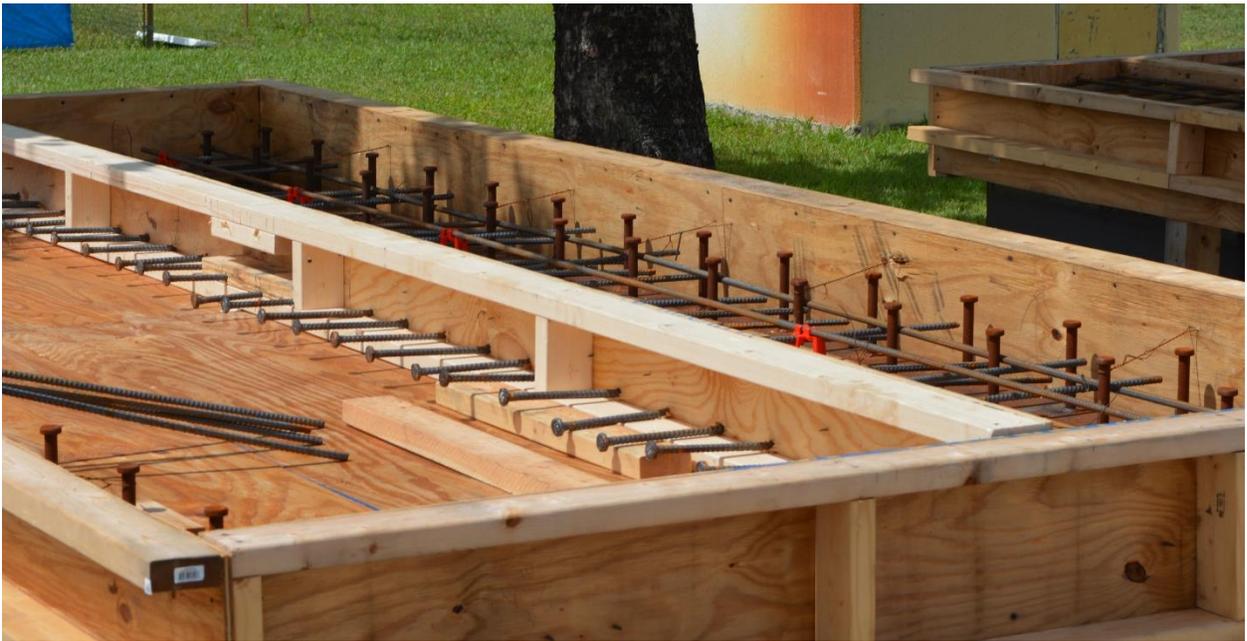
Fig. 5. Showing construction of the headed bar closure pour detail, modeled after Bridge A.

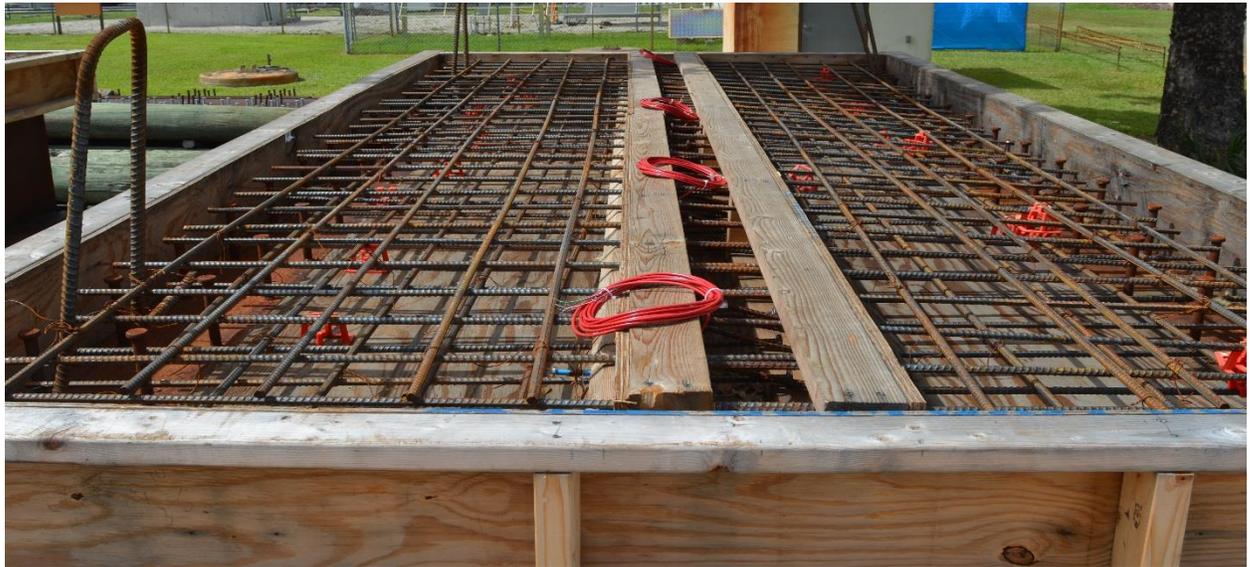
Fig. 6. Showing construction of the closure pour detail with hairpin bars, modeled after Bridge B.

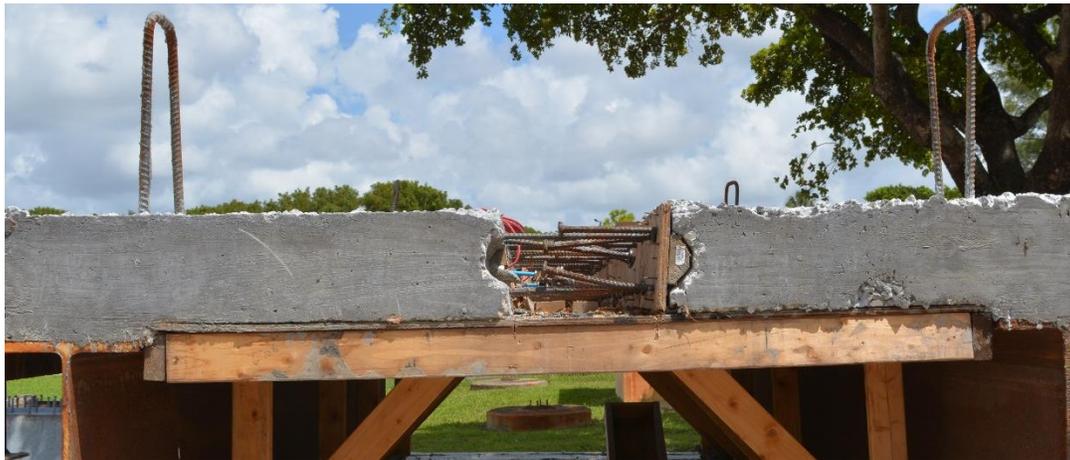
Fig 7. Showing headed bar detail. Note that forms have not been completely removed.

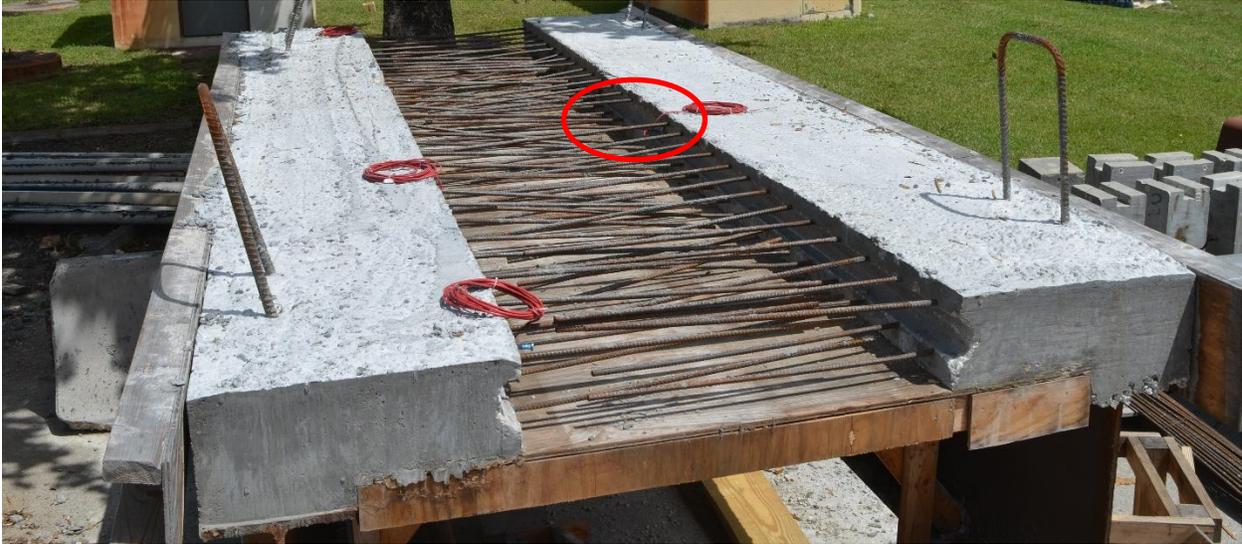
Fig. 8. Mass 14 detail, note bars are not extending through joint.

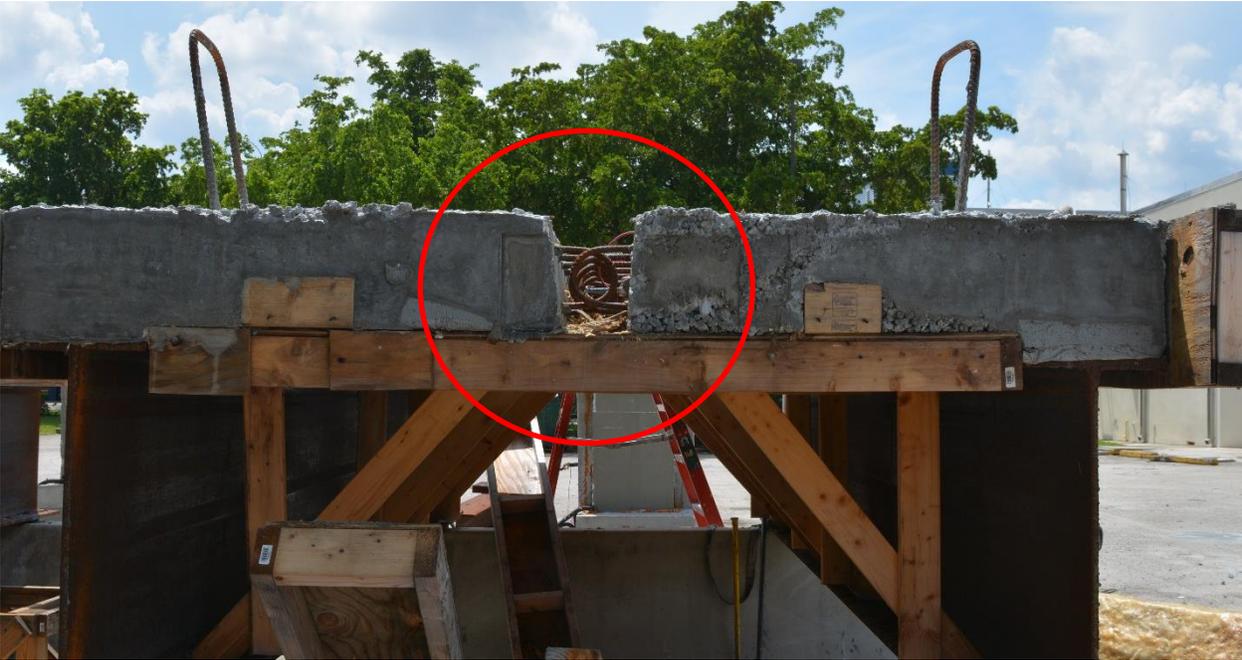
Fig. 9. Hairpin detail, note lack of keyway on this end.

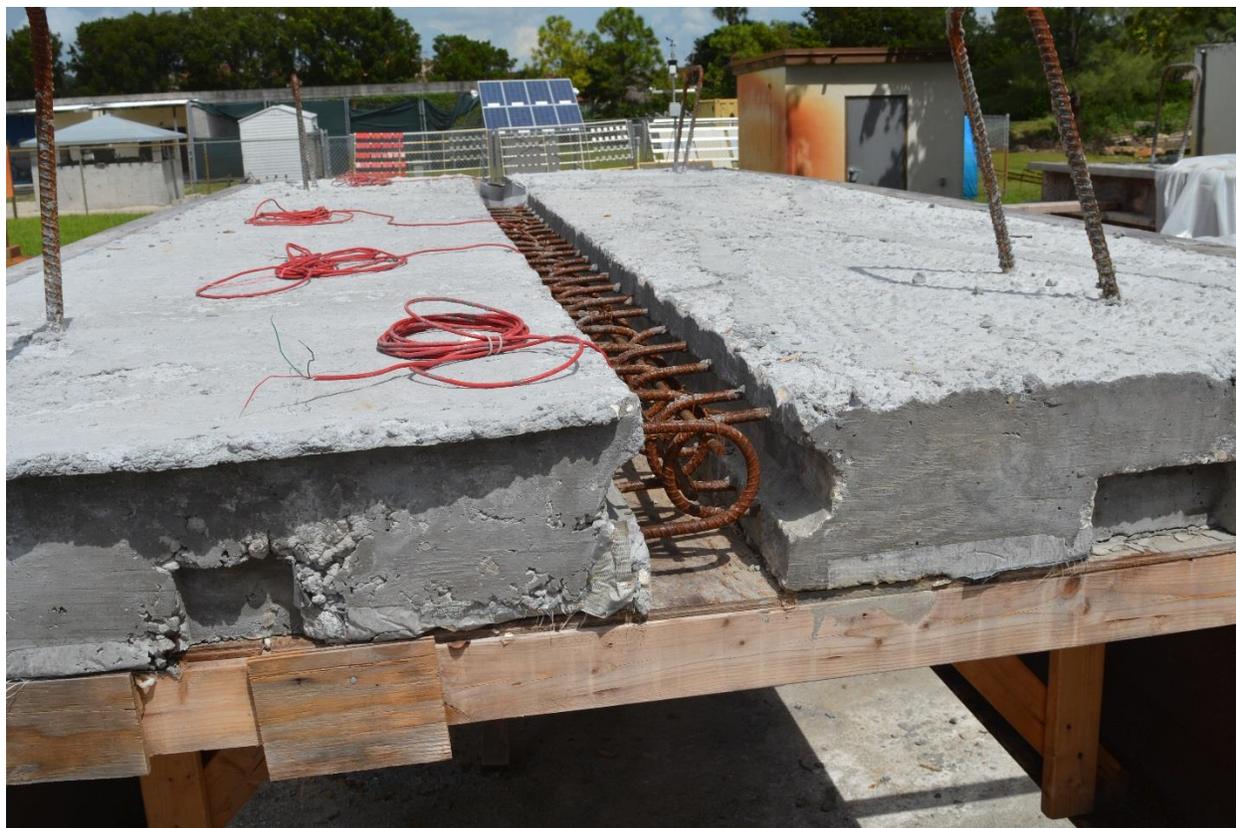
Fig. 10. Hairpin detail, note the keyway is present on this end.
