# Precast Concrete Bridge Barriers for Accelerated Bridge Construction

**Final Report**  
**October 2018**

**Sponsored by**  
Accelerated Bridge Construction  
University Transportation Center

IOWA STATE UNIVERSITY  
Institute for Transportation

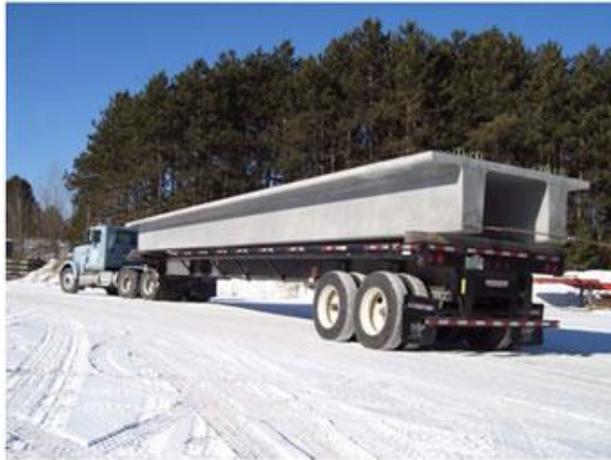
With ABC, the bridge components are built outside of the traffic area and transported to the bridge site where they can be installed quickly (Figure 1.2). This helps reduce the on-site construction time, weather-related delays, and impacts to traffic, while improving worker safety.

**Figure 1.2. Prefabricated bridge element**

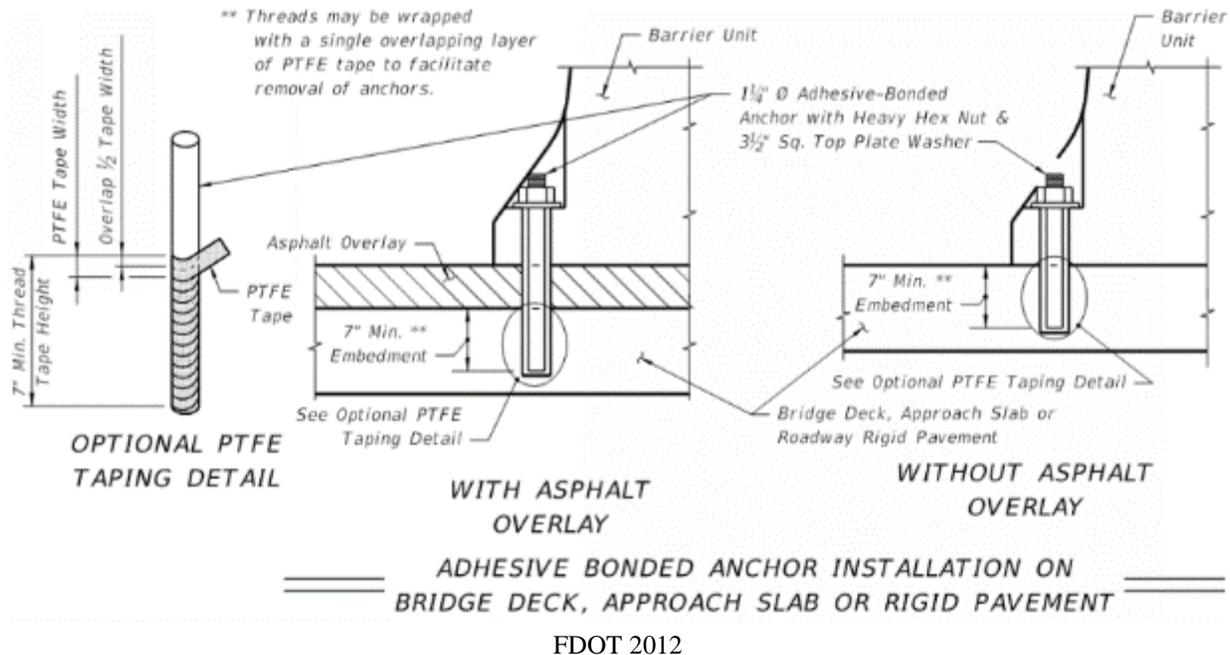
Another precast concrete barrier anchoring technique that is used by the Florida DOT is an adhesive-bonded anchor. This method involves drilling a hole into the bridge deck and then inserting a threaded bolt through the barrier and into the deck. The bolt is then secured with an adhesive. This method can be seen in Figure 2.5. This concept is used by the Florida DOT for median traffic barriers, but may also be used on concrete bridge decks. One issue with this anchoring method is the anchorage strength of the adhesive used.

**Figure 2.5. Adhesive-bonded anchor detail**

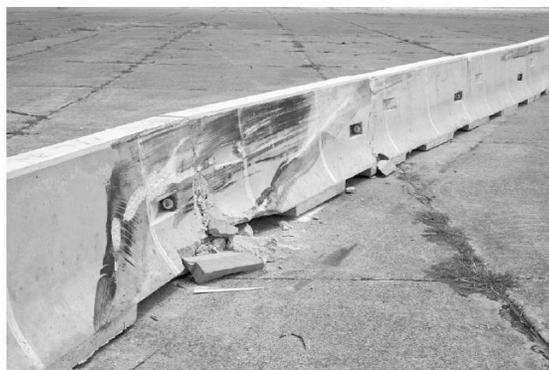
The barriers had a standard F-shape profile and were 32 in. in height. The cross bolts used a 7/8-in. diameter threaded rod and were 25-1/4 in. and 29 in. in length. The cross-bolt barriers were tested under TL-3. There were two crash tests conducted. One test consisted of 20, 10-ft long concrete barrier sections for a total test installment length of about 200 ft. A 4,960 lb pickup truck was used for the crash test. The resulting damage is shown in Figure 2.12. Some permanent deformation of the connection bolts was noticed when disassembling the barrier. The barrier system experienced 27.0 in. of maximum deflection.

**Figure 2.12. Damage to 10-ft long prefabricated barrier with X-bolt connections**

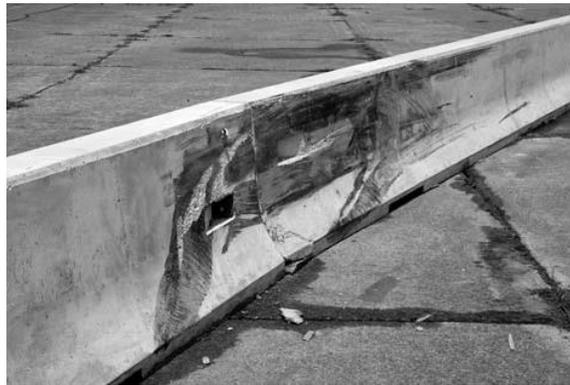
The second test had the same barrier and connection details, but the test installment included seven 30-ft barrier segments for a total length of about 210 ft. The pickup truck used for this experiment was 4,531 lbs. The damage resulting from the vehicle impact is shown in Figure

2.13. After the test, the connection bolts could easily be removed and possibly reused. The maximum deflection experienced by the system was 19.0 in.

**Figure 2.13. Damage to 30-ft long precast barrier with X-bolt connections**

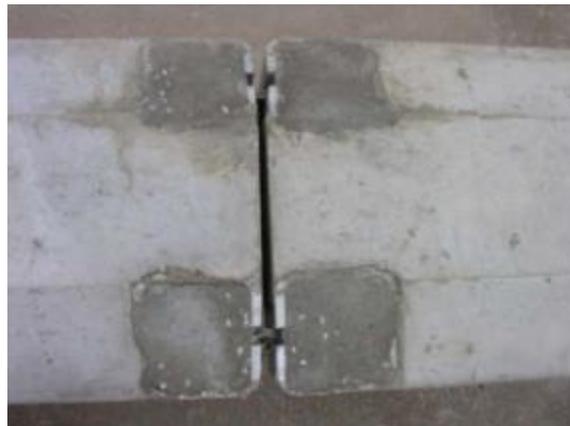
**Figure 2.16. A plan view of MWRSF I-shaped rail connection**

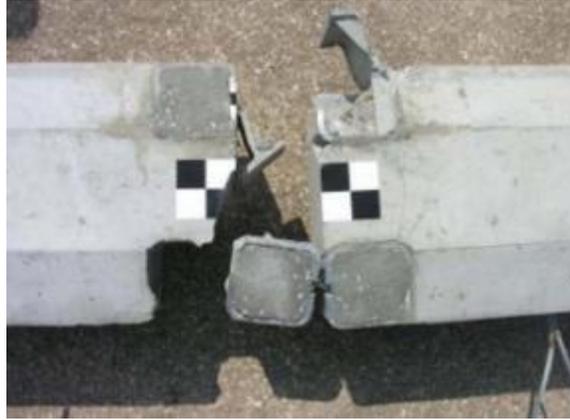
During the test, the joint failed and the rail segments completely separated. The connection was able to resist a force of 143 kips, exceeding the design forces needed for TL-4. The test connection and the failure of the connection are shown in Figure 2.16 and Figure 2.17, respectively.

**Figure 2.17. Failed MWRSF I-shaped rail connection**

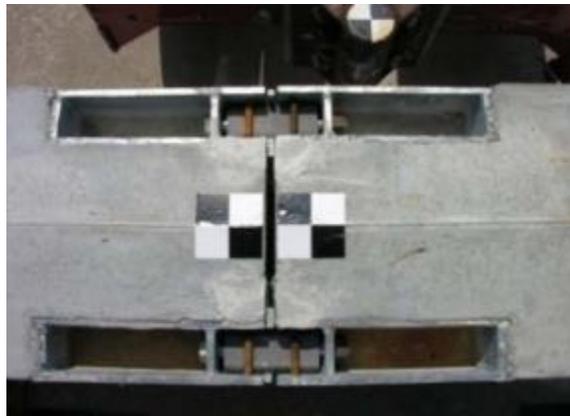
The second tested connection used two bolts and two shear tubes to connect the adjacent rails. During this test, the rails stayed connected, but the joint was severely damaged. The concrete between the steel pockets completely broke apart. The connection was able to resist a force of 102 kips, exceeding the design force of 54 kips needed for TL-4. The test connection and the failure of the connection are shown in Figure 2.18 and Figure 2.19, respectively. After these experiments were conducted, the results were analyzed, and they were redesigned according to their failures.

**Figure 2.18. Side bolts and shear tube connection prior to testing**

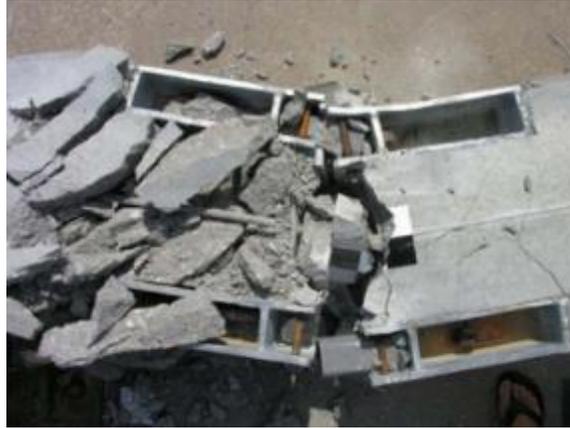
**Figure 2.19. Side bolt and shear tube connection failure**

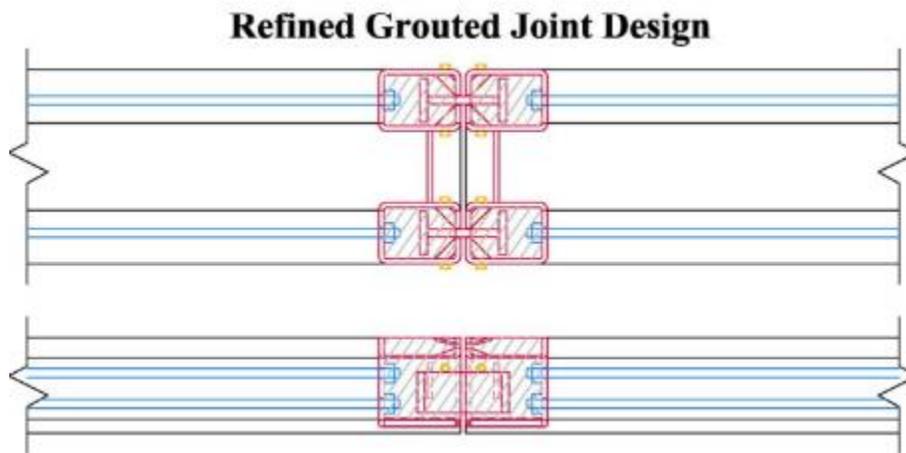
Redesign of the I-shaped steel connection included an increase in reinforcing steel bar sizes from no. 5 longitudinal reinforcing bar to no. 7 threaded reinforcing bar and the steel pockets were changed to steel tubes. The shear reinforcement was modified as well. To prevent the connection from prying open, shear bolts were added. This is detailed in Figure 2.20.

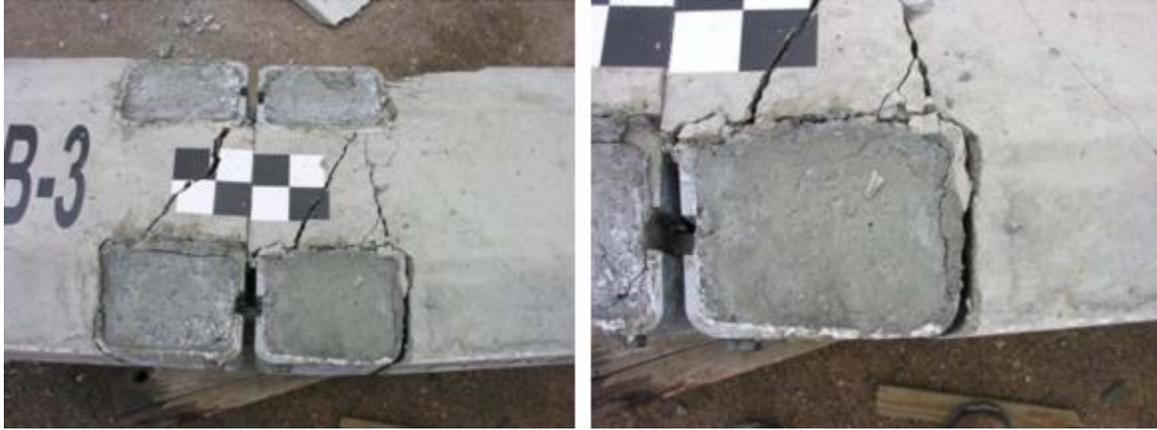
This joint held up to an approximate load of 100 kips, exceeding the design impact force of 62 kips. The joint also sustained minimal damage. The resulting damage is shown in Figure 2.21.

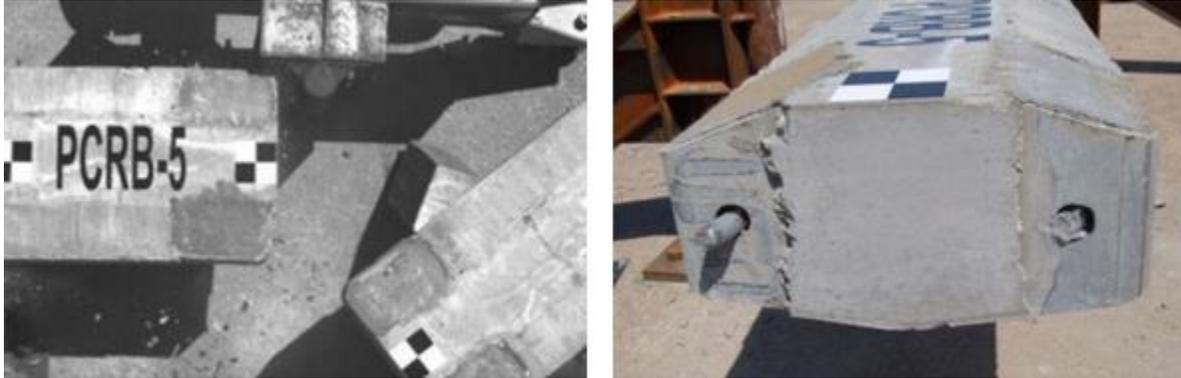
This joint sustained a load that averaged over 100 kips and absorbed slightly more energy than the grouted I-shaped joint. However, the specimen suffered much more damage from concrete spalling and cracking. Damage after testing is illustrated in Figure 2.23.

**Figure 2.23. Alternate redesign I-shaped rail connection failure**

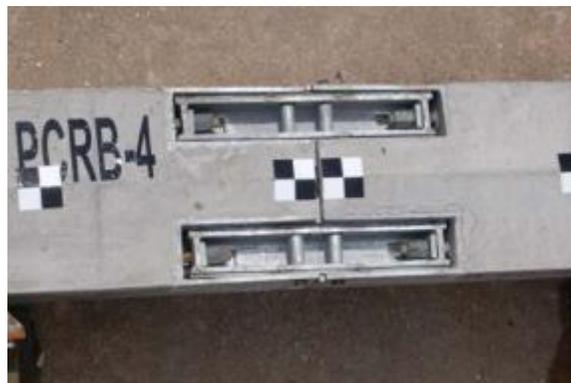
The side bolt and shear tube connection were modified in a similar fashion. The longitudinal steel size was increased to a threaded no. 8 bar, the steel tubes were cut to form U-shaped pieces, the size of the joint pockets increased, and shear bolts were added. See Figure 2.24.

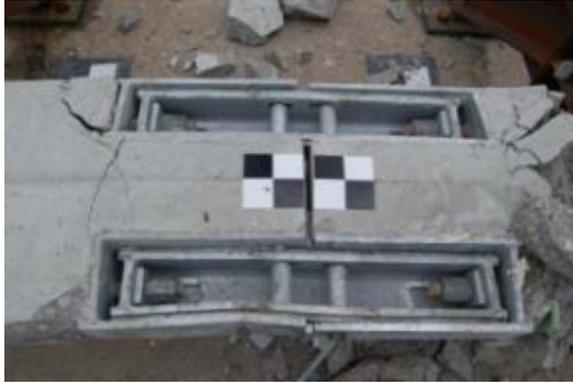
The testing results of this joint proved that the connecting threaded rods were too weak and failed at a load just over 60 kips. Resulting damage is shown in Figure 2.25.

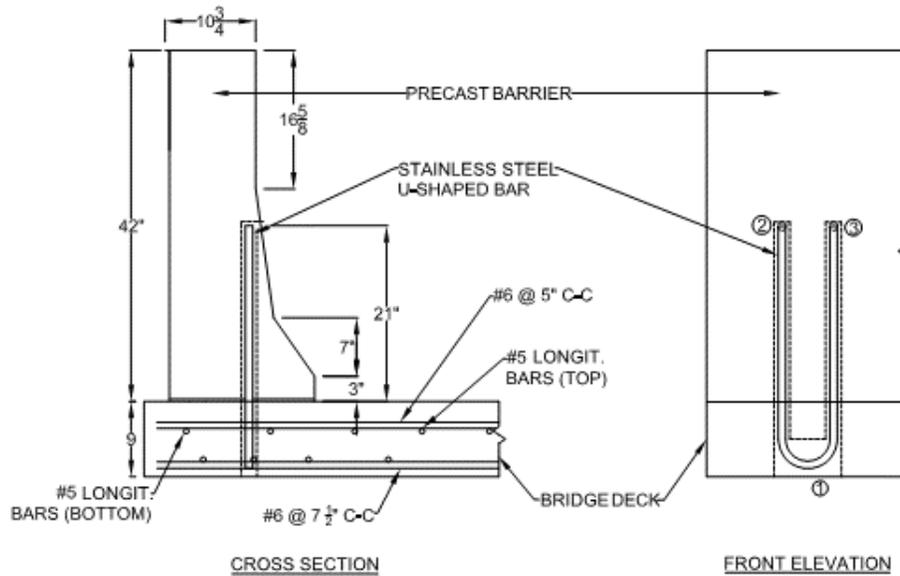
The second connection that was designed includes a U-shaped reinforcing steel bar that was inserted under the bridge overhang, through the bridge deck and into the precast barrier, and grouted. A schematic showing this detail appears in Figure 3.2.

**Figure 3.2. U-bar connection between precast barrier and deck**

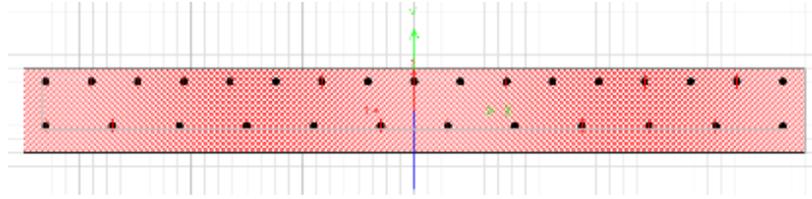
The bridge deck was designed to meet the Iowa DOT standards and some of the reinforcement quantities were refined according to the expected loading conditions. The selected failure mechanism for the entire deck and barrier system was within the barrier connection reinforcing bars. To ensure this, the deck had to be able to withstand the loading applied to the barrier, and analysis of the deck reinforcement was done in SAP2000. According to Iowa DOT standards, typical AASHTO type decks use #6 reinforcing steel bar with 10-in. spacing. For this project, the main concern was the response of the barrier. To ensure that premature failure would not take place in the deck, additional deck reinforcement was added, and the corresponding strain demand was monitored. The top mat of the deck would experience the most tension during the tests. As a result, the reinforcement was adjusted to #6 bars with 5-in. spacing. The bottom mat was adjusted to #6 bars at 7.5 in. spacing. The force distribution from the application of the load to the barrier was assumed to be based on a 1:1 slope, which is consistent with the recommendation in AASHTO. This resulted in a 7-ft distribution length on the bottom of the barrier and edge of the deck and a 10.5-ft distribution length when the load was applied sufficiently away from the edge of the barrier. These values were used in the SAP2000 analyses to establish the respective moment-curvature responses. The analyzed profiles for the 7- and 10.5-ft sections are displayed in Figure 3.4 and Figure 3.5, respectively.

**Figure 3.4. End of bridge deck reinforcement (7-ft segment analysis)**

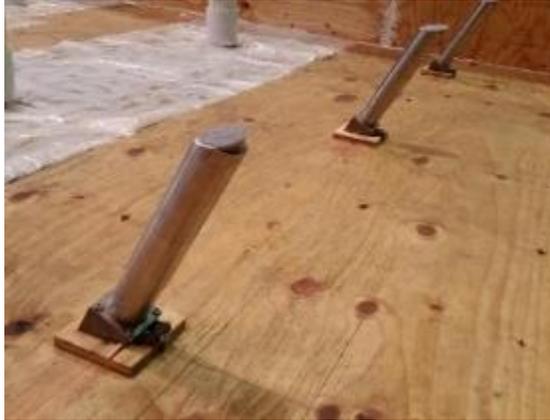
**Figure 4.7. Connected inclined receiving end piece to the deck formwork**

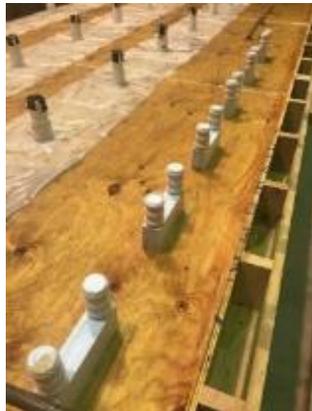
As noted, the U-bars for the PBU connection were inserted from the underside of the overhang into pockets in the bridge deck. Cutouts were made, and proper blockage was established before pouring the deck concrete. The block outs of these access pockets are shown in Figure 4.8.

**Figure 4.8. Deck block outs to facilitate U-bar installation**

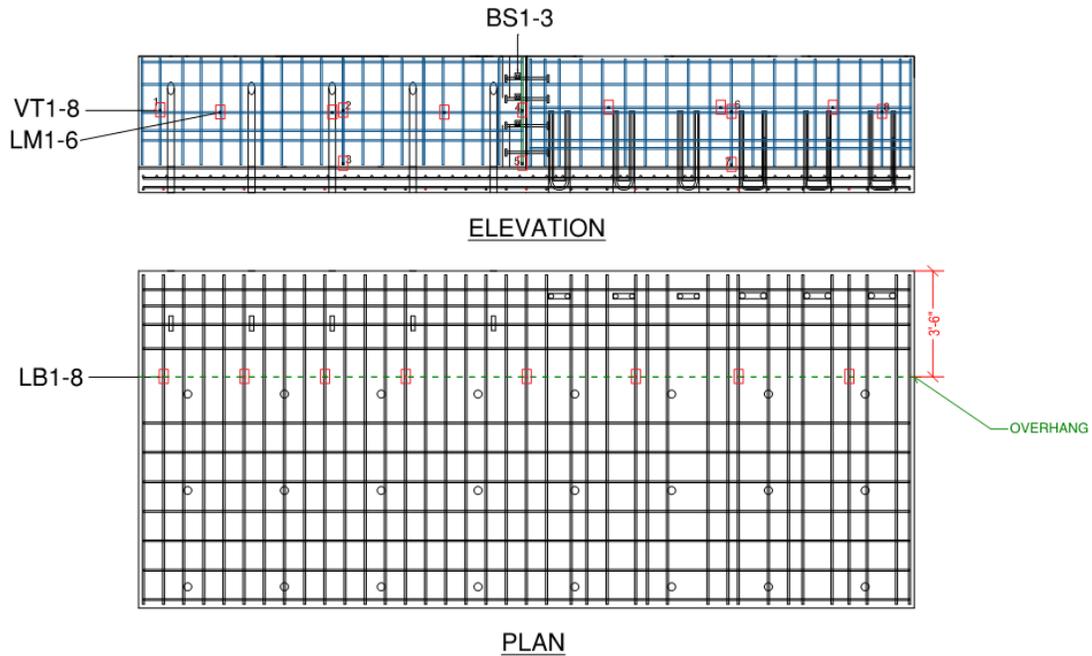
To measure the longitudinal strain in the steel reinforcing bars at critical locations, strain gauges were used. These gauges were attached to the deck reinforcing steel bar, the precast barrier reinforcing steel bar, and selected steel reinforcement used in the connections. Figures 4.25 and 4.26 show the location of these strain gauges. Since not all gauges were connected simultaneously to the data acquisition system (DAS), only the strain gauges within the 45-degree slope from the load application region were primarily monitored during each test.

**Figure 4.25. Location of strain gauges in precast barrier reinforcement and bottom deck reinforcement**

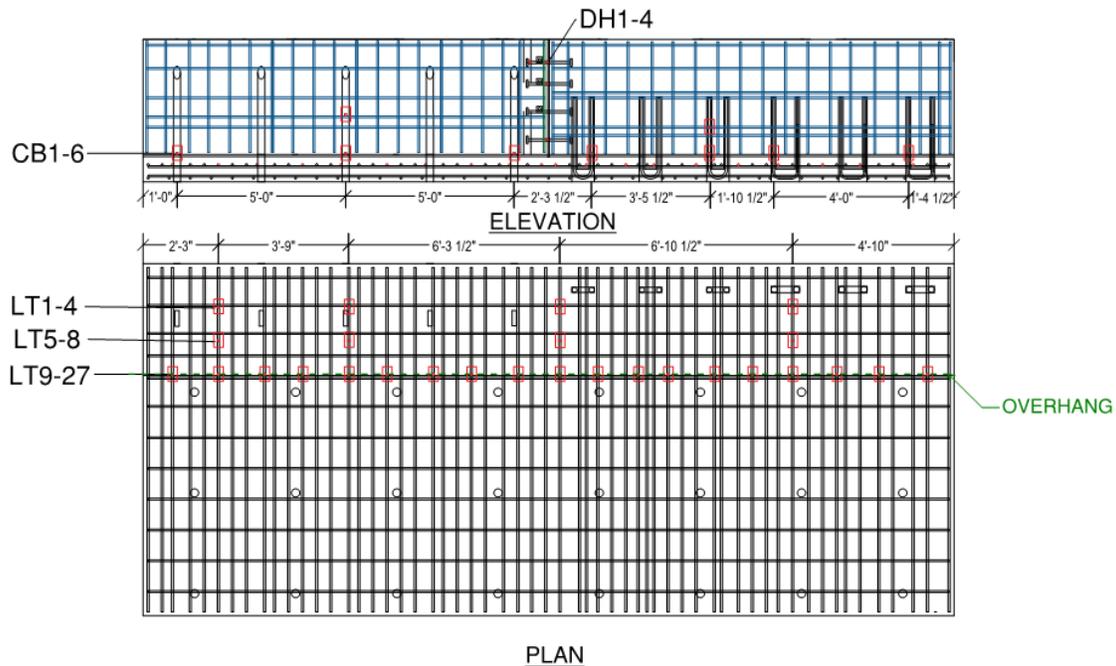
**Figure 4.26. Location of strain gauges in barrier connection reinforcement and top deck reinforcement**

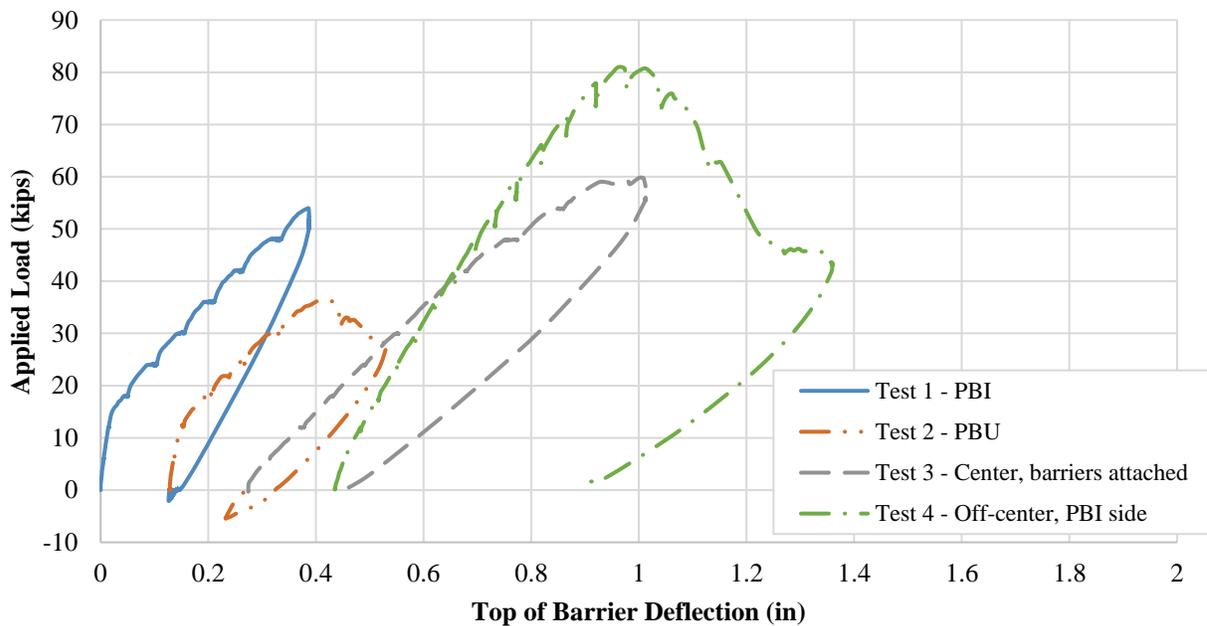
Since the precast barriers were designed for TL 4, they were required to sustain a maximum lateral load of 54 kips that is applied uniformly over 3.5 ft. During testing, the load was applied incrementally up to 54 kips. A load step of 6 kips was used and the test was paused at the end of each load step to observe any damage to the test unit. As planned, six different tests were conducted and a summary video of the tests is available at <https://youtu.be/up6sMEeqfaU>. For the first two tests performed, the barrier-to-barrier connection was left ungrouted and disconnected. Barrier PBI with an inclined bar connection was tested first. PBU with the U-bar connection was tested next before the barrier-to-barrier connection was established. This was accomplished by threading the transverse bar splicers and grouting the connection region. Once the connection between the two barrier segments was established, the third test was conducted directly at the center of the two barriers. For the fourth test, the load was applied 1.75 ft from the barrier-to-barrier connection. It was tested on the PBI side of the test specimen to ensure that the selected failure mechanism was achieved. The last two experiments included load application to the free ends of both PBI and PBU, where the load resistance was expected to be only 50 percent of those from Tests 1 and 2. The chart in Figure 5.1 illustrates the top of the barrier's deflection throughout the course of the first four tests. Even though the actuator was moved for each test, a single reference point was used at the center of the entire test specimen and was used to create the continuous plot to demonstrate the performance during different tests.

**Figure 5.1. Continuous test plot of top of barrier deflection for Tests 1–4**

PBI was subjected to the desired target force of 54 kips during Test 1. During Test 2, PBU experienced premature failure and thus the test was terminated after applying 36 kips. Test 3,

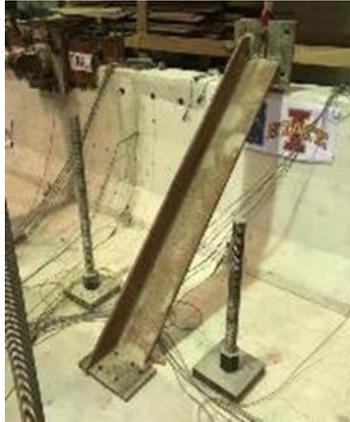
**Figure 5.2. Brace beam**

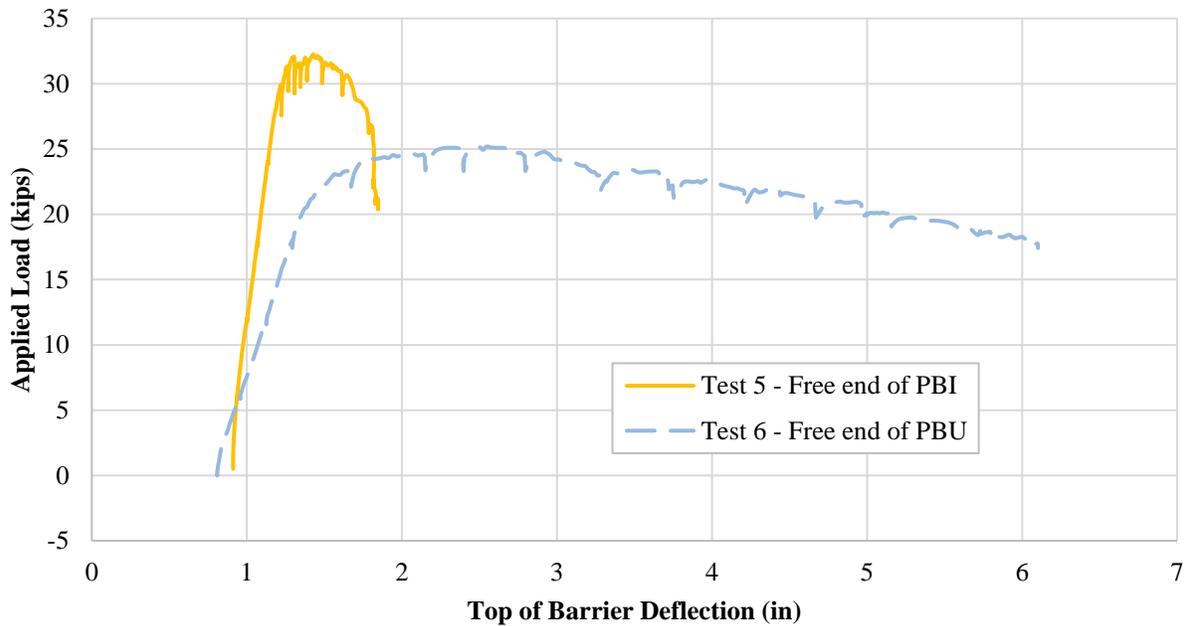
**Figure 5.3. Top of barrier deflection for Tests 5 and 6**

Test 5 was conducted on the free end of PBI in the push direction and was taken to failure. The brace beam was attached during Test 5. Test 6 was conducted on the free end of PBU in the push

direction and was taken to failure. The brace beam was disconnected during Test 6. In both tests, the barriers were pushed to deflect the extent of the hydraulic actuator used to apply the force. They were also pulled in the opposite direction to observe the damage. In comparison to Tests 1 and 2, lower resisting forces were obtained during Test 5 and 6. This is because the barrier ends were not designed to simulate the bridge end condition, producing 50 percent of the resistance at the barrier ends of the test unit rather than away from them.

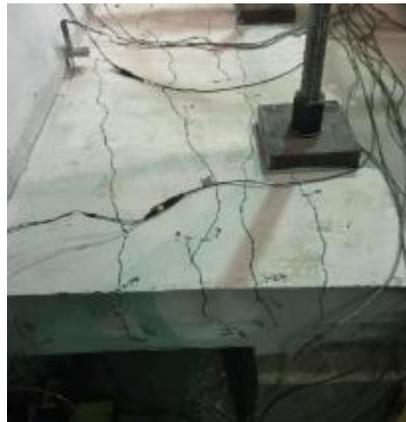
The loading block and actuator were set up to apply the load at the center of PBI at the top of the barrier over 3.5 ft length. The first two load increments produced no visible cracks on the test unit. The deck began to crack as the applied load approached 18 kips. The initial flexural cracks were noticed on the bridge deck overhang, as seen in Figure 5.4; three somewhat uniformly spaced flexural cracks formed on the deck overhang and they were visible along the entire length of PBI. The lateral deflection at the top of the barrier was 0.105 in. after applying 18 kips.

**Figure 5.4. Test 1: Formation of flexural cracks on the deck overhang**

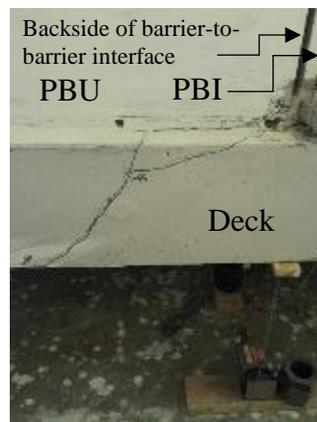
After the loading was complete, the crack widths were measured. The thickest cracks appeared on the backside of the bridge deck behind PBU (Figure 5.6).

**Figure 5.6. Formation of crack on backside of test unit during Test 1**

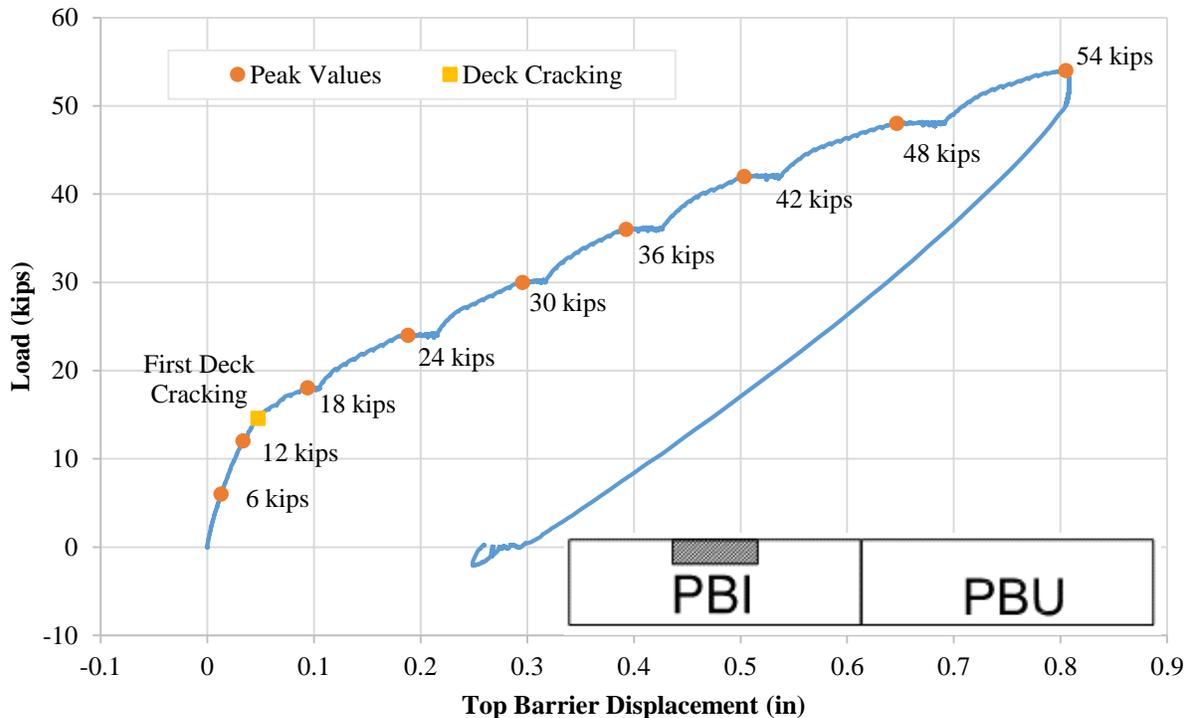
**Figure 5.7. Force displacement for Test 1 – PBI**

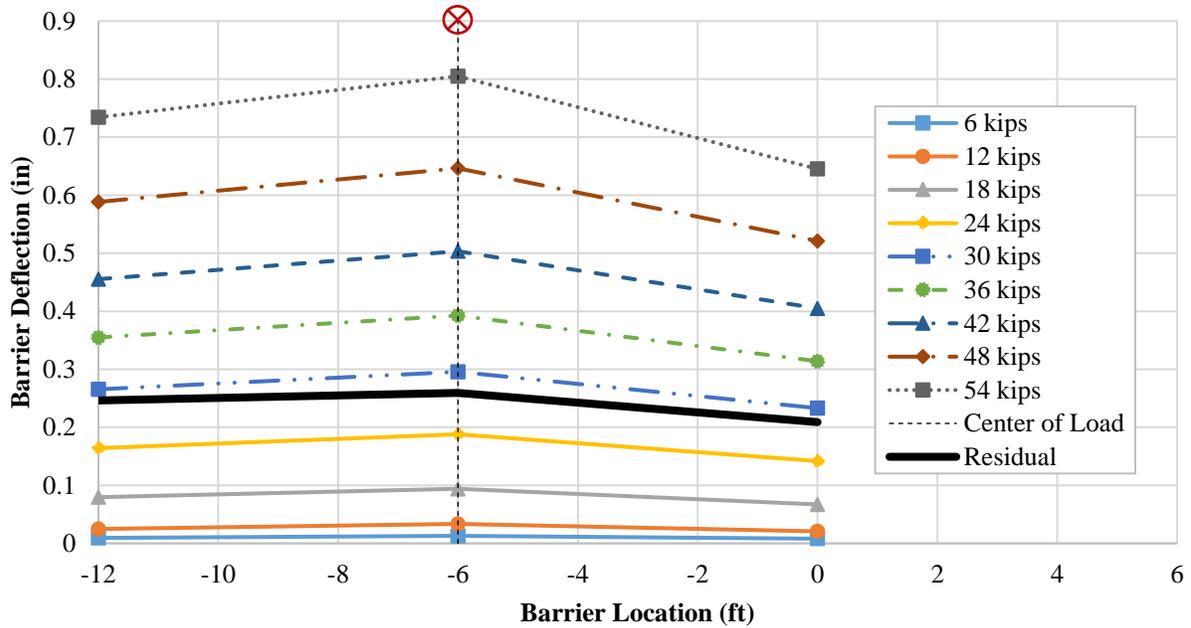
**Figure 5.8. Top barrier deflection profiles of PBI during Test 1**

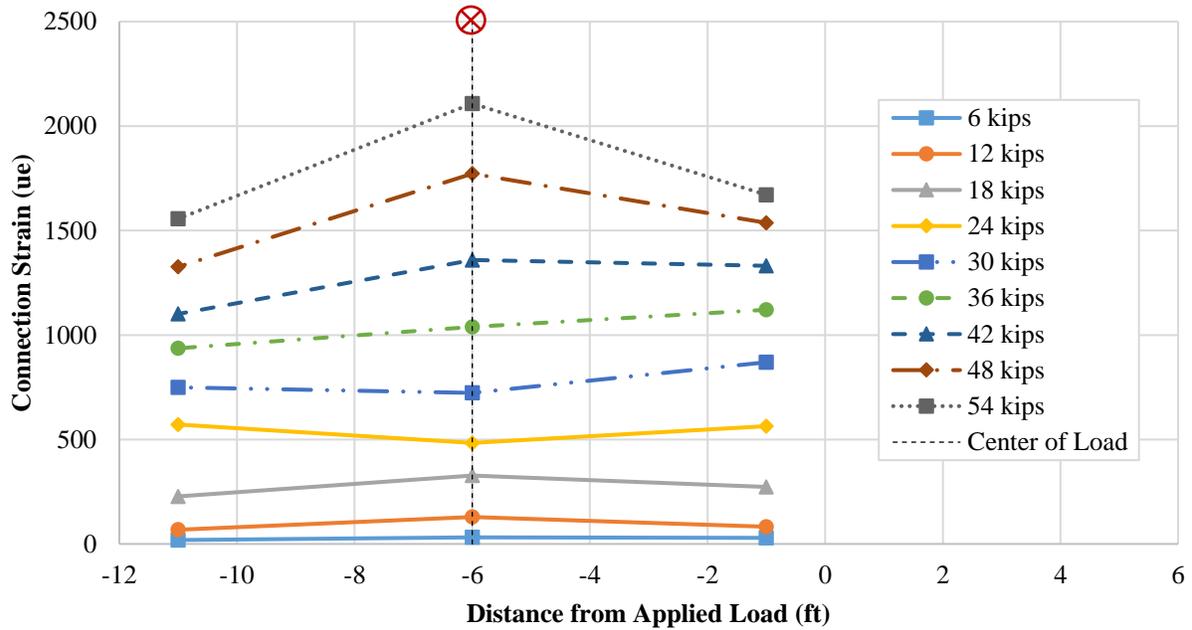
**Figure 5.9. Strain profiles of the inclined reinforcement barrier connection bars at the deck interface during Test 1**

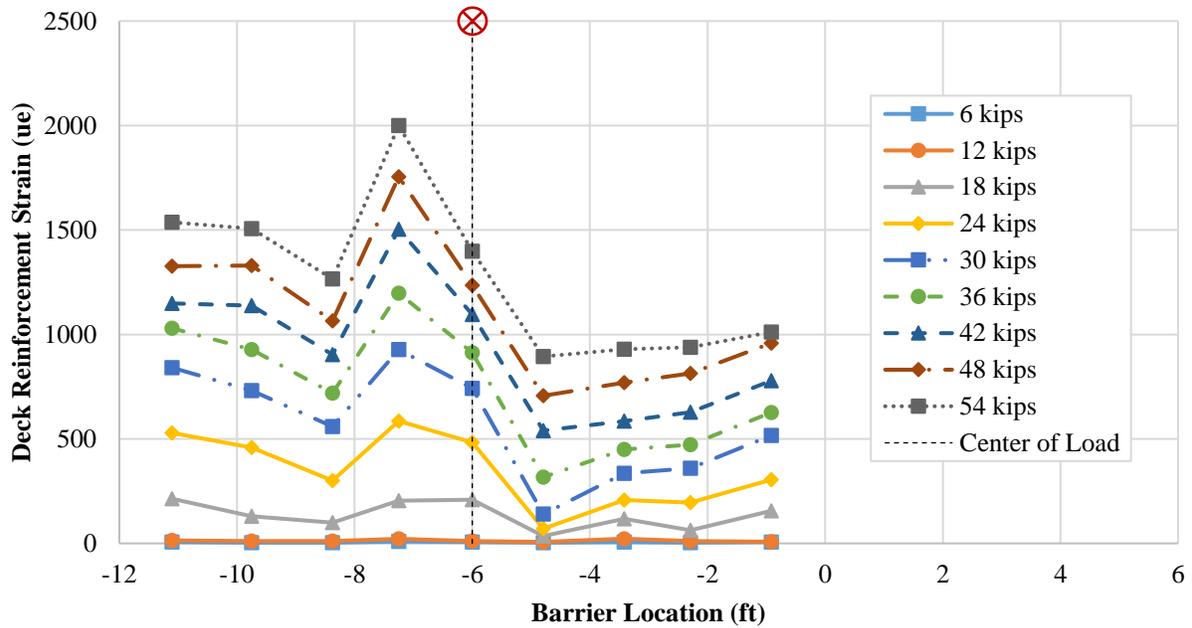
**Figure 5.10. Strain profiles of the deck reinforcement at the front barrier interface during Test 1**

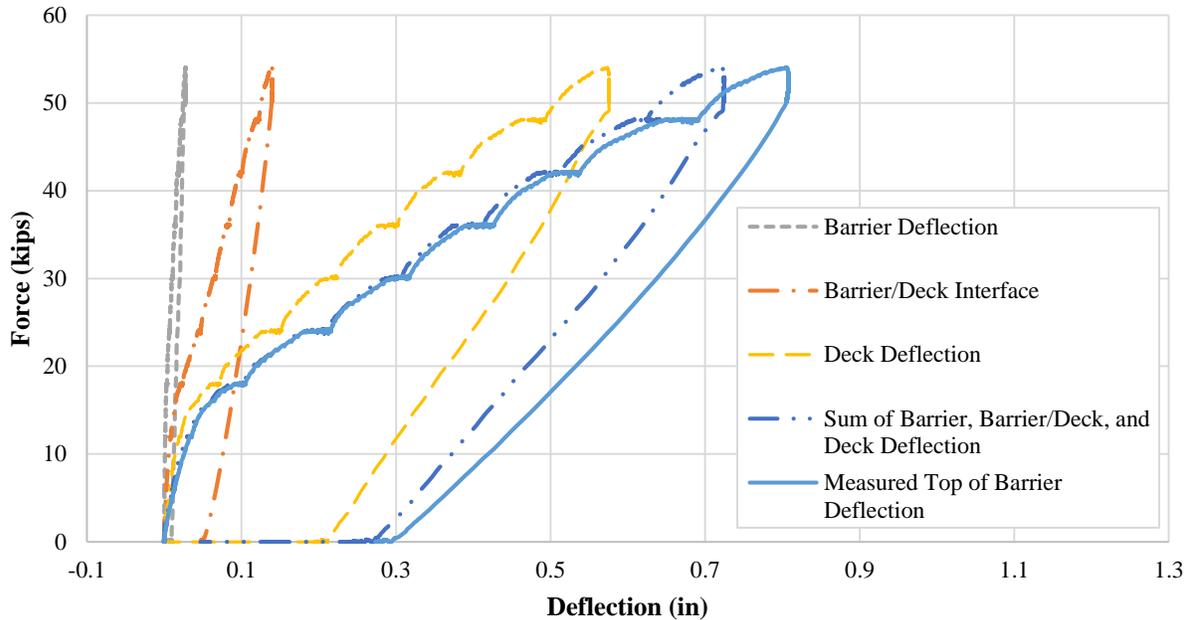
**Figure 5.11. Components of the measured PBI deflections**

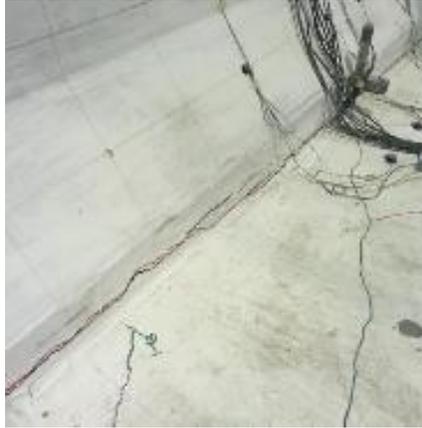
**Figure 5.12. Crack at the barrier-to-deck interface in PBU during Test 2**

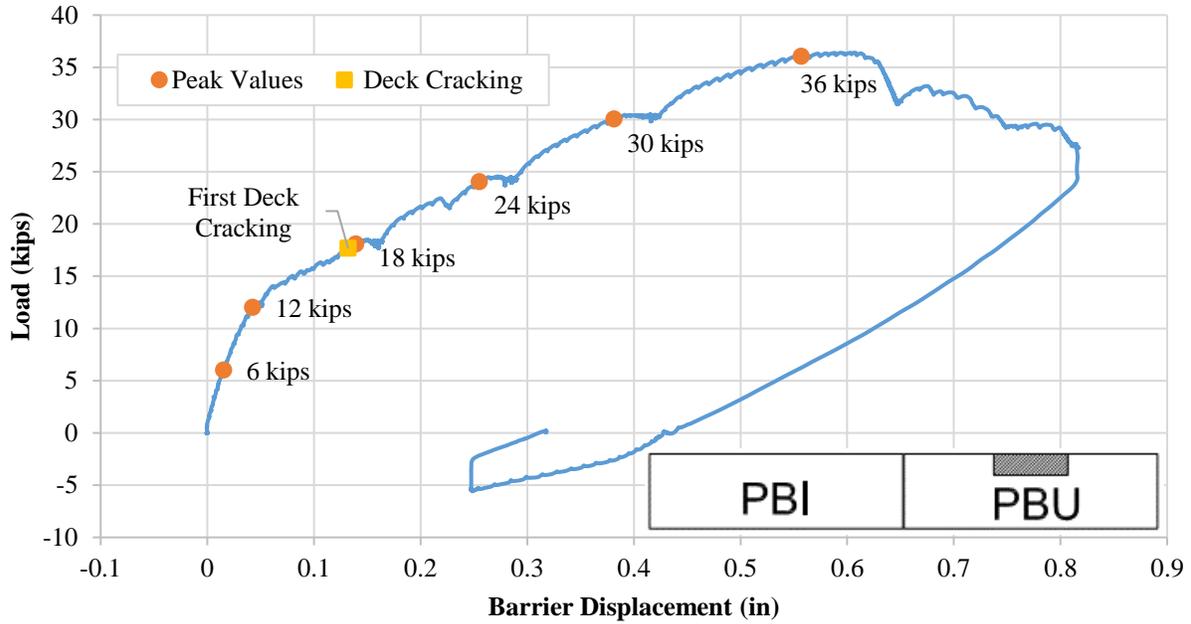
**Figure 5.13. Lateral versus force displacement obtained for Test 2 – PBU**

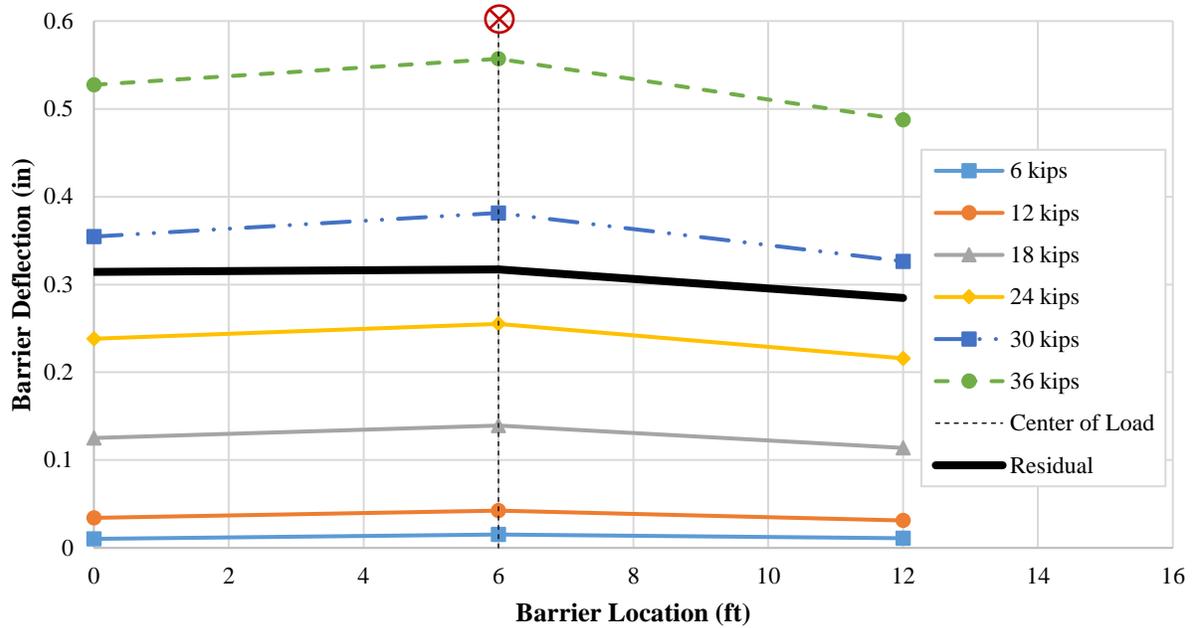
**Figure 5.14. Lateral top deflection of PBU during Test 2**

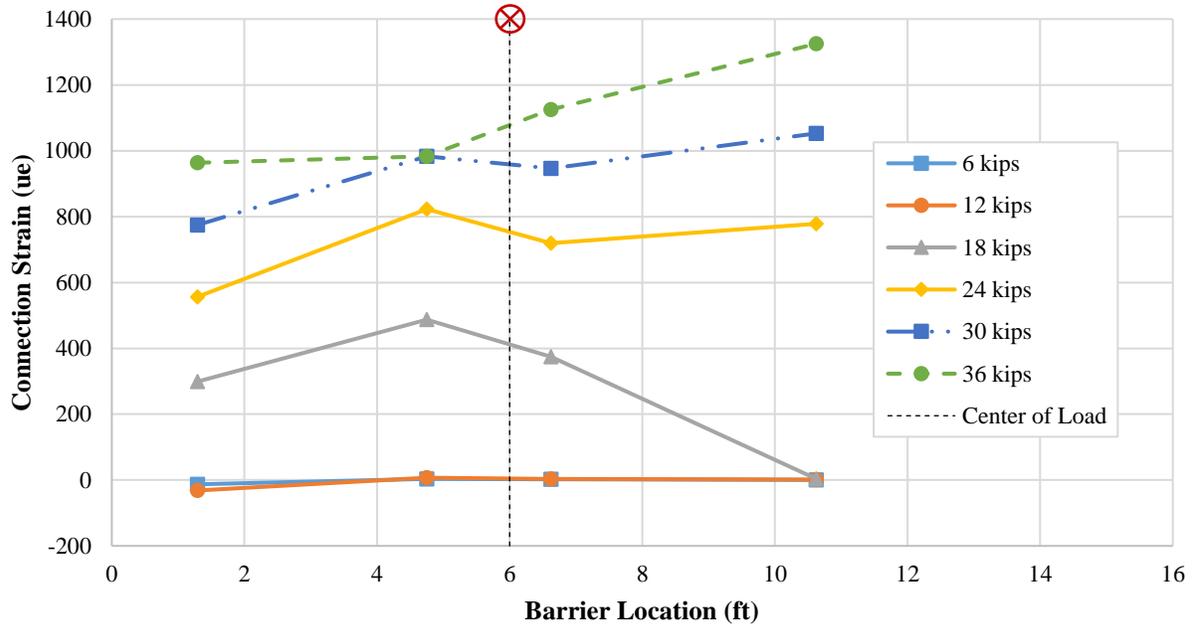
Figure 5.15 shows the strain in the U-bar connection at the barrier-to-deck interface.

**Figure 5.15. Strain in the U-bar at the deck to barrier interface during Test 2**

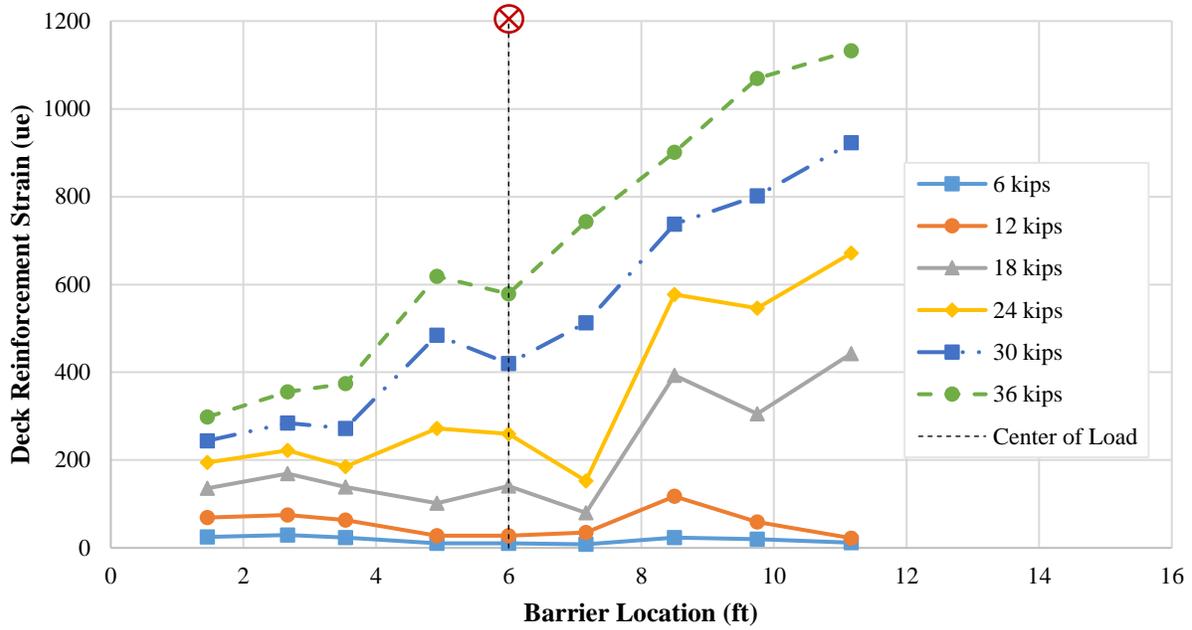
**Figure 5.16. Strain profiles of the deck reinforcement at the front barrier interface during Test 2**

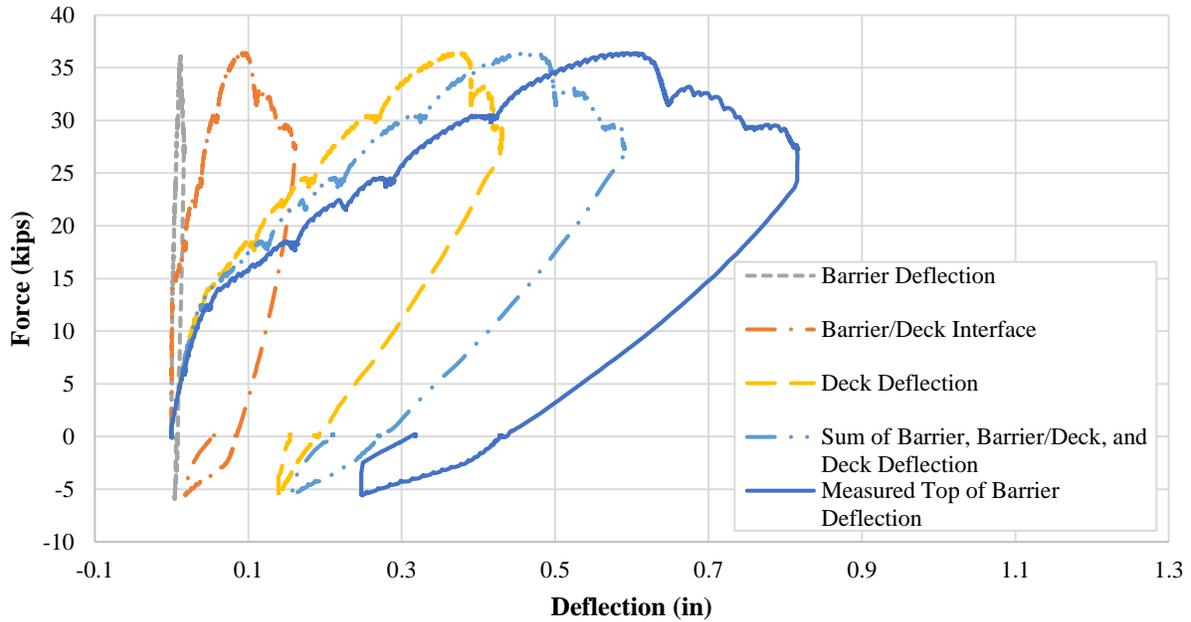
**Figure 5.17. Deflection of components**

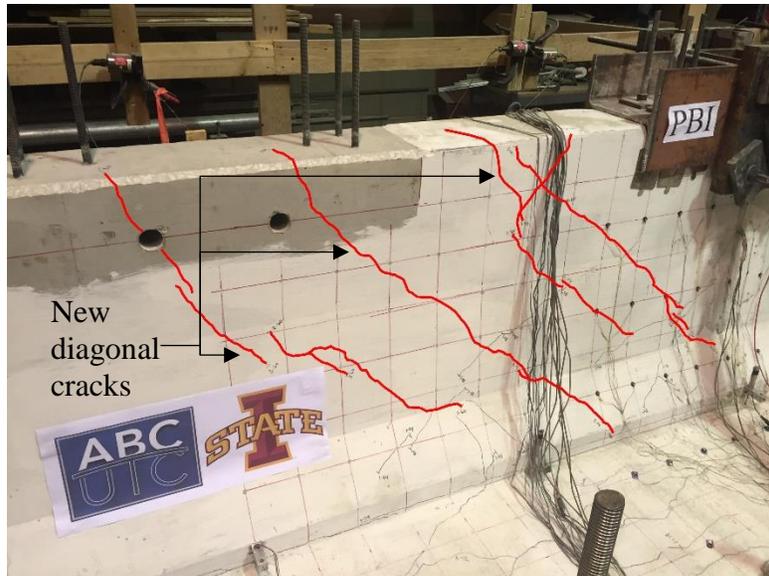
**Figure 5.18. Diagonal cracks developed on PBI during Test 3**

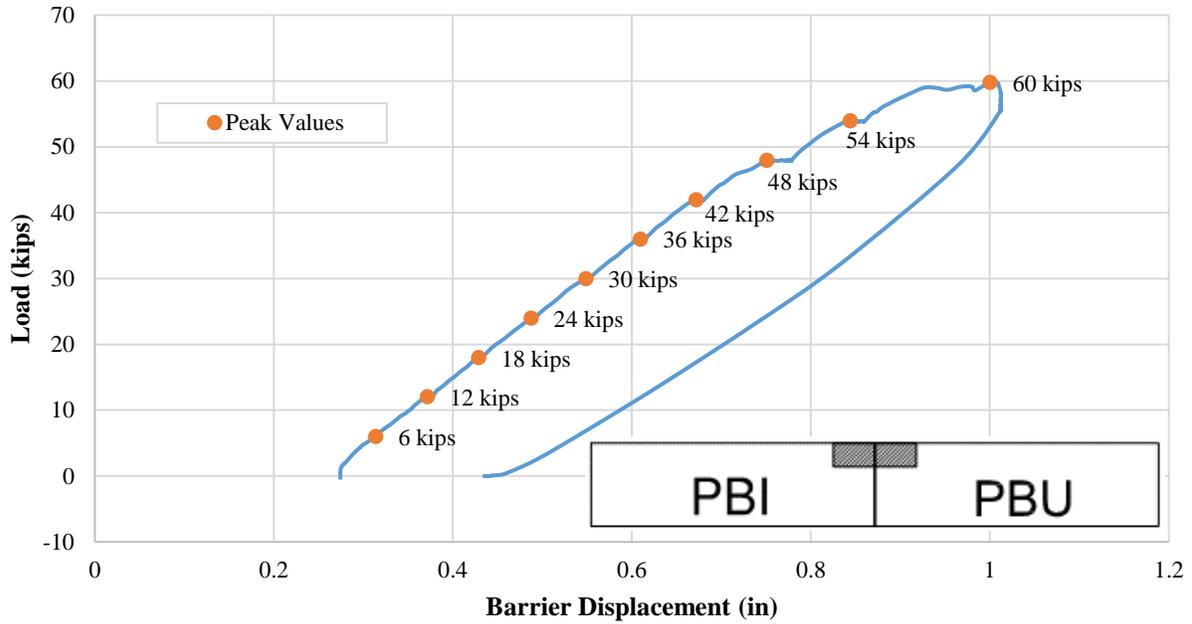
**Figure 5.19. Force-displacement response obtained for Test 3**

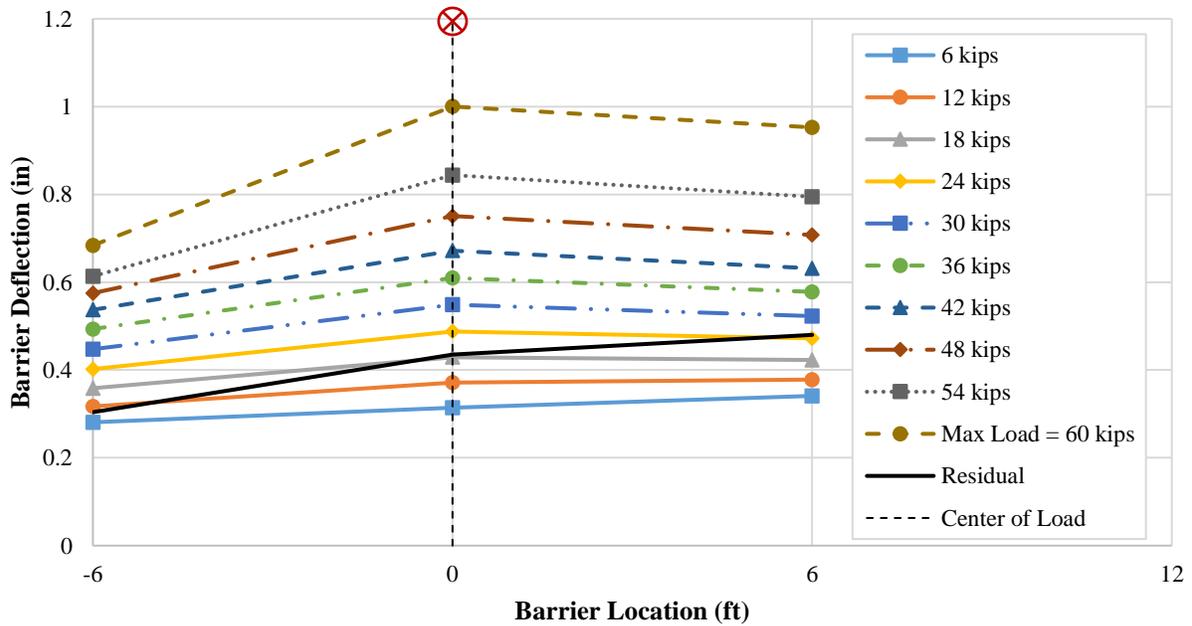
**Figure 5.20. Top barrier deflection profiles established from Test 3 data**

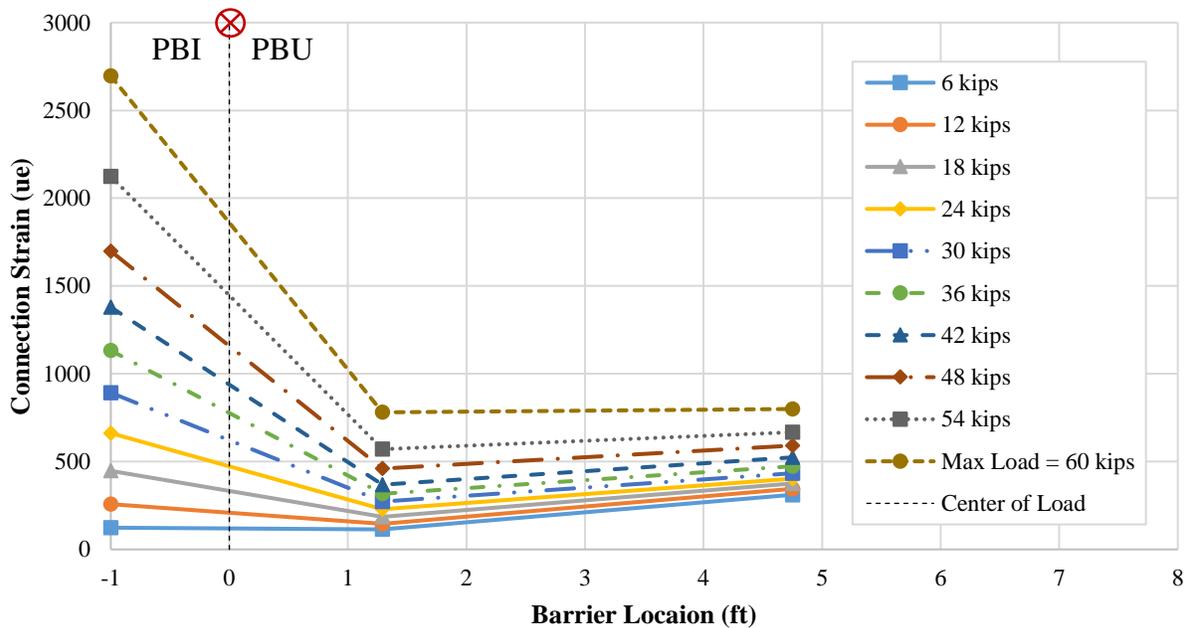
**Figure 5.21. Strain in barrier-to-deck connection interface during Test 3**
