# Precast Concrete Bridge Barriers for Accelerated Bridge Construction

**Final Report**  
**October 2018**

**Sponsored by**  
Accelerated Bridge Construction  
University Transportation Center

IOWA STATE UNIVERSITY  
Institute for Transportation

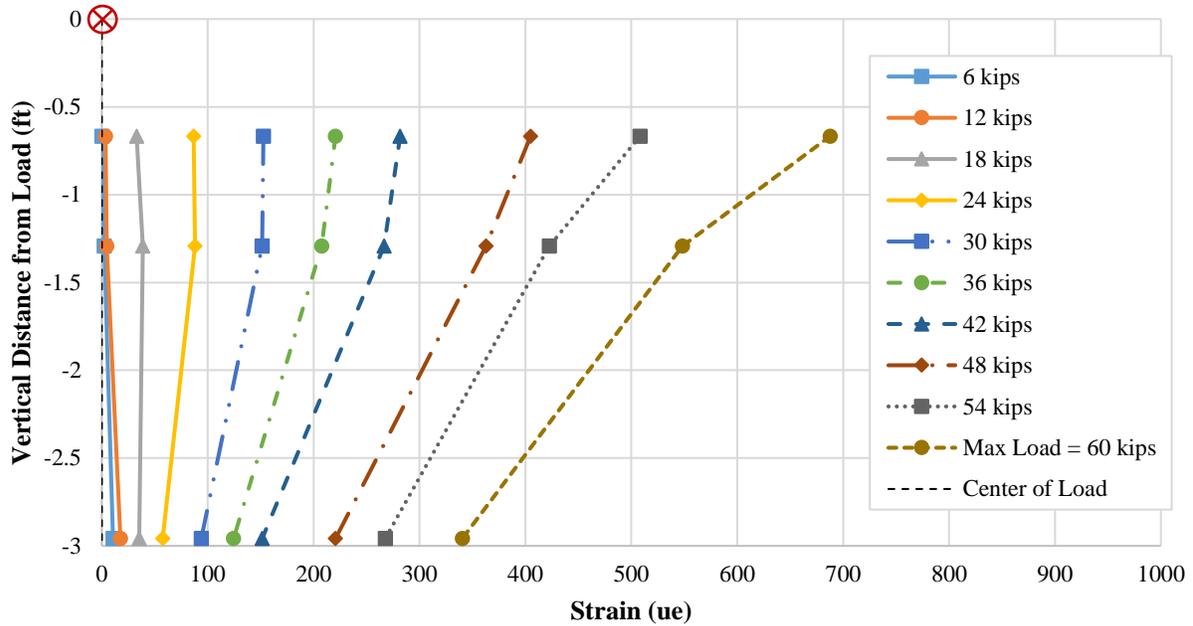
**Figure 5.22. Strain in the center of the longitudinal double-headed ties in barrier-to-barrier connection during Test 3**

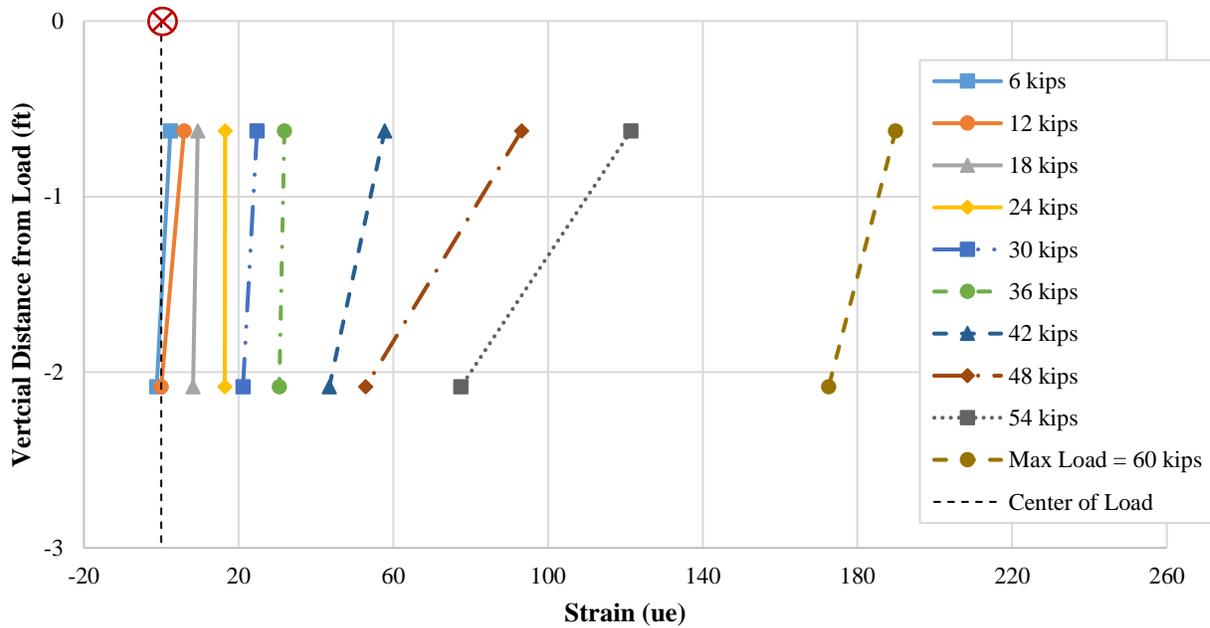
**Figure 5.23. Strain in transverse double-headed ties placed near the barrier-to-barrier connection during Test 3**

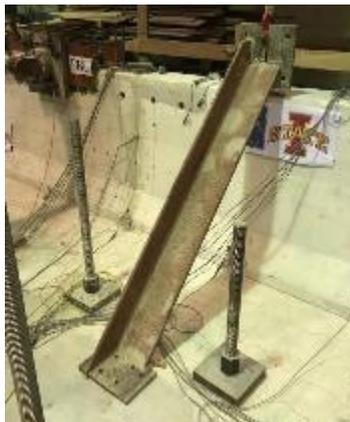
**Figure 5.24. Beam used to brace PBU with respect to the deck during Test 4**

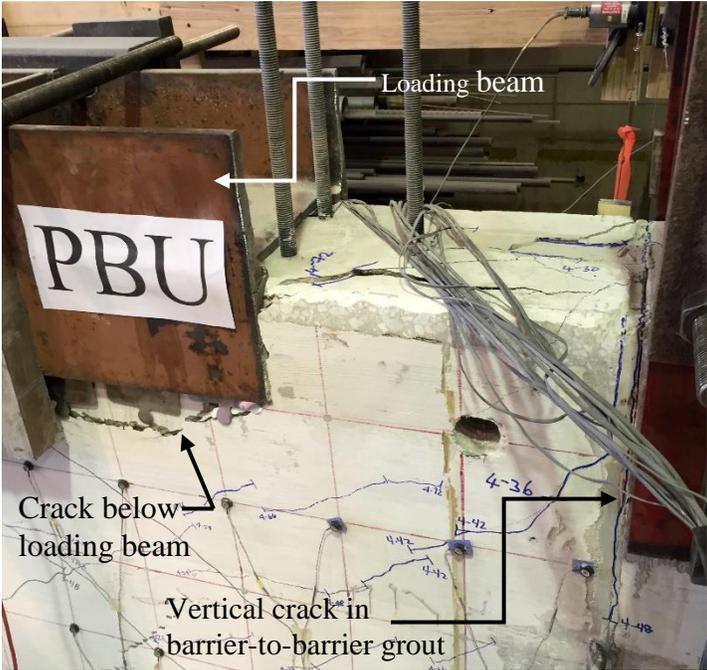
Figure 5.25. Cracking under the loading beam on PBI during Test 4

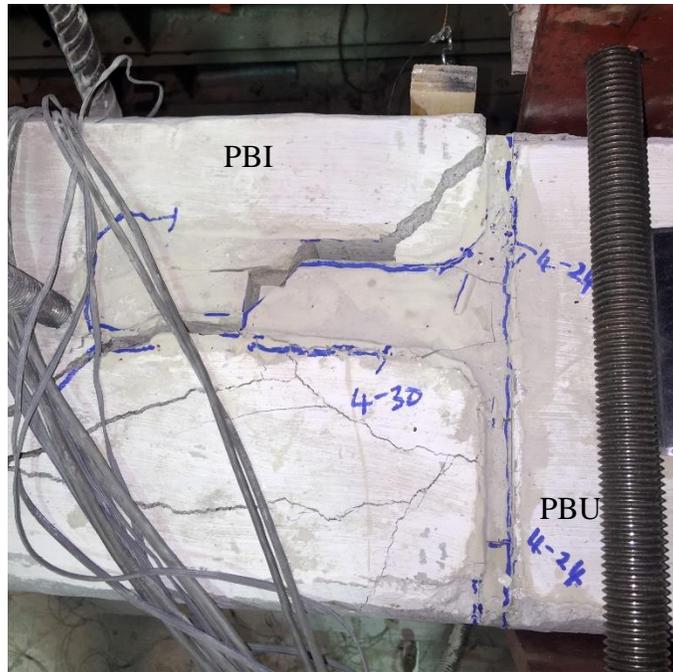
**Figure 5.26. Failure pattern of barrier-to-barrier connection at the end of Test 4**

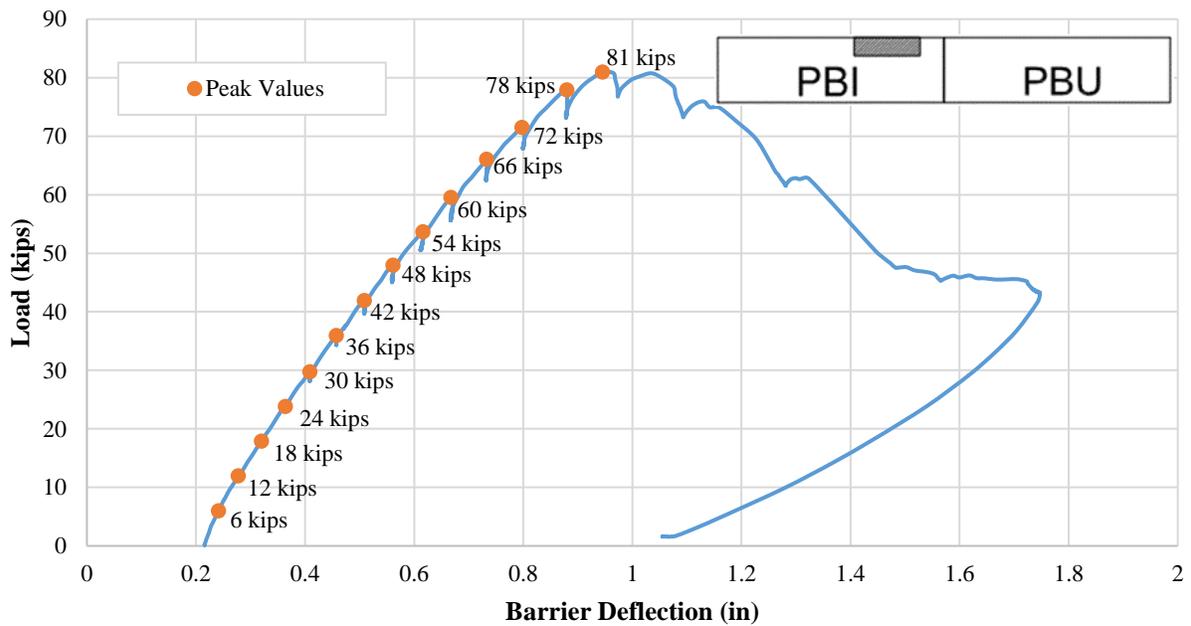
**Figure 5.27. Force-displacement response obtained for Test 4**

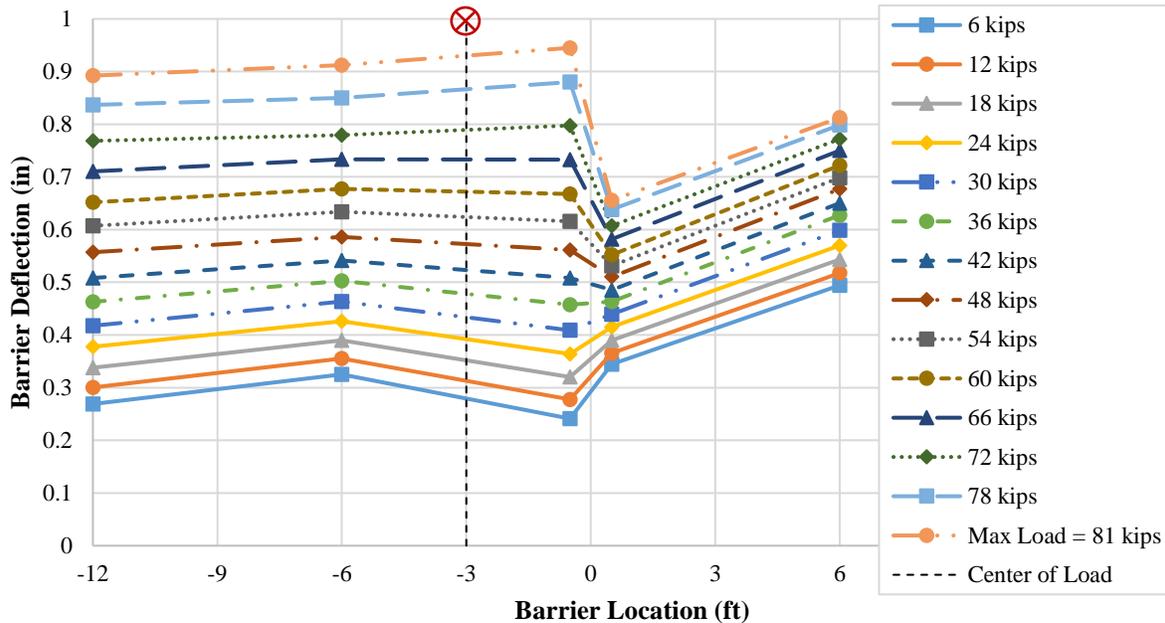
**Figure 5.28. Top lateral deflection of barrier during Test 4**

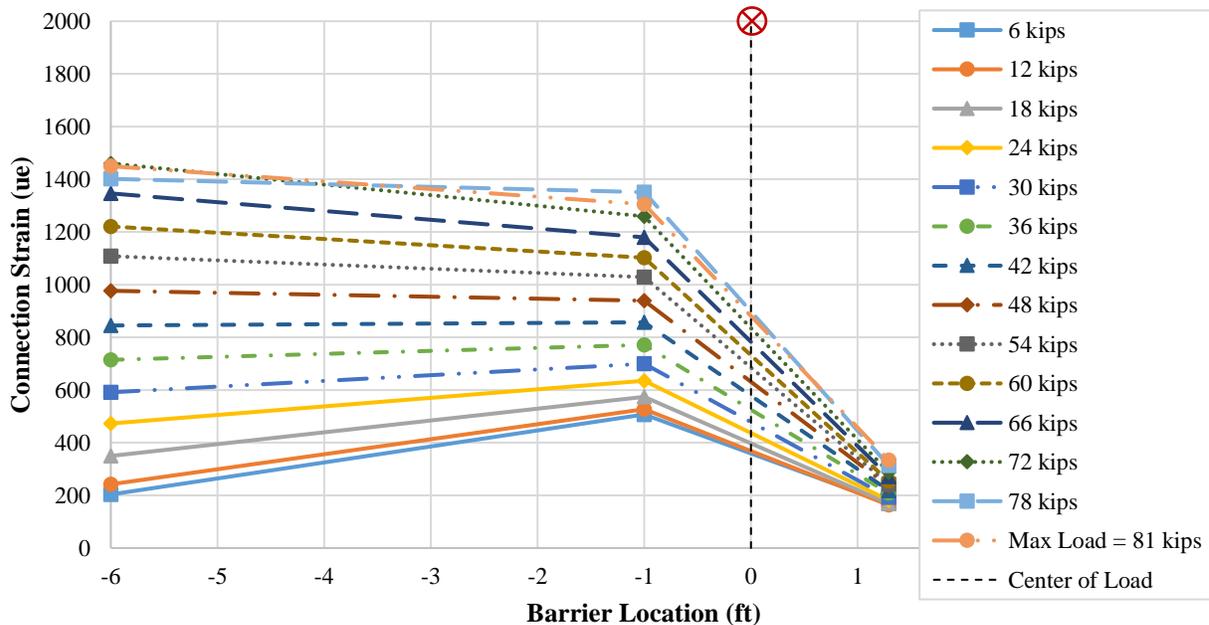
**Figure 5.30. Strain in barrier connection reinforcement at the deck interface during Test 4**

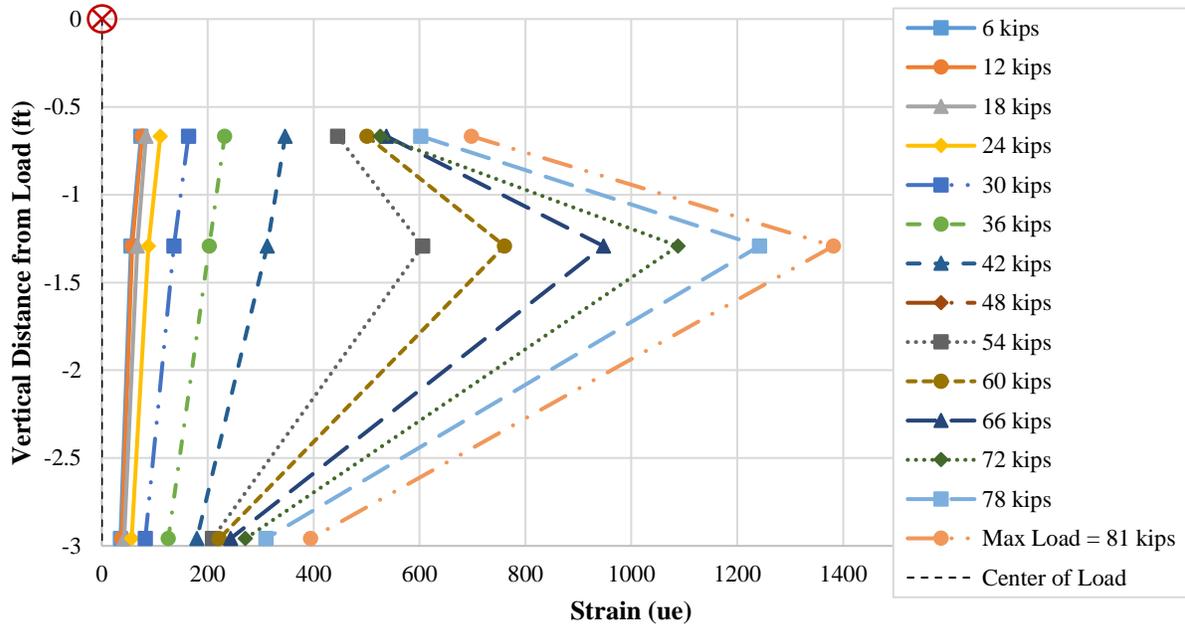
**Figure 5.31. Strain in longitudinal double-headed ties in barrier-to-barrier connection during Test 4**

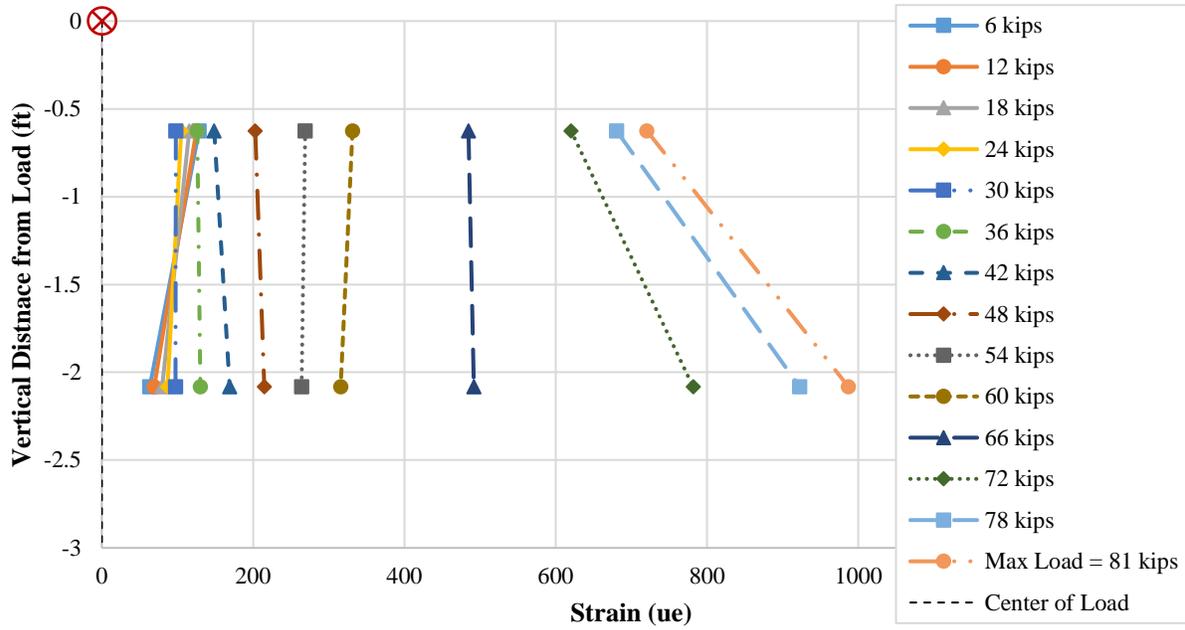
**Figure 5.32. Strain in transverse double-headed ties during Test 4**

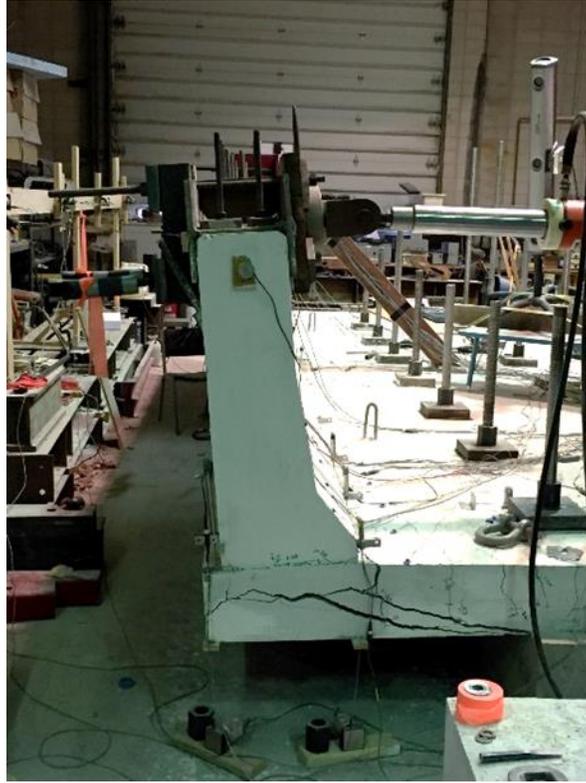
**Figure 5.33. Final barrier deflection and cracking in bridge deck during push direction loading in Test 5**

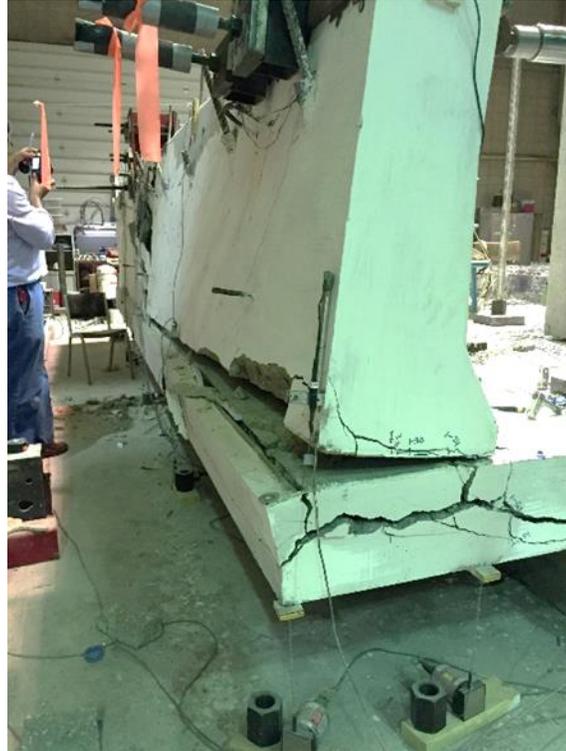
**Figure 5.34. Damage to barrier and deck after Test 5 pull test**

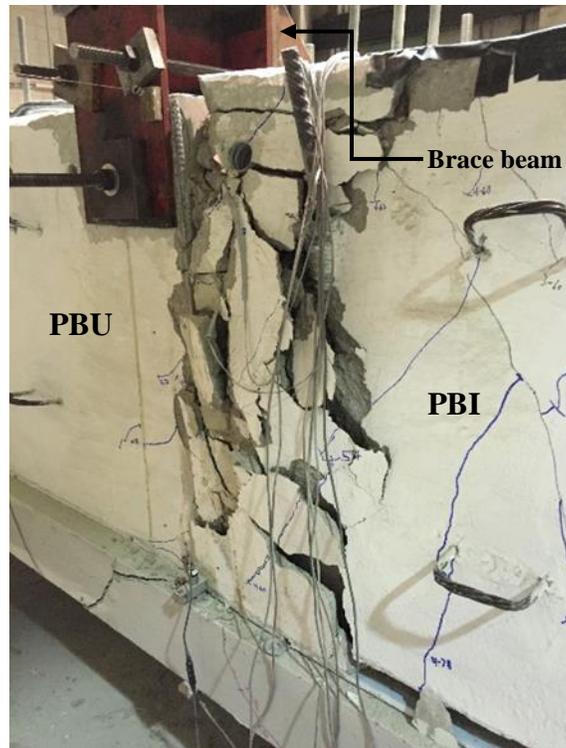
**Figure 5.35. Damage to barrier-barrier interface after Test 5**

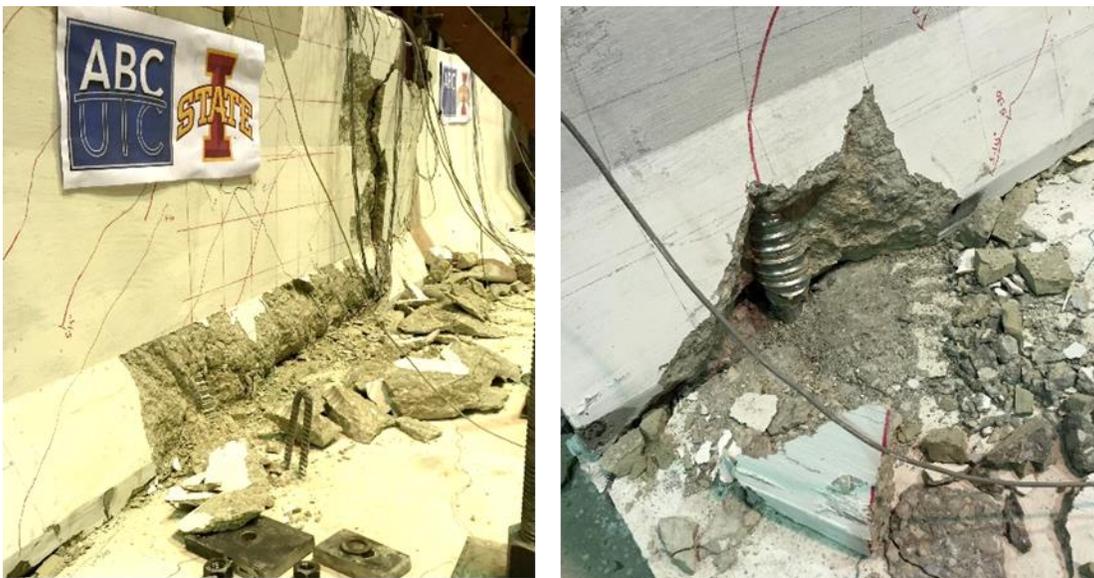
**Figure 5.36. Concrete spalling on front of PBI at deck interface and barrier-to-deck connection**

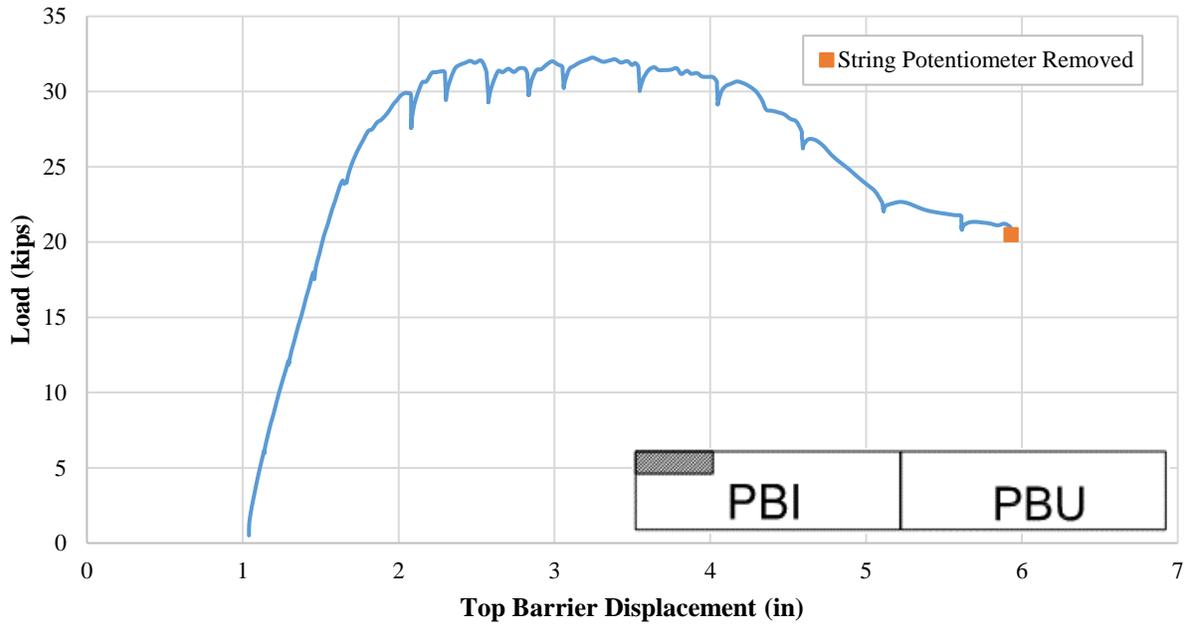
**Figure 5.37. Recorded force-displacement response during Test 5**

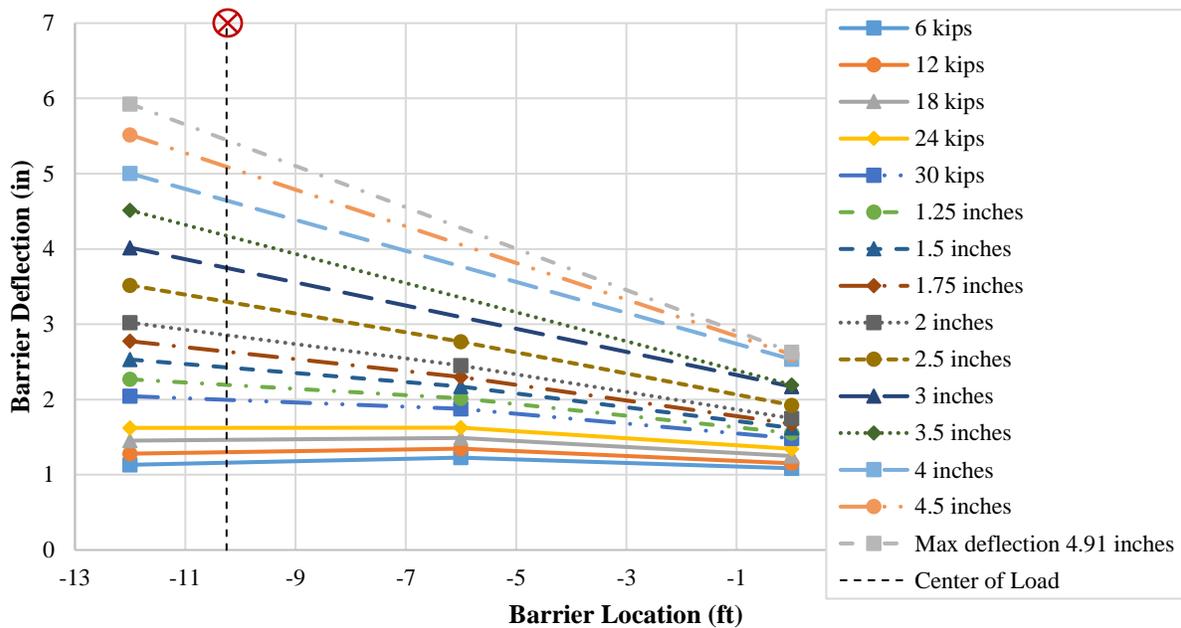
**Figure 5.38. Deflection at the top of the barrier during Test 5**

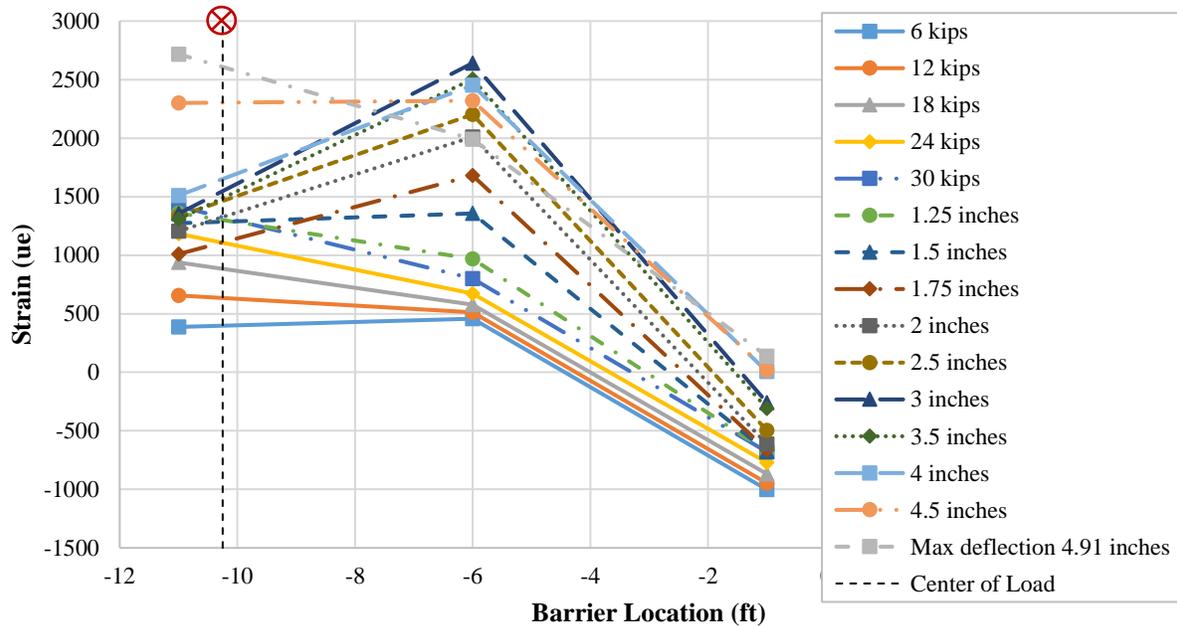
**Figure 5.39. Strains in PBI at the barrier-to-deck connection interface during Test 5**

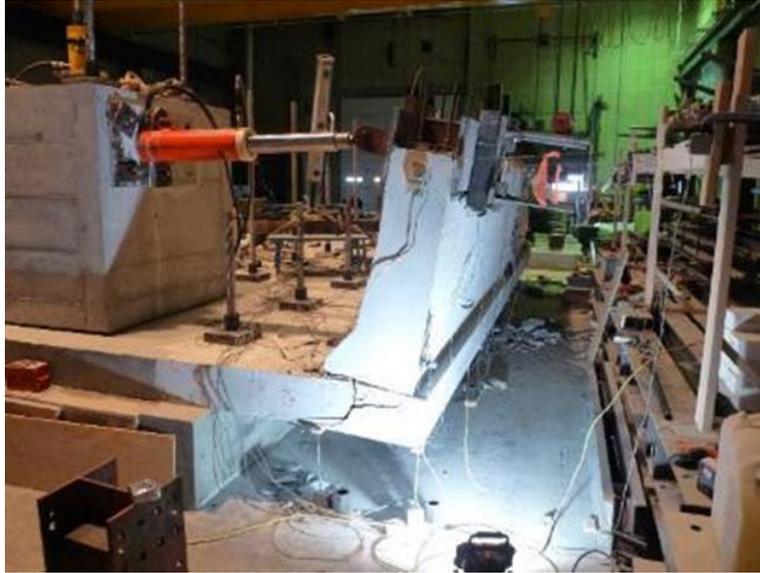
**Figure 5.40. Final barrier deflection and the corresponding damage to the bridge deck during Test 5**

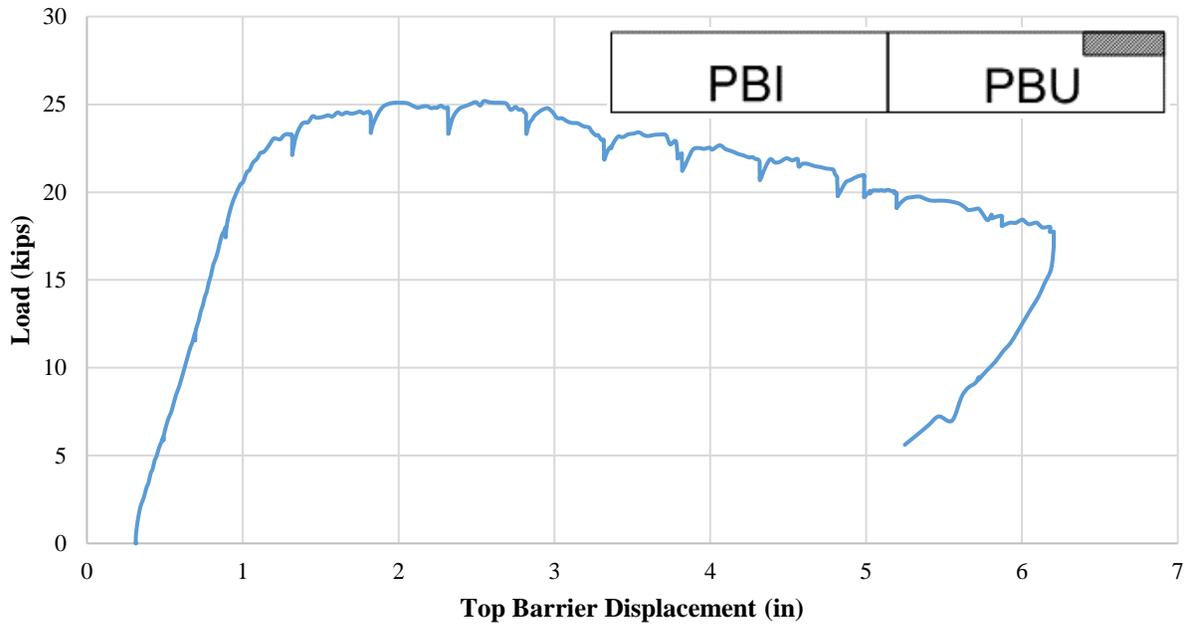
**Figure 5.42. Recorded force-displacement response for push direction loading in Test 6**

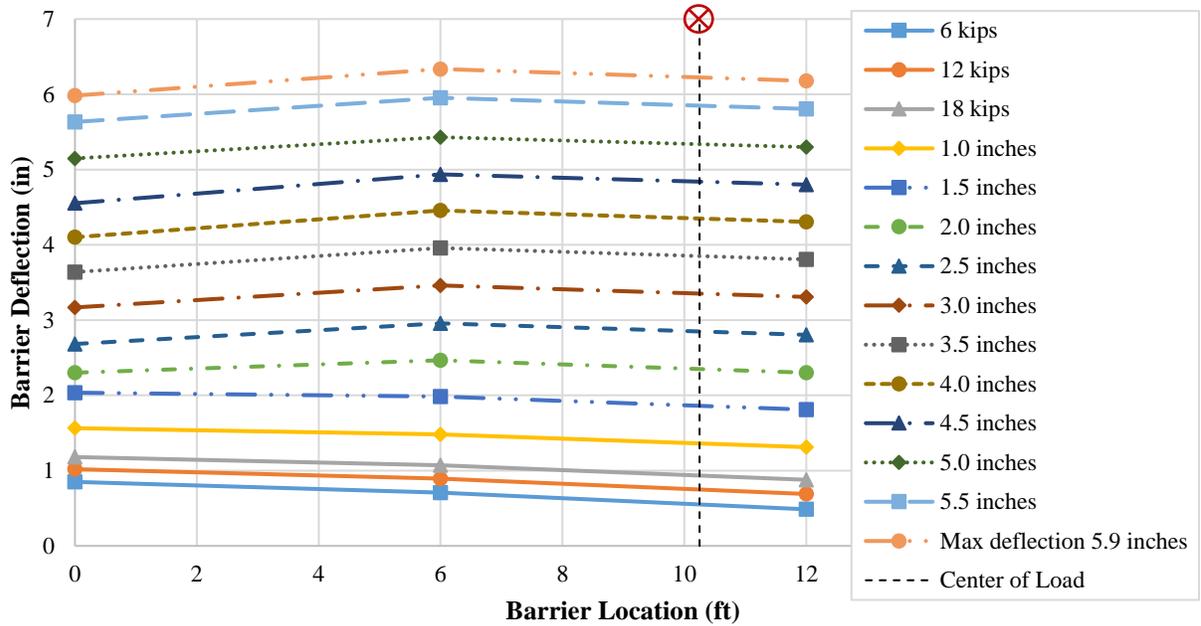
**Figure 5.43. Top barrier deflection during push direction loading of Test 6**

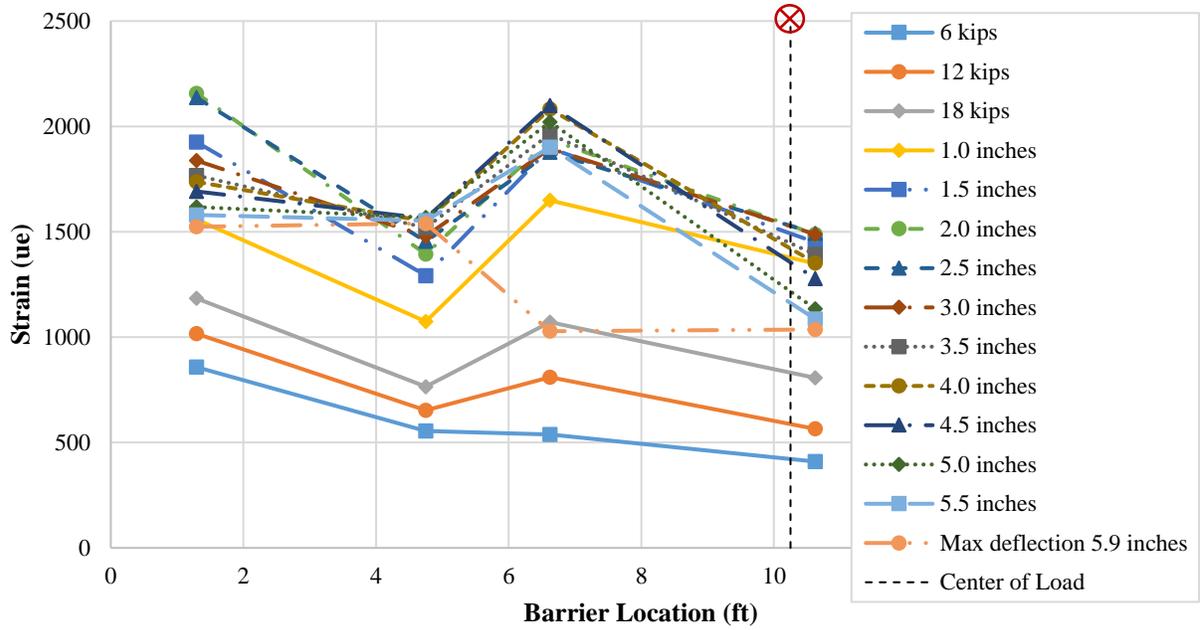
**Figure 5.44. Strain in barrier-to-deck connection interface in PBU during push direction loading in Test 6**

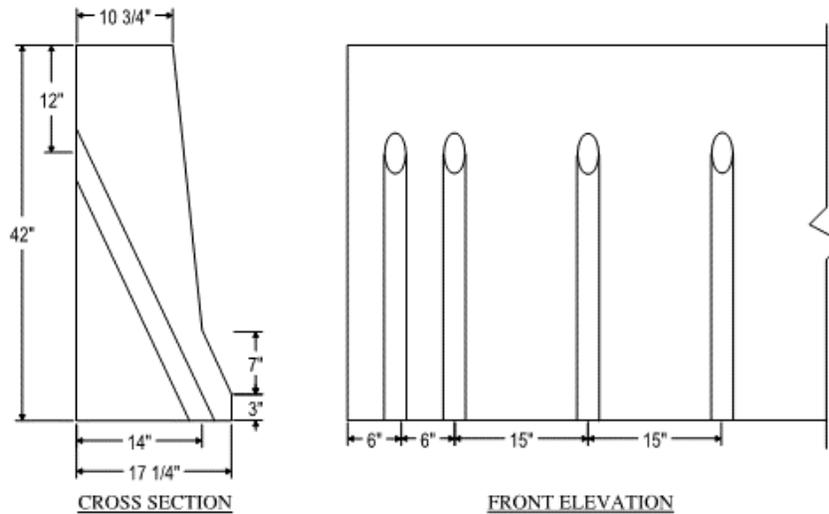
**Figure 6.1. Recommended spacing for inclined bar connection at a bridge end**
