EXPERIMENTAL INVESTIGATION OF HIGH PERFORMING PROTECTIVE SHELL USED FOR RETROFITTING BRIDGE ELEMENTS

Submitted by
Alireza Valikhani

FINAL REPORT

Department of Civil and Environmental Engineering
Florida International University
Miami, Florida

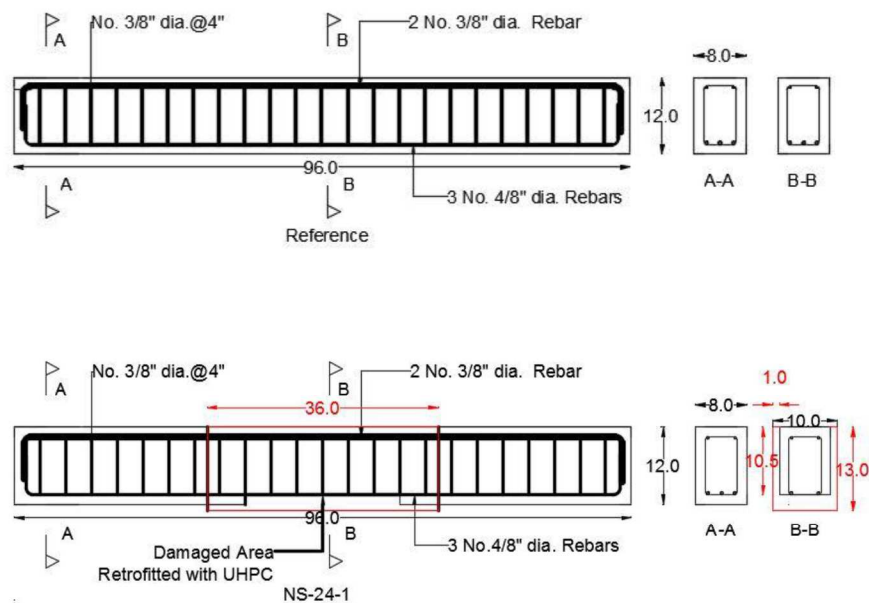
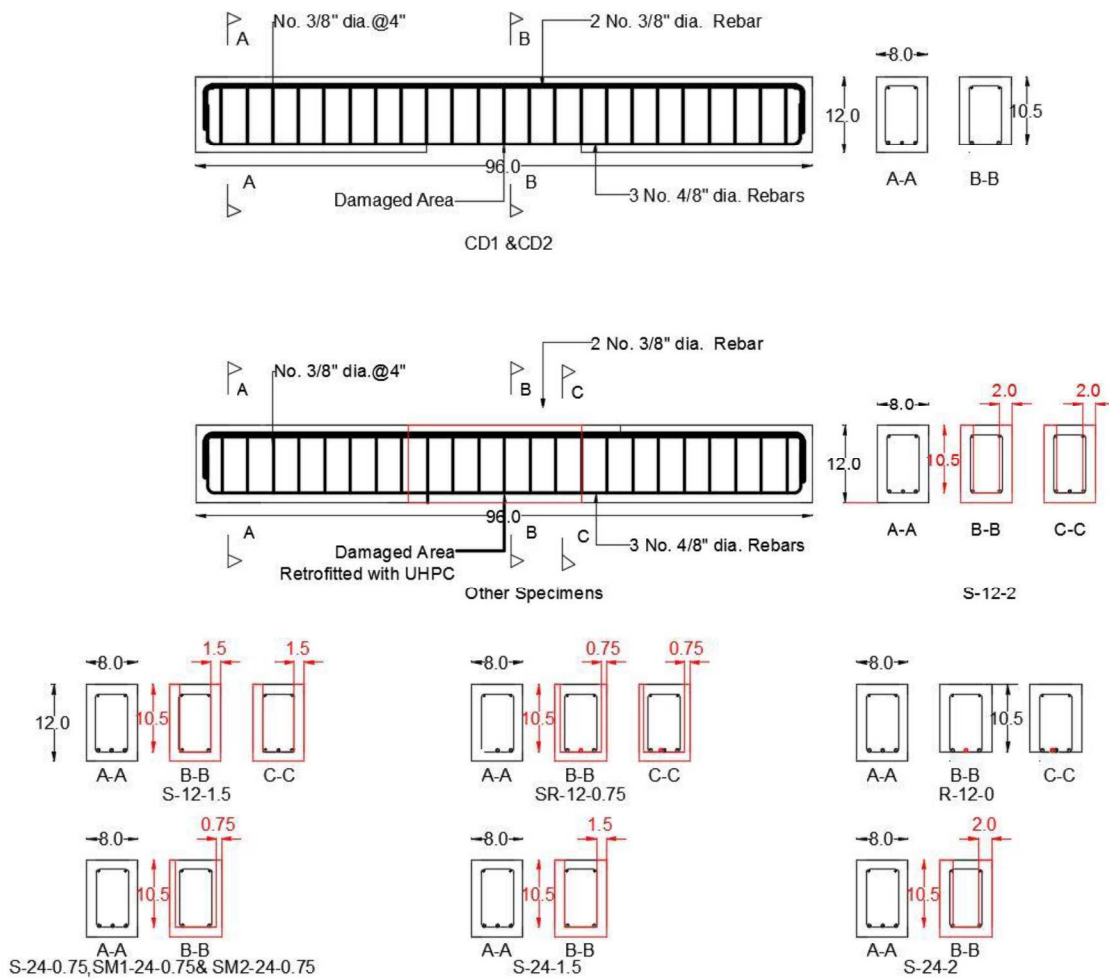
FIGURE 1 Test specimens details.

As shown in Figure 1, in all damaged specimens, part of the bottom concrete cover was removed, exposing the longitudinal tensile reinforcements. The discontinuity in concrete is 8 x 1.5-in., and 24-in. long in the middle of the beam. Each specimen included three number 4 reinforcing bars. In damaged specimens, in the middle of the beam, one of longitudinal reinforcements was cut.

These damages are in the form of removing cover concrete in the bottom of the beam and removing some of the longitudinal tension reinforcement. Specimens CD1, CD2 and NS-24-1 were identical, except that the simulated damage area in specimen NS-24-1 was repaired using thin layer of UHPC shell.

SM1-24-0.75 and SM2-24-0.75 were repaired using thin layer of UHPC shell and using mechanical connections between the UHPC shell and regular concrete with different patterns. Specimens S-24-1.5 and S-24-2 were identical as specimen S-24-0.75 in concept of using only UHPC in the damaged area without any mechanical connections and their difference is the thickness of UHPC shell in the sides. As shown in Figure 1.

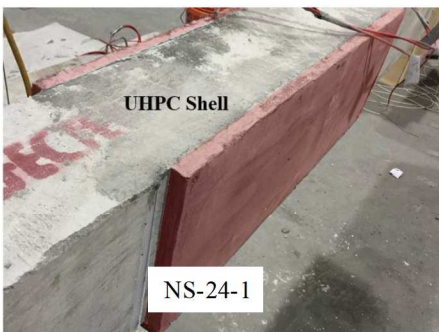
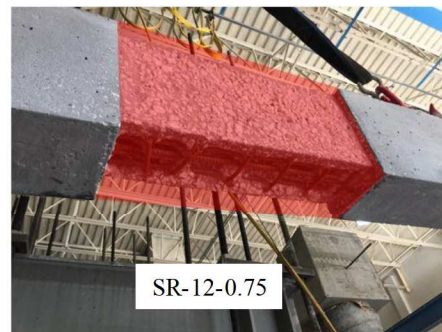
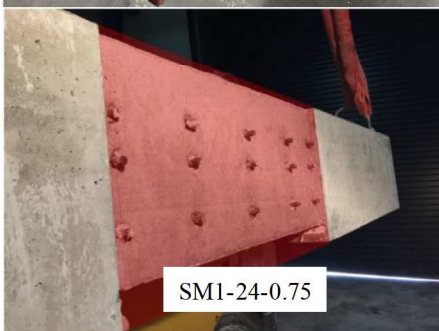
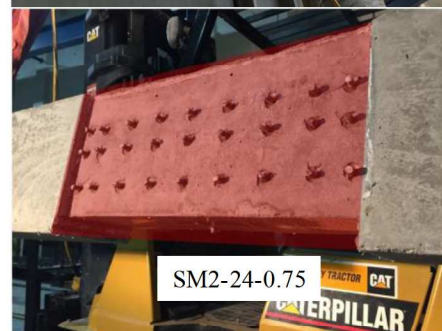
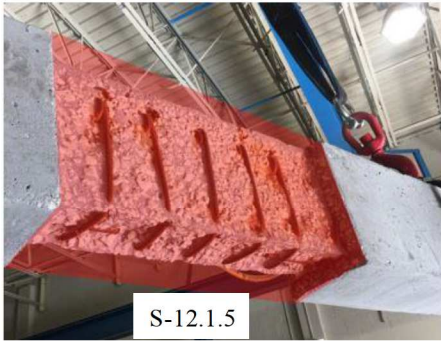
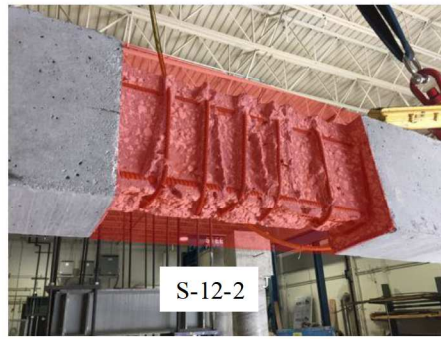
FIGURE 2 UHPC shell detail.

For specimen NS-24-1, the UHPC was poured from one side of formwork to ensure a uniform shell around the damaged area Figure 2. It should be noted that the UHPC shell placed on sides of test specimen NS-24-1 was firmly attached to the bottom side of the beam, while the vertical sides did not incorporate any mechanism for positive attachment. Further, the surface of the beam was not prepared in any way prior to placing the UHPC. For the rest of test specimens, the selected strategies include mechanical connections and having the entire shell element being flushed with surface of existing concrete and sand blasting the damaged surface before retrofitting with UHPC as shown in Figure 2.

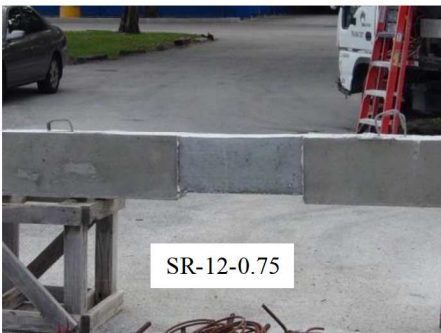
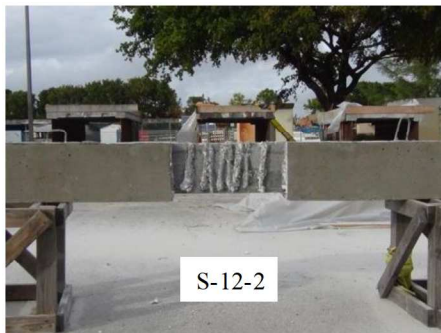
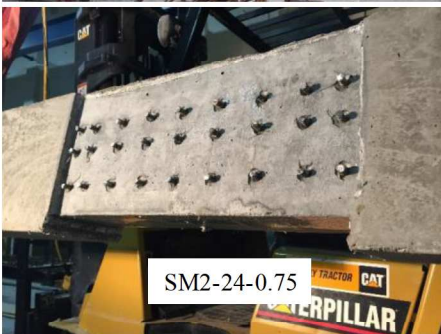
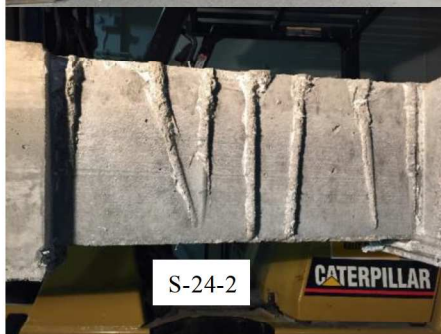
FIGURE 3 Detail of the test specimens surface before sand blasting.

For most of damaged test specimens, surfaces were prepared with the sand blasting and making the surfaces coarse for making better bonding between the UHPC shell and the regular concrete Figure 3 and Figure 4 show the surfaces before and after preparation. For rest of test specimens, the cut length of rebar was 12 inches long and for SR-12-0 and SR-12-0.75 a rebar with length of 22 inches was added to the damaged area.

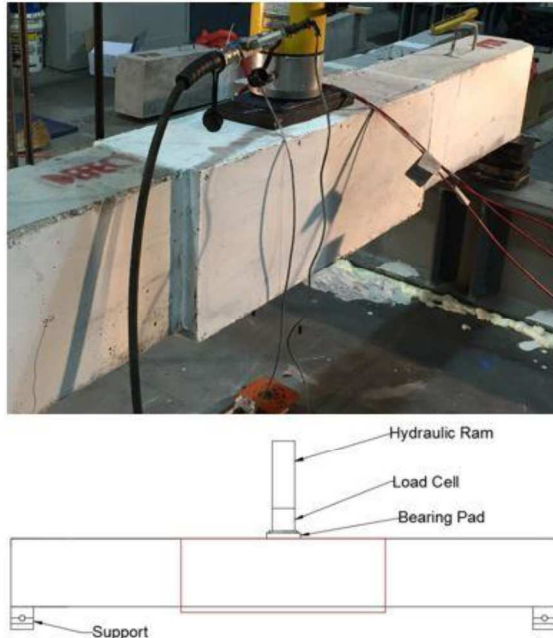
FIGURE 5 Test set up detail.

Flexure testing using three-point loading was used. Testing of specimen was achieved by placing the beams over roller type supports and loading each specimen using single hydraulic jacks, as shown in Figure 5.

Deflections of the test specimens were measured by using three linear string potentiometers which were located at supports and mid-span. Each specimen was loaded until failure load and deflection was observed continuously during the tests.

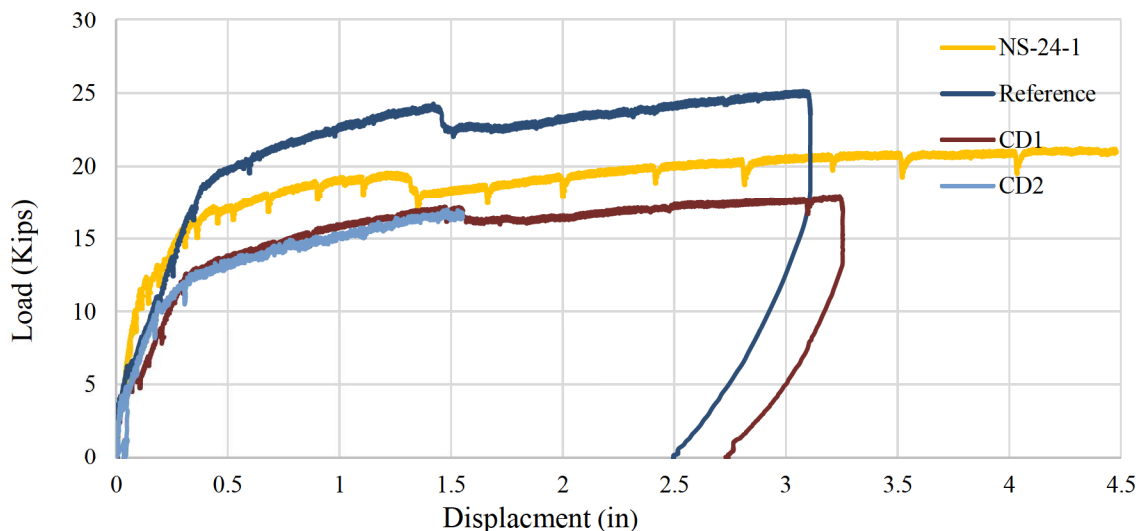
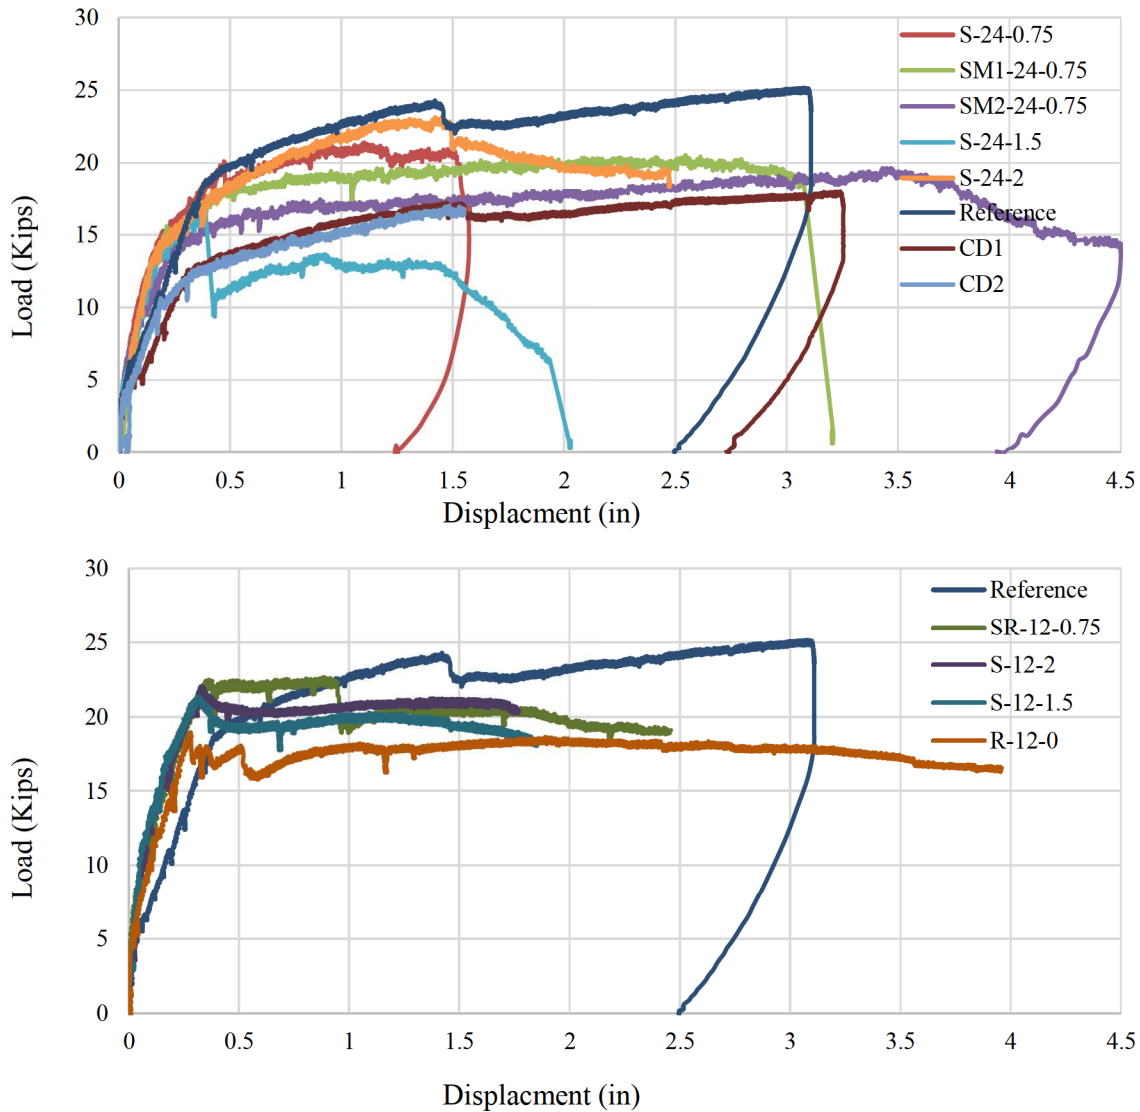
FIGURE 7 Test specimens results.

Reference specimen was loaded at a rate of 0.4 kips/min. The first flexural cracks were observed at the load of $P = 5$ kips, $\Delta = 0.07$ in. By increasing the loads the flexural cracks increased in the length and the height of the beam and the beams failed when applied load reached 23 kips with corresponding deflection, $\Delta = 0.14$ in (Figure 7).

the middle of UHPC and outside of the UHPC on the regular concrete. By increasing the load up to 20 kips, $\Delta = 0.37$ in, the flexural cracks increased in the middle of UHPC shell and at the end test specimen crushed at load of 19.5 Kips, $\Delta = 1.4$ in. The resulting load displacement responses of all thirteen specimens are provided in Figure 7. The results of retrofitted beams show an increase of almost 35% capacity in the flexure capacity of the beam compared to damaged beams.
