# **NDT METHODS APPLICABLE TO HEALTH MONITORING OF ABC CLOSURE JOINTS**

**Quarterly Progress Report  
For the period ending February 28, 2019**

**Department of Civil and Environmental Engineering  
Florida International University  
Miami, FL**

**ACCELERATED BRIDGE CONSTRUCTION  
UNIVERSITY TRANSPORTATION CENTER**

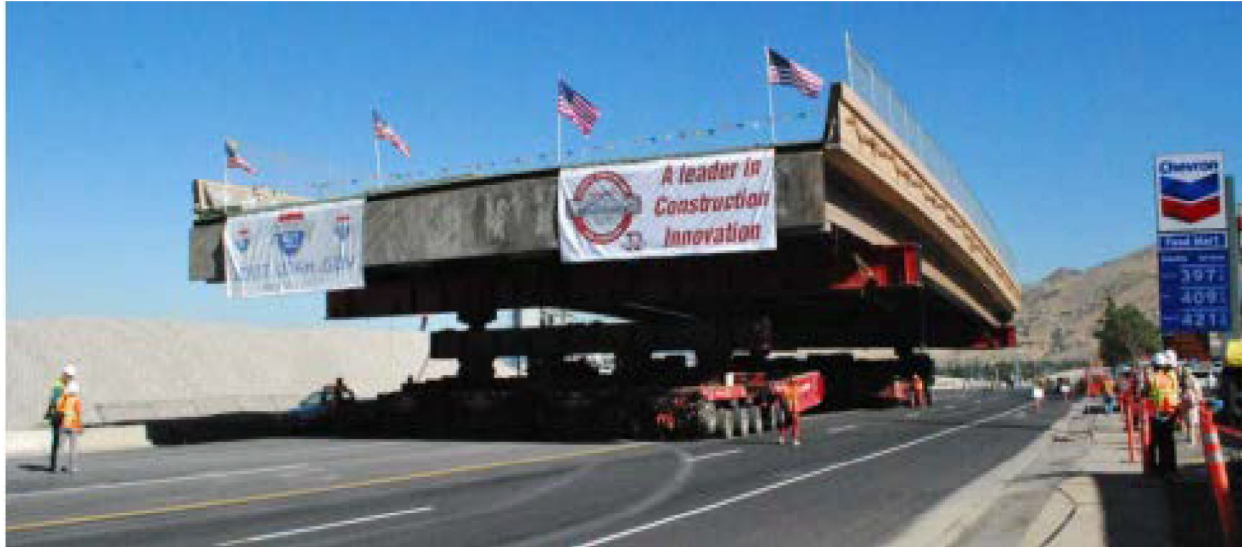
**Figure 1: ABC superstructure positioning [5]**

Owing to these advantages, application of ABC methods is growing across the US (Fig. 1).

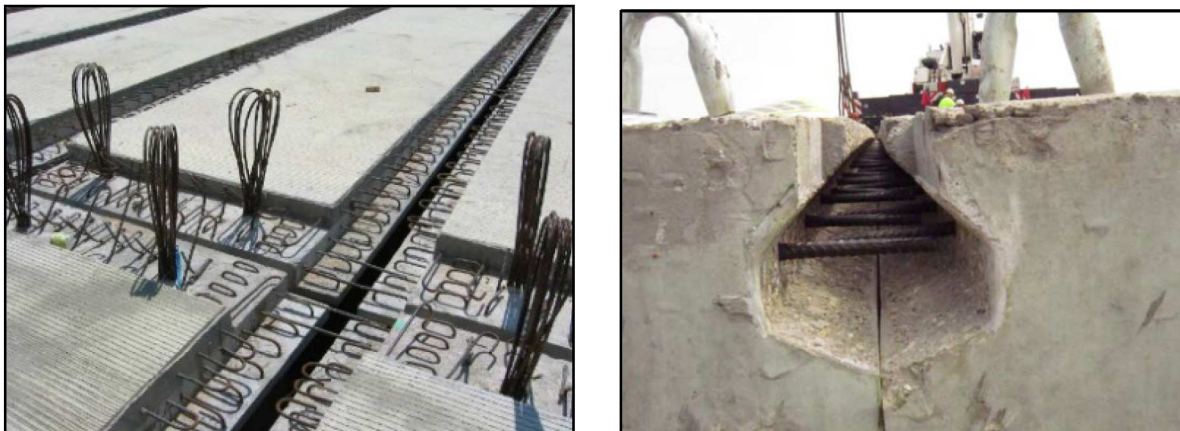
**Figure 2: Examples of various types of ABC closure joints [6]–[9]**

Closure joints normally refer to joints for connecting the bridge deck elements to each other and to the substructure. Other joints are used for connecting superstructure to substructure as well as substructure elements to each other (Fig. 2).

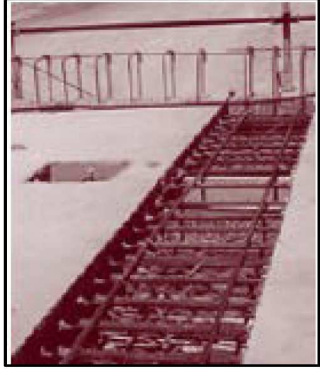
**Figure 4: Type 2 Joint [7], [9]**

Type 2 Joint designation refers to linear joints that normally join full-depth precast decks to each other, and precast decks to precast concrete beams (Fig. 4).

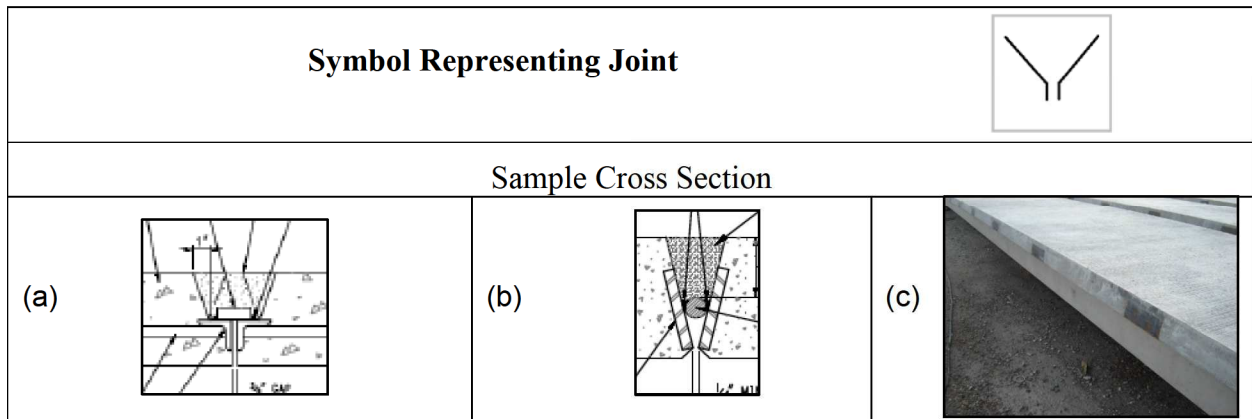
**Figure 6: Type 4 Joint [7], [8], [12]**

Type 4 Joint designation refers to linear joints that normally joins two prestressed tee beams or double beam, and in some cases full or partial depth deck panels. The V shaped joint is cast in the longitudinal direction (Fig. 6).

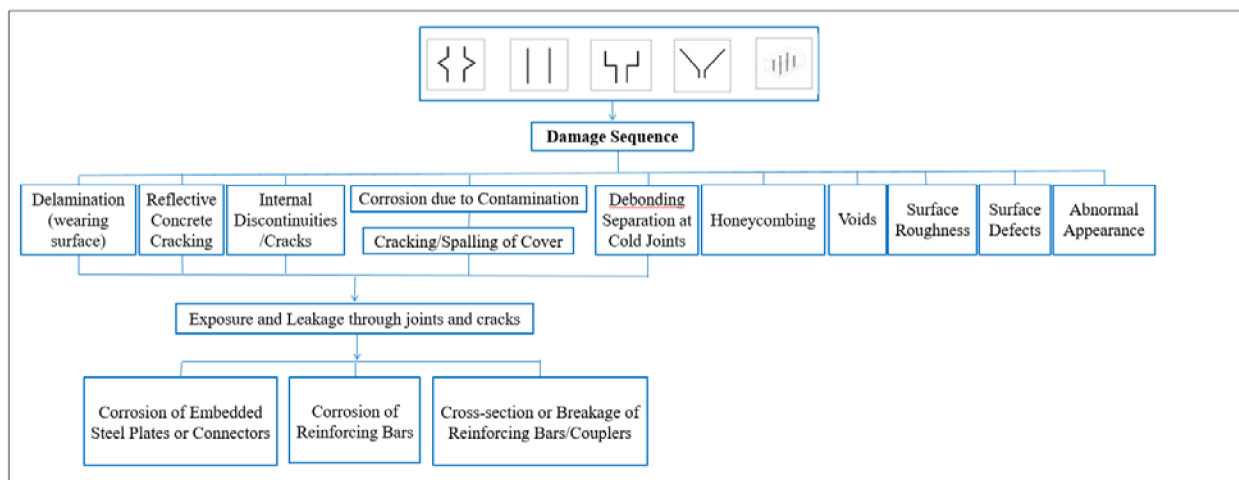
**Figure 8: Sequence of damages for ABC closure joints [46-47]**

In addition to the type and configuration of closure joints, a reliable etiology for defects is believed to facilitate the selection of effective NDT methods as well as their application to closure joints. For example, water leakage caused by cracking at joint will lead to the use of NDT method(s) capable of detecting cracks. Also, presence of crack may point to a cause or source that would indicate potential for other type of damages associated to that source, and therefore prompt the application of certain NDT method. According to previous observations and inspections, common defects observed in concrete decks on general and closure joints in specific may be caused by one or more of sources including design issues, material deficiencies, workmanship problems, mechanical and loading effects, or environmental conditions. Table 3 shows the relationship(s) between common damages/defects in ABC closure joints and their potential main causes as the defect etiology. The relationships shown in the table, as described above, can lead to selection of the proper NDT method and its effective application. The type of defect, certainly, plays a significant role in selection of the most applicable NDT method for evaluation of the closure joints. Therefore, evaluation of NDT methods is to be performed in relation with the type of closure joints and expected defects/anomalies. Defective closure joints may include various levels of damages, one caused by another. A knowledge of interrelation between various damages and their sequence will be able to guide the selection of an appropriate NDT method. The sequence of the damages constructed for closure joints is shown by Figure 8.
