Integral Abutment Connection Details for Accelerated Bridge Construction

Final Report
October 2018

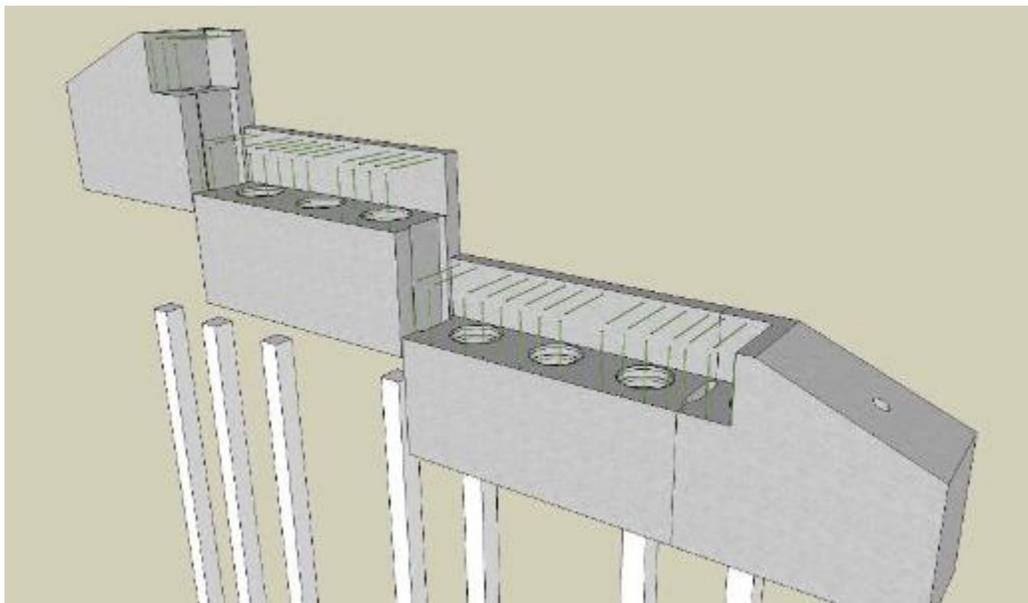
The implementation of a cast-in-place concrete closure pour is typically the method used in ABC to create the integral abutment connection (Figure 1).

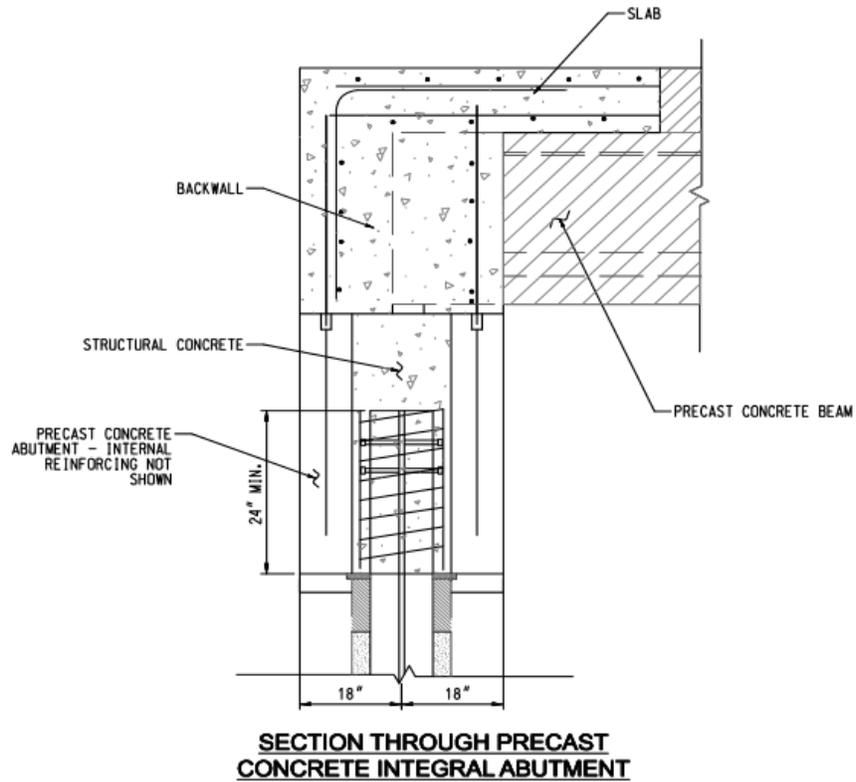
The common practice during construction of integral abutments has been to place the precast pile cap on top of the driven piles, place the precast girder, and then place a closure pour over the connection to create an integral connection between the two elements (Figure 2).

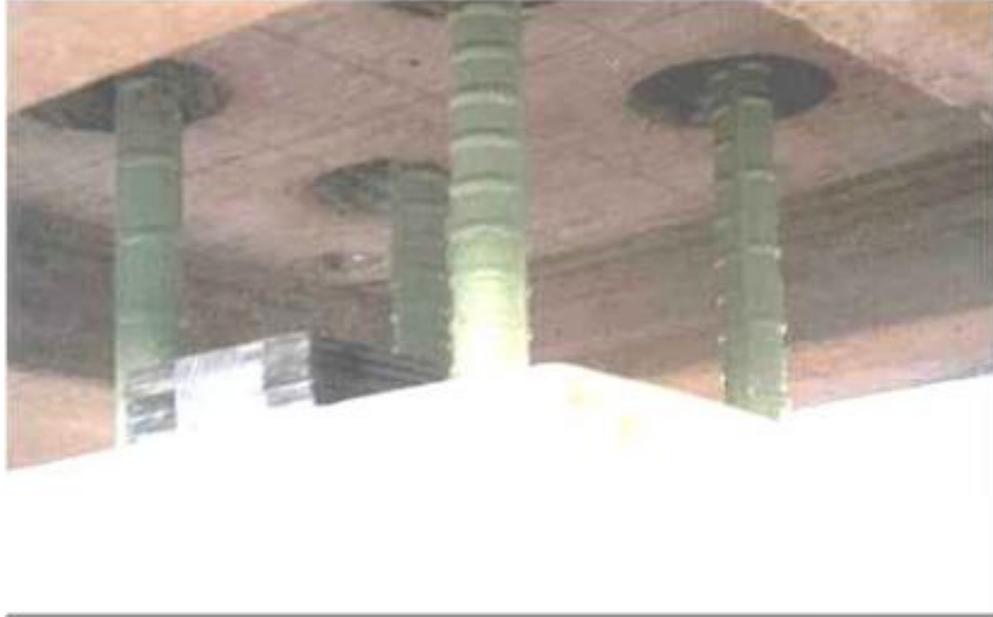
To eliminate some of this construction time, the use of different integral connections is being introduced to the bridge engineering spectrum. One of these is the use of grouted reinforcing bar splice couplers, which utilizes a protruding reinforcing bar on one element being inserted into a sleeve in the other element to be connected (Figure 3).

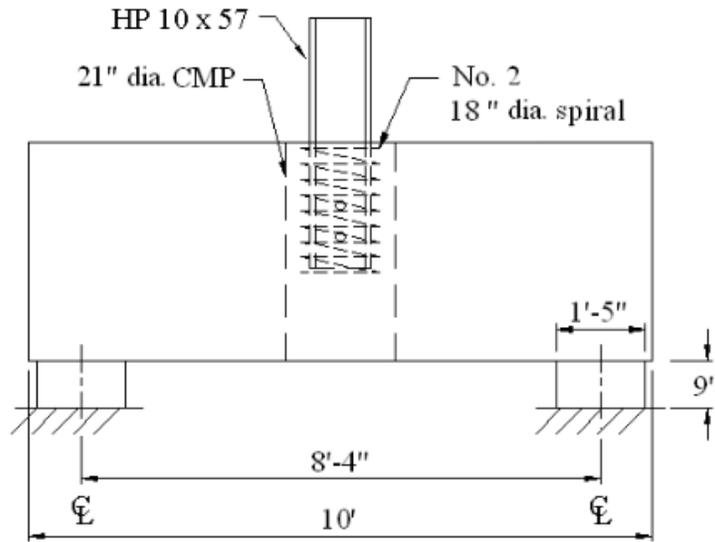
The setup of the specimens was representative of the conditions that would be applied to the element in the field. A single-pile (Figure 4) and double-pile (Figure 5) cap abutment was set up and tested similarly by applying loads onto the inverted pile cap setup.

The single-pile cap abutment was designed to represent a negative moment applied in the field, and the double-pile cap abutment was to represent a positive applied moment in field conditions. Also, since the double-pile cap had yet to fail after moment testing, a shear test was conducted to see if the connection would fail through “punching” through the precast section.

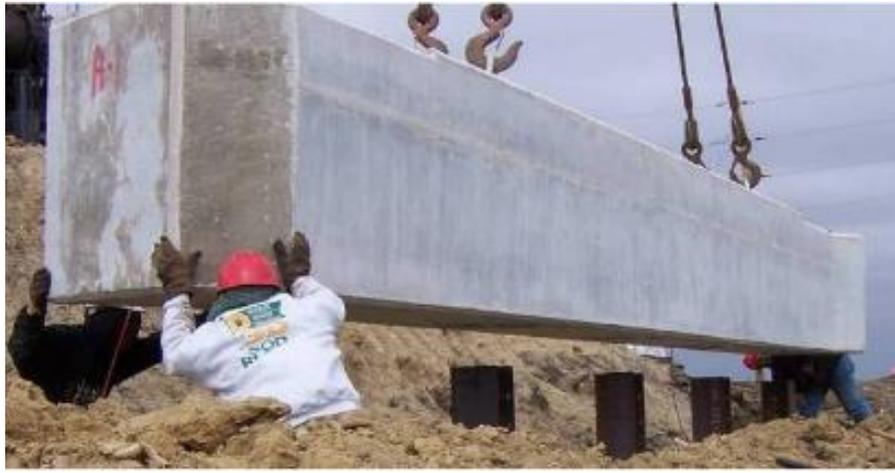
Figure 6. Abutment being lowered into place

The construction of the pile cap abutments was reported to have gone smoothly with the only waiting time being the arrival of the delivery truck. There were no clearance issues recorded between the CMP and the H-piles (HPs), and the installation of the abutments took approximately 15 minutes (Wipf et al. 2009) (Figure 6).

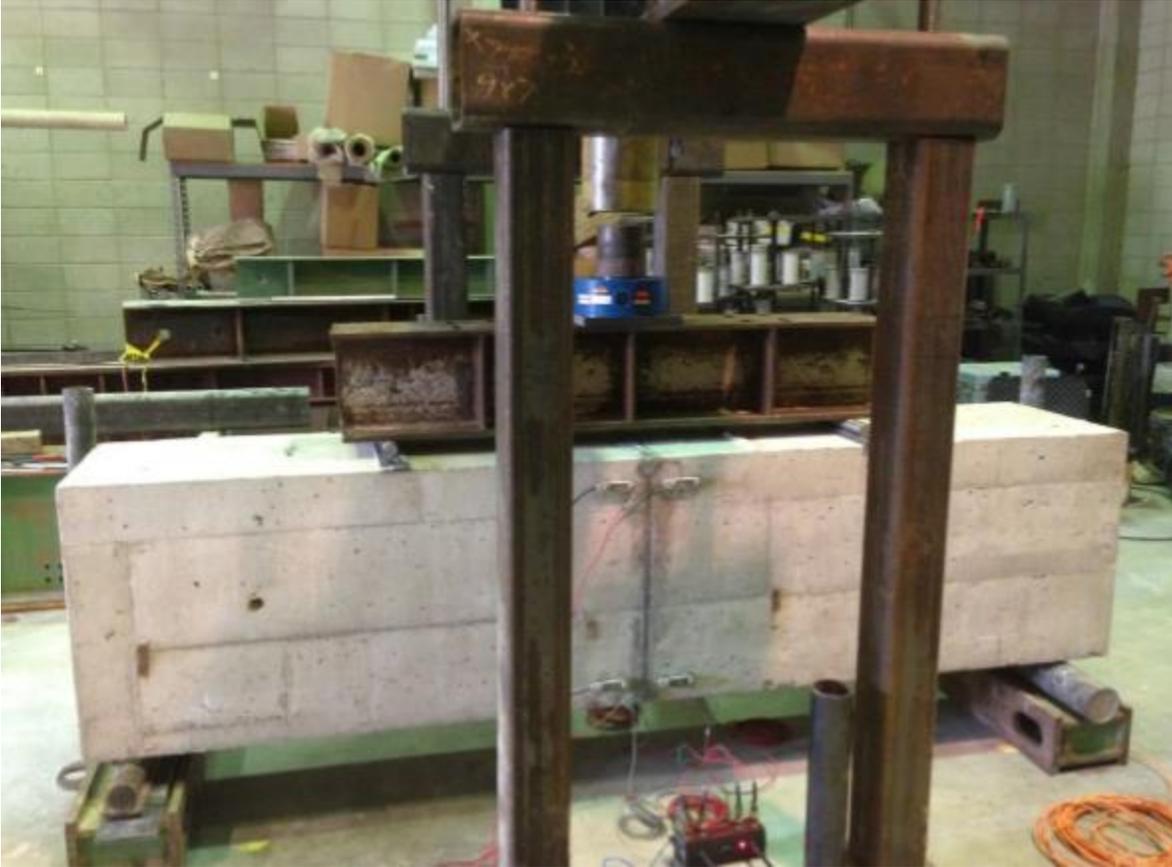
Five of the seven specimens utilized the W.R. Meadows 588-10K grout to fill the grout bed, while two used UHPC. The specimens were erected, underwent a “dry-fit” for the coupler connections, were grouted together per manufacturer’s instructions, and were set up for four-point testing (Figure 8).

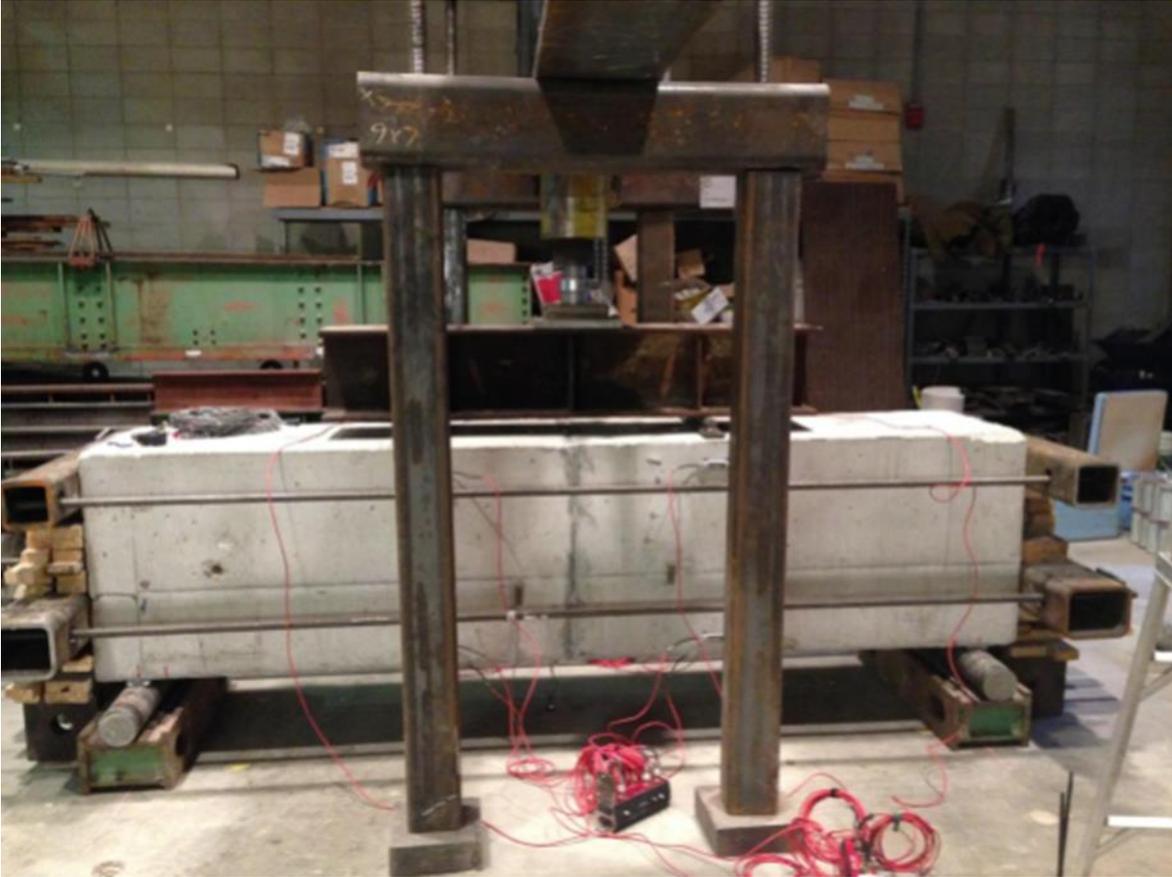
It was suggested to the research team that an axial load be applied to the ends of the specimen to represent the dead load of the bridge on the columns and that these additional loads may have an impact on results of the four-point bending tests (Figure 9).

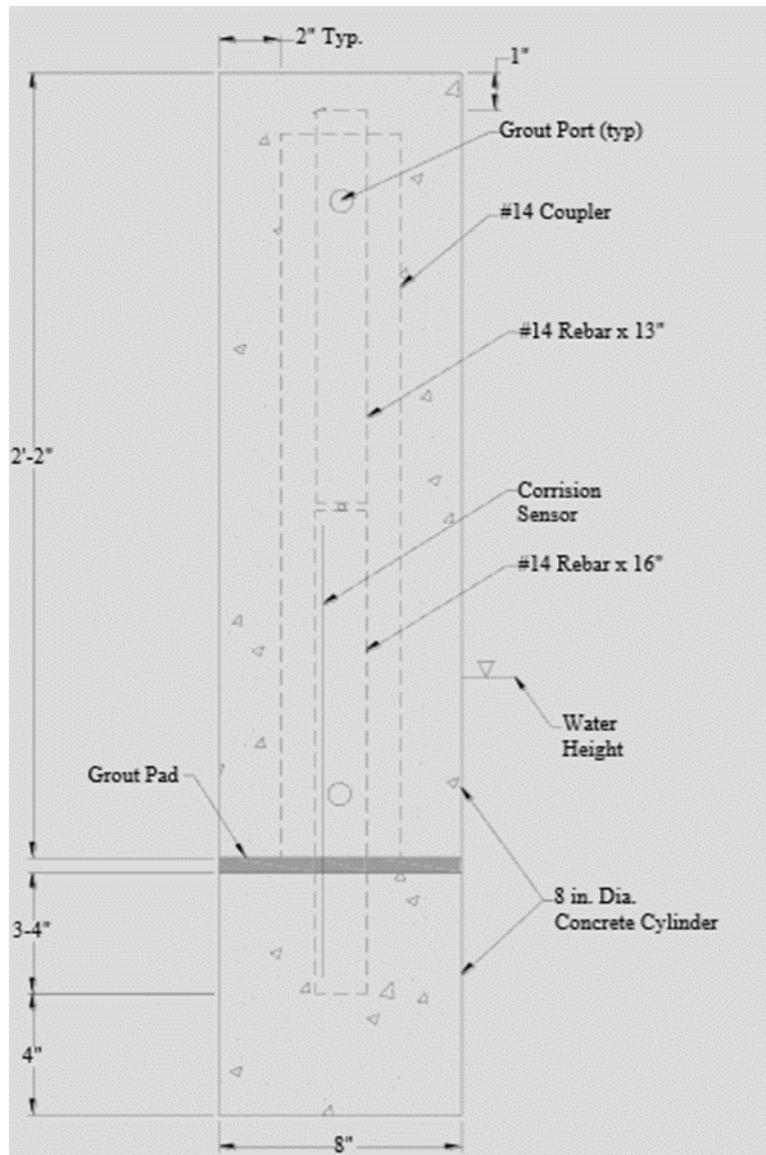
In addition to the four-point bending test, corrosion testing was done on three cylinders with the grouted reinforcing steel coupler to determine if corrosion of the reinforcing steel was probable when submerged in a 3% chlorine bath for six months (Figure 10).

- With no cracks present in the three cylinders for the corrosion testing on the couplers, no evidence of corrosion was detected

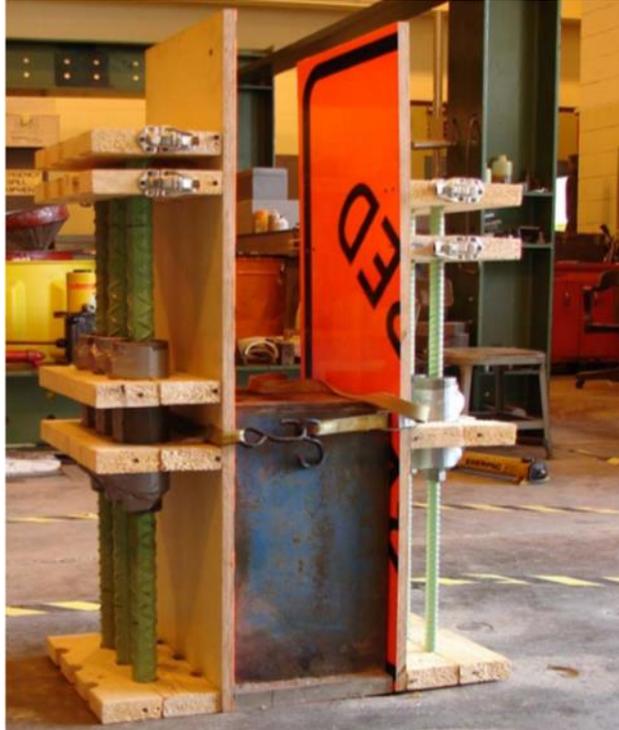
Figure 11. Lenton Interlok specimens

To ensure there would be no concentric loading on the specimens, the specimens were constructed vertically in a constructed fixture to hold each piece of the splicing mechanism in place vertically while being installed. The Lenton Interlok (Figure 11) has one threaded end and one grout filled end, while the NMB Splice Sleeve (Figure 12) has both ends grout filled.

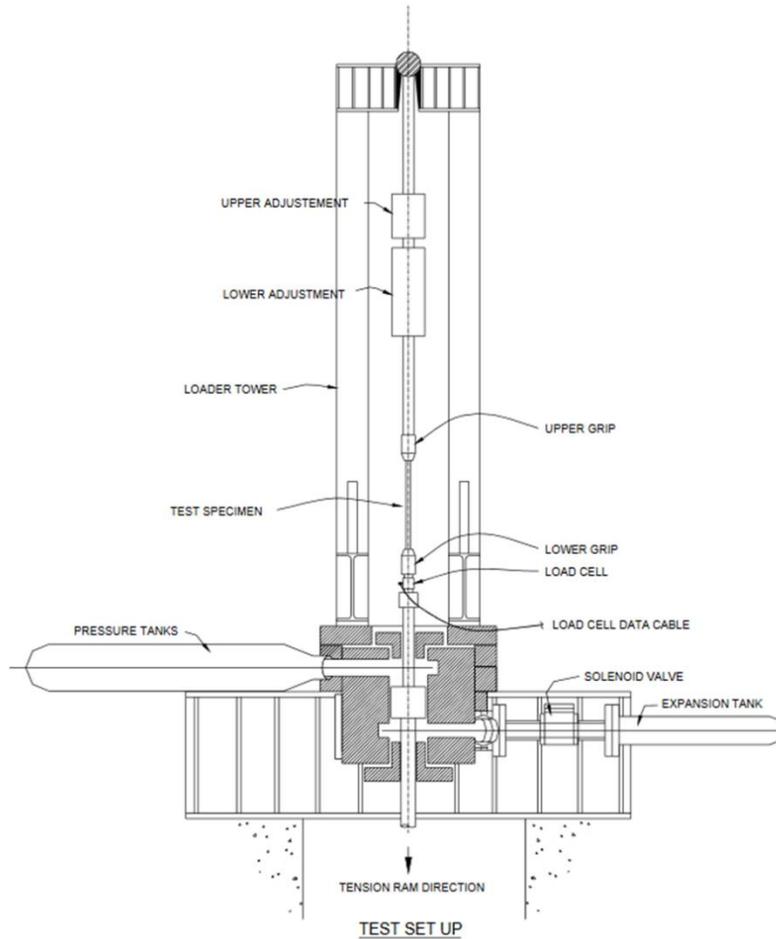
This design standard set the objective for this study to test the performance of mechanical couplers when subjected to high-strain rate stressing. This study would either validate available couplers or provide a guide for further testing and validation of mechanical couplers in blast-resisting structures. To do this, control specimens were tested in tension as were the specimens of both reinforcing bar and a mechanical coupler (Figure 14).

The results of the testing were that only one of the five coupler products passed the updated criterion without requiring further testing, which was the grout-filled coupling sleeve. The shear-screw coupling sleeve and taper thread coupler specimens both failed the new criterion, while the last two require further testing to validate them under the new criterion and be applied to blast-resistant structures (Rowell 2015).

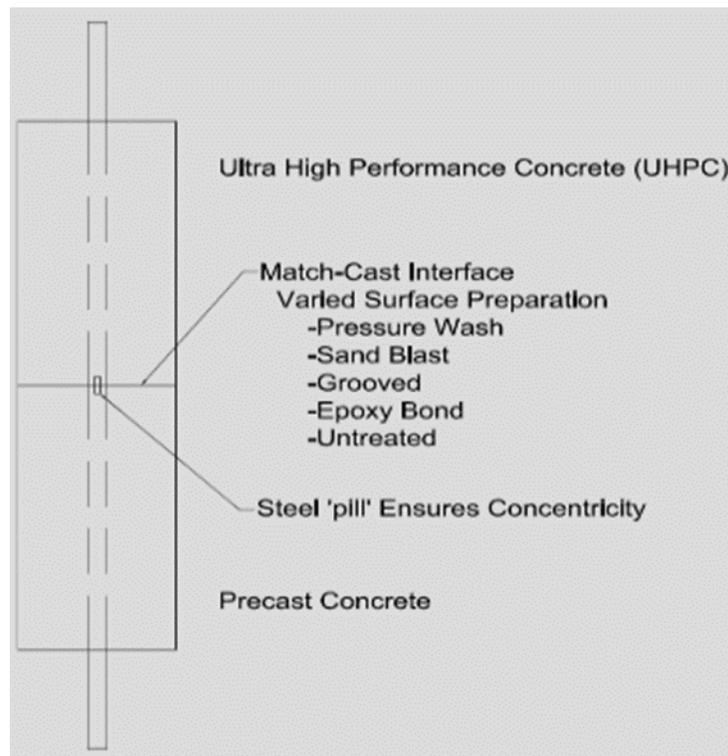
The bond testing in the laboratory measured the strength of the bond through two test types: Direct Tension Testing and Simulated Modulus of Rupture (MOR) Testing. The direct tension testing consisted of 4 in. diameter cylinders cast in half with a threaded steel rod, one half precast HPC that cured 28 days, and then the other half was UHPC match cast onto the half-cylinder. The interface preparation of the specimens varied, as to see how it affected results, between 1,500 psi pressure wash, 3,000 psi pressure wash, plywood (untreated), sandblasted, groove cut, and epoxy bonding agent (Figure 15).

Figure 15. Direct tension test specimen

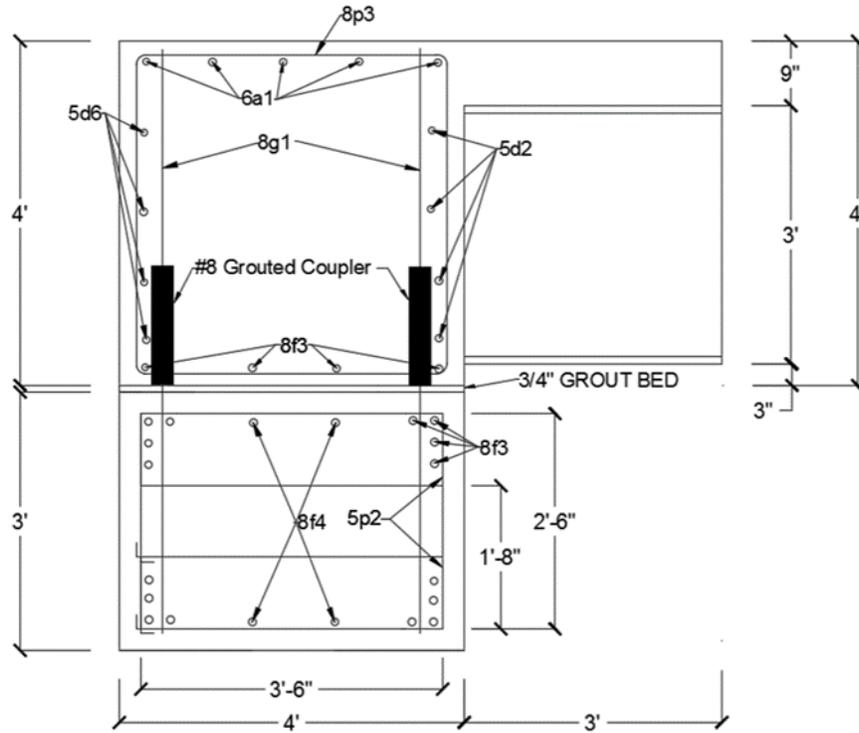
This report was Phase I for the project of focus, hence the project had the same research objectives. Three specimens were tested to determine the strength, durability, and constructability of two proposed connections compared to a cast-in-place control specimen. The two proposed connections were: grouted reinforcing bar coupler (GRBC) (Figure 17) and pile couplers (Figure 18).

Figure 17. Grouted reinforcing bar coupler

- Tight tolerances typically seen with grouted reinforcing bar couplers were alleviated through a match-casting procedure
- Strength and durability of the grouted reinforcing bar coupler specimen were similar to the cast-in-place control specimen. The crack width of the back face of the integral abutment was measured at the precast joint to be 0.035 in. for the grouted reinforcing bar coupler, and 0.019 in. for the cast-in-place control specimen, which means the grouting reinforcing bar coupler's resulting crack width was about 1.8 times greater than the control specimen

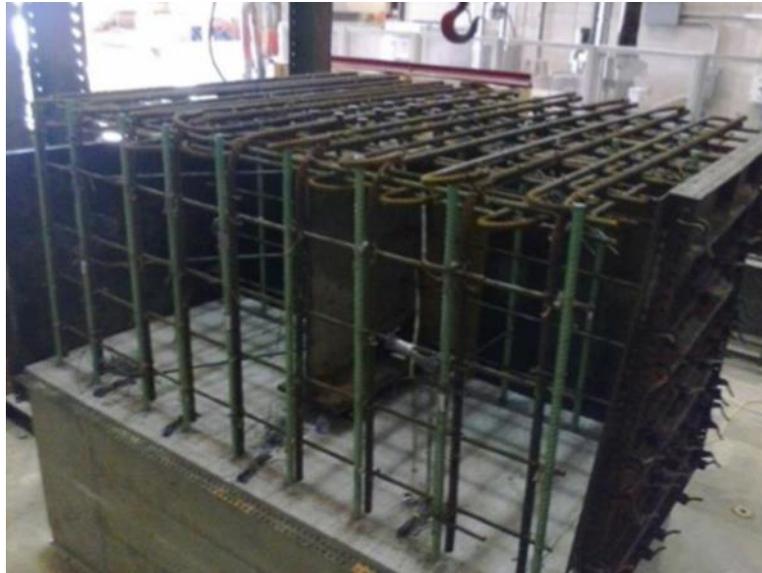
Figure 19. Cast-in-place specimen reinforcing cage

Construction of the three specimens did not pose any significant challenges. The cast-in-place control specimen was erected by forming the steel reinforcement cage (Figure 19), and then simply pouring concrete.

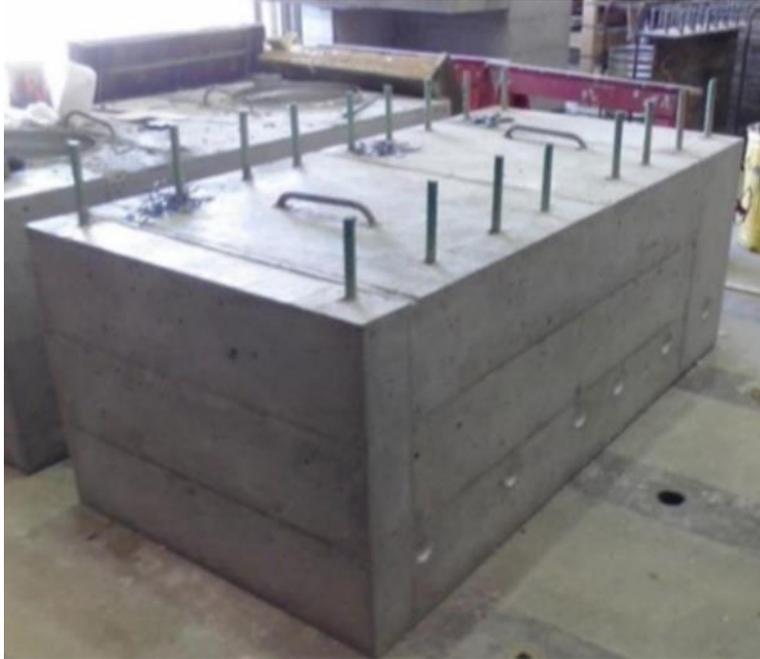
Figure 20. Grouted reinforcing bar coupler pile cap

The grouted reinforcing bar coupler specimen had the pile cap cast with protruding reinforcing bars (Figure 20), utilized a match-casting procedure (Figure 21) to cast the sleeves for the connection in the integral diaphragm element, the integral diaphragm was placed on top of the pile cap via crane (Figure 22), and finally the sleeves were filled with grout to complete the connection.

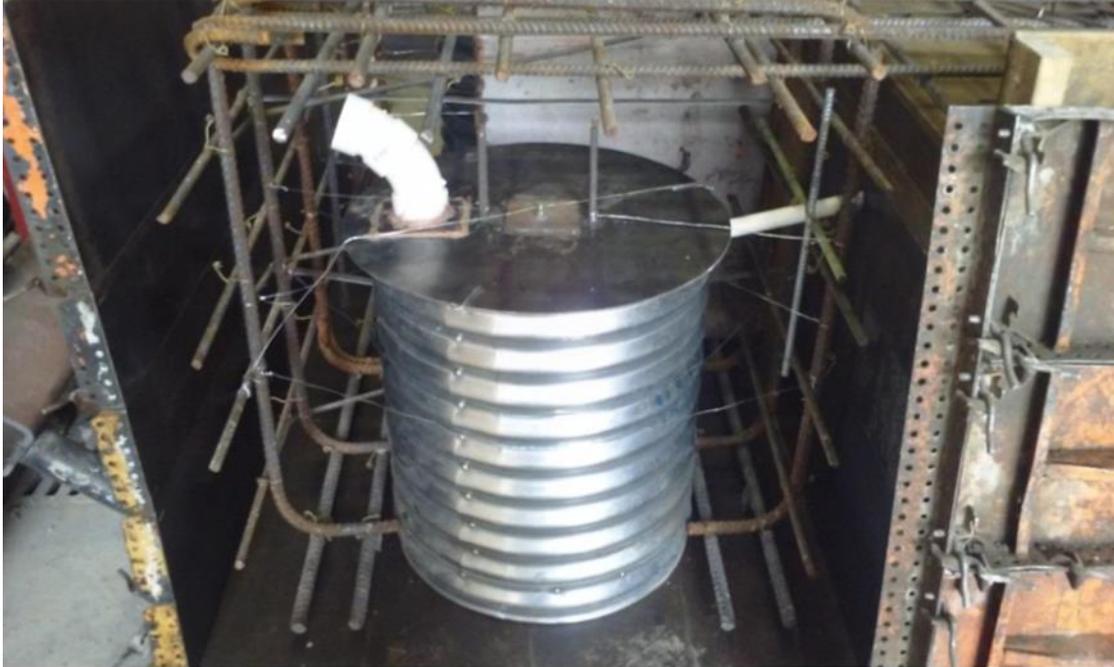
Figure 23. Integral diaphragm CMP void for pile coupler

The pile coupler was constructed like the grouting reinforcing bar coupler, by having two elements cast with a part of the connection, but instead of protruding reinforcing bars and sleeves, each element had CMP voids. The integral diaphragm had a longer CMP void with the HP section being suspended within the void (Figure 23 and Figure 24), while the pile cap had CMP voids half the length of the HP section (Figure 25).

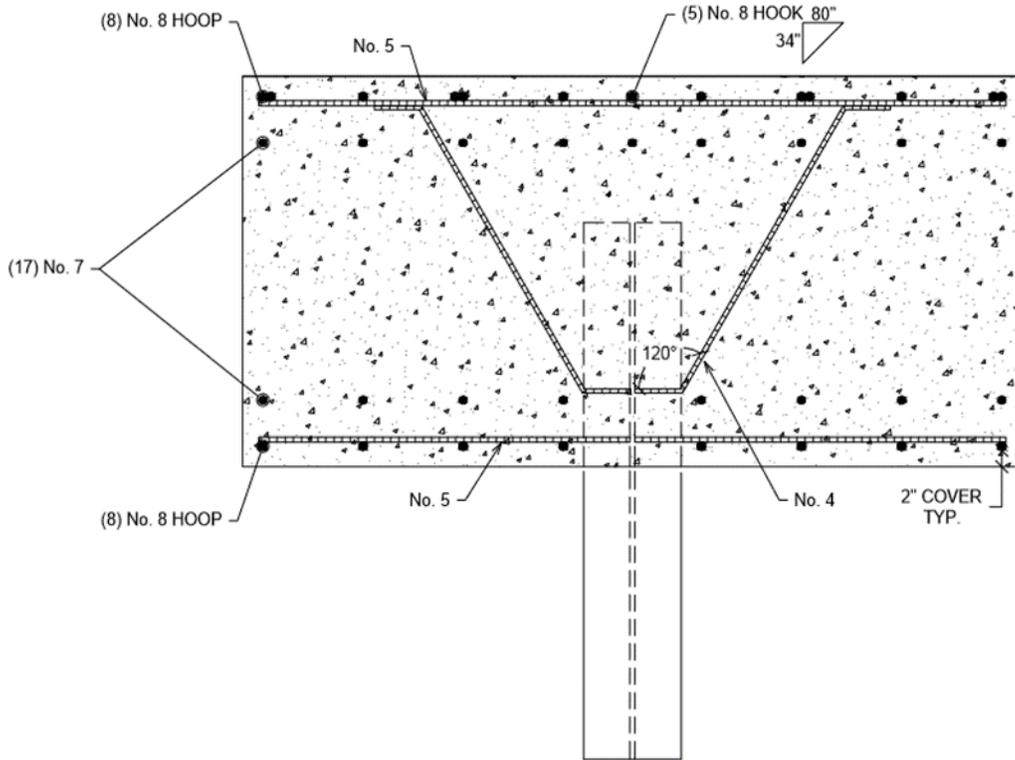
The Iowa DOT developed this connection to utilize the ABC method of “slide-in construction,” and UHPC. UHPC was chosen in lieu of concrete or a grouting material due to the increased flowability characteristic of UHPC, as well as its impermeability and high strength. The placement of reinforcement throughout the specimen was based on the reinforcement of the grouted reinforcing bar coupler specimen from Phase I, except for the connection bars, which used 17 #7 reinforcing bars (Figure 27).

Figure 27. Plan view of UHPC joint specimen showing locations of connection bars

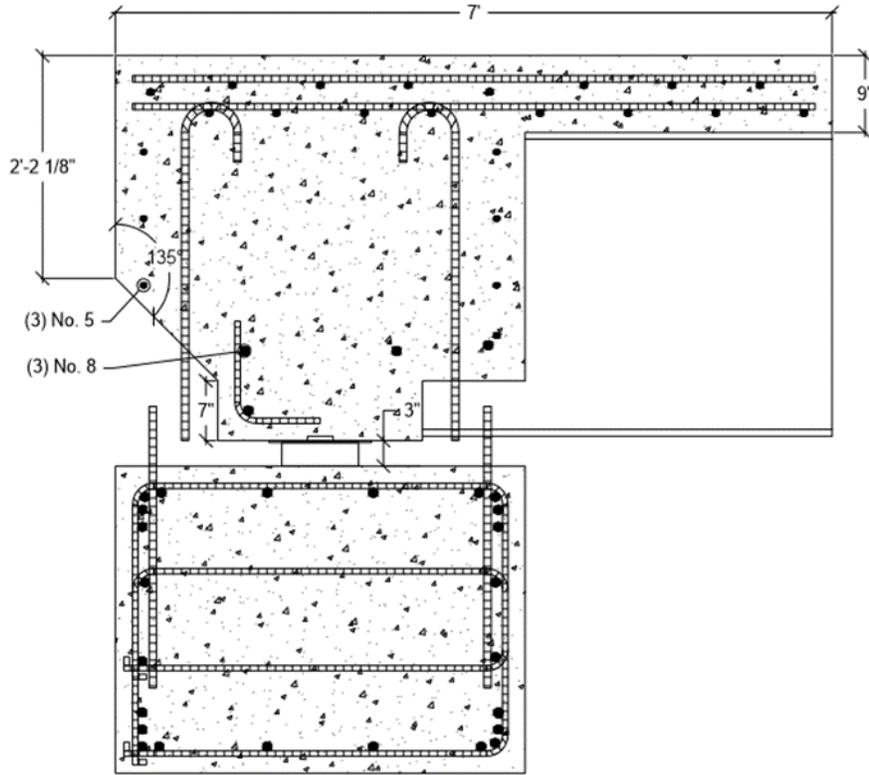
One of the initial design notes for this specimen was the eight #7 reinforcing connection bars on the front face of the pile cap of the specimen would need to utilize a mechanical coupler to eliminate the issue of the protruding bars from the pile cap interfering with the steel beam during the slide. These mechanical couplers were designed to be Dayton Superior D310 Taper-Lock Standard Couplers, which were chosen over other couplers due to ease of installation in the tight space while maintaining acceptable strength and durability. Another design note was to create two 7 in. wide “chimneys” along the rear face of the integral diaphragm, which was to create a pressure head to aid the flowability of the UHPC (Figure 28).

Figure 28. UHPC joint specimen section through “chimney”

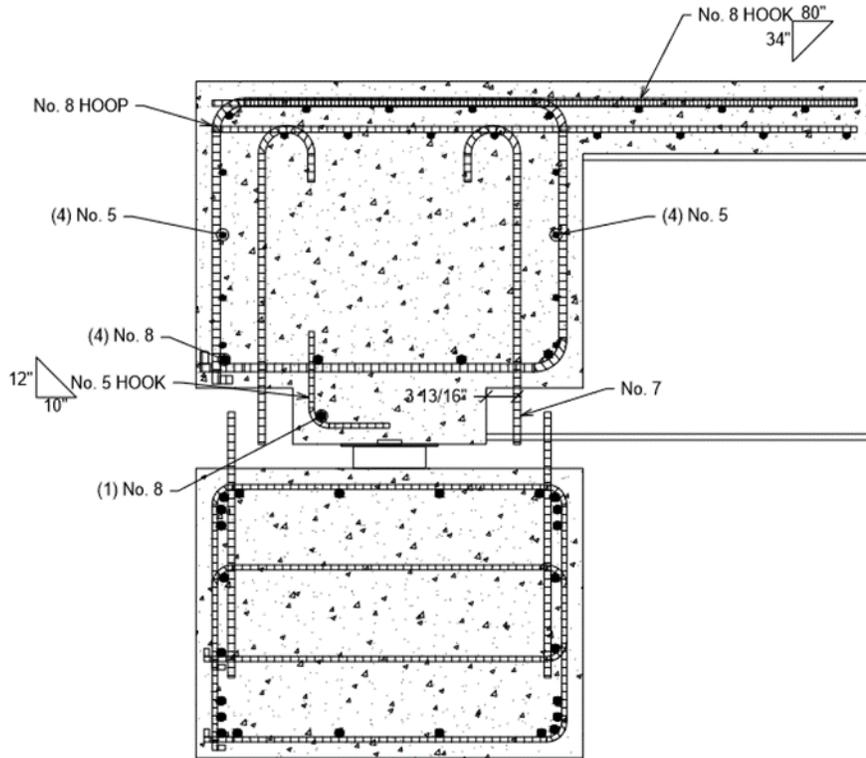
The overall size of the specimen does not vary in size from the other two specimens, except for the height of the integral diaphragm, since the “grout-bed” for this specimen is 3 in., instead of the $\frac{3}{4}$ in. grout bed seen in the other two specimens. To maintain the overall height of the specimen, the height of the integral diaphragm is decreased (Figures 29 and 30), and is governed by the concrete cover of the steel bearing plate and beam.

Figure 29. UHPC joint specimen section view

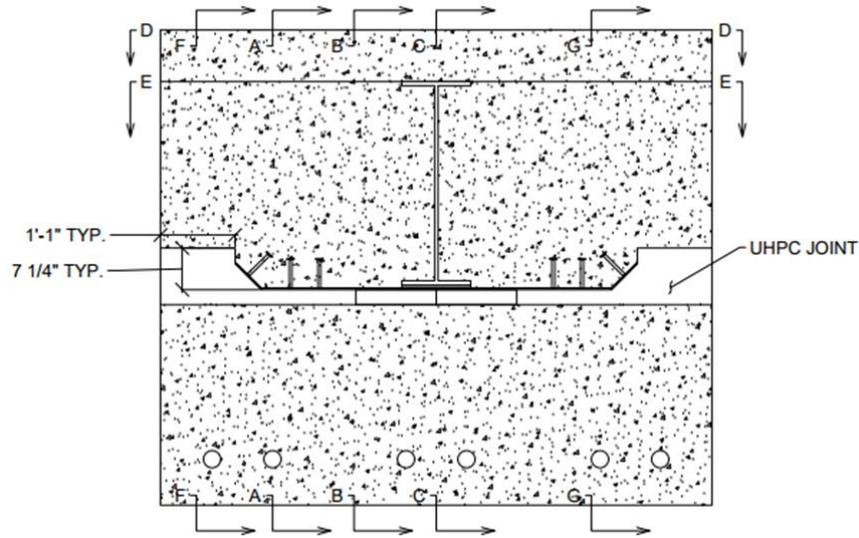
The UHPC joint specimen would utilize the ABC application of “slide-in construction,” using laminated neoprene pads with Teflon and stainless-steel sliding “shoes” (Figure 31).

Figure 31. UHPC joint specimen front view showing “sliding shoes” and pads

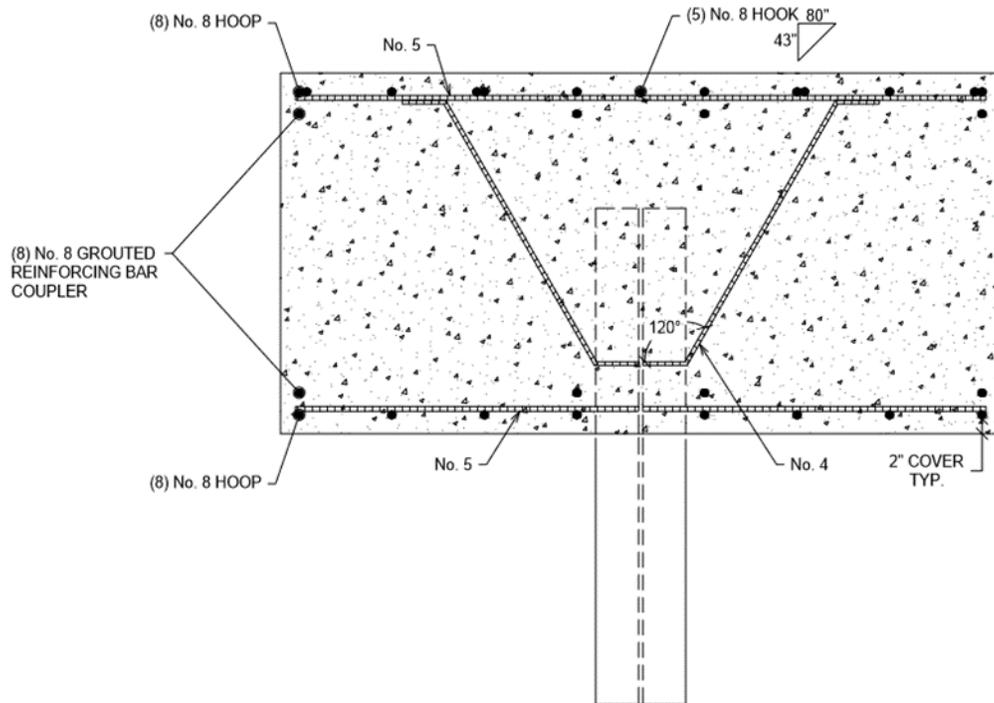
The design of this specimen was based on the design from the Phase I testing of the connection, with the only difference between the two phases being a reduction in the number of grouted reinforcing bar couplers. Phase I had 17 couplers, while Phase II only has 8 (Figure 35).

Figure 35. Plan view of grouted reinforcing bar coupler showing locations of couplers

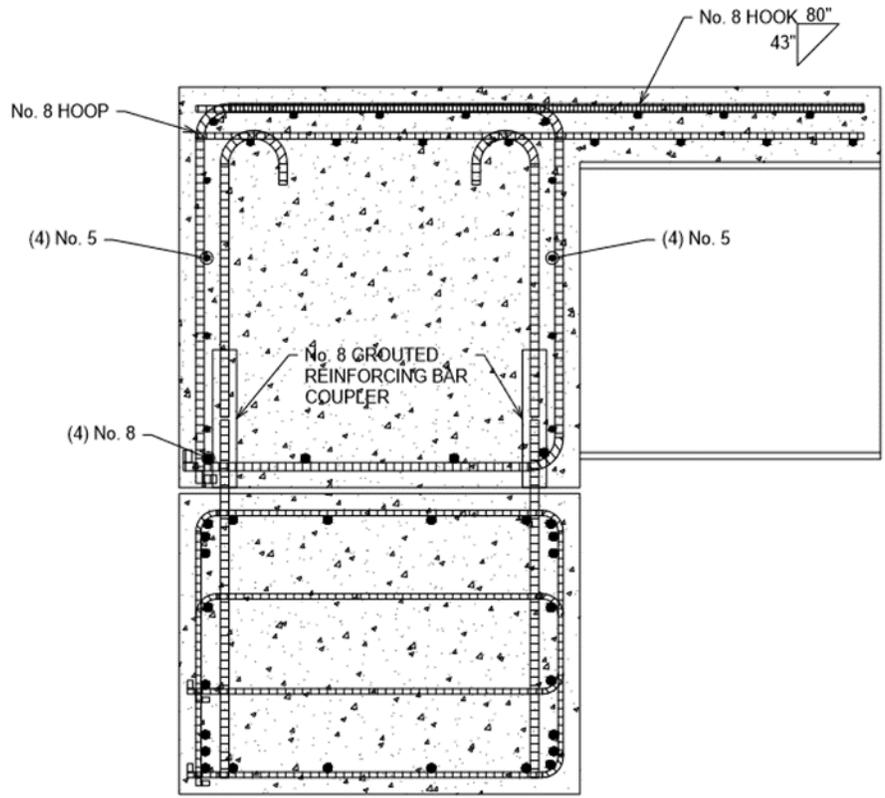
The design of the couplers is the same as the couplers used in Phase I, being the couplers were designed to be #8 epoxy-coated reinforcing bars with Dayton Superior D410 Sleeve-Lock Grout Sleeves filled with Dayton Superior D490 Grout (Figure 36).

Figure 36. Grouted reinforcing bar coupler section view through couplers

The overall size of the specimen and the distribution of the reinforcement is the same design as seen in Phase I, which was done to eliminate variances in design other than the couplers (Figures 36 and 37).

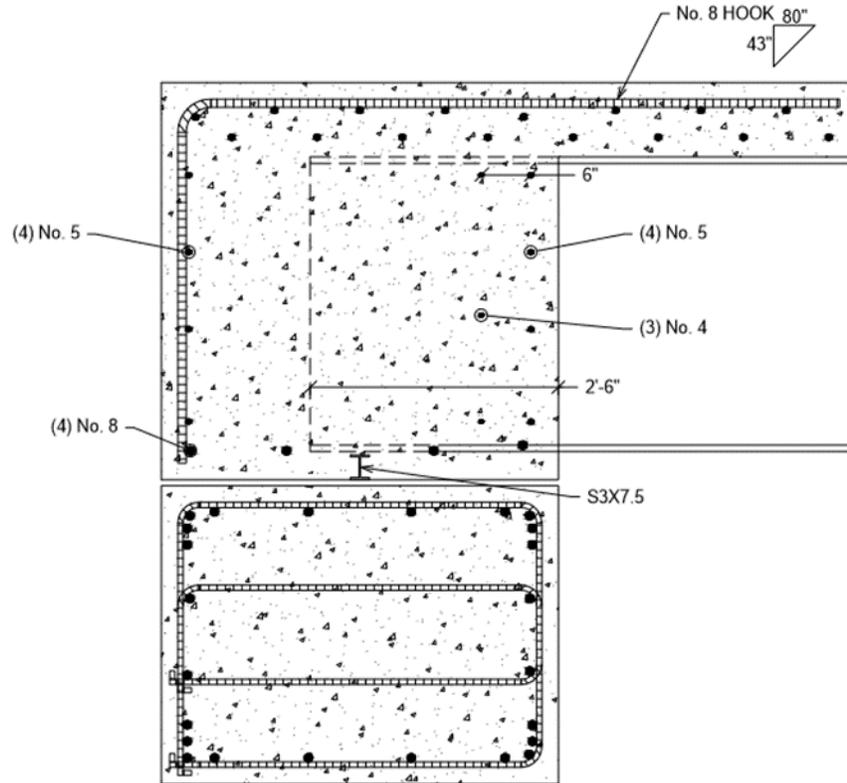
Figure 37. Grouted reinforcing bar coupler section view through beam

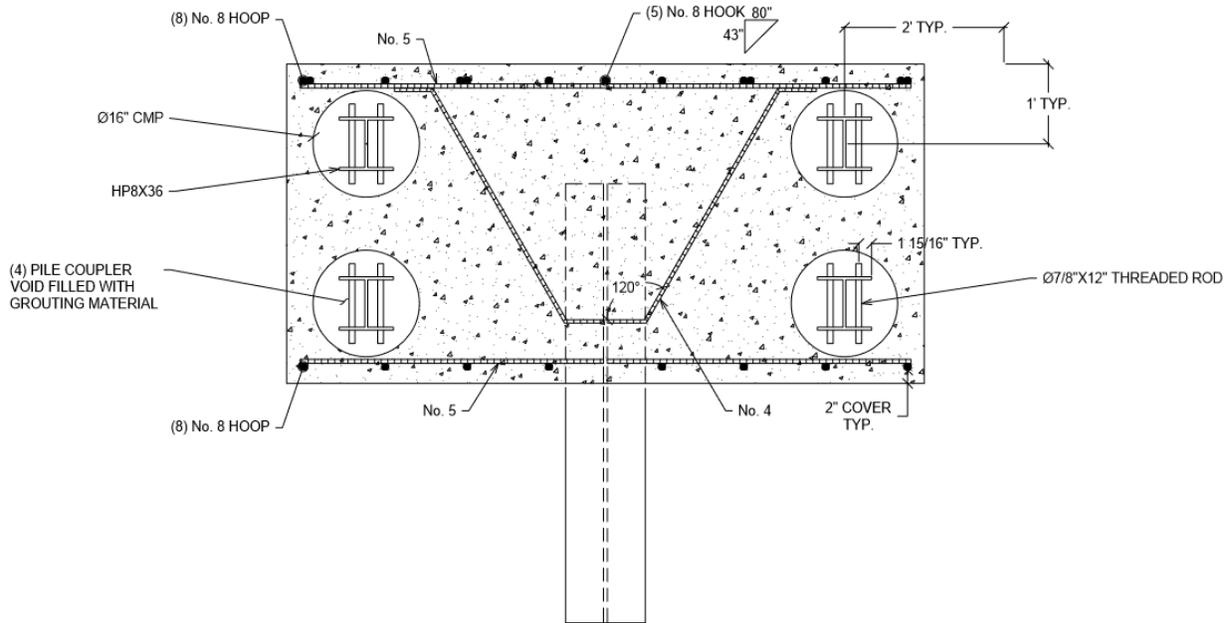
This specimen was designed per Phase I design, and recommendations made after the results of testing. The Phase II pile coupler specimen uses the concept of the piles being the connection through the CMP voids being filled with a grouting material, but this design has four HP8X36 couplers acting as a force couple instead of having only two HP10X57 couplers at the center of the diaphragm/pile cap as Phase I did (Figure 38).

Figure 38. Plan view of pile coupler showing locations of couplers

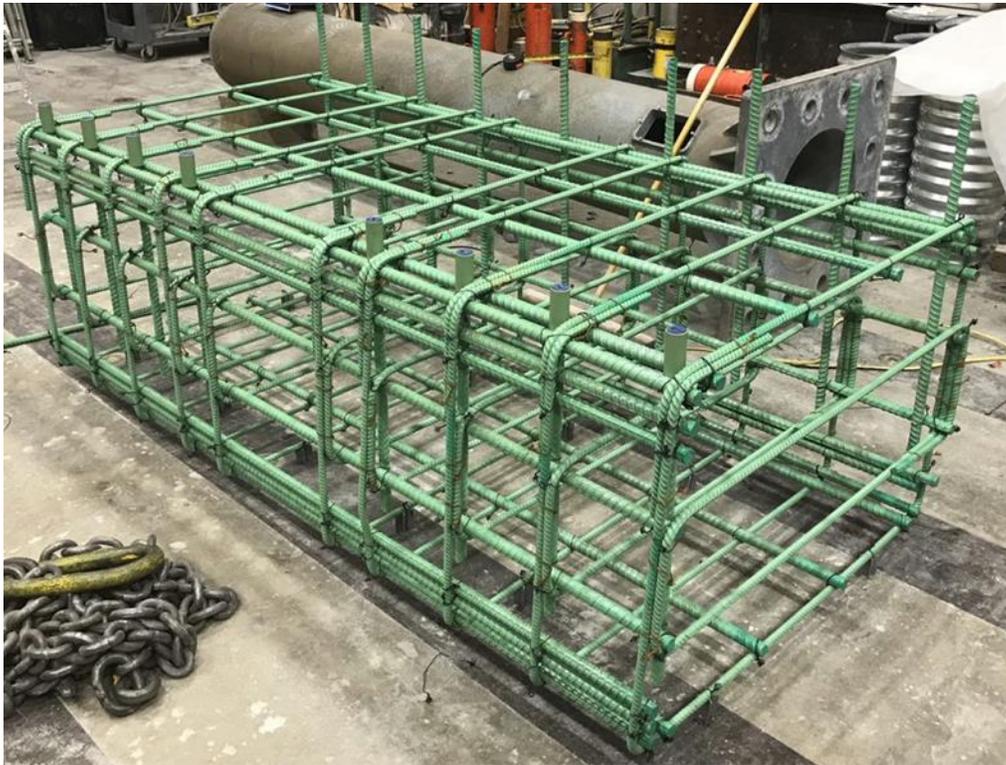
Construction of the specimen began with the pile cap. A reinforcing cage was erected following the design drawings (Figure 42).

Figure 42. UHPC joint pile cap reinforcing cage

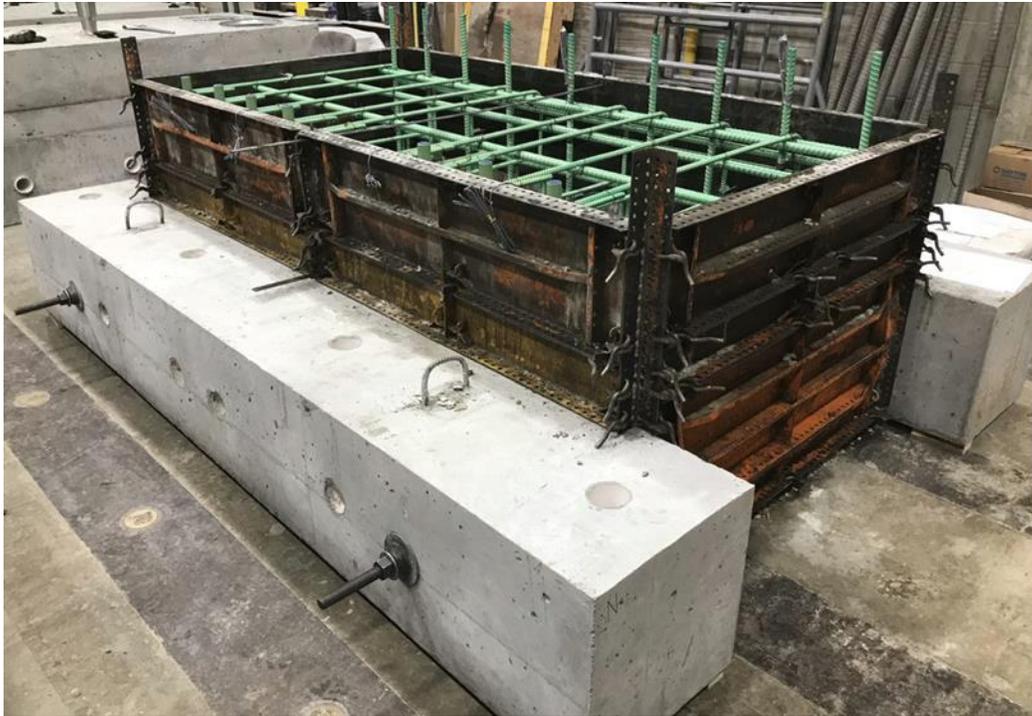
With the cage complete, formwork for the pile cap was erected and the cage was then placed inside (Figure 43).

Figure 43. UHPC joint pile cap formwork

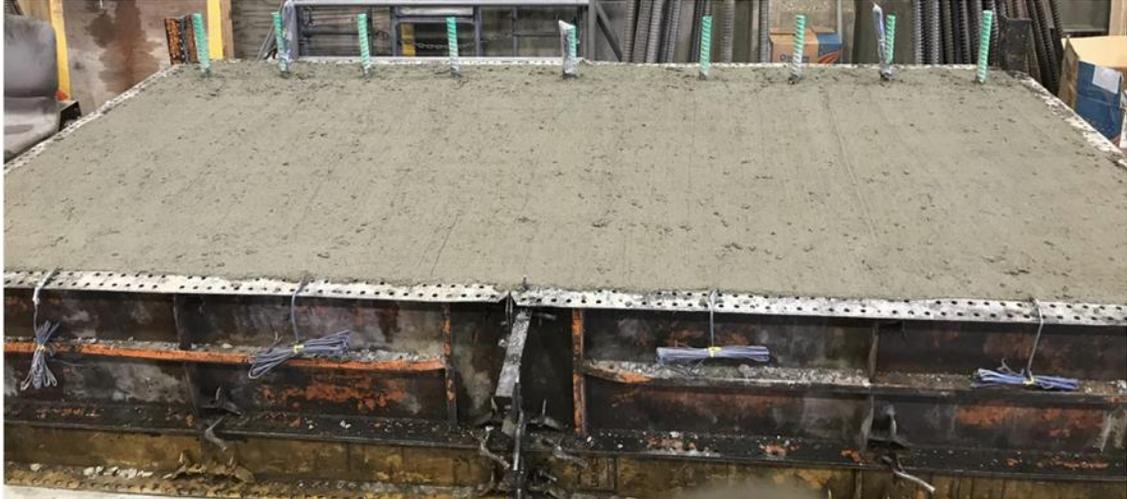
Figure 44. UHPC joint pile cap cast in concrete

Concrete from a local ready-mix plant in Ames, Iowa, was cast in the formwork using materials in the Structural Engineering Research Laboratory at Iowa State University. Electric concrete vibrators were used to make sure the concrete was encasing the cage and filling the form to maximum capacity. The surface was given a roughened finish to ensure a 1/4 in. amplitude, which is required by the Iowa DOT, by roughly brushing with a stiff-bristled broom in multiple directions (Figure 44 and 45).

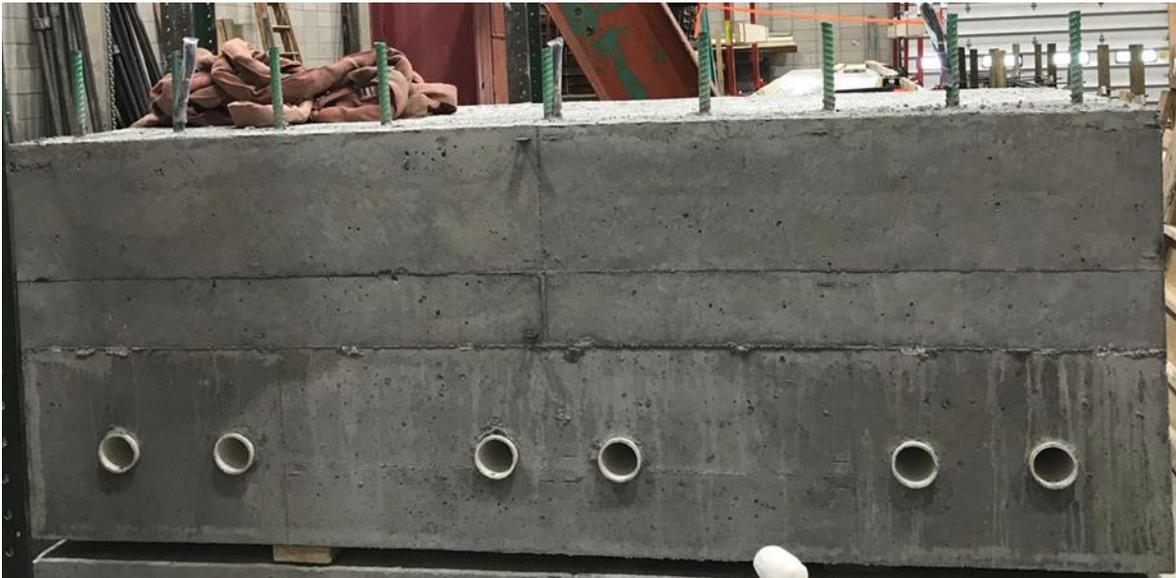
Figure 45. UHPC joint pile cap completed

Also, the surface was removed where concrete was covering the tops of the D310 threaded couplers.

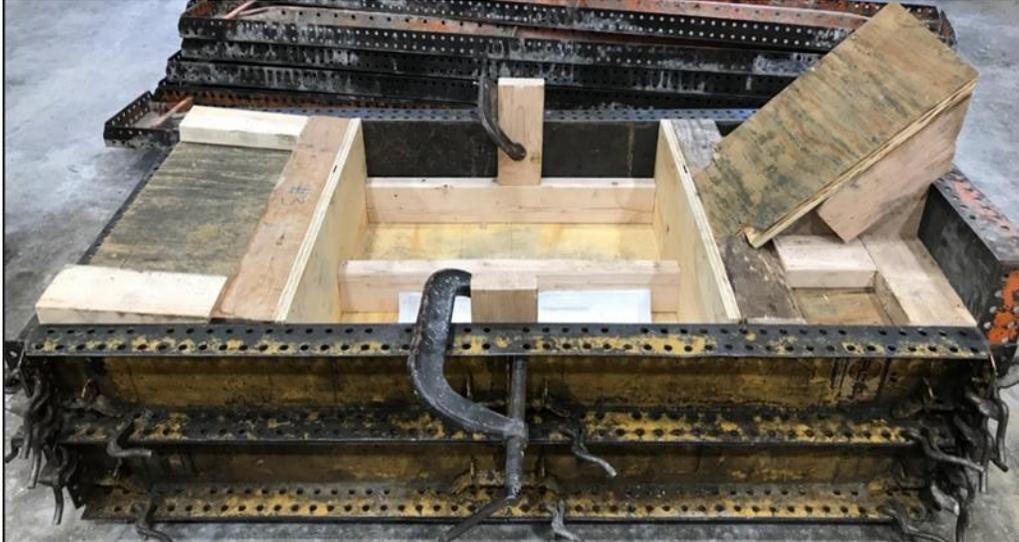
Figure 46. UHPC flowability test formwork

The initial step for constructing the integral diaphragm for the UHPC joint specimen was to conduct the flowability test of the UHPC in the proposed cross section. A decision was made by the design team to negate the initial cross section, and test only the 5° rise cross section (Figure 46).

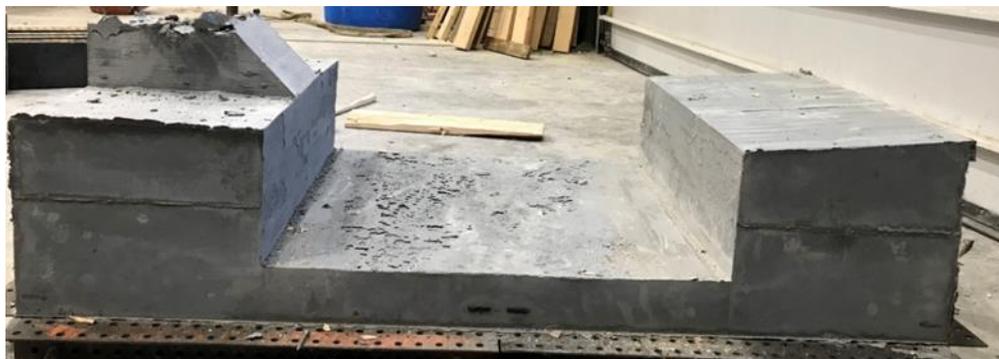
The UHPC mix produced by Ductal from Lafarge was used as the UHPC material for this project, and the mix proportions used were that of the Special Provisions document by the Iowa DOT for ultra-high performance concrete (Iowa DOT 2014). The flowability quantity of approximately 5.11 ft³ was designed to fill the test section, fill multiple testing cylinders, and account for the material loss. The section was filled and left to cure for three days, at which point the formwork was stripped to analyze the adequacy of the flowability of the UHPC (Figure 47).

Figure 47. UHPC flowability test completed

As shown in Figure 47, it is apparent that the UHPC material successfully filled the entirety of the cross section without any issues of voids caused by the volume of air. With this knowledge, the formwork for the integral diaphragm could be constructed through multiple $\frac{3}{4}$ in. plywood diaphragms fastened together, which had the same dimensions used for the flowability test section (Figures 48 through 50).
