Integral Abutment Connection Details for Accelerated Bridge Construction

Final Report
October 2018

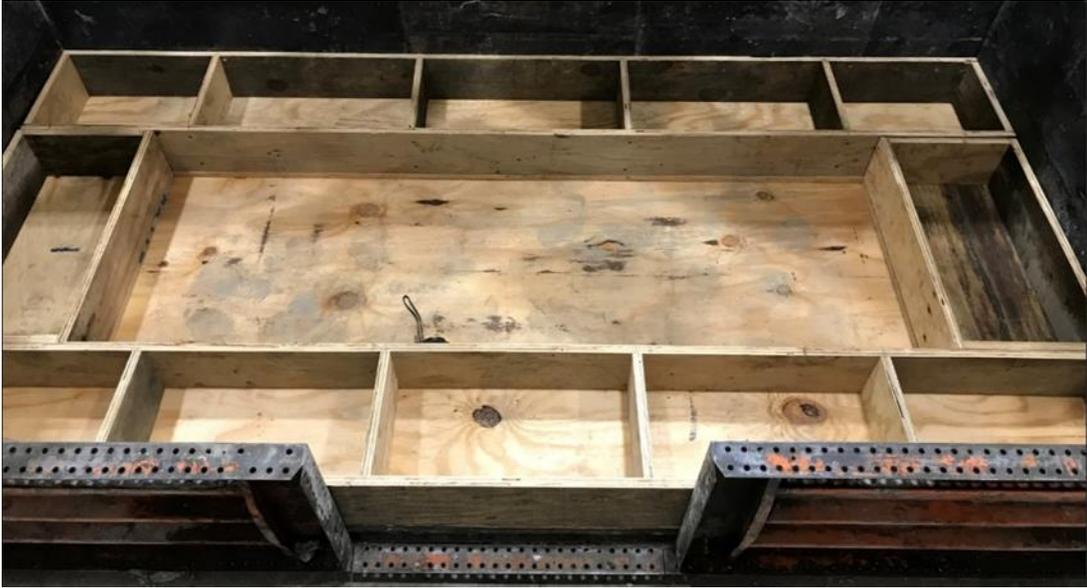
Figure 48. UHPC integral diaphragm formwork top view of diaphragms

As shown in Figure 47, it is apparent that the UHPC material successfully filled the entirety of the cross section without any issues of voids caused by the volume of air. With this knowledge, the formwork for the integral diaphragm could be constructed through multiple $\frac{3}{4}$ in. plywood diaphragms fastened together, which had the same dimensions used for the flowability test section (Figures 48 through 50).

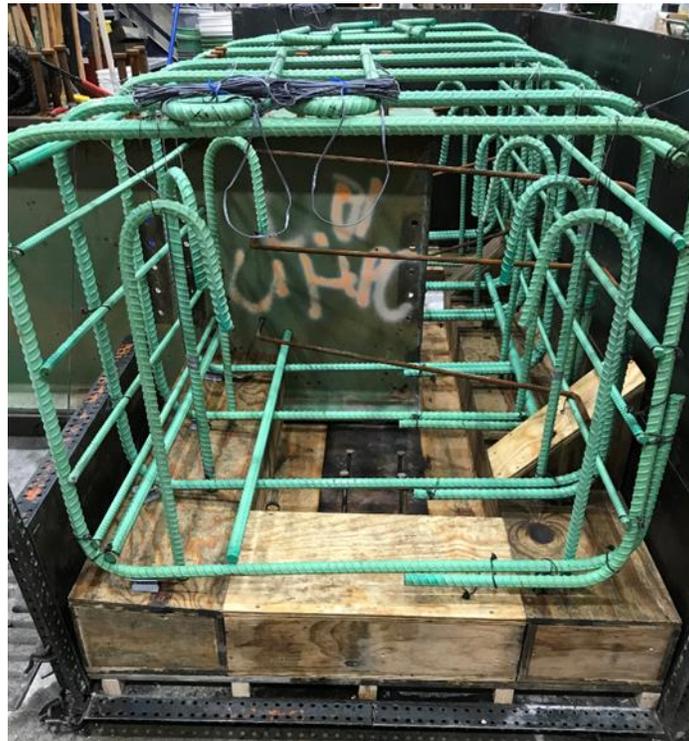
Figure 51. UHPC integral diaphragm reinforcement cage

With the bottom formwork completed, the reinforcement cage was erected. One important note was to ensure the 17 coupling #7 bars would protrude through the bottom plywood formwork by 1 in. to ensure the bars would protrude through the bottom of the section at the required 8 in. (Figures 51 and 52).

Note the coupler bars passing through the plywood formwork.

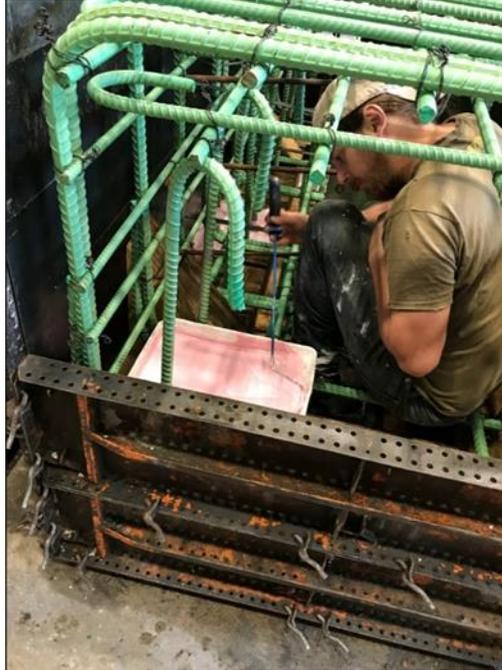
Figure 54. Form retarder being applied to integral diaphragm formwork

Also, the design drawings called for the sliding shoe to protrude from the bottom of the integral diaphragm, but this was not done for the specimen in the laboratory. The purpose of this protrusion is to prevent any concrete catching on the laminated neoprene pads with Teflon during the actual slide of the bridge but no slide would be done in the laboratory, instead, the diaphragm was to be lifted into place by crane. Therefore, to simplify formwork in the laboratory, the sliding shoe was not protruding from the bottom of the diaphragm. To create the best bond surface for the UHPC and precast concrete interface, a form retarder needed to be applied to the bottom formwork of the integral diaphragm. To apply the form retarder (Figure 53), it was decided to use a paint roller and brush to ensure the form retarder would be applied to the entirety of the formwork, while not being applied to any reinforcing bars (Figures 54 and 55).

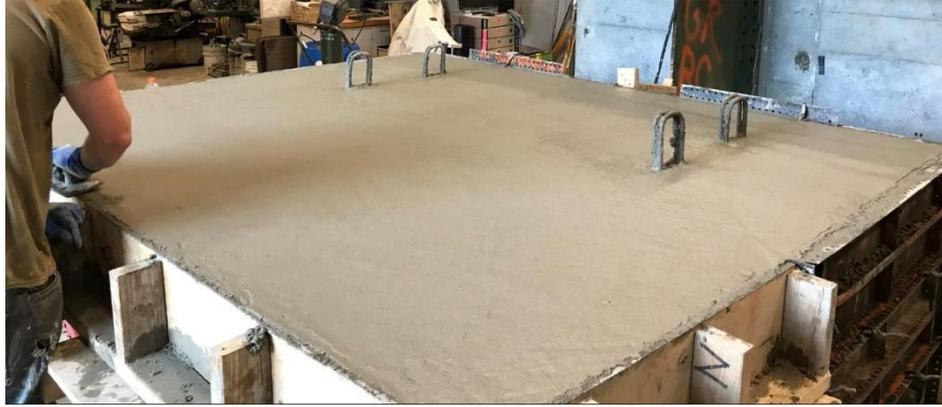
With the form retarder applied and final checks done to the formwork, the integral diaphragm was cast in concrete (Figure 56).

Figure 56. UHPC integral diaphragm cast in concrete

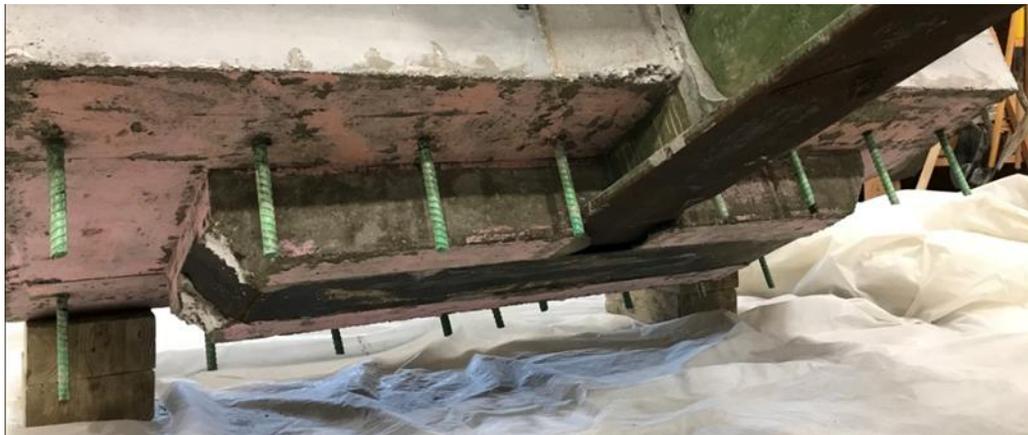
The formwork was stripped, and the integral diaphragm was inspected, and it was noted that concrete did not pass underneath the beam as intended, and the coupler bars did not have consistent protruding lengths from the bottom of the section (Figure 57).

Figure 57. UHPC integral diaphragm completed

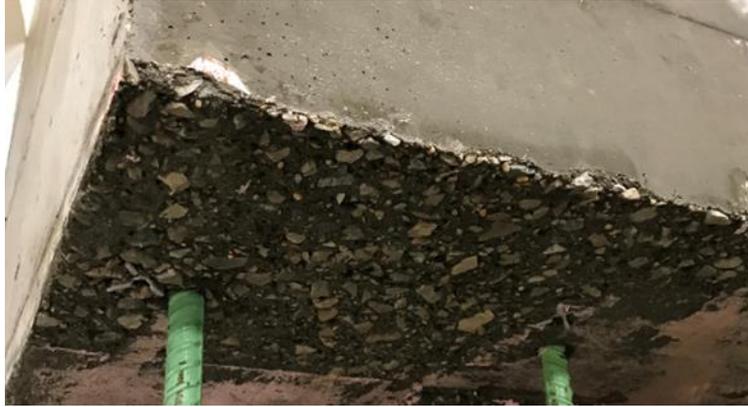
To finish the required bottom-side finish for the integral diaphragm, a 3,000-psi power wash was used to spray off the form retarder and leave an exposed aggregate finish (Figure 58).

Figure 58. UHPC integral diaphragm exposed aggregate finish

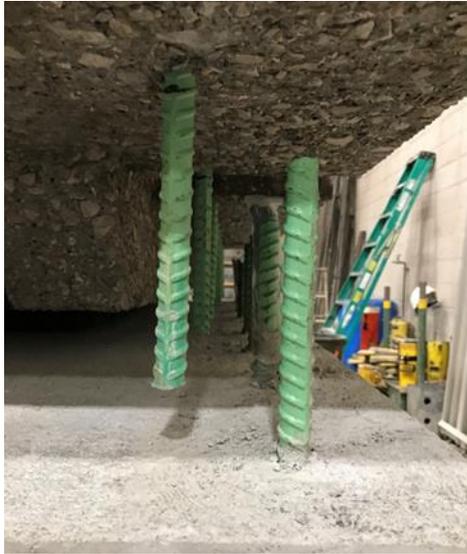
Figure 59. UHPC joint rear connection bars with adequate clearance

The integral diaphragm was craned over to the test area where the pile cap was installed and ready for the connection. Since this connection would utilize the ABC method of “slide-in” construction, a slide had to be simulated to ensure the protruding bars on the back side of the abutment would have proper clearance during the installation process. The integral diaphragm was suspended just over the neoprene pads enough to allow for movement, the slide was simulated, and the clearance of the rear bars was proven to be adequate (Figure 59).

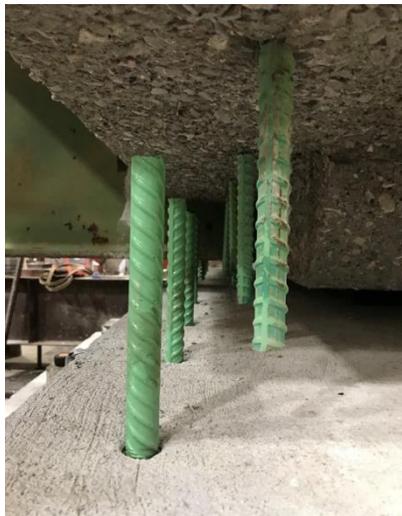
Figure 60. Front connection bars with installed threaded bars in pile cap

After the integral diaphragm was placed in its final location, the threaded bars on the front side of the specimen were installed. One concern was the available space to insert the bar into the threaded coupler in the pile cap and be able to properly tighten the bar, but this was proven to be done without any issues (Figure 60).

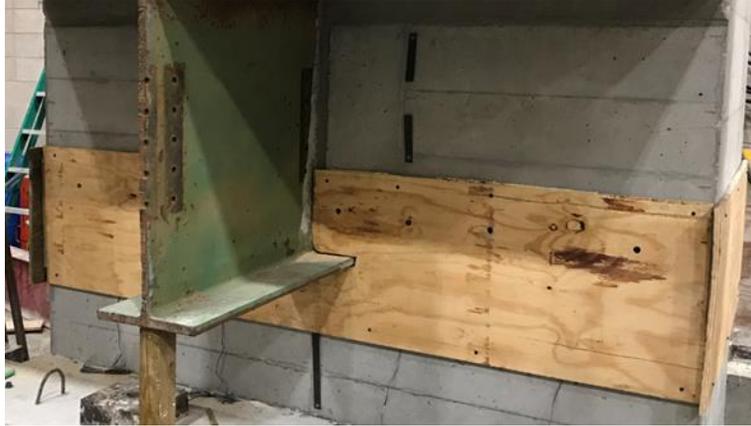
Figure 61. Front face joint formwork with air ports

With the connection bars properly installed, the joint formwork was erected. This formwork included ports along the side and front faces to allow for air to be pushed out by the UHPC during the install, and a spout and chimney system to allow for a simplified installation of the material into the joint from the mixer (Figures 61 through 63).

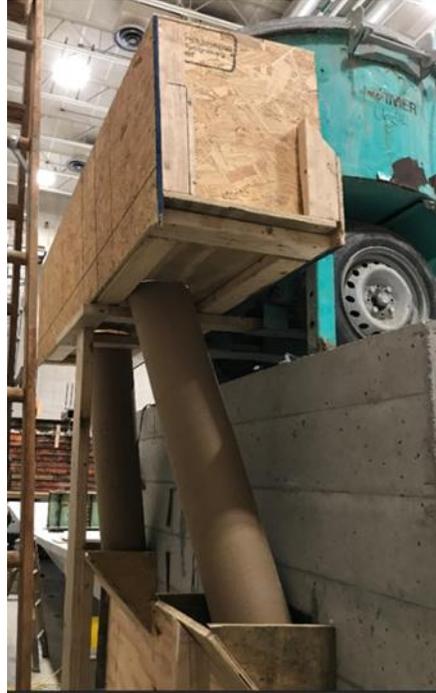
Figure 63. Spout and chimney system for installation of UHPC material

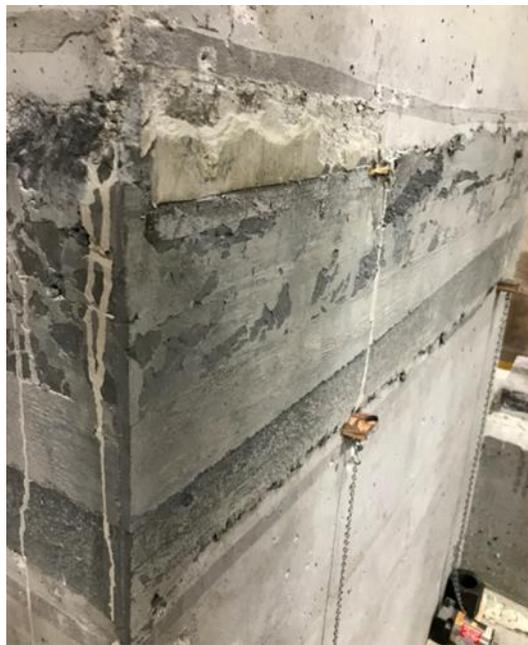
The UHPC material, Ductal by LaFarge, had to be installed in five batches due to the equipment available in the structures laboratory, and each batch took approximately 30 minutes to mix and then pour into the joint. This caused issues with the casting of the joint since each batch set up too quickly to allow for the batch being cast to flow into the previous batch, which caused layers of material within the joint instead of one layer of material (Figure 64).

Figure 64. Completed UHPC joint showing the multiple layers of material

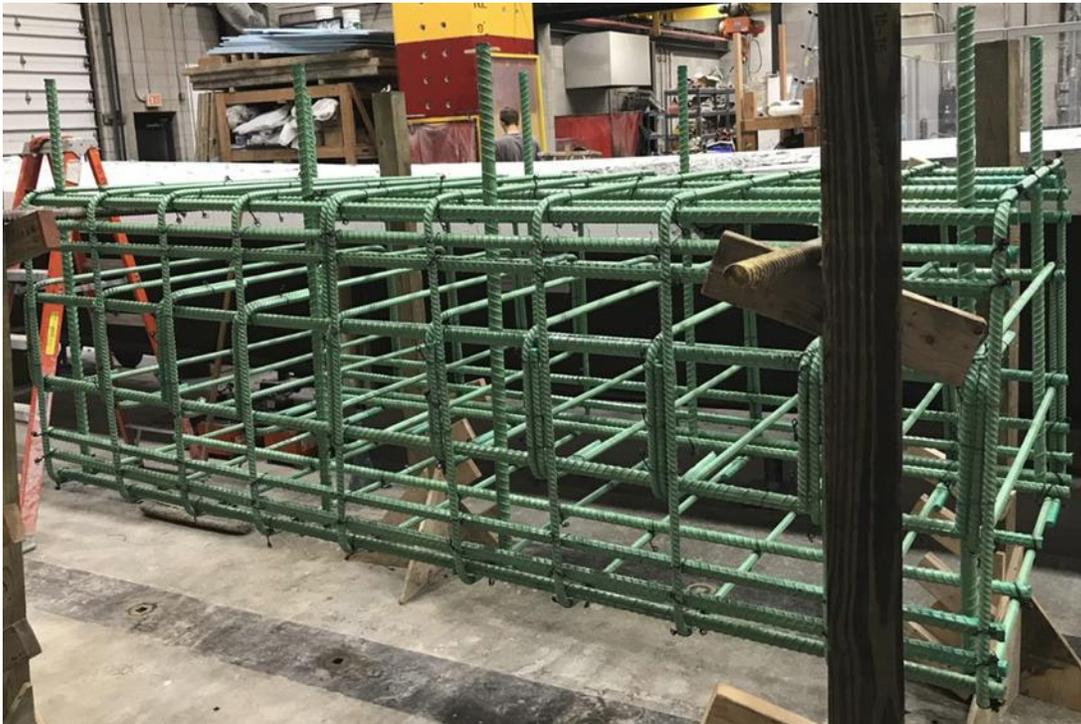
Construction of the specimen began with the pile cap. A reinforcing cage was erected following the design drawings (Figure 65).

Figure 65. GRBC pile cap reinforcing cage

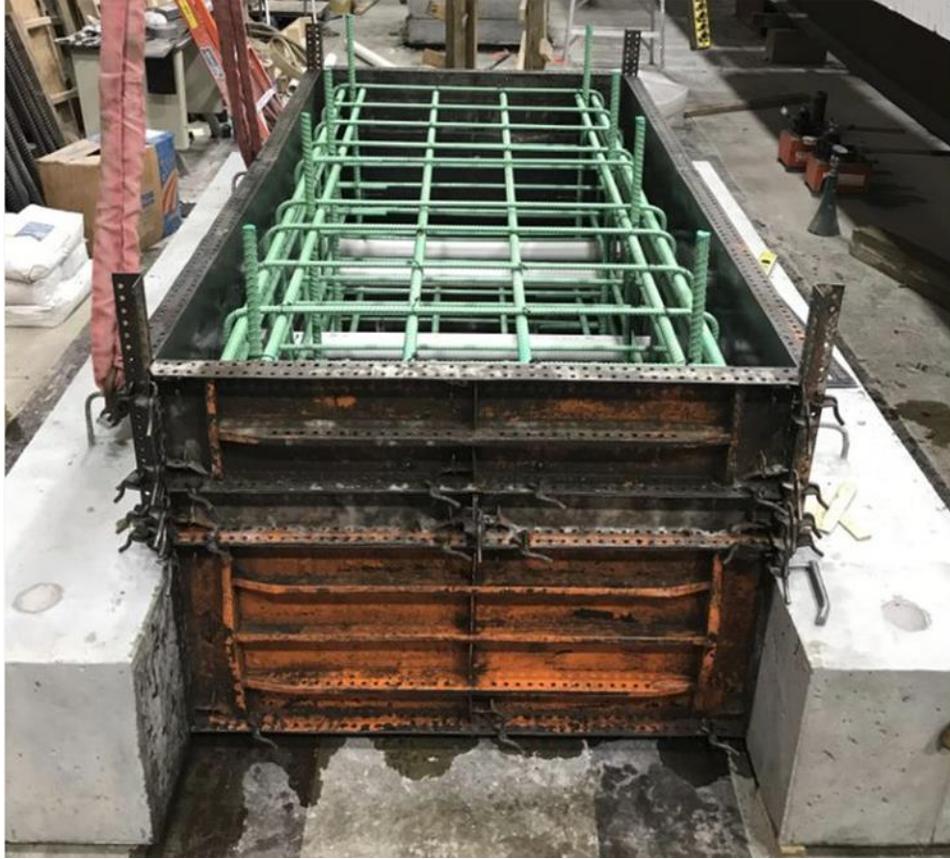
With the cage complete, formwork for the pile cap was erected and the cage was then placed inside (Figure 66).

Figure 66. GRBC pile cap formwork

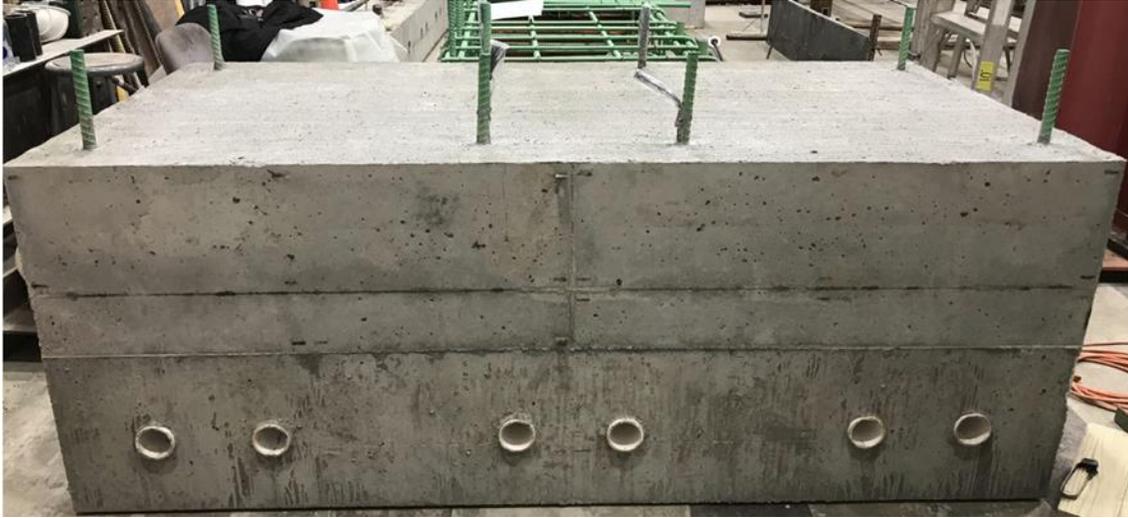
Concrete from a local plant was cast in the formwork using materials in the Structures laboratory at Iowa State University. Electric concrete vibrators were used to make sure the concrete was encasing the cage and filling the form to maximum capacity. The surface was given a roughened finish by brushing with a stiff-bristled broom along the long direction (Figure 67).

Figure 67. GRBC pile cap completed

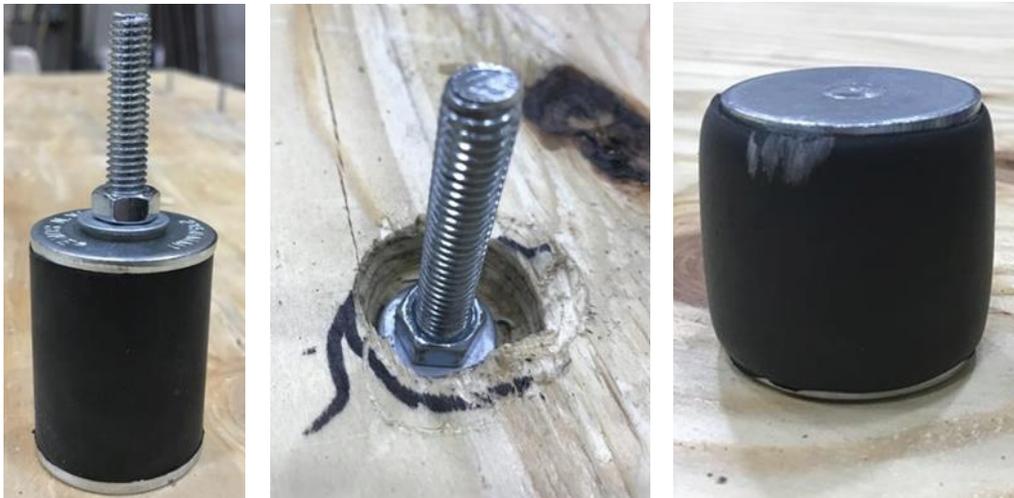
To properly align the protruding bars to the grout sleeves, match-casting was used to set the locations of the grout sleeves. Using a full 4 ft x 8 ft x 3/4 in. sheet of plywood, the Dayton Superior D492 Sleeve-Lock form plugs (Figure 68) were installed to hold the grout sleeves in place during erection of the GRBC integral diaphragm.

Figure 68. Dayton Superior form plug

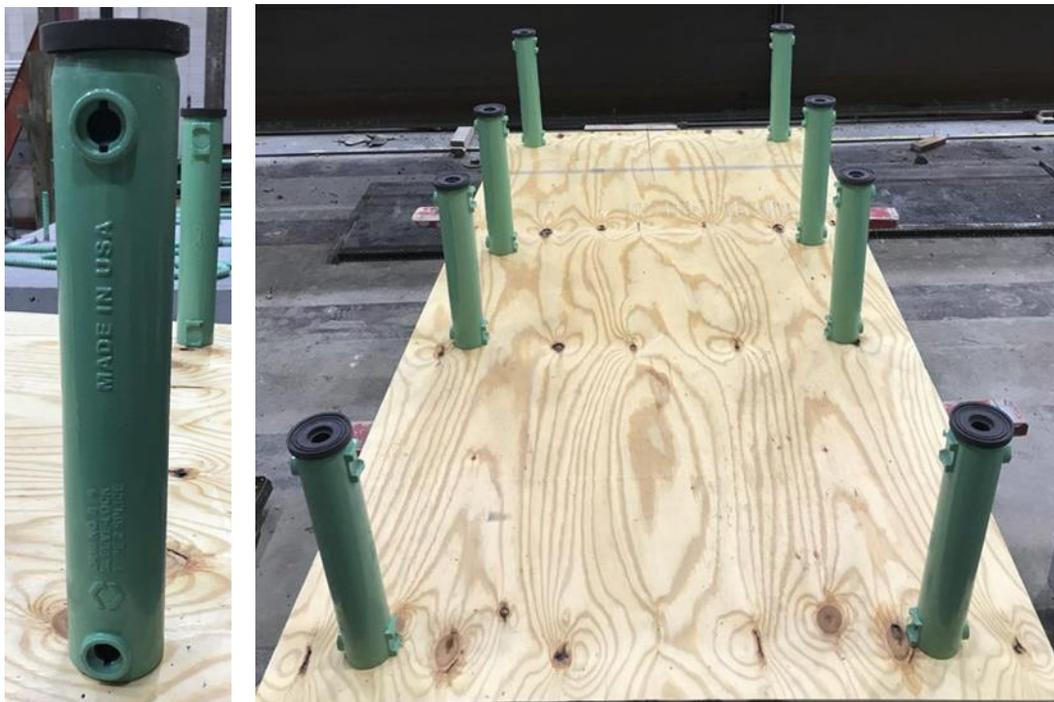
The form plugs were installed and tightened, with a 14-mm socket, enough to allow for the grout sleeves to be placed and turned to have the port plugs facing the designed locations, which were out the front and back faces of the integral diaphragm. When the position of the sleeves was verified, the form plugs were tightened until the sleeves would not turn, and the Dayton Superior D487 seal plugs were placed on the tops of the grout sleeves (Figure 69).

Figure 69. Dayton Superior grout sleeves match-casted topped with seal plugs

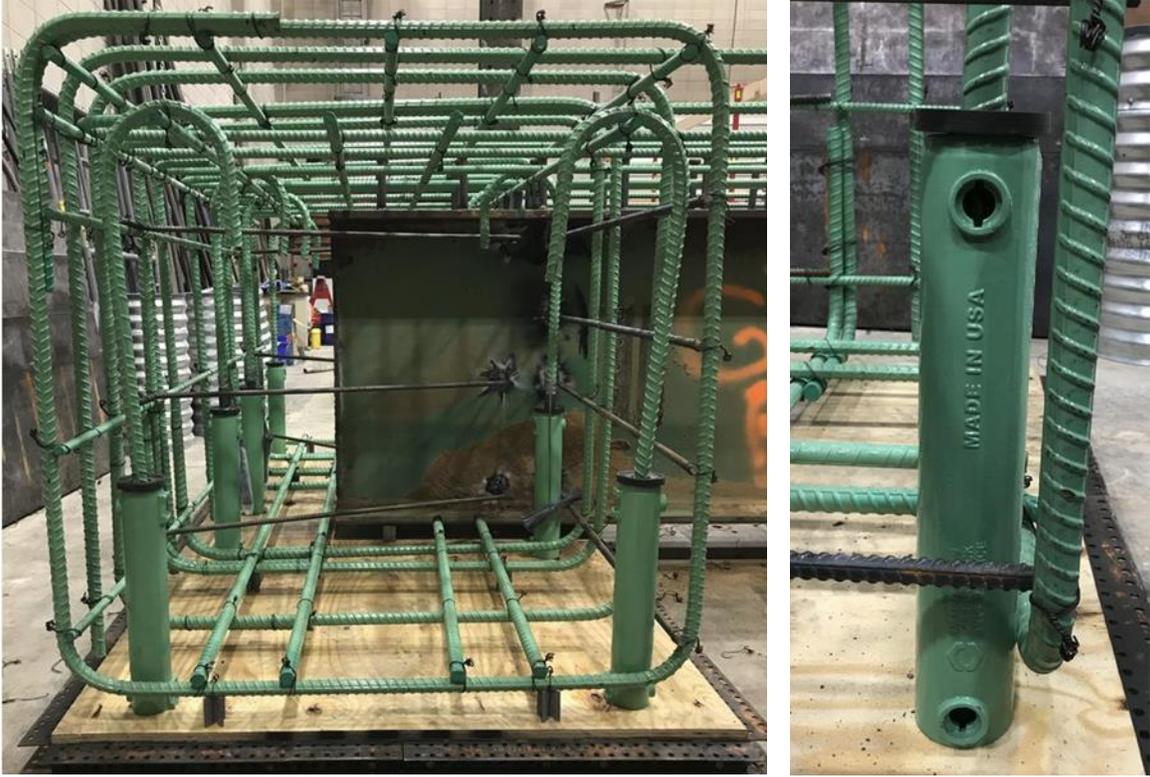
The bolts of the form plugs were cut to be flush with the plywood surface, and then the match-casted formwork was placed down to begin the formwork for casting the integral diaphragm in concrete (Figure 70).

Figure 70. GRBC reinforcing cage with Dayton Superior grout sleeves

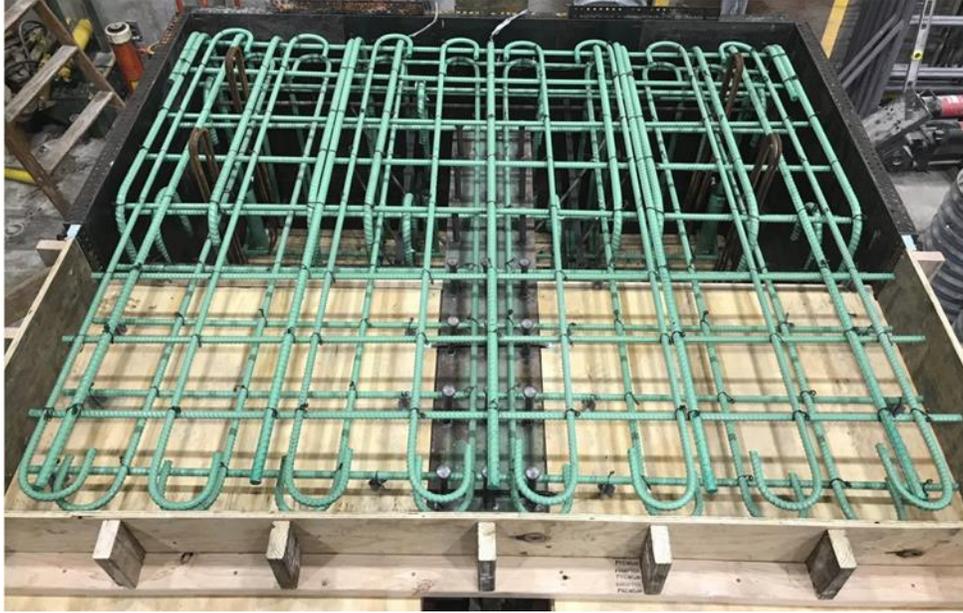
Figure 71. GRBC reinforcing cage

With the grout sleeves and steel beam set in their designed places, the reinforcing cage was erected, and formwork was placed. Steel forms made up most of the formwork, but custom woodwork was required to adequately provide formwork for the area around the beam. Finally, the integral diaphragm was encased in concrete (Figures 71 through 73).

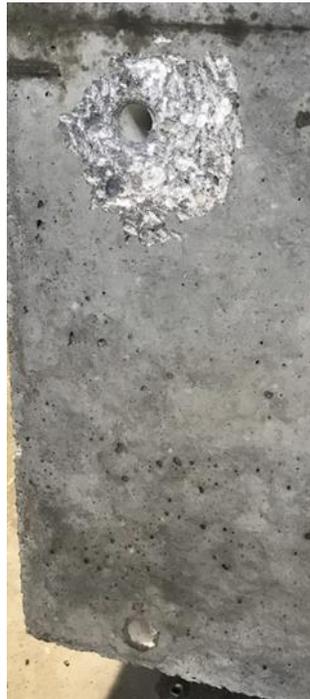
Figure 74. GRBC grout sleeve ports located post concrete casting

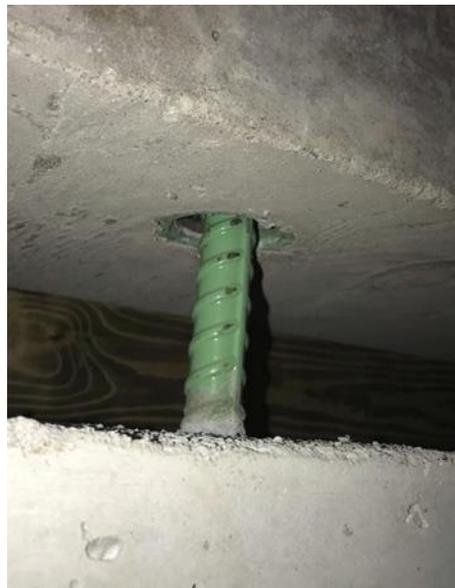
Figure 75. GRBC connection alignment

After the pile cap was set in place for testing, the integral diaphragm was lowered into position. A dry fit was done to make sure all the protruding bars and grout sleeves were in alignment, and all eight connections lined up without any issues (Figure 75).

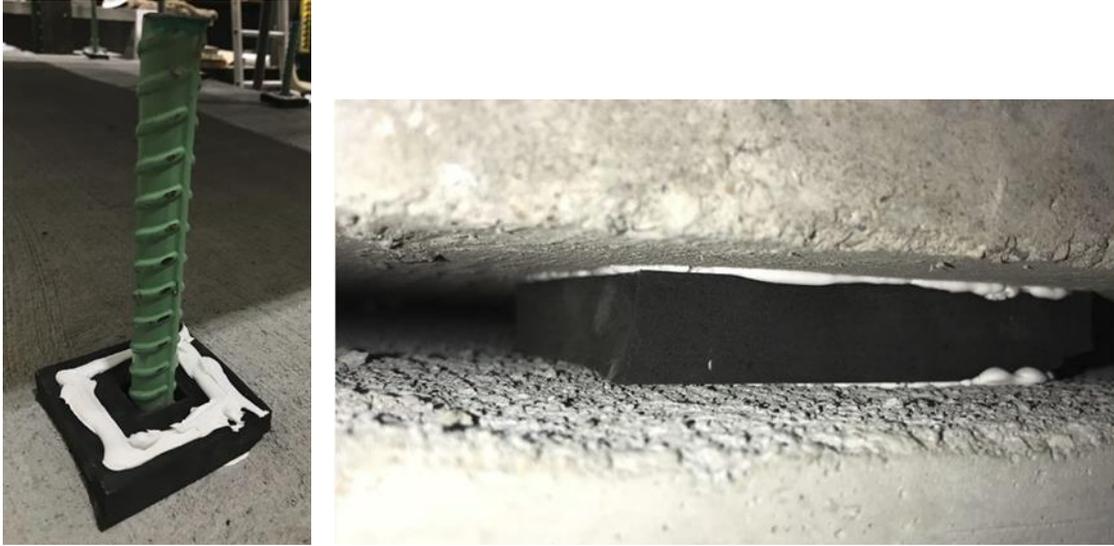
Figure 76. GRBC 3/4 in. neoprene pad and silicone seal

To create the 3/4 in. gap between the pile cap and integral diaphragm for the grout bed, 3/4 in. neoprene pads were installed. These pads were cut to be larger than the grout sleeve opening, and have a hole in the middle for the protruding bar. To ensure a seal around the neoprene pads and grout sleeves, silicone was placed around the neoprene pads and dispersed when the integral diaphragm was installed (Figure 76).

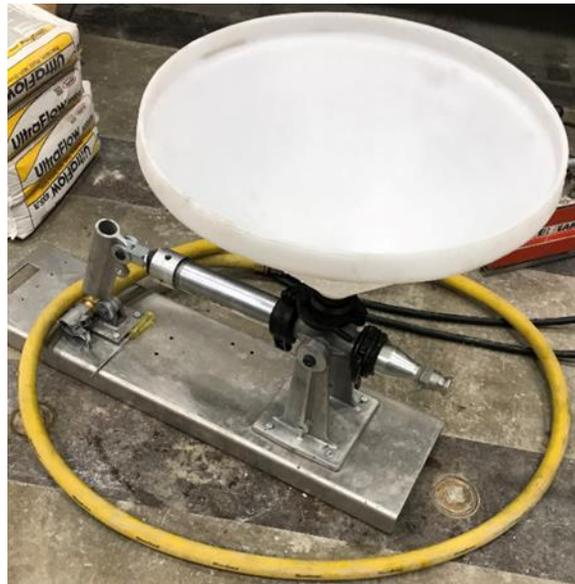
Figure 77. Grout pump

Next, the formwork for the grout bed was erected, and Dayton Superior D490 grout mix was pumped into various ports within the formwork with a grout pump (Figure 77).

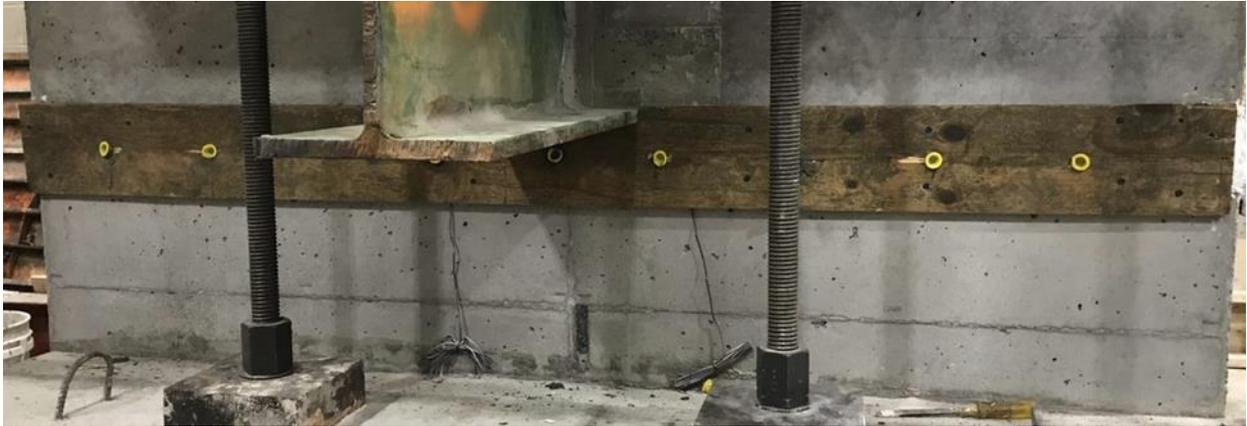
Figure 78. GRBC grout bed completed

Port plugs were installed into ports when the grout would begin to seep out until the entirety of the bed was filled with grout and all ports were plugged (Figure 78).

One important note was to ensure the lower port for the grout sleeves was plugged so no grout from the grout bed would enter the port.

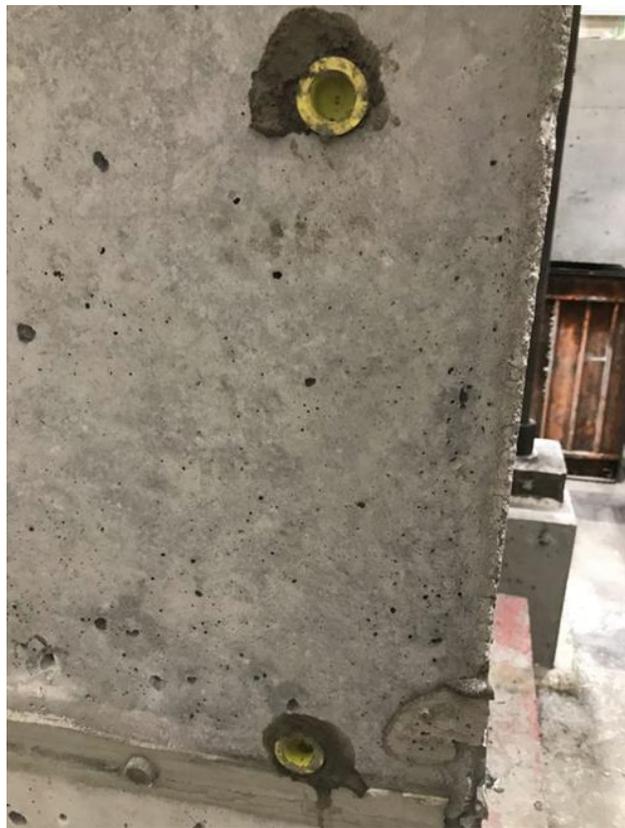
Figure 79. GRBC grout sleeve completed

The formwork was removed after the grout bed had set, then the eight grout sleeves were filled with the Dayton Superior grout mix. After the sleeves were verified to be clear of debris, the pump hose was placed into the lower port and grout was pumped so that the grout was seeping out of the top port, then both ports were plugged (Figure 79).

This procedure is meant to ensure that the air within the sleeves is pushed out by the grout and properly encasing the coupling bars.

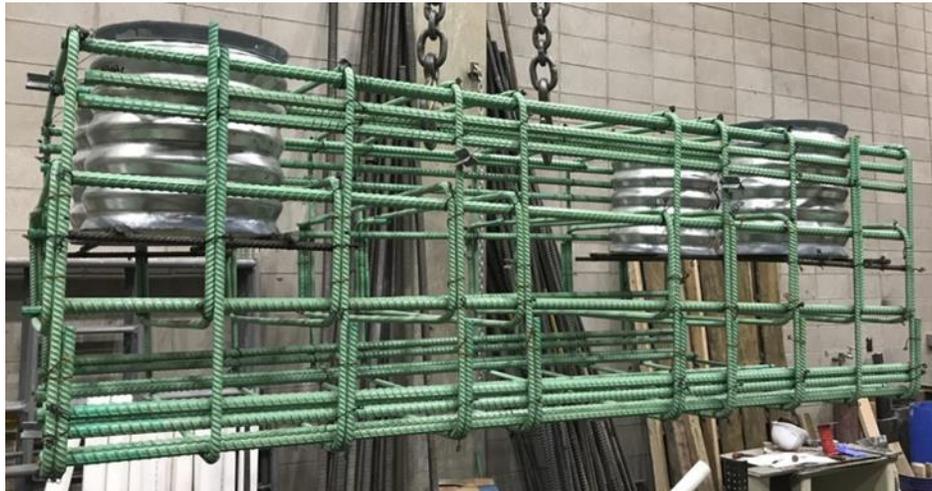
Figure 80. Pile coupler pile cap reinforcing cage

Construction of the specimen began with the pile cap. A reinforcing cage was erected following the design drawings (Figure 80).

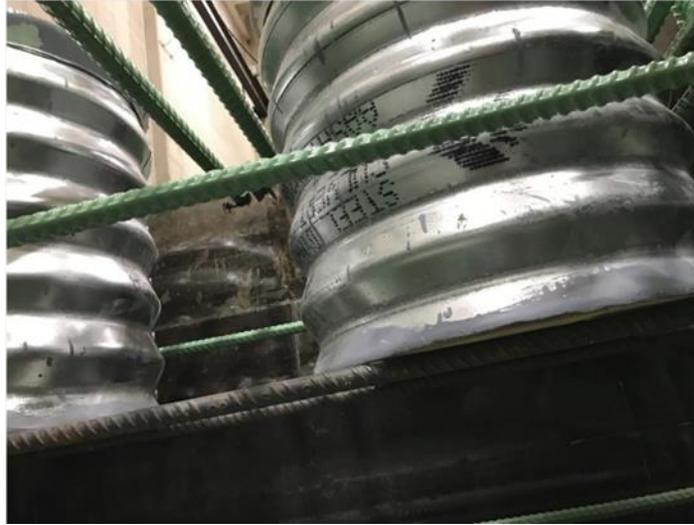
Figure 81. Salvage reinforcing steel bar holding up CMPs

Multiple checks were done to ensure the corrugated metal pipes (CMPs) were in the proper locations, specifically that the tops of the CMPs would be flush with the top surface of the pile cap. The CMPs were installed into the reinforcing cage using salvage rebar to set the elevation (Figure 81), and metal wire to set the locations (Figure 82).

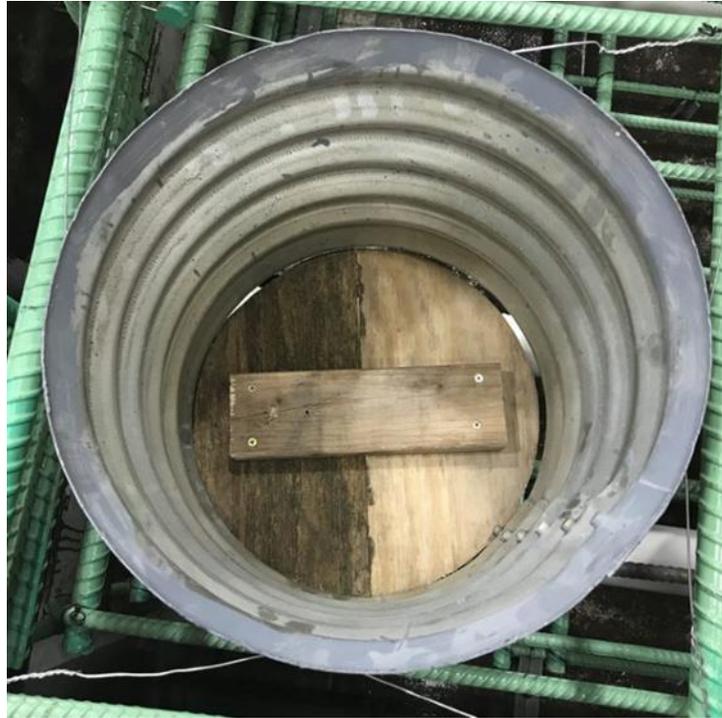
Figure 83. CMP plug

To keep the concrete from flowing to the inside of the CMPs, a plug was constructed by using a circle of plywood cut to the inside diameter of the CMP, cut in half to allow for pullout when casting is complete, and a 2 in. x 4 in. piece of plywood holding the two halves together (Figure 83).

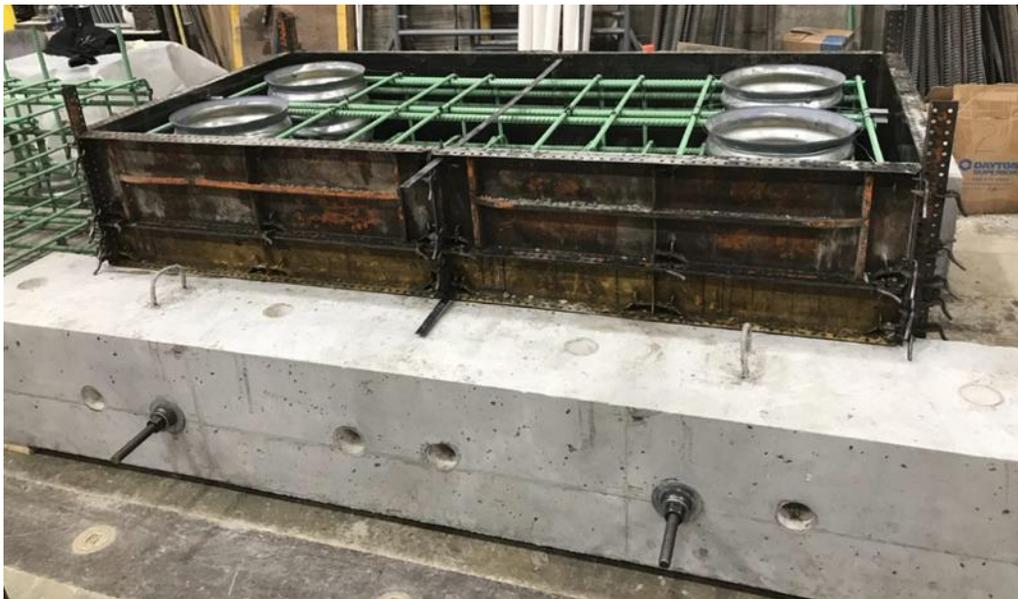
Figure 84. Pile coupler pile cap formwork

With the cage complete, formwork for the pile cap was erected and the cage was then placed inside (Figure 84).

Since a process referred to as “match-casting” was to be done to align the PVC ducts to the reaction blocks, the blocks were utilized as formwork in addition to the EFCO steel formwork. With the

cage set in the forms, checks were done to ensure the 2 in. concrete cover required per design were going to be met, all reinforcement was secure and installed at the designed locations, and the formwork was properly fastened.

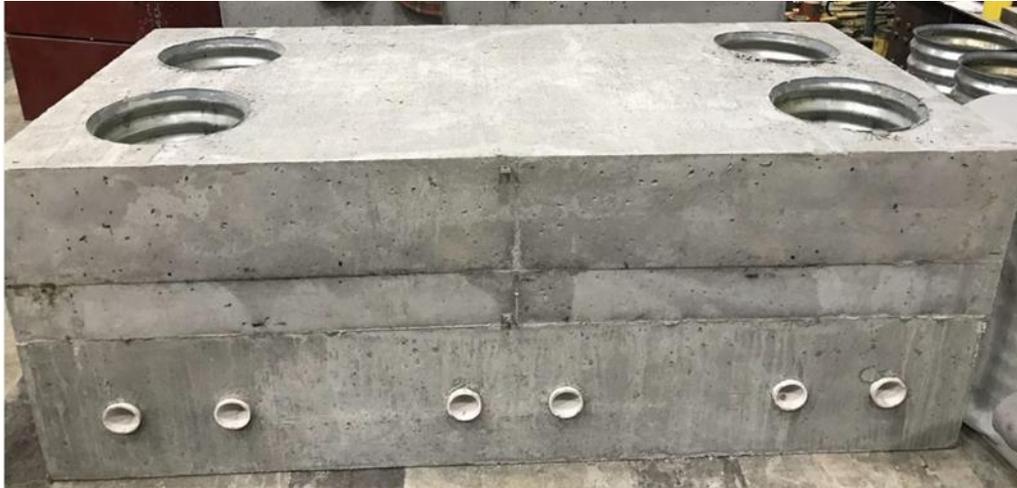
Figure 85. Pile coupler pile cap completed

Concrete from a local plant was cast in the formwork using materials in the Structures laboratory at Iowa State University. Electric concrete vibrators were used to make sure the concrete was encasing the cage and filling the form to maximum capacity. The surface was given a roughened finish by brushing with a stiff-bristled broom along the long direction (Figure 85).

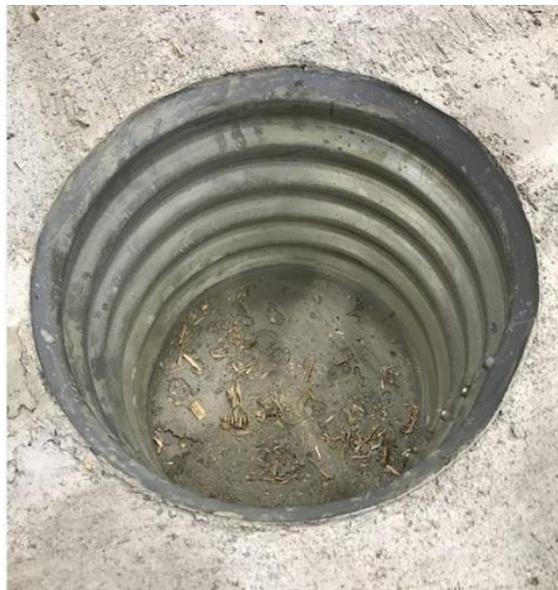
Figure 86. CMP void completed

After the concrete had cured, the formwork was removed, and the plugs were taken out of the CMPs (Figure 86).

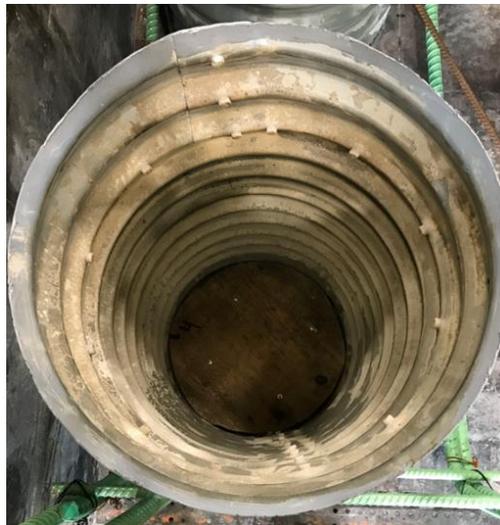
Figure 87. Plywood alignment of integral diaphragm CMP

Plywood circles were made to align the CMPs in the integral diaphragm to be aligned with the CMPs of the pile cap (Figure 87).

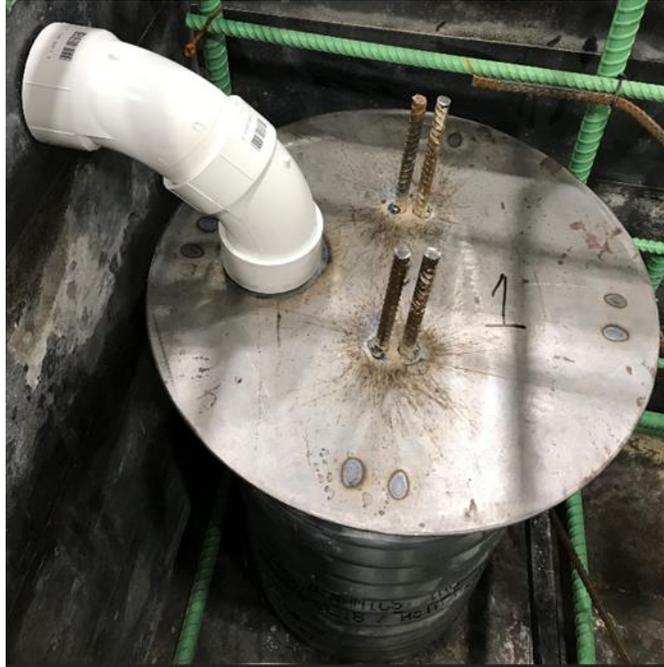
Figure 88. CMP lid with accessories

The CMP lid was fabricated using a circular steel plate that was fabricated to have the 3 in. duct to install the cementitious material into the CMP void, four reinforcing steel bars to act as guides for the steel sections to be encased within the CMPs, and a U-bolt that would act as a pulley system for the wire to raise and lower the steel section within the CMP voids. The wire would pass through the 1 in. duct installed at the top of the CMP just below the lid, and this duct also acts as an air-port to allow all air within the voids to be forced out when the cementitious material is installed (Figures 88 through 90).

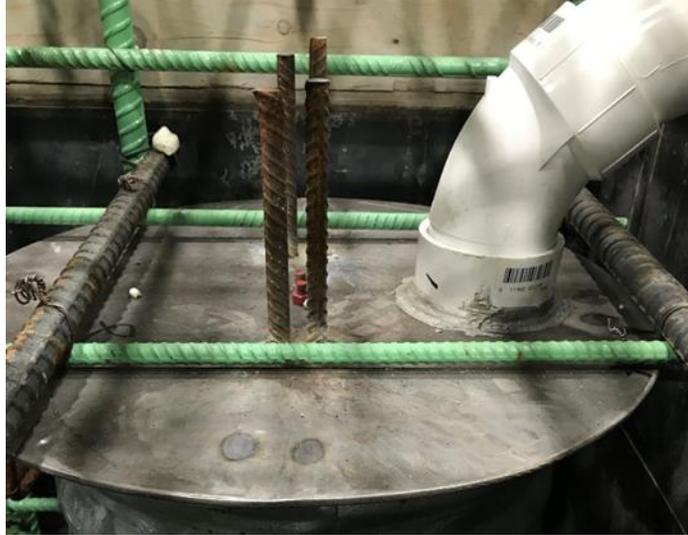
Figure 91. CMP “locking” reinforcing steel bar

To ensure the CMPs would not shift upwards when casting the integral diaphragm, a “locking” mechanism was installed within the reinforcement cage. This mechanism consisted of using salvage reinforcing steel bars to span across the CMP lids to be tied to other reinforcing bars, which were then tied to the reinforcement cage (Figure 91).

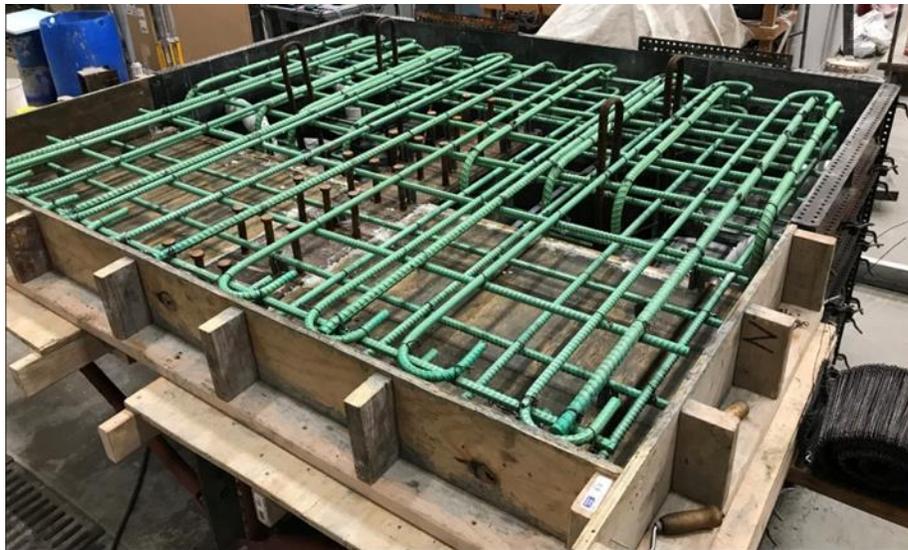
Figure 92. Pile coupler reinforcement cage

With the CMPs, and accessories, and steel beam set in their designed places, the reinforcing cage was erected, and formwork was placed. Just as the GRBC specimen, steel forms made up most of the formwork, but custom woodwork was required to adequately provide formwork for the area around the beam. Finally, the integral diaphragm was encased in concrete (Figures 92 and 93).

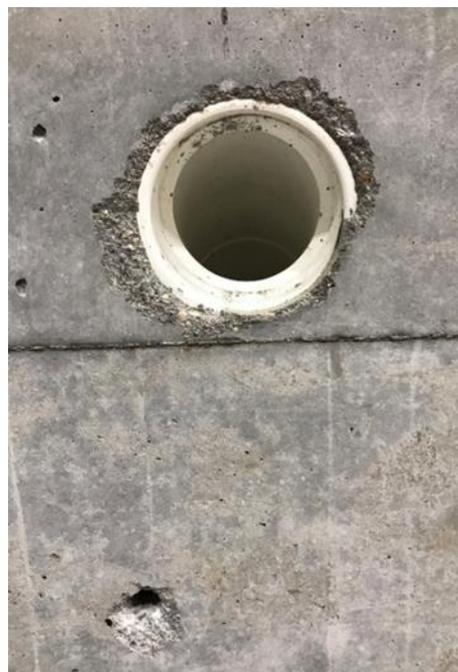
Figure 94. Surfaced 3 in. duct and 1 in. duct found after chipping concrete

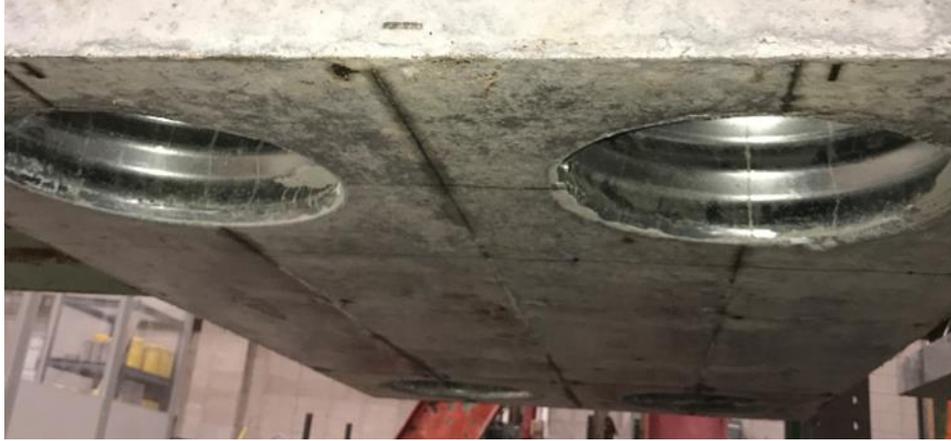
Figure 95. Surfaced CMPs

When the formwork was stripped from the completed pile coupler integral diaphragm, a few of the 1 in. ducts had to be found through chipping away of concrete, but all of the 3 in. ducts and CMP voids had successfully surfaced (Figures 94 and 95).

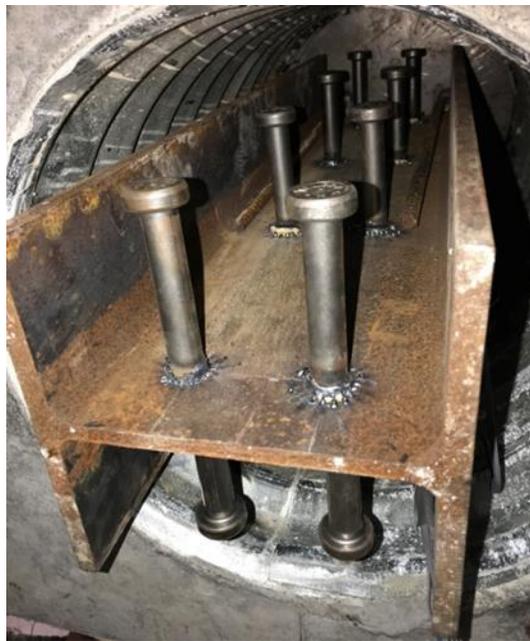
Figure 96. Steel section coupler with shear studs

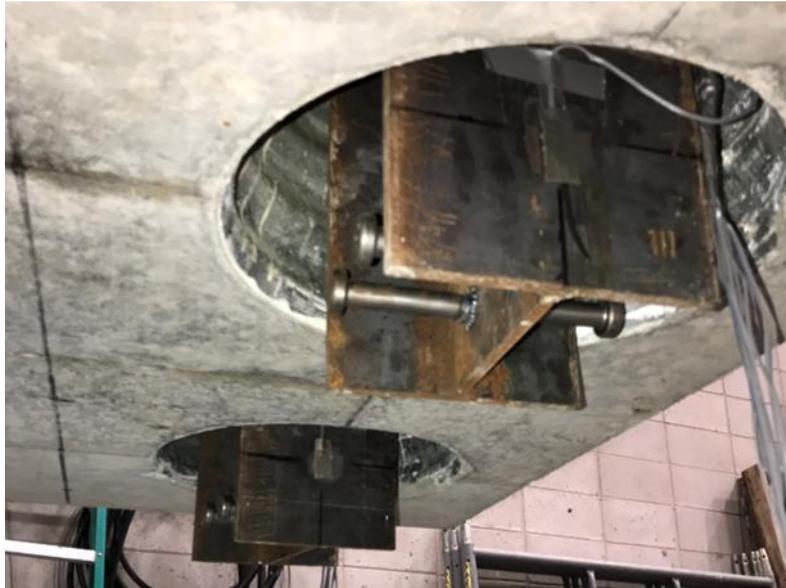
Figure 97. Steel sections suspended within integral diaphragm CMPs

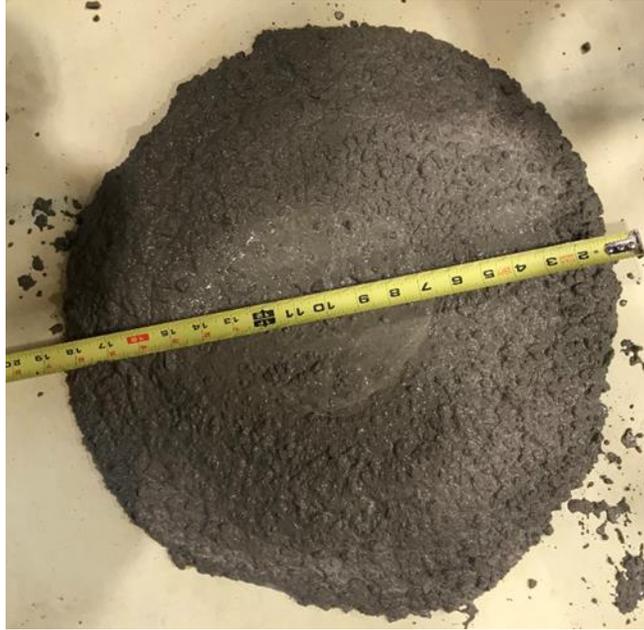
Figure 98. SCC 18-in. spread

The CMPs were filled with a self-consolidating concrete (SCC) mix from a local plant, which had an 18-in. spread (Figure 98).

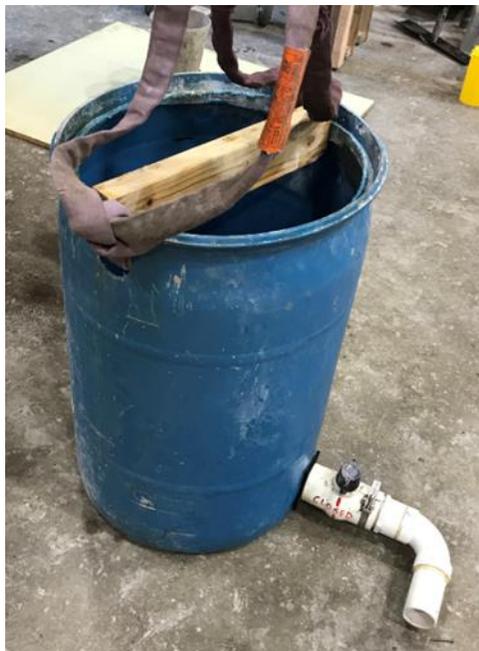
Figure 99. Barrel with funnel to install SCC

The SCC was installed by using a barrel with a funnel, as well as dumping with buckets (Figure 99).

- SCC aggregate consolidated to the bottom of the barrel with funnel when installing, and bucketing material had to be done to finish the install
 - Avoid using equipment that would allow for settlement of SCC aggregate
 - Add water to SCC to cause larger spread, and higher flowability
- Reinforcing steel bar guides for steel sections were too close to edges of web and flanges, preventing the sections from being completely suspended within CMP voids
 - Revise design of guides to avoid this “pinching” issue

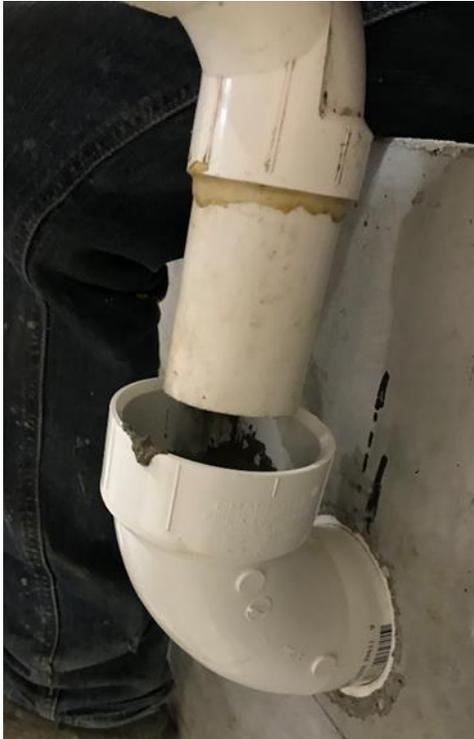
Figure 100. SCC installed through 3 in. duct

The SCC was installed through the 3 in. ducts until filled, and also the 1 in. duct was plugged when material began to flow through it (Figures 100 and 101).

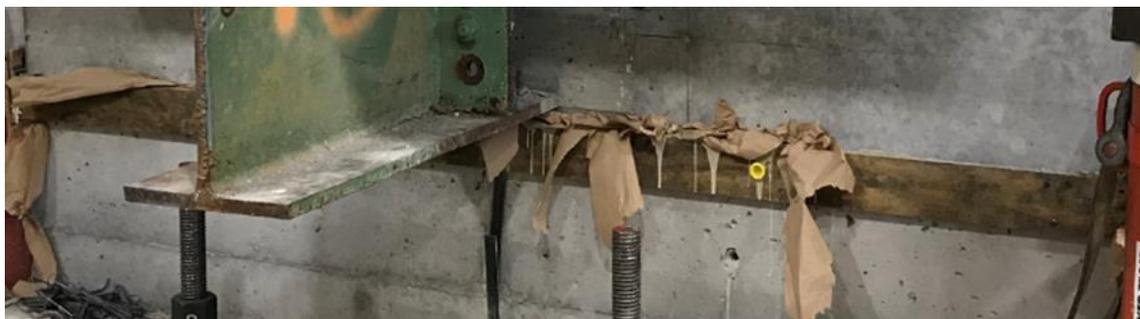
Figure 103. Pile coupler grout bed completed

The 3/4 in. grout bed was created by using 3/4 in. thick nuts to create the required gap. To ensure a seal around the CMP voids, 1 in. insulation foam rings were glued around the pile cap CMP voids, which would compress when the diaphragm was installed. Formwork similar to the GRBC grout bed formwork was erected and a non-shrink grout complying to Iowa DOT standards (Figure 102) was installed using the grout pump and procedure used for the GRBC grout bed (Figure 103).
