Integral Abutment Connection Details for Accelerated Bridge Construction

Final Report
October 2018

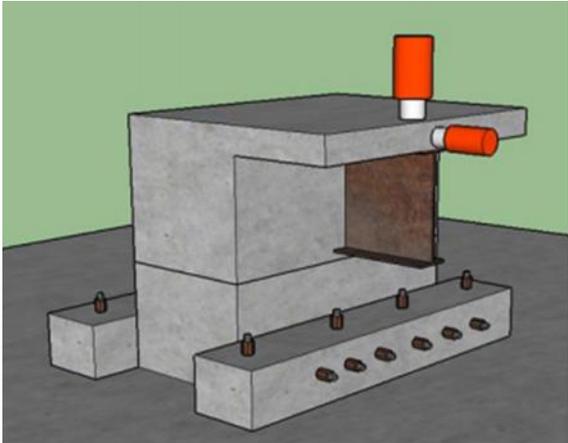
Figure 104. Model of testing setup - front view

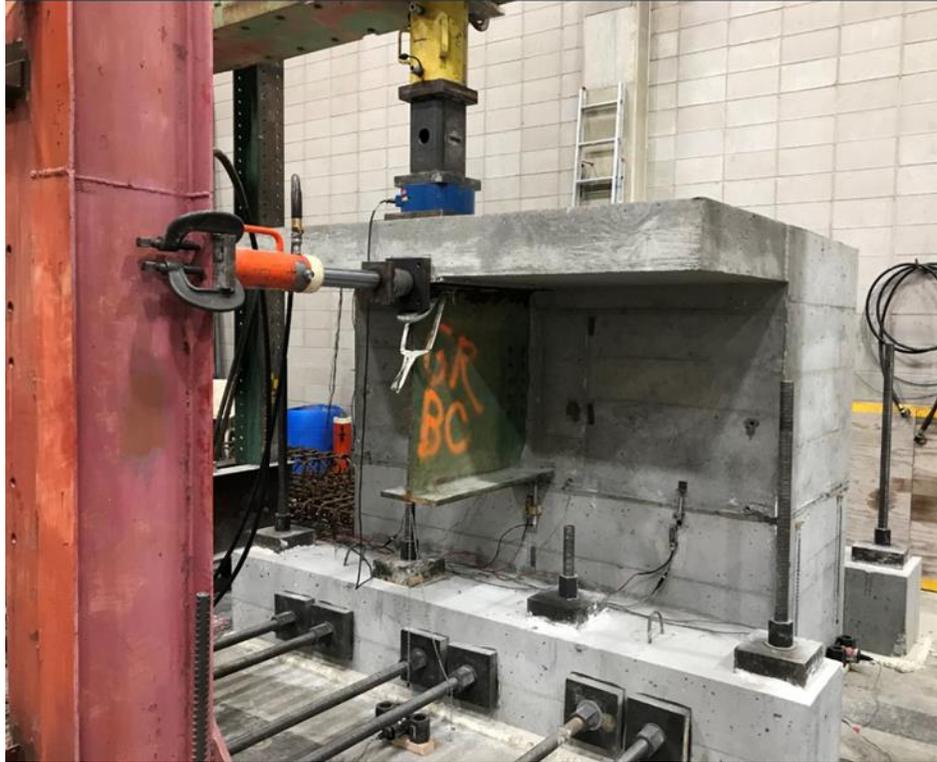
Figure 106. Laboratory testing setup

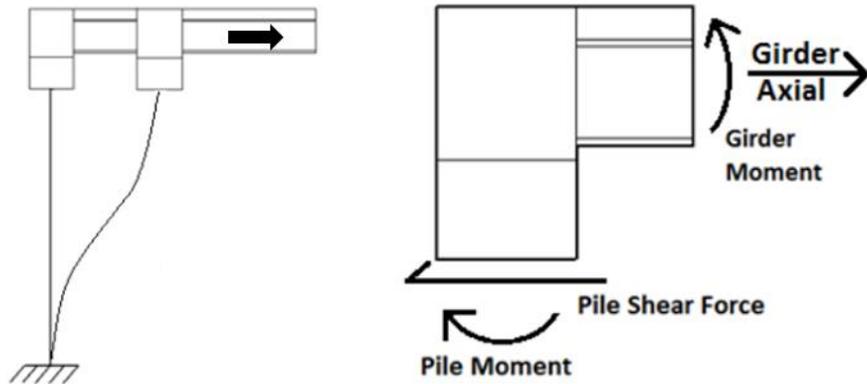
Figure 107. Structural analysis for thermal contraction of bridge

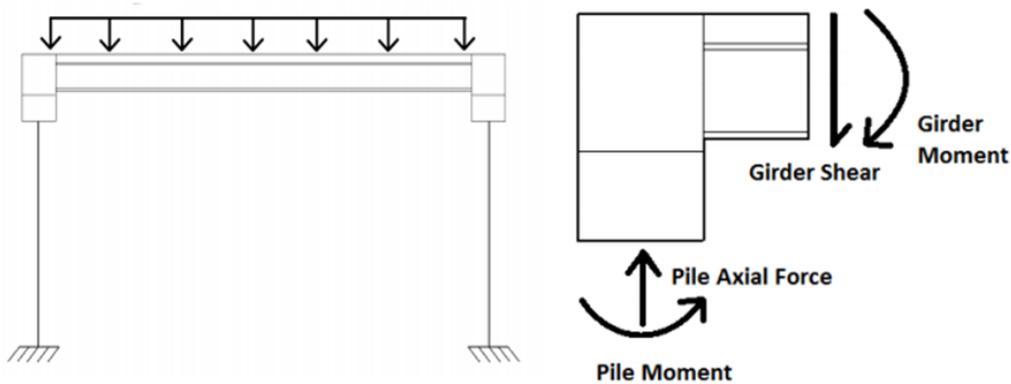
Figure 109. Structural analysis for live loading of bridge

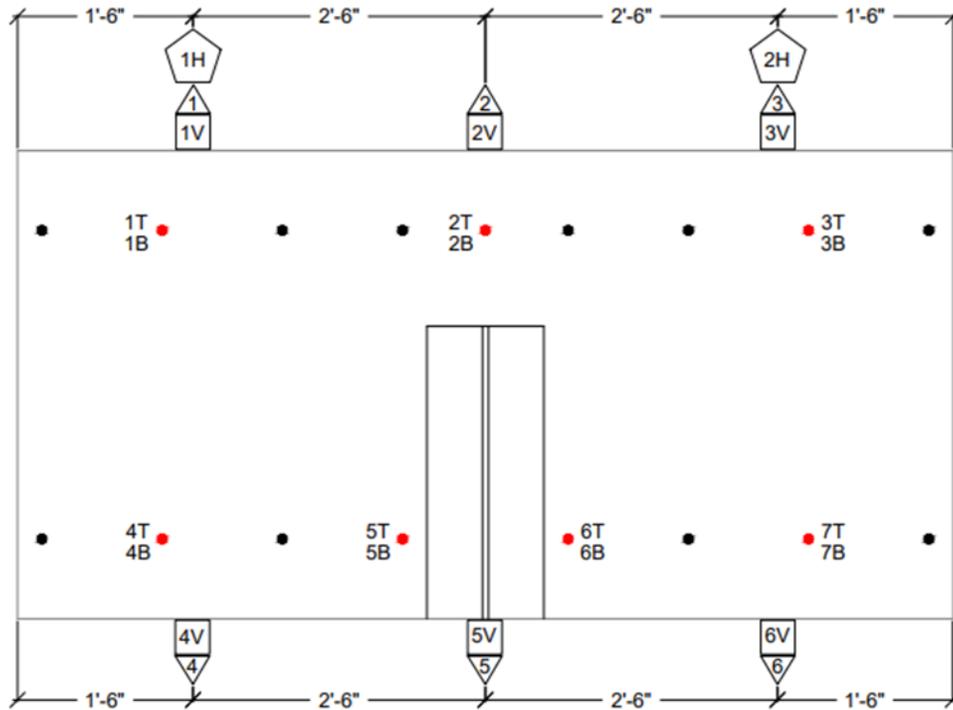
Figure 110. Instrumentation plan for UHPC joint

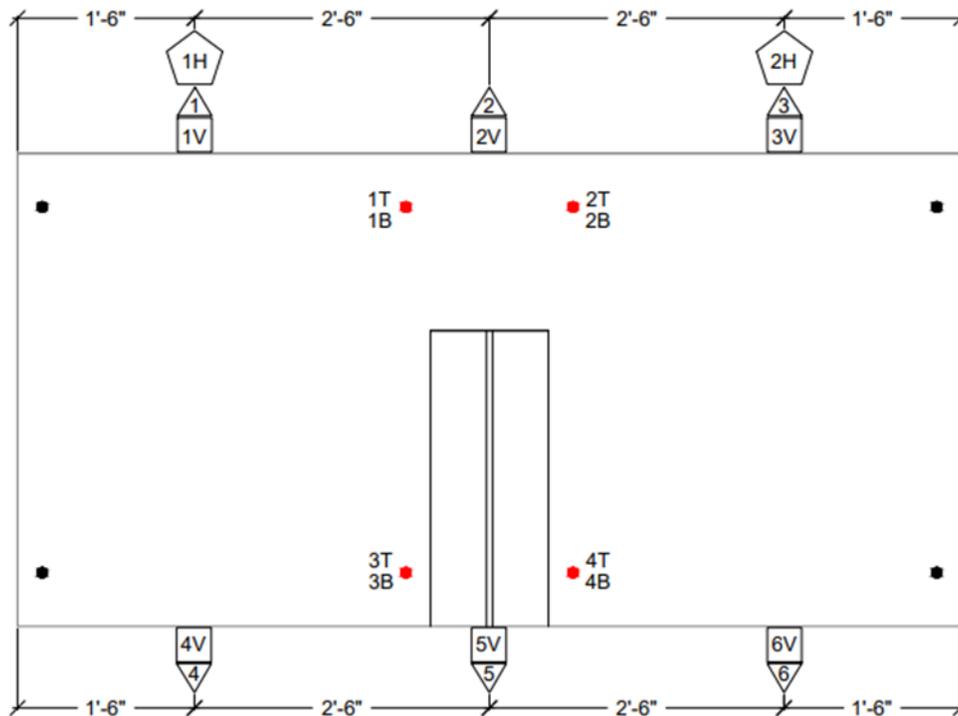
Figure 111. Instrumentation plan for GRBC

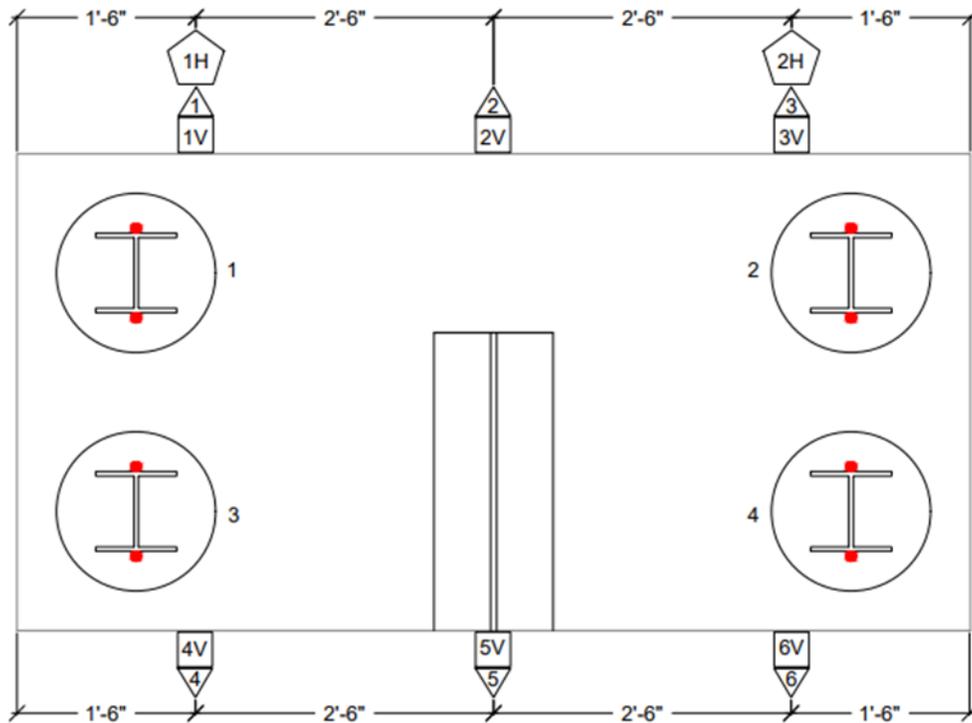
Figure 112. Instrumentation plan for pile coupler

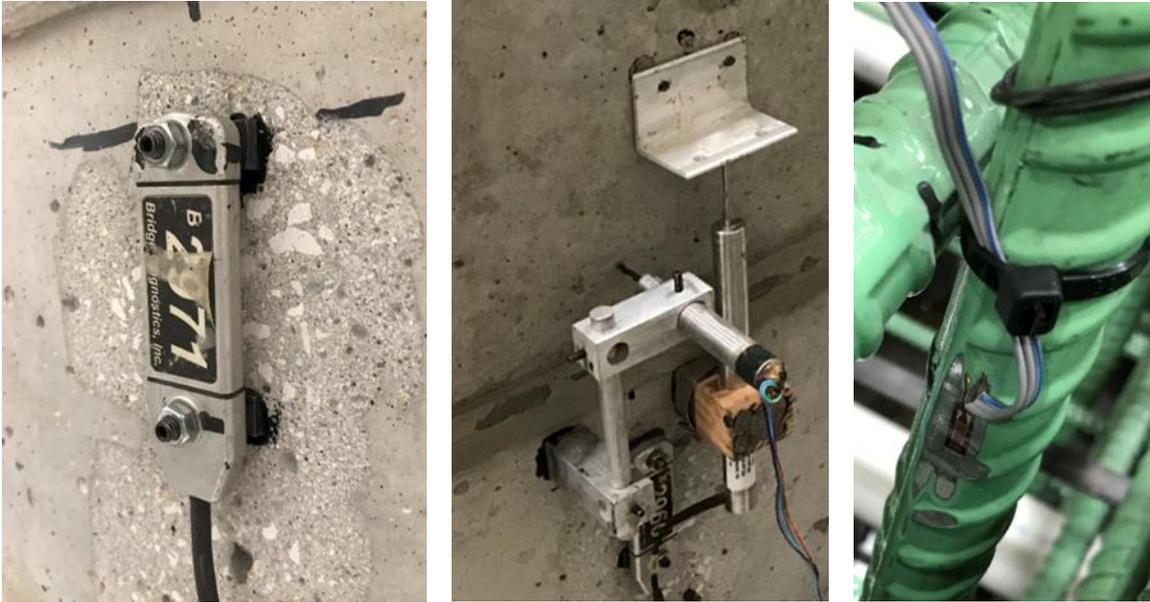
Figure 114. External strain gauge (left), vertical displacement transducer, horizontal displacement transducer, and external strain gauge (center), and sacrificial strain gauge (right)

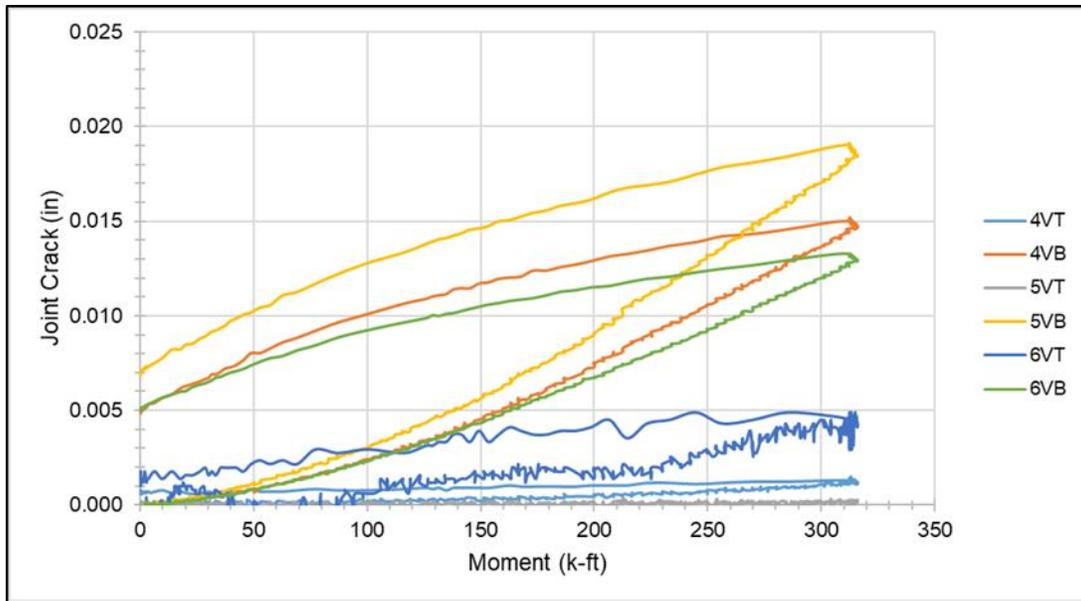
Figure 115. Crack width versus moment due to horizontal load

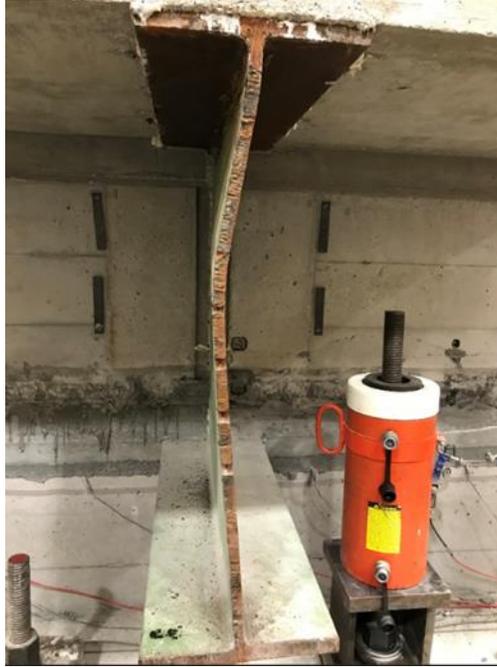
Figure 116. Beam buckling failure causing end of test

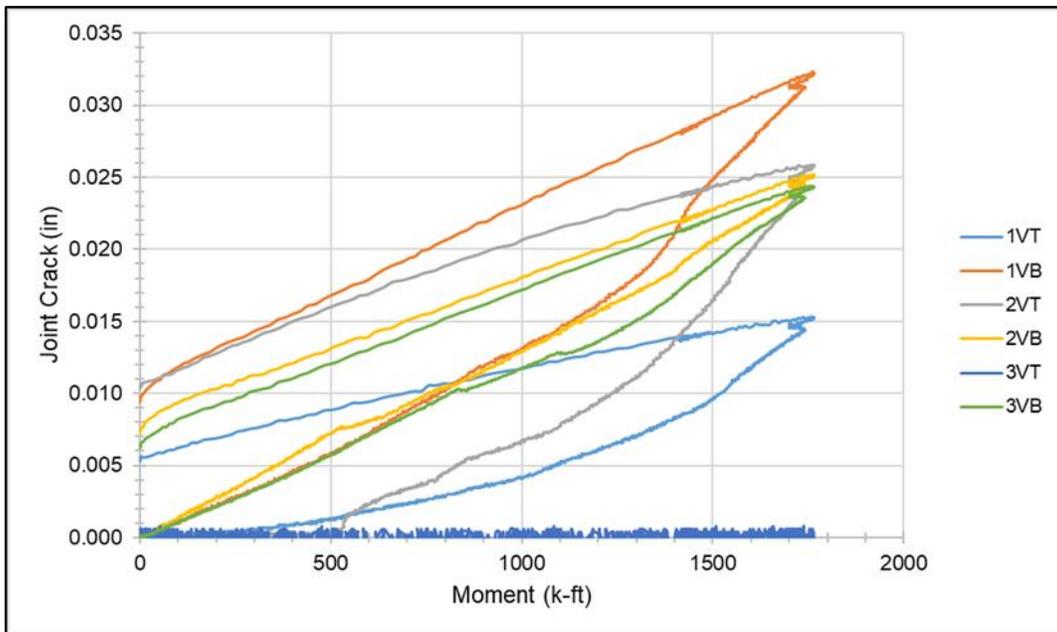
Figure 117. Crack width versus moment due to vertical load

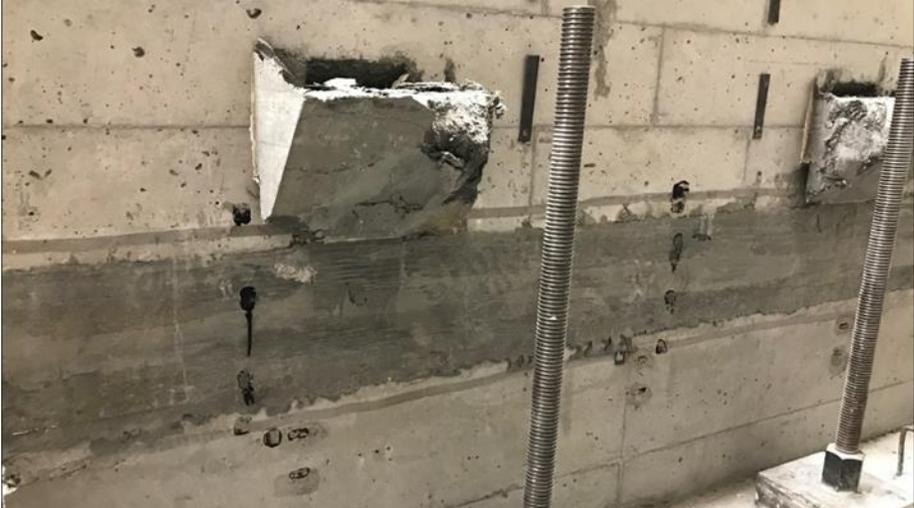
Figure 118. UHPC joint rear face after testing

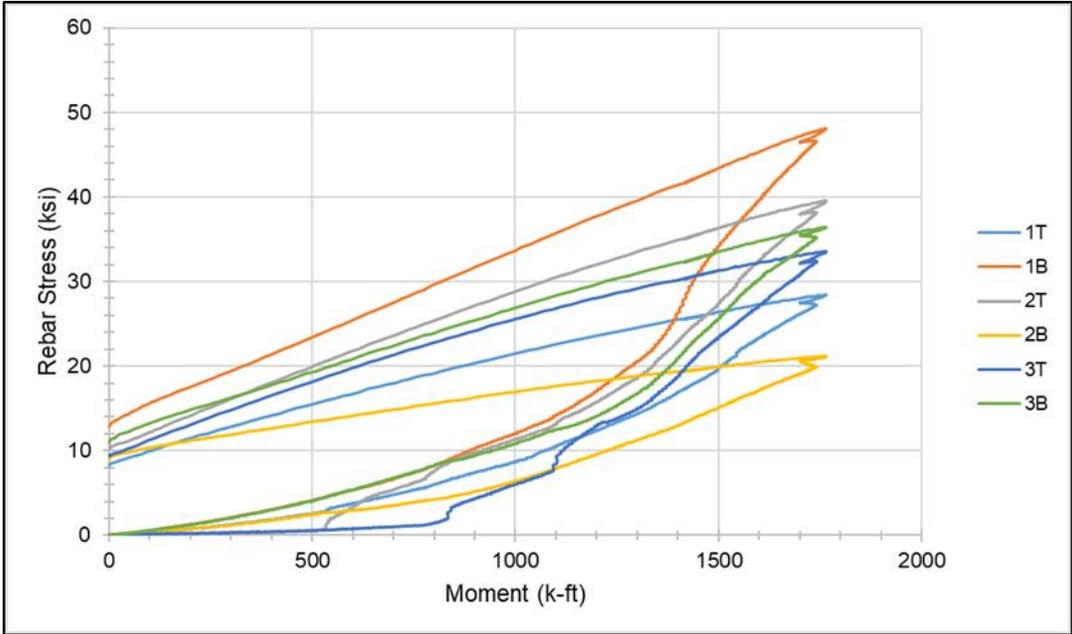
Figure 119. Tension reinforcing bar stress versus moment due to vertical load

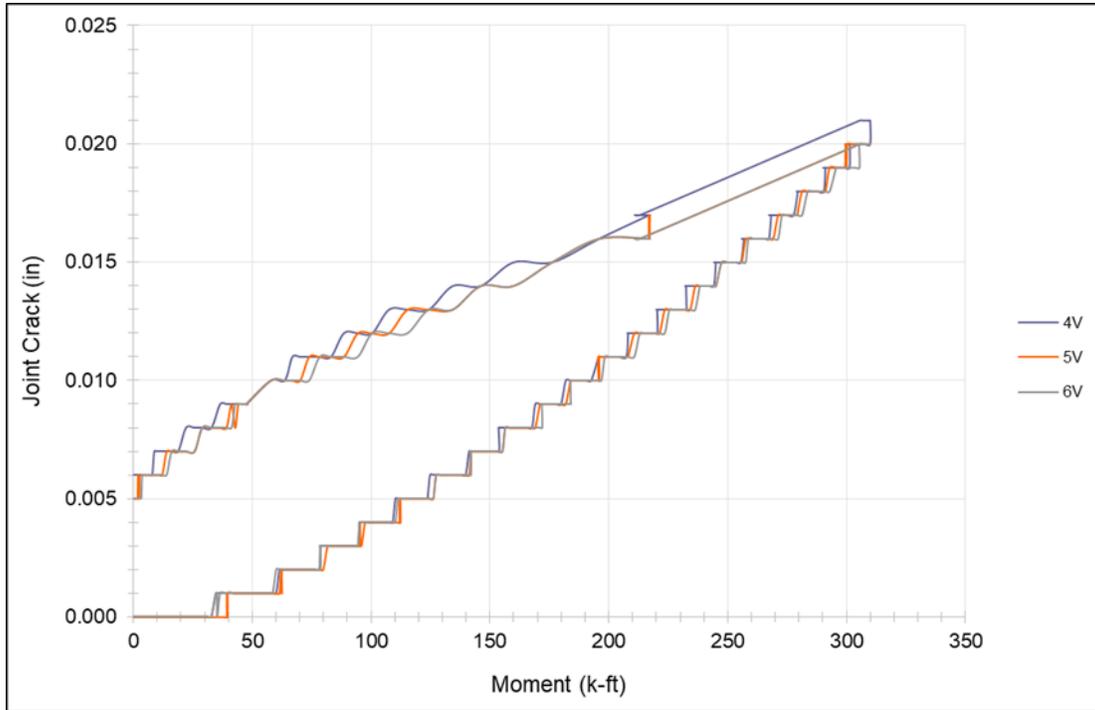
Figure 120. Crack width versus moment due to horizontal load

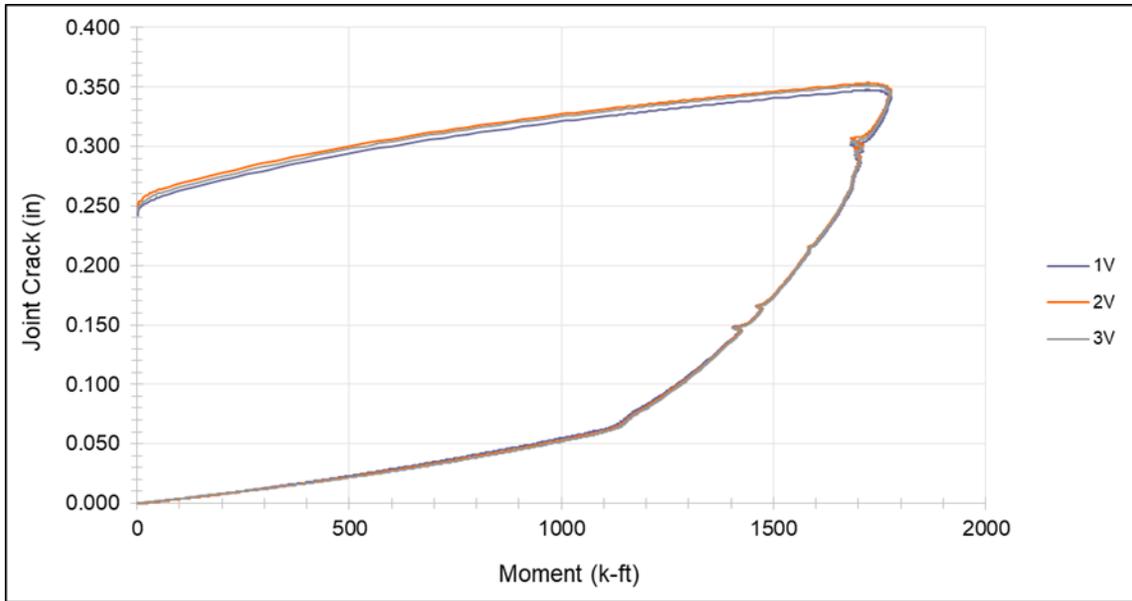
Figure 121. Crack width versus moment due to vertical load

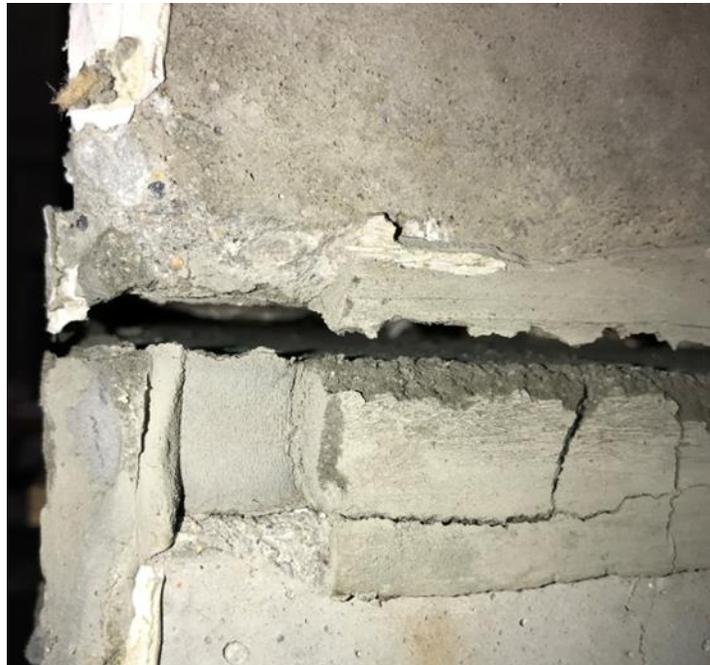
Figure 122. GRBC rear face crack due to vertical load

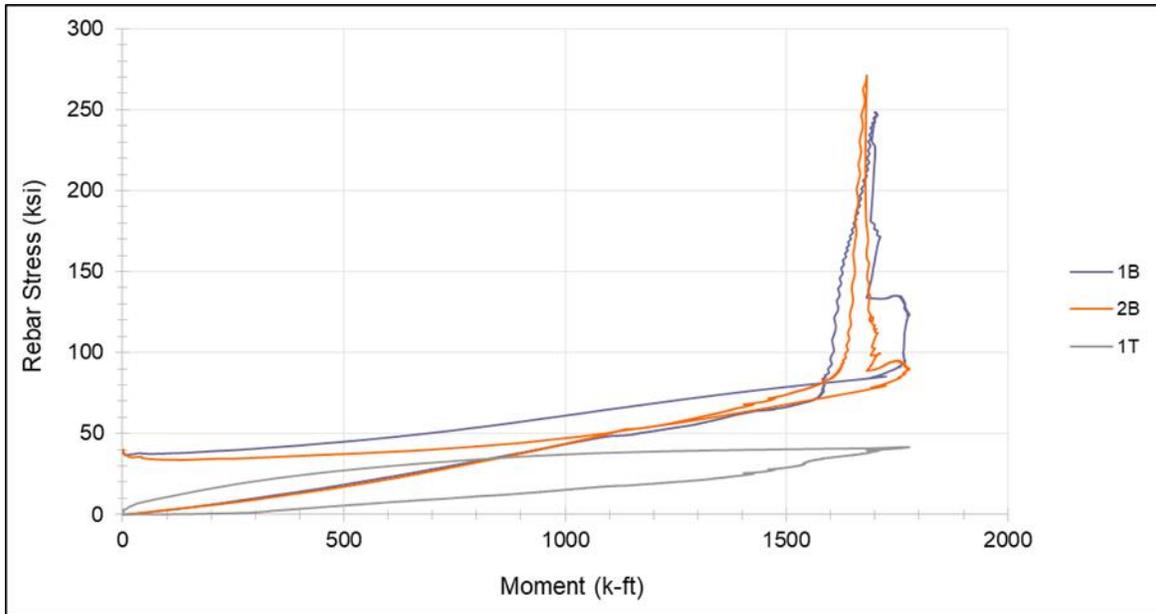
Figure 123. Tension reinforcing bar stress versus moment due to vertical load

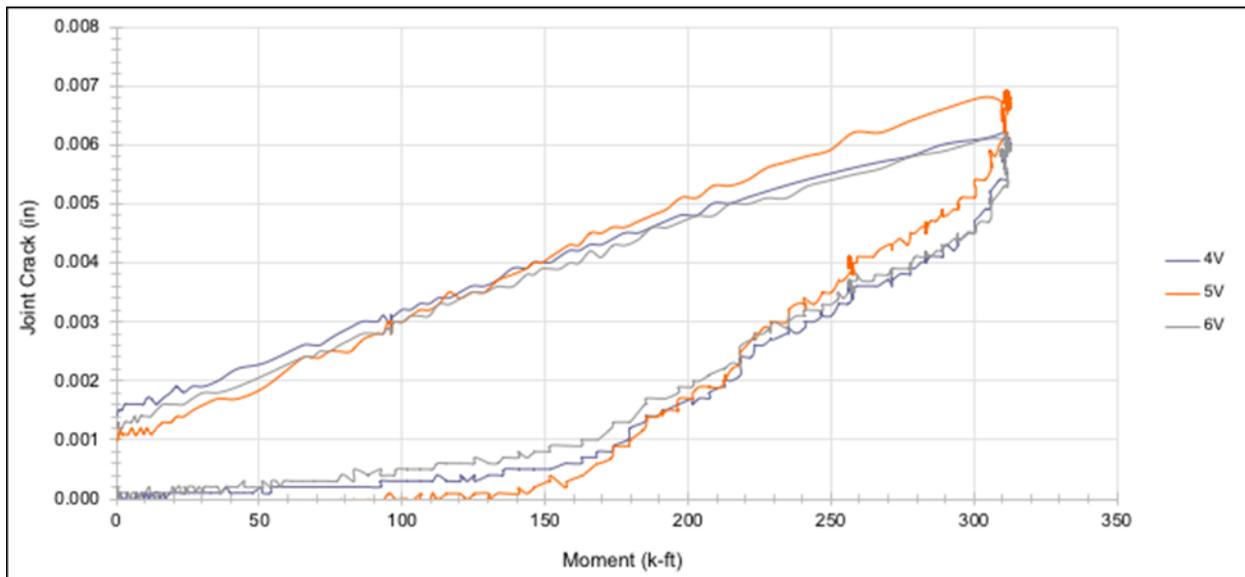
Figure 124. Crack width versus moment due to horizontal load

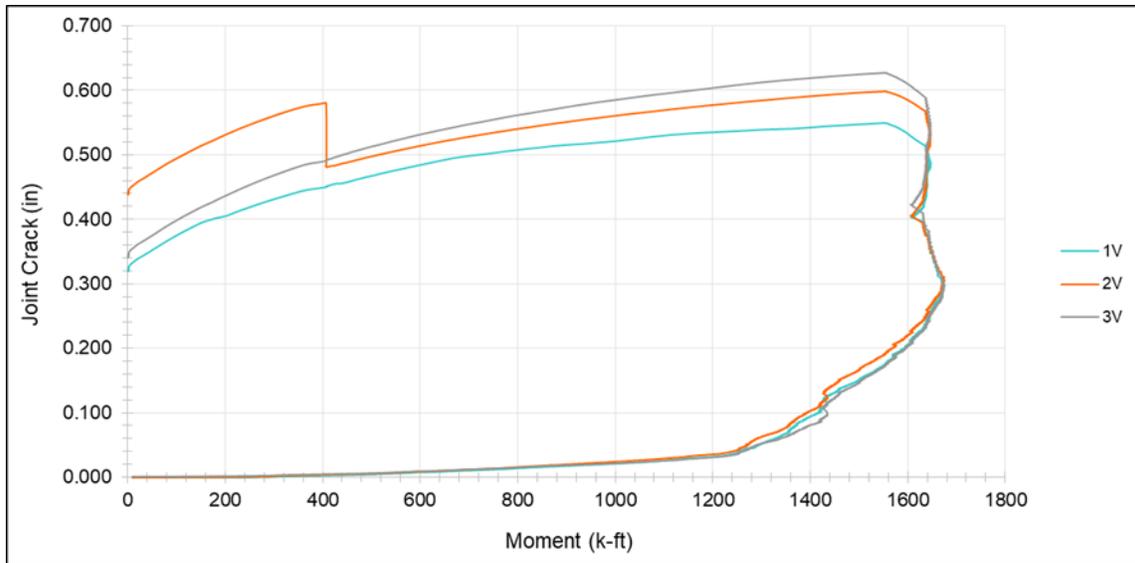
Figure 125. Crack width versus moment due to vertical load

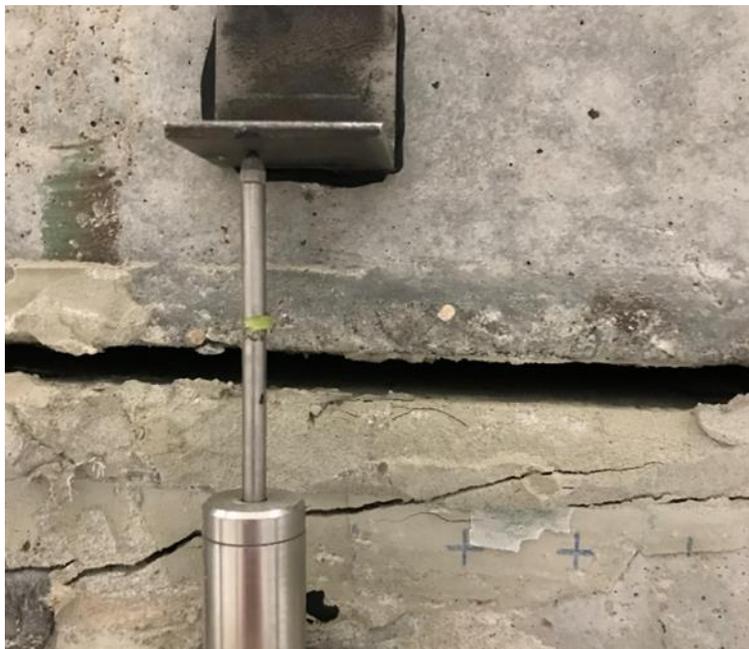
Figure 126. Pile coupler rear face crack due to vertical load

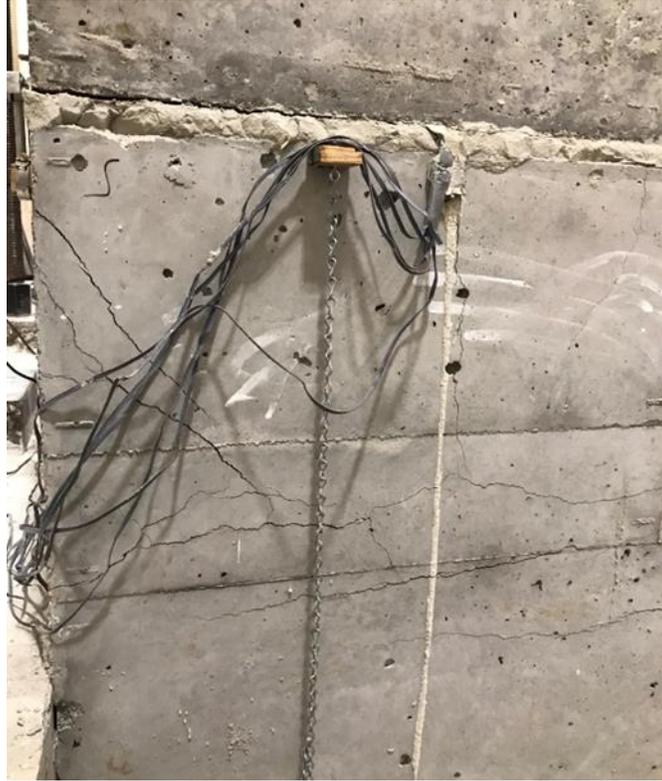
Figure 127. Pile coupler pile cap cracking due to vertical load

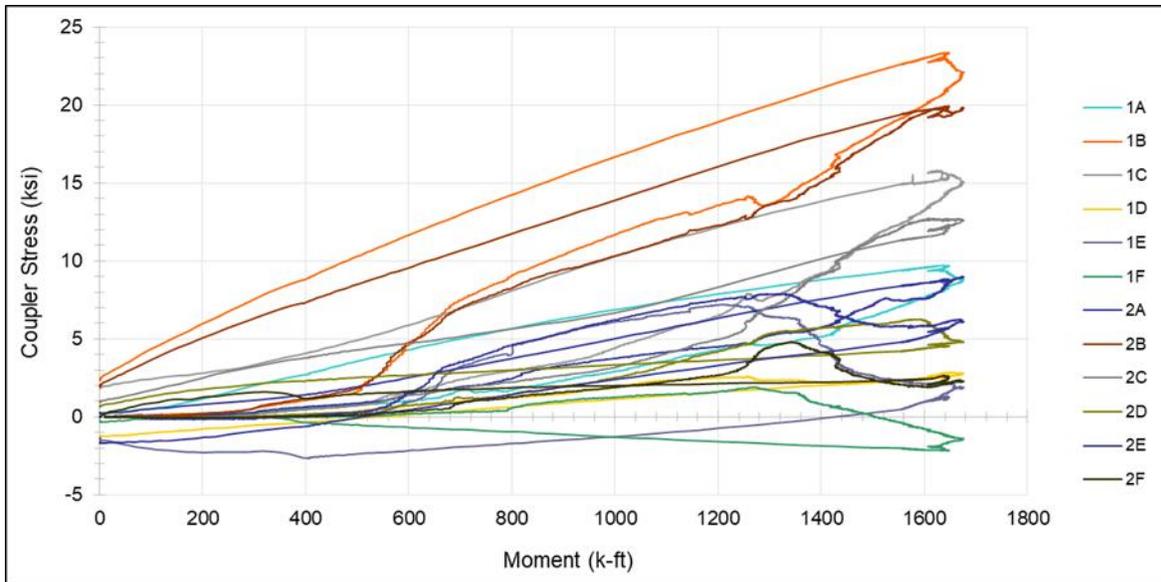
Figure 128. Abutment tension-side steel section stresses versus moment due to vertical load
