**More Choices for Connecting Prefabricated Bridge Elements and  
Systems (PBES)**

**Quarterly Progress Report  
For the period ending August 31, 2019**

**Department of Civil and Environmental Engineering  
University of Nevada, Reno**

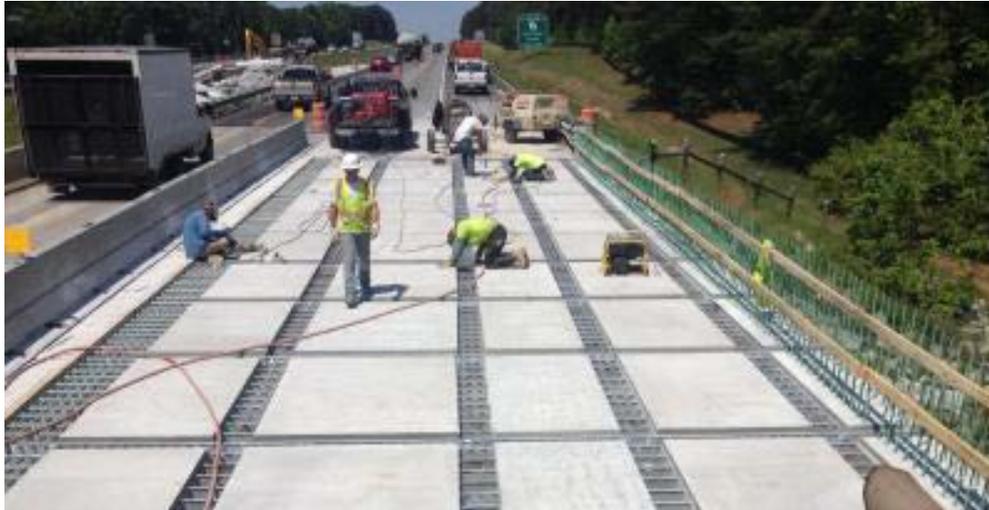
**Fig. 1** – Field connections/joints for precast deck slabs (photo credit: Georgia DOT)

precast deck slabs as shown in Figure 1. Precast slab panels can be conveniently connected to prestressed concrete or steel girders using shear studs (Shrestha et al. 2017). Then, advanced materials such as UHPC are used to connect the precast deck panels while maintaining acceptable load transfer mechanism (e.g. slab reinforcement lap splices).

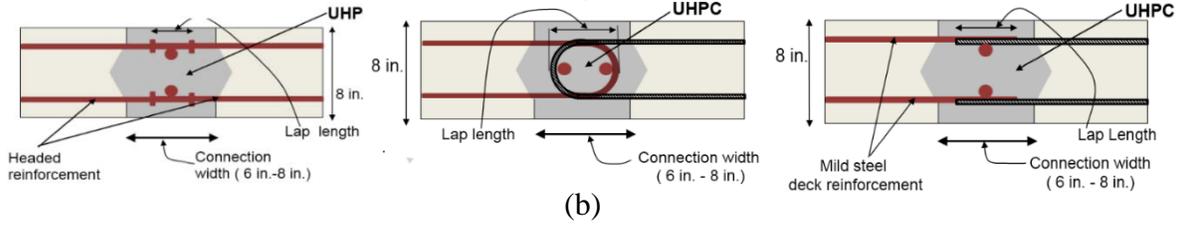
**Fig. 3** – Precast bridge deck field connections: (a) different joint configurations (female-female shear keys), (b) details of reinforcement (headed rebar, loop splice, and straight splice).

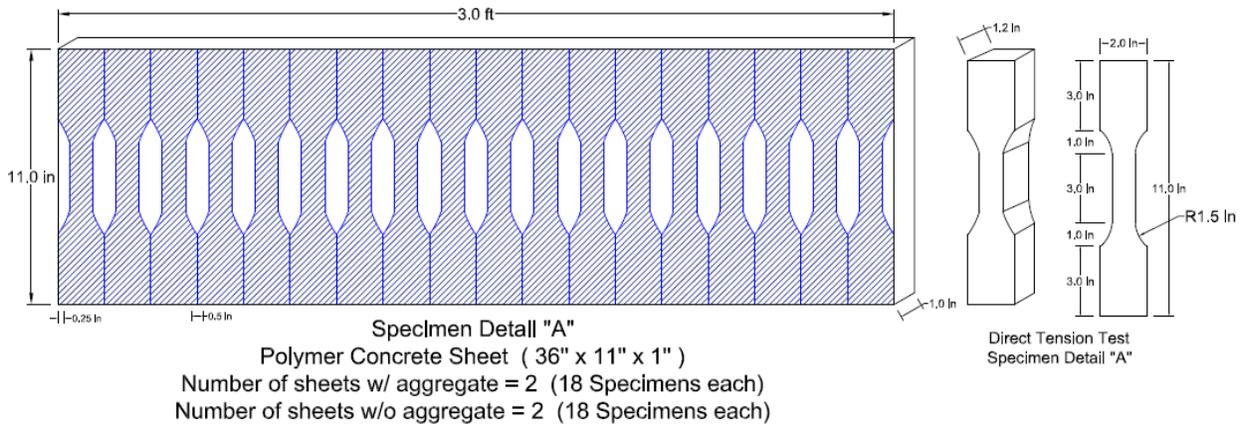
**Fig. 4** – Polymer Concrete specimens’ layout and dimensions for direct tension test

Most of the new or evolving cementitious materials are extensively tested to characterize fresh and harden state properties with less focus on mechanical properties characterization. In this task, the mechanical properties of the selected materials from Task 1 will be further characterized. Various material tests will be considered to determine compressive strength, tensile strength, Young’s modulus, and modulus of rupture from bending tests. Direct tension tests will be considered to better characterize tensile strength rather than using cylinders splitting tests or three- and four-point bending tests. Polymer concrete sheets were received and tension specimens will be prepared using water jet cutting. Figure 4 shows the cutting layout of the dog bone specimens and individual specimen’s dimensions.

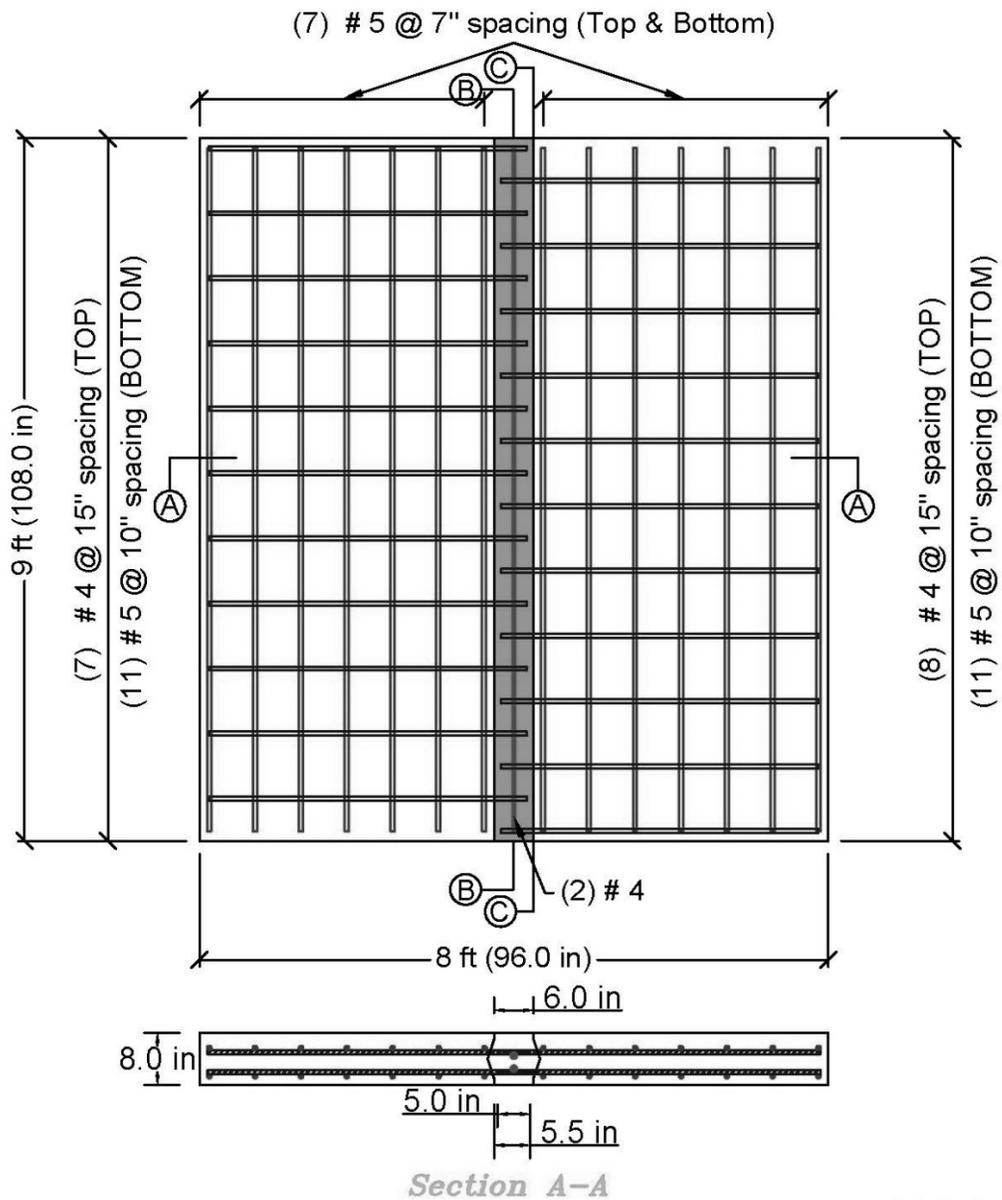
**Fig. 5** – Structural details for the transverse specimens.

Table 2. The design of the specimens was done according to the AASHTO LRFD Bridge Design Specification (AASHTO, 2012). The positive and negative design moments were determined based on the AASHTO Equivalent strip method. The moment values provided in this method takes into account the largest values that could be experienced by the deck slabs with respect to different loading conditions. The bridge example that was used to analyze the reinforced concrete deck slab in this study has a cross-section consisted of five steel girders spaced at 12 ft on center and a deck slab of 8 in thickness.

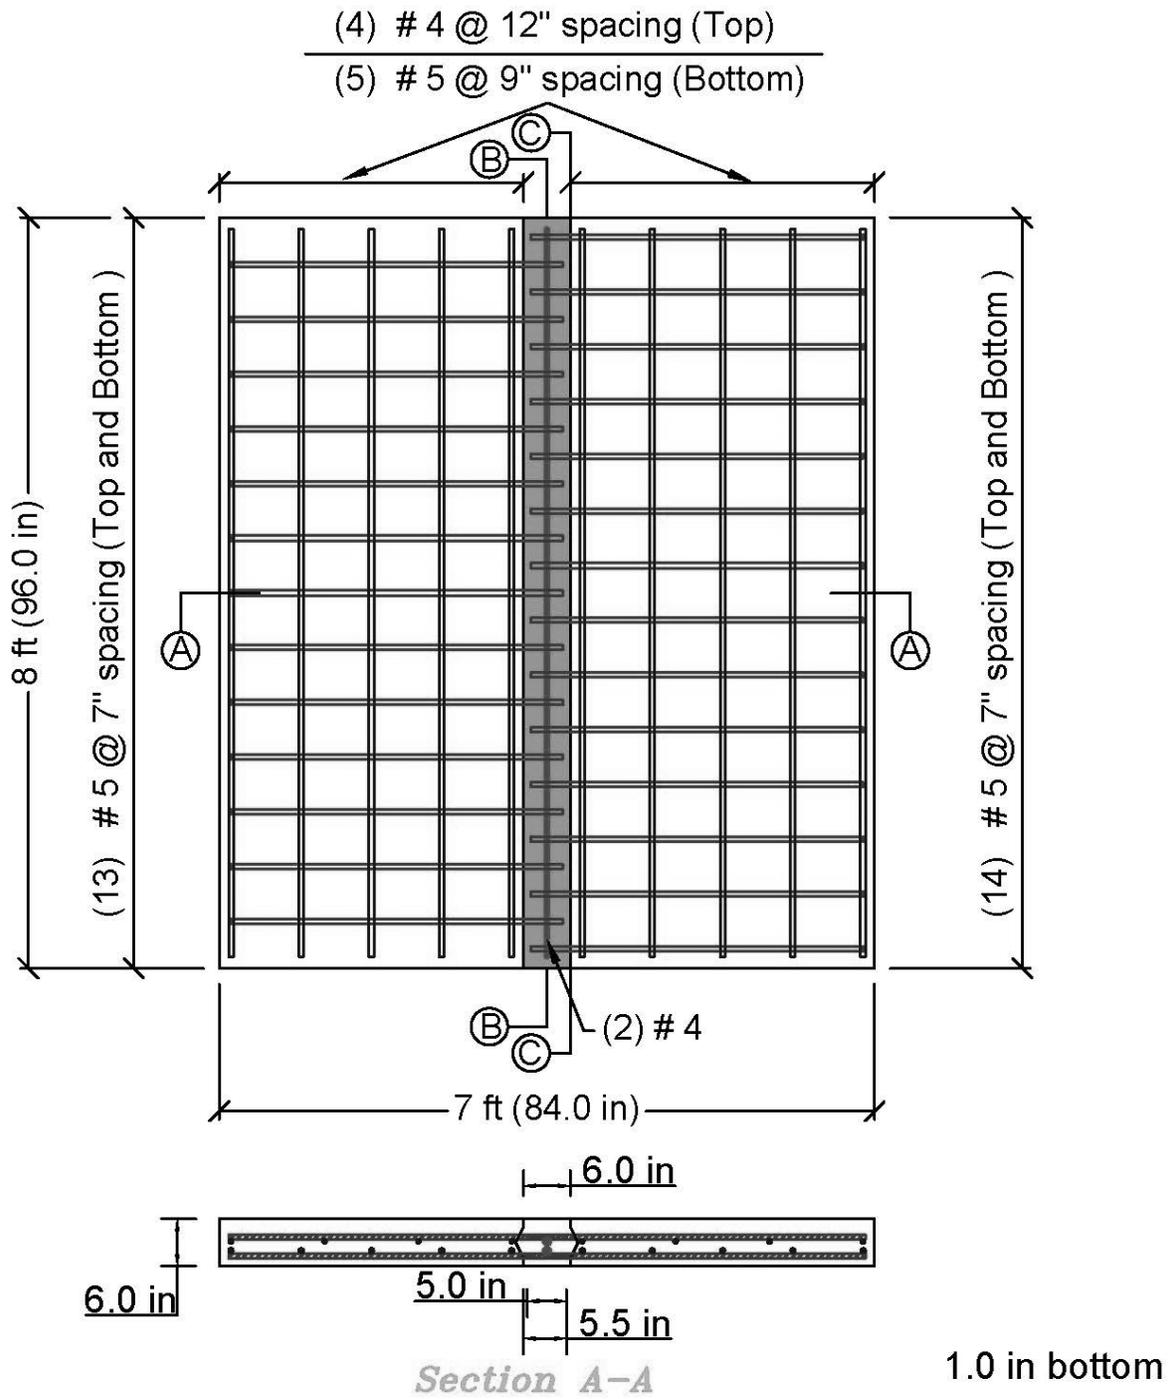
Fig. 6 – Structural details for the longitudinal specimens.

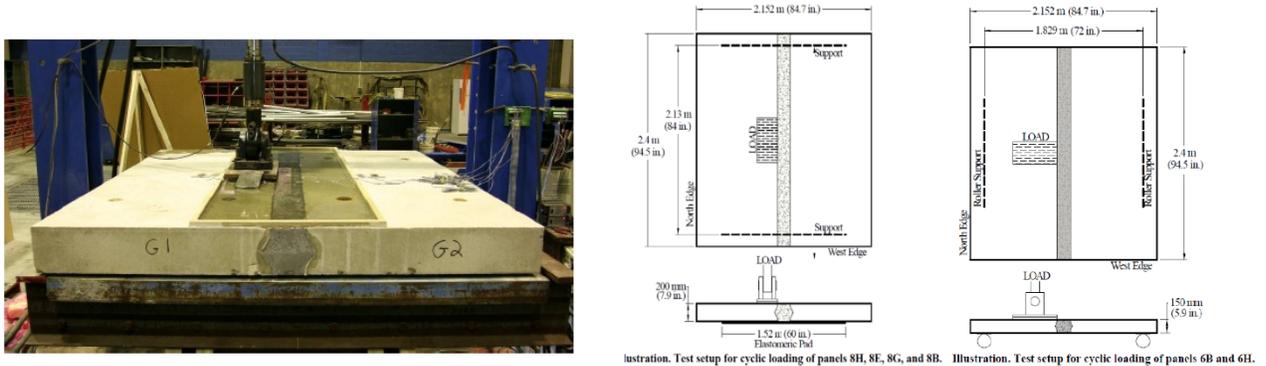
**Fig. 7 – FHWA cyclic test setup for deck panels with UHPC joints (Graybeal 2010)**

Extensive precast deck panels with field and UHPC joints have been tested (e.g. Perry and Royce 2010, Graybeal 2010, Hartwell 2011). Testing procedures from previous studies is adopted to conduct large-scale testing on deck panels connected using the new alternative material. The FHWA test setup and specimens dimensions (Figure 7) will be almost replicated for comparison purposes with UHPC (Gaybeal 2010). The construction and assembly of all the deck panels for the test specimens have been completed at UNR as shown in Figures 8-13. The figures show also the sequence of construction. Recently, we have finished experimental testing of the transverse and the longitudinal specimens.

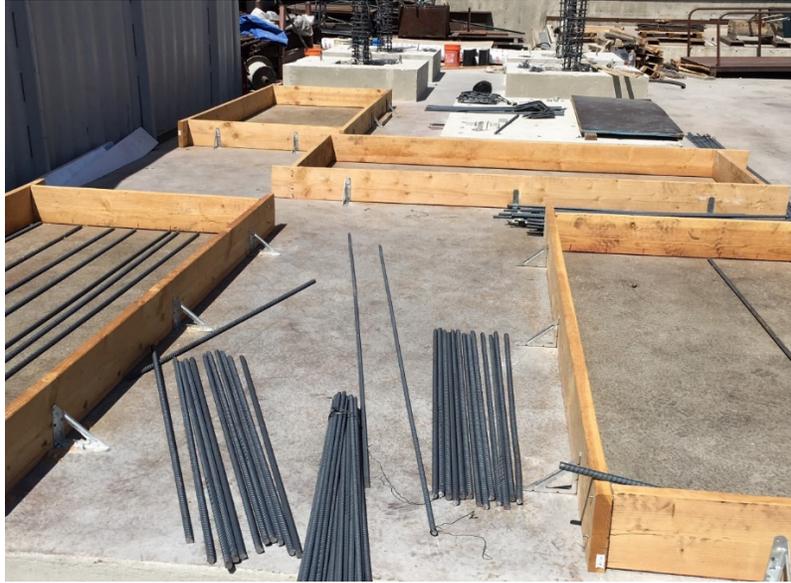
**Fig. 8** – Formwork for construction of deck panels and specimens

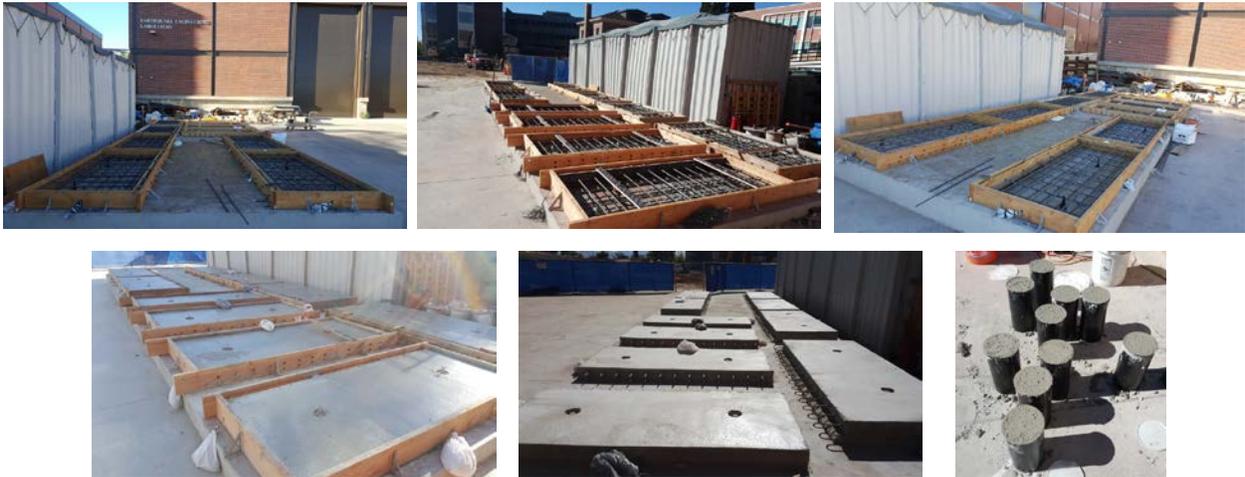
**Fig. 9** – Deck panels' construction, reinforcement, and cast concrete

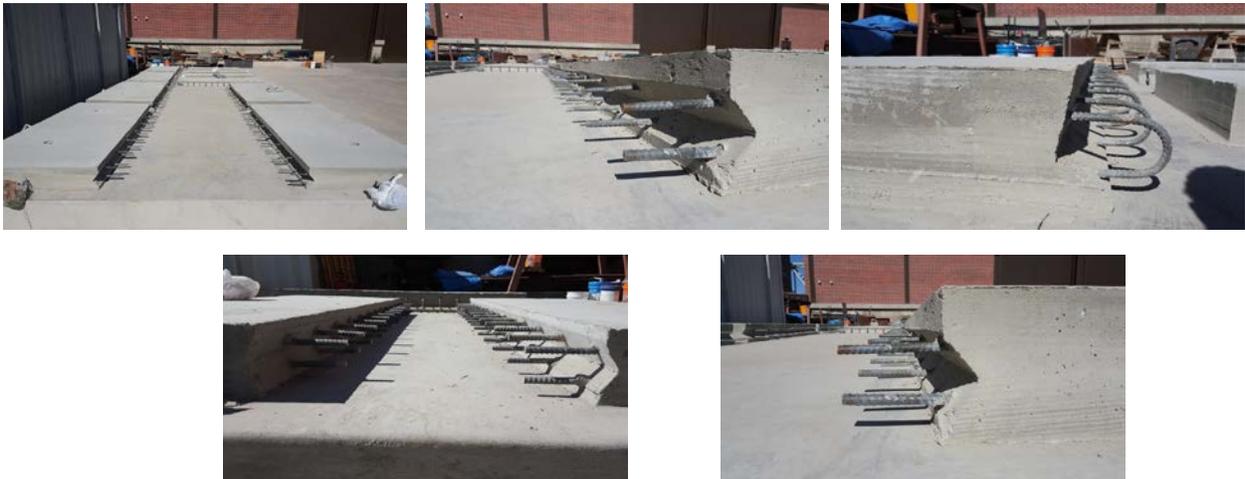
**Fig. 10** – Close-up views of the constructed deck panels and shear keys for the field joints

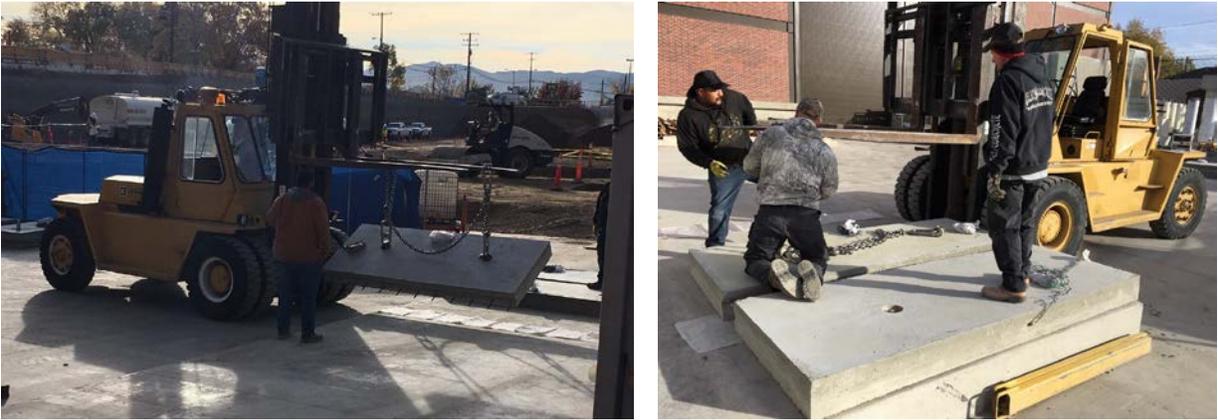
**Fig. 11** – Alignment and assembly of test specimens at UNR

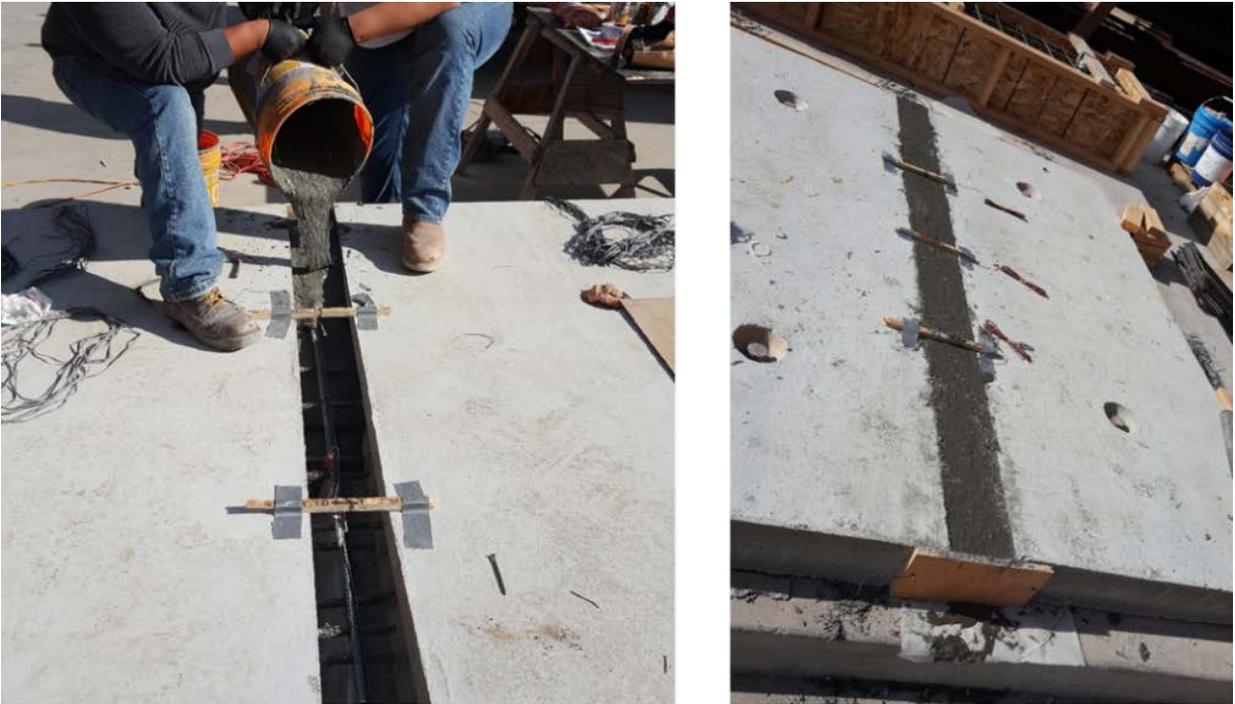
**Fig. 12** – UHPC and polymer concrete Closure pours for the field joint for the test specimens

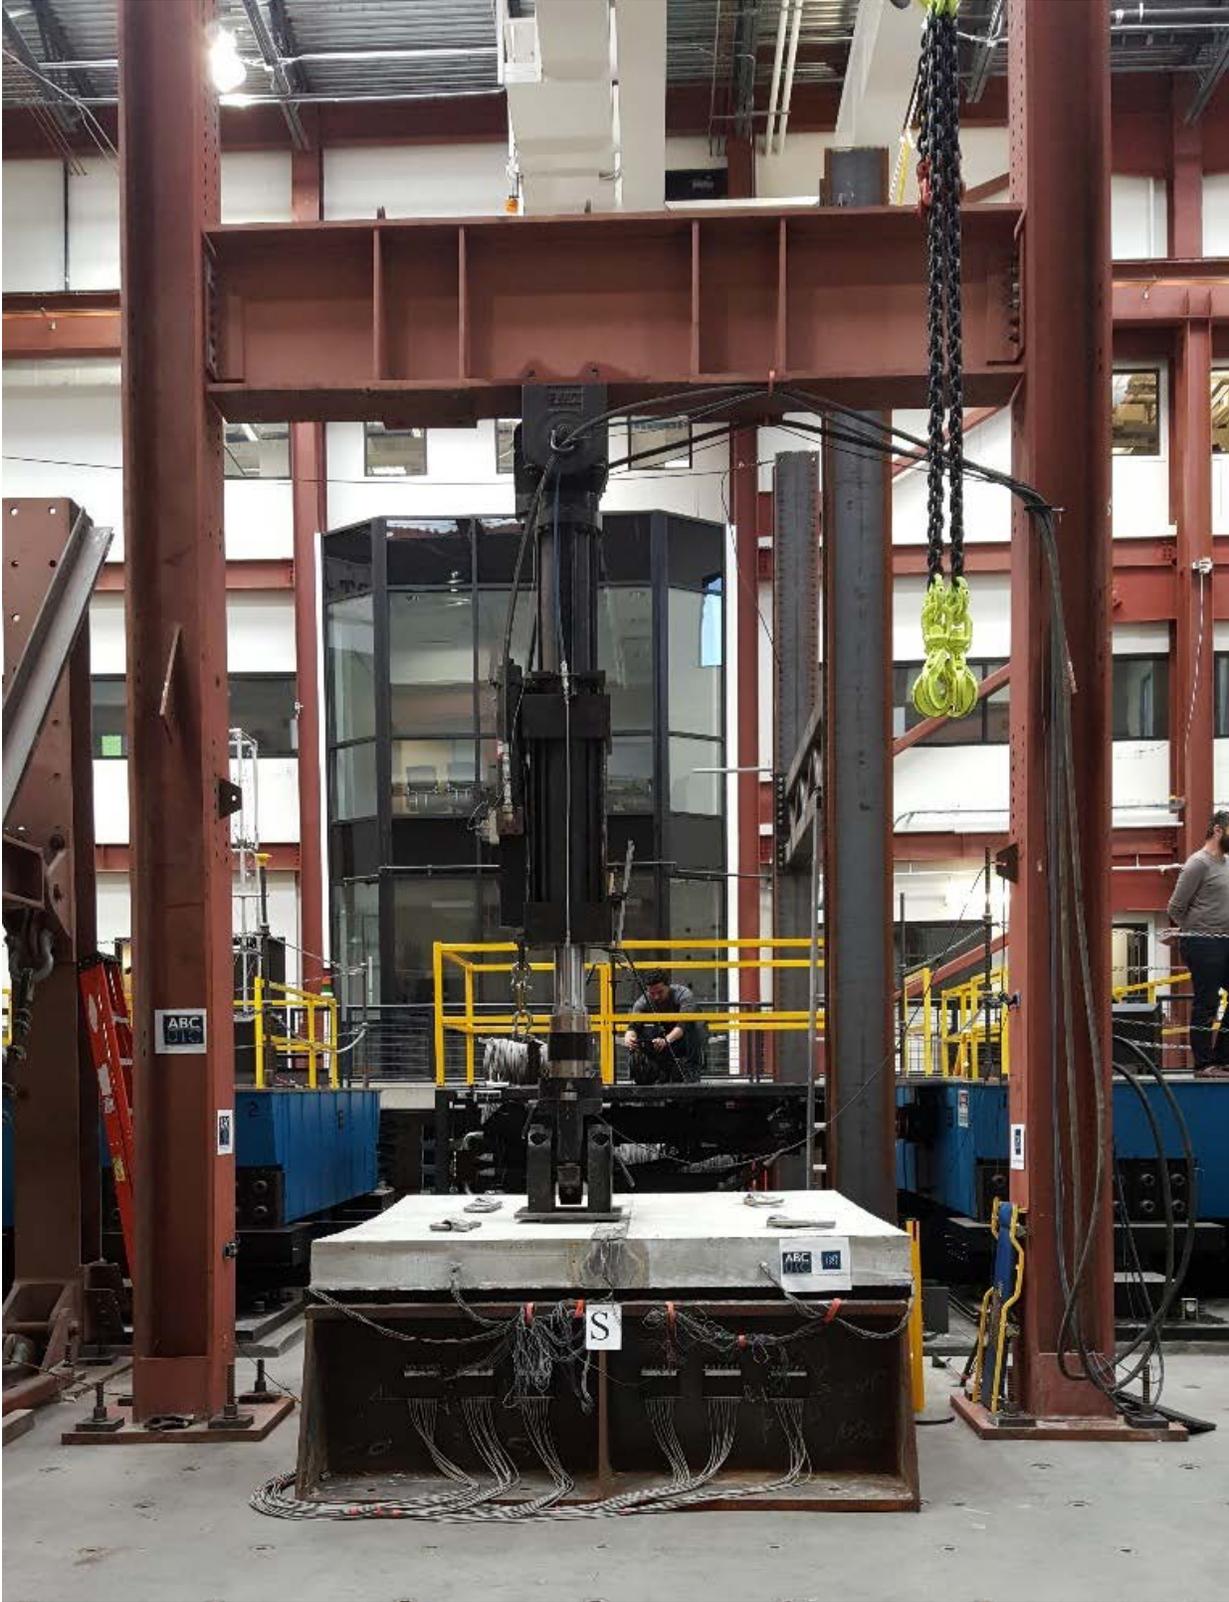
**Fig. 13 – Deck panels test setup at UNR**

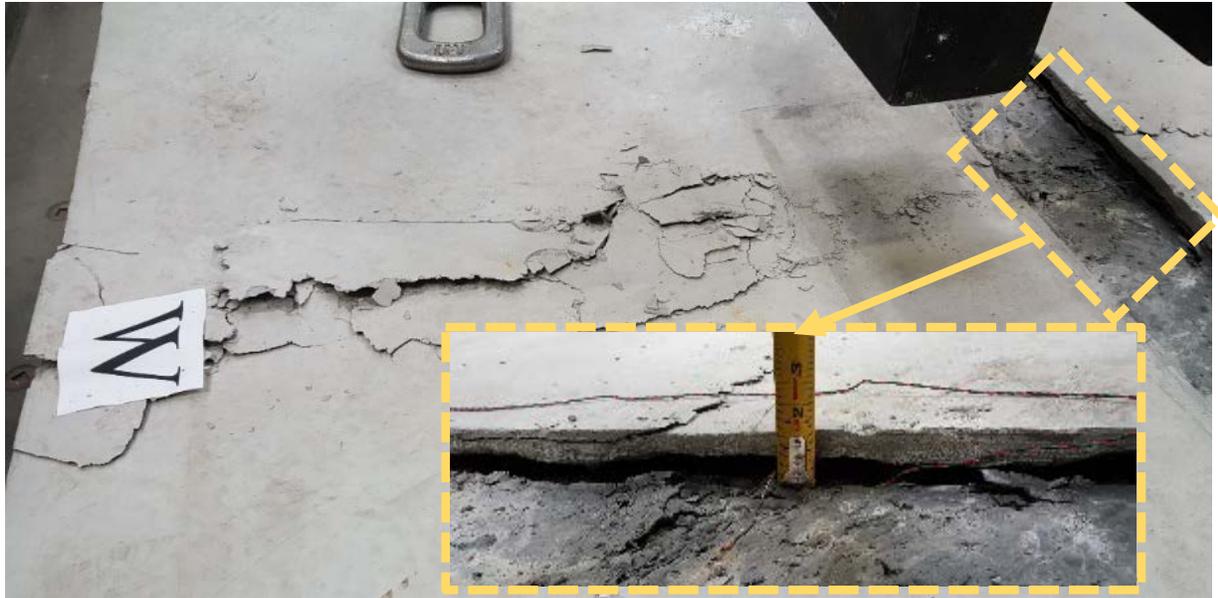
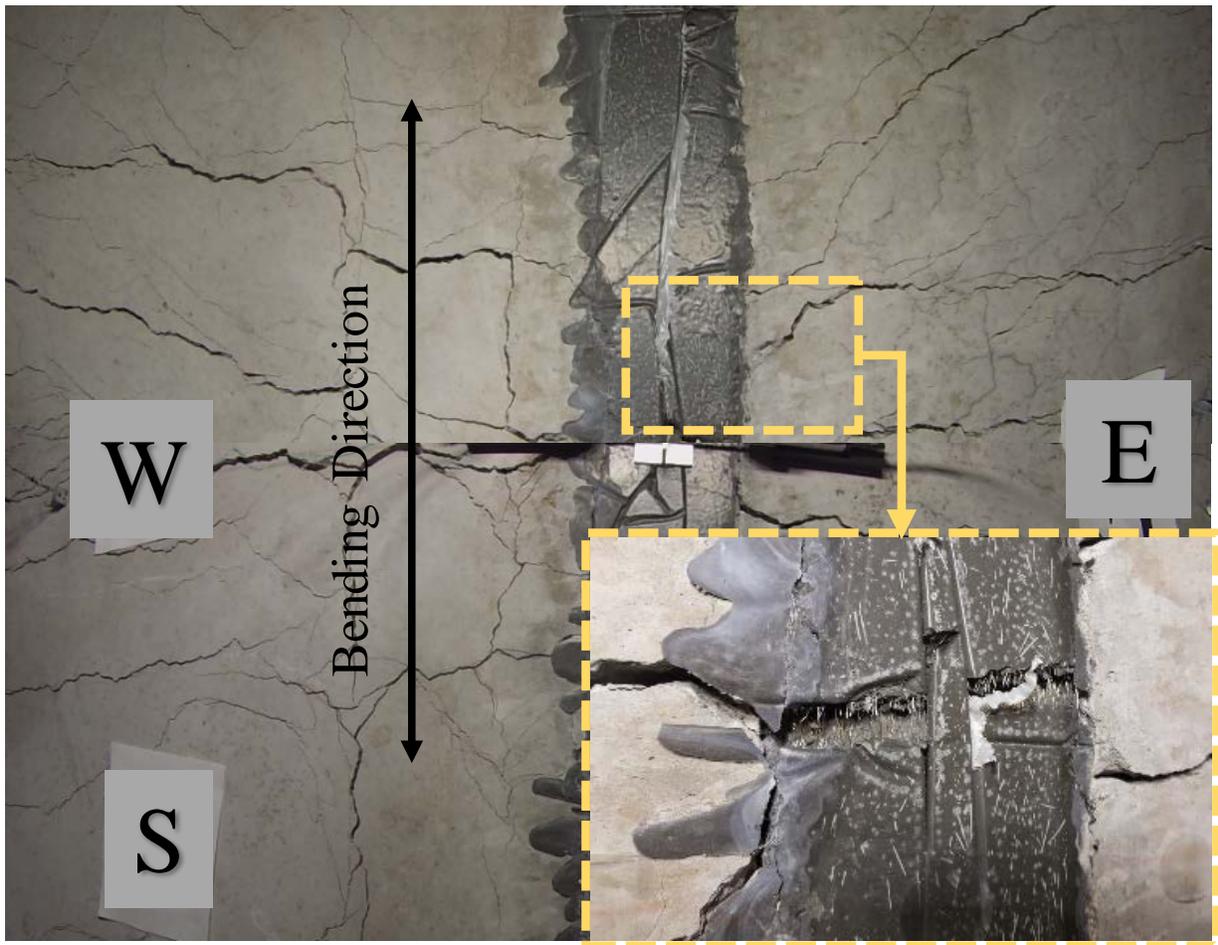
**Fig. 14** – Crack pattern, damage, and mode of failure at the top and bottom sides of specimen SP1-T-S-UHPC.

The measured peak load of specimen “SP1-T-S-UHPC” was 117.9 kips at 2.33 in mid-span vertical displacement. The observed mode of failure for the UHPC transverse specimen was yielding in the main reinforcement due to flexure accompanied with crushing of the concrete at the top part of the loaded west side of the specimen. Deep and wide flexural cracks were observed at the bottom face of the precast slabs interrupted by two main localized cracks in the UHPC at the measured peak load. An interface crack at the top surface of the slab was observed between the unloaded east side and the UHPC connection at the peak load as shown in Figure 14. The depth and length of this interface de-bonding were then increased as the applied displacements increased. After reaching the peak load, a series of drops in the force capacity was observed along with excessive flexural cracking at the bottom and crushing of the deck panels’ concrete at the top (see Figure 14). The test was stopped after a rebar popping sound was heard after reaching approximately 80% of the peak load, which was found to indicate the rupture of the bottom transverse rebar inside the field connection. The flexural capacity of the specimen was much bigger than the required limit state moments (Ultimate and Service) specified in the AASHTO LRFD using Equivalent strip method. Therefore, the proposed UHPC field connection was capable of creating a precast deck system that can emulate the behavior of the cast-in-place deck systems in terms of strength requirements.

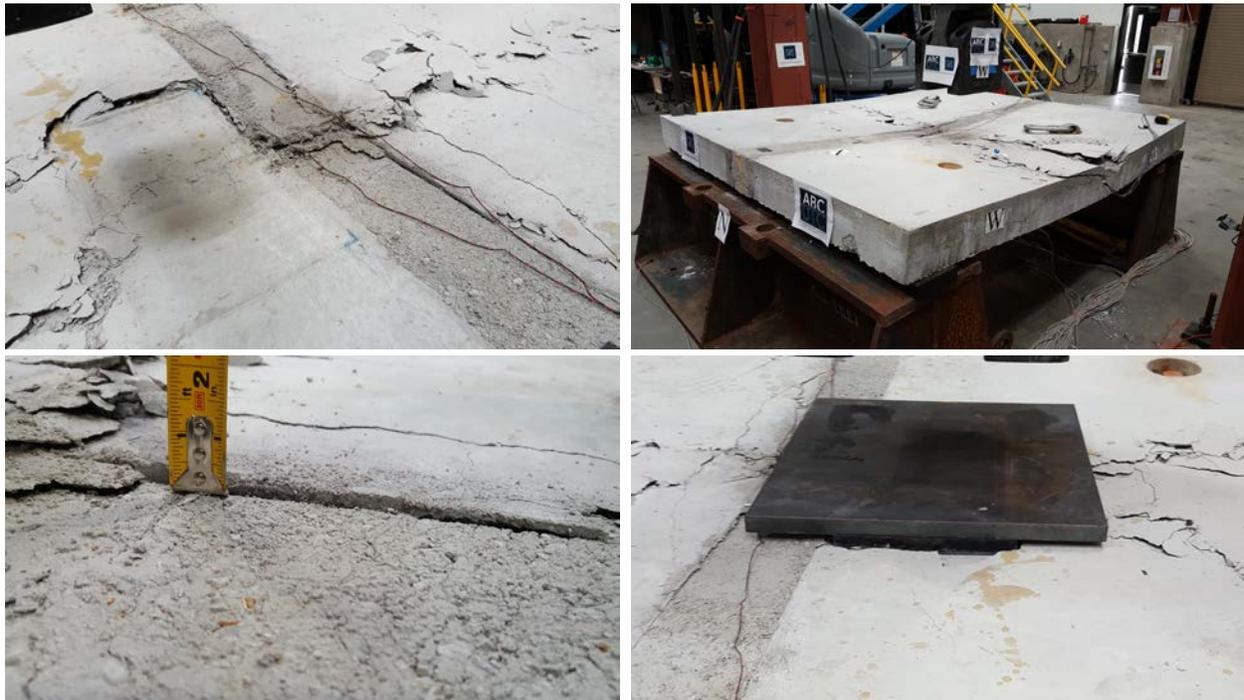
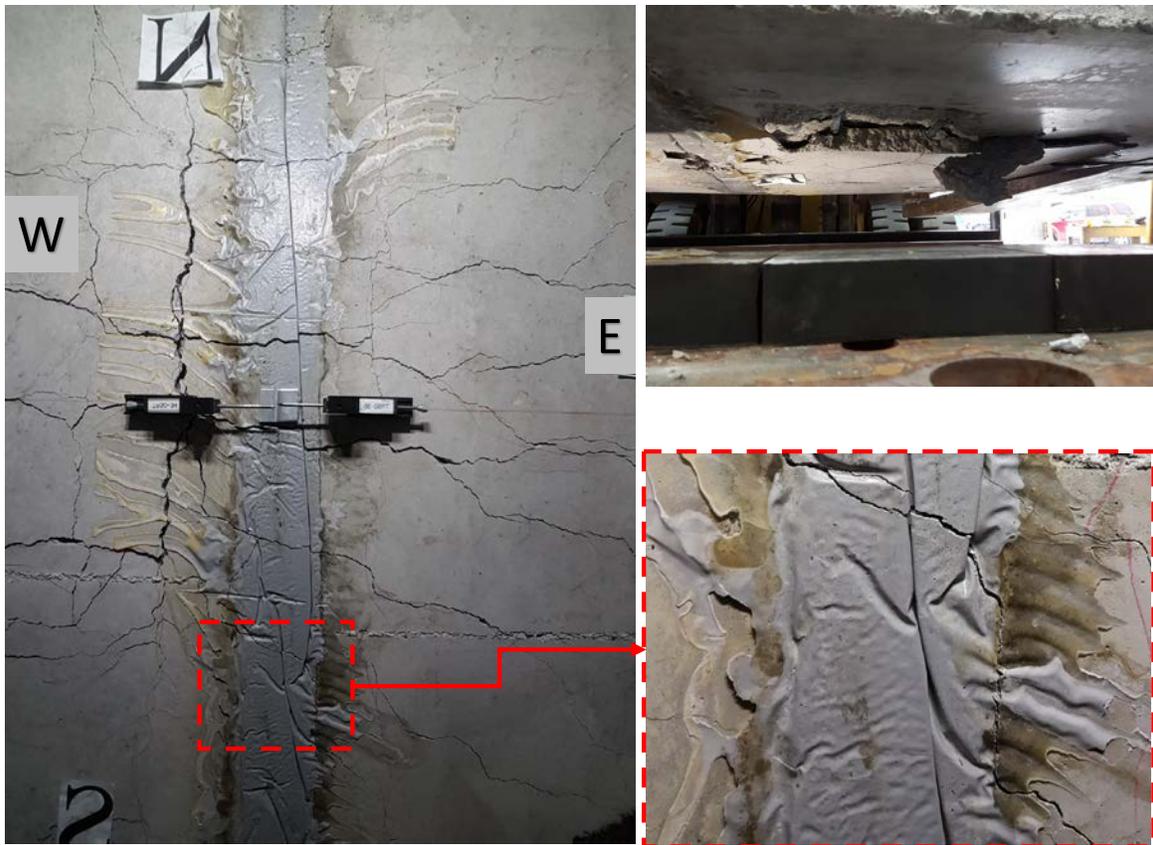
Fig. 15 – Crack pattern, damage, and mode of failure at the top and bottom sides of specimen SP2-T-S-PC.

The measured peak load of specimen “SP2-T-S-PC” was 113.2 kips at 2.53 in mid-span vertical displacement. The observed mode of failure for the PC transverse specimen was similar in the beginning to the UHPC case with yielding in the main reinforcement due to flexure. However, a rebar rupture was observed at the peak load of the specimen which caused a sudden drop in the ultimate load capacity of the specimen. Crushing of the concrete was then observed at the top surface of the loaded west side of the specimen and continued to propagate through the joint until reaching the unloaded east side. Deep and wide flexural cracks were observed at the bottom face of the precast slabs, these cracks continued to propagate through the joint when approaching the peak load. No interface cracking was observed at the top surface of the slab between the precast slab and the PMMA-PC connection at the peak load. However, a short-length and small-depth interface cracking of approximately 0.2 in was observed at the top surface of the slab between the unloaded part and the PC connection while approaching the end of the test. The test was again stopped after reaching approximately 80% of the ultimate load. Figure 15 shows the overall damage and final status of the SP2-T-S-PC specimen after testing.

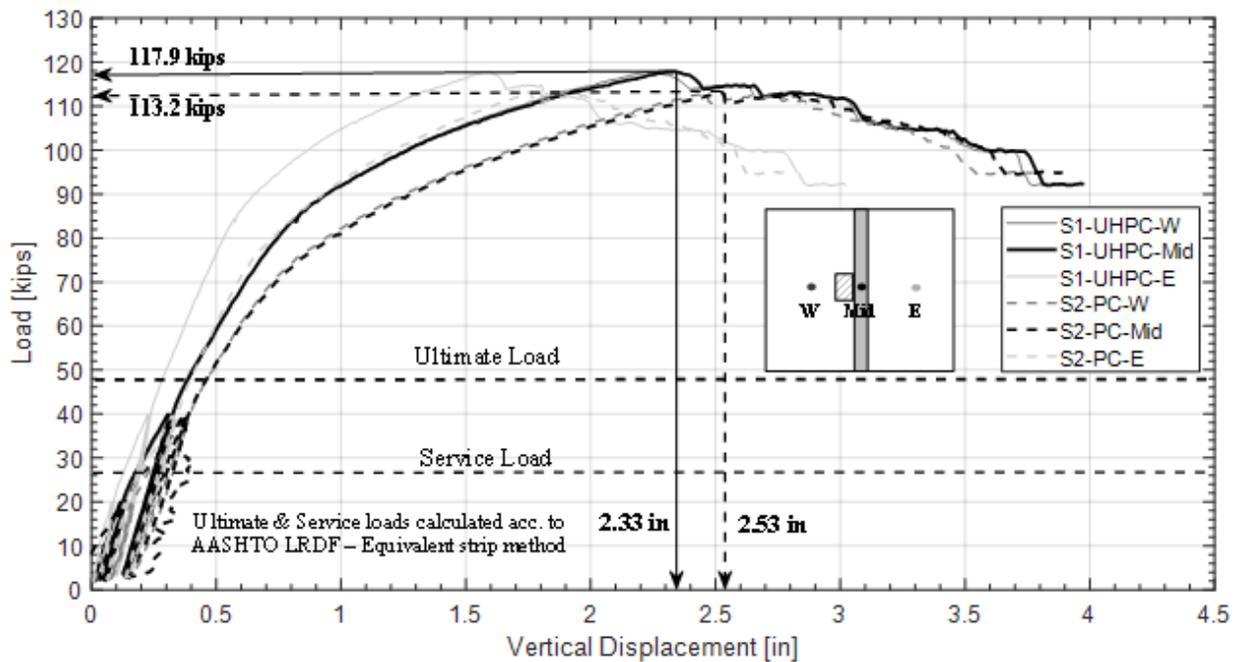
Fig. 16 – Load-deflection relationship at mid-span of specimens S1-UHPC and S2-PC as measured at three different locations.

The overall load versus the mid-span vertical displacement obtained from three different string potentiometers for the first and second specimens are presented in Figure 16. It is noted that the data acquisition readings in the third cycle of SP2-T-S-PC test had some noise that partially affected the quality of the load-deflection relationships at this loading level. Two main observations can be drawn from Figure 16: (1) the overall behavior of the two specimens with UHPC and PC joints is very comparable, and (2) the flexural capacity of both specimens exceeded the two code limit states, i.e. service and ultimate loads specified in the AASHTO LRFD using Equivalent strip method. Therefore, both UHPC and PC field connections were capable of providing an ABC precast deck system that can emulate the behavior of conventional CIP deck systems in terms of strength requirements.

The load-deflection curves shown in Figure 16 can be divided into different regions of behavior. The first portion of the behavior represents the elastic behavior of the specimen when the applied load is approximately below 20 kips. During this stage, only hair flexural cracks in the longitudinal direction were observed in the bottom face of the slab. A hair transverse crack located approximately 5 inches apart from the edge of the connection and ran parallel to the connection in the loaded west side of the slab was also observed. No cracks were observed in the unloaded east side of the slab. No interface de-bonding or concrete crushing was observed during the “service” level loading of the behavior. No cracks were also observed in the field joints because of the higher tensile strength of the UHPC and PC as compared to the conventional concrete. The second region in defining the load-deflection curve represents the onset and progression of the inelastic behavior as the applied load exceeded the elastic load. This started in the third and fourth cycles of loading around the 40 kips vertical load when the flexural stiffness decreased and the residual displacement increased. The cracks at this level were still narrow and the main reinforcement was not yet yielded. It is worth noting that there were no flexural or interface cracks observed in the field connections until reaching the AASHTO specified ultimate load. The slight inelastic response continued as the load increased to approximately 85 kips and 75 kips for specimens S1-UHPC and S2-PC, respectively. As the load increased beyond this limit, the third region of the load-deflection curve can be defined by the significant reduction in stiffness as the specimens started to soften due to yielding of the middle and west side transverse reinforcement in the bottom mesh. Hence, deep and wide flexural cracks were observed in the bottom side of the slab. No rebar slip was observed until reaching the peak load for both specimens. Following the peak load capacity, the fourth region can be defined by a global softening behavior where the load capacity started to decrease with larger displacements. It is noted that the goal of pushing the specimens to such high levels of loads and displacements beyond code-required limits was to have better understanding of mode of failure and check whether the different system components stay intact.

It can be also seen from Figure 16 that the UHPC specimen exhibited larger flexural stiffness than the PC specimen because of the higher tensile and compressive strengths of UHPC. The early measured flexural stiffness of the UHPC specimen was found to be 240 kips/in versus 190 kips/in for the PC specimen, i.e. the PC specimen stiffness was about 80% of that of the UHPC specimen. To further investigate the relative deflection between two slab panels in a given specimen, the deflection was observed at three different locations in the middle of the specimen as illustrated in Figure 16. It is shown that the loaded west side of the slab and the field joint deflection were almost identical which was the case for both specimens. However the unloaded east side attained lower deflections, which was expected because of the asymmetry of the specimen loading in the longitudinal direction, i.e. east-west direction. Another interpretation for this observation is that the field connection is not transferring the full applied loads between the two sides of the slab as there was discontinuity in the reinforcement between both the two sides. Moreover, this difference in deflections increased with the increase of the applied load due to the influence of the reduction in stiffness of the slabs after the propagation of excessive cracking. This is consistent with results from a previous finite element study (NCHRP 10-71, 2011) which showed that the shear and moment forces on the field joint are greatly reduced due to the stiffness reduction accompanied with cracking of the specimen.

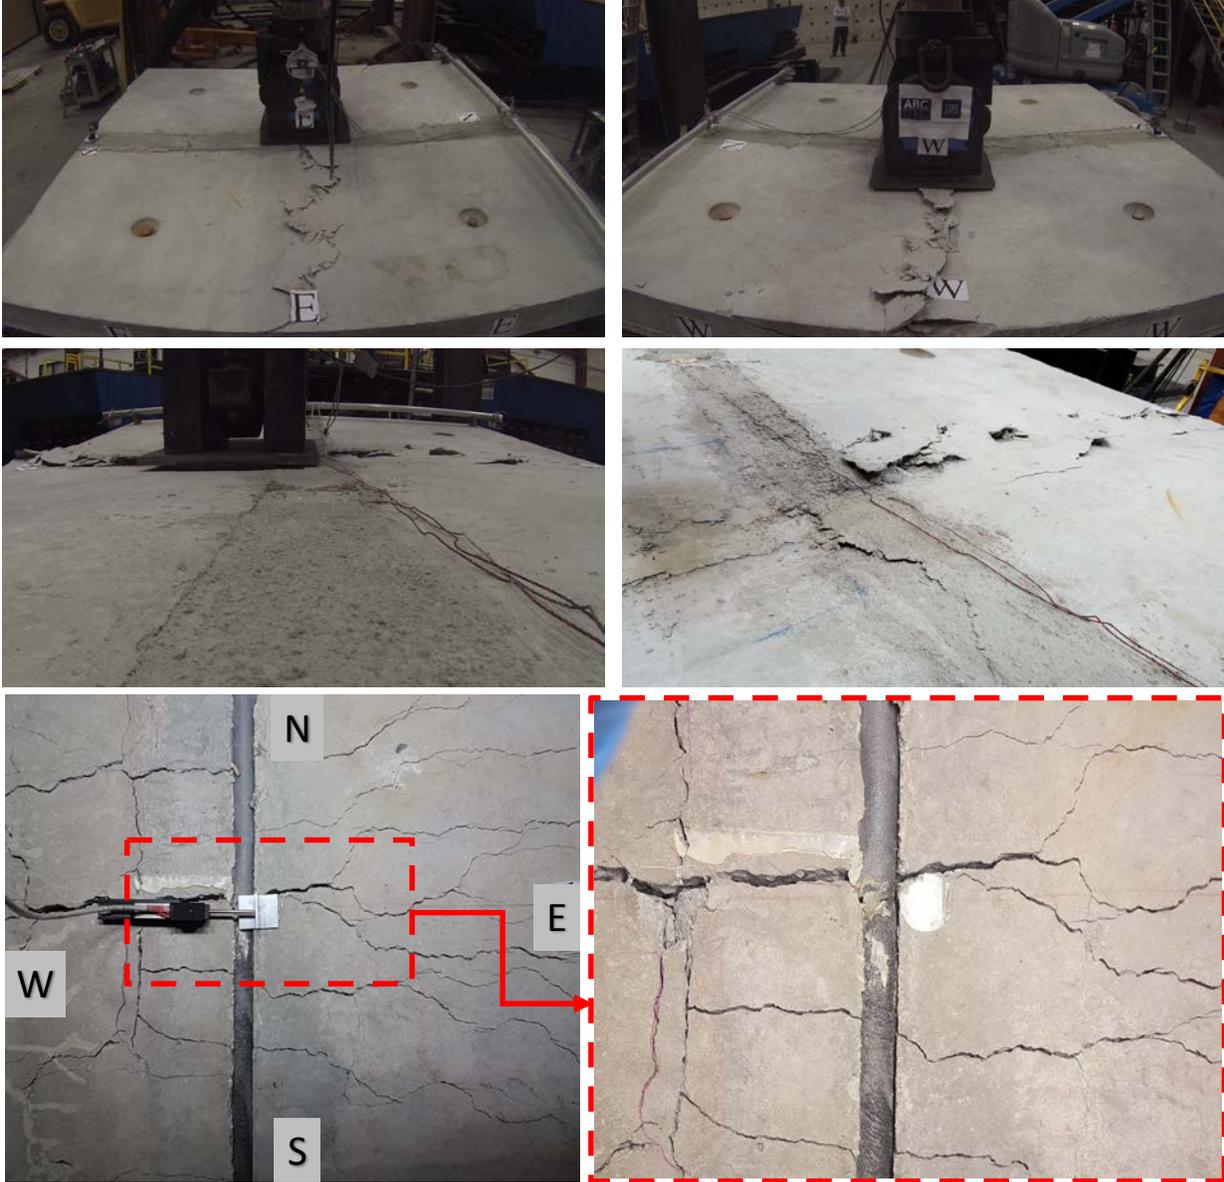
**Fig. 17** – Crack pattern, damage, and mode of failure at the top and bottom sides of specimen SP3-T-L-PC.

The observed mode of failure for the PMMA-PC transverse specimen with loop splice was yielding in the main reinforcement due to flexure accompanied with crushing of the concrete at

the top part of the slab towards the loaded side of the specimen. After reaching the maximum load there was crushing of concrete in the west side of the slab. Afterwards, crushing started to propagate across the span in the east and west sides includes significant crushing damage observed in the west side. Deep and wide flexural cracks was observed at the bottom face of the precast slabs, these cracks continued to propagate through the joint at the ultimate load. No interface cracking was observed at the top surface of the slab between the precast slab and the PMMA-PC connection at the ultimate load. After reaching the ultimate load, a series of drops in the force-displacement curve was indicated followed by excessive flexural cracking at the bottom and crushing of the conventional concrete at the top. The test was stopped for safety concerns after reaching approximately 80% of the ultimate load. The ultimate load of this specimen was recorded to be 122.5 kips at 2.63 mid-span vertical displacement. Figure 17 shows an overview of the crack pattern at the bottom face of the test specimen during the test under the ultimate applied load.

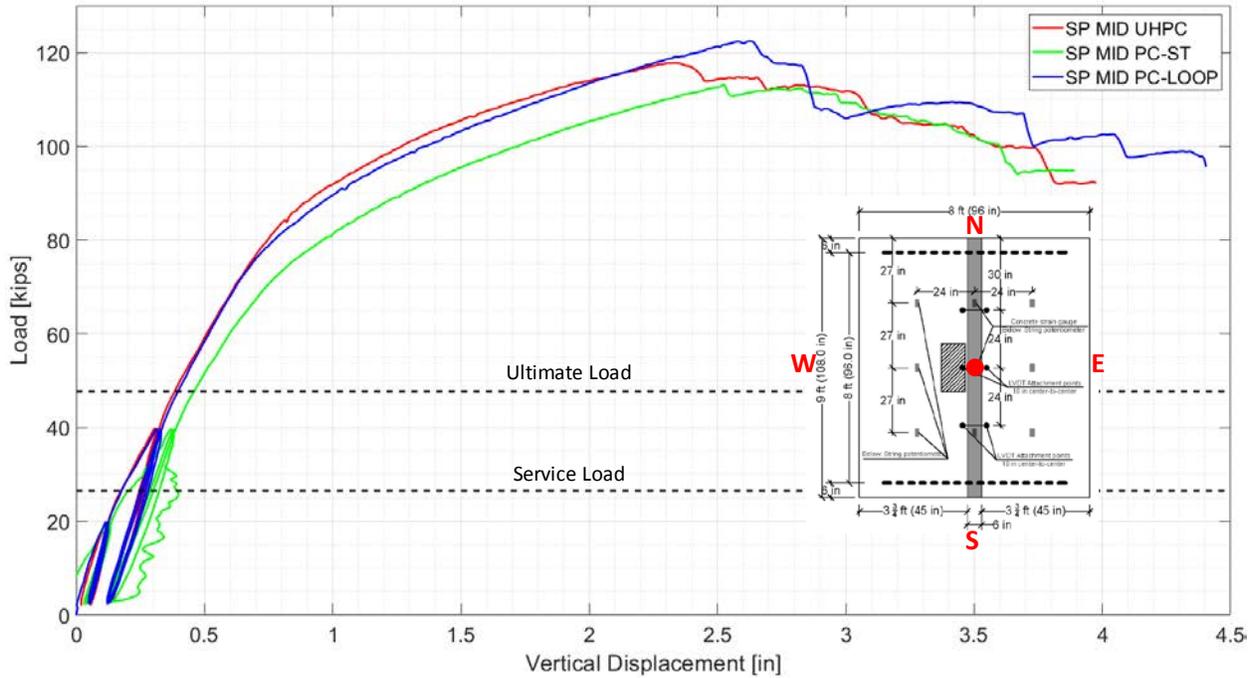
**Fig. 18** – Load-deflection relationship at mid-span of the three transverse specimens.

The overall load versus the mid-span vertical displacement obtained from the middle string potentiometers for the three transverse specimens are presented in Figure 18.

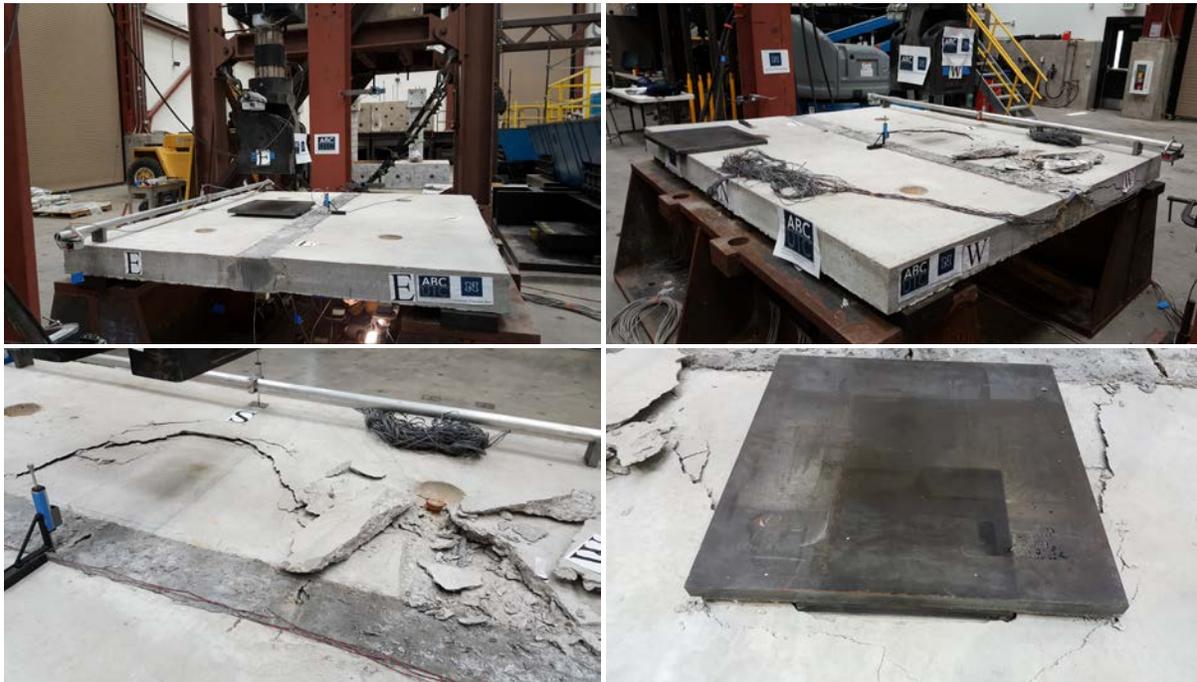
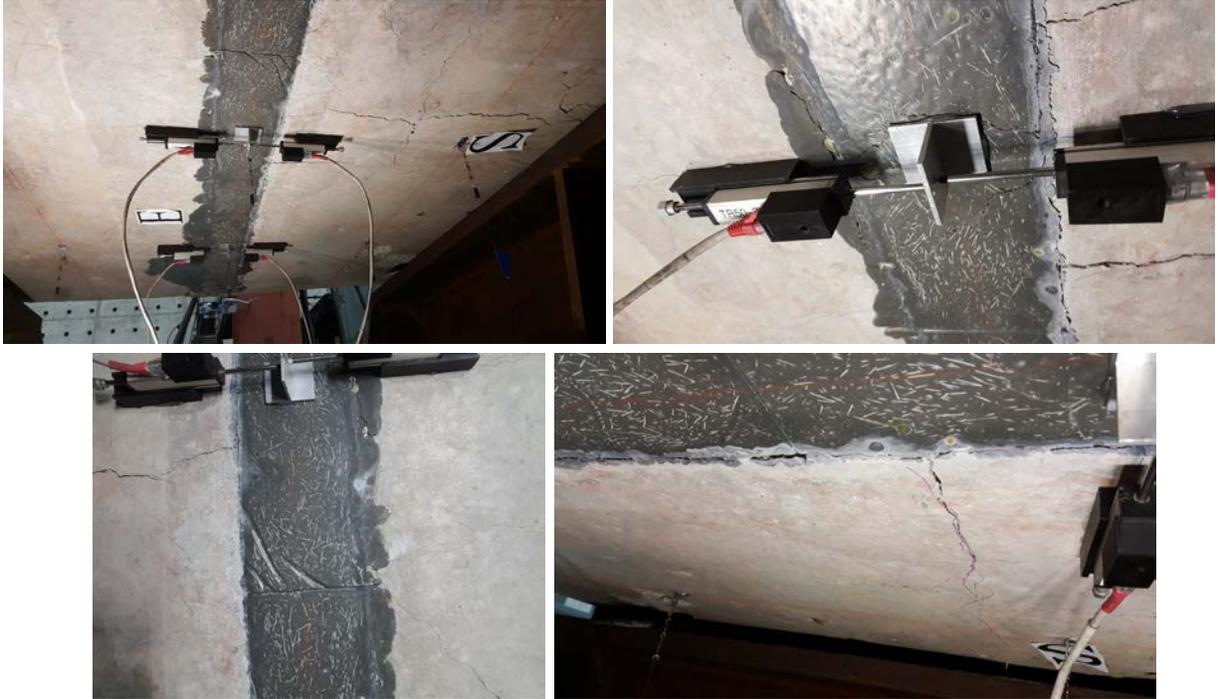
**Fig. 19** – Crack pattern, damage, and mode of failure at the top and bottom sides of specimen SP4-L-S-UHPC.

The measured peak load of specimen “SP4-L-S-UHPC” was 115.8 kips at 1.51 in mid-span vertical displacement. The overall damage and final status of the SP4-L-S-UHPC specimen after testing is shown in Figure 19.
