**More Choices for Connecting Prefabricated Bridge Elements and  
Systems (PBES)**

**Quarterly Progress Report  
For the period ending August 31, 2019**

**Department of Civil and Environmental Engineering  
University of Nevada, Reno**

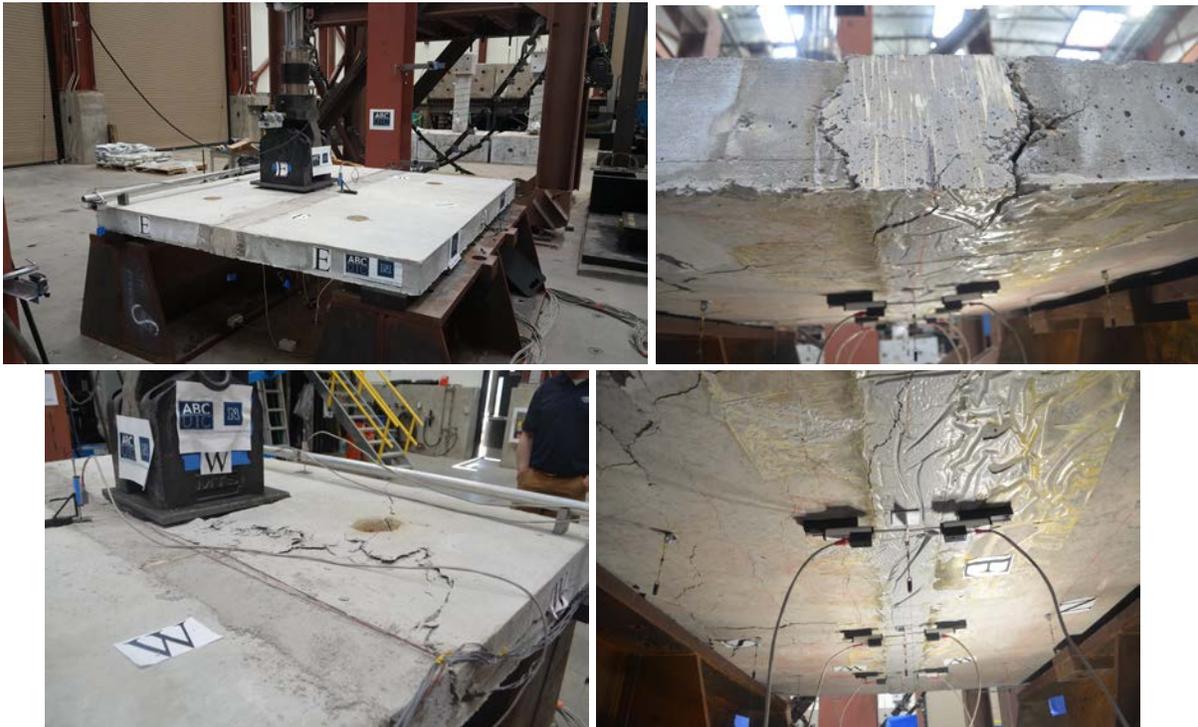
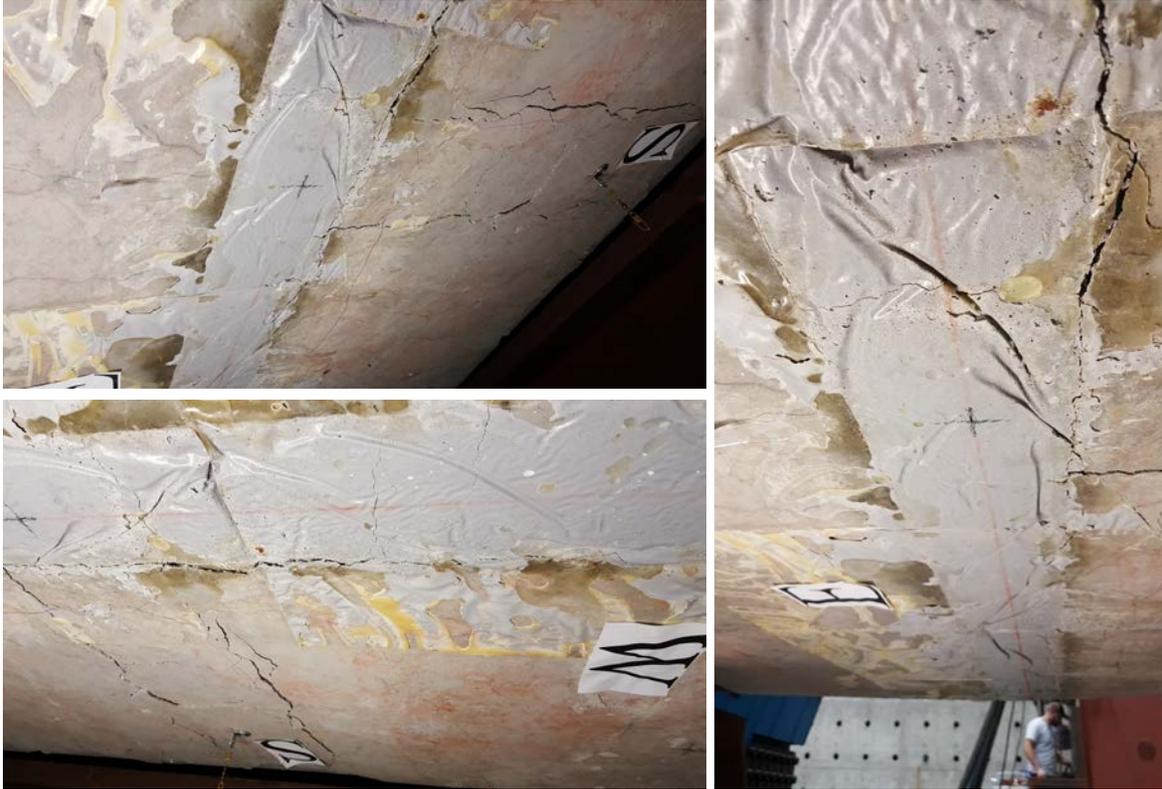
**Fig. 20** – Crack pattern, damage, and mode of failure at the top and bottom sides of specimen SP5-L-S-PC.

The measured peak load of specimen “SP5-L-S-PC” was 98.2 kips at 1.41 in mid-span vertical displacement. The overall damage and final status of the SP5-L-S-PC specimen after testing is shown in Figure 20.

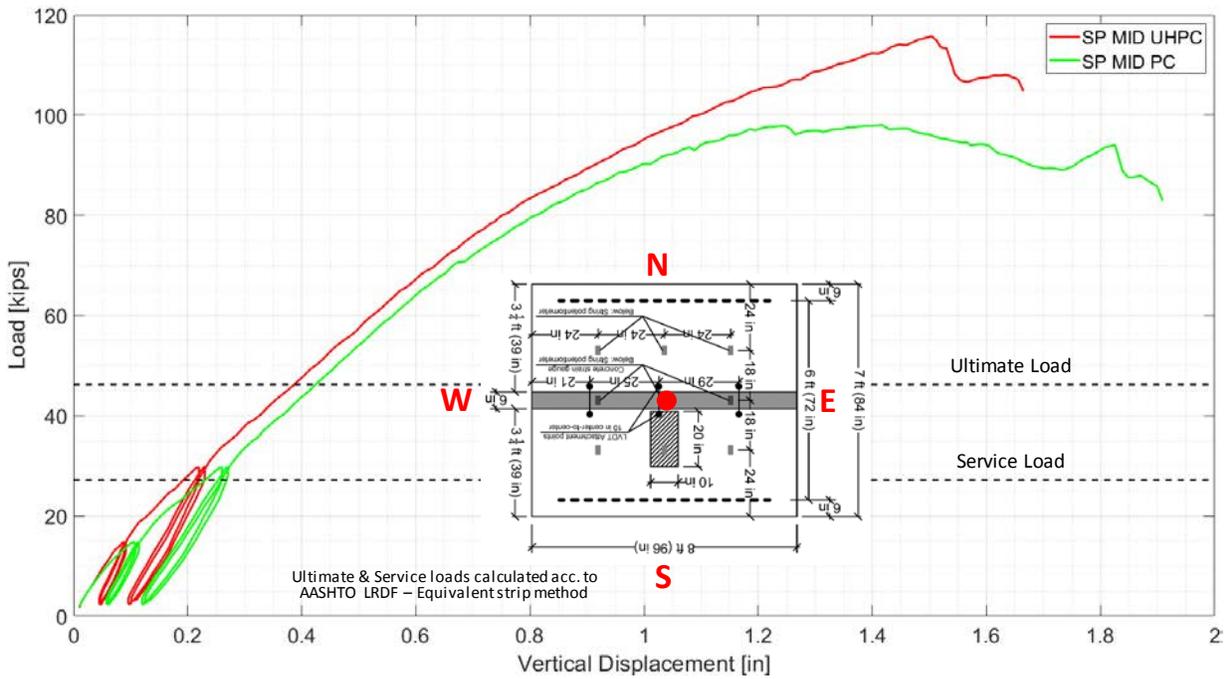
**Fig. 21** – Load-deflection relationship at mid-span of the two longitudinal specimens.

The overall load versus the mid-span vertical displacement obtained from the middle string potentiometers for the two longitudinal specimens are presented in Figure 21.
