# UTILIZING ABC TECHNIQUES FOR AN EMERGENCY BRIDGE REPAIR ON THE GARDEN STATE PARKWAY

Bridge No. 112.1NO is a three-span, simply supported, multi-stringer structure that carries the Garden State Parkway (Parkway) northbound outer roadway over Middletown-Lincroft Road. A backhoe carried on a flatbed trailer impacted the 36-foot long center span superstructure in November 2017, causing irreparable deformation of the east fascia and first interior stringers and damaging the adjacent diaphragms as shown in Figure 1. Following the temporary stabilization of the bridge by the on-call emergency services contractor, HNTB and the New Jersey Turnpike Authority (Authority) adapted Accelerated Bridge Construction (ABC) methods to rapidly replace the damaged superstructure in a single weekend.

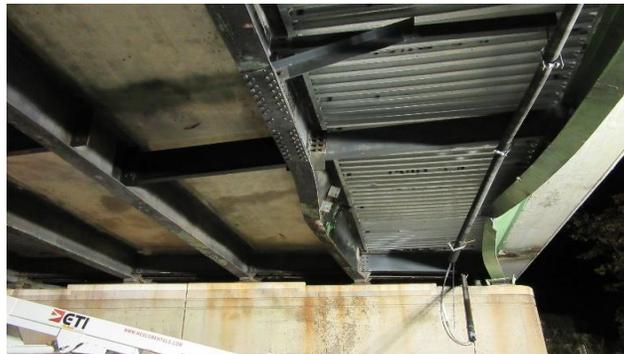
Figure 1: Stringer Impact Damage

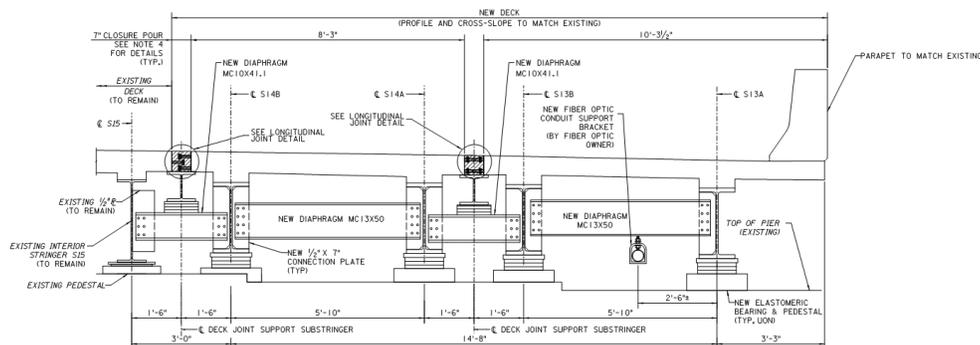
The Parkway is one of the busiest toll roads in the country and conventional construction methods using long-term duration lane closures for the permanent work would significantly disrupt traffic. An ABC solution was selected to minimize interruption. The ABC work activities were scheduled in a 67-hour high intensity construction cycle (HICC) from 10 am Friday to 5 am the following Monday and required closure of two of three lanes on the Parkway outer roadway in addition to the underpassing local roadway. Due to the roadway's high traffic volume, the HICC was scheduled for April 2018 during a limited weekend timeframe to avoid the peak travel season summer shore traffic. Two prefabricated bridge units (PBUs), each comprised of two steel stringers and a reinforced concrete deck, were proposed to replace the damaged members as shown in Figure 2.

Figure 2: Proposed PBU Replacement Cross-Section

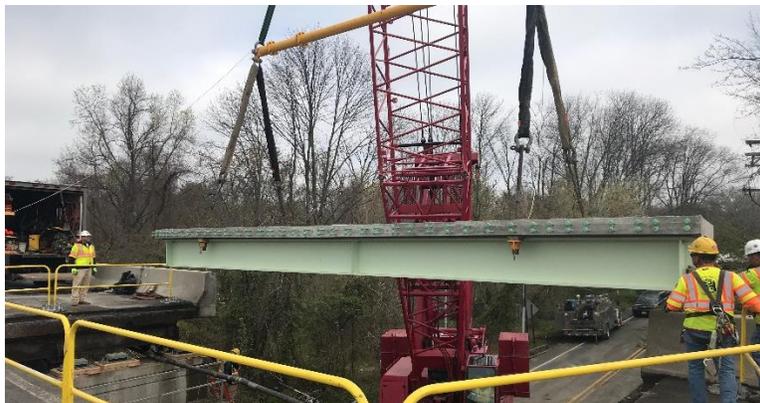
- Partial demolition of existing deck, stringers, bearings, and parapet and removal of debris
- Preparation of pier seats and installation of remaining bearings
- Installation of PBUs, sub-stringers, and intermediate diaphragms (See Figure 3)
- Installation of grout in longitudinal closure pour joints (See Figure 4), membrane waterproofing, and asphalt wearing surface

*Figure 3: PBU Erection*

The PBUs were limited in width to control weight and provide the contractor with greater flexibility for crane size and placement during erection. The parapet was constructed in place to reduce the fascia unit pick weight, improve handling during erection, and ensure accurate geometric tie in with the existing parapet in adjacent spans. Sub-stringers were installed beneath the longitudinal joints to act as a closure pour form, provide additional support for the grout, and alleviate potential future grout cracking.

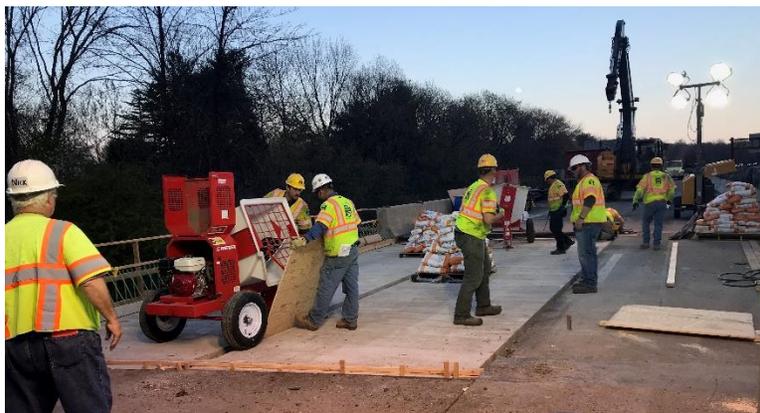
*Figure 4: PBU Longitudinal Closure Pour Grouting*
