REPLACEMENT OF THE MBTA FRANKLIN LINE OVER EAST STREET WESTWOOD, MA

ABSTRACT

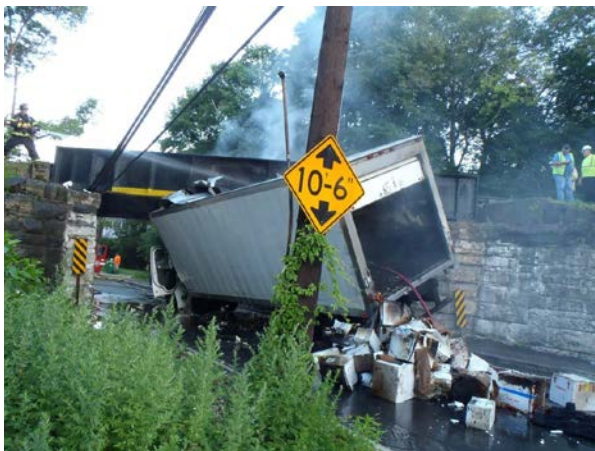
Photo #1: A fireman puts out the fire when an over height truck struck the East Street Bridge

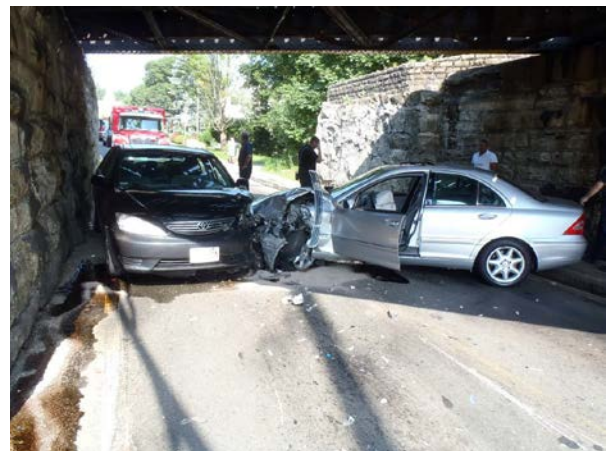
Photo #2: Two cars collide under the East Street Bridge

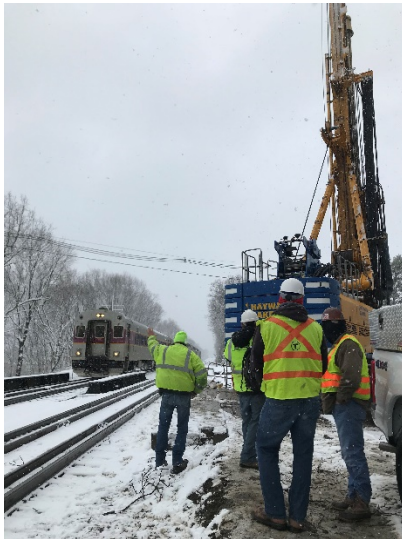
Photo #3: Both tracks active

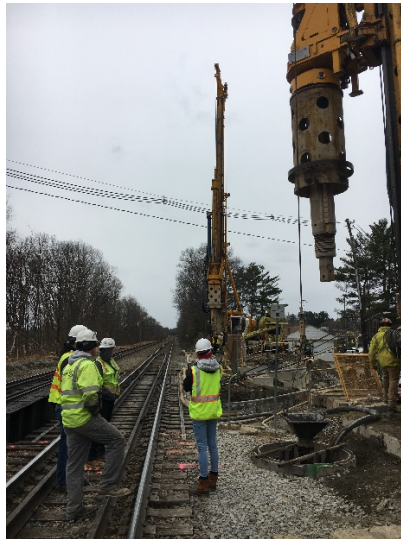
Photo #4: Single track shutdown

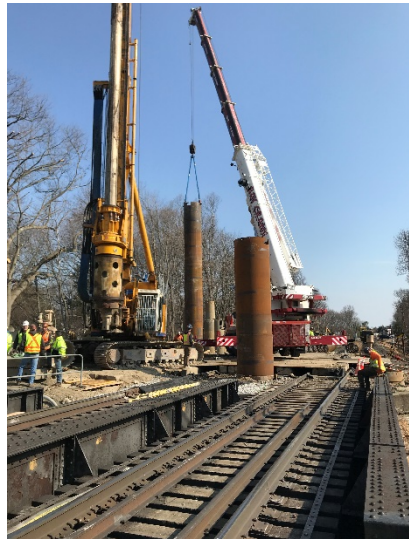
Photo #5: Both tracks shutdown

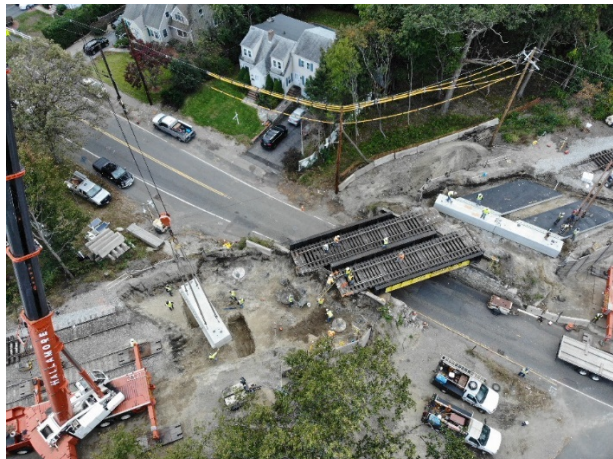
Photo #6: Drone view of substructure installation

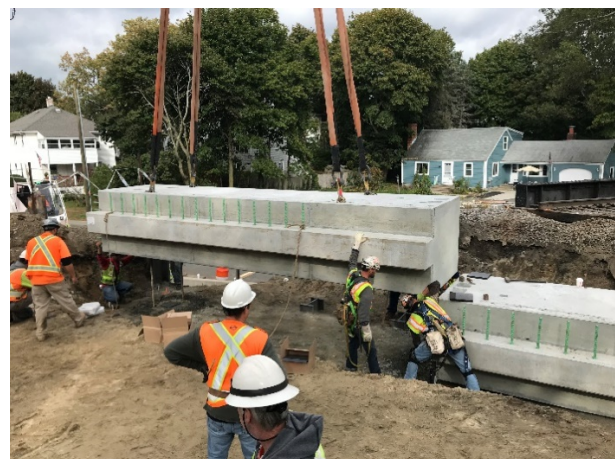
Photo #7: A precast cap is lifted into place on the drilled shaft foundation

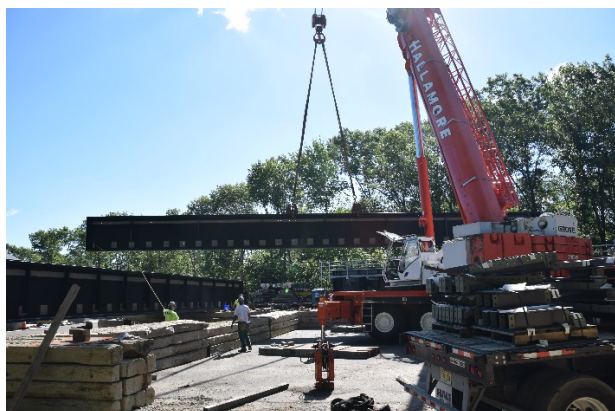
Photo #8: A girder is lifted into place in the MassDOT yard off site

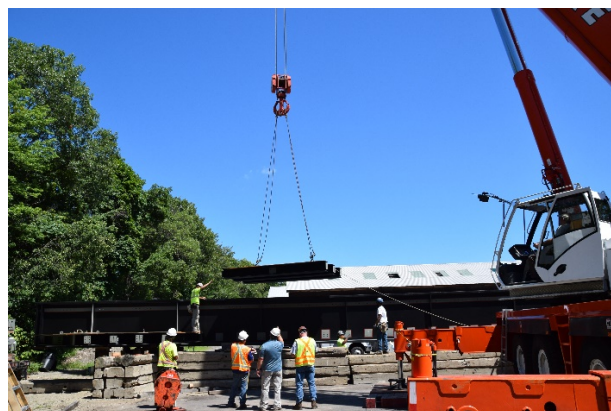
Photo #9: A floorbeam and deck plate section is lifted into place with the braced girder

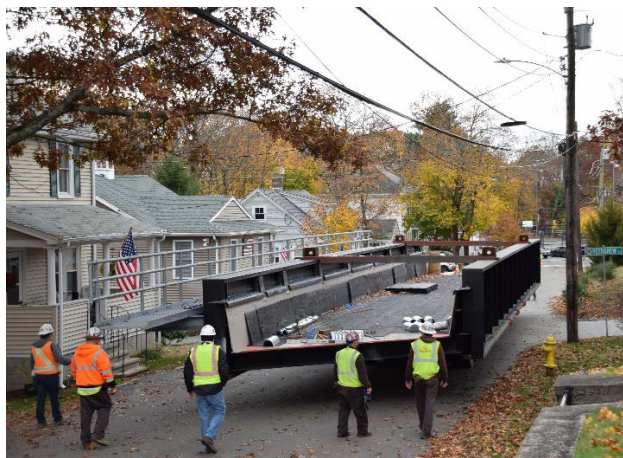
Photo #10: The project team 'walks' a bridge through the local neighborhood on SPMTs

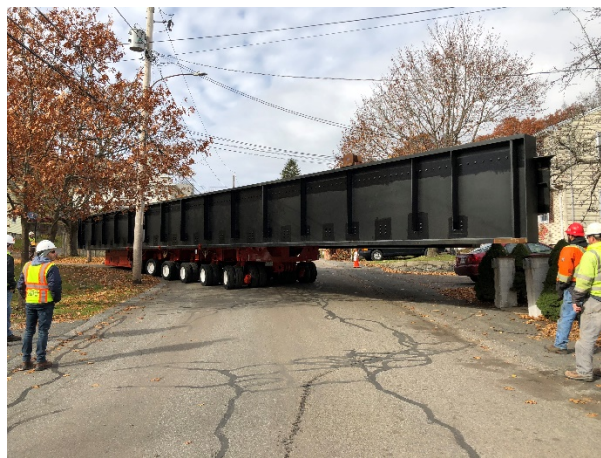
Photo #11: The SPMTs maneuver around a tight corner on the way to the bridge site

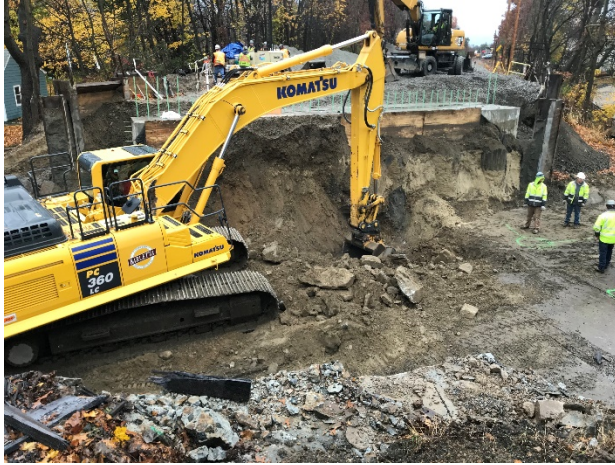
Photo #12: Existing abutment demolition

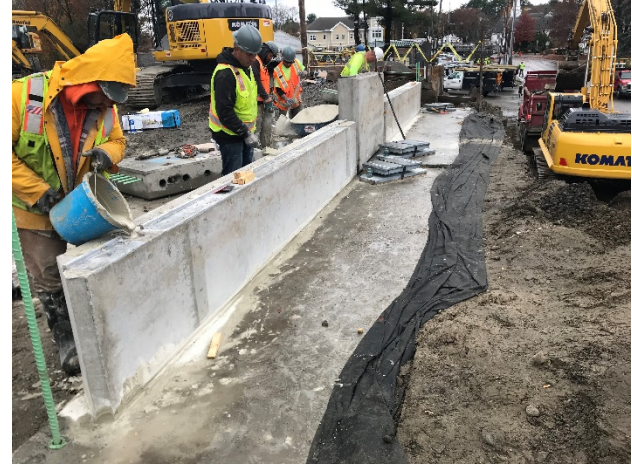
Photo #13: Precast backwall and bearing installation

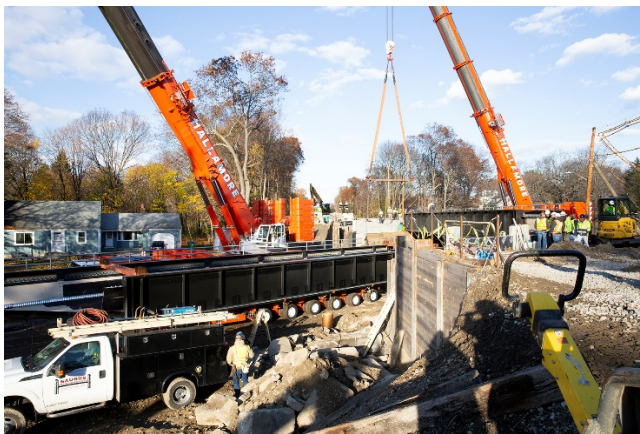
Photo #14: Bridge superstructure erection

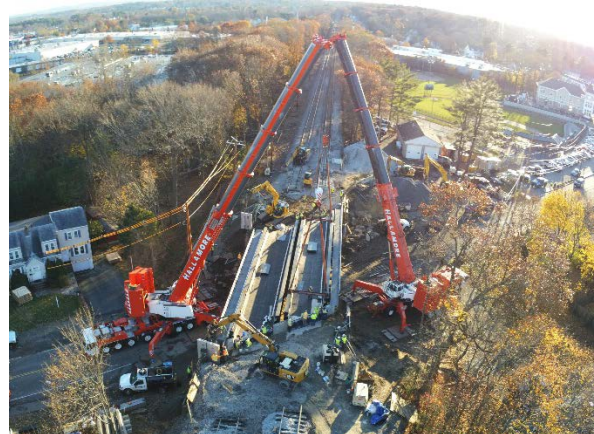
Photo #15: Drone view of superstructure erection

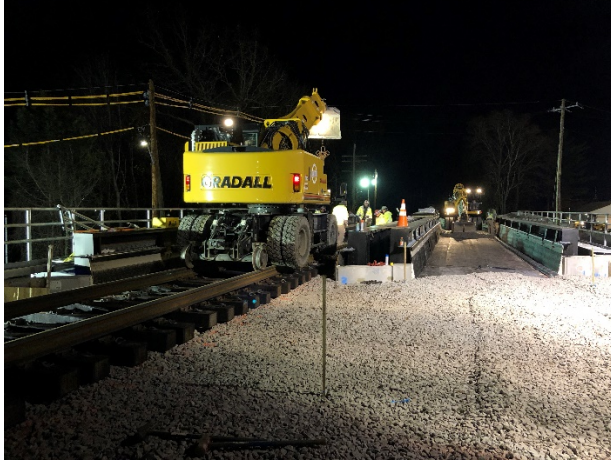
Photo #15: Final track work on bridge

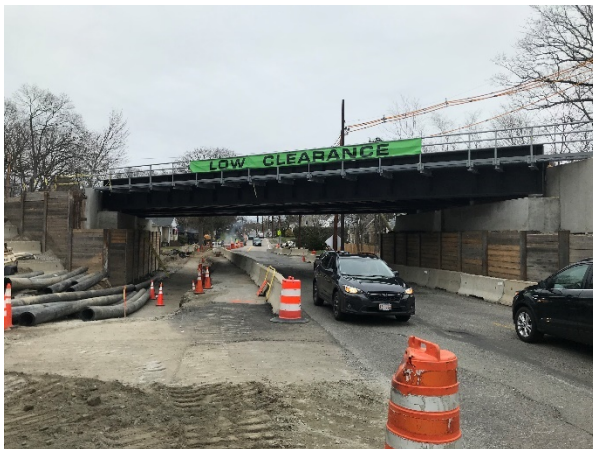
Photo #17: Final utility and roadway work around active traffic

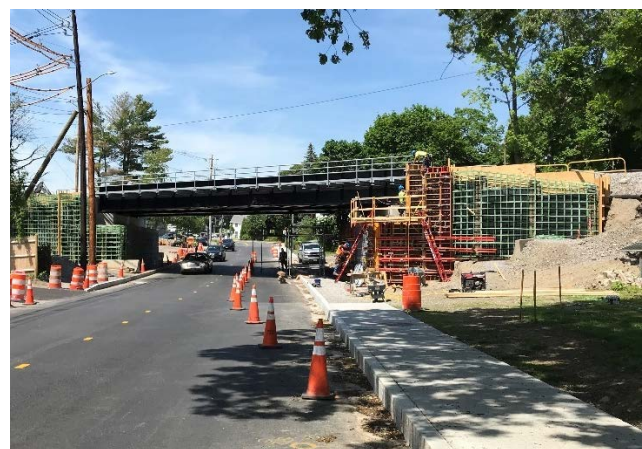
Photo #18: Installation of C.I.P. concrete facing on the soldier pile and lagging walls
