USING EXISTING AND NEW INNOVATIVE METHODS TO ACCELERATE REHABILITATION OF FOUR I-89 BRIDGES

Scott Burbank, PE, VHB, (802) 497-6157, sburbank@vhb.com
John Whittaker, Kubricky Construction Corp., (518) 792-5864, jwhittaker@dacollins.com

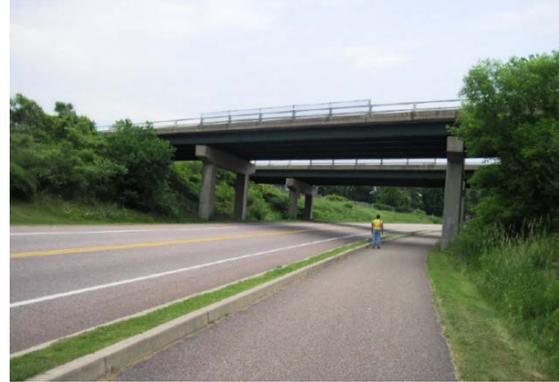
Figure 3 - Bridge 76S Looking East

Bay Road is a local road that connects the Colchester Bay Area with US Route 2/7. There is a private campground immediately adjacent to I-89 on the northwest corner of Bridge 76S. In addition to vehicular traffic, Bay Road has a shared-use path on its south side that goes under the bridges (see Figure 3) and connects neighborhoods in the Colchester Bay area with those in Colchester Center. The shared-use path is also part of the Champlain Bike Way, which goes along state and local roads along Lake Champlain from southern Vermont to the Vermont/Canadian border. In addition to a local vehicular detour, a bike detour was required when Bay Road was closed for construction on Bridges 76N&S.

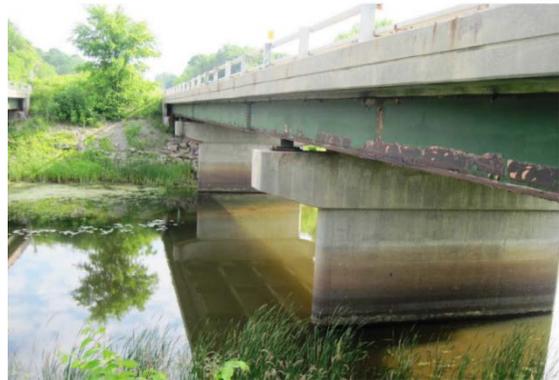
Figure 4 - Bridge 77N Looking North

Mallets Creek is an environmentally sensitive area with wetlands at the edges of the channel (see Figure 4) and a fish-breeding habitat. Due to its proximity to Lake Champlain, additional Vermont state permitting was required for the installation of a causeway to allow for the placement of cranes between and near the ends of the bridges during construction.

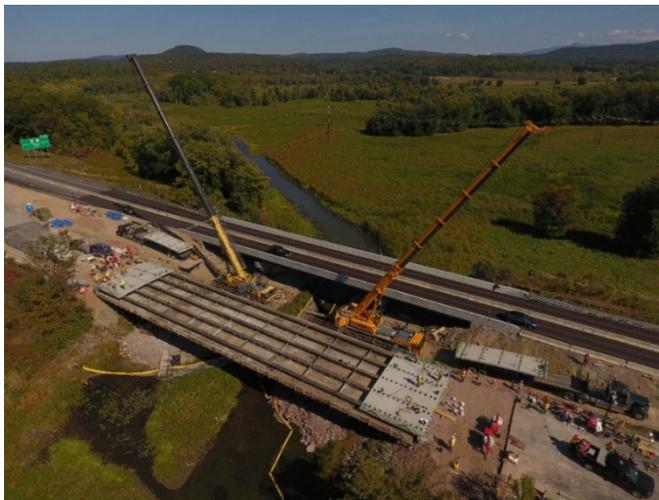
Figure 7- Erecting Precast Concrete Deck Panels on Bridge 77S

ready to be set (see Figure 7). This installation process worked from each end of the bridge; the first deck panel at each end became the anchor for the other deck panels when the precast concrete deck panels were jacked. Plastic shims were set in place on each beam at both joint locations to hold the deck panel at the correct elevation, which allowed the 1" foam to compress 1/4 of an inch to create the required seal for the haunches. Once they were set and determined to be in alignment, restraints were welded in place to hold the deck panels in alignment and hold them down when the deck panels were jacked. These restraints allow the deck panels to be jacked at a grout strength of 3500 psi, which was much less than the grout

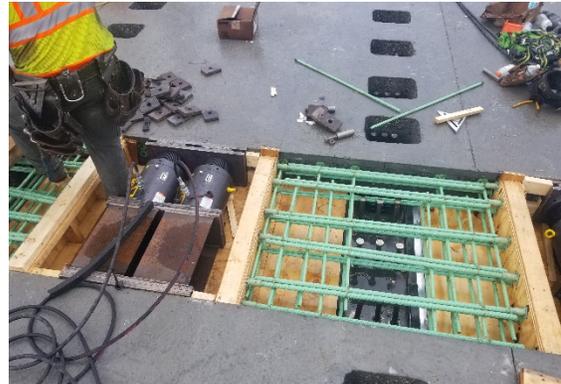
Figure 8 - Precast Conc. Deck Panels Closure Pour with Jacking and Reinforcing Installed (Bridges 77N&S)

Once all the precast concrete deck panels were set in place, an approximate 3'-6" closure pour was left remaining in the center of the bridge. Formwork was installed from under the deck panels using coil rod threaded into inserts that were cast into the precast concrete deck panels. This also created a location to set the hydraulic jacks in place to jack the deck panels and place them in compression. The deck panels were jacked once the specified grout strength (3500 psi) was reached in the end deck panel's shear pockets. Once the deck panels were jacked, reinforcing was installed in the closure pour between the jacks and Rapid Set High Performance Concrete (HPC) was placed between the jacks to keep the compression force locked into the deck panels (see Figure 8).

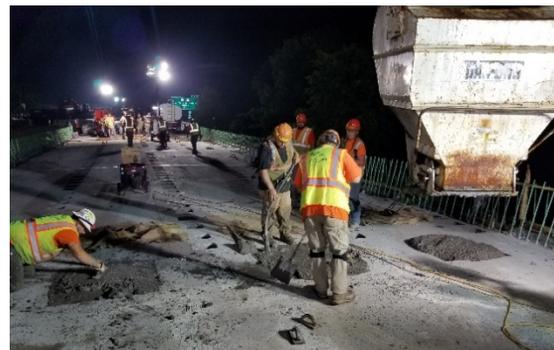
Figure 10 - Placement of Rapid Set HPC at Closure Pour after Removal of Jacks

The innovative nature of the construction method and the Vermont location made it difficult to get the materials approved through the VTrans approval process. For example, Rapid Set HPC concrete (Figure 10) drove the critical path in multiple instances throughout the closures. The project required a mix design that would reach 85% of its capacity in six hours and provide enough working time to properly install the product on site. The product still needed to meet the 5000-psi strength requirement,
