ABC-UTC GUIDE FOR:

SELECTION OF NDT METHODS APPLICABLE TO HEALTH MONITORING OF ABC CLOSURE JOINTS

March 2019

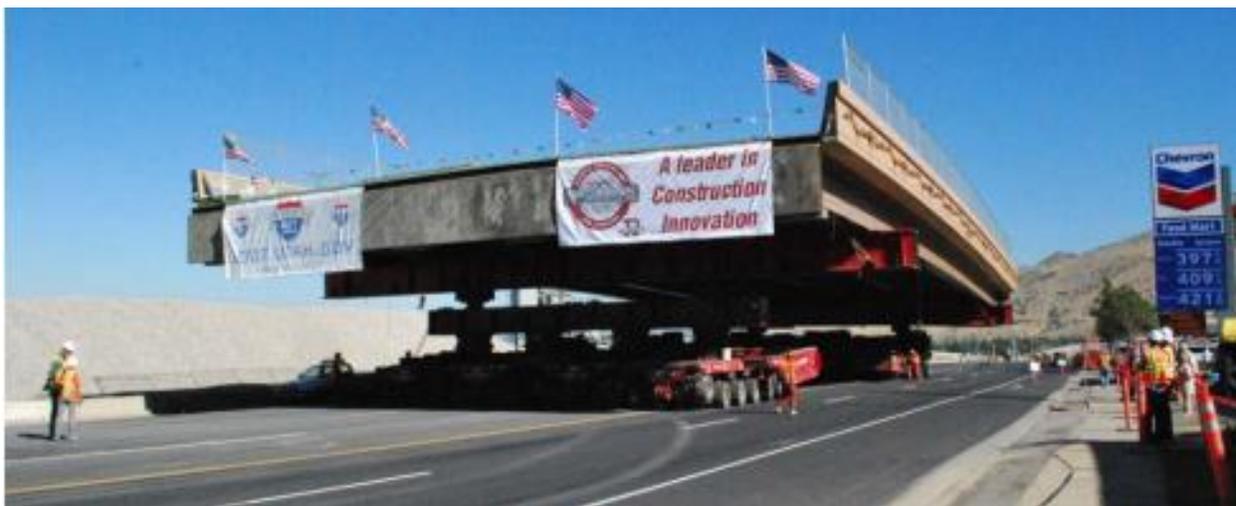
Figure 2: ABC superstructure positioning; bridges in Utah [4]

Owing to these advantages, application of ABC methods is growing across the US (Fig. 2).

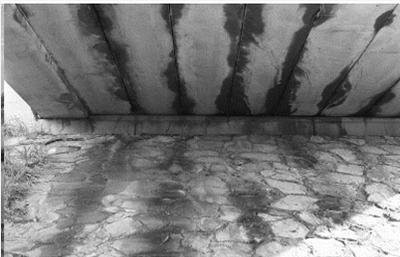
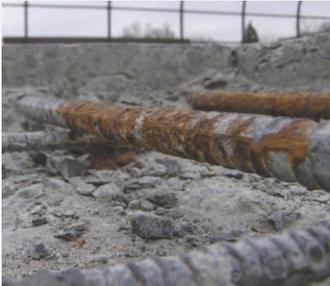
<p>Surface Discontinuities [23]</p>	<p>Corrosion of Reinforcing Bars [16]</p>	<p>Spalls [16]</p>

Table 7: Examples of defects and anomalies in bridge superstructure [15–23]

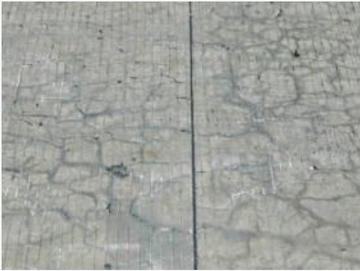
<p>Honeycombing [17]</p>	<p>Abnormal Appearance [16]</p>	<p>Leakage Through the Joints [19]</p>

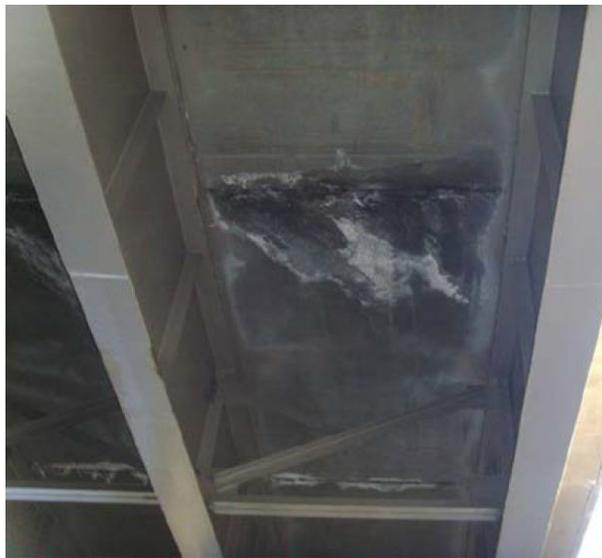
Figure 4: Typical joint leakage at deck panels (I-84 WB over Weber Canyon with welded-tie connections from 2009 inspection) [24]

Workmanship issues are commonly mentioned as potential cause for typical anomalies in ABC deck joints. As an example, honeycombing and voids are two typical defects in concrete structures which can be caused by improper mix design, and substandard concrete mixing, placing and curing process. One of the most detailed investigation on the evaluation of performance of ABC closure joints has been performed by Utah Department of Transportation (UDOT). In their investigations, shrinkage cracks in blockouts have been reported after construction pointing to selection of an improper concrete mix as the major cause [22]. Their report also mentioned bleeding of the excess water in concrete that contributed to increase in shrinkage (Figure 4). In another case, shrinkage crack in several blockouts were observed and selection of wrong construction materials was blamed as the major cause of the defect (Figure 5). Such causes are considered as mix design and workmanship issues in the etiology of defects in bridge closure joints summarized later in the Damage Sequence Tree (DST). Welded tie connections have been reported by the Utah department of transportation [24] to have performed the worst among others. Leakage and efflorescence was observed for this type of connection (Figure 4).

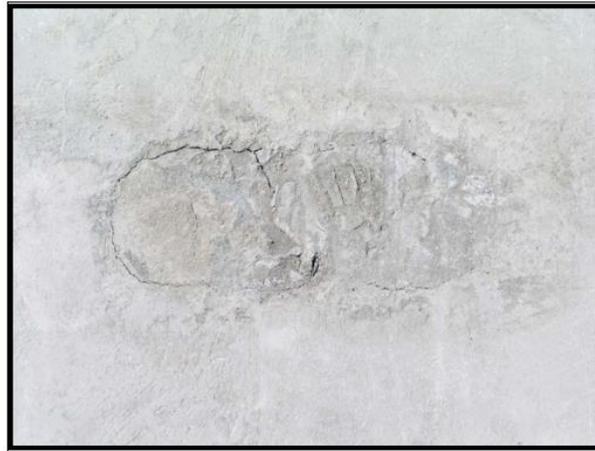
Figure 5: Shrinkage crack in the blockout type of ABC closure joint [22]

Other investigations have been conducted for evaluation of different types of cracks in closure joints. Reflective cracking is a type of crack that initiate from sharp corners and cold joints inside the deck, because of stress concentration and/or shrinkage, and finds its way to the surface through

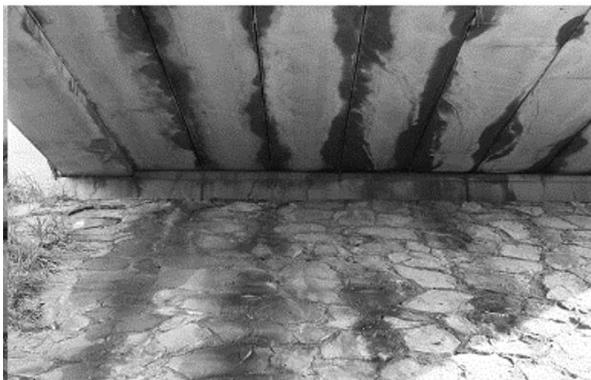
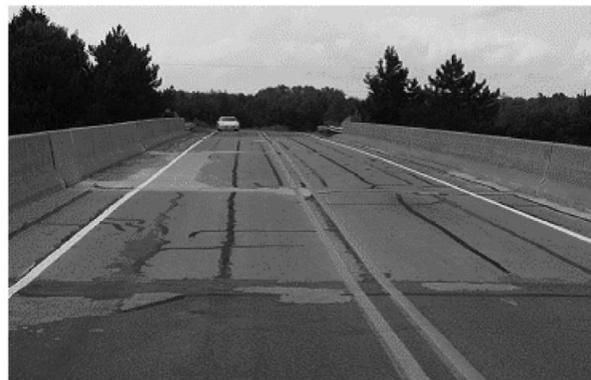
Figure 6: Longitude deck cracking of ABC closure joint [23]

wearing surface or other upper layers. Longitudinal cracking along linear joints is another type of damage which in turn causes leakage issues for closure joints (Figure 6).

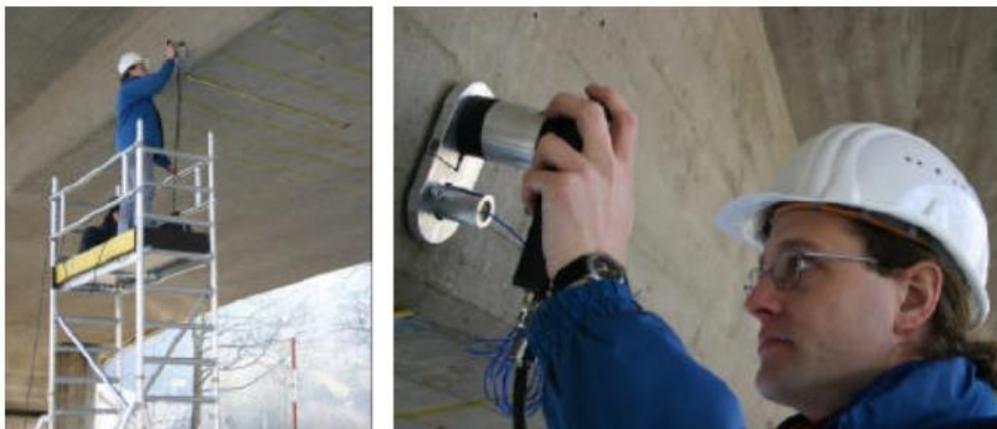
Figure 12: Void detection at bridge concrete by using IE method [44]

As shown in Fig. 12, for IE, the surface of element is impacted by a steel ball or small impulse hammer [34]. The energy of reflected wave is recorded using an accelerometer receiver which is mounted on the surface near the impact location [42]. In IE method, evaluation process is associated with a relatively sparse grid, and lane closure. This method also has some limitations for crack detection for elements in which there is a gap between the overlay and deck [16]. The ability of IE for void detection in reinforced-concrete is somehow limited because of the interfering effect of steel embedment in distribution and reflection of the waves [42]. IE has been used for void detection for the concrete in a bridge structure [44]. For crack detection, IE has high level of accuracy, repeatability of measurements, and speed of data collecting and analyzing. However, the cost of testing and the ease of use rate is graded in moderate level by Gucunski et al. [16].

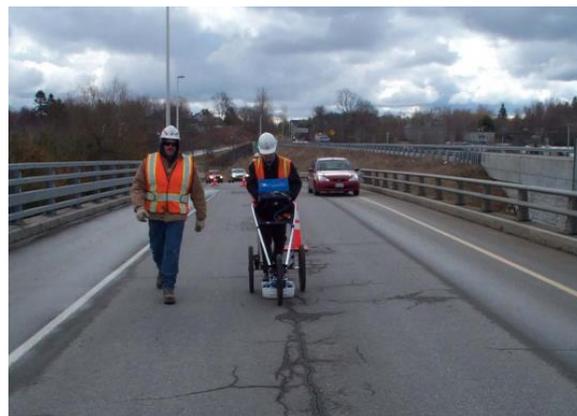
Figure 13: An example of GPR Testing [47]

As it was mentioned earlier, Ground Penetrating Radar Testing (GPR) or Impulse Radar Testing (IRT) is one of the most applicable methods among Microwave Testing (MW) methods. The most common use for GPR is for locating reinforcing bars and other inclusions in reinforced concrete structures, and it is often used in combination with other NDT methods. However, GPR is also applicable to bridge decks and other bridge elements for detecting damage, delamination, cracks and voids by exploring the propagation model of electromagnetic waves which are sent through the deck via antenna, and received from internal reflectors (Fig. 13) [34], [37], [38], [42], [46], [47]. In other words, internal defects are identified with moderate accuracy by analyzing and interpretation of the reflected pulses [42]. GPR was employed by Huston at el. [48] for monitoring concrete bridge deck, and introduced as a reliable NDT method which is applicable with and without asphalt overlays owing to its relative insensitivity to ambient conditions. Various types of damages to the asphalt layer used as wearing surface for concrete bridge decks such as rutting and fracture has been, experimentally and theoretically, studied by researchers. Based on concrete cover, the effective depth of GPR is varied. For instance, penetrating depth will be around 24 in. for high frequency in the range of ~ 500 – 3000 MHz [42]. Higher cost of this method as compared to other methods is one of the drawbacks of this method [34]. Different aspects of using GPR technique is experimentally analyzed by Gucunski et al.[16] in detection of delamination. They considered GPR as a good method for its speed of data collecting and analyzing. They also placed GPR technique in the group of low level for its accuracy and the ease of use rate. The repeatability of measurements with GPR testing is graded moderate for this method. It is important to mention that GPR is preferred method for detection of presence and location of steel reinforcement and embedment. For this, several other NDT methods rely on GPR for locating reinforcing bars. This makes GPR a candidate for NDT methods applicable to closure joints.

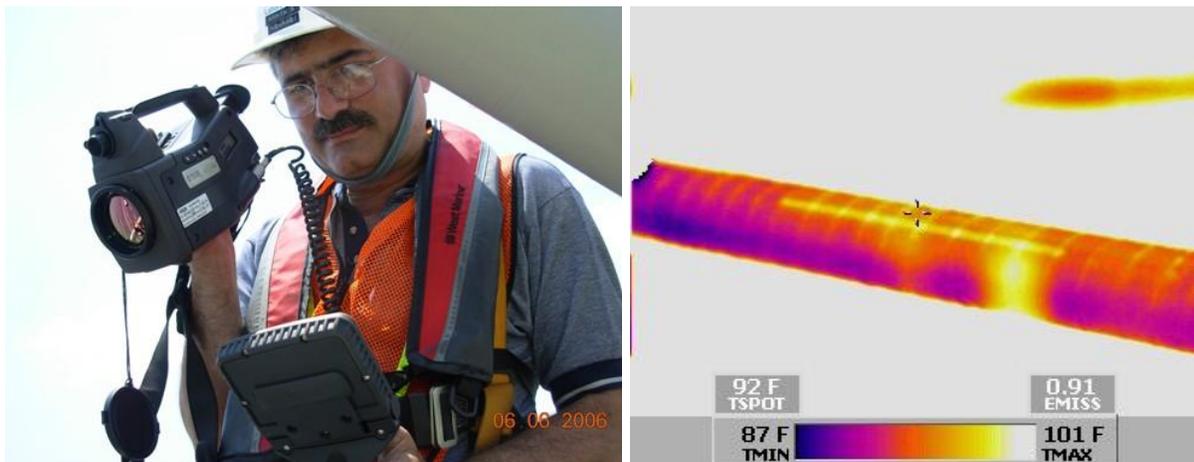
Figure 19: Infrared Thermal Imaging; Use of IRT camera (left) and a thermal image (right) [61]

ambient heat or cold can be used for testing. Testing immediately after sunrise, right after sunset, or wetting of the surfaces can produce effective results with minimal efforts. Nondestructive evaluation of the health monitoring of cable-stayed bridges using Infrared thermography testing by Mehrabi (Fig. 19) [61].

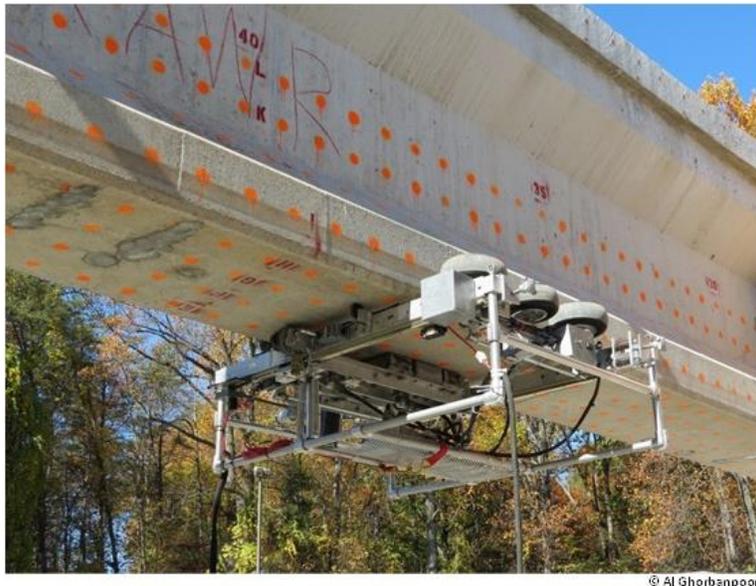
Figure 24: The Magnetic Flux Leakage testing for Bridge inspection (Courtesy of Ali Ghorbanpoor)

MFL technique is not often used as an independent method because of its size limitations. MFL has been used successfully for detection of steel defects in stay cables and post-tensioning tendons [61]. This method may be applicable to damage detection in tendons with both non-metal and metal ducts [42]. Like Radiography, the Magnetic Flux Leakage Testing requires extensive experience and training, and carries some safety concerns for its operation. Based on the condition, one or more magnetic sensors may be used in MFL testing. This type of nondestructive testing can be utilized by moving the set-up manually or mounted on a trolley or moving vehicle traveling the surface of the bridge element (Fig. 24) [70].
