2019 International Accelerated Bridge Construction Conference, including Automation, Service Life and Ultra High-Performance Concrete

Collection of Conference Papers/ Extended Abstracts

WSDOT Ferry Terminal at Colman Dock Pedestrian Bridge Utilizing Innovative Materials for Accelerated Bridge Erection

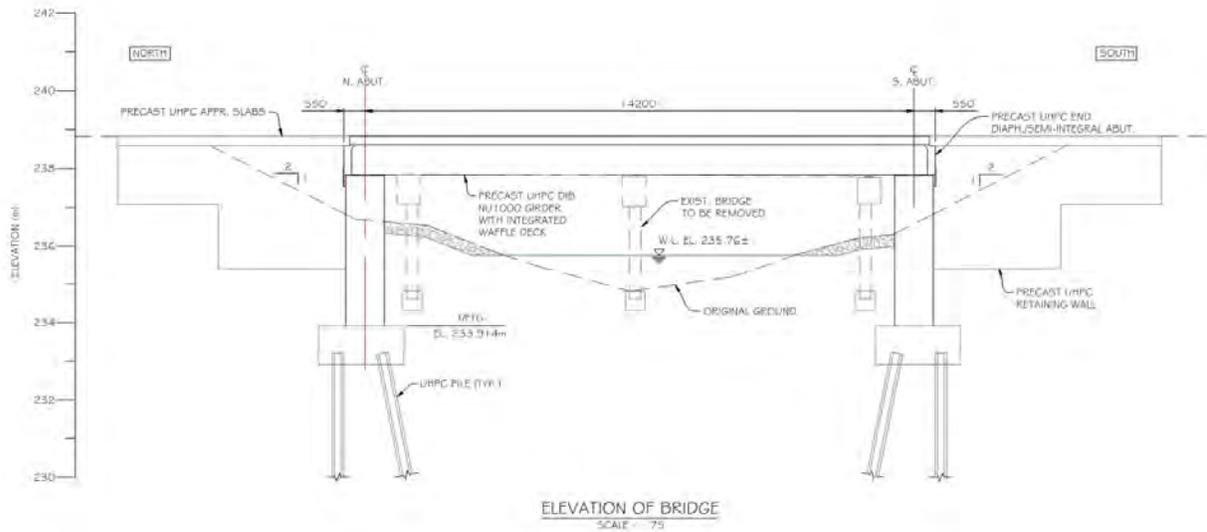
Figure 1. Proposed UHPC DIB Bridge Elevation

The proposed UHPC DIB vehicular bridge is a replacement for a deteriorating private timber structure in Shanty, Ontario with a posted load rating of 500 kN. The owner of the bridge has requested the new structure to be designed for the CL-625-ONT truck loading (625 kN total axle load) according to the Canadian Highway Bridge Design Code (CHBDC) (1). The new bridge will be a 15-m single span structure which eliminates the pier in the creek as in the existing bridge. Figure 1 shows the elevation of the proposed bridge and outline of the existing structure.

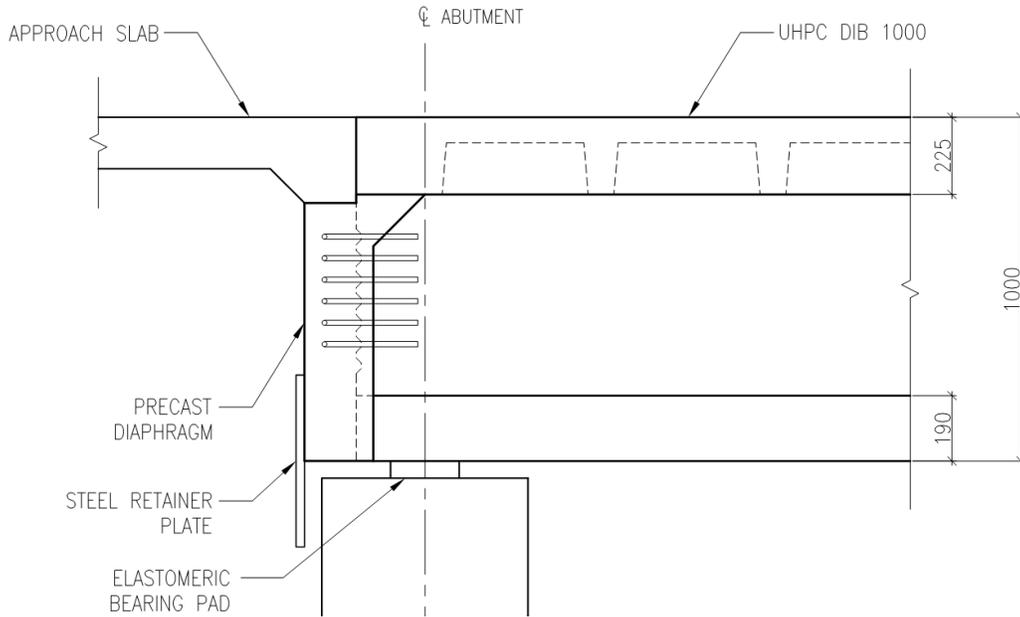
Figure 7. Abutment Detail (Typical reinforcement not shown for clarity)

In order to transfer the approach slab loads down into the bearings, the loads must be transferred from the diaphragm into the DIB. Smooth UHPC cold joints have very low interface shear capacity. Therefore, trapezoid deformations will be precast into the DIB at both ends of the beam using form liners. The trapezoidal sections will force a shear failure plane to pass through the UHPC engaging the high shear friction capacity of the fibers. Additionally, 6-15M (#5) steel reinforcement will be provided to ensure there is a clamping force between the two elements.

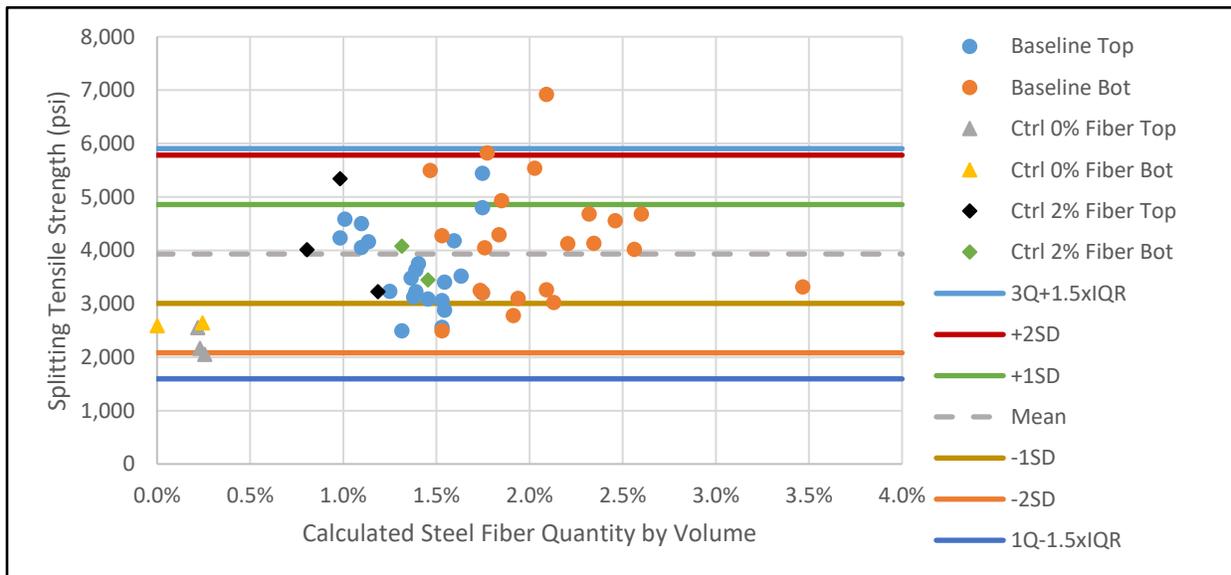
Figure 9. Calculated Steel Fiber Quantity by Volume vs. Splitting Tensile Strength Test Results of Baseline Samples

Each half-core and control sample was measured, weighed, and then subjected to a splitting tensile strength test. The measured splitting tensile strength of all of the half-cores and control samples greatly exceeded 725 psi (5 MPa), being nearly 3 times to nearly 10 times greater, including cores with cracks in them and including the control sample with no steel fiber. Furthermore, almost all test results were within two standard deviations of the mean with no extreme outliers (Figure 9).

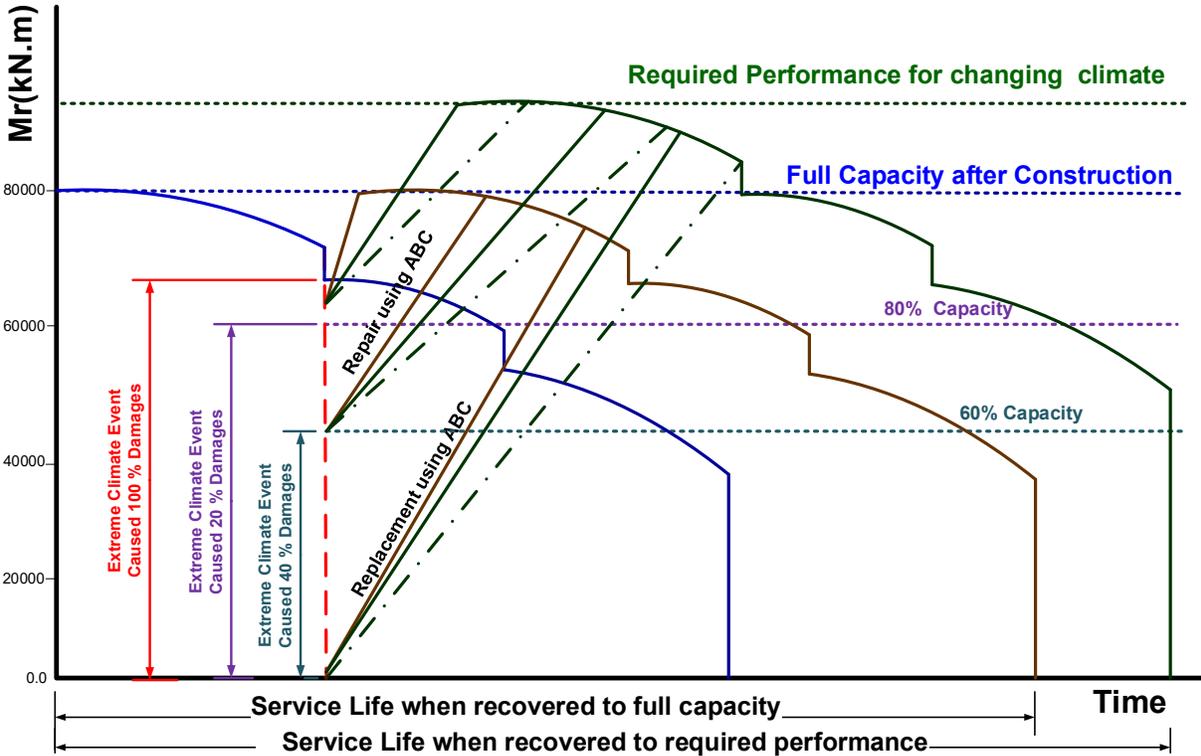
Figure 4 Frame bridge system resilience with ABC versus traditional rehabilitation for different damage levels due to extreme climate events

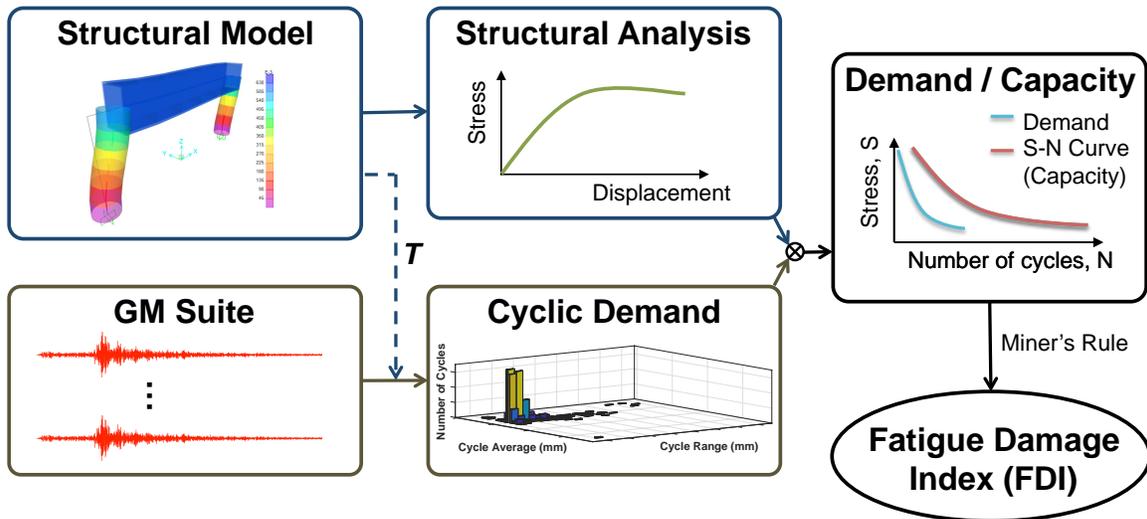
Figure 2: Framework for calculating the Fatigue Damage Index (FDI).

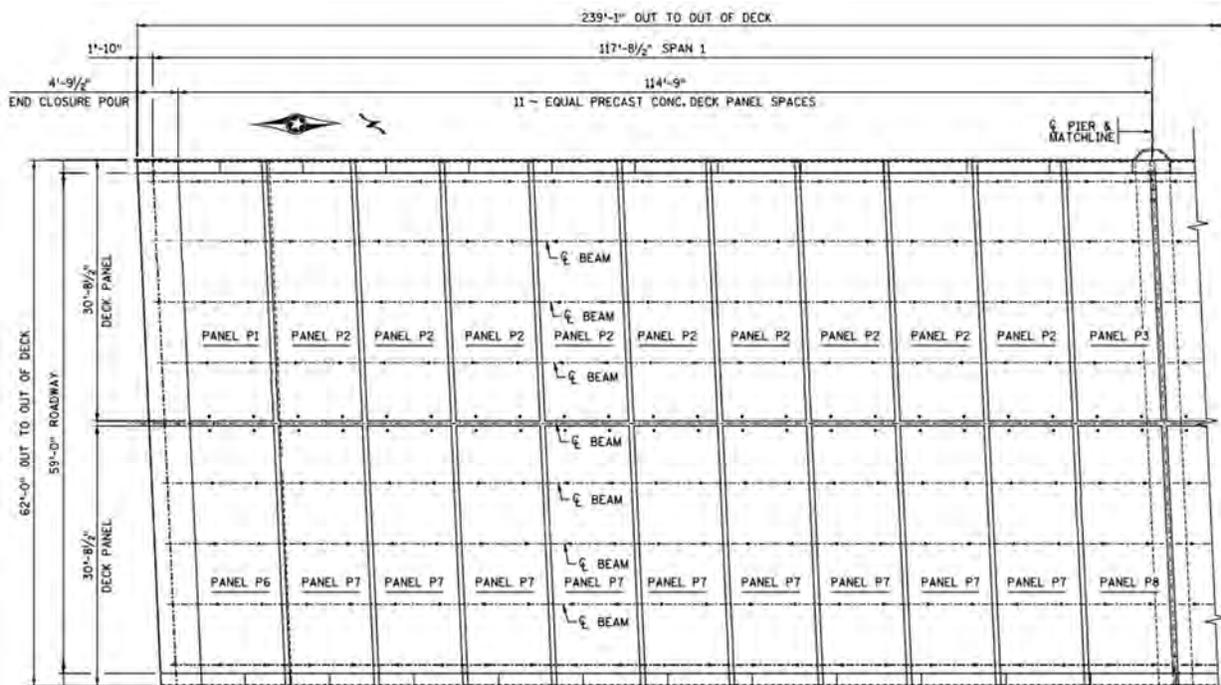
Figure 6 - Partial deck plan showing panel layout in one of two spans.

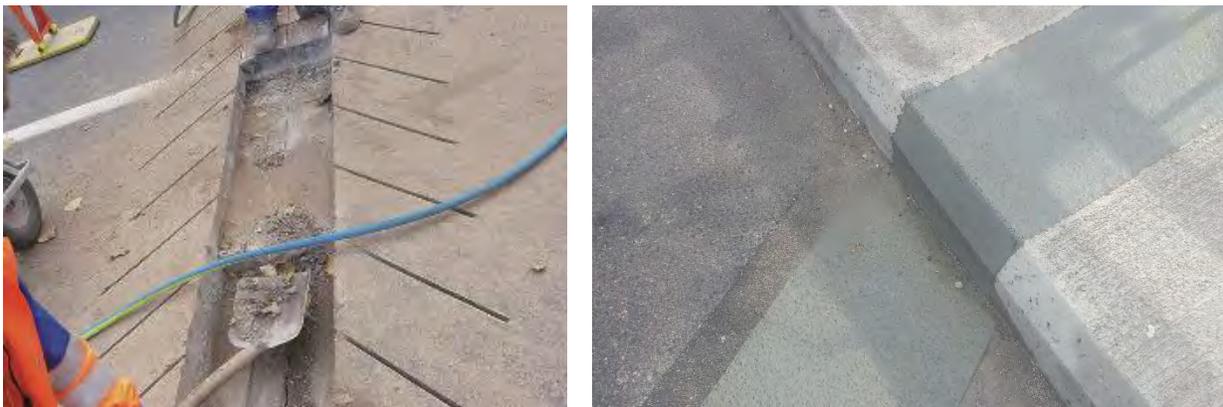
Figure 3: Installation to replace an existing joint of any type is simplified by the fact that the new joint can typically be placed within the depth of a bridge's surfacing, avoiding the need to break out (and replace) concrete or steel (left), and the PU material used offers exceptional geometrical flexibility (right)

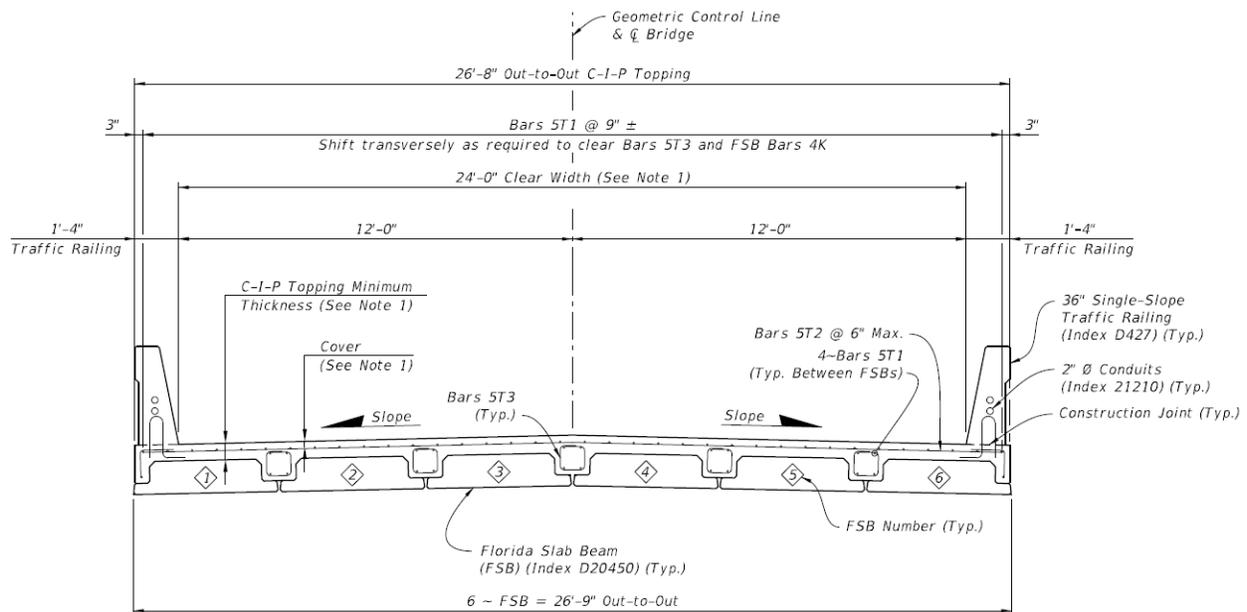
Figure 3: Typical section for FSB standard bridge configuration available in 12, 15, & 18-inch precast thicknesses

When devoid of complications from post-tensioning of special connection details, these PBES systems can be a rapidly constructible, cost effective, and offer a robust superstructure solution for modest spans. These beams couple nicely with GRS-IBS systems when geotechnical and hydraulic conditions allow for a complete bridge system, as demonstrated on the SR-373 Bridge over St Marks Trail (28). This project which involved the replacement of a structurally deficient bridge, was completed in six weeks during the summer of 2014. These prestressed-slab beams were the prototype for the standardized Florida-Slab Beams (FSB) (29) that have now been designed into at least 70 bridges with 36 completed as of November 2019. Typical cross-section details are shown in **Figure 3**.

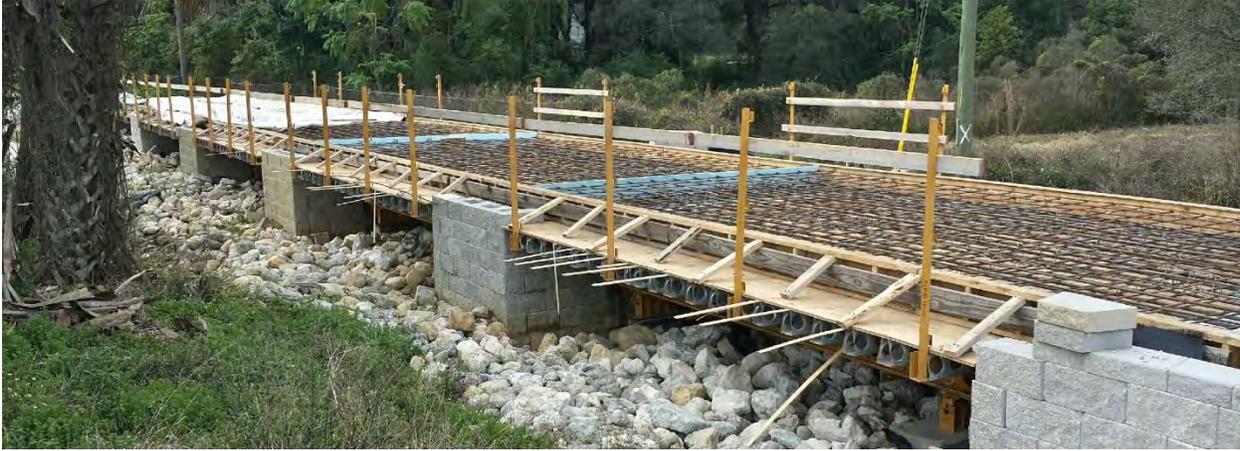
Figure 4: GRS-IBS intermediate piers for multi-use trail along US301, under construction in 2016.

GRS-IBS was standardized by FDOT in 2014 through the Structures Design Guidelines (Section 3.12.7) (37) and Developmental Standard Index D6025 (38). Seven projects have utilized the system to-date with both prestressed slab beams and I-beam superstructure types. One of the more unique application was for the intermediate piers supporting a five-span precast-slab multi-use trail bridge crossing an intermittent floodway along US-301 near Dade City, FL. as shown in Figure 4. The design of a significantly more demanding application utilizing Florida-I beams on a GRS-IBS foundation with an integral diaphragm and bearing slab will be presented by Quan-Yang Yao et al. (2019) (39) at this conference.

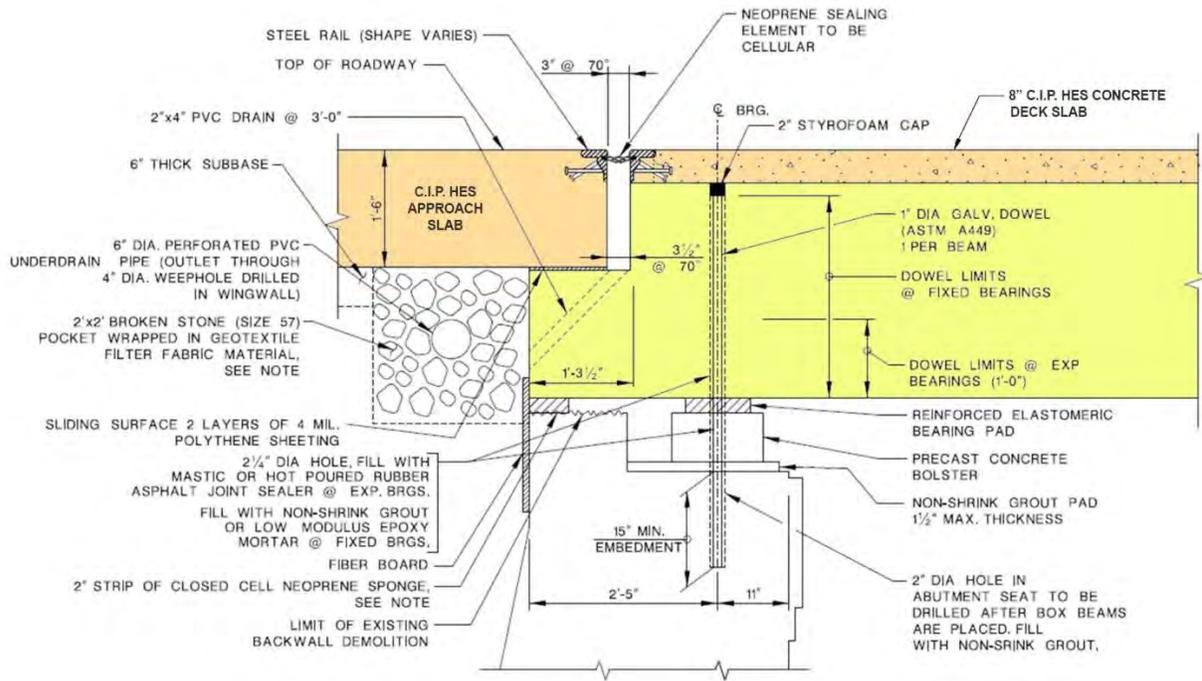
Joint Detail

In conjunction with NJDOT, a joint detail was developed that minimized any possible joint leakage in the future. A standard strip seal was installed, but it was located over a concrete corbel extending from the superstructure beams. These corbels had PVC drains so that any water from possible future holes in the strip seal membranes, took place away from the bearings and bearing seat, and was directed to a perforated PVC underdrain that was behind the backwall. See detail below.

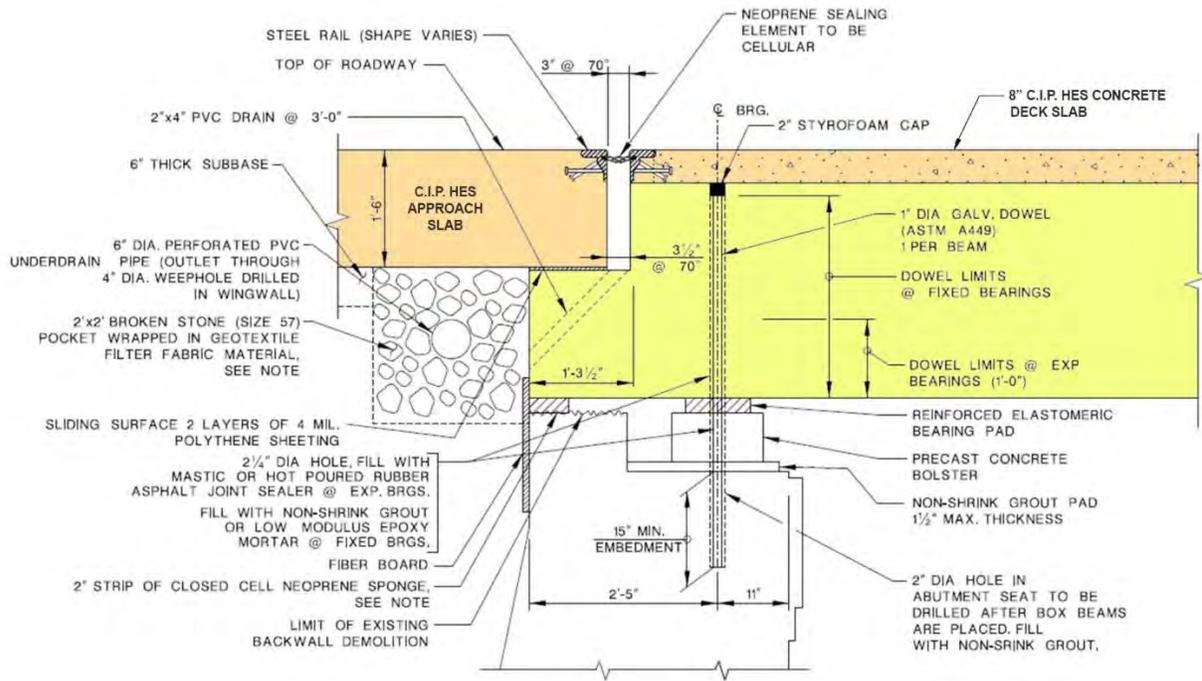
Joint Detail

In conjunction with NJDOT, a joint detail was developed that minimized any possible joint leakage in the future. A standard strip seal was installed, but it was located over a concrete corbel extending from the superstructure beams. These corbels had PVC drains so that any water from possible future holes in the strip seal membranes, took place away from the bearings and bearing seat, and was directed to a perforated PVC underdrain that was behind the backwall. See detail below.

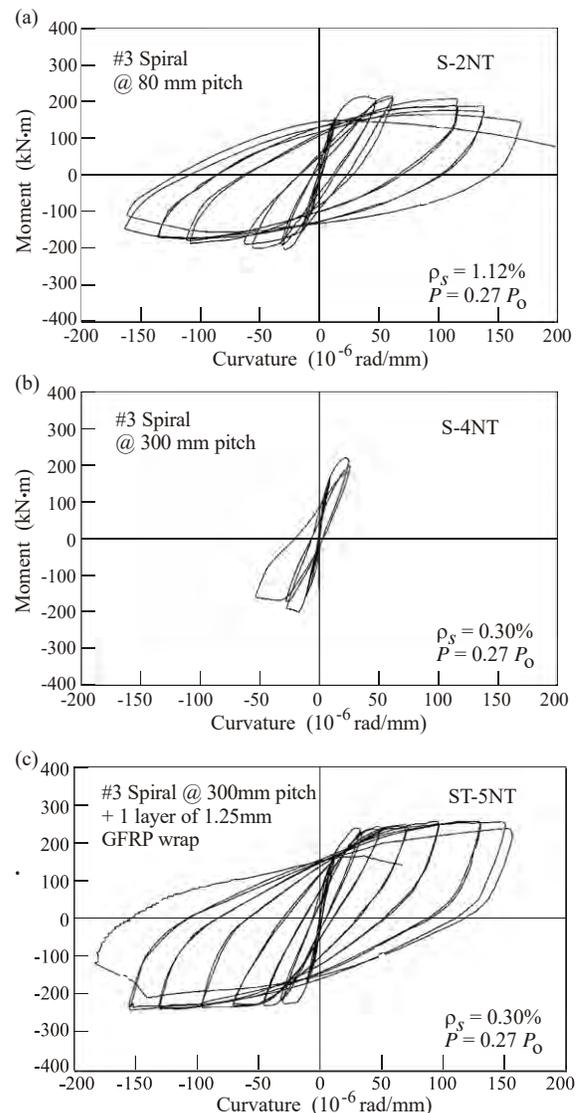
Fig. 7 Moment-curvature behavior of columns

A comparison of the moment-curvature responses of Specimens S-2NT and S-4NT underlines the importance of the spiral steel and its spacing on the seismic resistance of columns. Strength, ductility, energy dissipation capacity and the number of cycles of inelastic excursions that a column can sustain depend on the effectiveness of the spiral steel and the confinement it provides. The deficiency of the column caused by the reduced amount of spiral steel and its larger than required spacing could be easily overcome by the addition of only one layer of GFRP wrap as shown by the

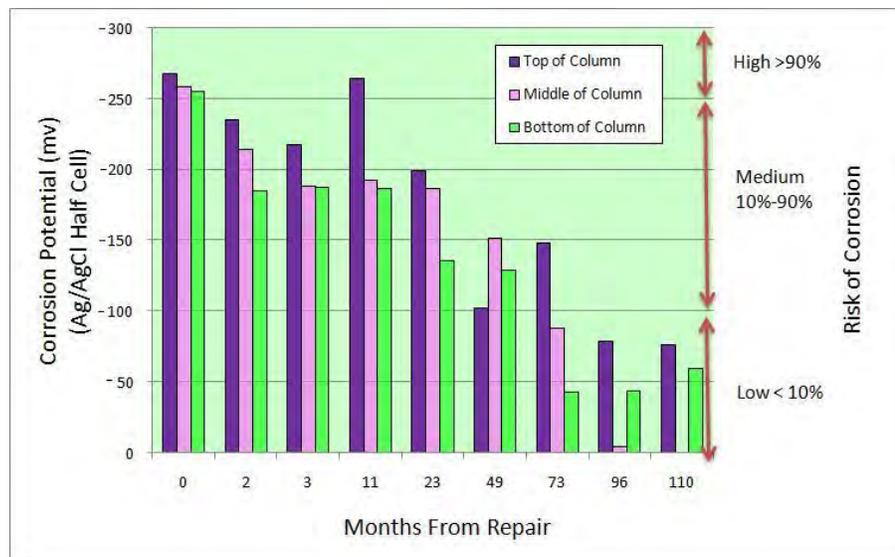
Fig. 11. Corrosion activity in repaired field columns

Corrosion activity recorded by half cells is shown in a graphical form in Figure 11 which displays the average corrosion potential in three columns at different locations along their height. The corrosion potentials can be used to provide some indication of the probability of corrosion activity in the columns at the time of the measurement (Broomfield 1997). The risk of corrosion thus determined is shown along Y-axis on the right side of the figure. Reduction in the corrosion activity and the reduced risk of corrosion over the years can be clearly seen in the figure. The average risk of corrosion in three columns at different locations along their height has reduced from high to low in about six years and remained low afterward. Monitoring of the corrosion activity was terminated at 100 months.

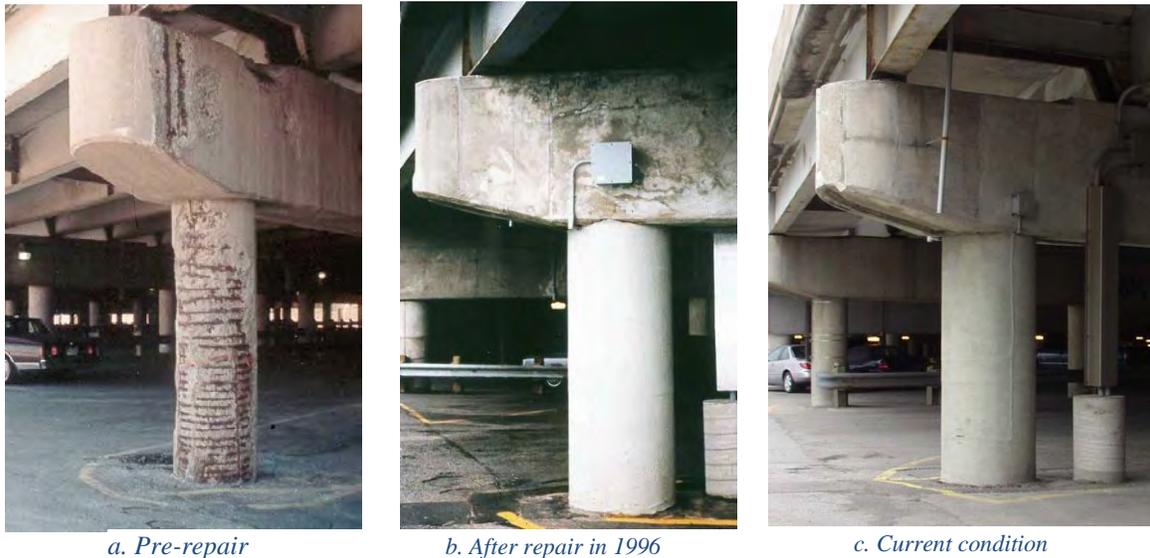
Fig. 12. Sustainability of the repair techniques

has stood the test of the time and performed flawlessly in an excellent manner. Traditional repair techniques have generally required a repeat of repair procedure every 8 years or so in similar cases.

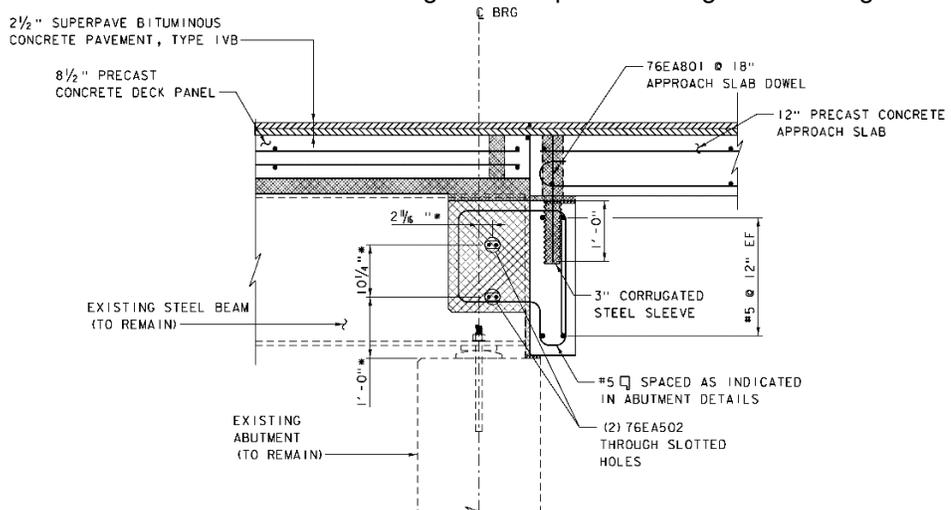
Figure 5 - Fixed End Precast Conc. Curtainwall & Approach Slab

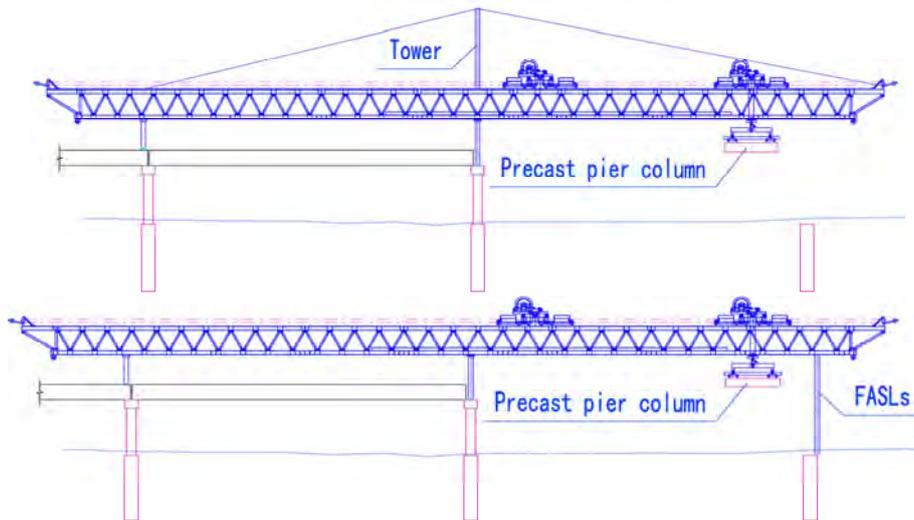
Figure1. General integrated EM structures: tower-crane integrated EM (top); front auxiliary support leg (FASL) integrated EM (bottom).

To improve efficiency and make better use of the time during the grouting and curing of the column and bent cap, an integrated double-working-face EM approach was designed. The column and bent cap are erected on the front working face, while the beam slab is erected on the rear working face. To implement this approach, two types of EMs were designed based on front-pivot EMs. One type of EM is a tower-crane integrated EM, which is similar to a cantilever crane; in this EM, the front working face is supported by a cable-stayed structure. The other type of EM is a front auxiliary support leg (FASL) integrated EM. This EM is supported by its front auxiliary support legs on the sides of the pile foundation. Figure1 shows the two EM structures.

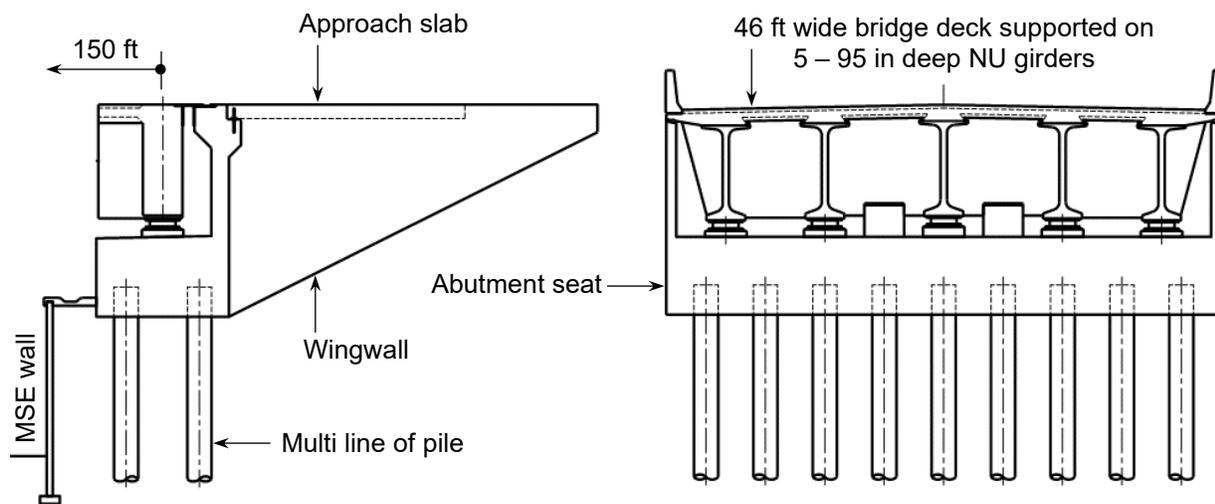
Figure 2: Conventional abutment with bearings, shear keys, and approach slabs (Type A)

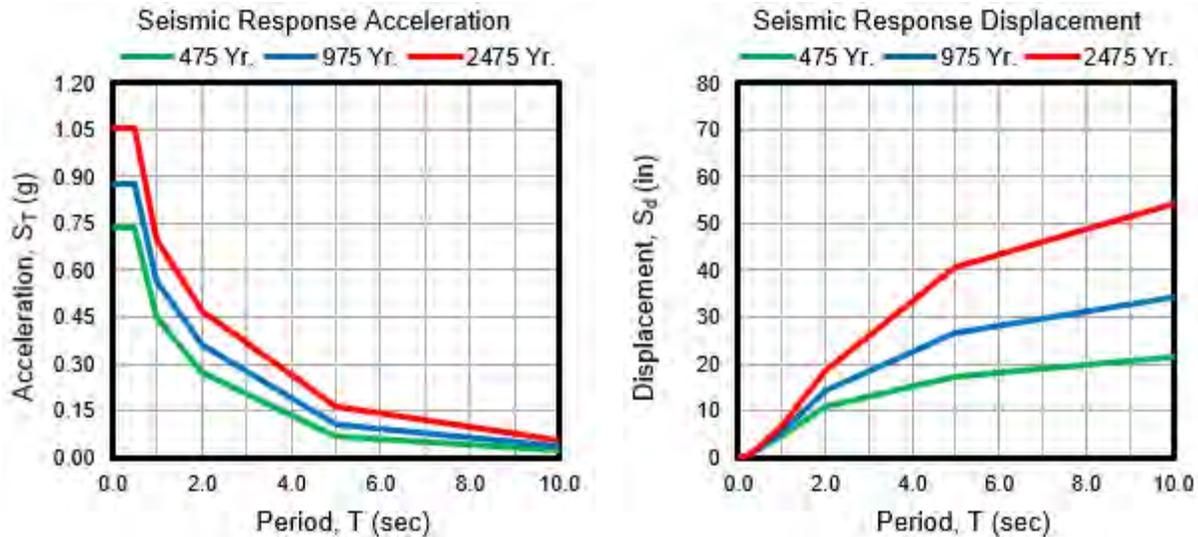
Figure 6: Seismic response acceleration (left) and displacement (right)

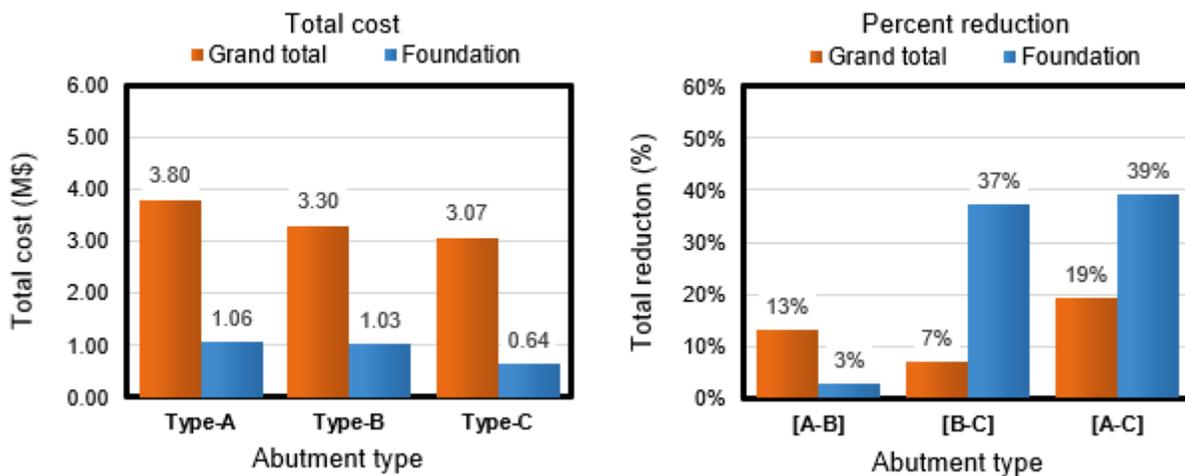
Figure 9: Total construction and foundation costs for the three different abutment types

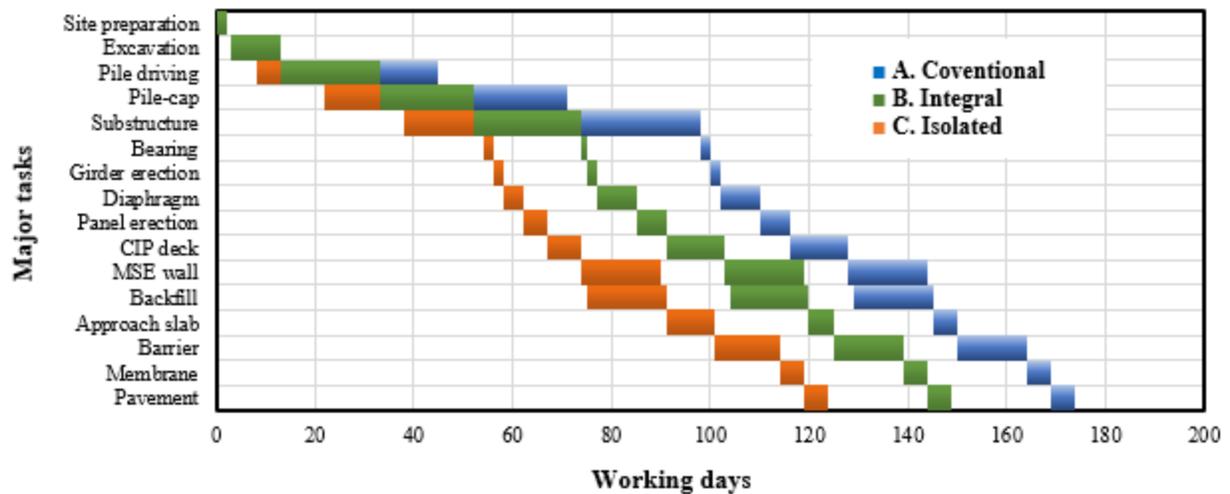
Figure 10: Assumed construction schedule for the three investigated abutment types

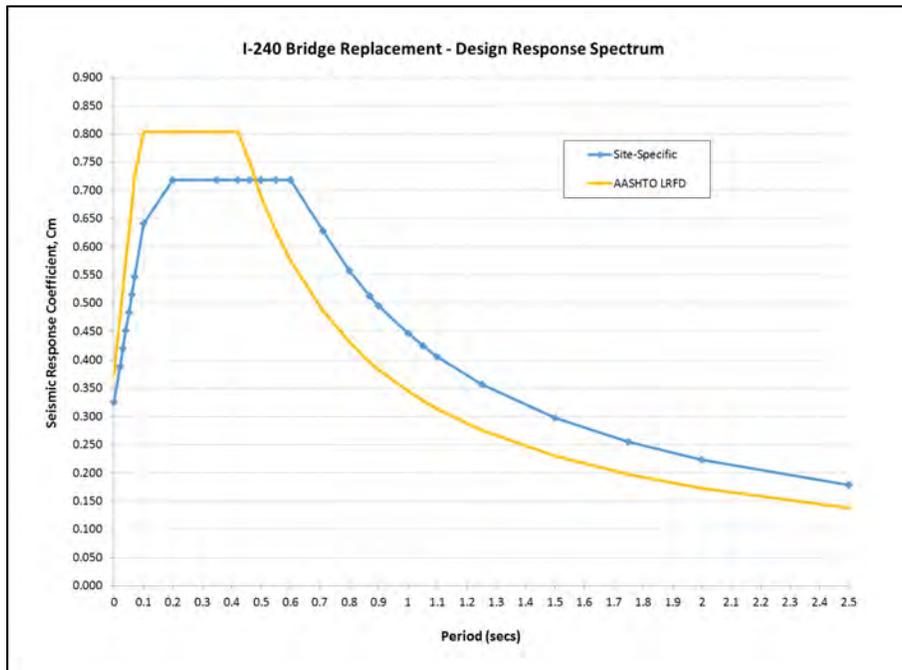
Figure 2 – Design Response Spectrum Comparison

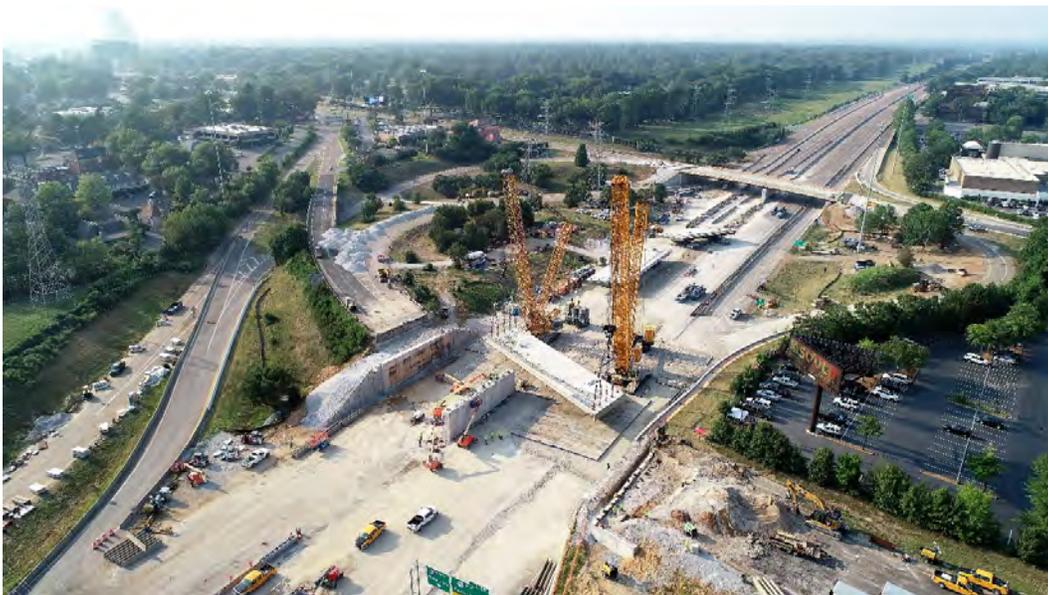
Figure 4 – Tandem Pick Between a 600 Ton and a 400 Ton Crane Superstructure Unit Erection

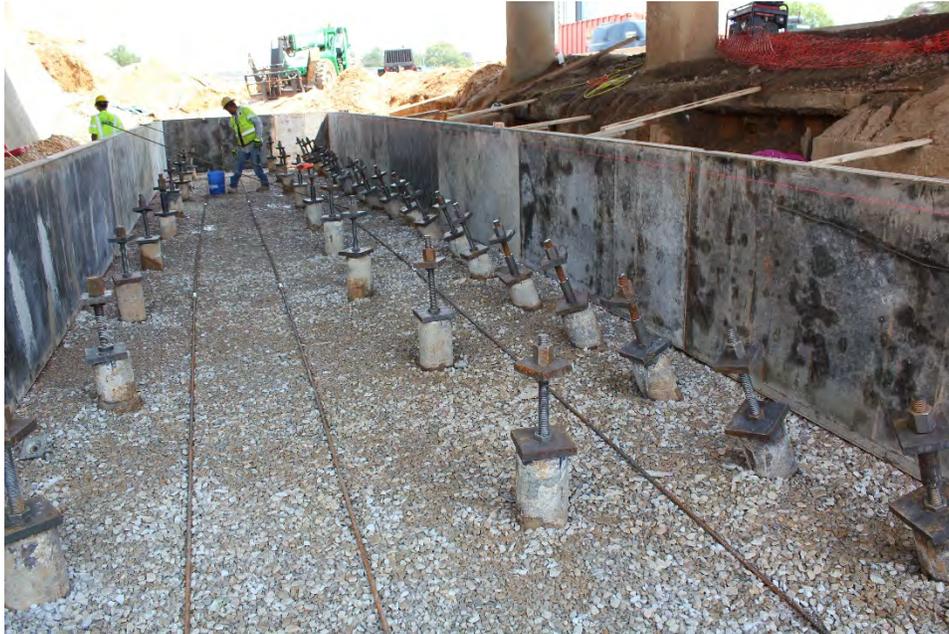
Figure 7 – Poplar Avenue Abutment Micropiles

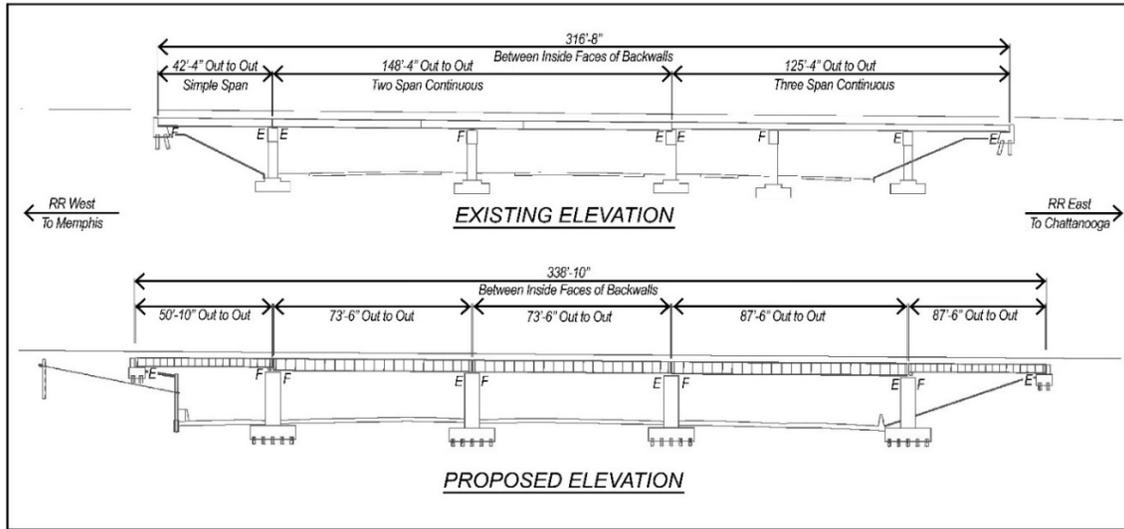
Figure 8 - Existing and proposed bridge elevations

requirements in accordance with codes developed by AREMA. The proposed replacement structure was a 338-foot-long, five-span, ballasted-deck, double-track, steel deck plate girder bridge.

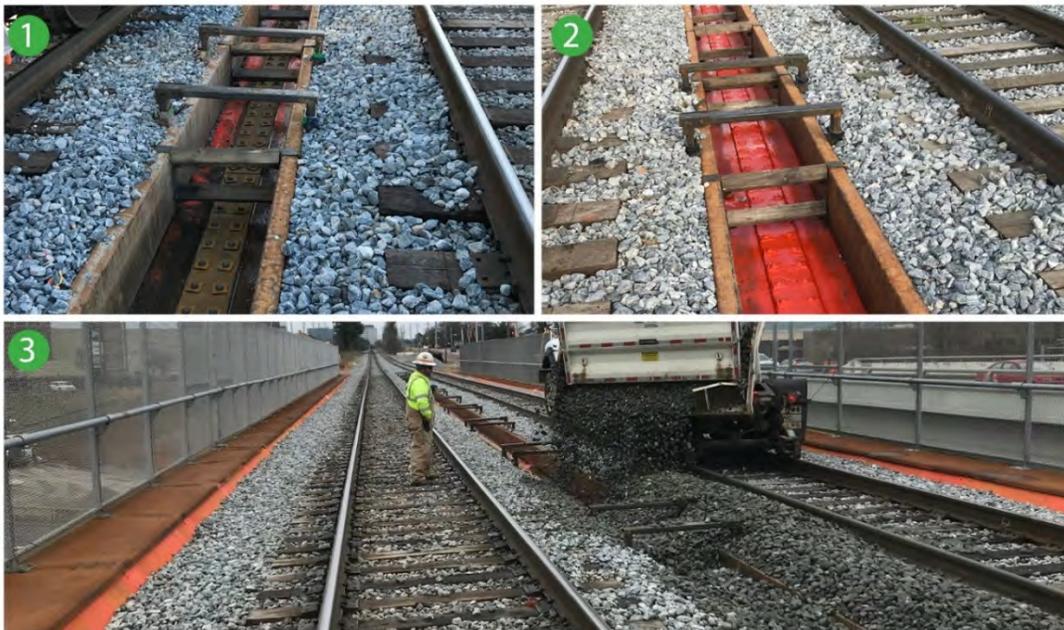
Figure 10 – Utilizing a first-of-its-kind center joint allowed the superstructure to be constructed separately and slid one track at a time. Incorporating a custom shoring system allowed the joint to be bolted up, waterproofed, and covered with ballast without impacting the rail.

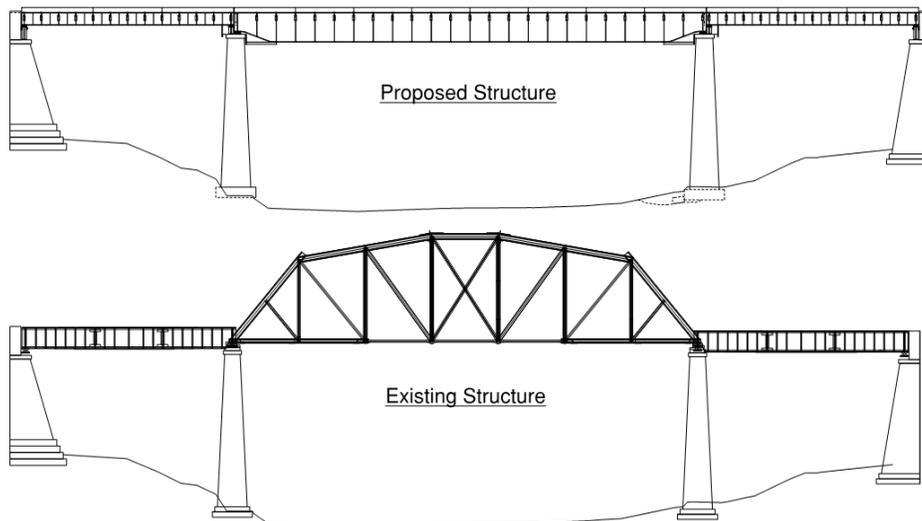
Figure 3: Elevation of proposed and existing structures

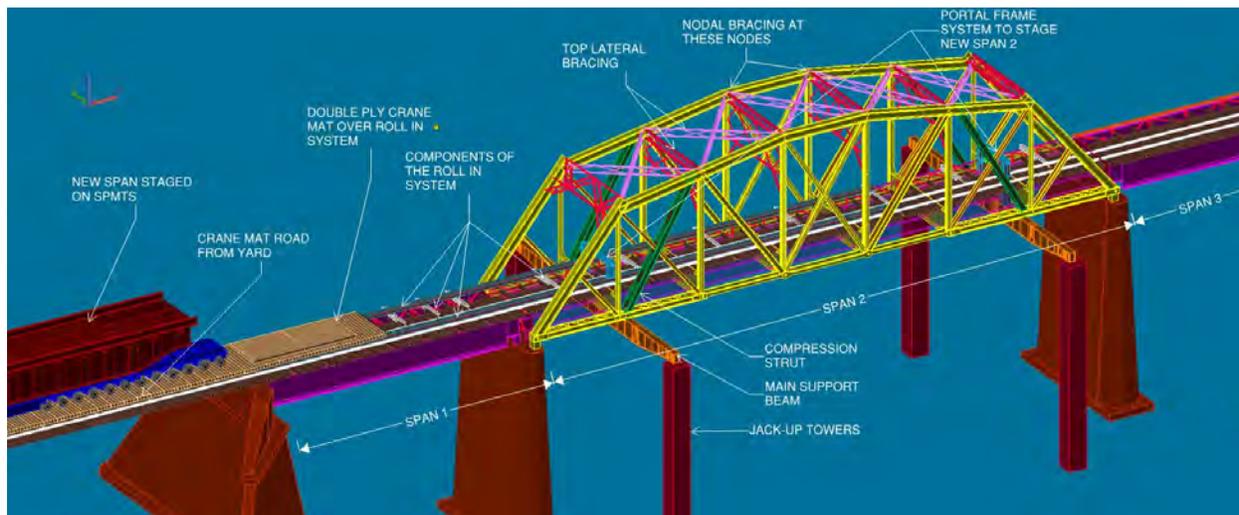
Figure 5: Components of the replacement scheme

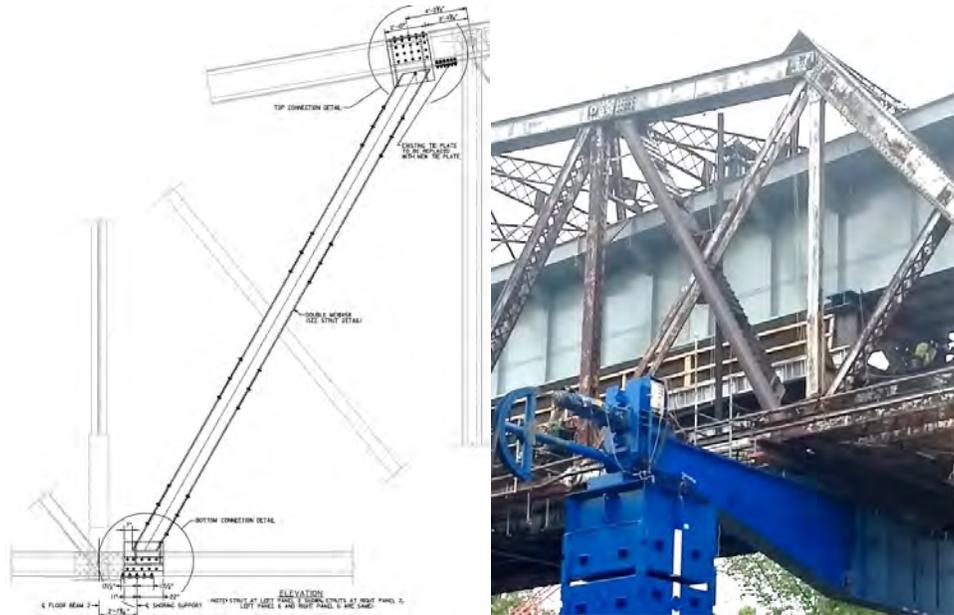
Figure 10 & 11: Final drawing of the strut & The strut as constructed on site

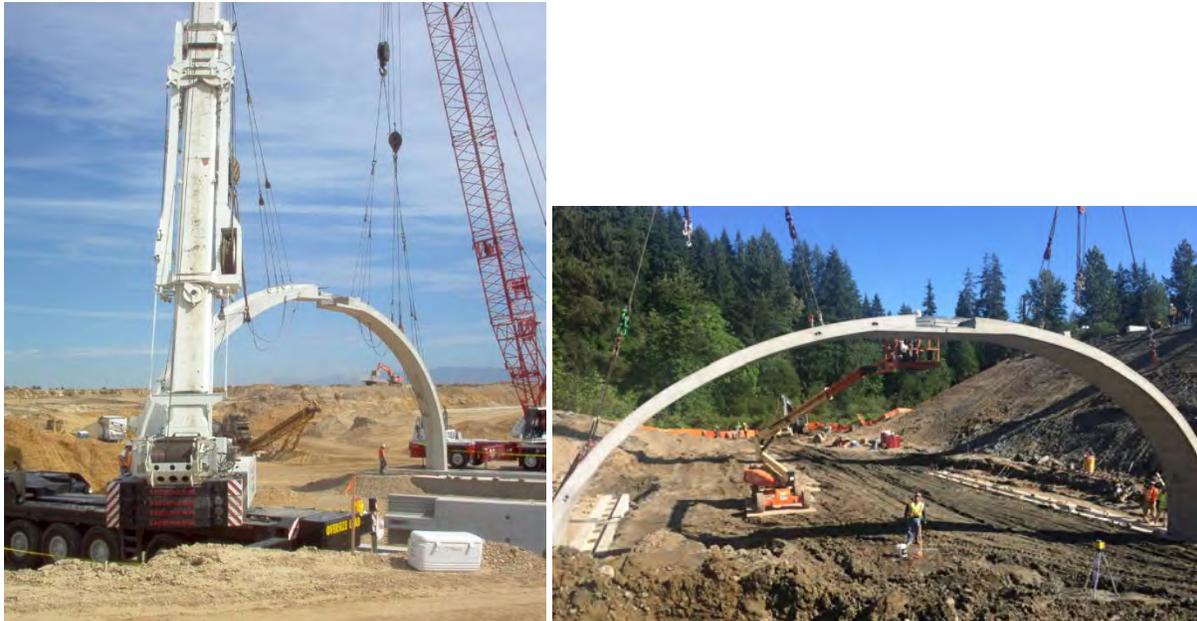
Figure 1: Twin-leaf arch erection

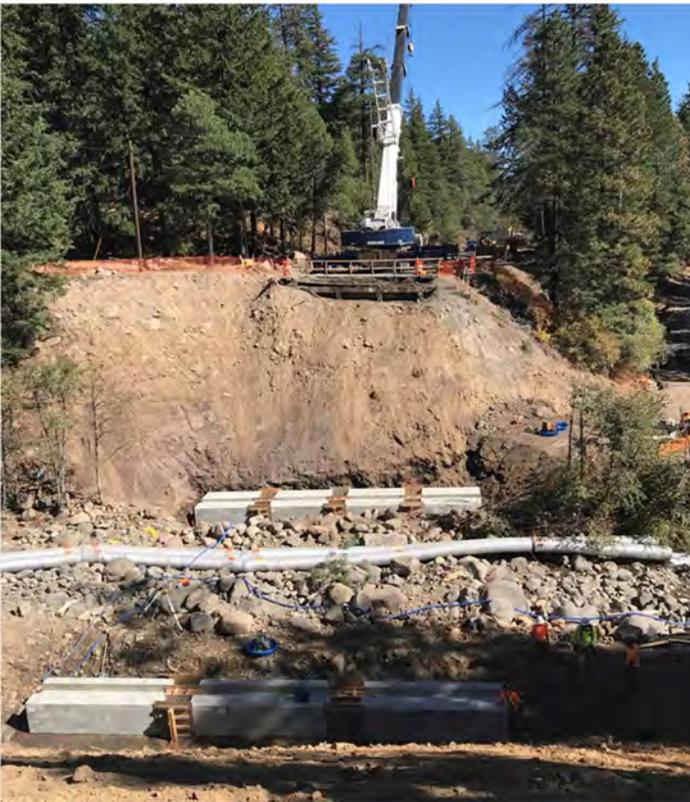
Figure 7: Precast Foundations Set in Place

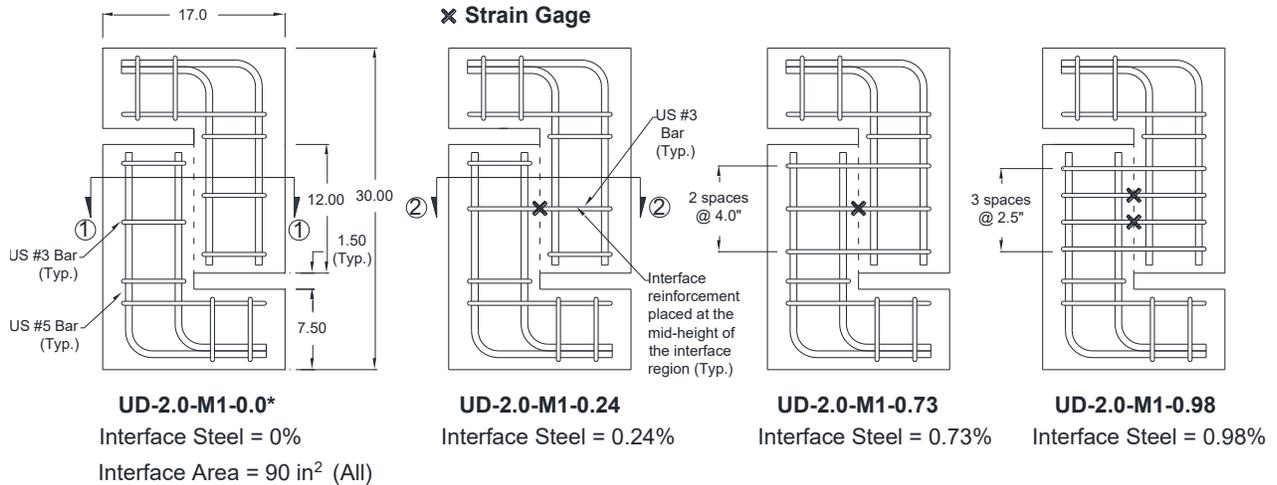
a) Specimen geometry and reinforcement layout: * Two identical specimens were tested.

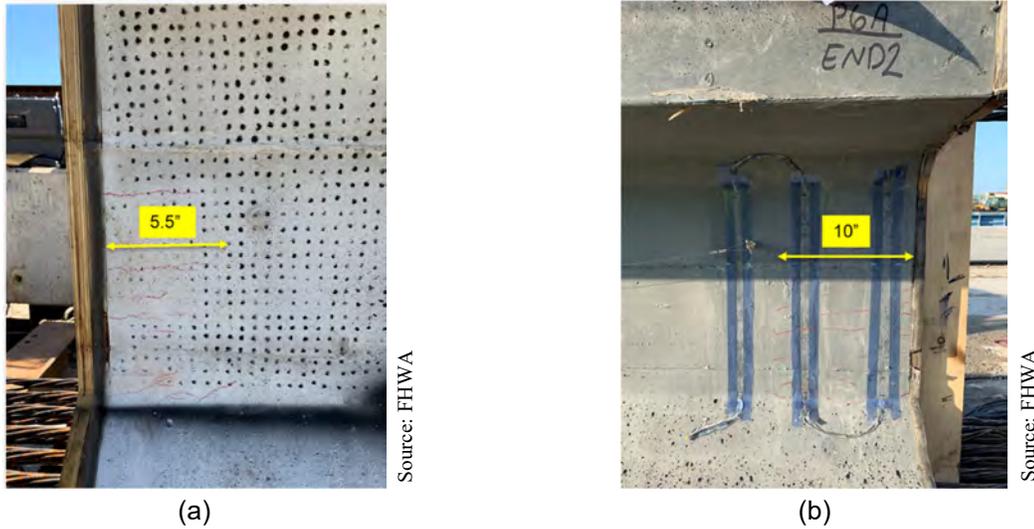
Figure 2. End zone cracking after release (a) Girder A (b) Girder B.
