2019 International Accelerated Bridge Construction Conference, including Automation, Service Life and Ultra High-Performance Concrete

Collection of Conference Papers/ Extended Abstracts

WSDOT Ferry Terminal at Colman Dock Pedestrian Bridge Utilizing Innovative Materials for Accelerated Bridge Erection

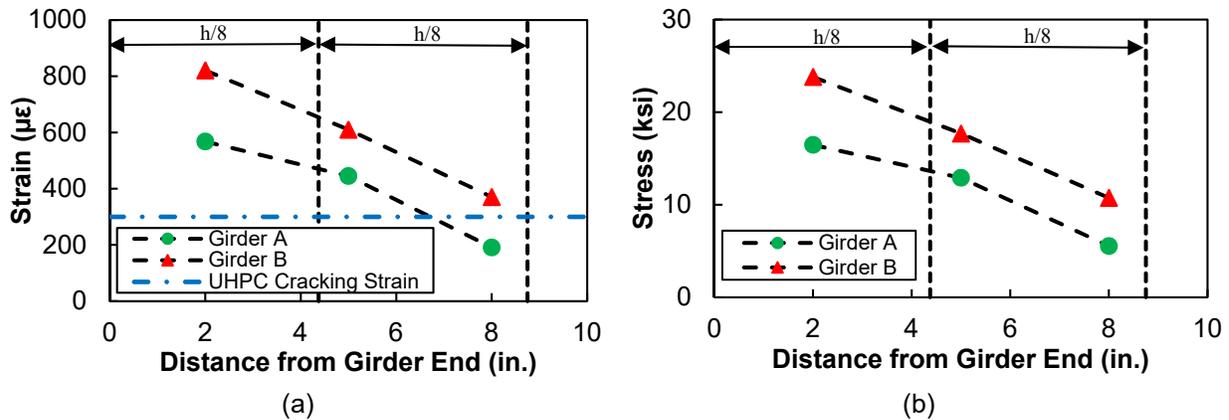
Figure 3. End zone behavior after release (a) Strain distribution (b) Stress distribution.

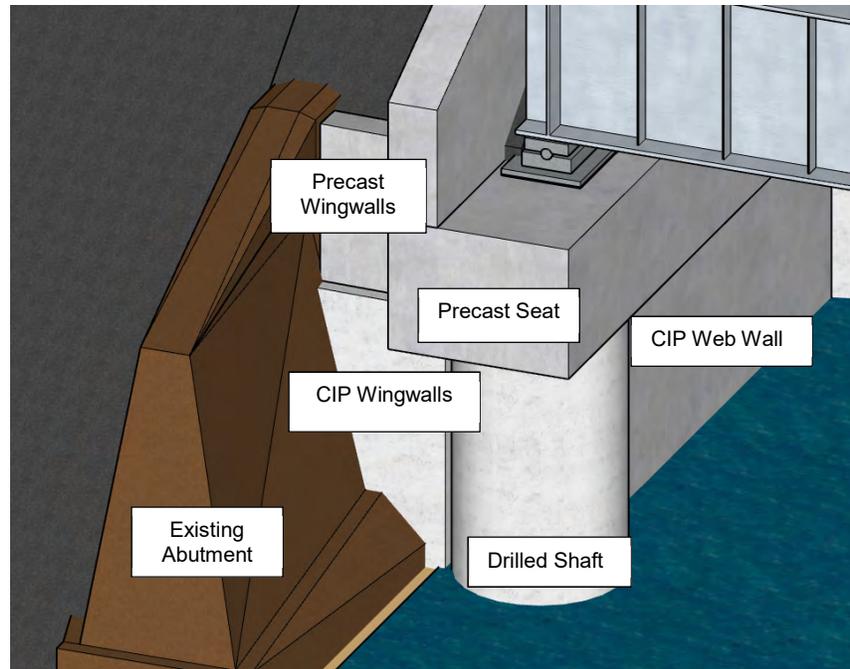
Figure 11 – New Bridge Abutment adjacent to Existing Abutment

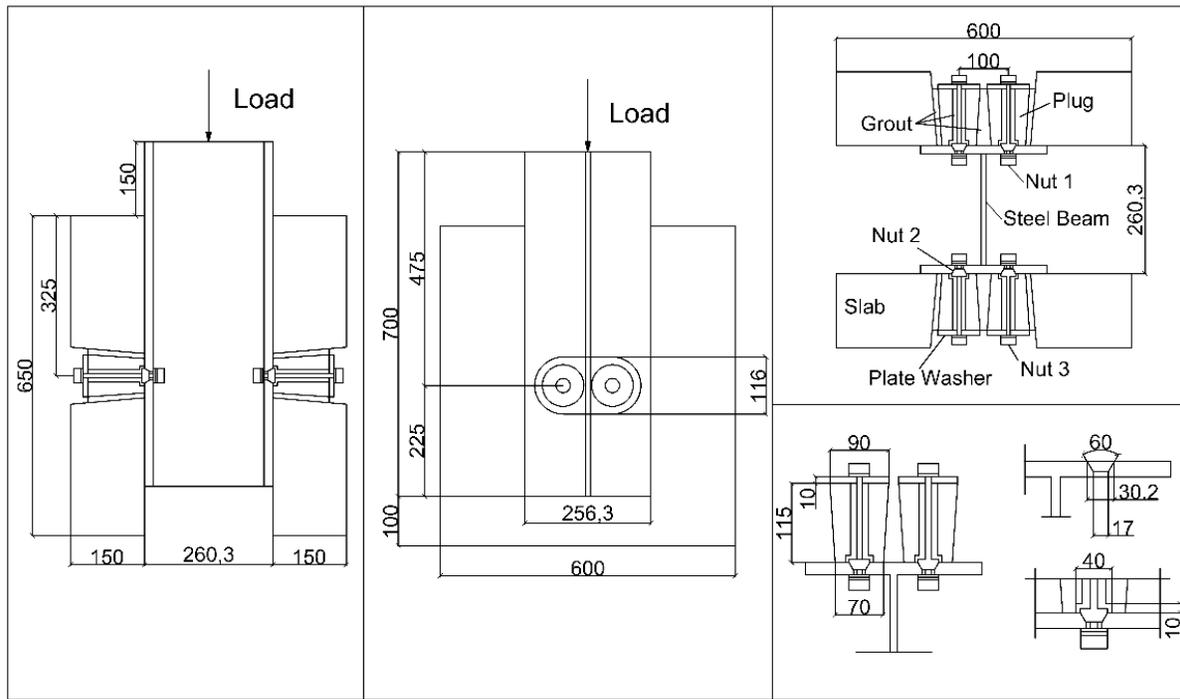
Figure 1. Details of the push-out test specimens

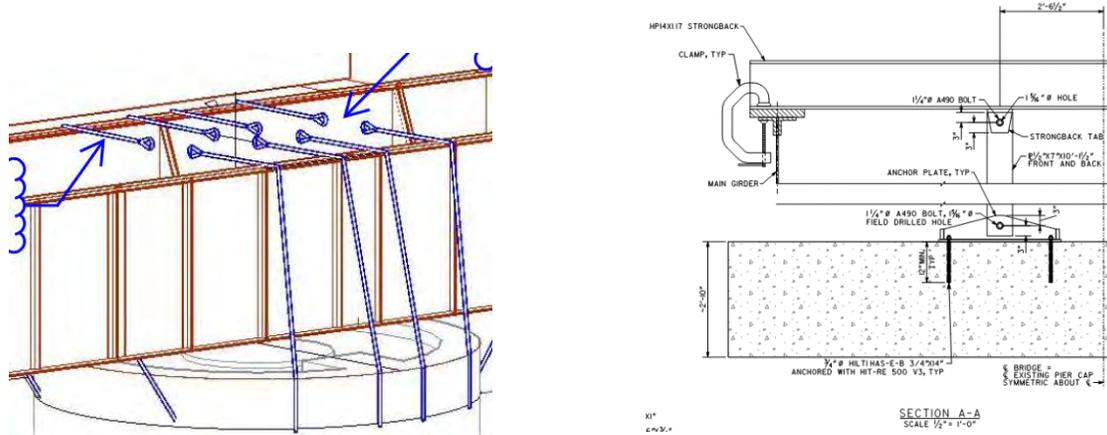
Figure 12 Conceptual Basket Hanger System (left) and Strong Back Beam and Anchor Plate System (right) – Heath & Lineback Engineers

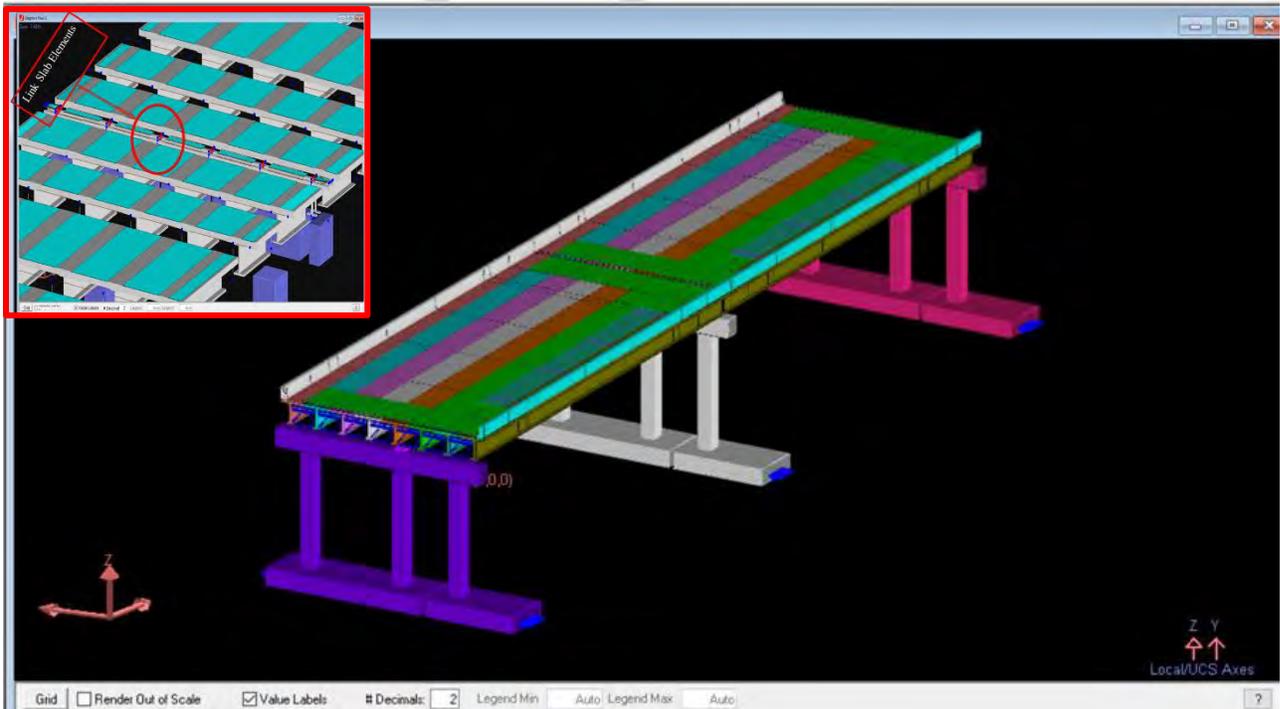
LARSA 4D model of link slabs along the I-95 Wilmington Viaduct project

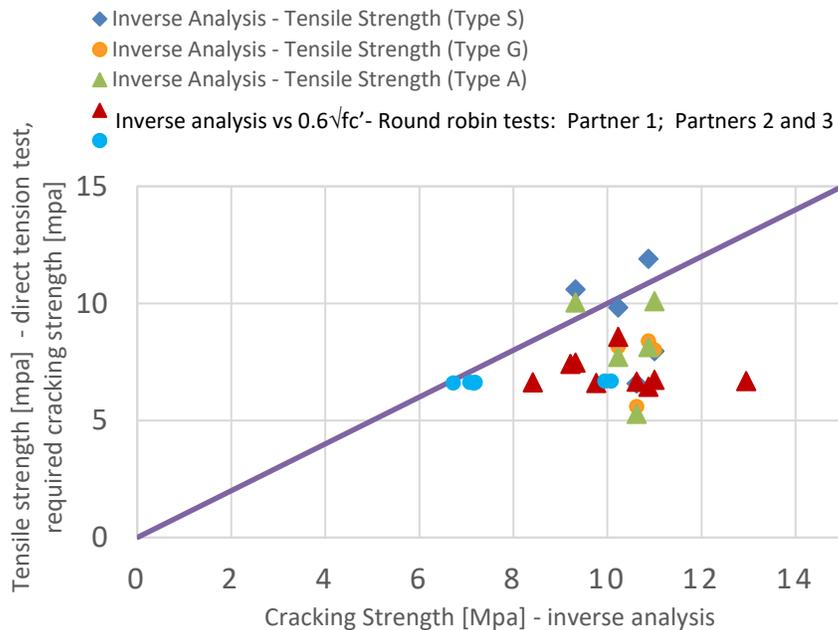
Figure 1: Comparison of results of direct tension tests and tensile strength values obtained from inverse analysis on tests conducted by three different test labs on the same UHPFRC materials (casting of specimens from a single mix by Partner 1). (Each point averages three identical specimens). Red and light blue circles compare results of inverse analysis with the estimate for cracking strength = $0.6\sqrt{f_c'}$.

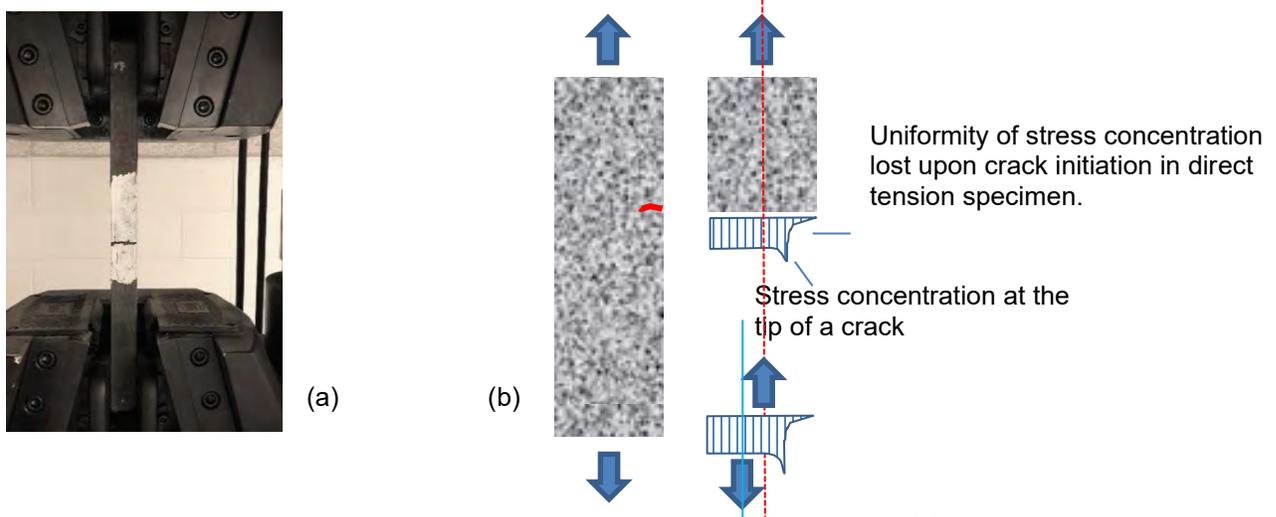
Figure 2: (a) Typical Direct Tension Arrangement – Side View: The specimen thickness is dictated by the available spacing of the grip (b) Eccentricity in direct tension specimen owing to the crack initiation leads to precipitous failure.

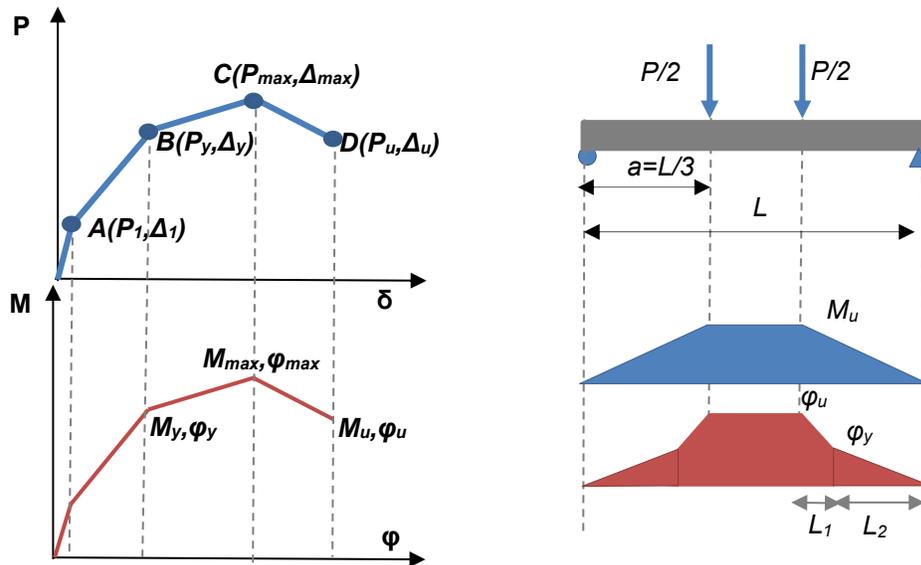
Figure 3: (a) Selection of milestone points on the load-displacement envelope. (b) To obtain the curvature – displacement relationship an assumption needs to be made regarding the “plastic hinge” zone (i.e. the zone L_1 in the figure, transitioning from the linear to the non-linear range).

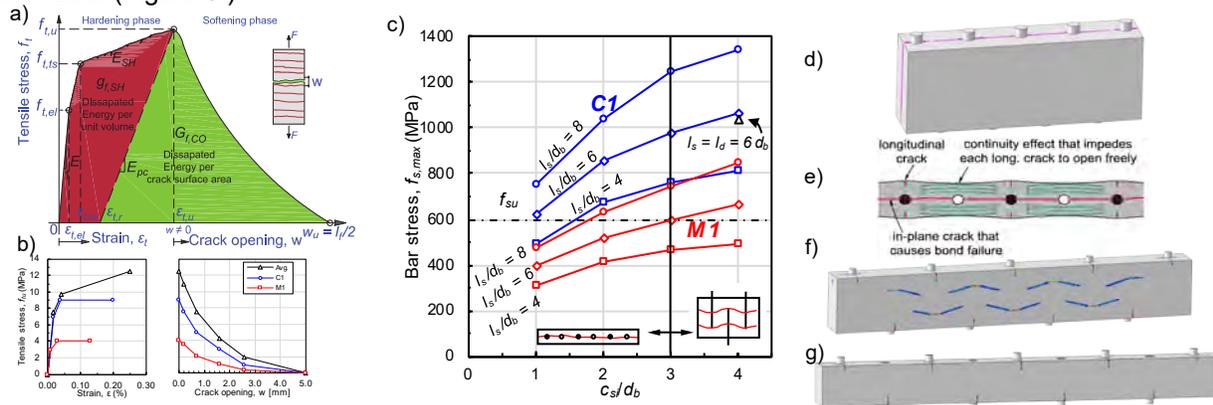
Figure 3 – Influence of noncontact lap splices: (a) Idealized modeling approach, (b) UHPFRC tensile models, (c) bar stress at bond failure versus c_{si} , d) $c_{si} = 1 db$, e) influence of the continuity on longitudinal splitting crack; (f) $c_{si} = 4 db$ (g) $l_s = l_d = 6 db$ and $c_{si} = 4 db$

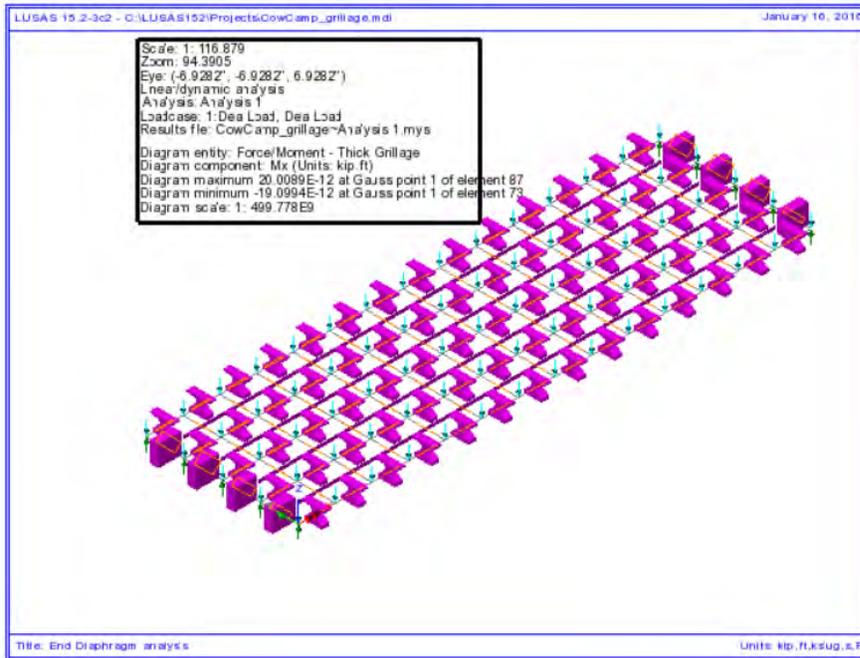
Figure 1 Grillage Model

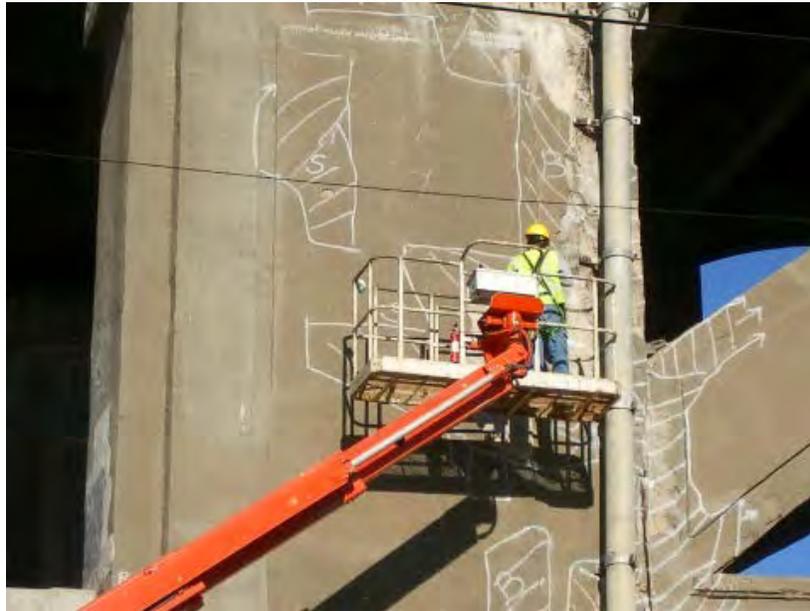
Figure 2: In-Situ Testing of Substructure

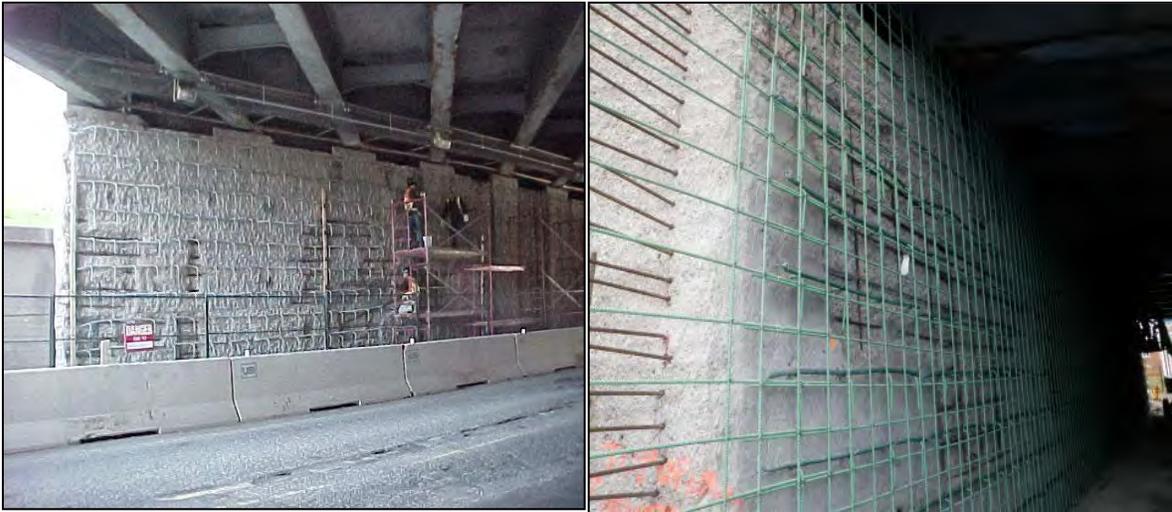
Figure 5: Removal of Damaged Concrete and Placement of Galvanic Anodes and Reinforcement

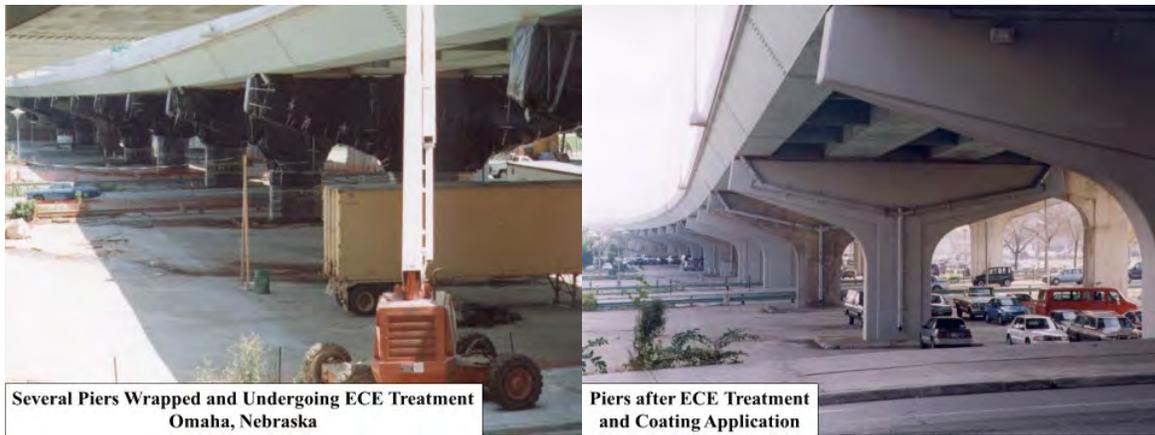
Figure 7: Before, During and After ECE Treatment of Piers

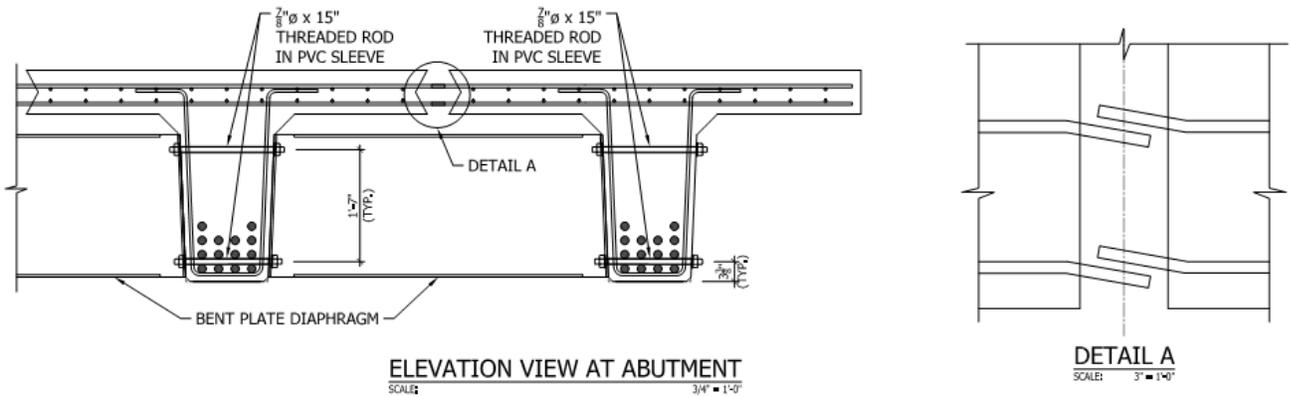
Figure 5- transverse rebar splice in UHPC Joint

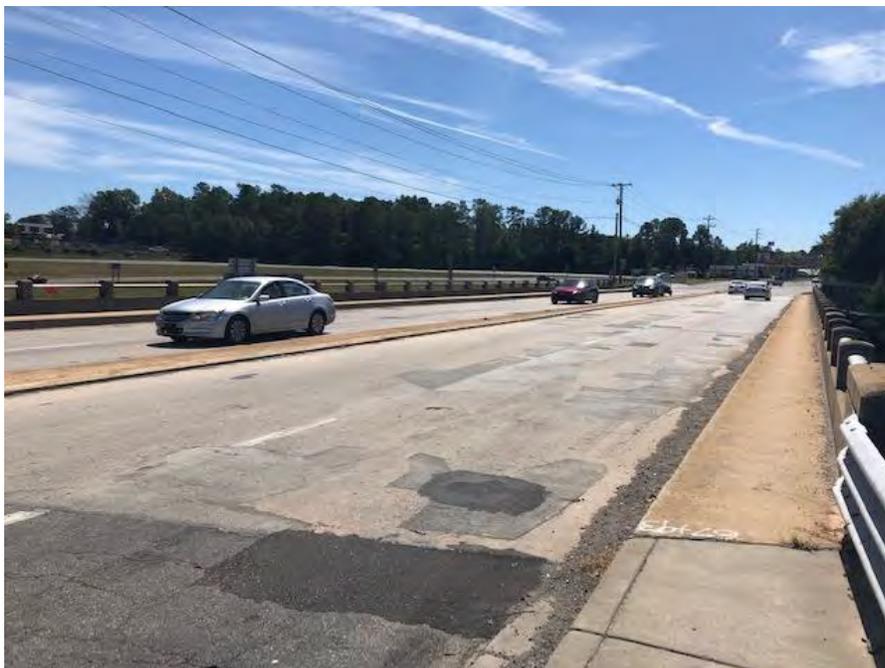
US 21 over I-20 – Columbia, SC - Existing Bridge Deck in Very Poor Condition – Fast Track Hydrodemolition and VESLMC Overlays were selected by the SCDOT to structurally repair the deck for 25 + years.

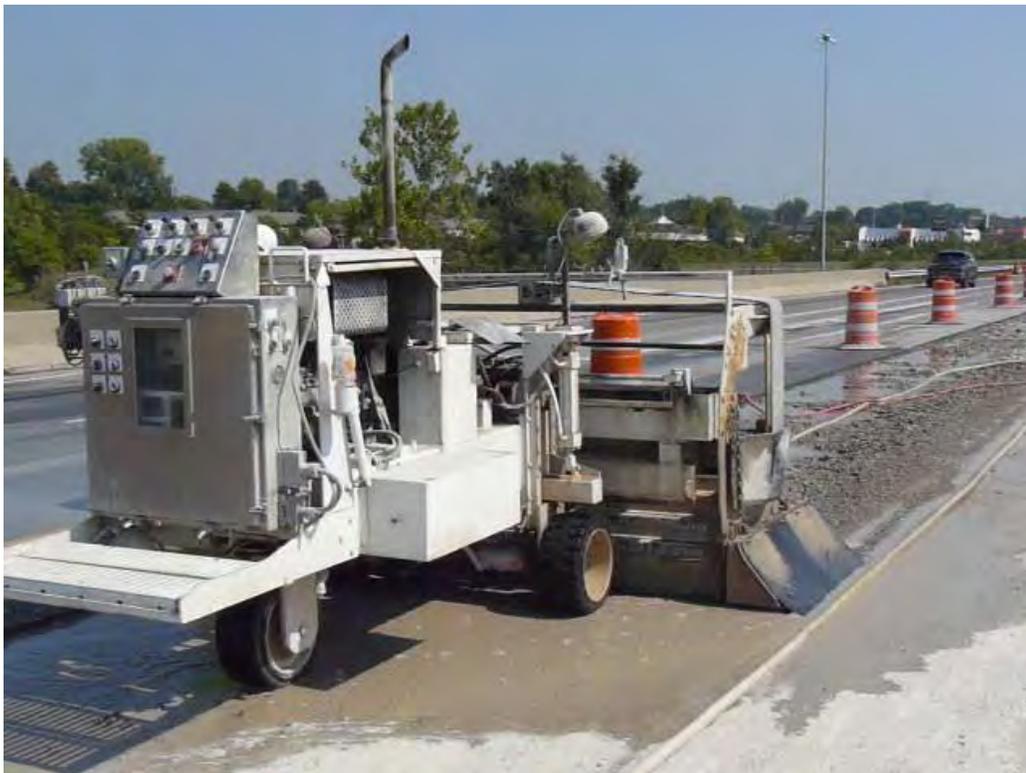
Hydrodemolition Robot performing Bridge Deck Surface Preparation on a weekend project next to live traffic
