1. Report No. ABC-UTC-2016-C2-UNR02-Final	2. Government Accession No.	3. Recipient's Catalog No.	
4. Title and Subtitle Synthesis of Repair Methods for RC Bridge Girders		5. Report Date August 2020

Synthesis of Available Methods for Repair of Reinforced Concrete and Prestressed Concrete Bridge Girders

Final Report

August 2020

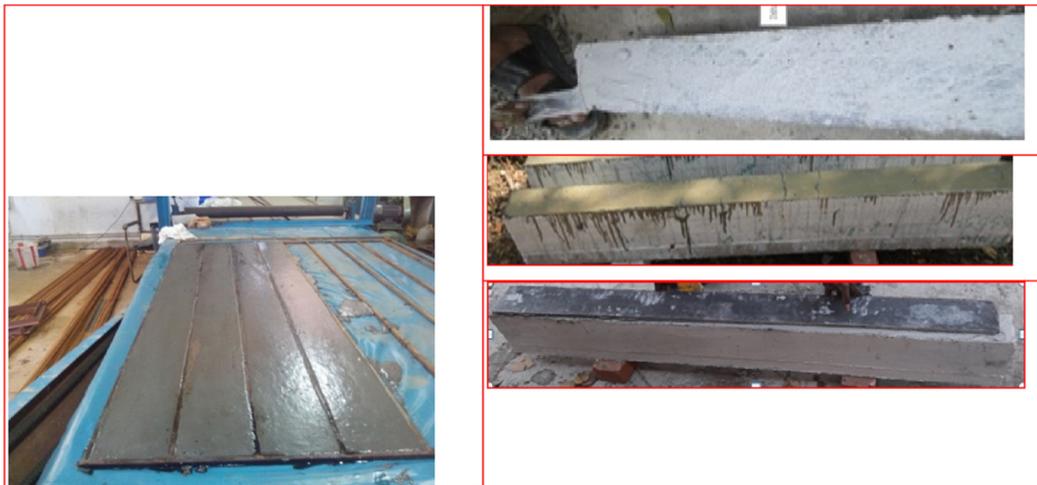
Application of this material for structural rehabilitation of concrete elements started more than a decade ago given the drawbacks associated with the two most popular retrofit materials mentioned earlier (FRP and steel). This material has low permeability, high strength, high tensile strength and high toughness. Compared to other common rehabilitation materials. It has more homogeneity due to the elimination of coarse aggregates in its matrix. It also contains lower amount of free water which result in superior characteristics. In addition, it is ductile and it can have excellent bond with normal concrete [58, 86, 258, 259]. Figure 2-12 shows an example application of the UHPC material to RC beams.

Figure 2-12. Application of UHPFRC strips to the damaged RC beam [58]

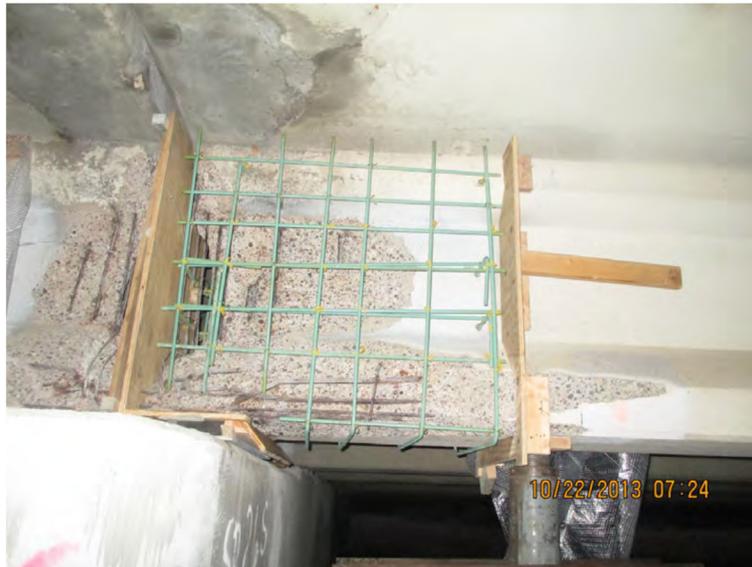
Shotcrete is dry cement, sand and aggregate wetted at a nozzle and sprayed at high velocity. This technique involves the pouring of sprayed concrete (shotcrete) on the supplemental reinforcement to the element to be repaired or strengthened [78]. Similar to Ferrocement, this material also requires more labor compared to prefabricated materials in laminates or sheets. Also, it increases the section size of the strengthened element, thus, changing the member capacity. Figures 2.13 to 2.15 illustrate the procedure for the implementation of this technique.

Figure 2-13. Supplemental reinforcement before application of the shotcrete [26]

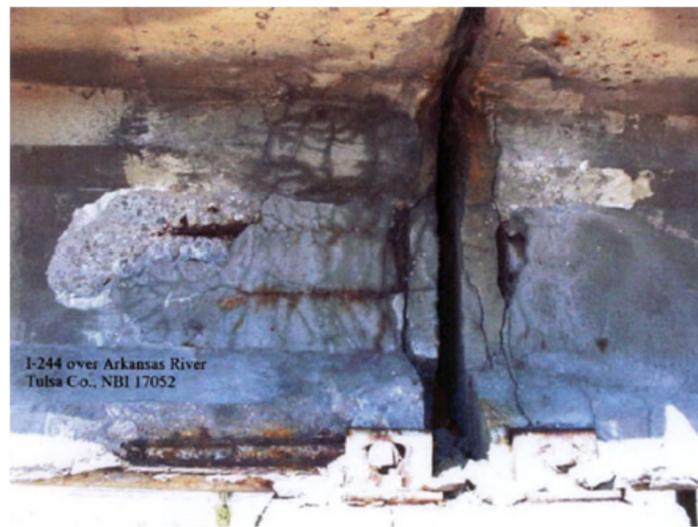
prestressed girders since the load is transferred to the beam through bond between the prestressing strands and the concrete in the end zones of such girders, causing even more shear demands. High potential for corrosion together with high shear demands, makes the girder end regions in need of special care in terms of shear capacity requirements [15]. One of the causes for corrosion is the deterioration of girder ends due to deicing salt exposure in cold climates [55]. Over the past 40 years, since the 1960s when officials started applying deicing salts in the winters to the bridge structures, the deterioration rate of the concrete girders has increased significantly. This has caused both economic and technical issues for bridge structures. Deterioration of the bridge girder ends is a particularly critical issue because of the proximity to the expansion joints. This becomes more crucial if the expansion joint fails and all of the deicing salts drain over the girder end. Furthermore, partially fixed girder end, such as one created by a frozen bearing, may impose additional stress at the girder end. When the build-up stress is relieved, the girder might crack in tension or in shear [23]. Figure 3-1 shows an example of a typical damage at the end of AASHTO bridge girders.

Figure 3-1. Damage in the end region of an AASHTO bridge girder [23]

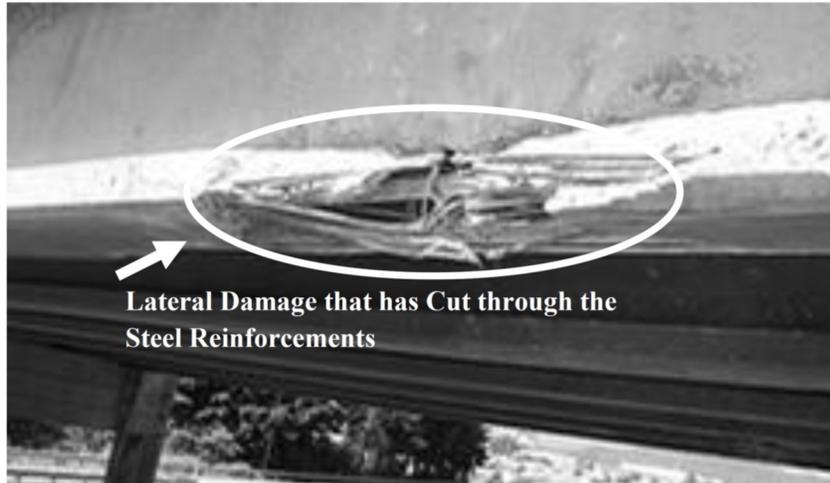
Figure 3-20. Example of lateral impact damage on the steel reinforcement [72].

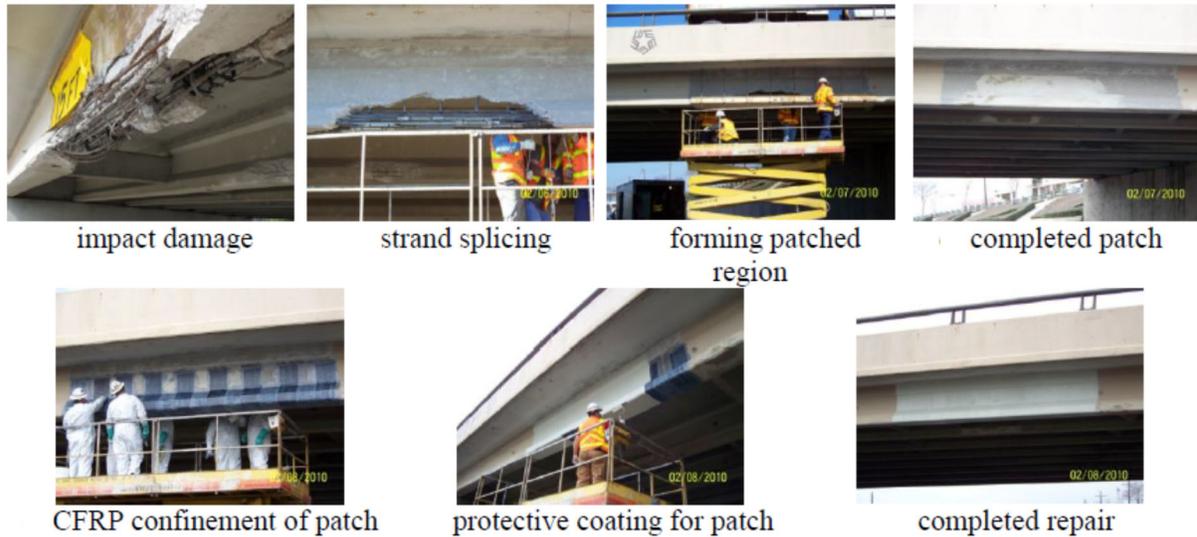
GFRP and epoxy resin from UV light exposure, a final protective top coat was applied. This also serves for aesthetic reasons as well [82].

Figure 3-32. Procedure for repair of an impact damaged girder using strand splicing, patching, and FRP U-wraps [82]

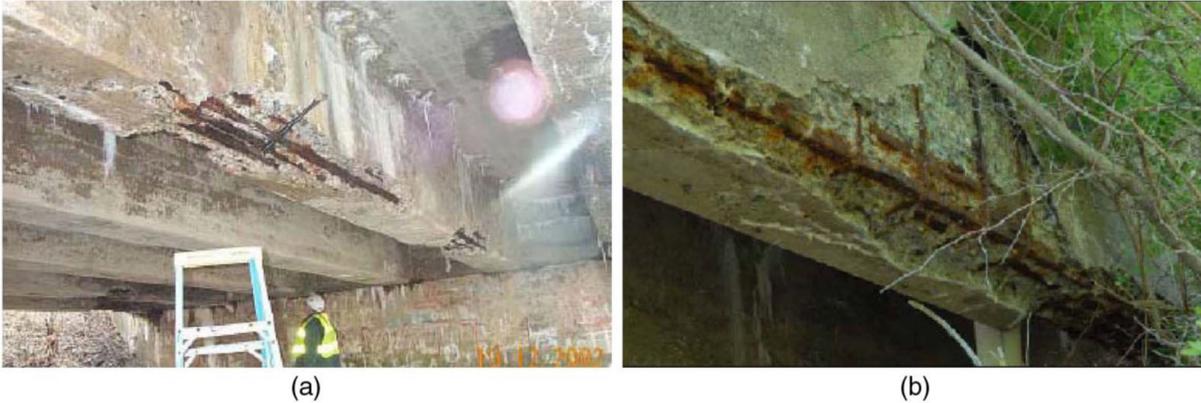
Figure 3-39. Extensive damage to the (1) interior and (2) exterior girders of a RC bridge in Pennsylvania [35]

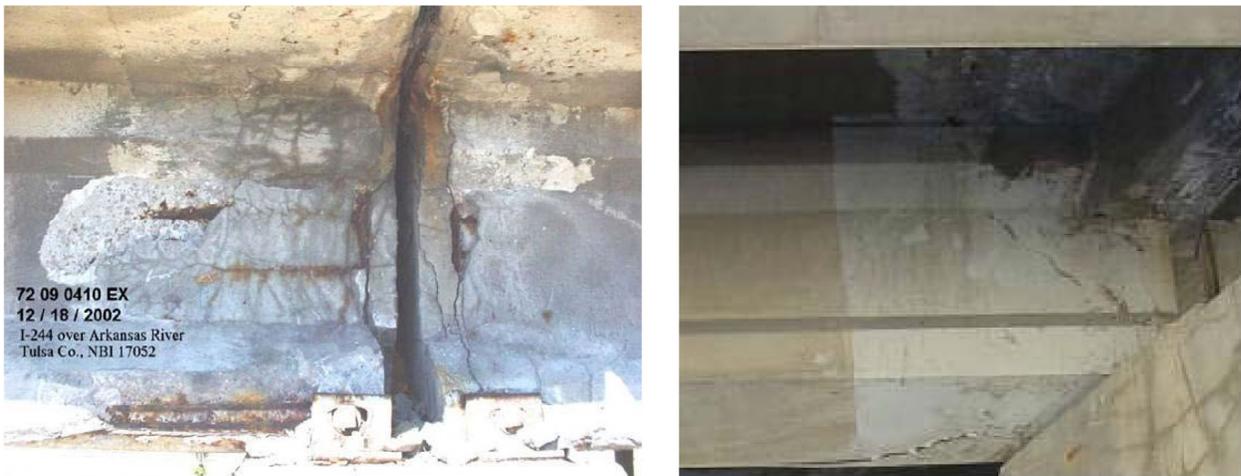
Figure 3-43. Example of girder end corrosion (left), and typical mortar repair (right) [55]

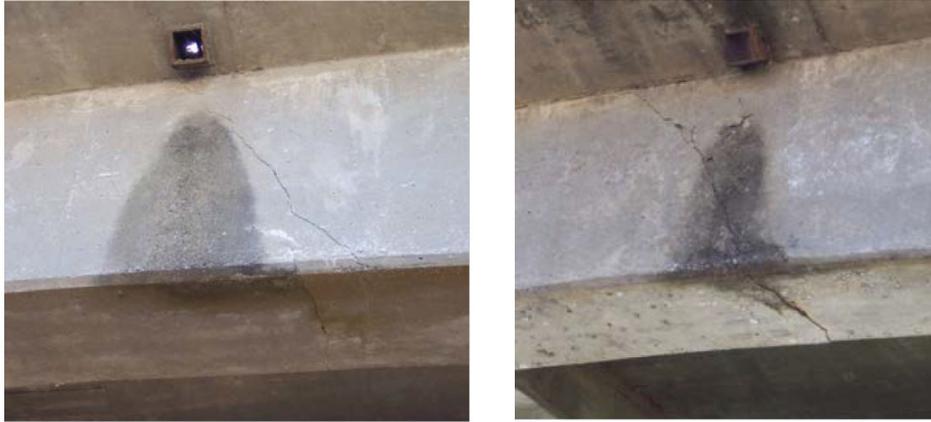
Figure 3-44. Diagonal cracks on the US 150 bridge in Kentucky [28]

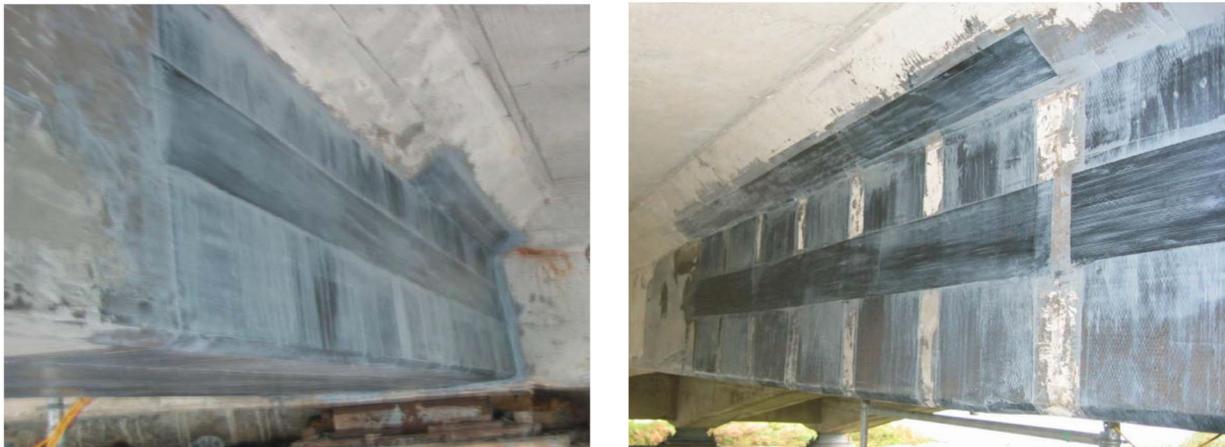
Figure 3-47. CFRP repair approach for two different girder sections [34]

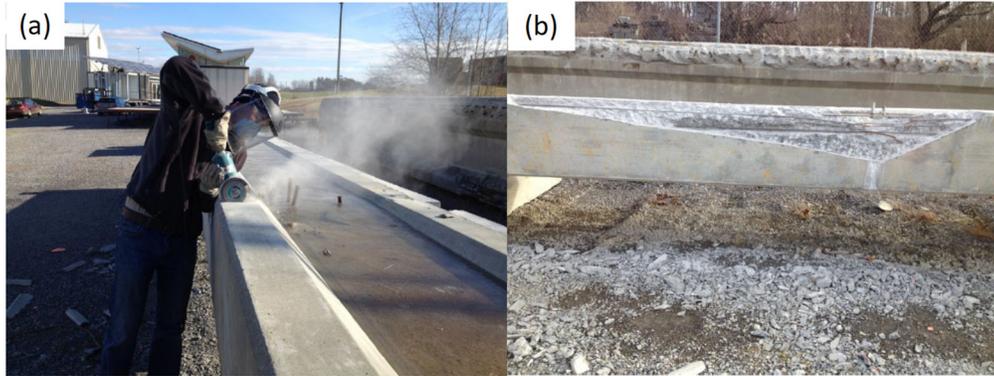
Figure 4-1. Cutting out the damaged area of the girder (a) process (b) final results [20]

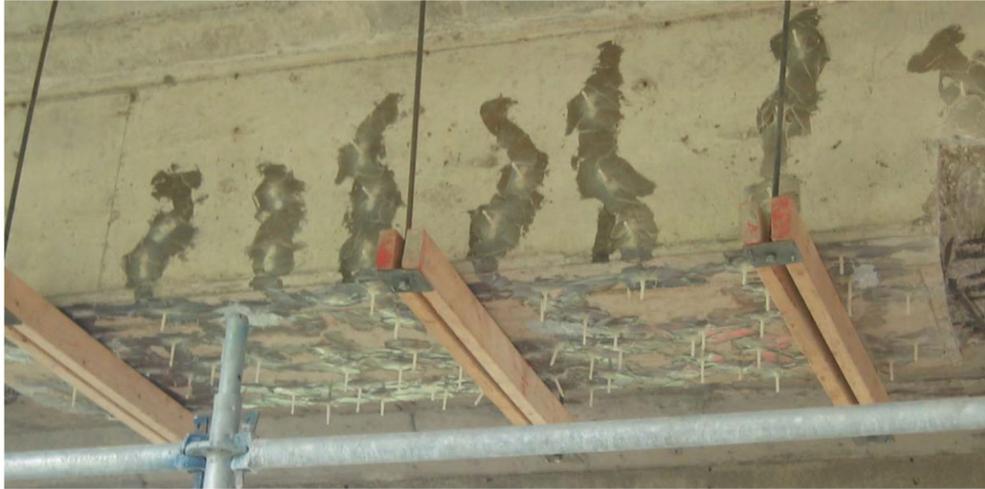
Figure 4-2. Concrete surface after epoxy injection [34]

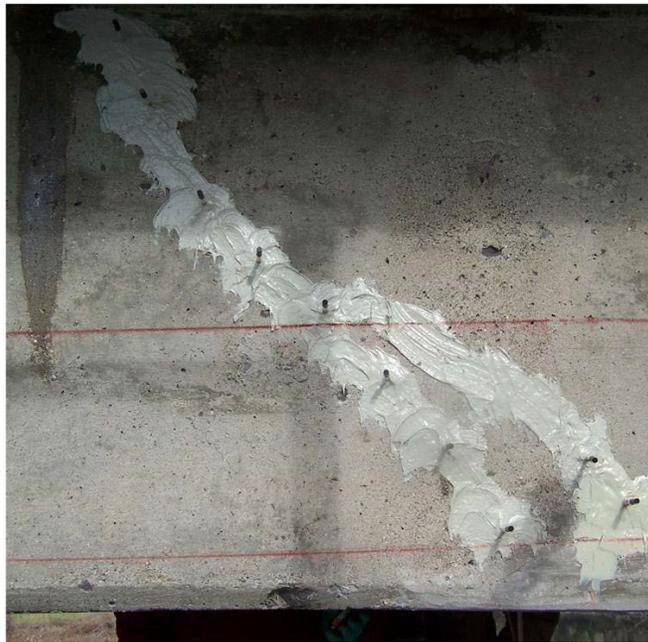
Figure 4-4. View of the crack filled with low viscosity epoxy [28]

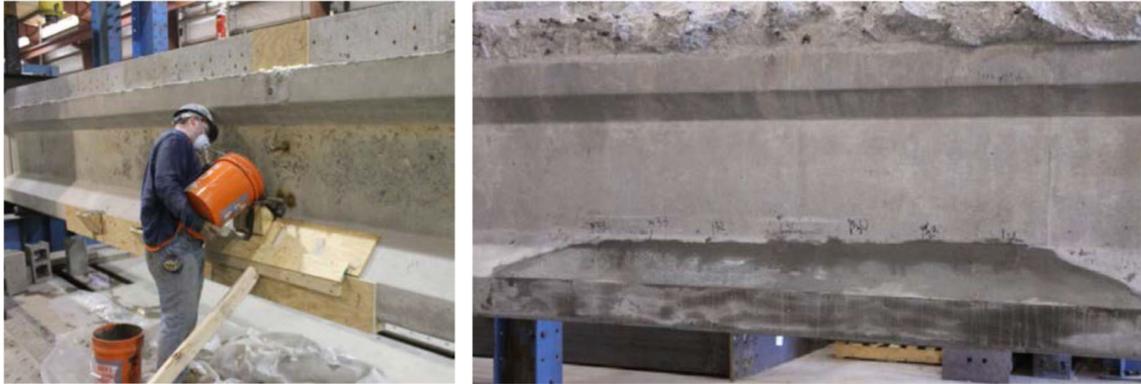
Figure 4-6. Mortar application of an impact damaged bridge girder [18]

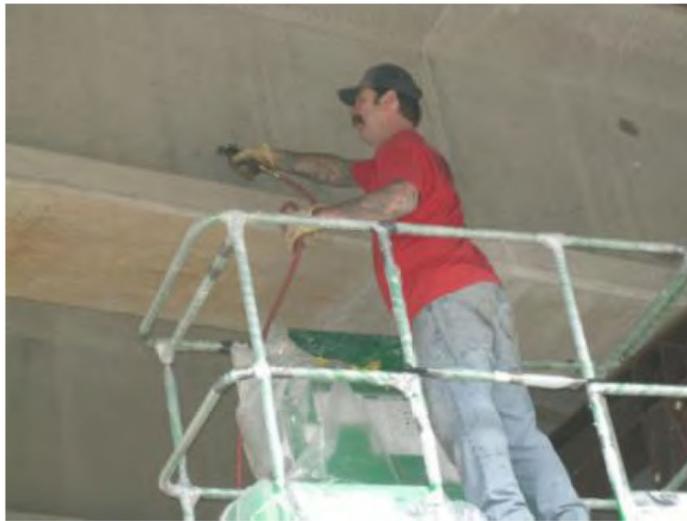
Figure 4-9. Surface cleaning using compressed air [36]

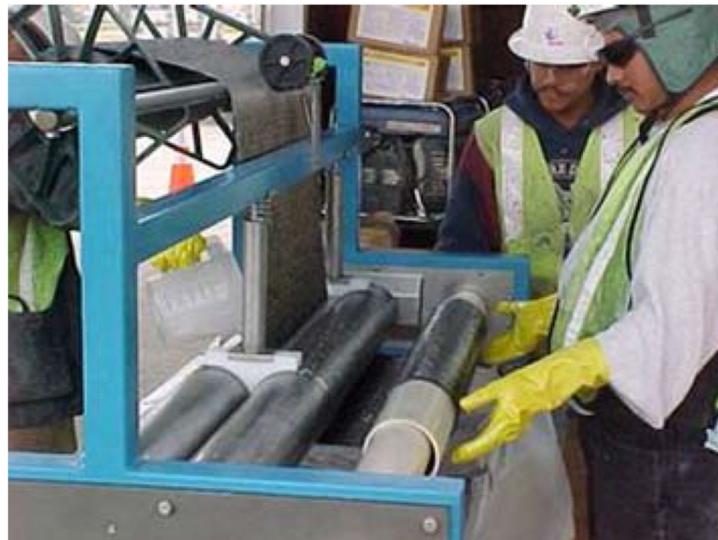
Figure 4-12. An illustration of a saturator machine [33]

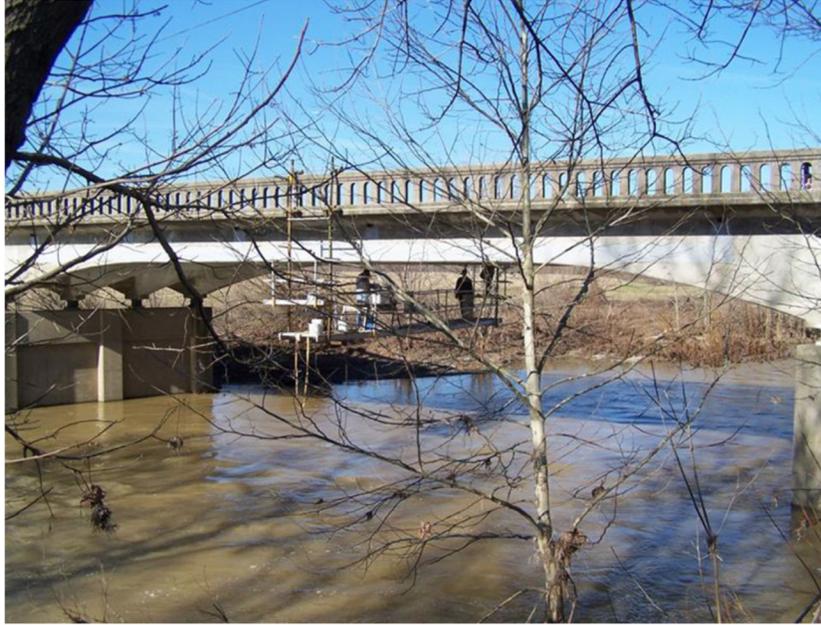
Figure 4-23. Implementation of the SFRP repair using adjustable and movable scaffolding [28]

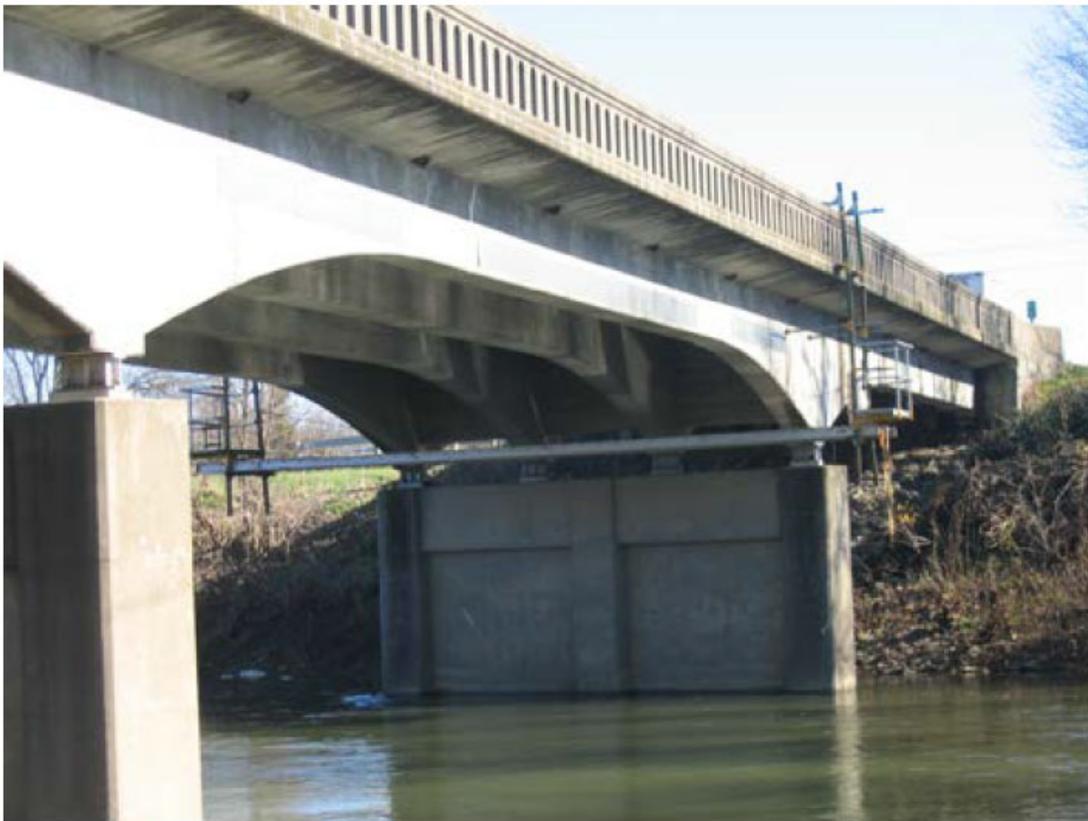
Figure 4-31. Beam strengthening using CRP over waterway [27]

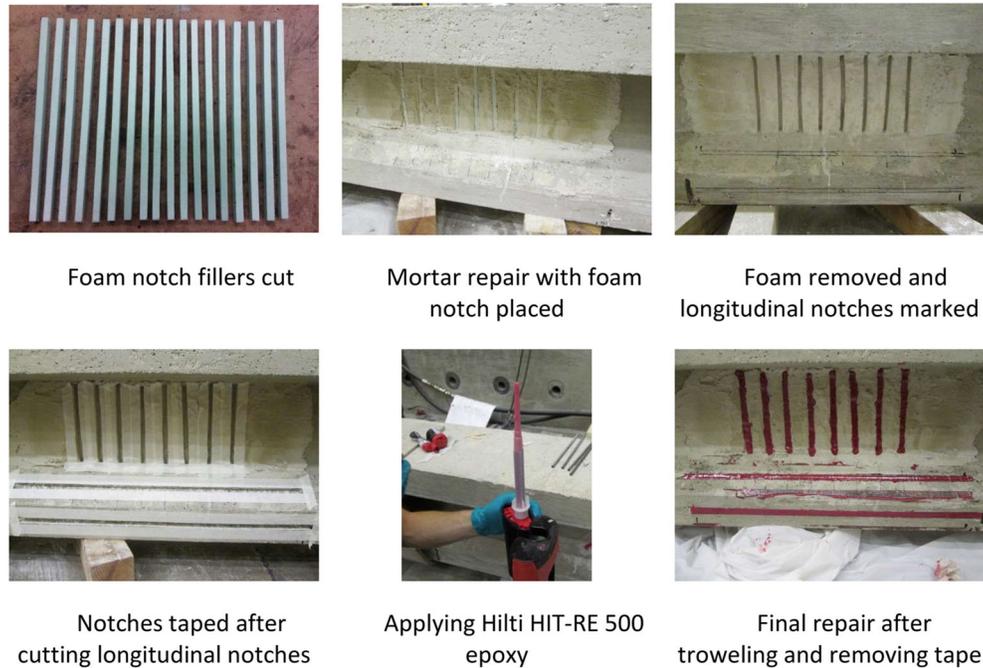
Figure 4-36. FRP NSM repair process [55]

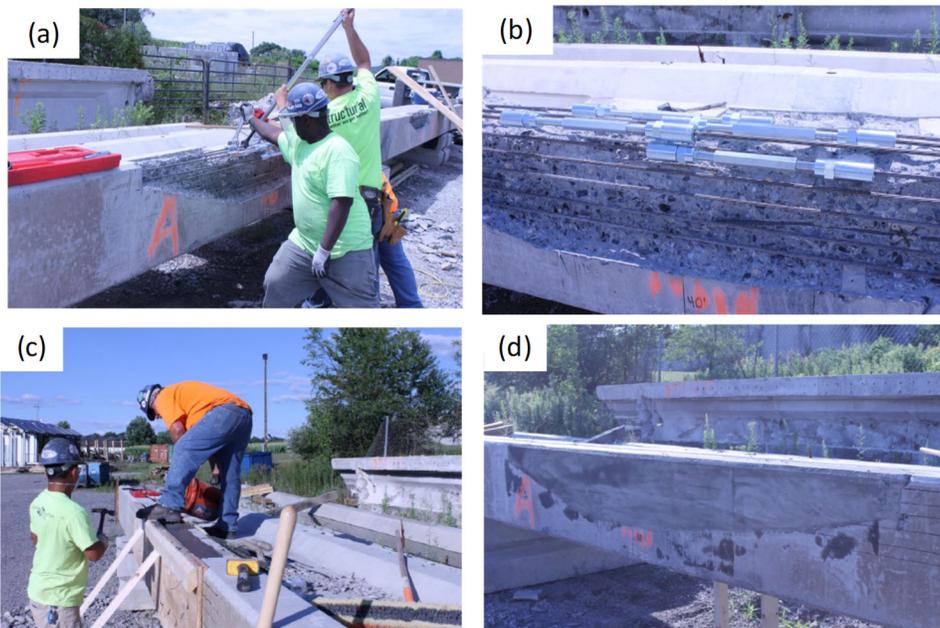
Figure 4-71. Repair procedure using strand splices: (a) installation of the strand splices (b) completed installation of the strand splices (c) placing the repair concrete (d) completed repair after concrete placement and form removal [20]
