ACCELERATED BRIDGE CONSTRUCTION  
UNIVERSITY TRANSPORTATION CENTER

ABC-UTC GUIDE FOR:

# REPAIR OF REINFORCED AND PRESTRESSED CONCRETE BRIDGE GIRDERS

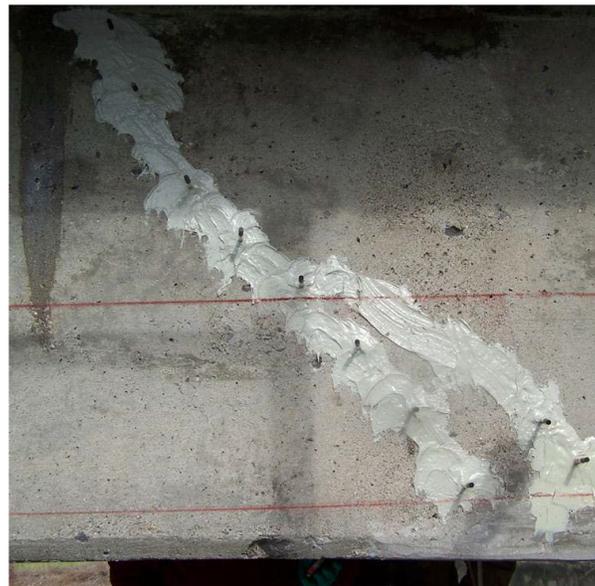
**Figure 1. View of the crack filled with low viscosity epoxy [32]**

extending entirely through the section, or if the defect goes beyond the reinforcement layer, or in general if the volume is large, (4) Synthetic Patching: This method is beneficial where Portland cement patches are difficult or impractical to apply. Examples are patching at freezing temperatures or patching very shallow surface defects. In these situations, epoxy and latex based products can be used. Epoxies can be used for a variety of purposes: a bonding agent, a binder for patching mortar, an adhesive for replacing large broken pieces, or as a crack repair material. Small deep holes can be patched with low-viscosity epoxy and sand whereas shallower patches require higher viscosity epoxy and are more expensive. Although epoxies offer excellent bond and rapid strength development, they are hard to finish and usually result in a color difference between the patch and the base concrete. Therefore, it is suggested that epoxy mortars be used only in situations where exceptional durability and strength are required. Latex materials are used in mortar to increase its tensile strength, decrease its shrinkage and improve its bond to the base concrete, thus helping to avoid patch failure due to differential shrinkage of the patch. Latex is especially useful in situations where feathered edges cannot be avoided, (5) Epoxy Injection: This method is used to repair cracks or fill honeycombed areas of moderate size and depth. It becomes an important part of the repair process specifically for corrosion damaged girders in which cracking and spalling of the concrete is commonplace. Epoxy injection should be done only appropriately trained personnel [24, 31]. Figure 1 shows an example of a concrete girder surface after epoxy injection.

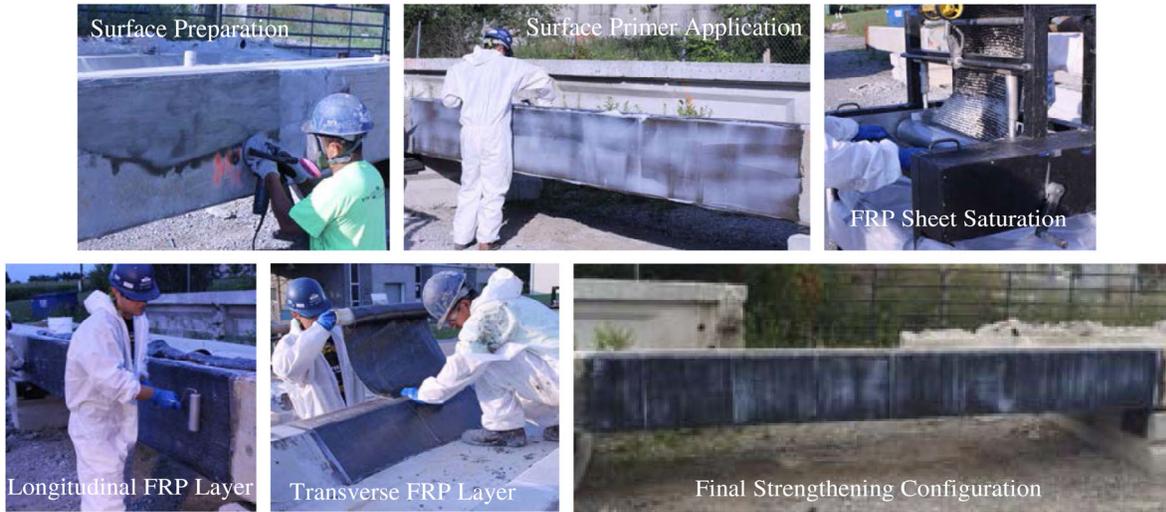
Figure 2. wet-layup approach for the application of CFRP sheets [17]

**EB technique:** The EB repair techniques using FRP materials are usually implemented in three ways: (1) wet layup (2) prepreg, or (3) pre-cured. In the wet layup approach (see Figure 2), the resin serves to both saturate the fibers and bind the sheet to the concrete surface. Dry fiber sheets impregnated with a saturating resin on site and bonded to the concrete substrate using the same resin to be cured. Usually, the saturating and the curing process are done on site. But, they also might be implemented at the manufacturer's facility off site as well. This method has the advantage of the flexibility of the FRP sheets. Thus, it is appropriate for application on surfaces that are relatively smooth, but have an abrupt or curved geometry. The relatively smooth surface is a requirement here to make sure that proper bond is achieved between the concrete and the strengthening material. Wet layup applications are suitable for column wrapping and U-wrap applications, however are not generally recommended for flexural repair for prestressed concrete girders [1, 19, 24, 39]. In the prepreg approach, the fiber sheets are saturated offsite and also partially cured. On the site, they are bonded to the concrete surface using resin and they often require additional heating to complete the curing [19]. In the pre-cured approach, the resin is only used for gluing the procured (fiber and matrix already combined) laminates, strips, or sheets to the concrete surface. The fibers are saturated and cured offsite like precast concrete members. Pre-cured strips are available from a variety of manufacturers in discrete sizes and a number of 'grades. As for CFRP strips, high strength (HS), high modulus (HM) and ultra-high modulus (UHM) grades are commercially available. In this method, the repair material is rigid and cannot be bended if a more flexible application is needed. Therefore, the application is limited to straight or slightly curves surfaces. This method is used when the surface of the structure is smooth and flat or when using the wet layup method is not practical [1, 19, 24, 29, 39].

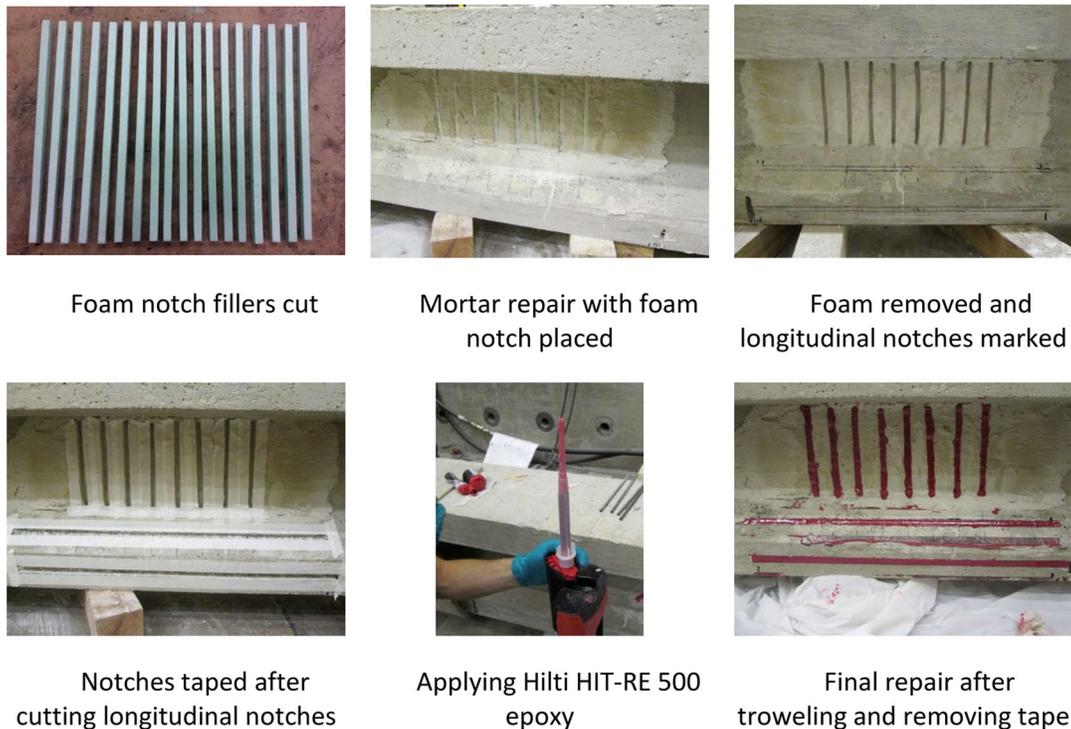
Figure 3. FRP NSM repair process [39]

**NSM technique:** first, grooves are made into the concrete surface, and the concrete in between the cuts is chiseled away. Then, the groove is cleaned and dust is removed using compressed air. In order to have a clean final appearance, tape can be applied to the sides of the grooves. The strengthening material (bar or thin strip, etc.) is then fastened into the groove using a filler material (epoxy resin, cement grout, etc.). Finally, the adhesive surface is leveled using a trowel and the tape is removed (prior to curing of adhesive) [39]. The procedure for an example application of the NSM repair is shown in Figure 3.

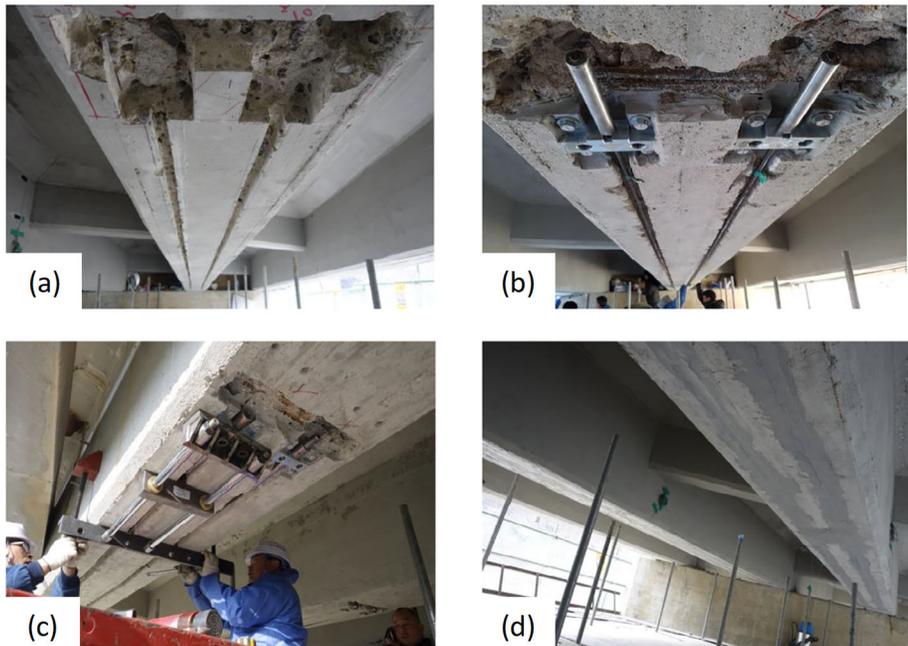
Figure 4. Implementation procedure for the prestressed NSM technique: (a) form the groove, (b) place the anchorage device, (c) apply pre-stress, (d) inject the filler [16].

To increase the efficiency of the repair, the material for both EB and NSM methods can be prestressed. Pre-stressing was first utilized for strengthening bridges in 1950s [40]. It enables the member to sustain higher loads and cover a longer span length due to the negative moment that is generated in the element. It is relatively fast and that it can be done without impacting traffic [41]. It also helps to upgrade the performance of the member in terms of both load-carrying capacity and serviceability (for instance, controlled deflections and crack initiation) that could not be achieved otherwise [42]. Some of the advantages of prestressing the repair material are: Fully utilizing the high strength of the material, improving the serviceability of RC beams, limiting the propagation of old cracks, delaying the formation of new cracks, enhancing the stiffness of the beams, better utilization of the strengthening material, smaller and better distributed cracks in concrete, unloading (stress relief) of the steel reinforcement resulting in higher steel yielding loads, potential for the restoration of service level displacements or performance of the structure, confining effect on concrete (and, significantly, any patch material) because they place the concrete into compression, and thus, they cause a delay in the onset of cracking and a reduction of crack widths [43, 44]. However, it should be noted that generally, different levels of prestressed forces will result in different failure modes. Also, despite all the advantages of prestressing the repair material, design of the end anchorage system requires accurate and expensive analysis due to the presence of large shear forces, large concentrated compressive forces, and induced moments due to the eccentric post-tensioning forces. If needed, the anchorage system should also be post-tensioned itself [19]. Figure 4 shows the prestressing setup and procedure for the implementation of the NSM technique for an RC girder.

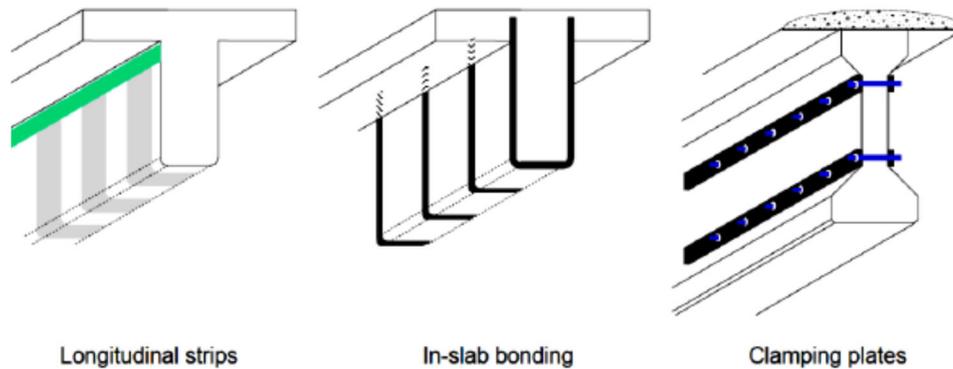
Figure 5. Schematic of the common anchorage methods

For cases of high peeling or shear stress, an anchorage system might be used in order to delay debonding of the strengthening system such as FRP materials. A proper anchorage system might allow the use of a strengthening plan that otherwise would not meet design code provisions, allowing the repair material to continue carrying load even after debonding occurs and thereby increasing its contribution. It can enable greater strengthening or the use of a wider range of possible configurations and material properties. Different anchorage systems has been introduced so far depending on the strengthening approach that they are used with. Some examples include: additional horizontal strips of the repair material, embedment of the repair material into the beam flange through precut grooves with adhesive bonding, various mechanical anchorage systems involving bolts and plates, and fan-shaped textile-based anchors [30, 39, 42, 45]. Figure 5 shows a schematic of the first three systems, while Figure 7 shows a real-life application of the horizontal strips which is the most common approach. Figure 6 provides an illustration of a typical fan-shaped textile-based anchor, while Figure 8 shows a real-life application of the anchors to the web-bottom flange interface of an RC girder. These anchors have the advantage of being light-weight and non-corrosive. Additionally, since the use of FRP-based or textile-based materials are commonplace for girder repair, using a compatible anchor material is also advantageous [7].

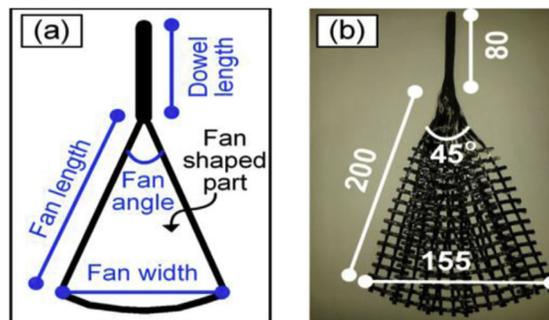
Figure 6. Fan-shaped textile-based anchors [7]

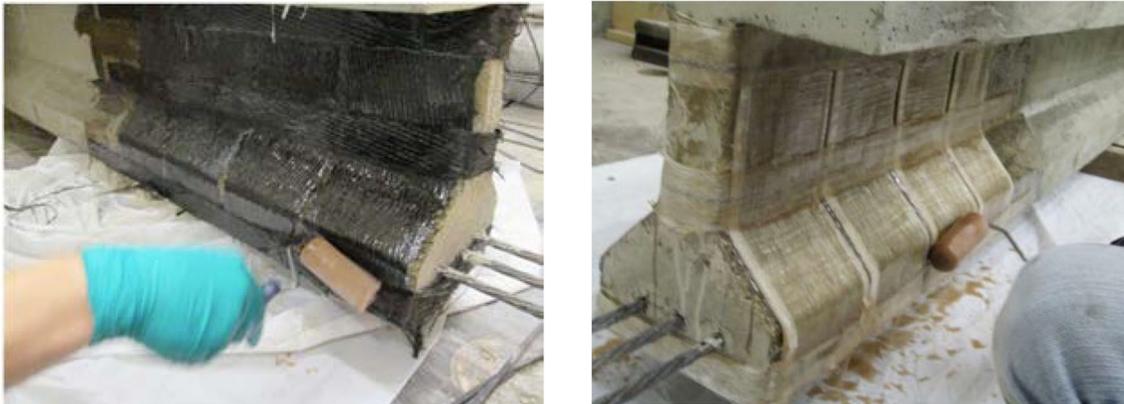
Figure 7. End anchorage system using CFRP or GFRP strips [39].

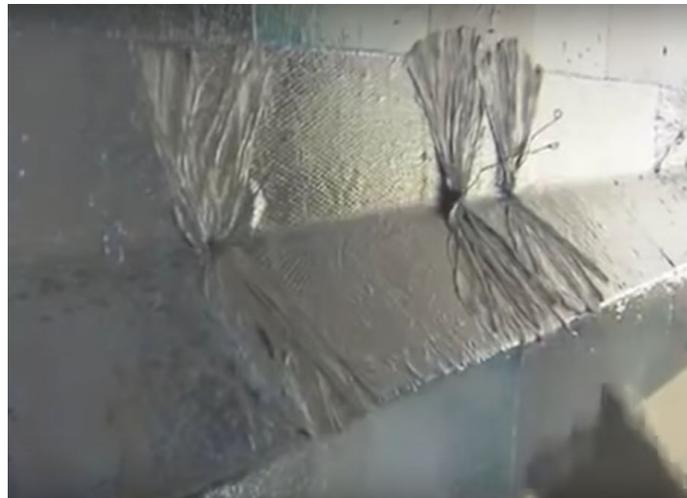
Figure 8. Plugs of CFRP anchors inserted into holes inside the concrete surface [46]

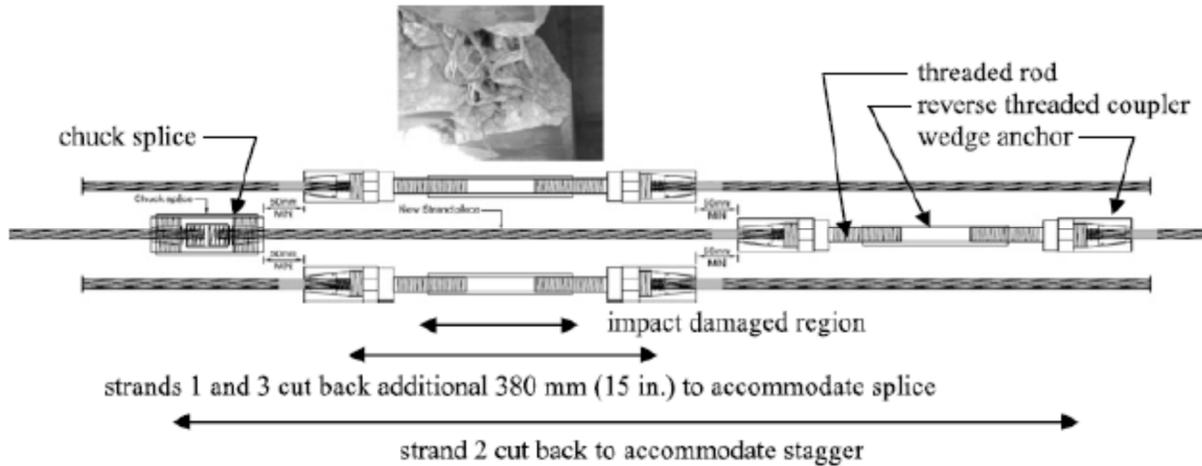
Figure 9. Staggering of the strand splices [47]

When one or more prestressing strands in a prestressed girder are damaged, strand splicing can be used to do the repair. It is a fast, efficient, and cheap repair method for reconnecting damage or broken prestressing strands in order to restore the prestressing force. strand splices alone cannot be relied on for fully restoring the ultimate strength of the strands or the element that is being repaired as they are limited to developing 85% of the nominal strength of the strands they are joining ( $0.85f_{pu}$ ), i.e. the advertised minimum strength of a strand splice. In order to increase their efficiency, the splices should be staggered (see Figure 9) and limited to splicing 15% of strands in a girder, regardless of staggering [47, 48]. It should be mentioned that commercially available splices are available for strand diameters only up to 0.5 in [19, 24, 47]. Additionally, strand splices are internal applications and therefore may be used with almost any external application. NSM method might be an exception since interference between the strand chucks and NSM slots might happen [24]. However, they can be combined with an externally bonded repair method using a repair material such as FRP or FRCM [49].

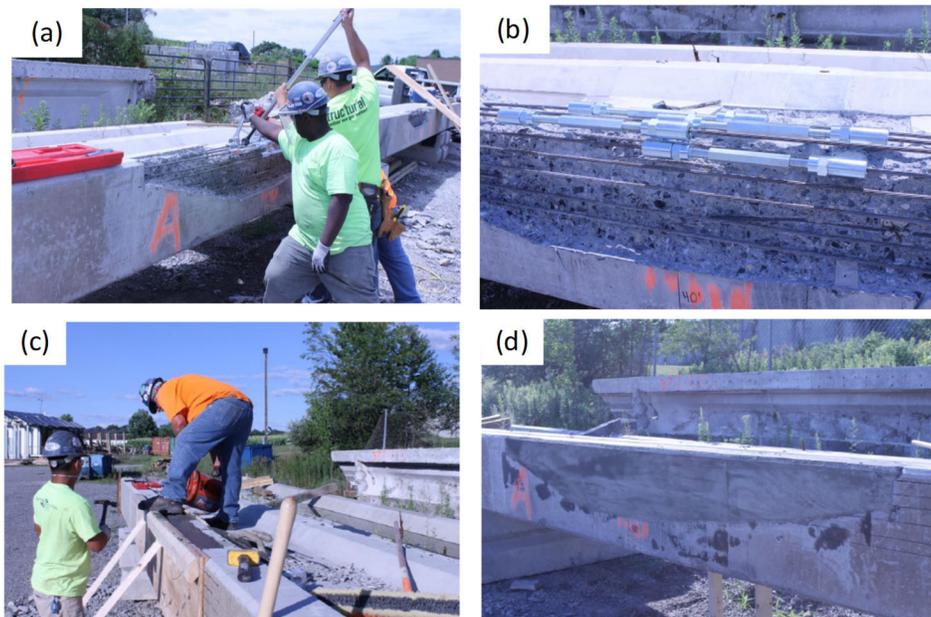
Figure 10. Repair procedure using strand splices: (a) installation of the strand splices (b) completed installation of the strand splices (c) placing the repair concrete (d) completed repair after concrete placement and form removal [19]

Figure 10 illustrates the procedure for strand splice repair of a RC girder.

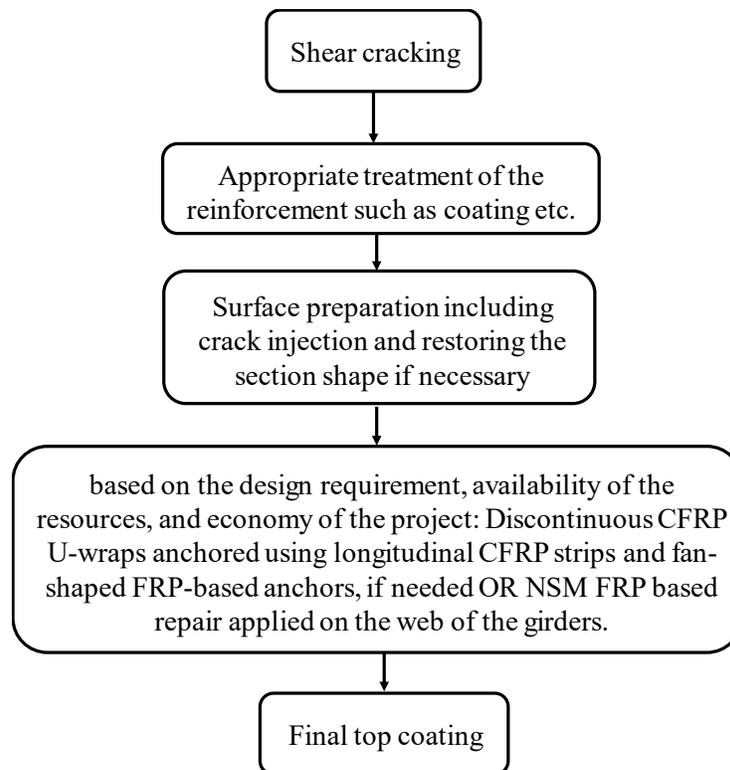
**Figure 11. Repair procedure for bridge girders with shear cracks**

Eventually, it seems that the EB FRP U-wraps with longitudinal FRP strips as the anchorage system is the most common and well-researched technique for shear repair of RC bridge girders, which can usually increase the shear capacity of the girders at least by 25 percent. In case more increase in the shear capacity is needed, use of fan-shaped FR-based anchors in conjunction with the longitudinal strips seems to be a promising approach that has gained popularity in the last few years. Depending on the conditions of the project in hand, if the human and monetary resources for the implementation of the NSM technique are available and its long term efficiency is proven to be superior to the EB method (if long-term efficiency is a requirement of the project), use of a NSM method

is also recommended. These conclusions are reflected in the recommended repair procedure chart shown in Figure 11.

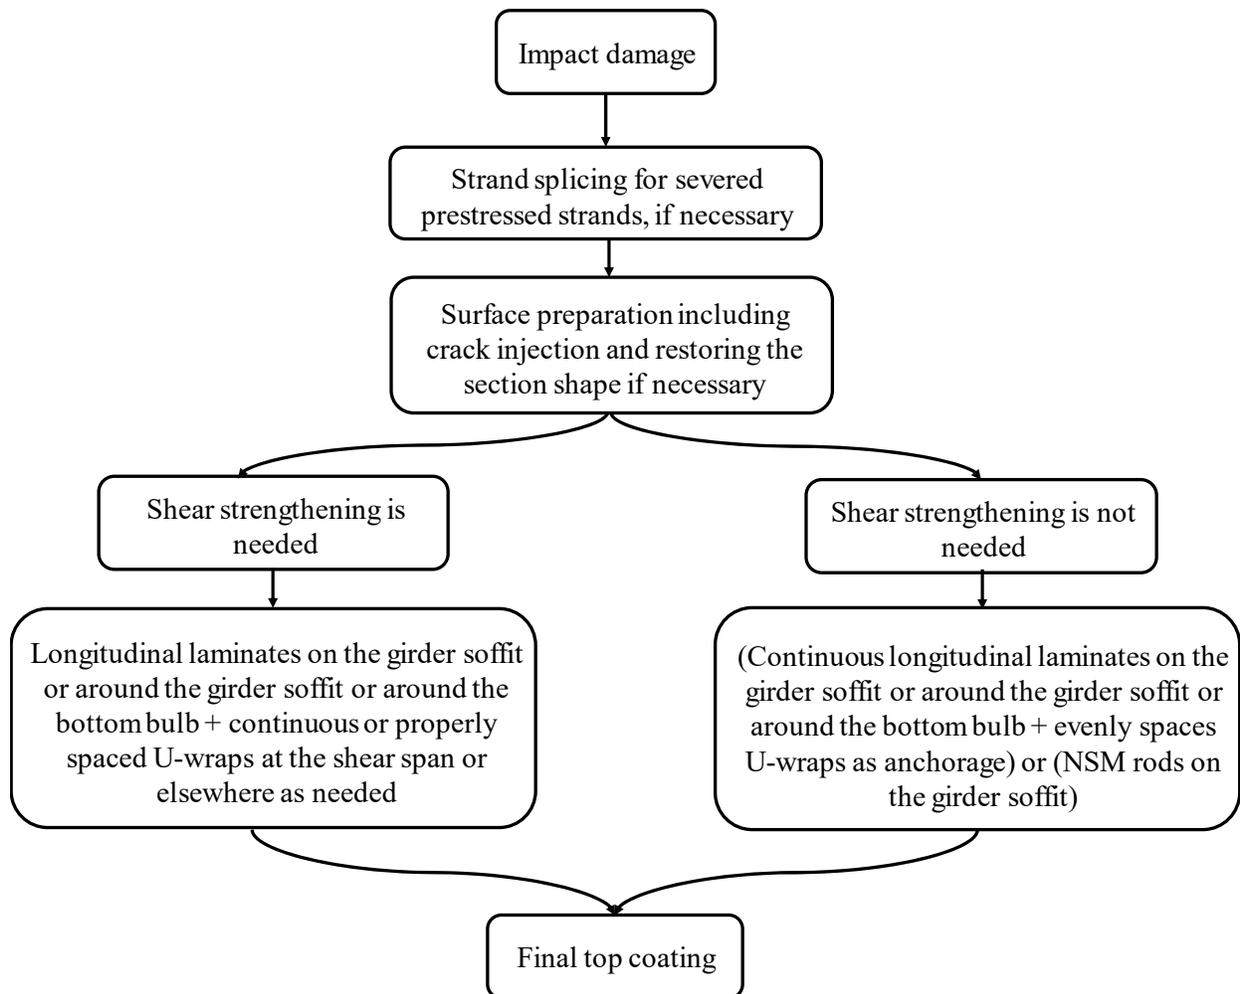
Figure 12. Repair procedure for bridge girders with impact damage

The recommended repair process based on the most commonly used repair approach in the literature, is shown in Figure 12, depending on whether or not shear strengthening is needed for the damaged girder. This will be longitudinal laminates EB to the girder soffit in conjunction with evenly spaced U-wraps as anchorage, where shear strengthening is not needed, or in conjunction with properly spaced U-wraps where shear strengthening is required. If the project conditions allow, NSM mounted rods on the girder soffit might also be used. As for the repair material, although the most popular repair material was found to be CFRP, the choice of the material depends highly to the specific project conditions.

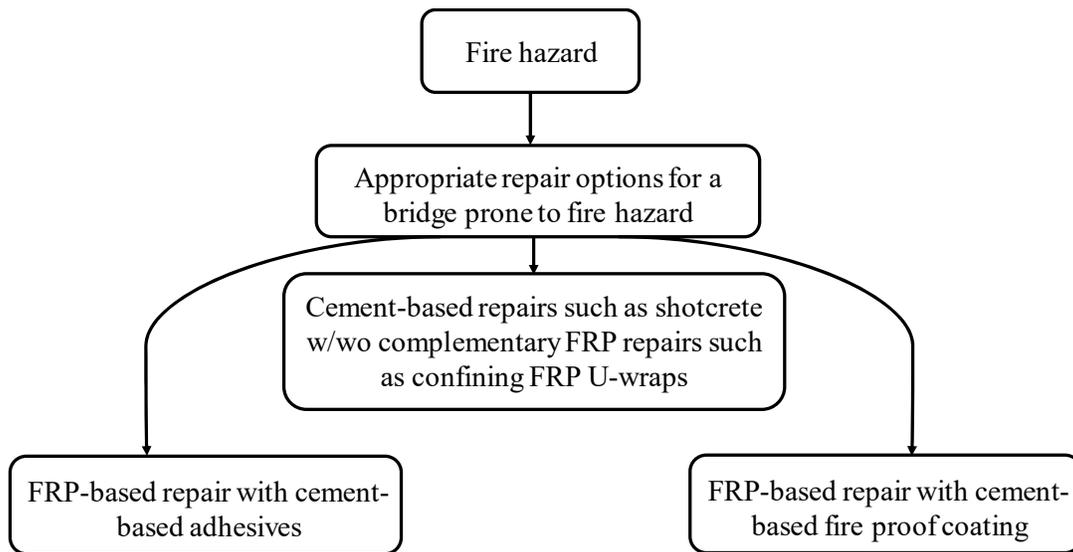
Figure 13. Appropriate repair approaches for bridges prone to fire hazard

Based on the repair approaches for fire-critical bridge girders found in the literature, a repair flowchart with three possible repair scenarios is provided in Figure 13.
