AUTOMATED MFL SYSTEM FOR CORROSION DETECTION

**Quarterly Progress Report
For the period ending November 30, 2022**

**ACCELERATED BRIDGE CONSTRUCTION
UNIVERSITY TRANSPORTATION CENTER**

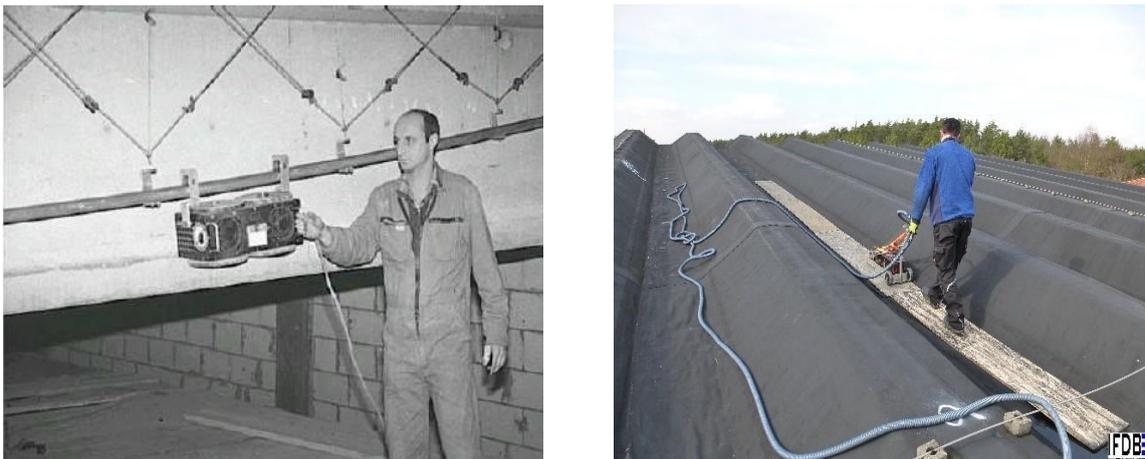
Figure 1.2: MFL application using manual equipment (Photo courtesy Prof. Bernd Hillemeier).

The method first was developed in late 1970s and has been subject to ongoing evaluation as sophistication of electronic instrumentation and data analysis techniques have improved. The two main components of the MFL system are the sensing and magnetizing units. The measurement of the signal is performed using an active or remnant method. A few field applications of MFL method is shown in Figure 1.2 which employs different magnetizing and signal measurement systems.

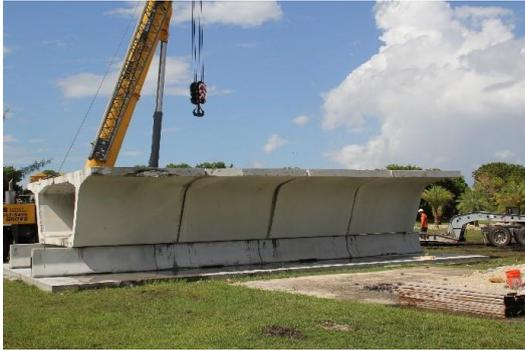
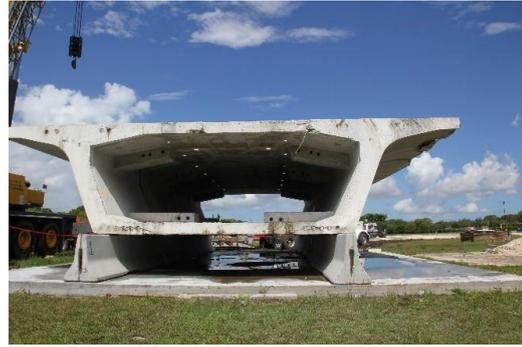
Figure 1.3: Segments of segmental concrete bridge at FIU.

This section provides a brief summary of one of the test that demonstrates the manual application MFL method. Figure 1.3 shows the segments of a segmental concrete bridge that were saw cut and brought to Florida International University (FIU) for the development of MFL method. These box girder sections contain an empty duct which is used as a test bed for the MFL method.

In this task, laboratory validation of the efficacy of the automated system utilizing small robots and wireless data acquisition system. The laboratory test will be conducted on the bridge segments at FIU as shown in *Figure 1.3*.

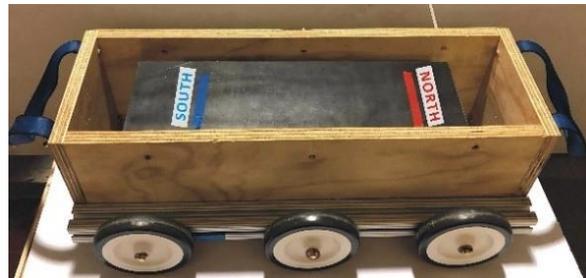
Figure 1.4: MFL equipment.

The un-grouted empty ducts provide an opportunity to simulate different test conditions. A group of strands, with known damages, were placed inside this duct and testing was carried out to assess the capabilities of the method. Figure 1.4 shows the MFL system which includes a permanent magnet, magnetic sensors, linear encoder, data acquisition system, and power supply.

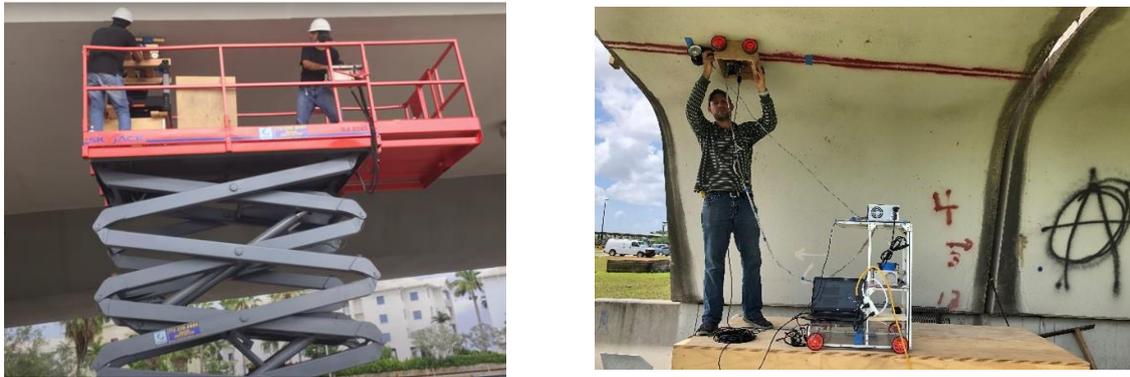
Figure 1.7: Challenges for field implementation [5].

the interference of signals from mild reinforcement. Although the method has shown promising results, but the field implementation is still challenging. The method essentially consists of magnetizing the tendon and then taking MFL signal measurement concurrently or independently with the magnetizing unit. For majority of applications, magnetizing of the tendons can be carried out from accessible area of the bridge. The main challenge is to perform signal measurement which can be cumbersome and difficult. *Figure 1.7* shows few photographs of the field challenges during signal measurement [5]. In addition, the tendons in prestressed structures are typically placed in a straight, harped or a parabolic profile. This arrangement of tendons increases the level of difficulty in implementing the MFL method. The complex profiles of these tendons limit the use of clamped, climbing assemblies and rotary systems. There is a need to develop an automated approach for signal measurement using a combination of robotics, unmanned automated aerial drones and advanced image and data processing techniques.

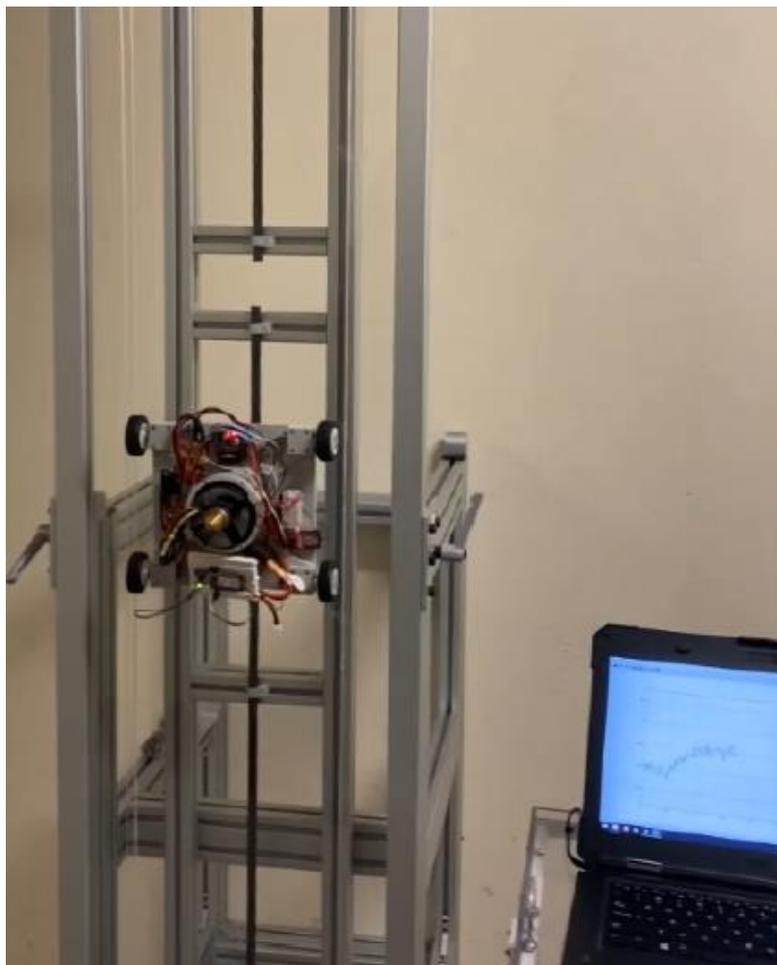
Figure 2.1: Suction based wall climber.

One of the first prototype developed at FIU consisted of a wall climbing robot. A small robot, as shown in *Figure 2.1*, has been utilized as first prototype and the MFL system with wireless data acquisition was mounted on it. The robot used a negative pressure- thrust suction method to climb vertically on walls.

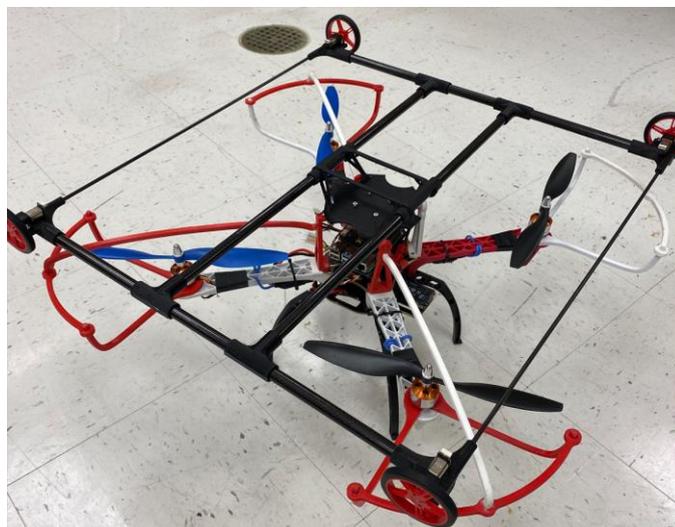
Figure 2.3: Fabricated drone for MFL testing.

The four corner wheels are mounted to provide greater stability, speed, payload capacity and to drive the drone on walls and roof. The fabricated drone is shown in *Figure 2.3*.
