1. Report No. ABC-UTC-UW 2016-3-2 -Final	2. Government Accession No.	3. Recipient's Catalog No.	
4. Title and Subtitle Economic Pier-to-Pile Connections for Permanently Cased Shaft (CFST) Piles		5. Report Date September 9, 2022

ECONOMIC PIER-TO-PILE CONNECTIONS FOR PERMANENTLY CASED SHAFT (CFST) PILES

Final Report
April 2022

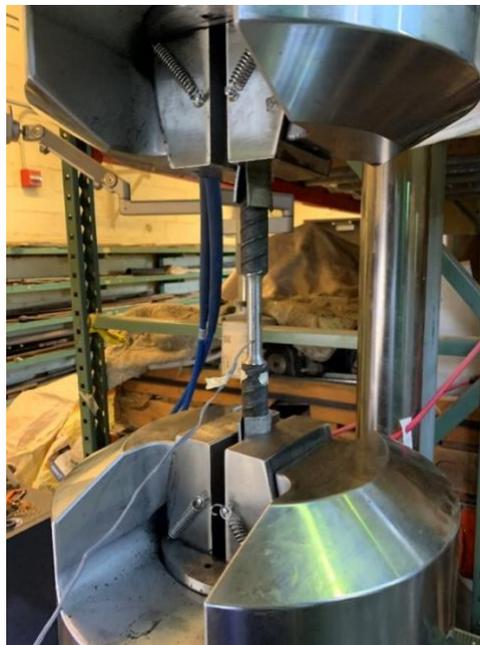
The reinforcement was expected to yield from the lateral loading during the test. To determine the actual stress-strain relation of the reinforcement, steel from the longitudinal column reinforcement was tested in tension to ASTM 370 standards. The test setup is shown in Figure 3.6. The stress-strain relationship of the reinforcement was characterized using the stress and strain at the Yield, Ultimate, and Fracture points, which are shown in Table 3.4 below.

Figure 3.6. Reinforcement Tensile Test Setup

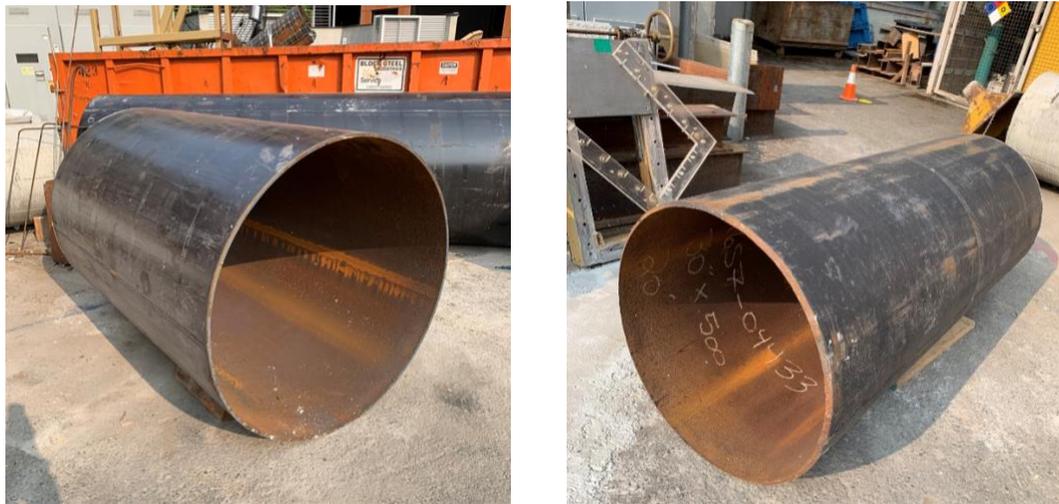
The straight seam welded steel tubes are API 5L X52 for the 30 in. diameter tube, a 52 ksi nominal yield strength, and API 5LB X42 for the 48 in. diameter tube, a 42 ksi nominal yield strength. Tubes were purchased from Richards Pipe & Steel, Inc. in Pacific, Washington.

a)
Figure 3.7. a) 48 in. and b) 30 in. Diameter Steel Tubes Cut to Size

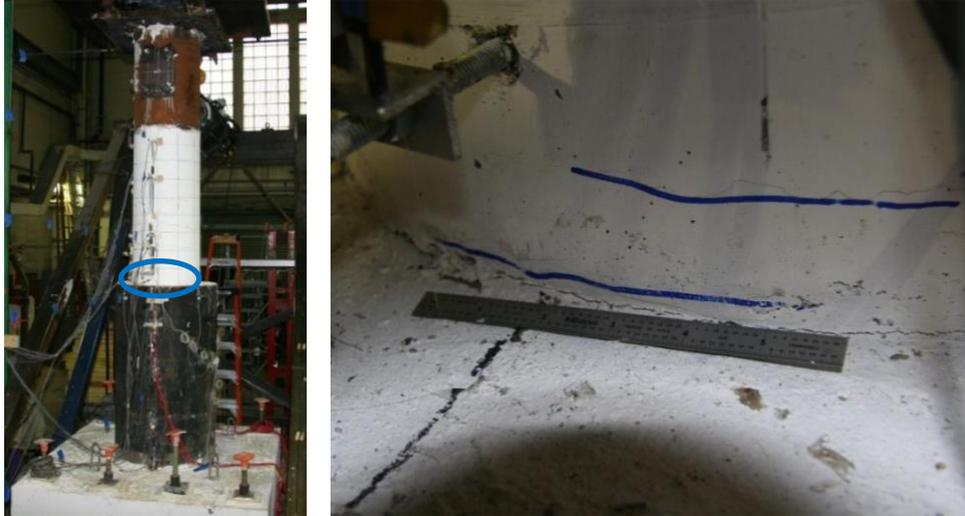
Horizontal cracks formed along the height of the column on both the north and south sides. The cracks, at the interface of the column and the top of the pile, ranged in width from 0.3mm to 0.5mm, shown in Figure 4.7.

Figure 4.7. Specimen 30-21 Interface Cracks on Southern Face at 0.9% Drift

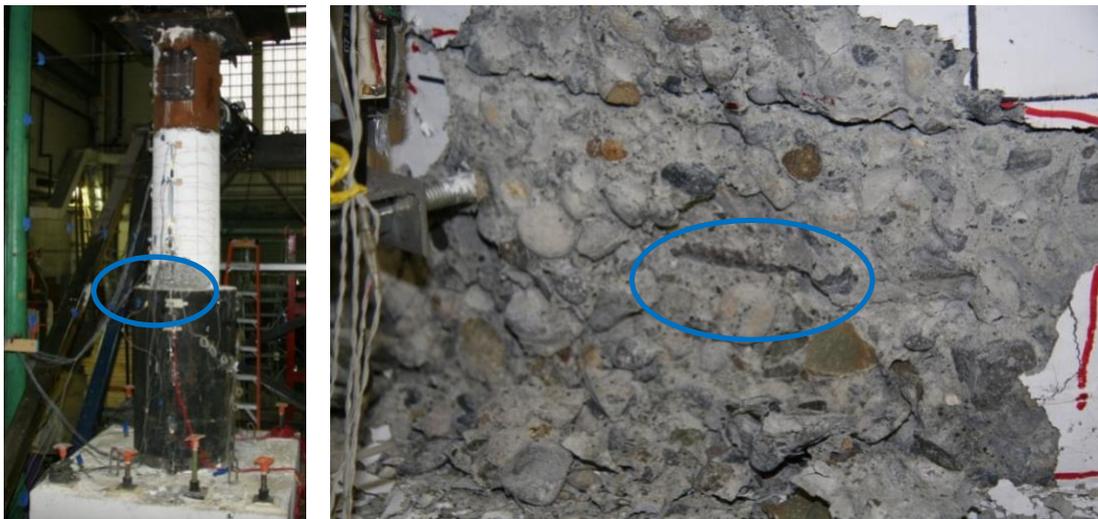
Figure 4.12. Specimen 30-21 Spalled Region on Northern Column Face at 3.7% Drift

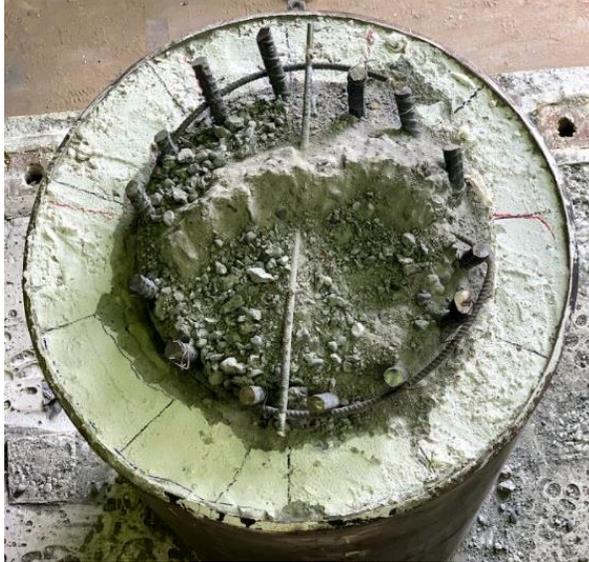
Figure 4.20. Top of Specimen 30-21 Pile with Column Removed

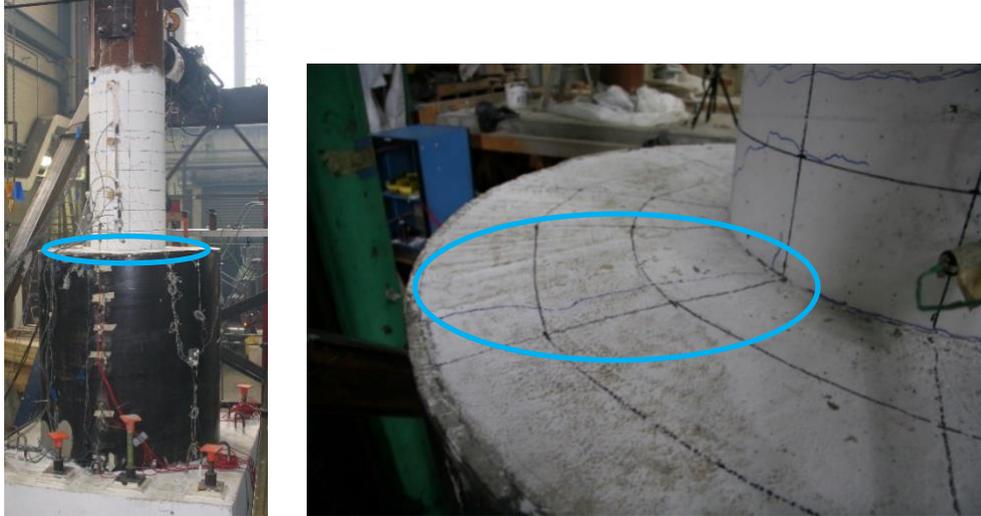
Figure 4.26. Specimen 48-21 Radial Cracks on Top of Pile Concrete at 0.8% Drift

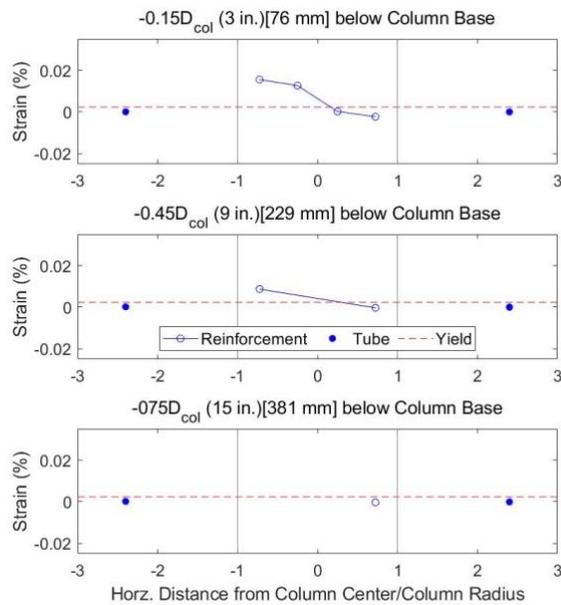
Figure 4.31. Specimen 48-21 Strain Distribution at 1.8% Drift

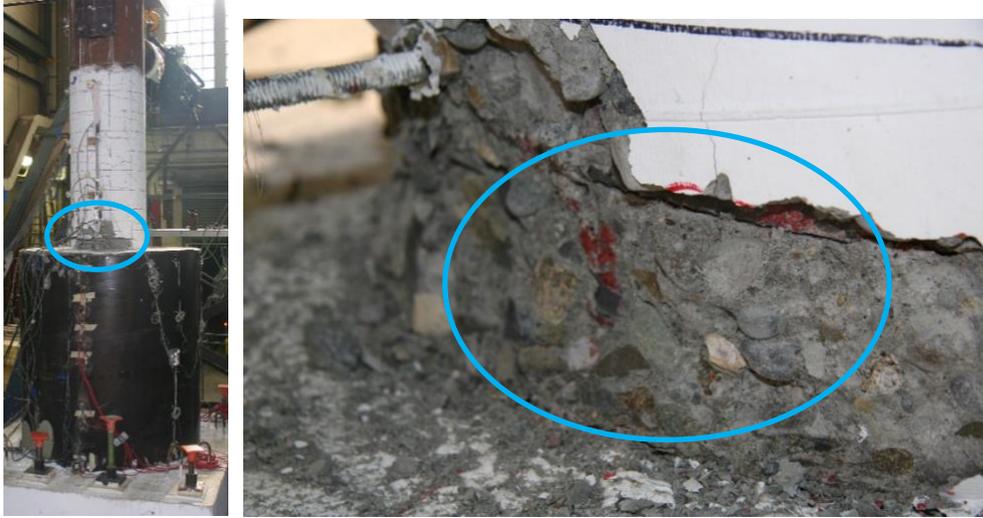
Figure 4.34. Specimen 48-21 Exposed Transverse and Longitudinal Reinforcement at 4.1% Drift

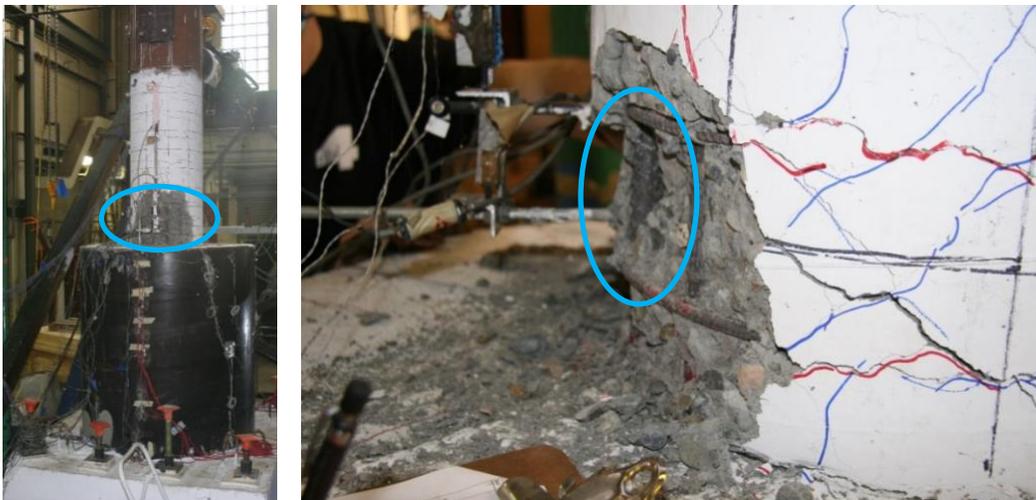
Figure 4.36. Specimen 48-21 Buckled Longitudinal Reinforcement at 5.8% Drift

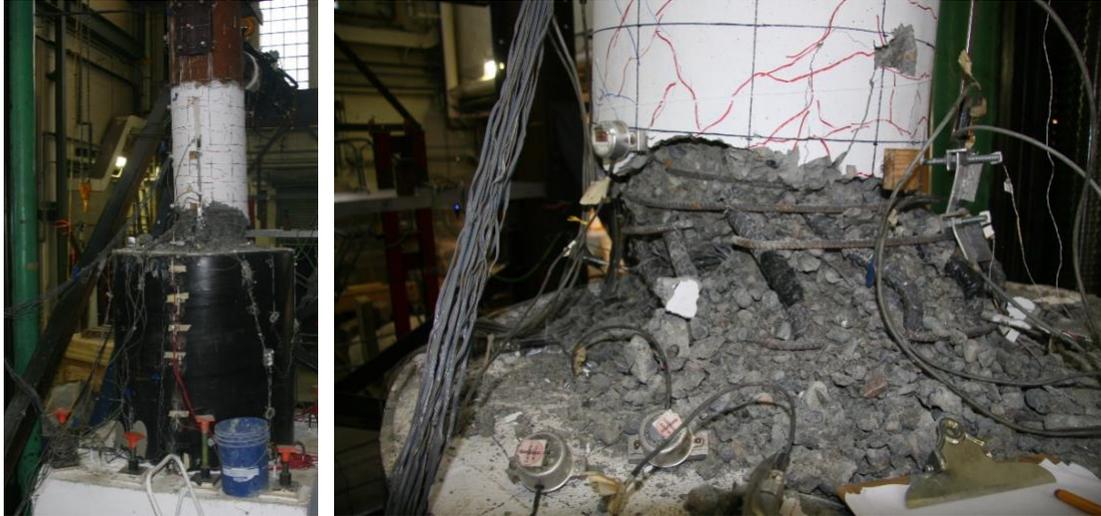
Figure 4.38. Final State of Specimen 48-21 after 9.7% drift

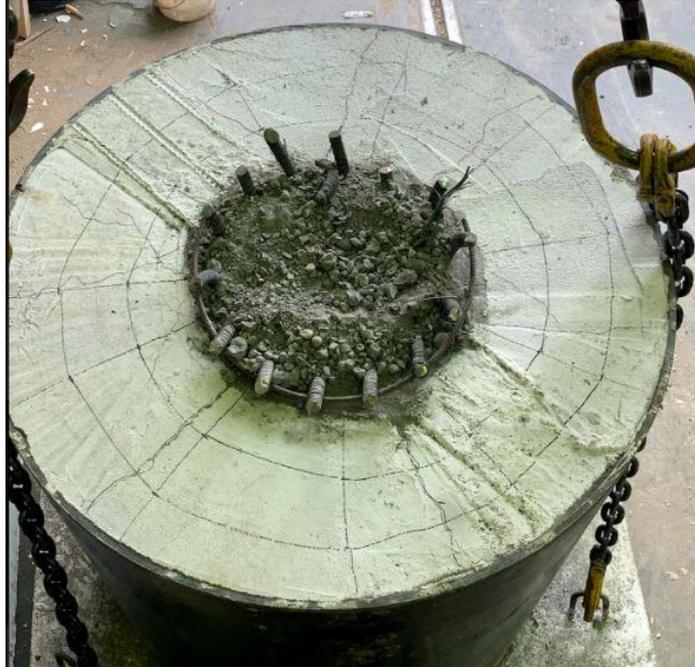
Figure 4.39. Top of Specimen 48-21 Pile with Column Removed
