Impact of Construction Eccentricity on Direct Pier-to-Pile Connections for Permanently Cased Shaft (CFST) Piles

Final Report
September 2022

Principal Investigators: Dawn E. Lehman and Charles W. Roeder
Department of Civil and Environmental Engineering
University of Washington

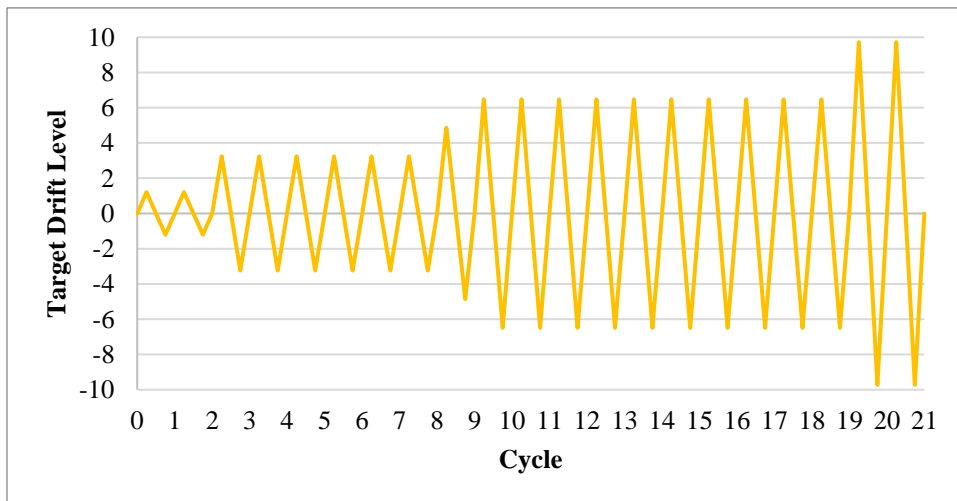
Figure 2.2. Specimen 30-21-LD Target Displacement History

Kortum modeled SDOF bridge columns under M9 ground motions. Assuming a bridge column located in Seattle, Washington, with a Bridge Strength Ratio, F_y/W , the bridges lateral strength divided by its weight, of 15%, bridge effective periods of 1.0 and 2.0s, and with a soil site classification of D3, 60 different hysteric displacement curves were modeled. Using the results of Specimens 30-21 and Kortum’s hysteric curves, it was determined that a typical bridge column would undergo 6 cycles at a ductility when first spalling would occur, $\mu=2.7$ or a column drift of 2%, one cycle at a ductility when full spalling would occur, $\mu=4.2$ or a column drift of 3%, and 6 cycles at a ductility when bar buckling would occur, $\mu=5.7$ or a column drift of 4%. The ductility is based on the results of Specimen 30-21 since it was identical to Specimen 30-21-LD. Based on these results, a testing displacement history was put together that consisted of 1 cycle at the expected yield displacement, 0.75 in., 6 cycles at 2.0 in, 1 cycle at 3.0 in., and then cycle to specimen failure, less than 50% of maximum strength at 4.0 in. This displacement history was slightly changed, as after 10 cycles at 6.5% drift the specimen had not failed, 2 cycles at 9.7% drift were run, as shown in Figure 2.8.

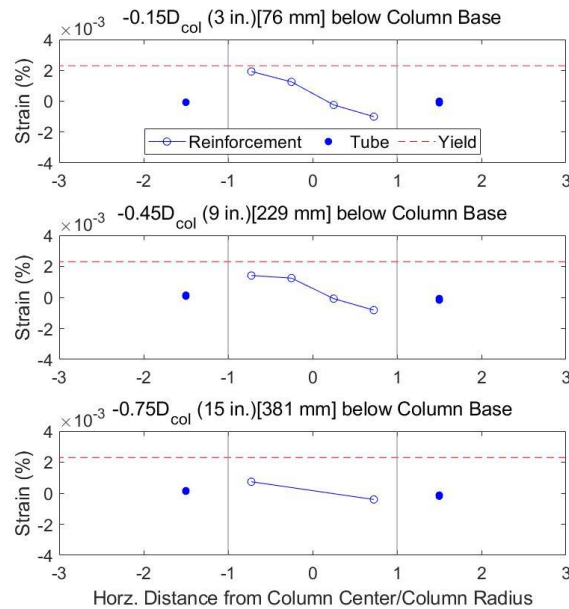
During the first cycle at 0.8% drift, the column reinforcement strain exceeded the yield strain of 0.0023 in/in at $0.3D_{COL}$ on the S bar, during the peak displacement as shown in Figure 3.16.

Figure 3.15. Specimen 30-21-R Strain Distribution at 0.8% Drift

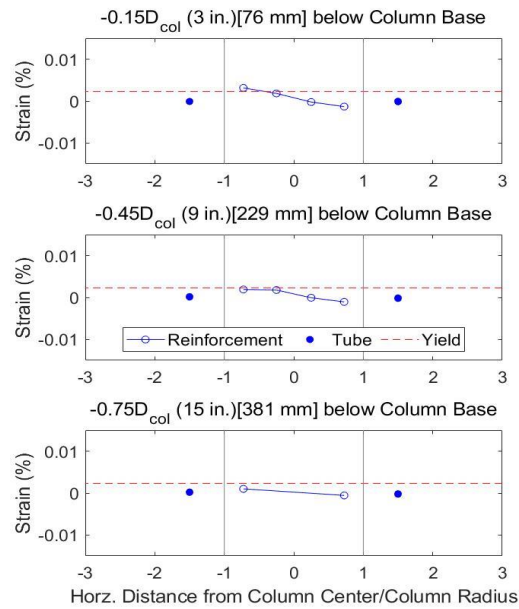
The strains measured at the peak displacement of this cycle, exceeded the yield strain for all locations from $-0.45D_{COL}$ to $0.45D_{COL}$, shown in Figure 3.17. The strains reached 0.004 in/in, at $0.3D_{COL}$ on the S bar. The locations at $-0.75D_{COL}$ did not reach the reinforcement yield strain.

Figure 3.17. Specimen 30-21-R Strain Distribution at 1.1% Drift

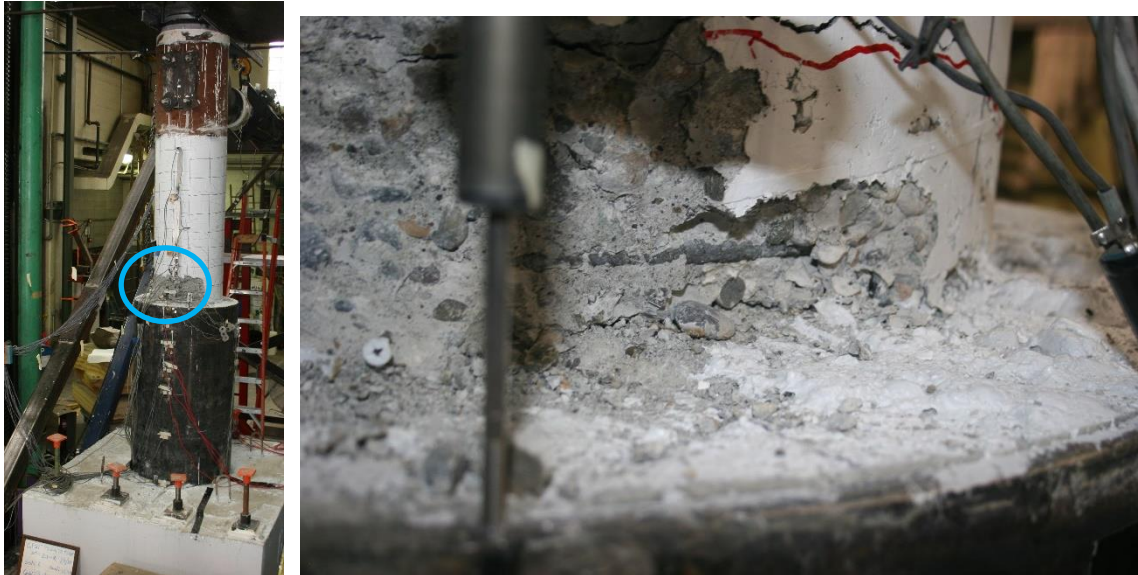
Figure 3.22. Specimen 30-21-R Exposed Transverse Reinforcement at 4.0% Drift

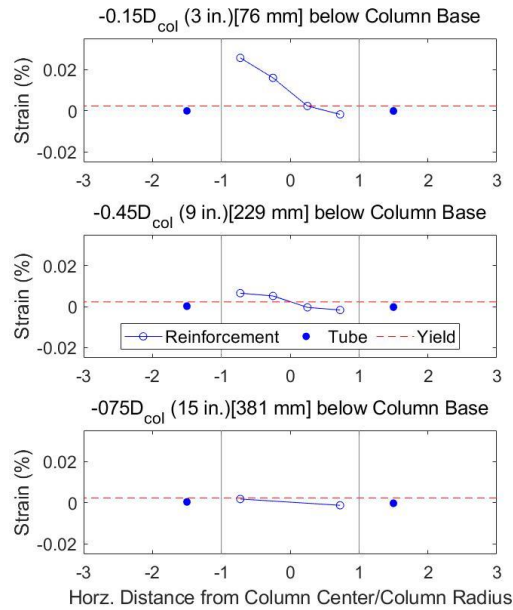
As with the previous cycle, the strains measured at the peak displacement of this cycle, exceeded the yield strain for all N and S bar locations, except for the N bar and S bar locations - $0.75D_{COL}$, as shown in Figure 3.24. The strains reached up to 0.028 in/in, which occurred on the S bar at $0.3D_{COL}$.

Figure 3.24. Specimen 30-21-R Strain Distribution at 4.0% Drift

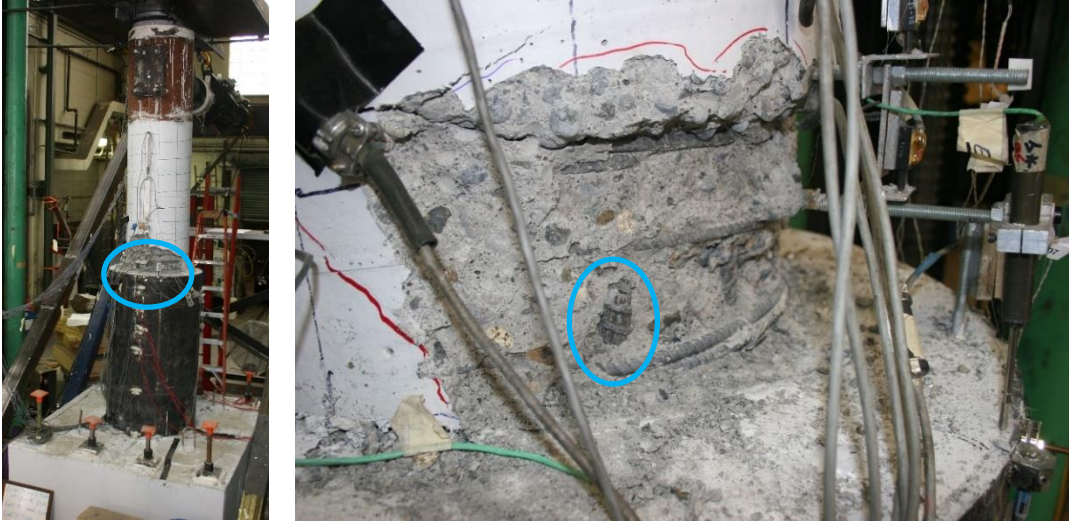
At drift cycles of 5.5%, the lateral load ranged from -1.4 to 1.3 F_n (-89.4 to 83.9 kips) approximately equivalent to the last cycle. At this drift level, in the negative direction, the maximum negative moment of $1.4M_n$ or 460.2 kip-ft. The spalled region and the crack at the column base increased in size and exposed the longitudinal reinforcement on the northern face, shown in Figure 3.25. The spalled region now had an area of 20 in. by 8 in. on the north side and 10 in. by 5 in. on the south side. From this point on the cracks were too large to be measured, but all continued to increase in size and quantity.

Figure 3.25. Specimen 30-21-R Exposed Northern Longitudinal Reinforcement at 5.5% Drift

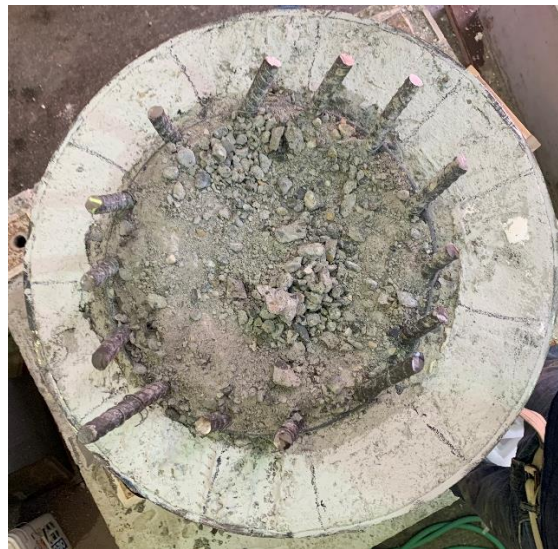
Throughout all load cycles, the pile and transfer block showed no visible damage. The largest measured strain in the pile was 0.008 in/in, which occurred 52 in. below the top of the tube, during the 4.0% drift cycles. No cracks formed anywhere on the transfer block. There was no noticeable slip between the pile concrete in comparison to the edge of the tube at any point of the test. The Duncan potentiometer measuring the slip had a maximum uplift of 0.003 in. As shown in Figure 3.30, the top of the pile concrete appears largely undamaged. Unlike Specimens 30-21 and 48-21, no radial cracks formed on the top of the pile concrete.

Figure 3.30. Top of Specimen 30-21-R Pile with Column Removed

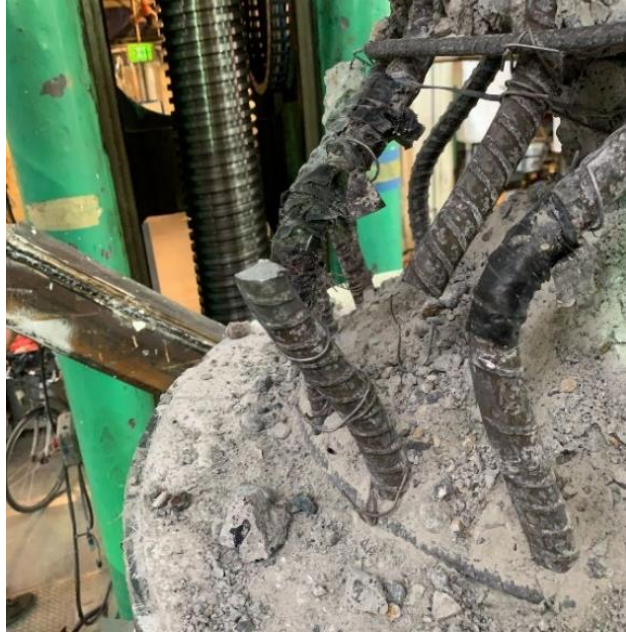
The day after the test, when working on removing the specimen from the testing rig, it was noticed that the most extreme southern longitudinal reinforcing bar had fractured overnight. No applied loads had occurred between now and the end of testing, but the fracture was caused by the weight of the column resting overnight. The fractured bar is shown in Figure 3.31.

Figure 3.31. Specimen 30-21-R Fractured Longitudinal Reinforcement

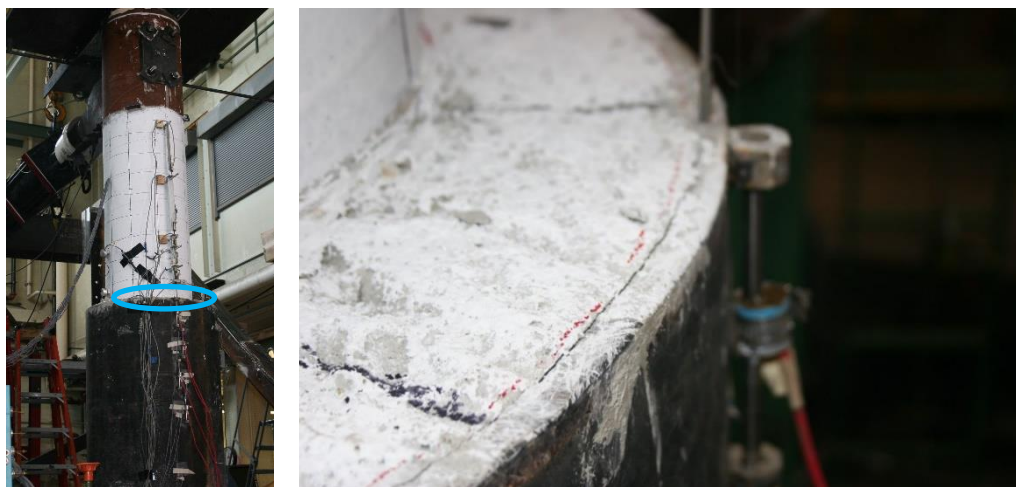
At 0.7% drift, the lateral load ranged from -0.8 to 0.8 times the nominal force, F_n , of 67.0 kips (-54.4 to 52.1 kips). Horizontal cracks on the northern and southern faces formed roughly every $0.25D_{COL}$ (5 in.) going up the height of the column, with the maximum width of the cracks being 0.5 mm, which occurred $0.25D_{COL}$ (5 in.) from the base on both the North and South sides. Cracks also formed around the perimeter of the tube, which can be shown in Figure 3.36.

Figure 3.36 Specimen 30-21-LD Cracks at Edge of the Pile at 0.7% Drift

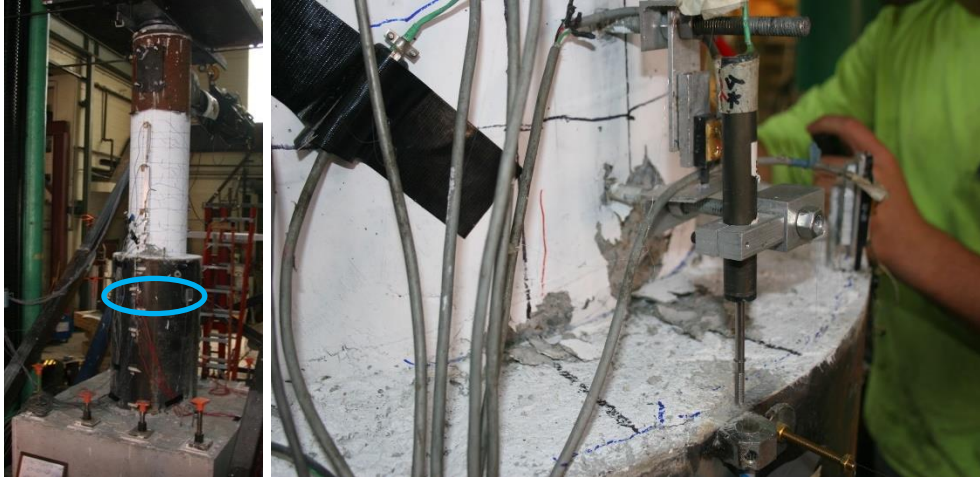
After the first cycle at approximately 2.4% drift, the lateral load ranged from -1.4 to $1.4F_n$ (-91.4 to 93.8 kips) an increase of $0.6F_n$ from the previous cycle. New cracks continued to form and already formed horizontal cracks continued to lengthen. The largest measured crack width was 1.3 mm, located at the Southern base of the column. Radial cracks formed around the column, from the edge of the tube to the base of the column. The first spalling also occurred at the base of the column on the northern face, which can be shown in Figure 3.38.

Figure 3.38. Specimen 30-21-LD 1st Spalled Region on Northern Column Face at 2.4% Drift

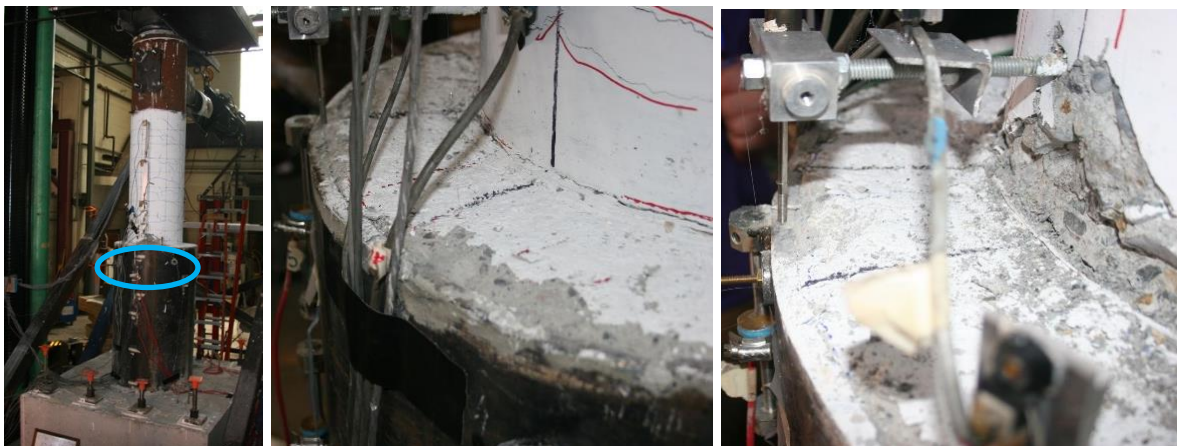
The two most noticeable observations were the damage that occurred to the top of pile concrete and the lateral force degradation with repeated cycles. The damage to the top of the pile concrete was substantially greater than noted for previous specimens. While the column concrete was damaged, the concrete fill at the perimeter of CFST pile was also damaged as shown in Figures 3.40a) and b). During these cycles, the lateral strength of the column was also decreasing. The first cycle at 2.4% drift had force peaks of -1.4 to $1.4F_n$ (-91.4 to 93.8 kips), while the 6th and last cycle had force peaks of -1.3 to $1.1F_n$ (-84.7 to 76.9 kips), both decreasing over $0.1F_n$ from the first cycle.

Figure 3.1. Specimen 30-21-LD a) Concrete Damage at the Edge of the Pile and b) Concrete Damage Near Base of the Column at 2.4% Drift

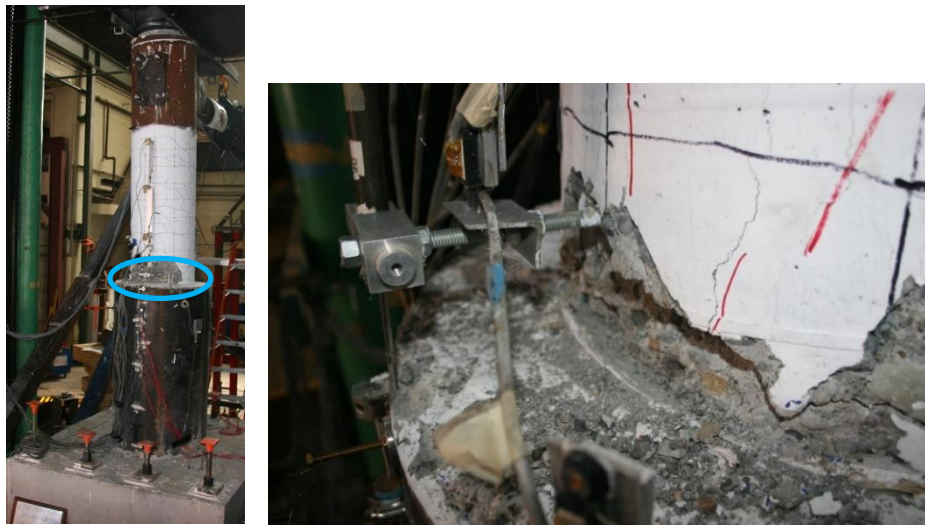
Figure 3.41. Specimen 30-21-LD Northern Column Face Spalled Region at 3.8% Drift

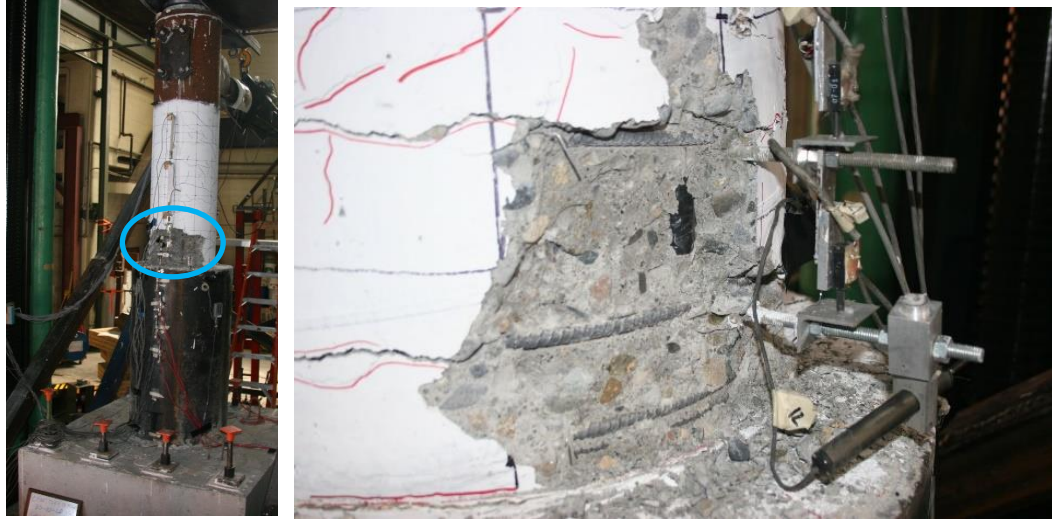
Figure 3.43. Specimen 30-21-LD Exposed Longitudinal Reinforcement at 5.5% Drift

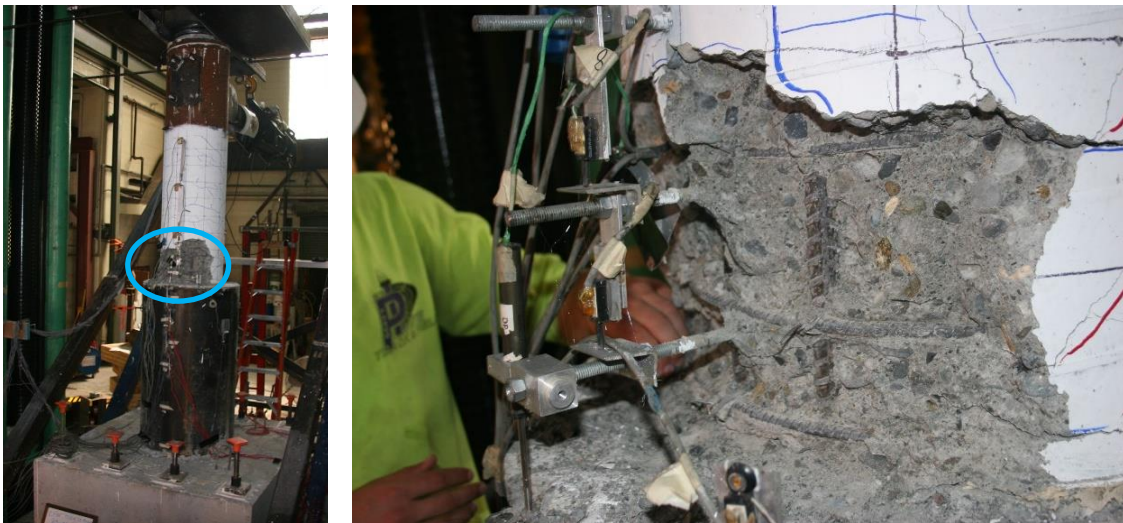
Figure 3.45. Specimen 30-21-LD Increased Spalled Region at 5.5% Drift

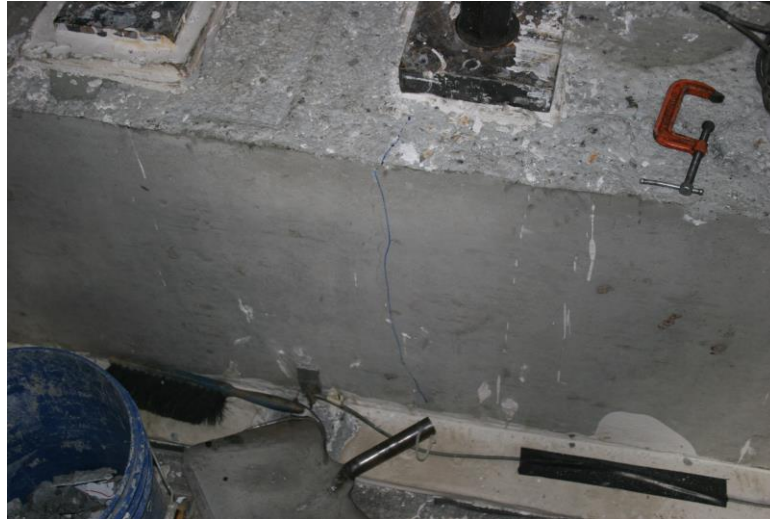
Figure 3.47. Specimen 30-21-LD Crack on Southern Side of Transfer Block

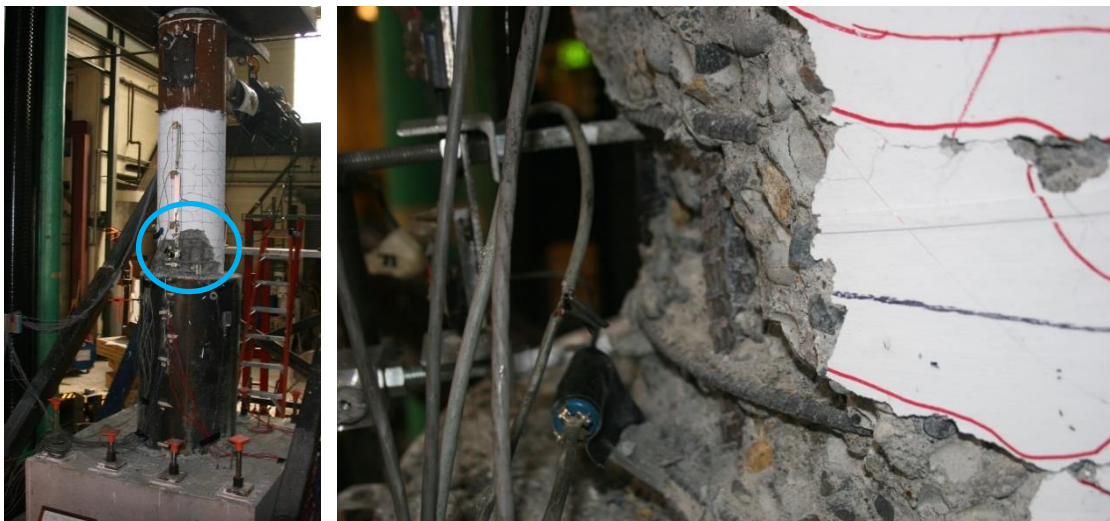
Figure 3.48. Specimen 30-21-LD Buckled Longitudinal Reinforcement on Southern Side of Concrete at 5.5% Drift

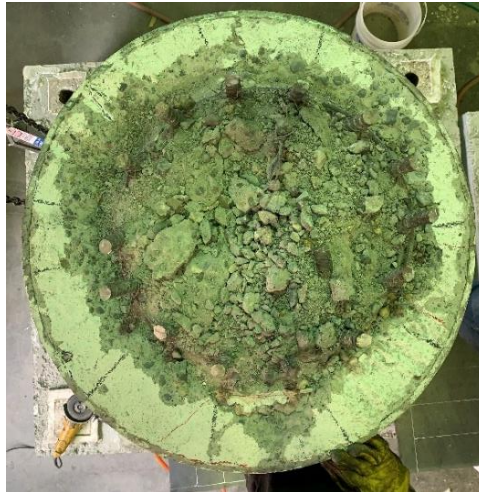
Figure 3.52. Top of Specimen 30-21-LD Pile with Column Removed

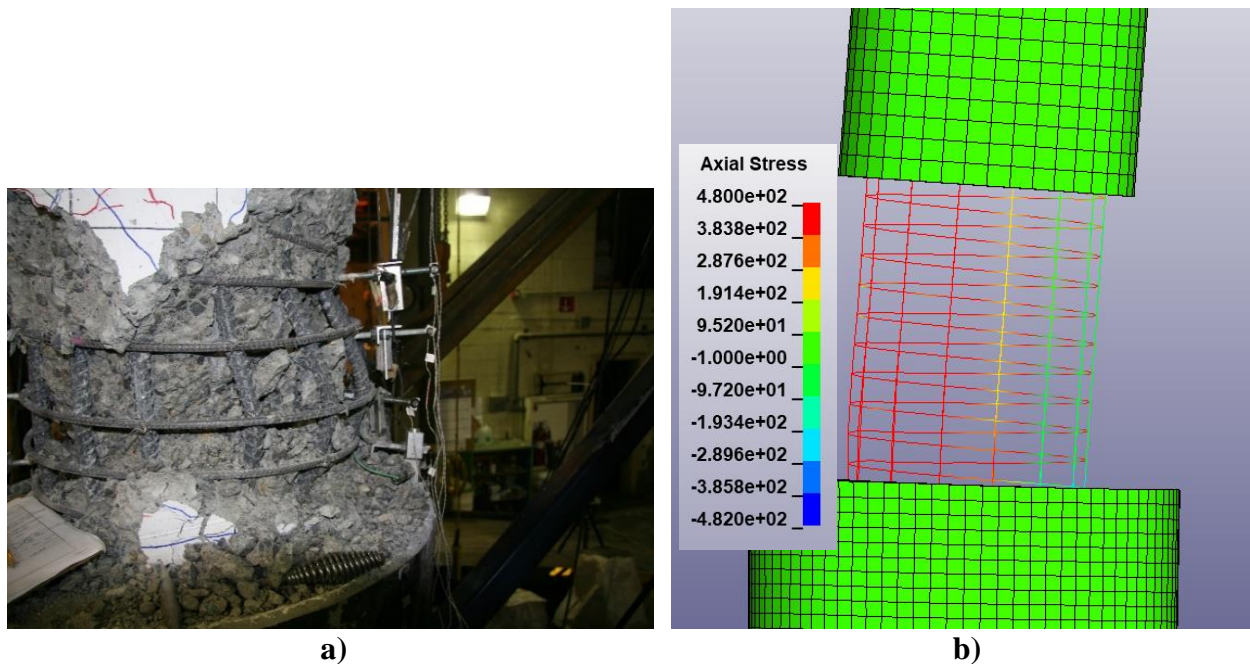
Figure 4.5. Specimen 30-21 Buckled Reinforcement at Base of Southern Column Face at 8.0% Drift: a) Observed and b) Simulated Reinforcement Axial Stress
