# **RAPID REPAIR AND RETROFIT OF TIMBER PILES USING UHPC**

**Quarterly Progress Report**  
**For the period ending [March 01, 2023](#).**

**Affiliation: Department of Civil and Environmental Engineering**  
**Florida International University**  
**Miami, FL**

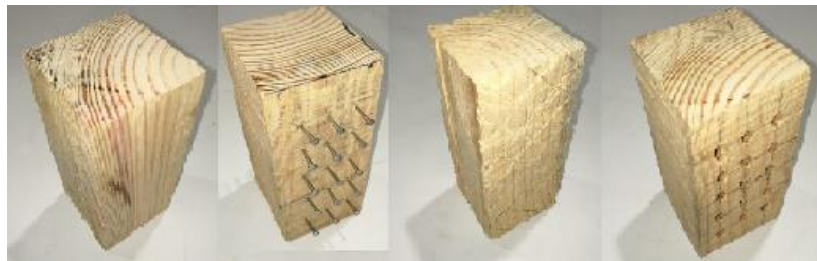
**Figure 6.** Different surface preparation for timber prisms

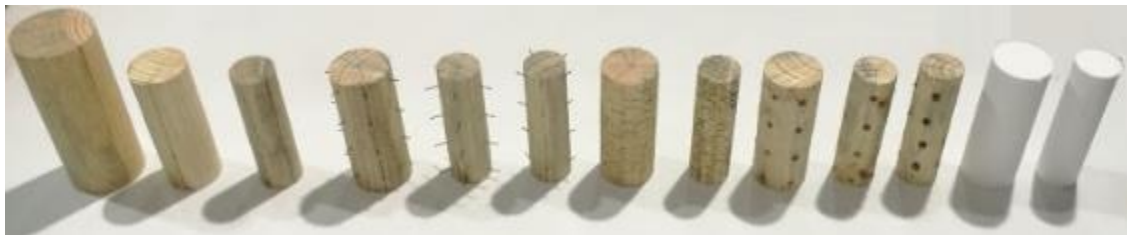
**Figure 12.** Different surface preparation for timber prisms

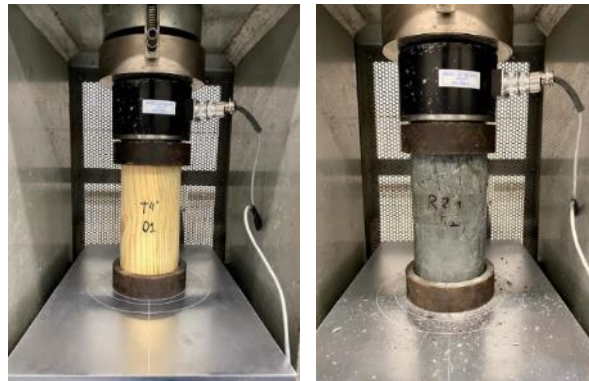
**Figure 13.** Test setup for load-carrying capacity. (a) timber specimen, (b) timber cylinder with UHPC encasement.

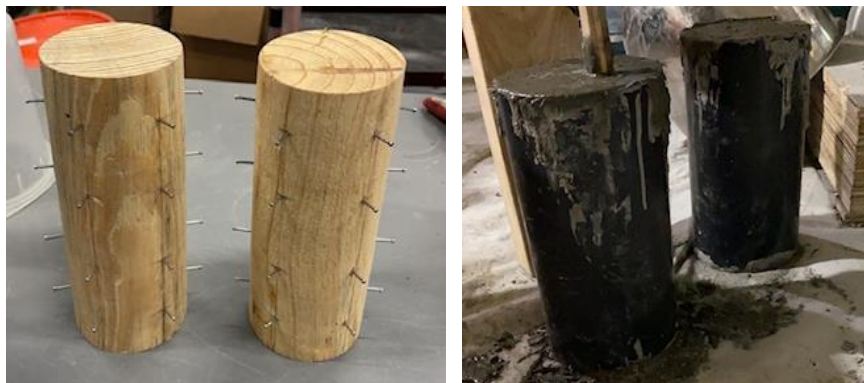
*Figure 15. New specimens to replace the ones that turned out deficient.*

**For load-carrying capacity,** timber cylinders were cut by woodturning as shown in Figure 8, some of them were cast with an outer UHPC shell and other specimens were just UHPC shells molded by the use of cylindrical inner cylindrical styrofoams, as shown in Figure 9. Two diameter-to-thickness ratios between the inner timber cylinder and outer UHPC shell ( $d/t$ ) of 6 and 2.57 were selected in this test as shown in Figure 9. All the specimens required cylindrical plastic molds for forming UHPC, as shown in Figure 10. Same surface preparations as bond strength specimens were replicated in the load-carrying capacity test as shown in Figures 11 and 12. Figure 13 shows the compression test setup and Figure 14 shows the final damage of one specimen. It should be noticed that two timber moisture preparations were conducted by (1) soaking timber in a water tank prior to casting UHPC (2) by spraying timber with water prior to casting UHPC. Tables 3 and 4 lists all specimen notations, failure load, and average failure load for each group. New specimens were cast as shown in Figure 15.

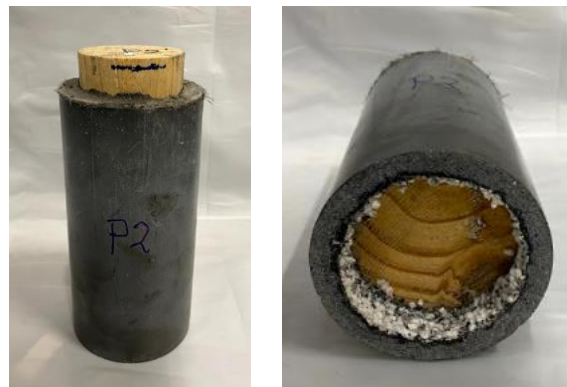
**Figure 20.** Encased timber cylinder. Left: front view, Right: bottom view

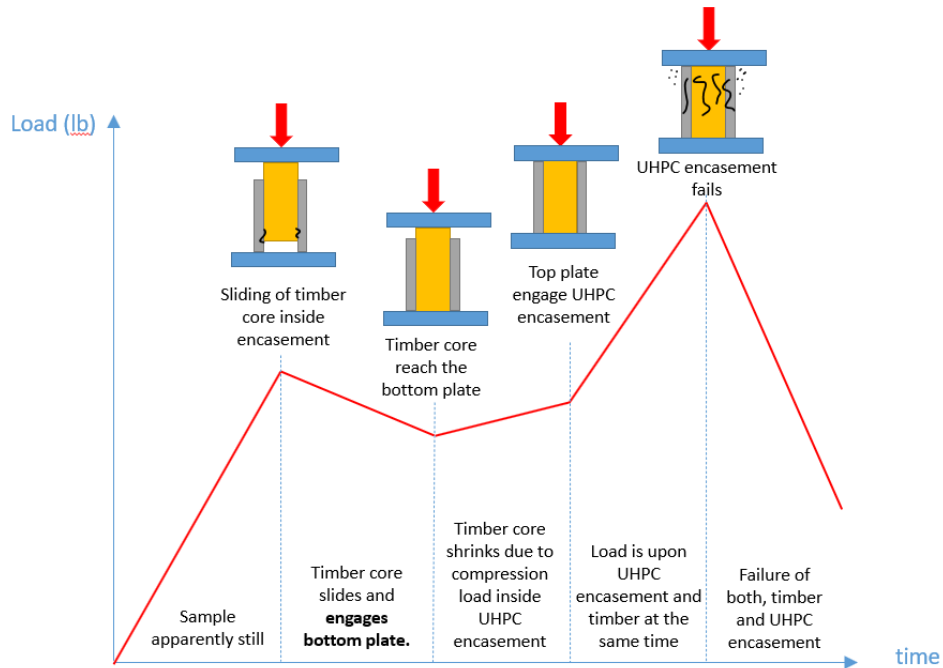
**Figure 21.** Behavior for types plain and nailed surfaces in timber.

Figure 21 shows the behavior of 'P' and 'N' type specimens. First, when tested, the friction between timber core and UHPC encasement is provoked allowing the sliding of the timber core inside the encasement. Second, once the timber core touches the bottom base plate, it started to be compressed. It should be noted at this stage the UHPC encasement was still uncracked. Finally, the loading plates touches both timber core and UHPC encasement that caused an increase in load carrying capacity since the UHPC enhanced is fully loaded.

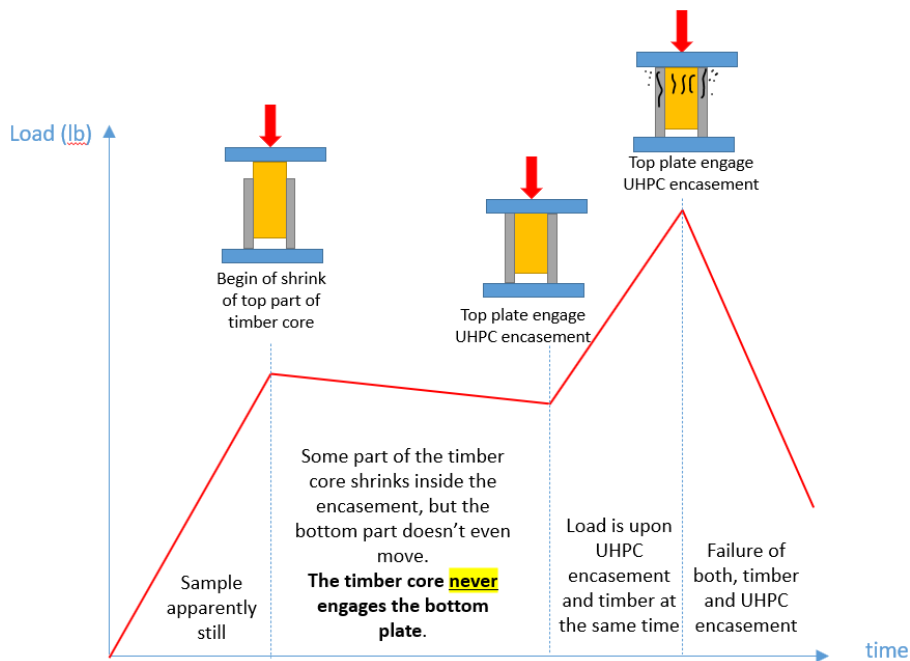
**Figure 22.** Behavior for zigzag type surfaces in timber.

Figure 22 shows the behavior of ‘Z’ type specimens. For this case, the timber core never slipped through the UHPC encasement due to the high friction between timber core and UHPC encasement which was induced by the corrugated surface preparation. Instead, the timber core was compressed completely until the loading plate touched the top surface of UHPC encasement and started to be loaded. Even though, this surface preparation is hard to be obtained for in-service timber, it may be a good idea in new timber piles that may require UHPC protection for aggressive environment.

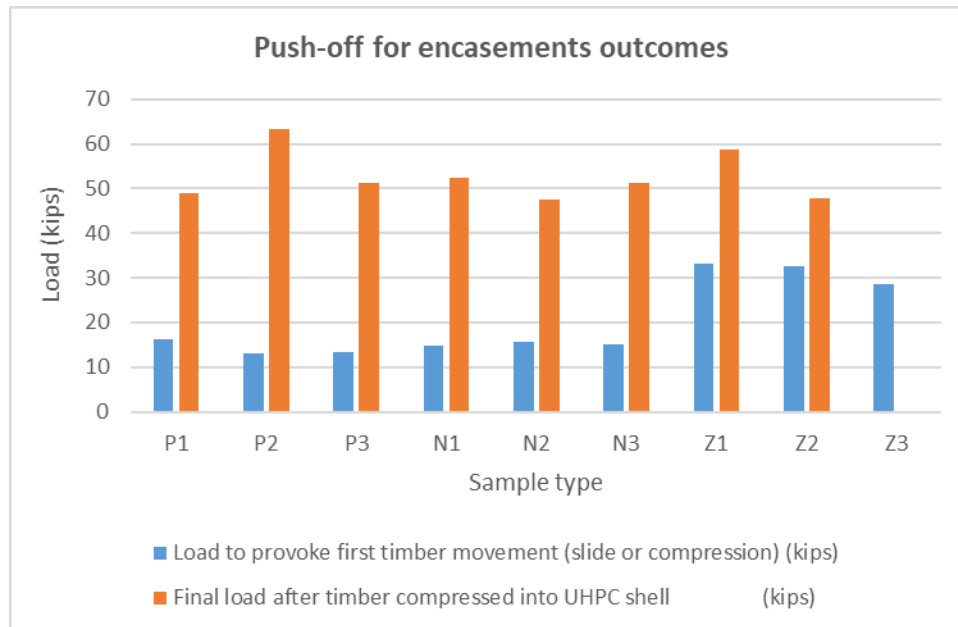
**Figure 23.** Behavior for zigzag type surfaces in timber.

Table 7 and Figure 23 shows the load values for each stage of loading for the three examined surfaces preparation.

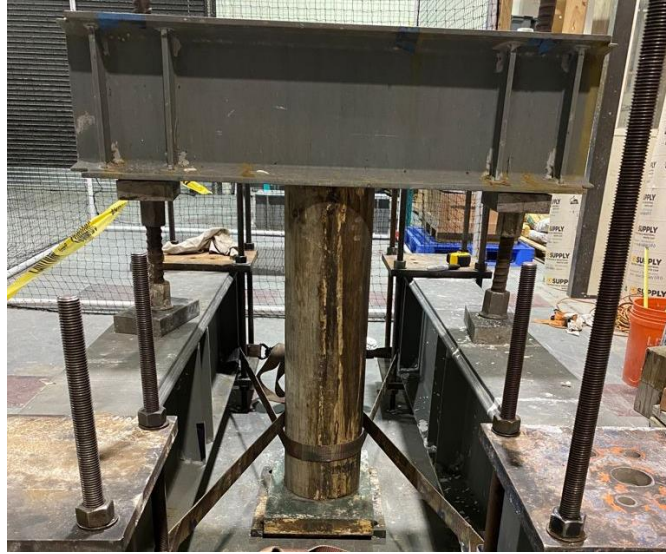
*Figure 24. Test setup for large-scale specimens*

In this task, experimental work will be conducted on the first specimen. The column will be tested under constant axial and lateral cyclic loads.

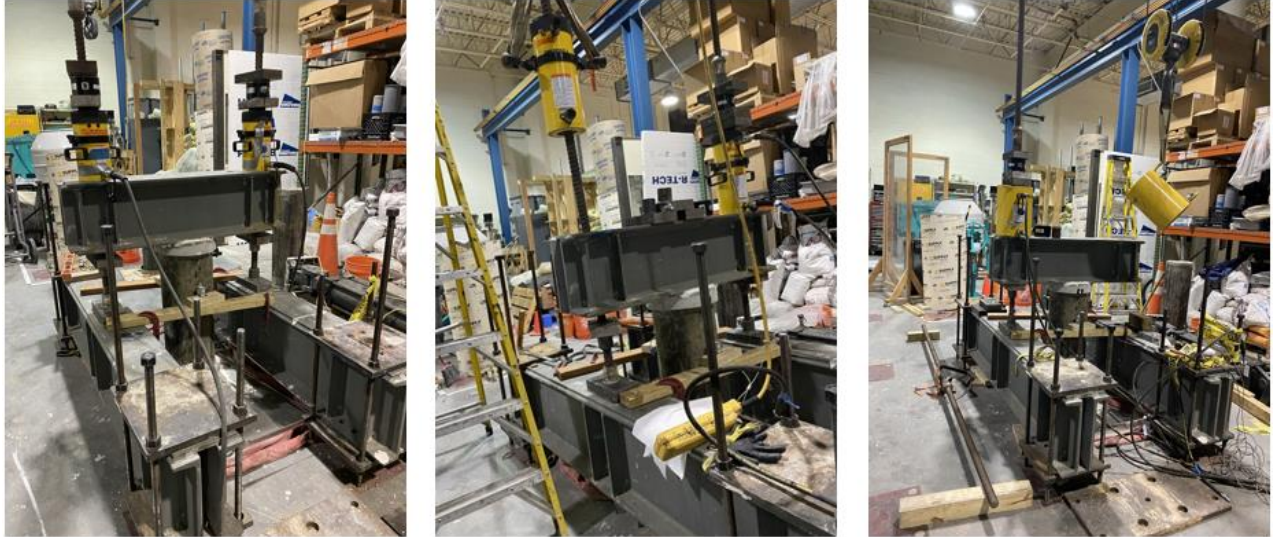
**Figure 26.** Different hydraulic cylinder used in the test.

For the axial load, many alternatives were studied. Because of the stiffness of the system the smallest hydraulic rams couldn't reach the desired force to break the specimens. So, bigger hydraulic rams were used to provide higher forces.

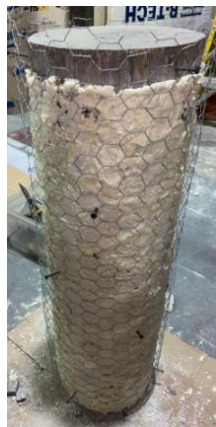
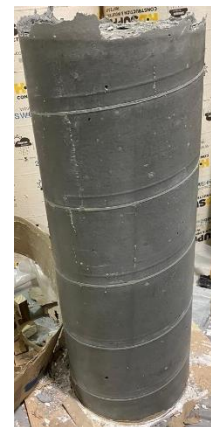
*Figure 28. Construction process for complete shell encasement.*

Figures 27 and 28 show steps of retrofit technique that involved the application sprayed foam in a thin layer to provide a gap between timber and UHPC shell to allow the volumetric changes of timber piles without affecting UHPC encasement. After that a chicken wire mesh is installed and mounted using to provide reinforced UHPC encasement against radial stress. Finally, UHPC was cast.

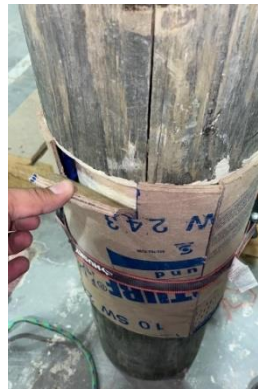
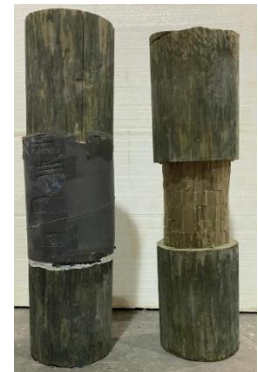
*Figure 29. Construction process for partial shell encasement.*

The next large-scale are specimens for partial repair. Figure 29 shows the construction of the dog-bone like specimen to examine the constructability. The specimens will be tested, and additional specimens will be added during the next quarter.

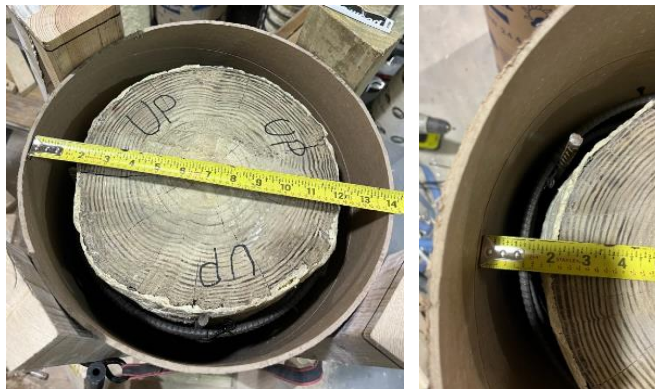
**Figure 51.** Uniform gap between timber and tube form.

After that the form tube was placed providing a uniform space all around the timber.

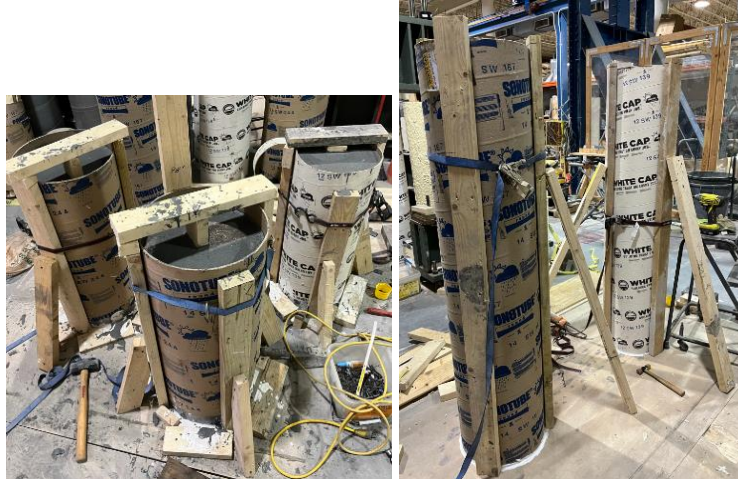
*Figure 52. Specimens after casting.*

After that formwork was properly prepared and placed into position to cast non-proprietary UHPC inside.

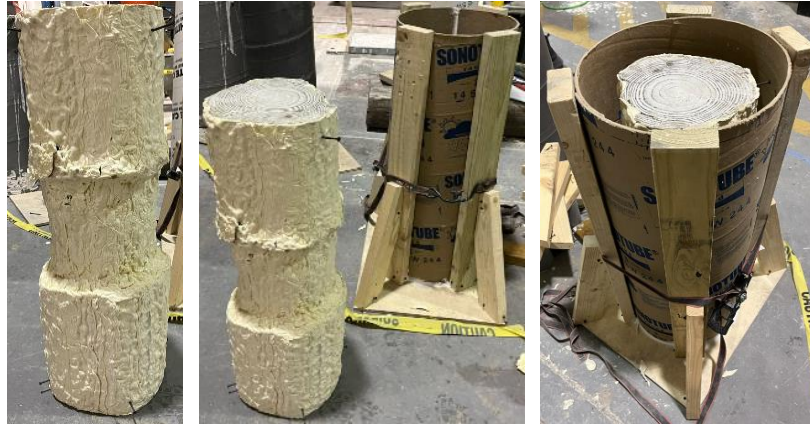
This specimen is the one used in test 16. It is 32.5 inches high and 13.75 inches in diameter. No steel rebar was used for retrofitting.

*Figure 57. Preparation of specimen for test 23*

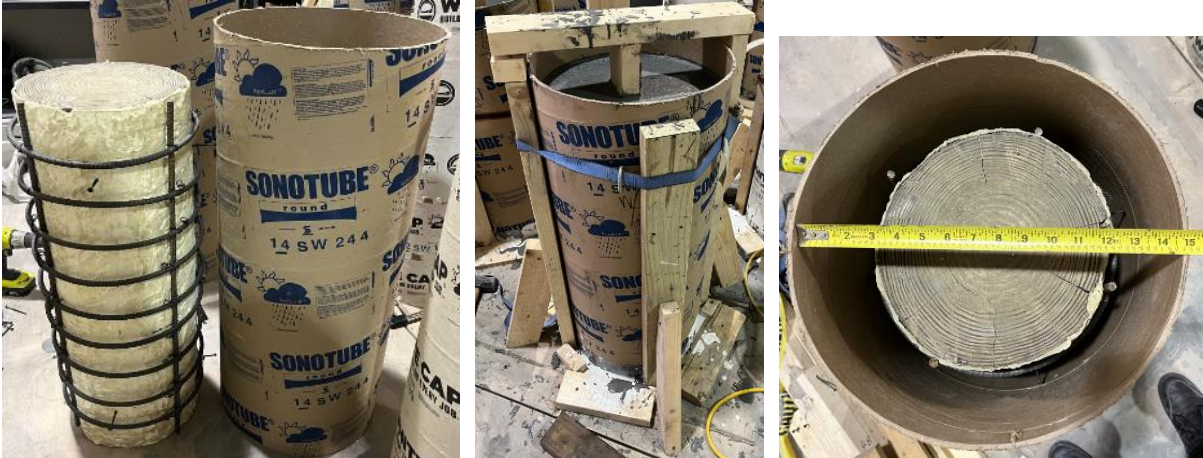
This specimen is completely new. It is 31.75 inches high and 14.5 inches in diameter. Steel rebar was used for retrofitting. Four longitudinal #3 bars were used, and #3 stirrups spaced 3 inches on center.

*Figure 64. Preparation of specimen for test 27*
