Design Guidance for UHPC Connections of Precast Girders Made Continuous for Live Load

Royce Floyd, Ph.D., P.E., S.E. (OK), The University of Oklahoma

ABC-UTC Research Seminar – July 28th, 2023

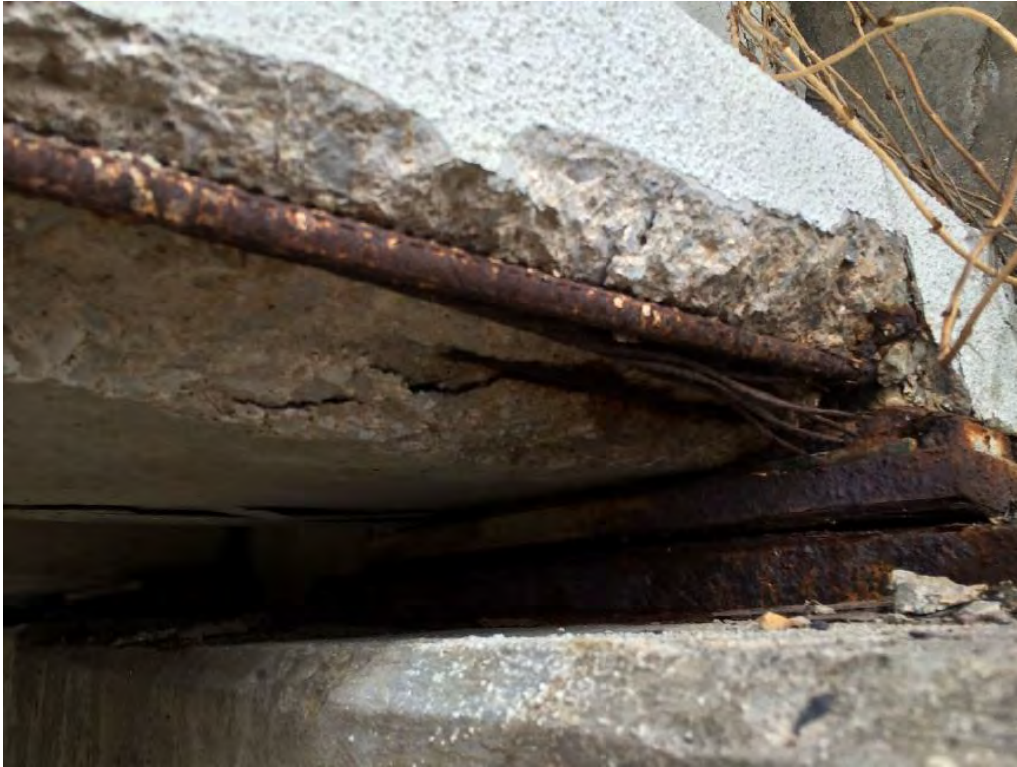
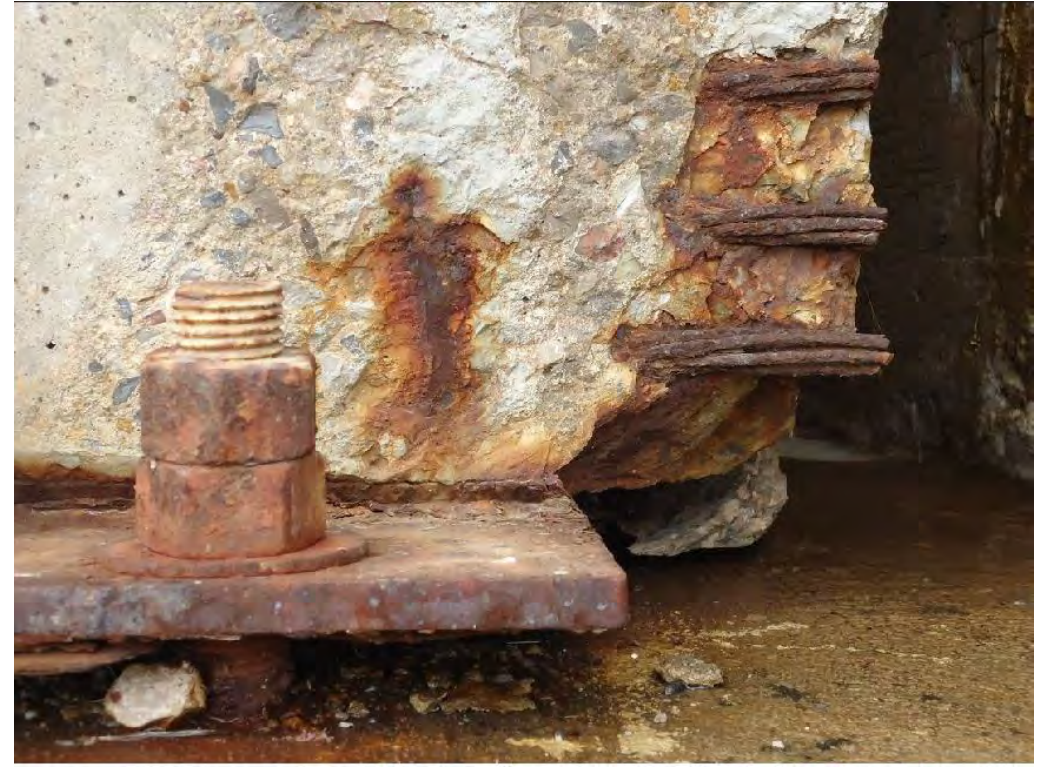
Corrosion and Spalling of Simply Supported Girders

Examples of beam end deterioration in Oklahoma bridges

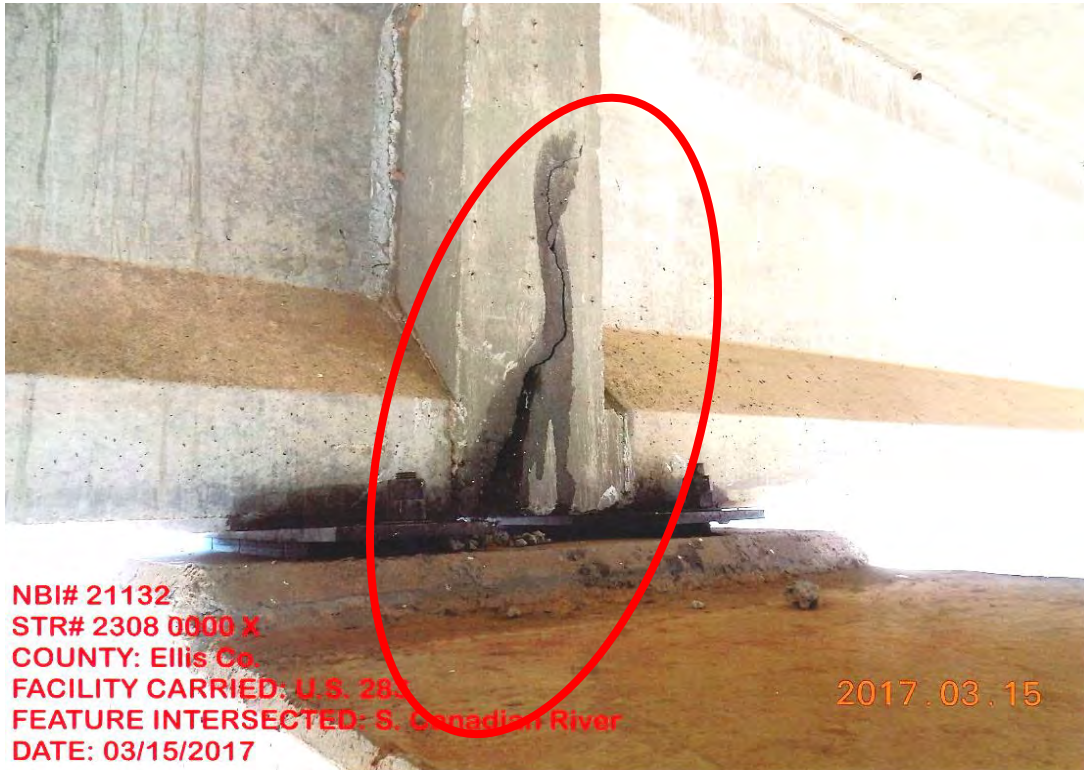
Typical cracking in continuity connection on U.S. 283 over S. Canadian River (Photo courtesy of Walt Peters)

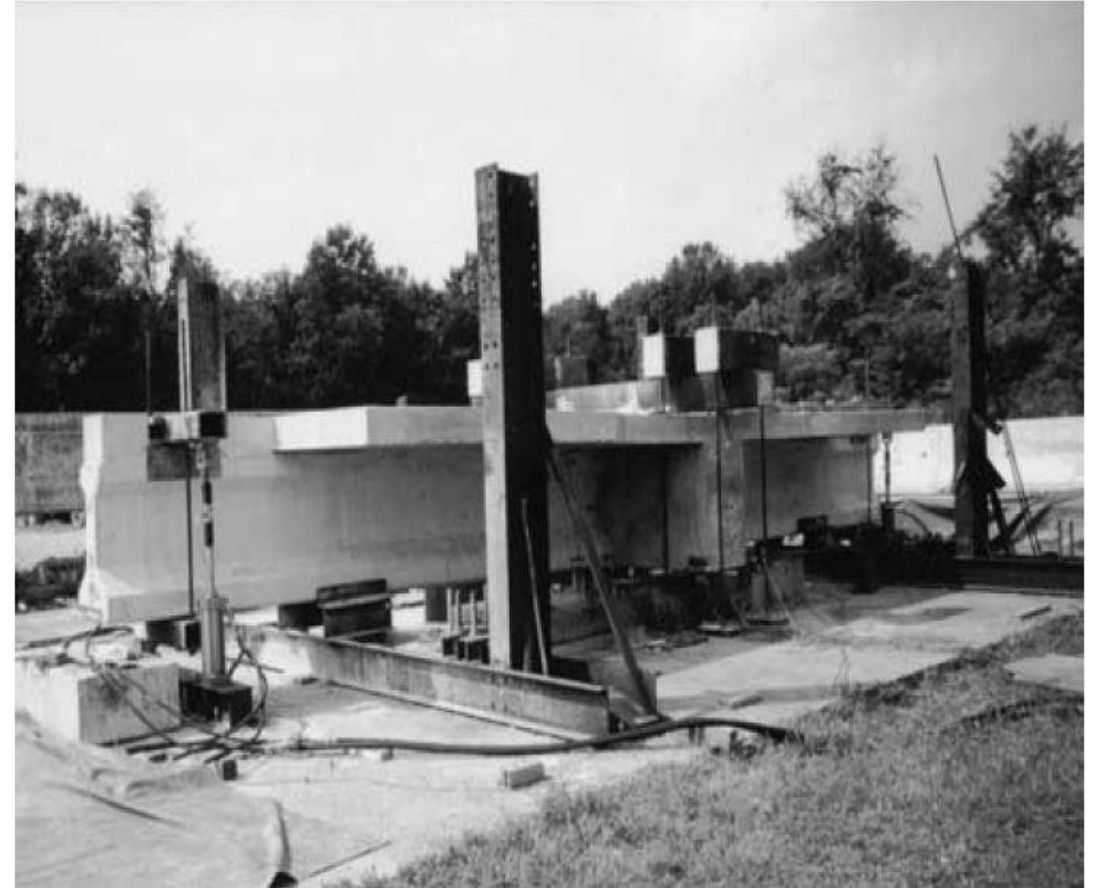
Full-scale load testing of a continuity connection by Miller (2004)

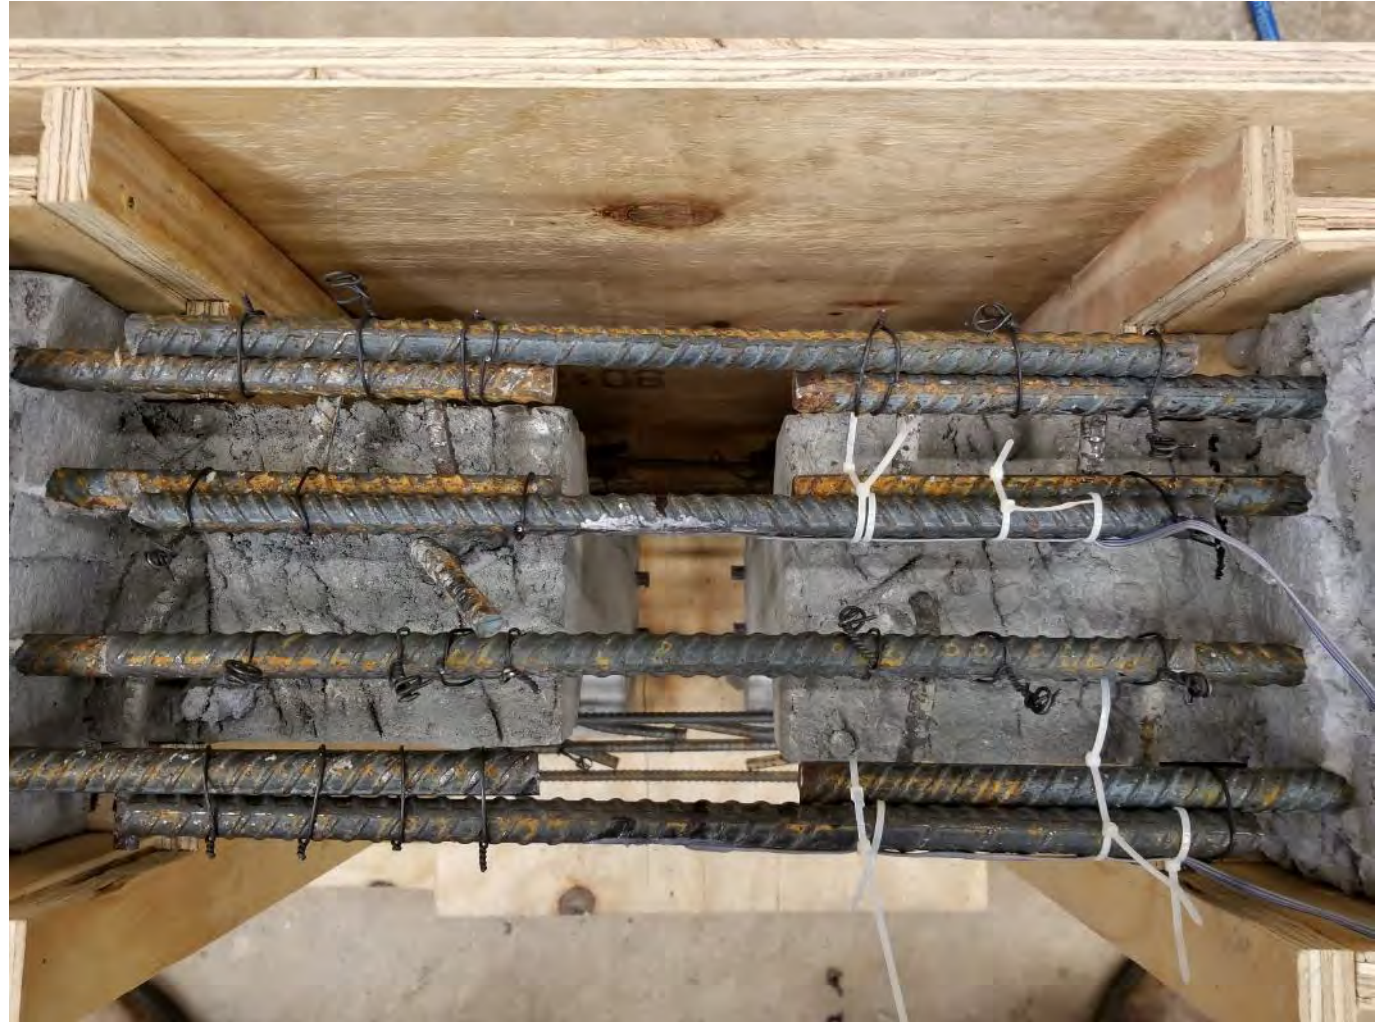
Retrofit construction continuity joint reinforcement immediately before casting

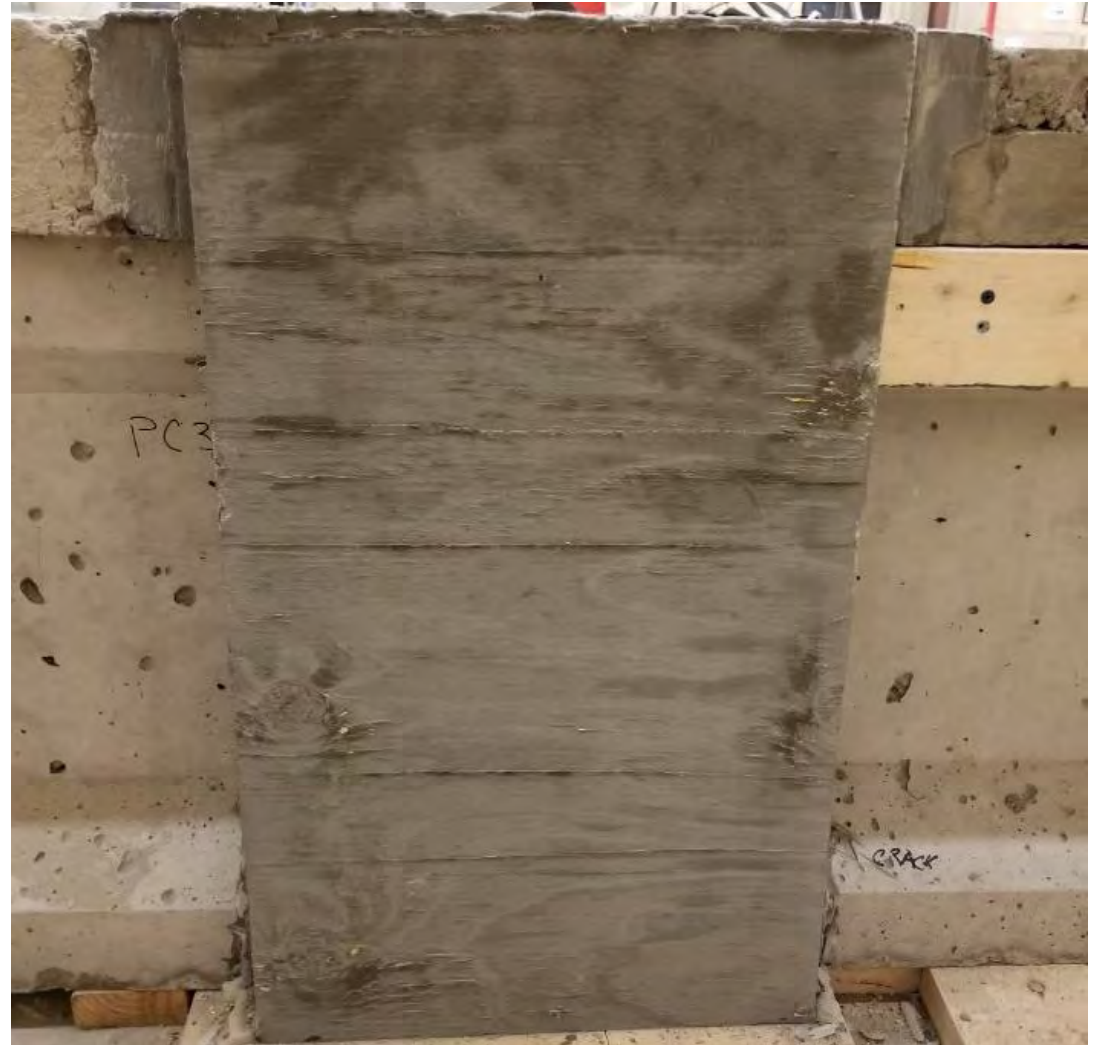
Retrofit construction continuity joint

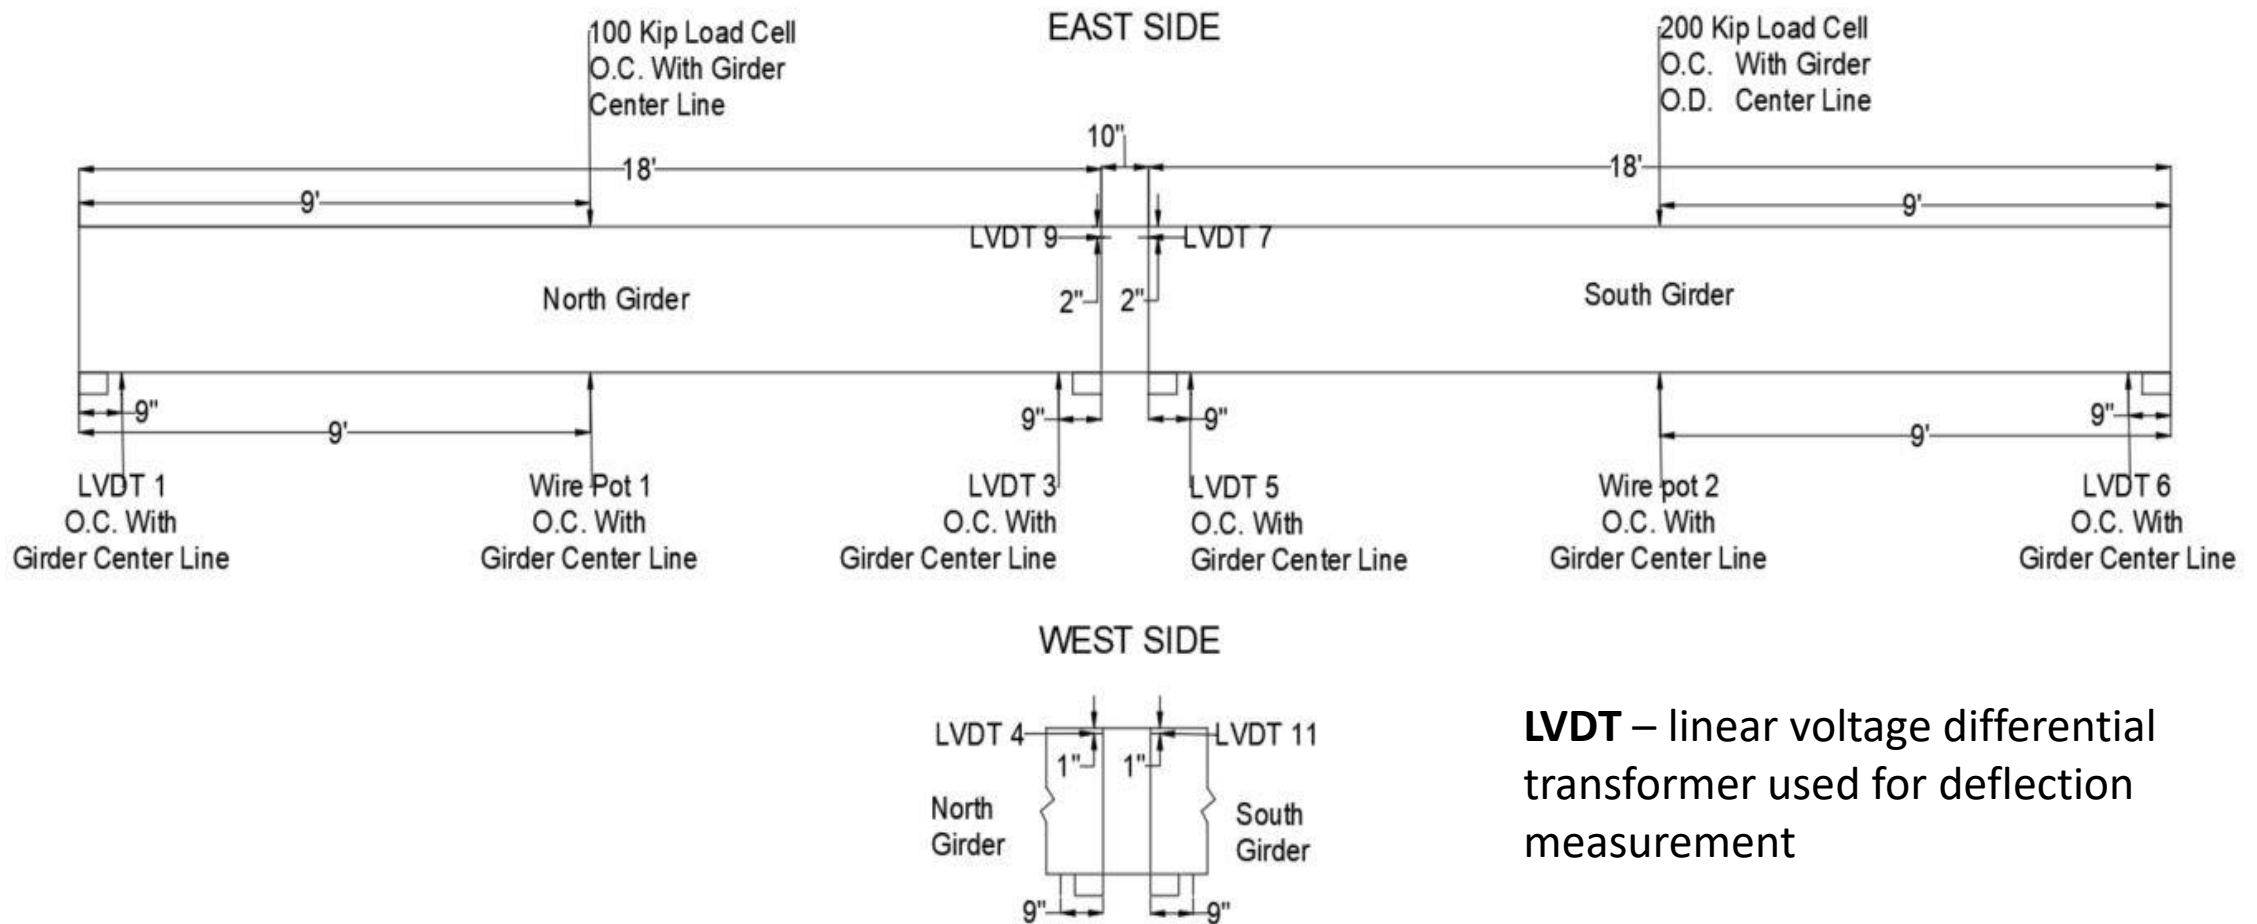
Sensor Location Diagram

LVDT – linear voltage differential transformer used for deflection measurement

Wire Pot – wire potentiometer used for deflection measurement

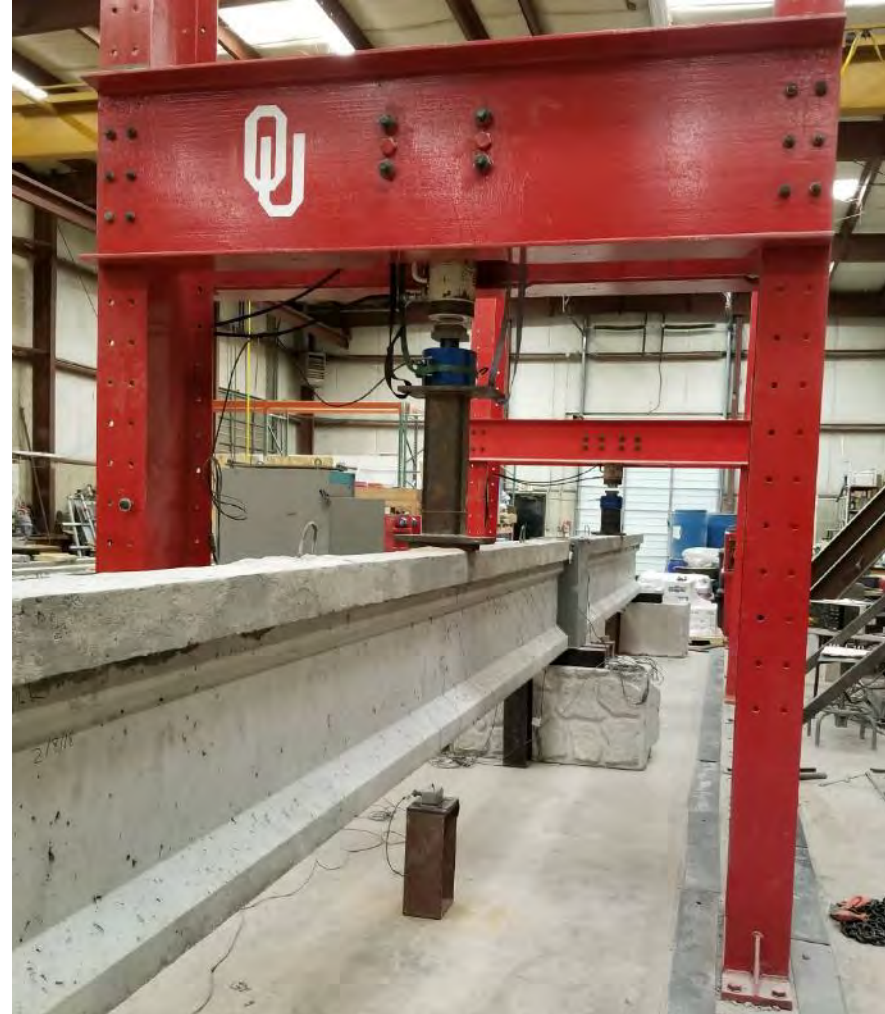
Two-span loading configuration used for testing continuity joints showing loads applied at mid-span of each beam

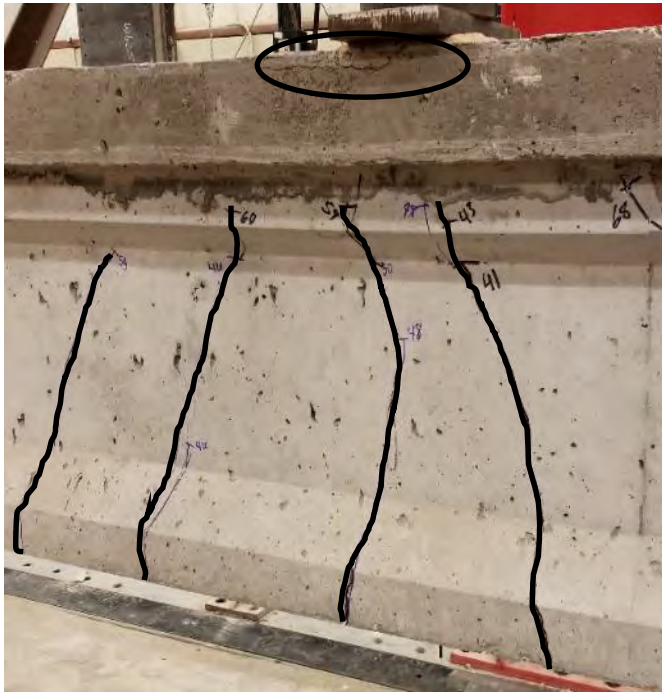
Flexural cracking under load point

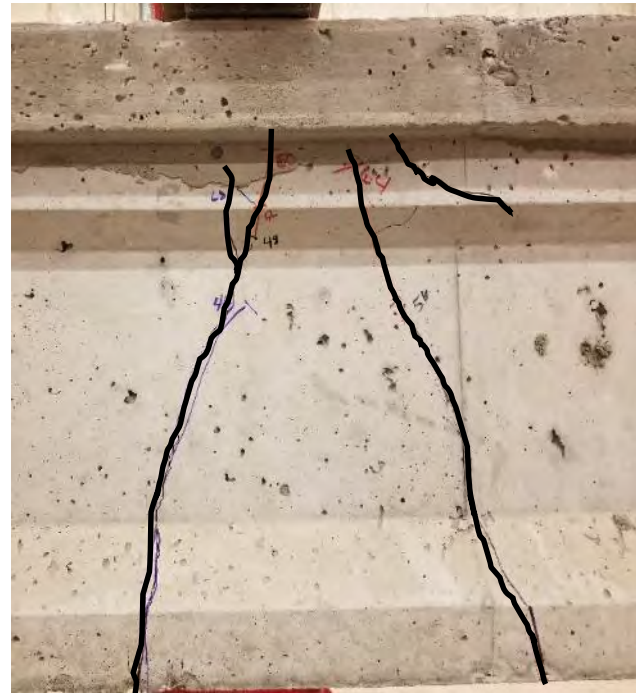
Flexural and flexure-shear cracking at joint interface

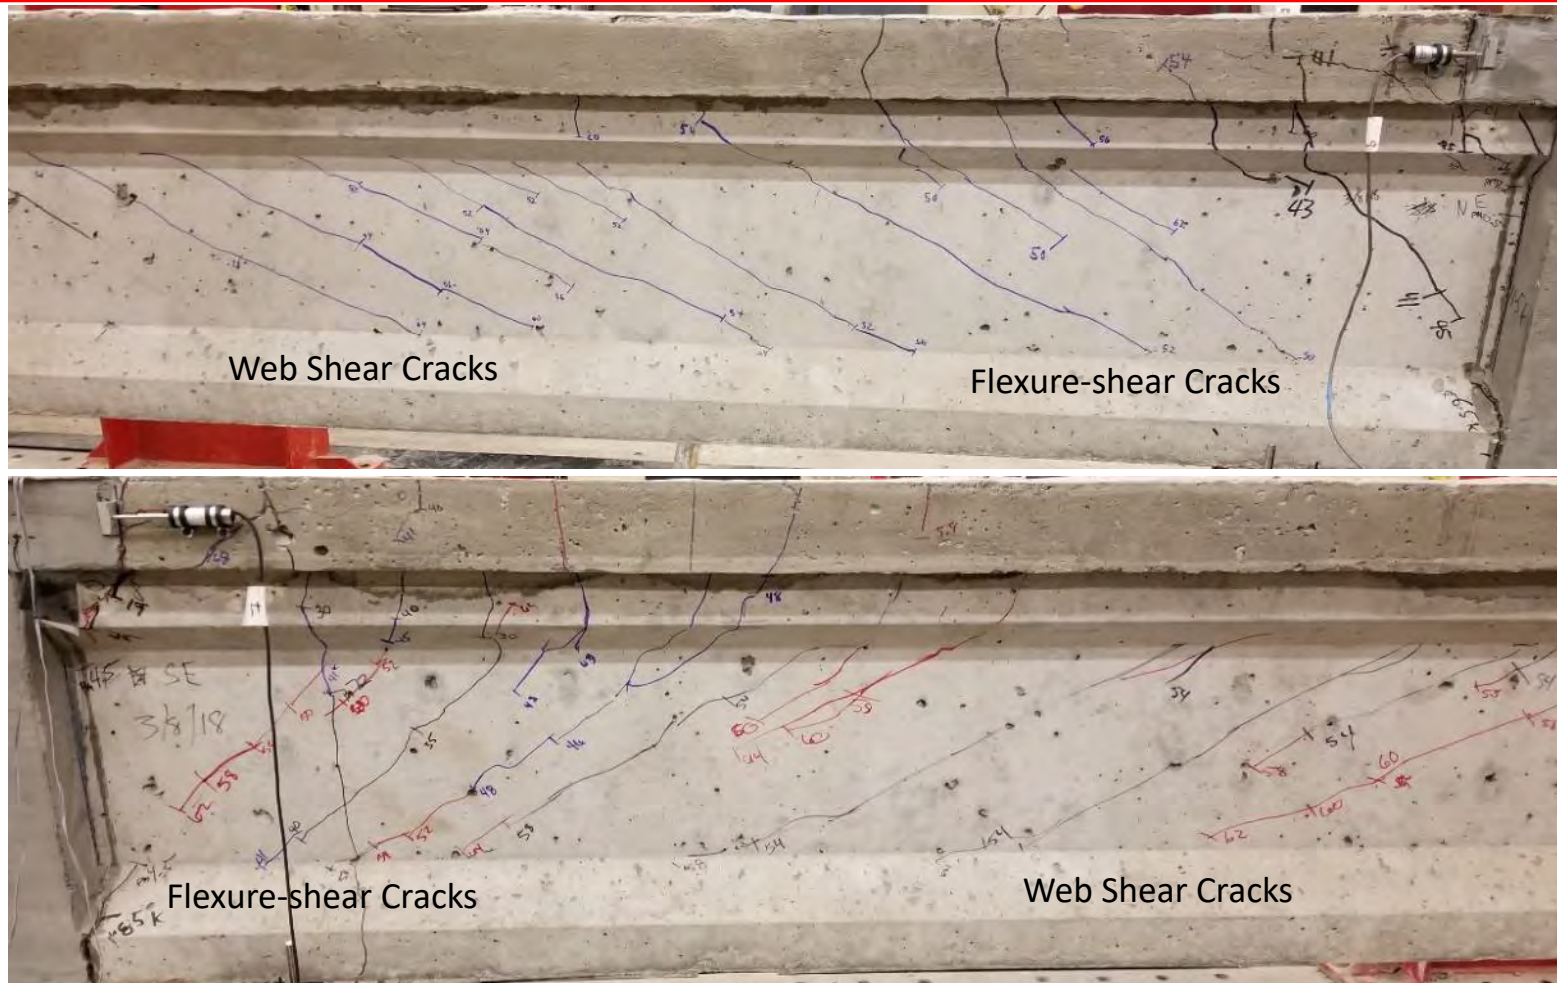
Cracking between load point and joint on each side of the joint due to negative moment, top shows north beam and bottom shows the south beam

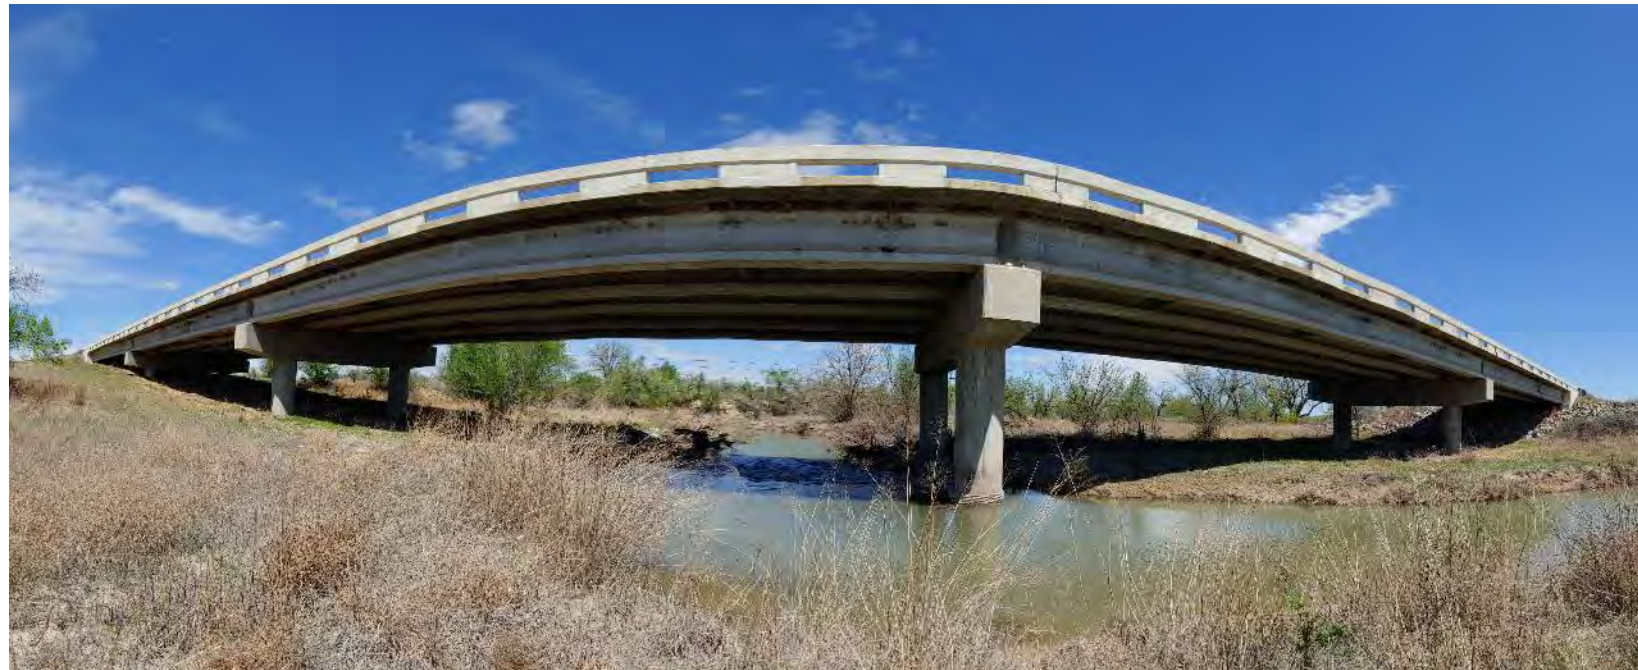
Panoramic view of U.S. 183/412 Bridge over Wolf Creek, Fort Supply, OK

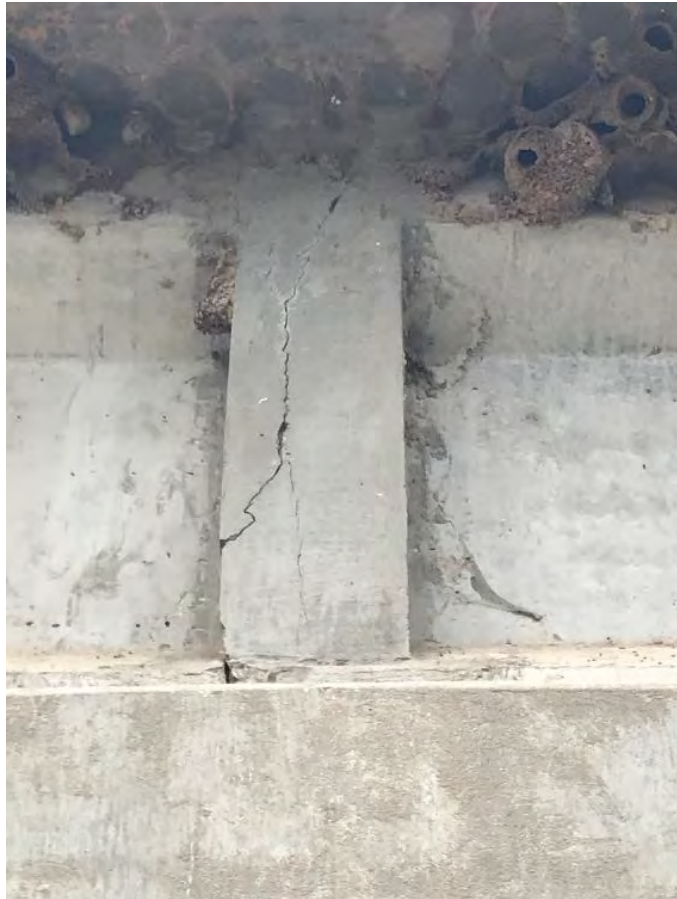
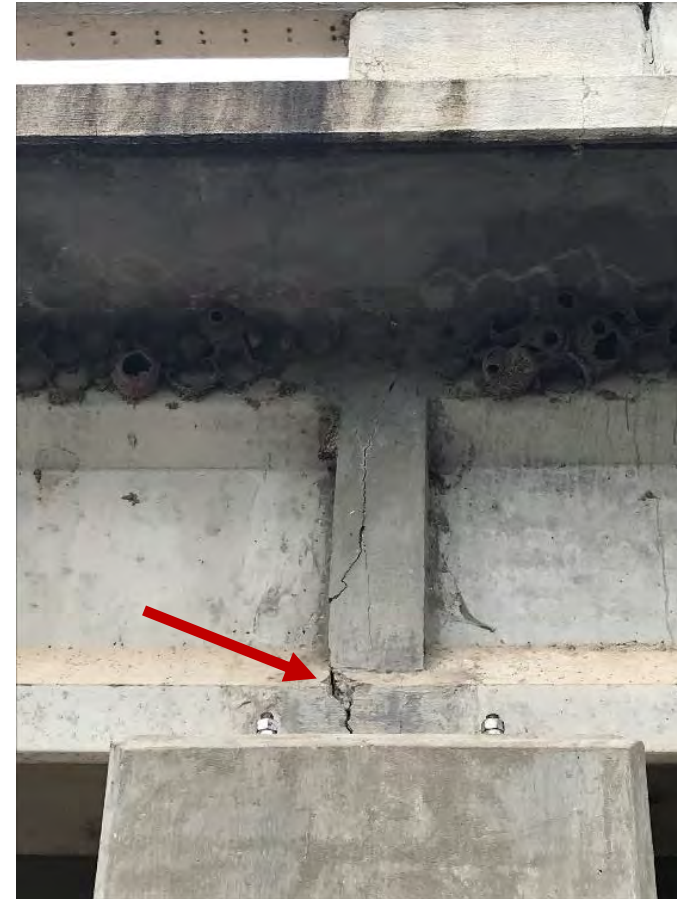
Cracking in continuity connections on U.S. 183/412 Bridge over Wolf Creek, Fort Supply, OK

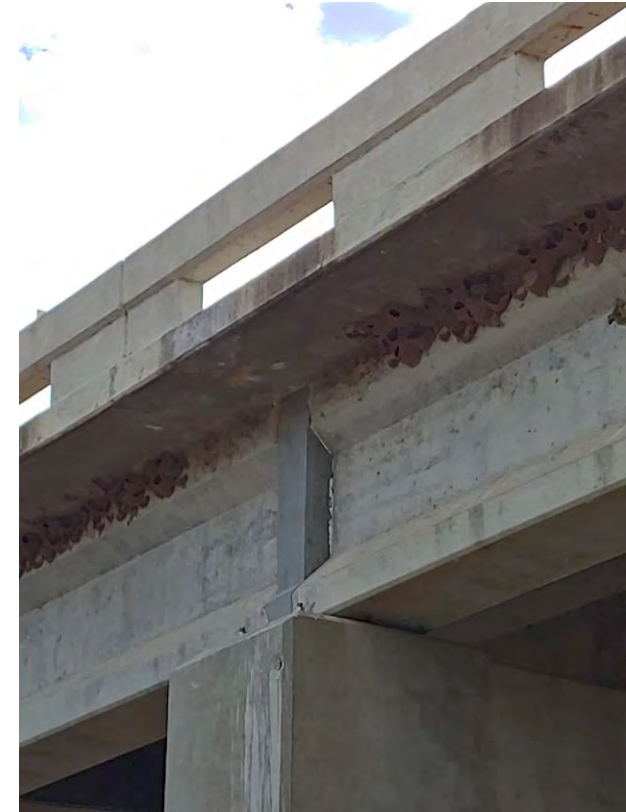
Completed UHPC joint

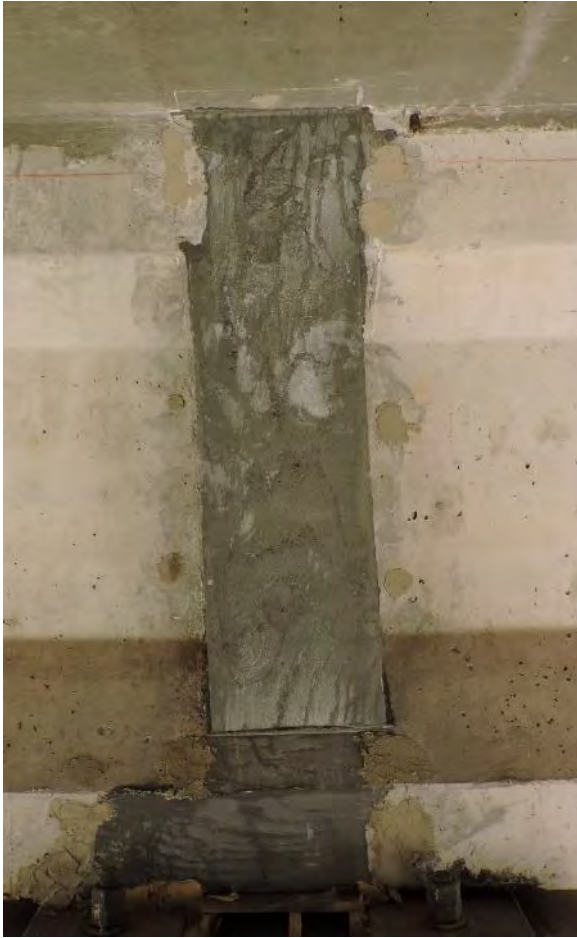
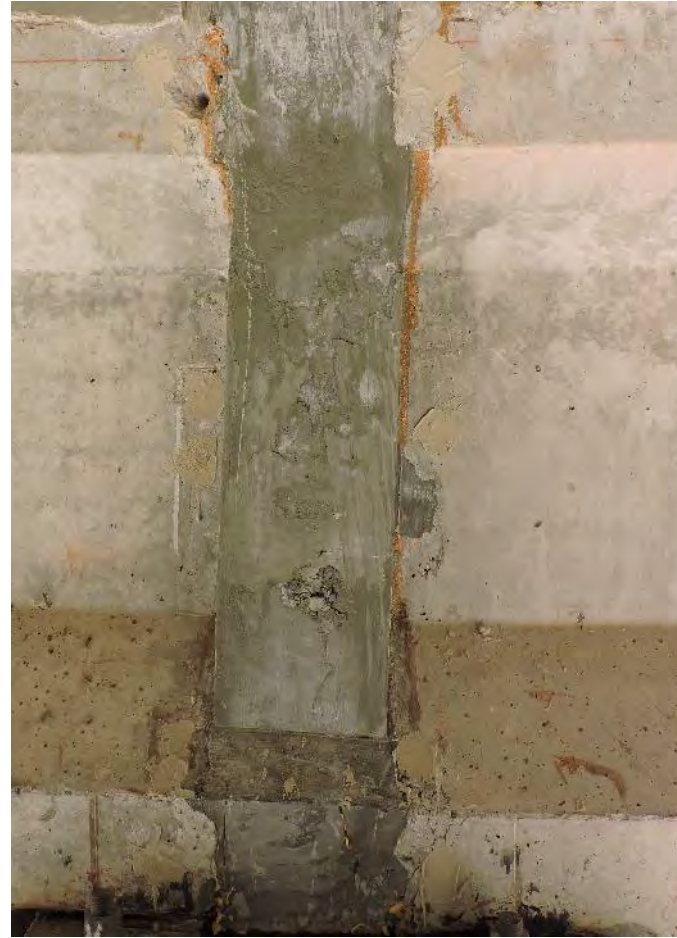
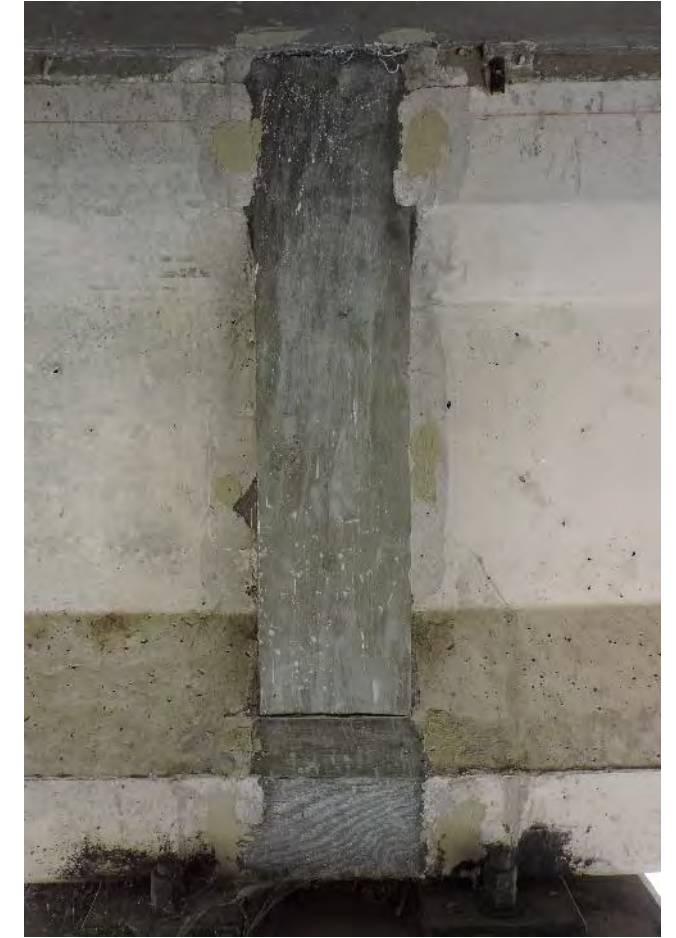
Joint Condition After 1 Year (December 2020)

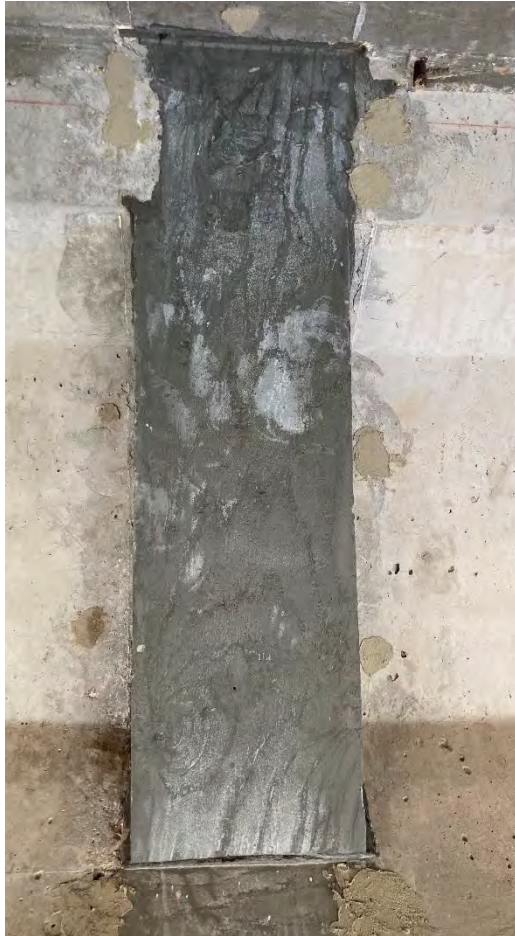
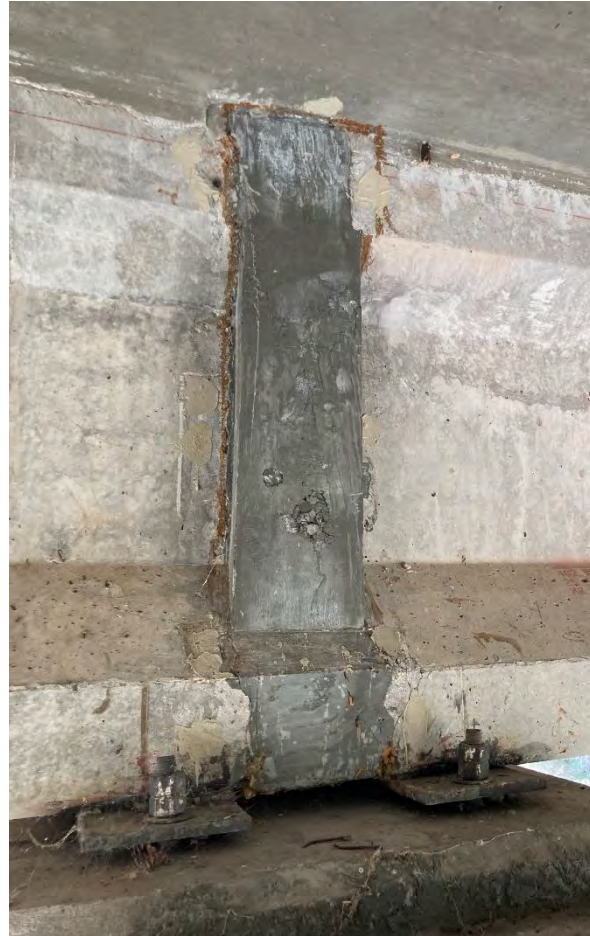
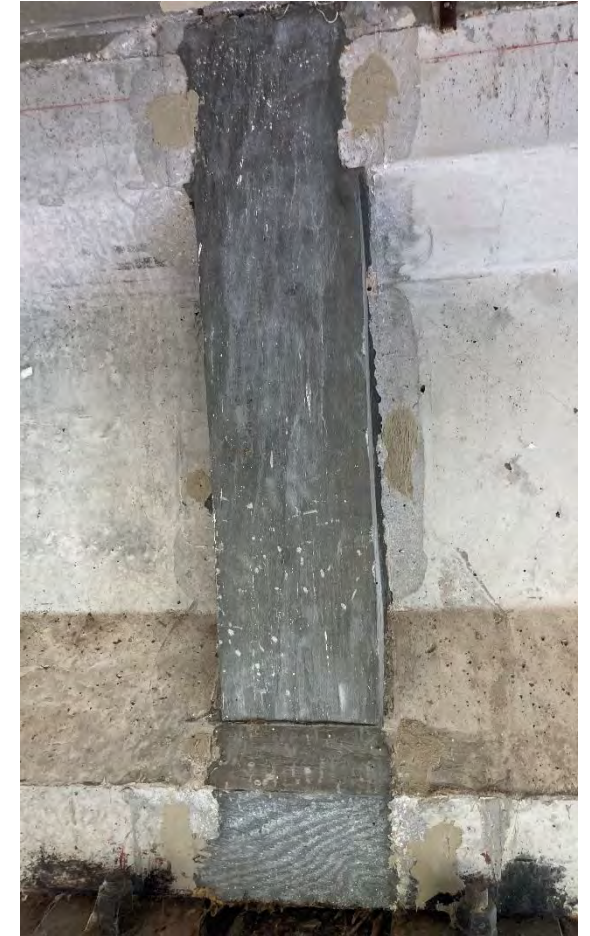
Joint Condition After 3 years (October 2022)

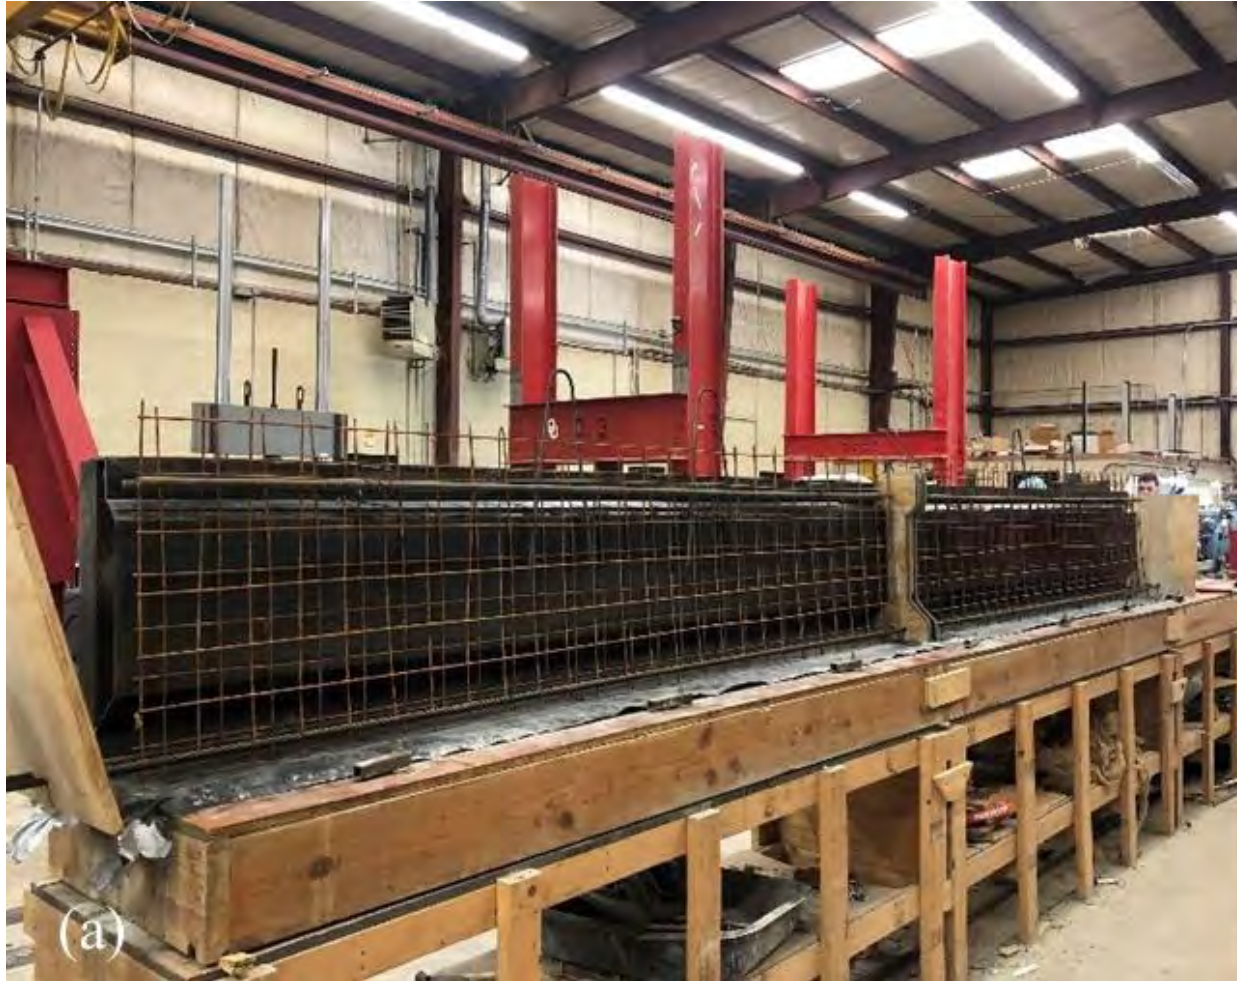
Beam formwork and reinforcement in place on the prestressing bed

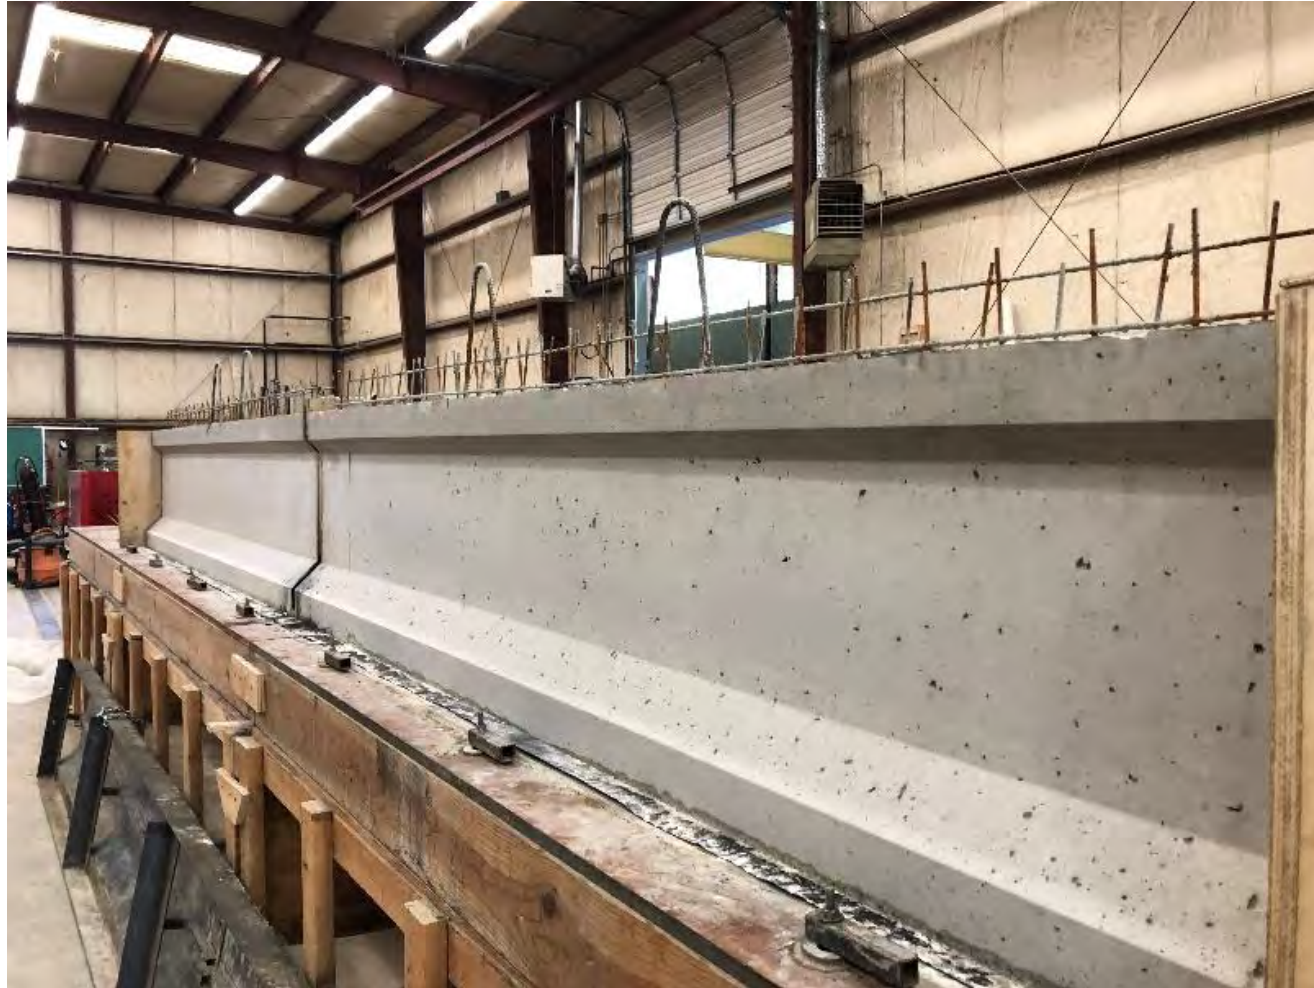
Completed girder specimens in place on the prestressing bed

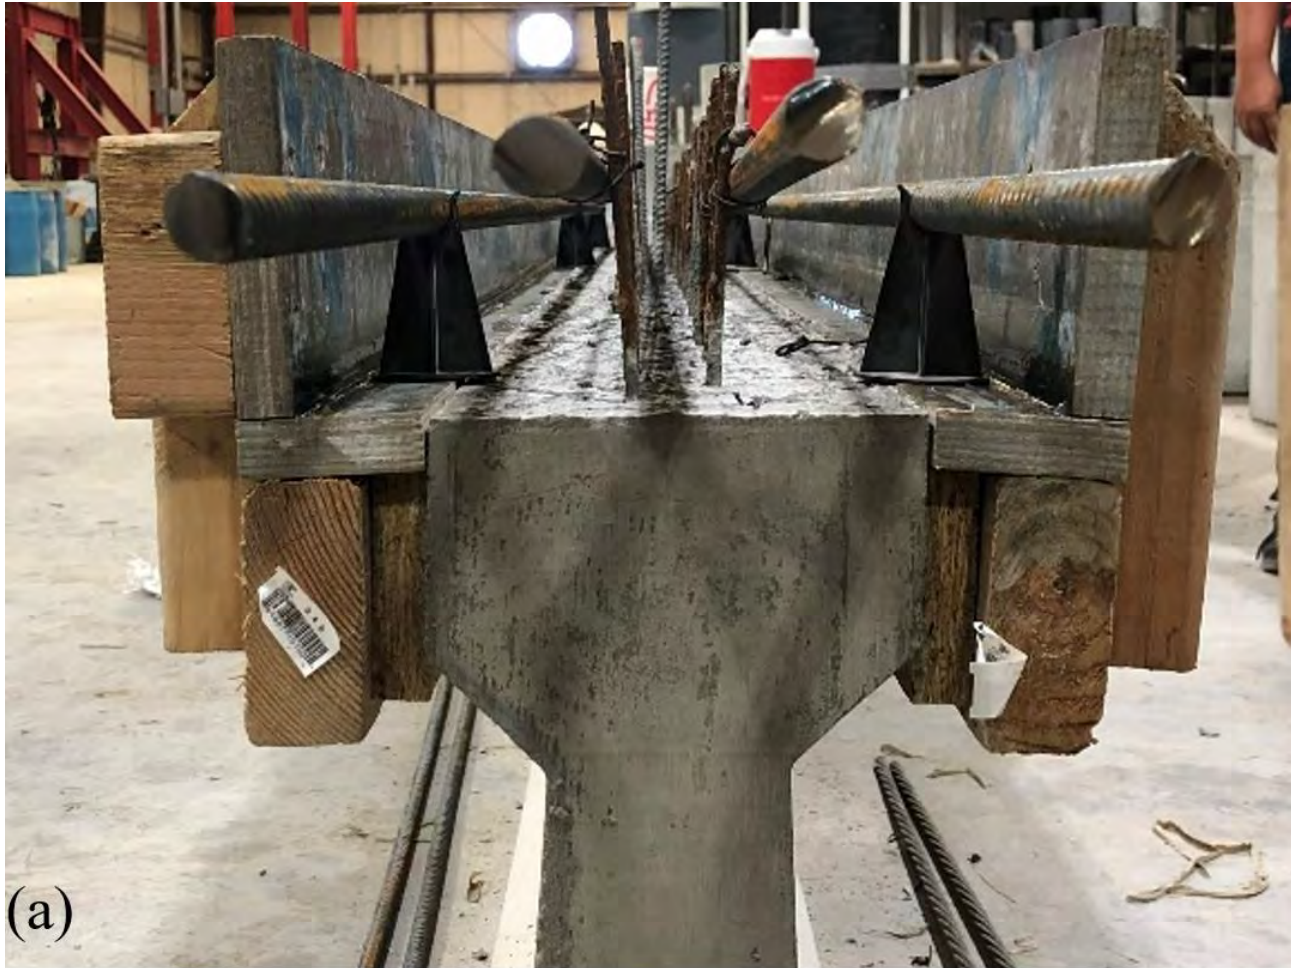
Deck reinforcement in place for casting

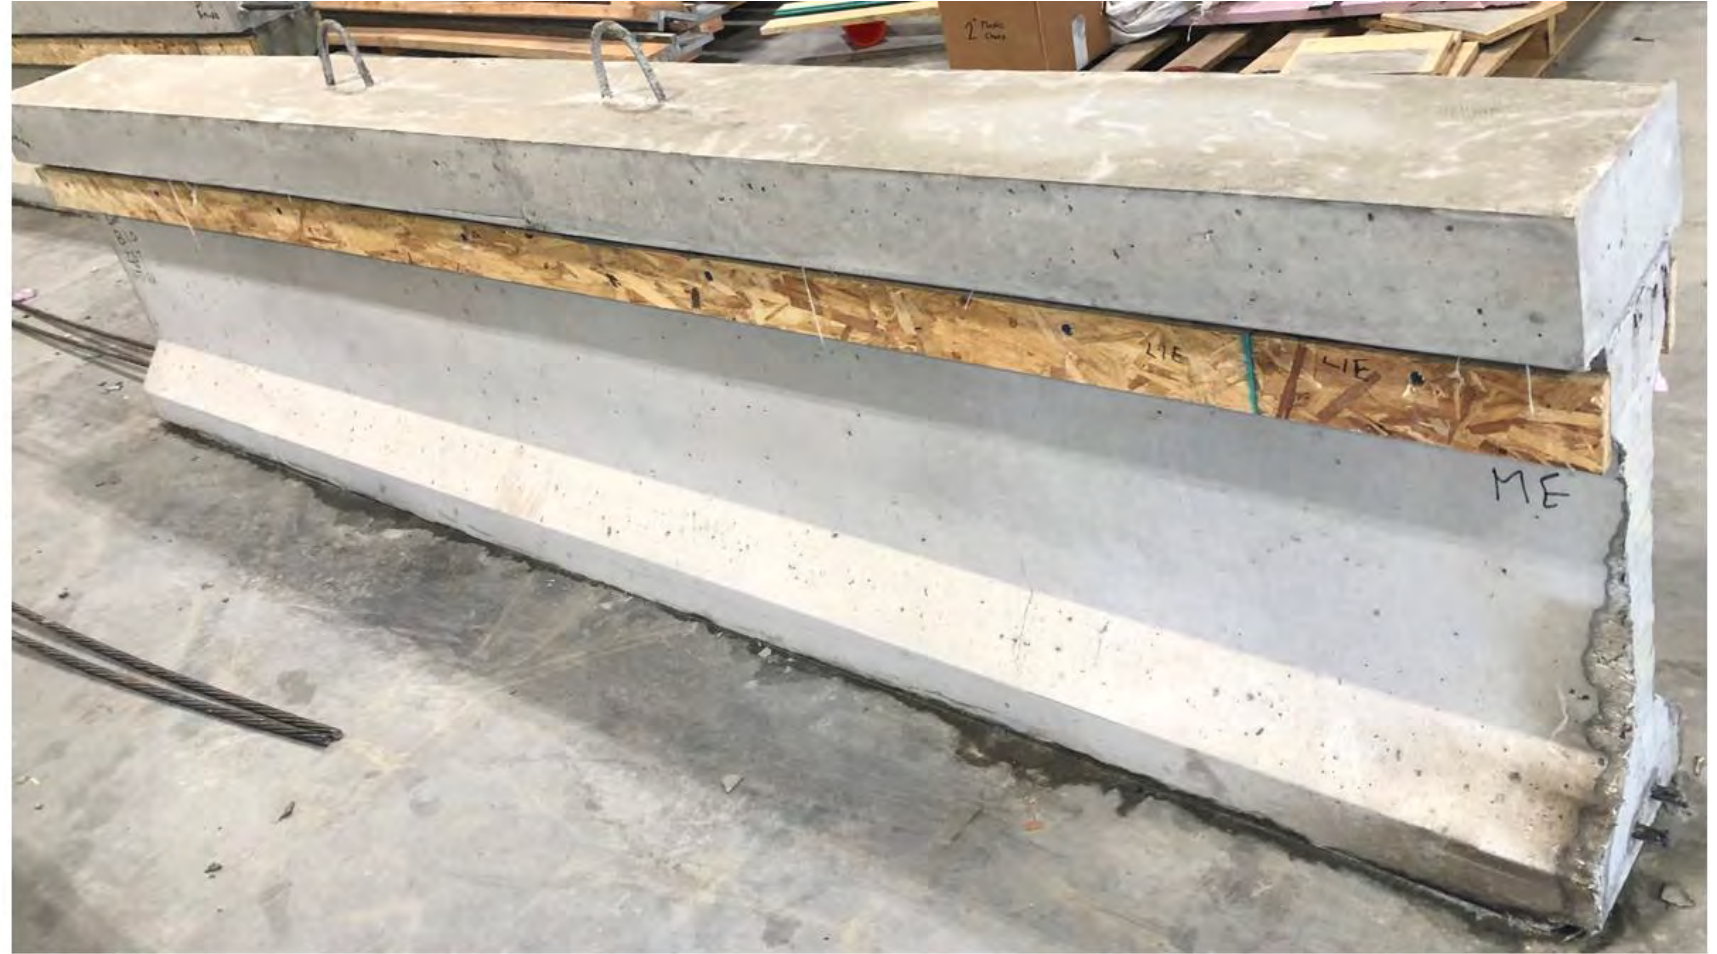
Completed specimen including the deck
