Design Guidance for UHPC Connections of Precast Girders Made Continuous for Live Load

Royce Floyd, Ph.D., P.E., S.E. (OK), The University of Oklahoma

ABC-UTC Research Seminar – July 28th, 2023

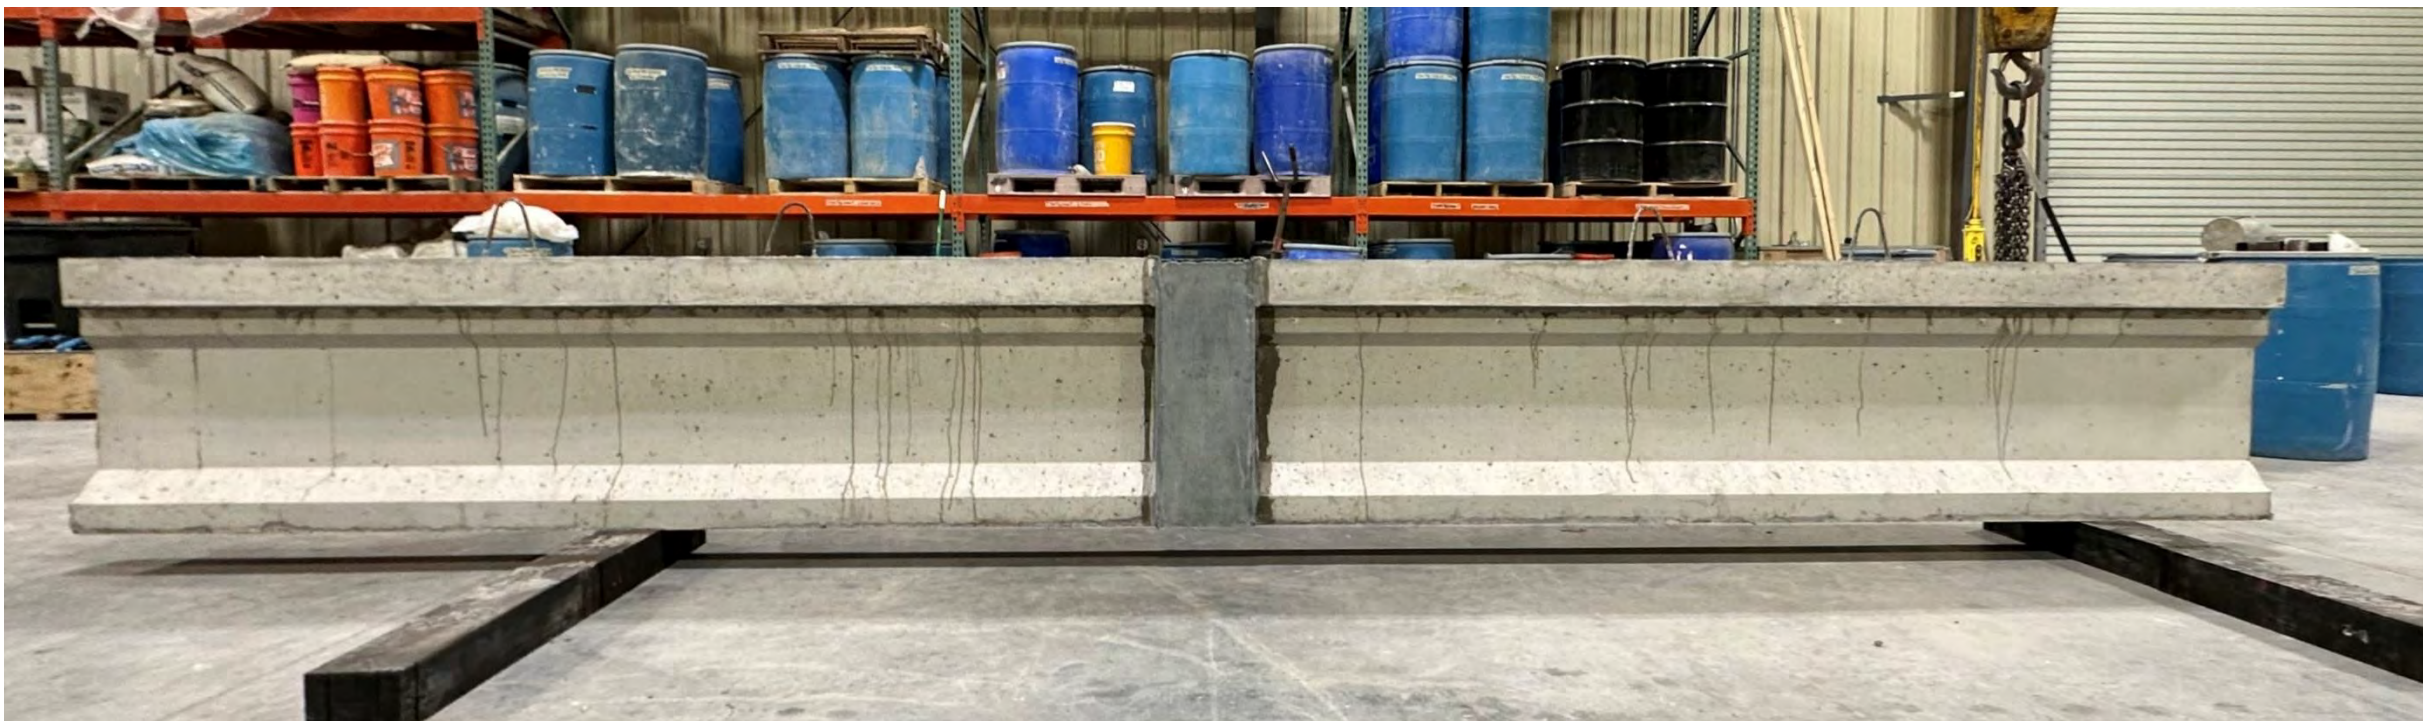
Completed connection specimen including two half-length beams and UHPC joint

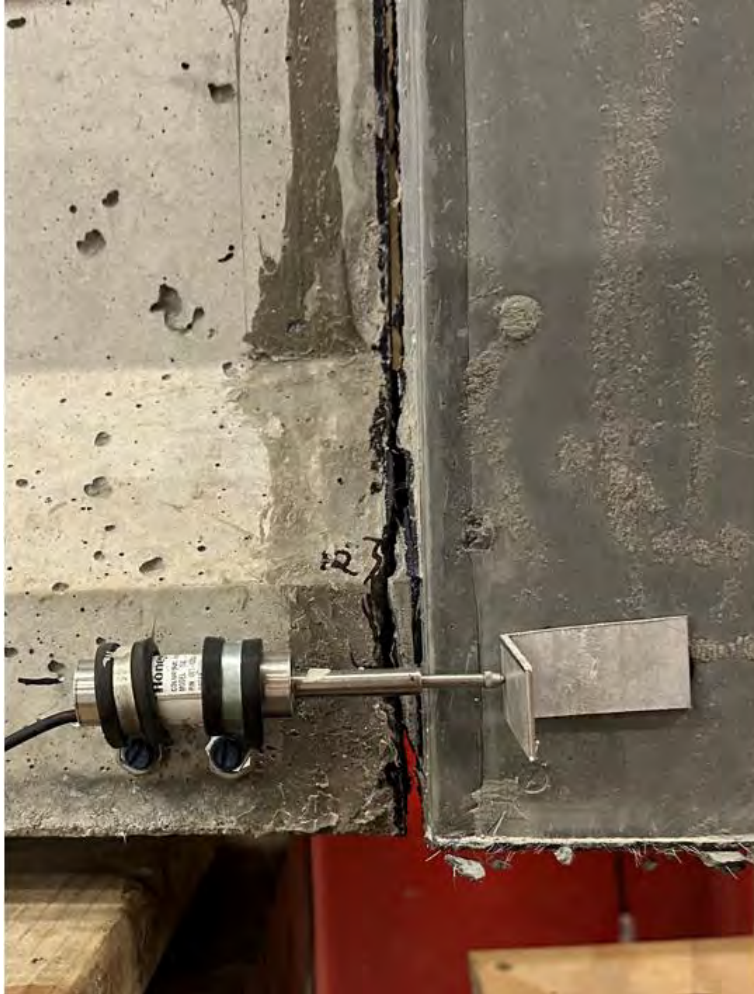
Typical separation at the interface between the girder and UHPC connection

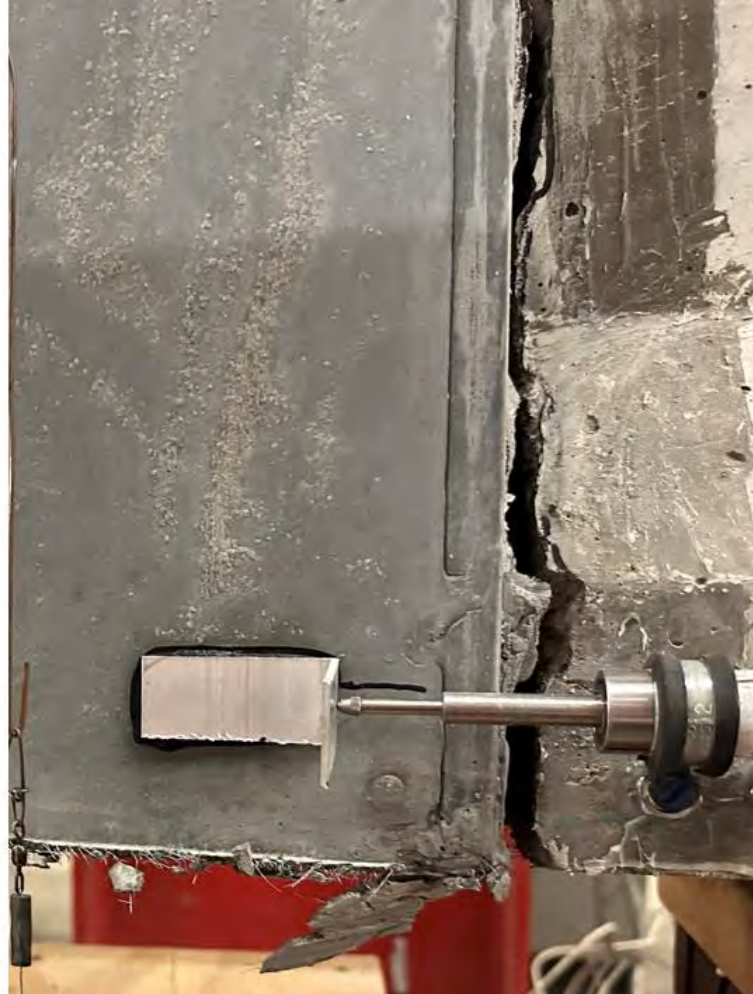
Cracking in the compression zone

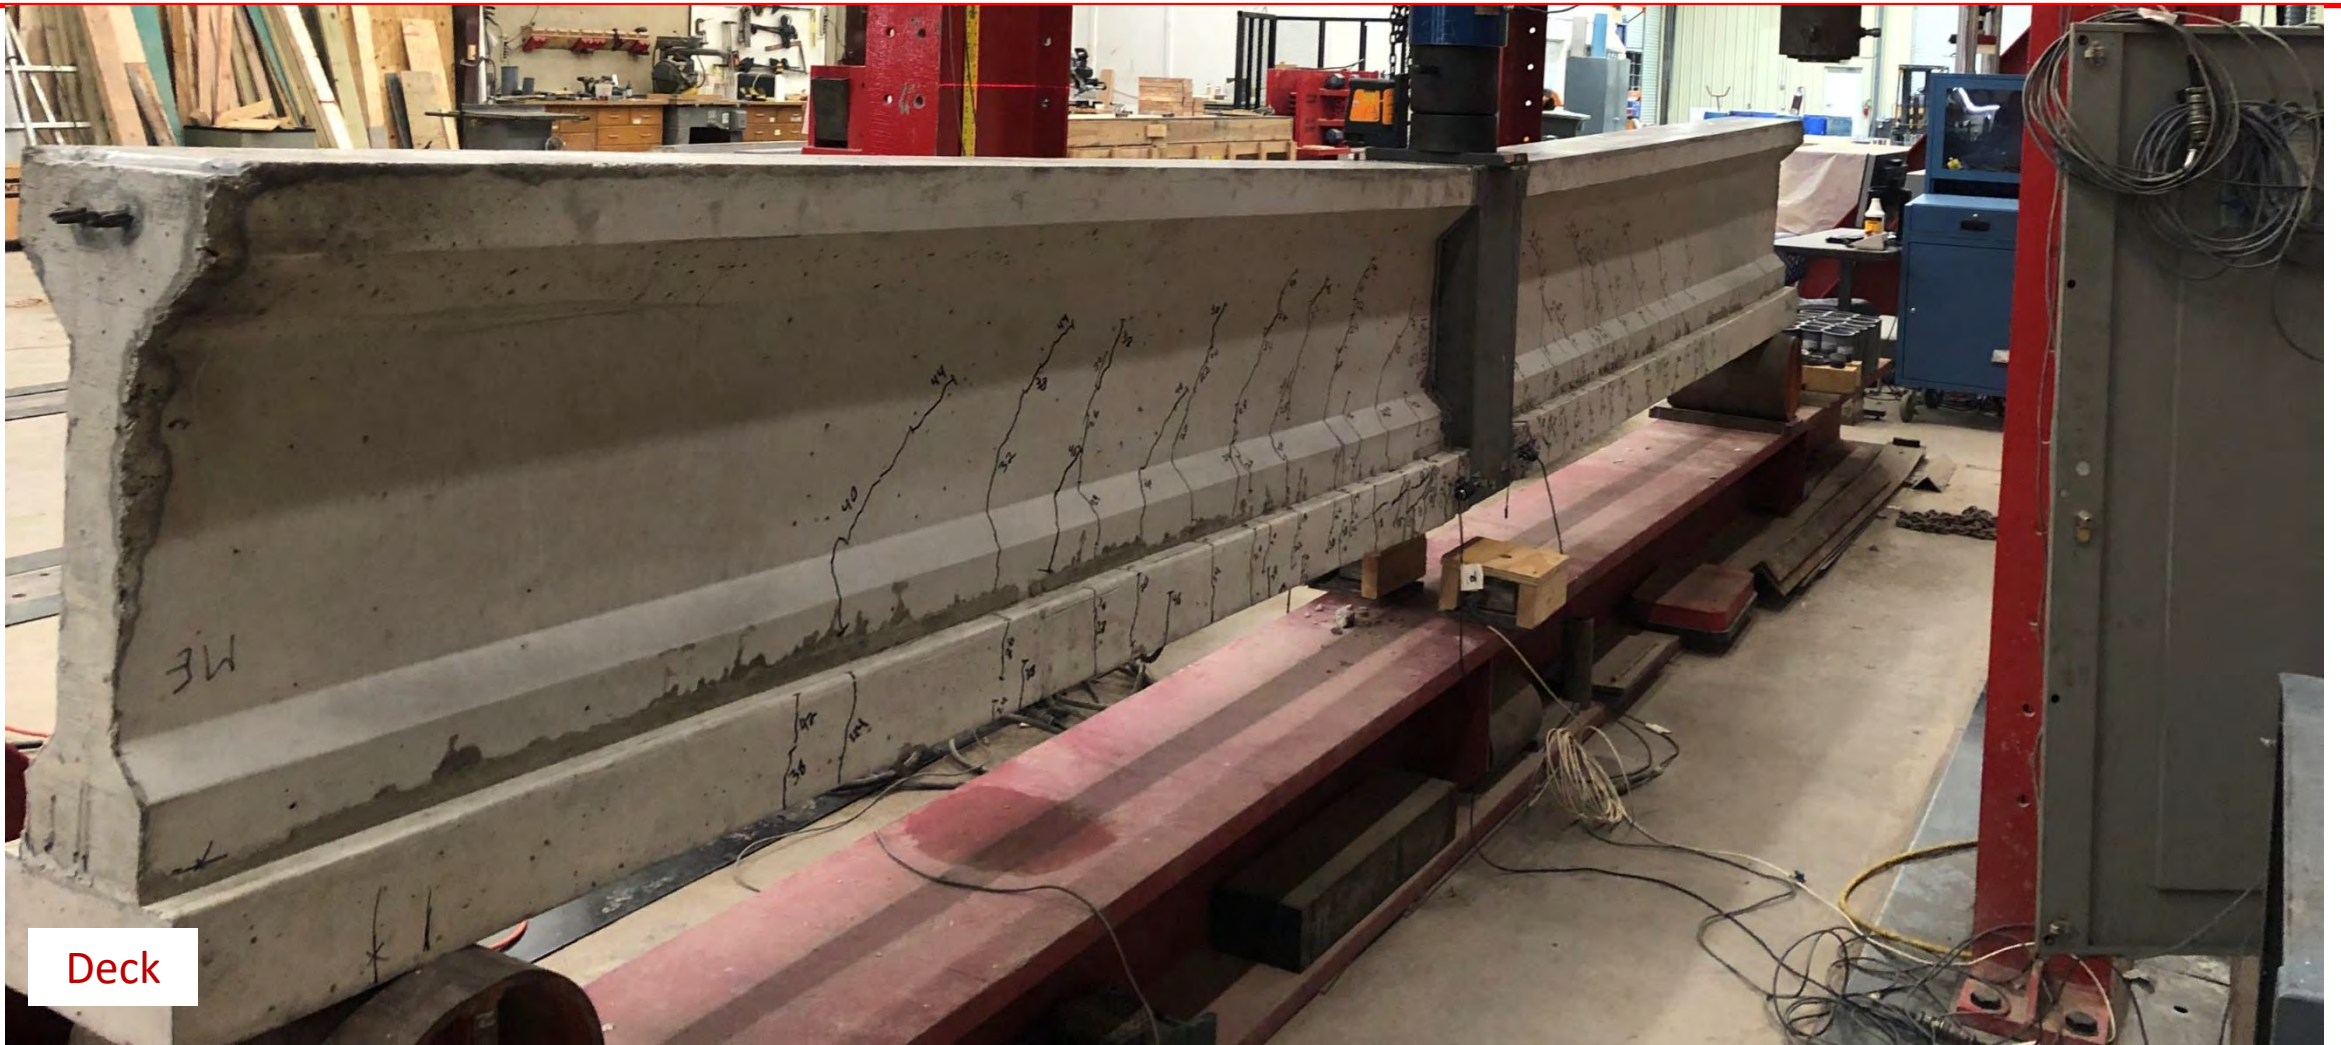
Flexural cracking in test with specimen loaded upside down to induce tension at the top of the connection

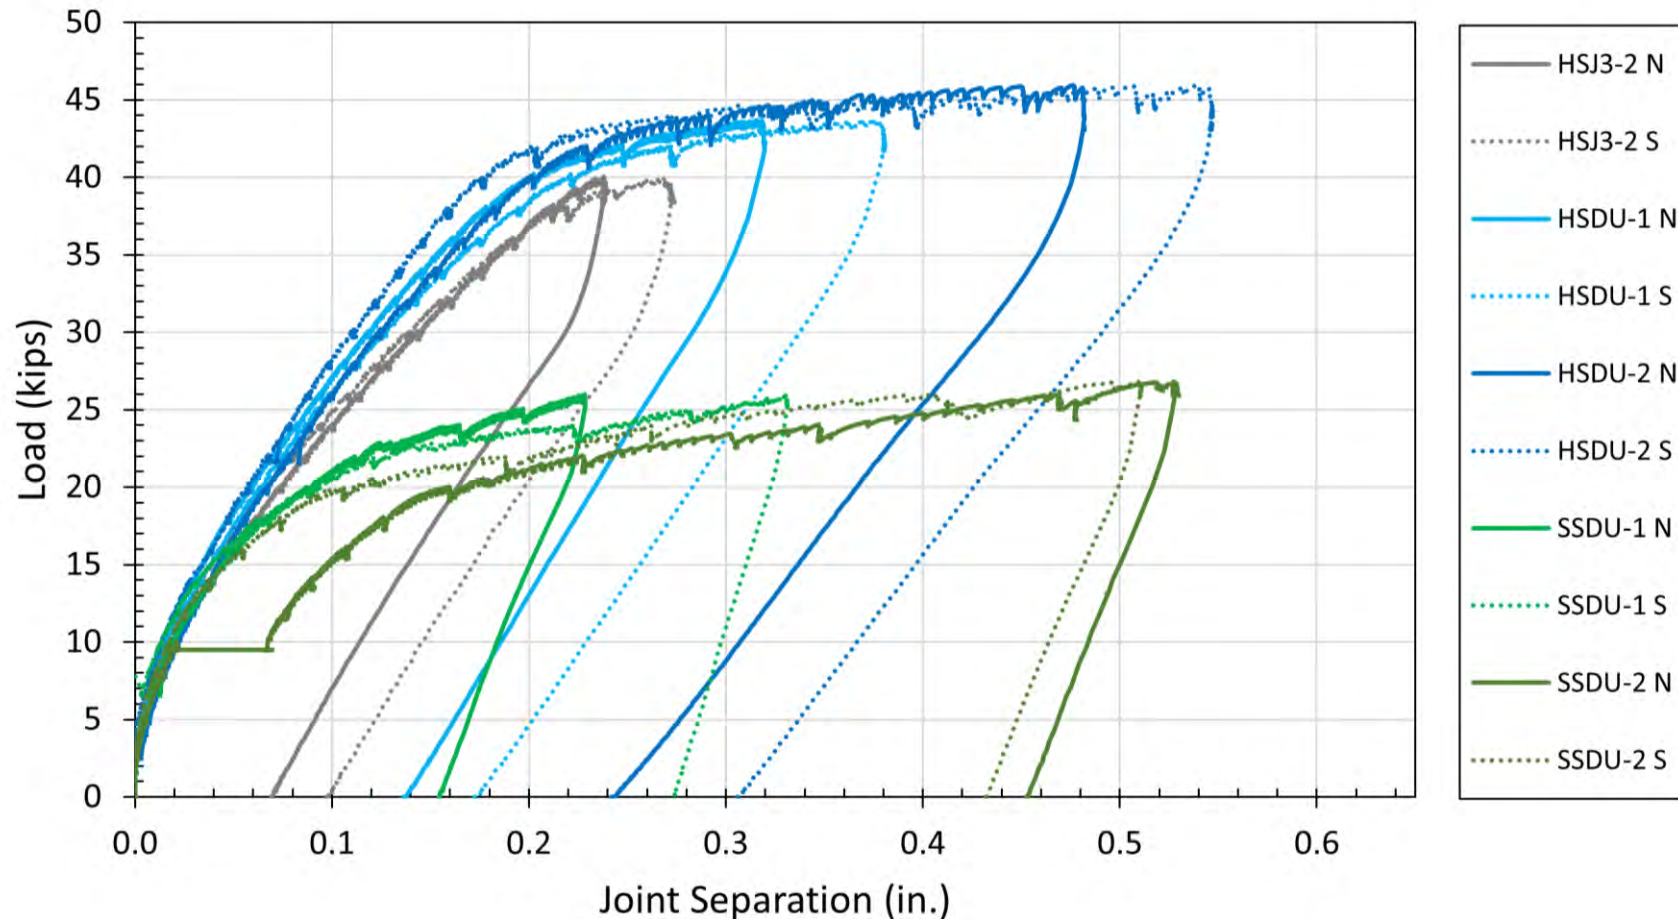
Load-Joint Separation Curves for Positive Moment Tests

- Hooked strand proprietary UHPC specimens performed the best
- Clear relationship between hooked vs. straight strands

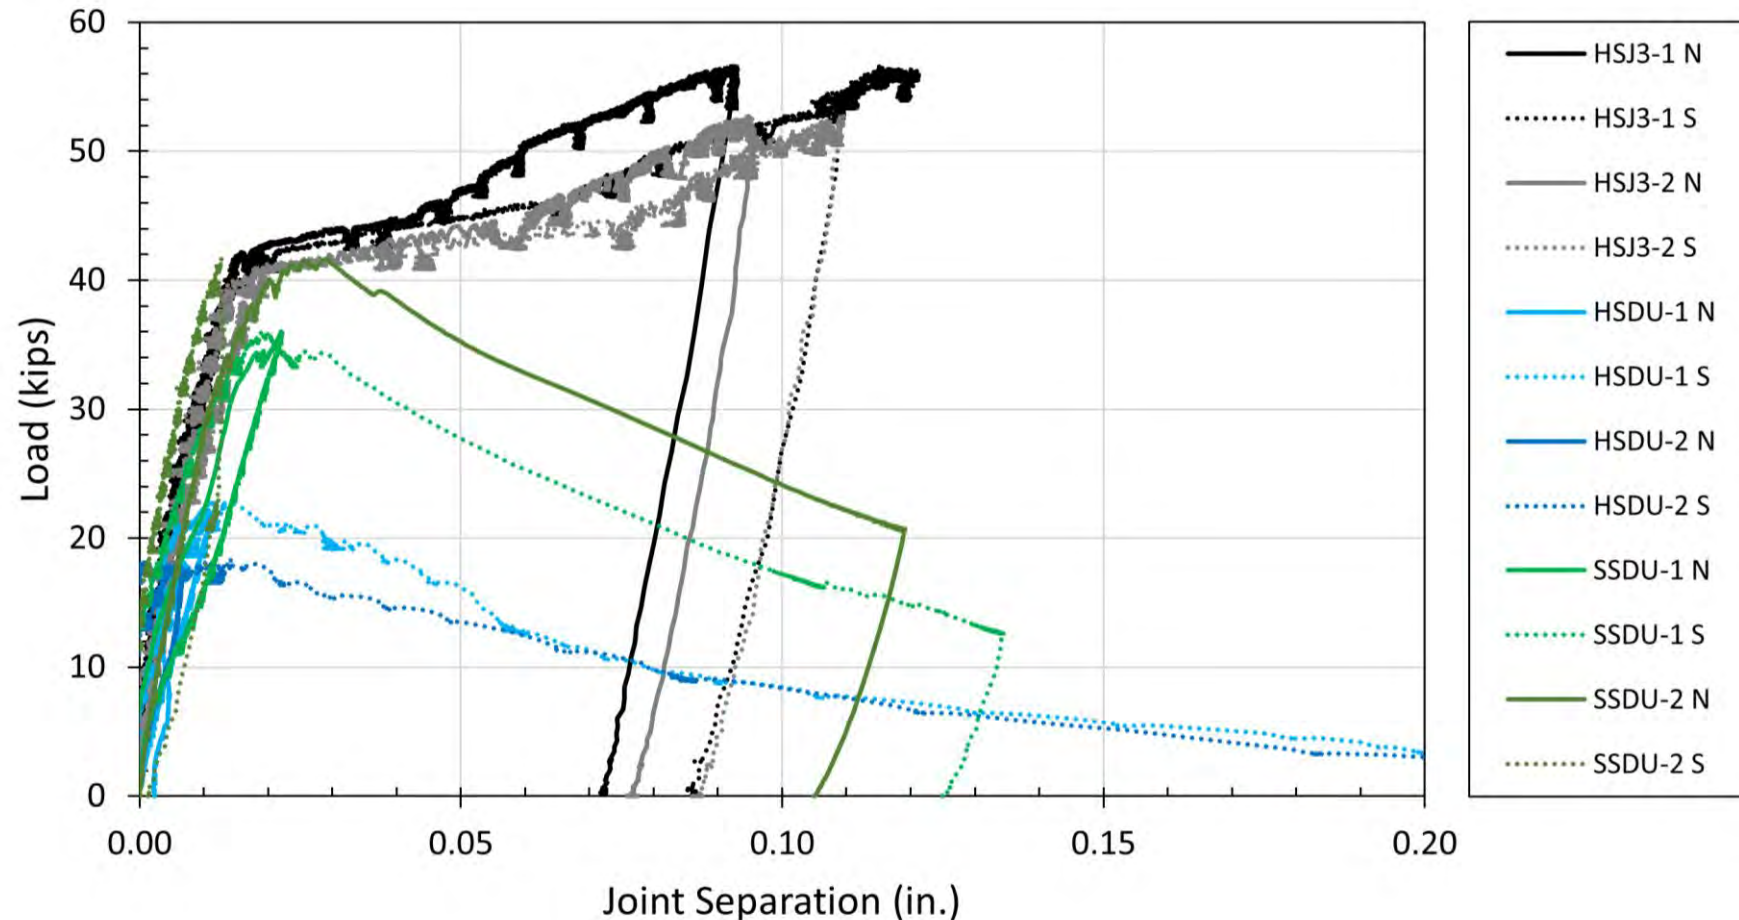
Load-Joint Separation Curves for Negative Moment

- Non-proprietary UHPC specimens showed significant joint separation at both interfaces
- Proprietary UHPC specimens showed joint separation at a single interface

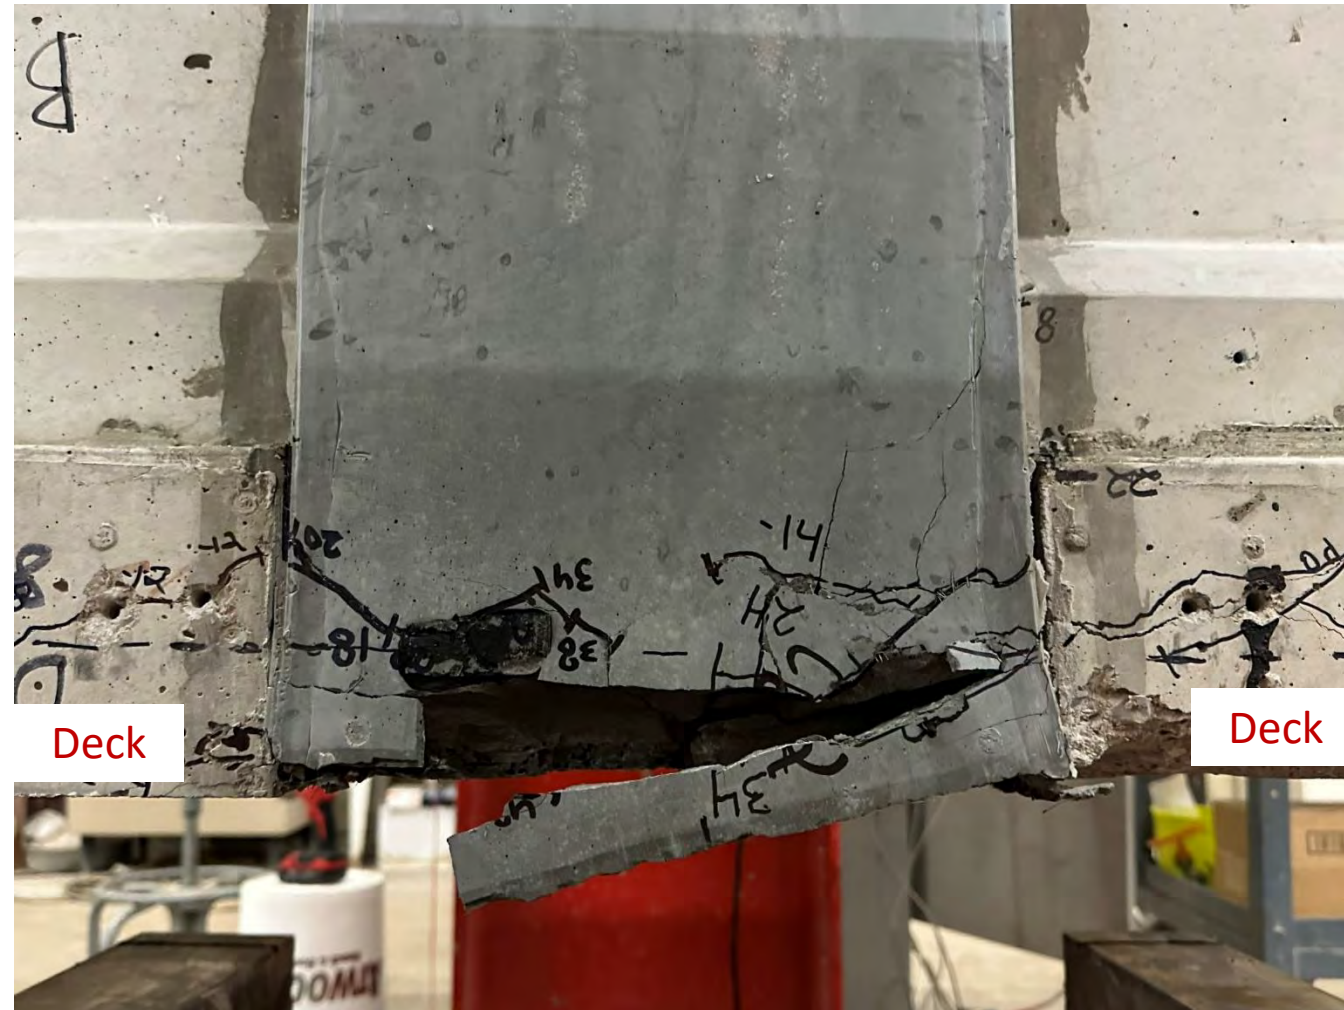
Horizontal cracking and spalling of UHPC with no fibers during negative moment test

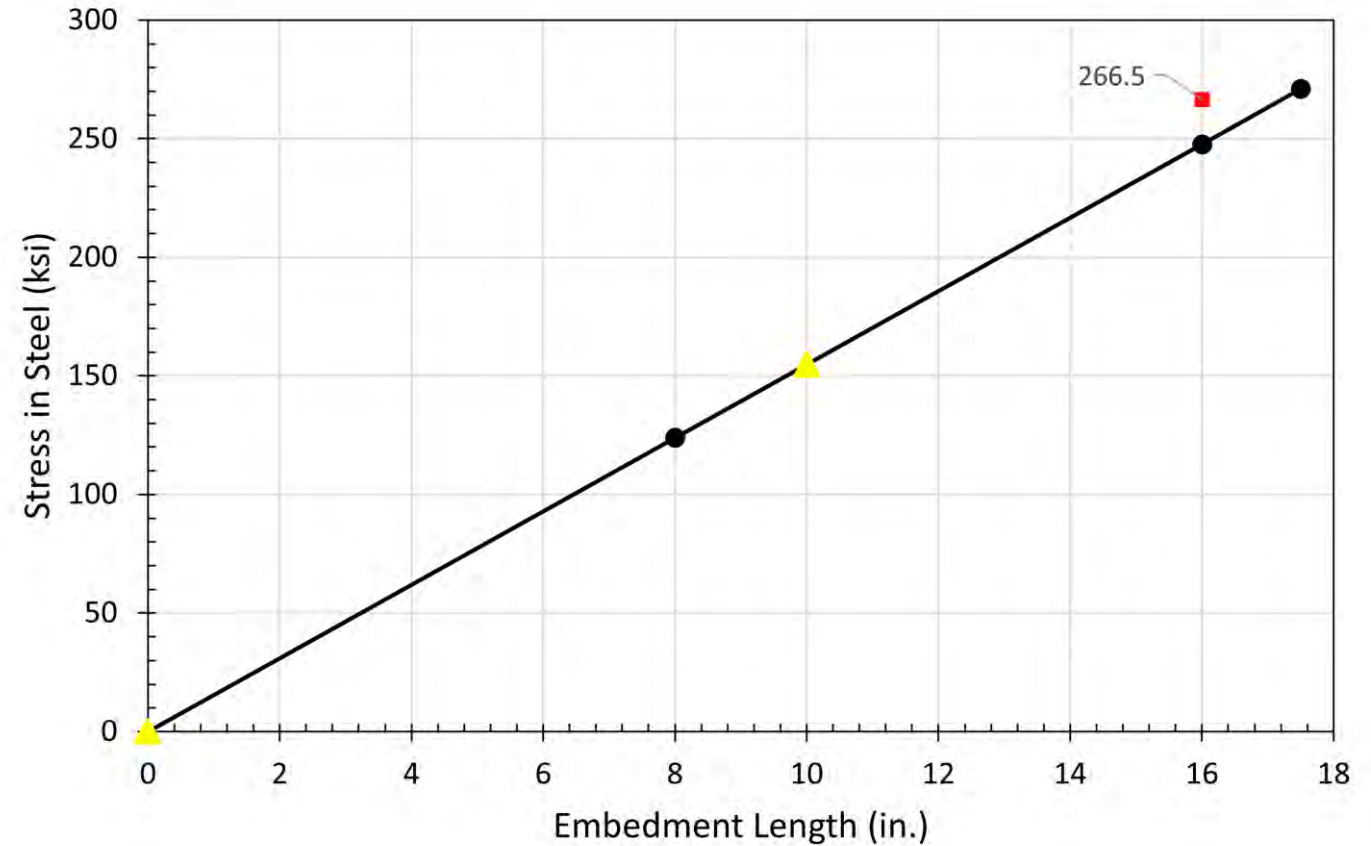
Assumed Linear Relationship

- Based on 10 in. straight strand proprietary UHPC specimens
 - Yellow triangle indicates values from straight strand specimen
 - Red square from hooked strand specimen
 - Others extrapolated

Embedment Length (in.)	Stress in Steel (ksi)
0	0
8	123.8
10	154.8
16	247.7
17.5	270.9
