Steel Bridge Rehabilitation Using UHPC to Repair Corroded Steel Beam Ends

Michael P. Culmo, PE, CHA Consulting, Inc.
Alexandra Hain, PhD, PE, University of Connecticut

IBT/ABC-UTC December 2023 Monthly Webinar
December 14th, 2022 | Virtual

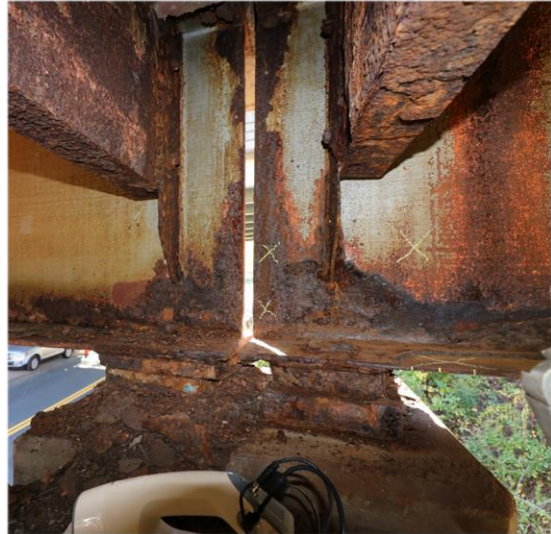
- Extensive corrosion of beams occurs beneath leaking joints
- Corrosion can significantly reduce bearing capacity
- US spends **\$8.3 billion annually** to repair or replace corrosion damaged bridges

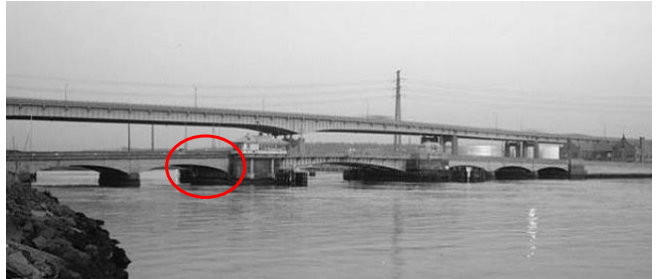
- Tomlinson Bridge, New Haven CT, 1990±
- Approach span beams were corroded at the bascule span counterweight pier
- 100% section loss in the webs
- Solution:
 - Encase the last 10 feet of the beam in concrete
 - Converted the beam end into reinforced concrete
- UHPC is like liquid steel
 - Can we use a similar approach with UHPC?
 - Goal: Eliminate jacking, bolting, and welding of plates
- CTDOT decided to fund a research project
- UConn was selected to execute the research

Concrete-encased riveted steel girders

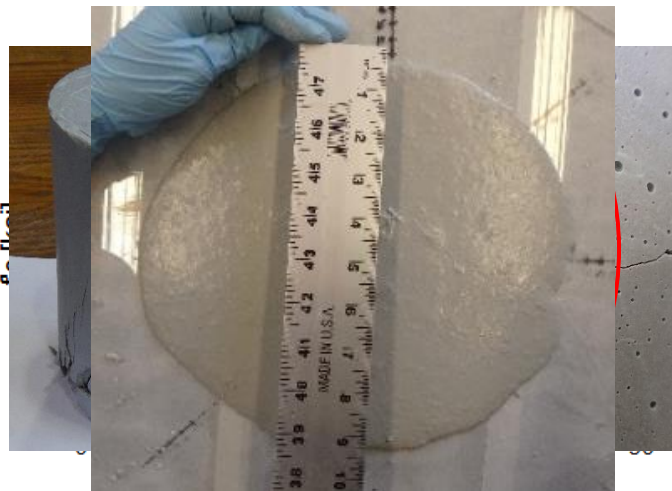
Background – UHPC Material

1. Compression strength
2. Sustained post-cracking tensile strength
3. Proven durability
4. Crack resistance
5. Flowability

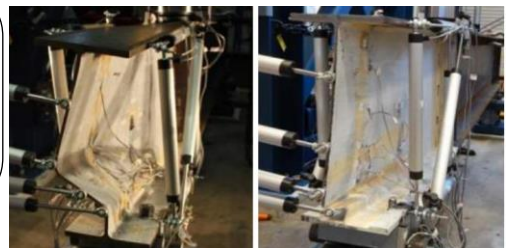
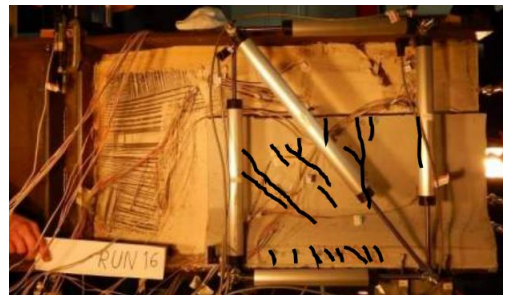
Phase 1
2013-2015

- Proof-of-concept experiments on third-scale girder specimens
- Developed finite element models to identify design parameters

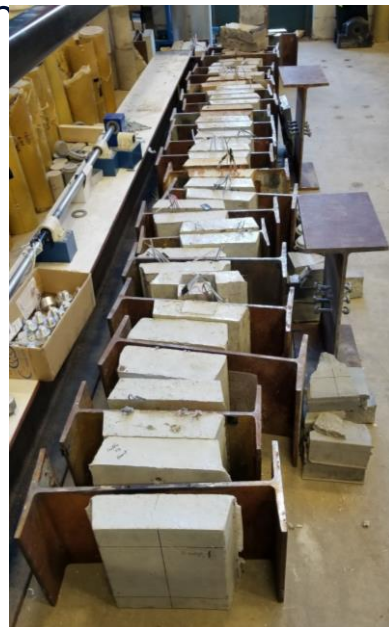
Phase 2
2015-2018

- Investigation of stud capacity embedded in UHPC
- Experimental study on 3 full-scale plate girder repairs

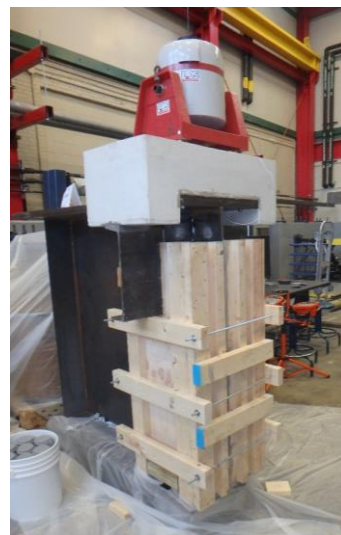
Background – Previous Research

- Investigation of stud capacity embedded in UHPC
- Experimental study on 3 full-scale plate girder repairs

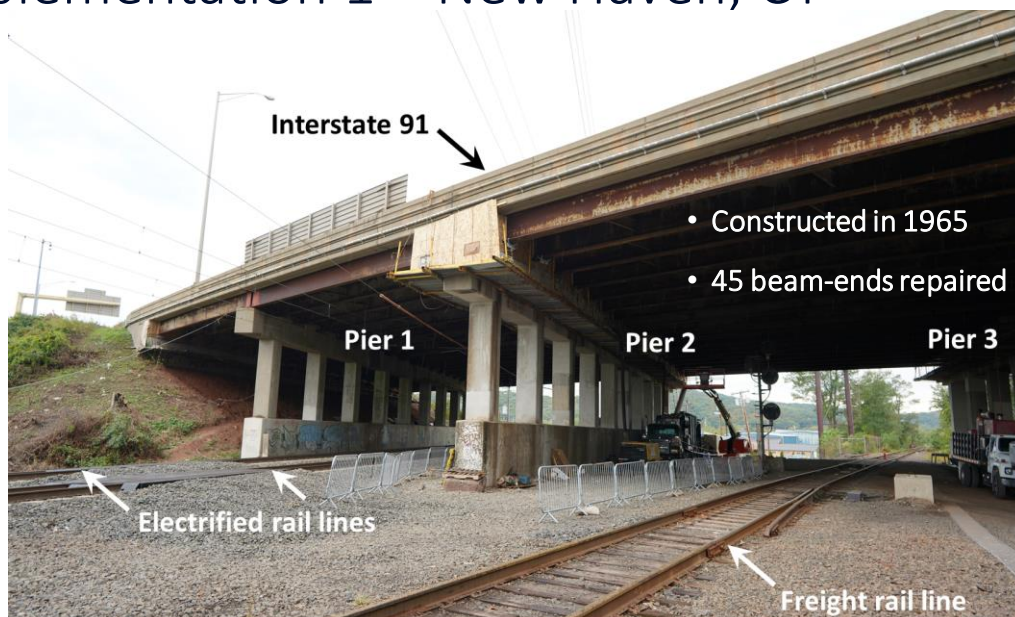
Implementation 1 – New Haven, CT

- Composite concrete deck
- Four simple spans, 273 ft
- Ranging skews 25° -35°
- Variable beam sizes, depths ranging from 33-36 in
- Different end conditions

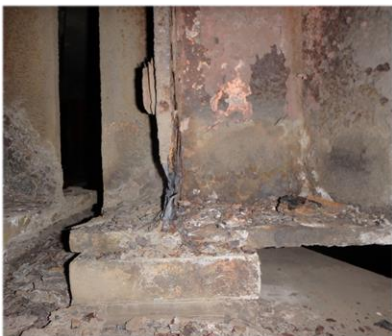
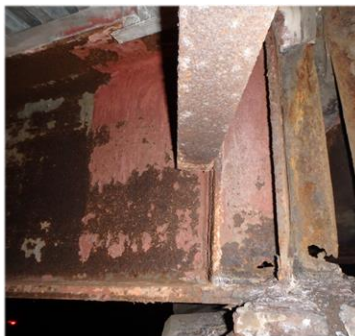
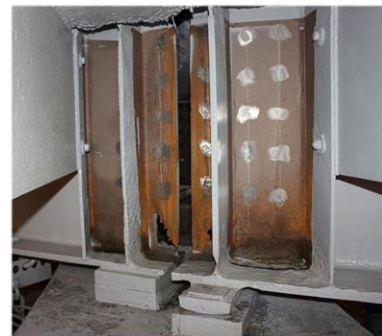
Implementation 1 – Condition of Bridge

- Rated as structurally deficient
- Beam ends, end diaphragms, and connection plates were severely corroded
- Web ends and bearing stiffeners have substantial section loss
 - Max bearing capacity loss: **72%**
 - Max shear capacity loss: **15.5%**

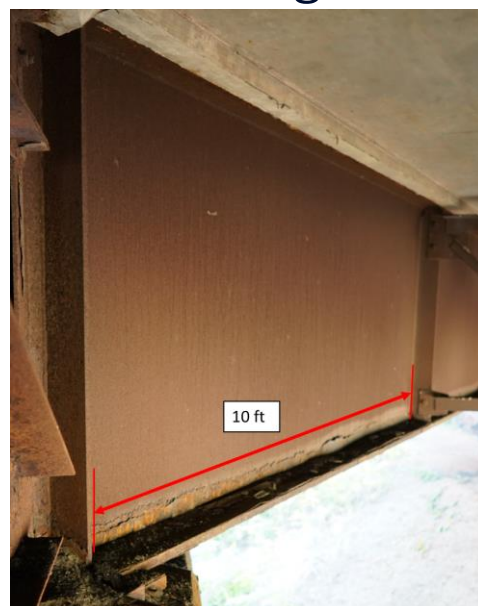
Implementation 2 – Condition of Bridge

- Rated as structurally deficient.
- Section loss extended an average of 7 ft from the end of the girders.
- The height of the deterioration was 4-8 in, localizing the damage to the bases of the webs.
- Interface shear strength was a concern.

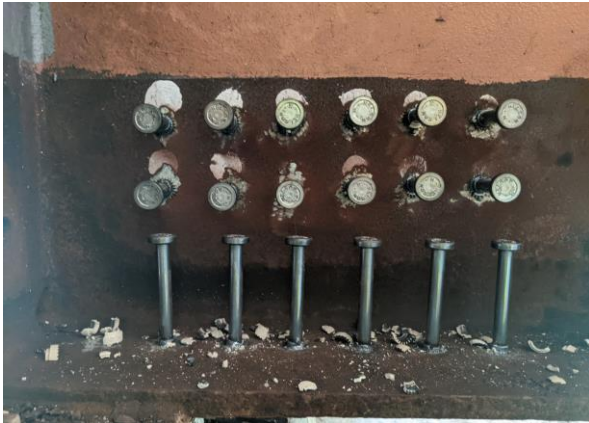
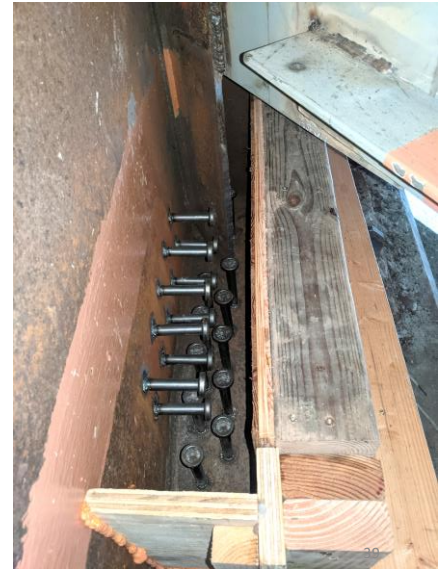
Implementation 2 – Stud Welding

- This repair design was unique in that studs were welded to the bottom flange to carry shear between the web and bottom flange.

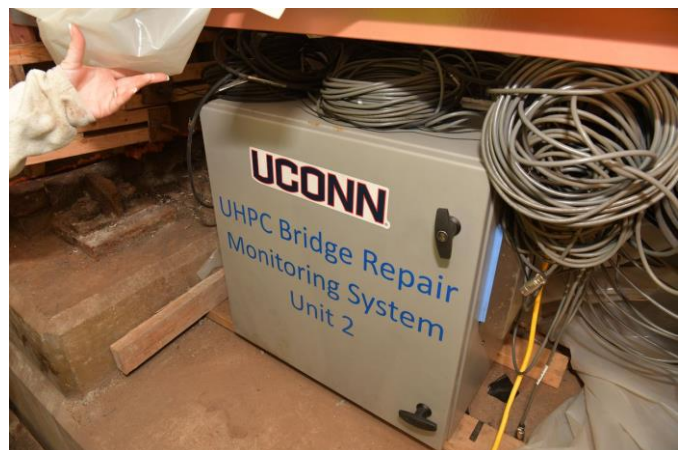
Implementation 2 – Monitoring

- Monitoring was based on learnings from previous implementation.
- Captured:
 - Accelerations
 - Temperature during curing
 - Strains on web, studs and in UHPC panels.

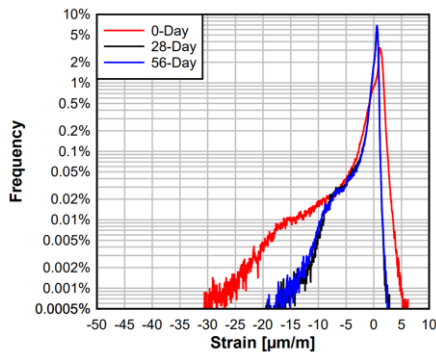
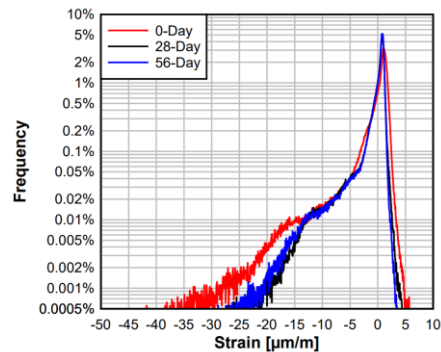
Data Collection on Repaired Beam Ends

- The repair reduced the maximum web strain from the baseline condition as well as the frequency of high-magnitude strain events.

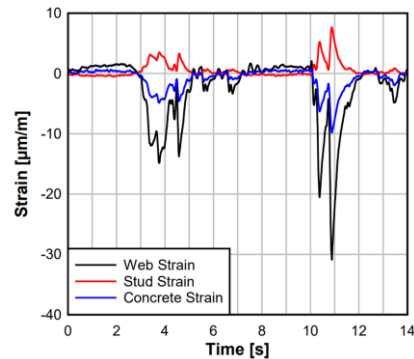
Data Collection on Repaired Beam Ends

- The results showed clear peaks in all strain responses under live load events.
- Prior to repair, the magnitude of web strain under live load was larger while the UHPC and stud strains were zero.
