PREFABRICATED BARRIER SYSTEM UTILIZING UHPC CONNECTIONS

Final Report

September 2024

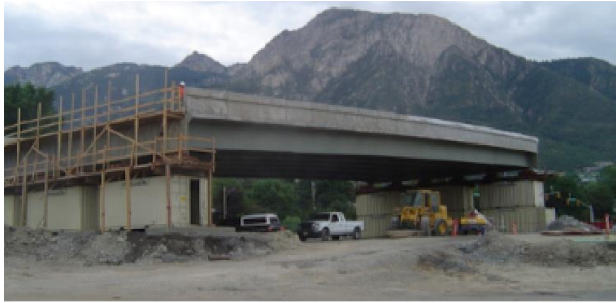
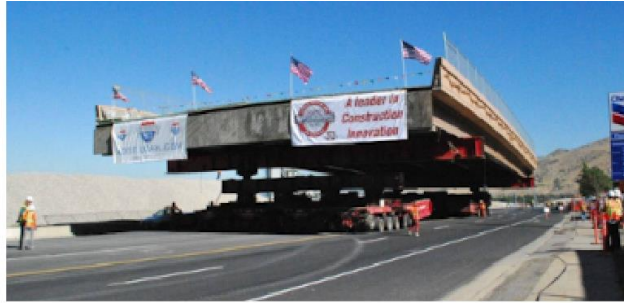
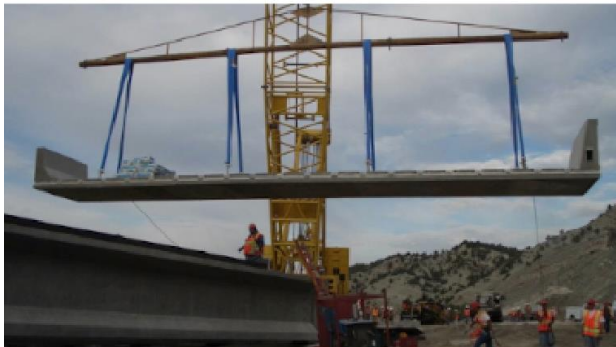
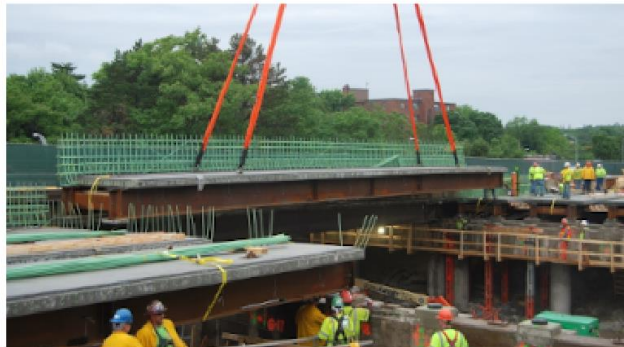
(a) Construction of a bridge using SPMT installation

(b) Modular construction of bridges with and without integral barrier

Figure 1 Construction and installation of bridge Systems using ABC methods [1].

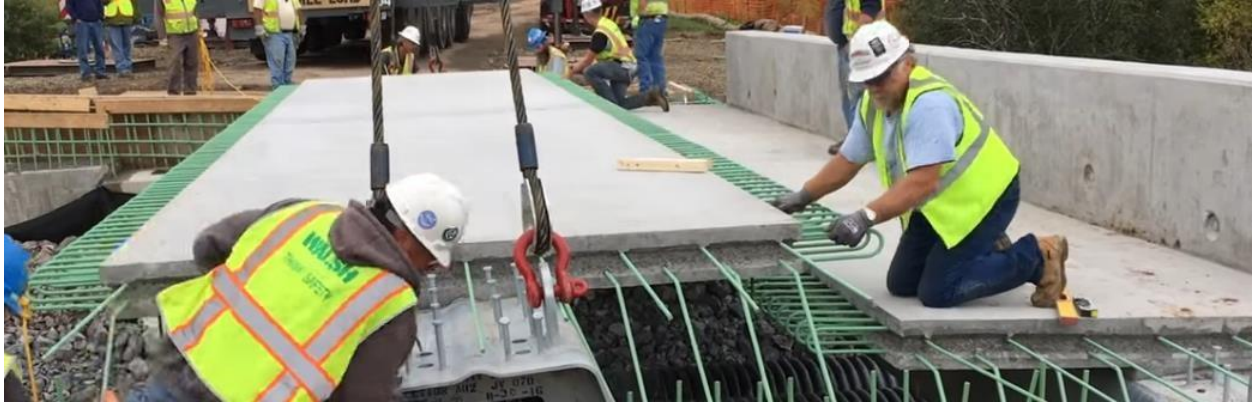
Figure 2 Modular construction with barrier system incorporated into the exterior module.

In the modular construction ABC method, there may be a need for prefabricated barrier systems. In the modular construction ABC method, the bridge superstructure is broken into larger pieces (modules), constructed offsite, transported to the final bridge location, and assembled by joining the modules to complete the bridge construction. There are many modular ABC Construction approaches, and the barrier system is incorporated in many ways. This can include using a precast panel deck that incorporates a barrier system and without a barrier system (Figure 1b), and several approaches that would need a prefabricated barrier system. Figure 2 shows an example of Modular Construction in Pennsylvania, where a barrier system was incorporated into the exterior module, eliminating the need for a prefabricated barrier system. In such cases, handling the exterior unit is somewhat complicated and demands careful attention to the pickup point while handling and transporting exterior modules.

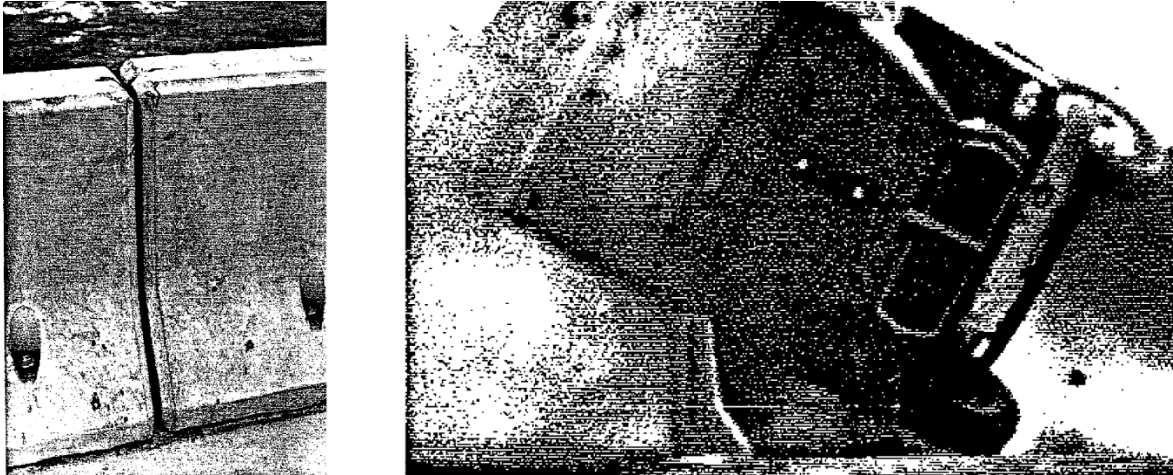
Figure 3 Crash tested L.B. Foster precast concrete bolt-down barrier system [7].

This barrier system was subjected to a crash test in compliance with the AASHTO guide specifications from June 1988 for Performance Level 2. The test involved an impact speed of 51.7 mph (83.2 km/hr) and an impact angle of 14.6 degrees, with the total weight of the impact vehicle being 18,000 lb (8,165 kg). The barrier system successfully contained and smoothly redirected the test vehicle, even though the vehicle did not remain upright post-collision. There was no lateral movement of the bridge rail, and a post-collision inspection revealed no signs of structural distress in the barrier, the anchoring system, or the bridge deck. Furthermore, minimal deformation of the occupant compartment was observed with no intrusion, and the vehicle's trajectory upon loss of contact indicated minimum intrusion into adjacent traffic lanes [7].

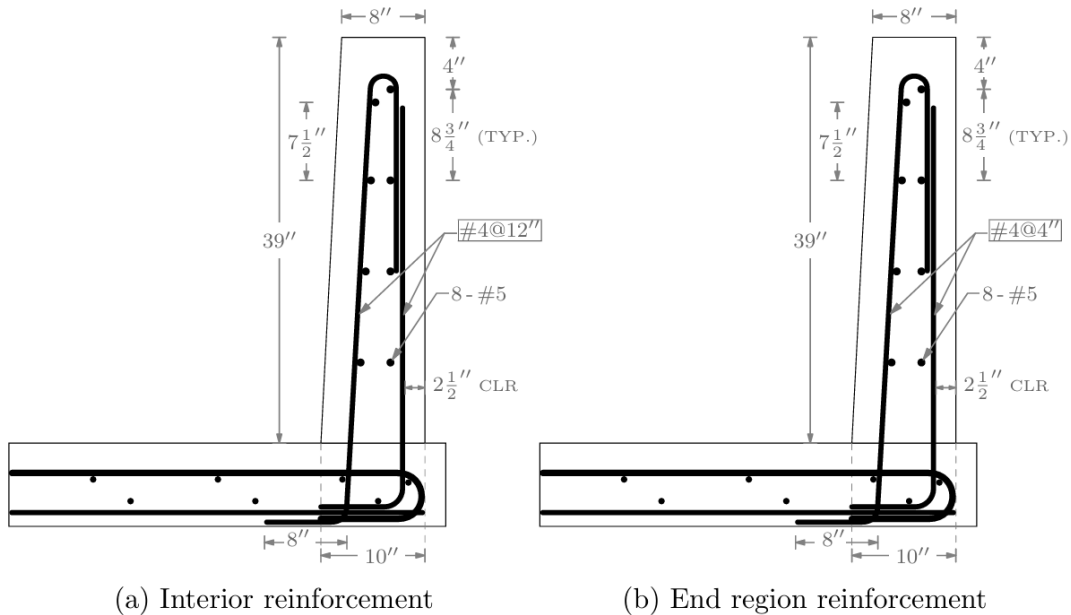
Figure 15 Cross sections of the TL-4 single-slope barrier [33].

The barrier reinforcement incorporated eight #5 longitudinal bars. Transverse reinforcement was provided by #4 stirrups, spaced at 12 inches on-center in interior regions and 4 inches on-center in end regions. All reinforcements had a clear concrete cover of 2.5 inches to protect against environmental factors and ensure durability. Figure 15-a and b show the dimensions and reinforcement details for the interior and end regions of the barrier.

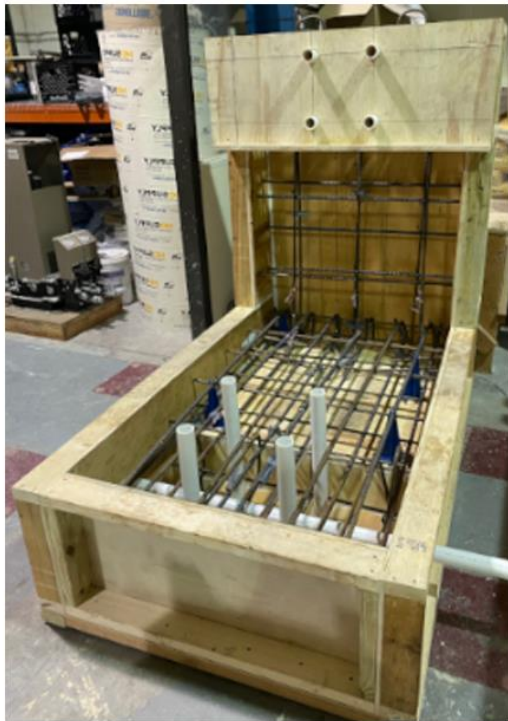
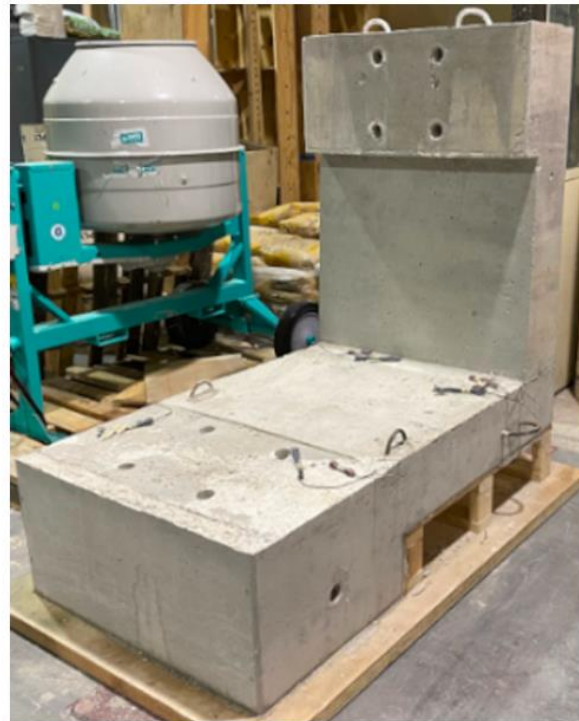
(a) Barrier and deck reinforcement

(b) Constructed specimen

For the CIP specimen, formwork was built, and reinforcement cages were placed inside. Traditionally, CIP concrete barriers are cast separately on top of an already cured deck, creating a cold joint at the barrier-to-deck interface. To accelerate construction and eliminate this cold joint, the CIP barrier and deck overhang in this project were cast together in a single pour (see Figure 18). By casting both components simultaneously, the construction process was accelerated and no cold joint in the barrier-to-deck interface was present.

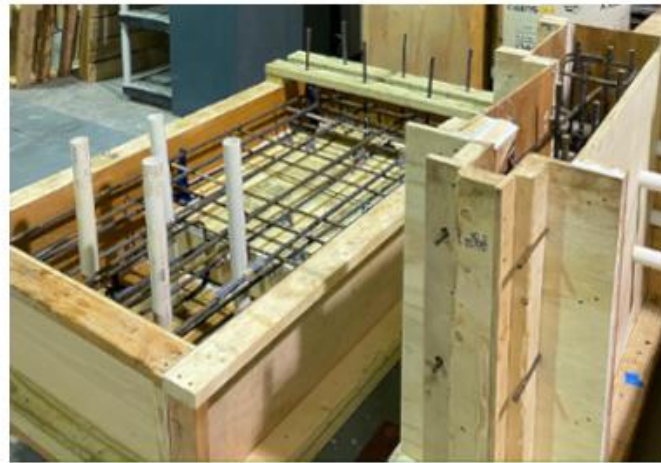
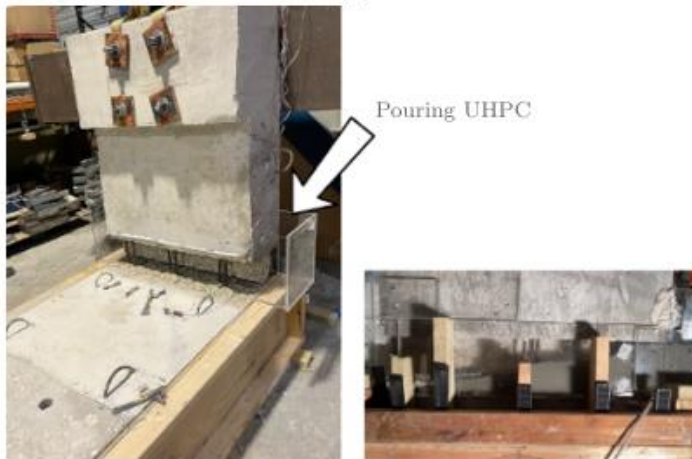
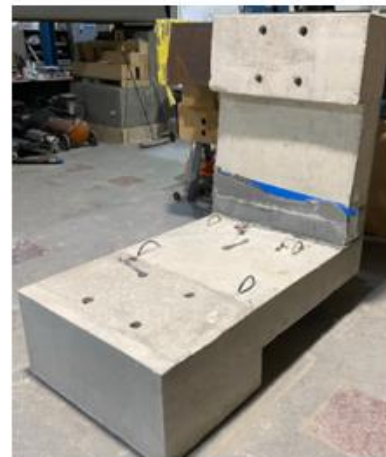
(a) Barrier and deck reinforcement

(b) Casting UHPC

(c) Constructed specimen

The U-shape connection specimen aimed to replicate prefabricated construction methods by constructing the barrier unit and deck overhang separately (see Figure 19). This approach presented challenges in stabilizing the barrier and forming the connection region. Temporary shoring was necessary to maintain the barrier's stability during assembly. Additionally, formwork was required on both the front and rear sides of the barrier to cast the connection region with UHPC. The complex casting sequence and the need for additional formwork highlighted practical difficulties in implementing the U-shape connection in field conditions. These challenges emphasized the necessity for a more constructible solution, which led to the development of the Recessed connection specimen.

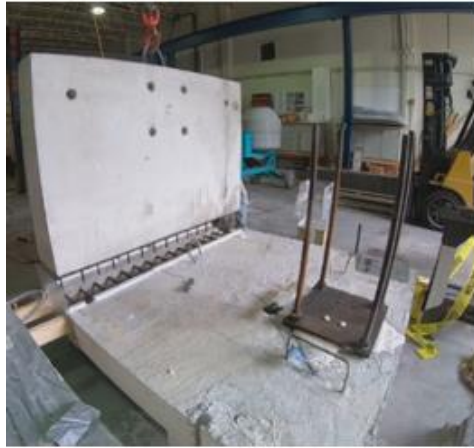
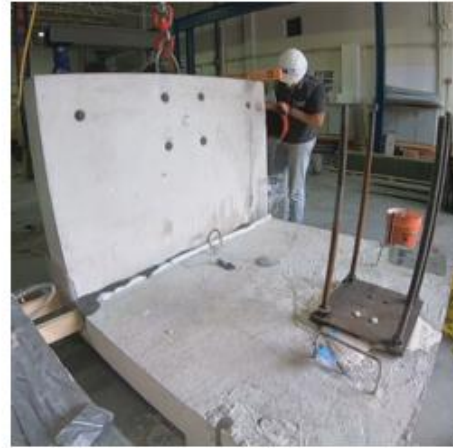
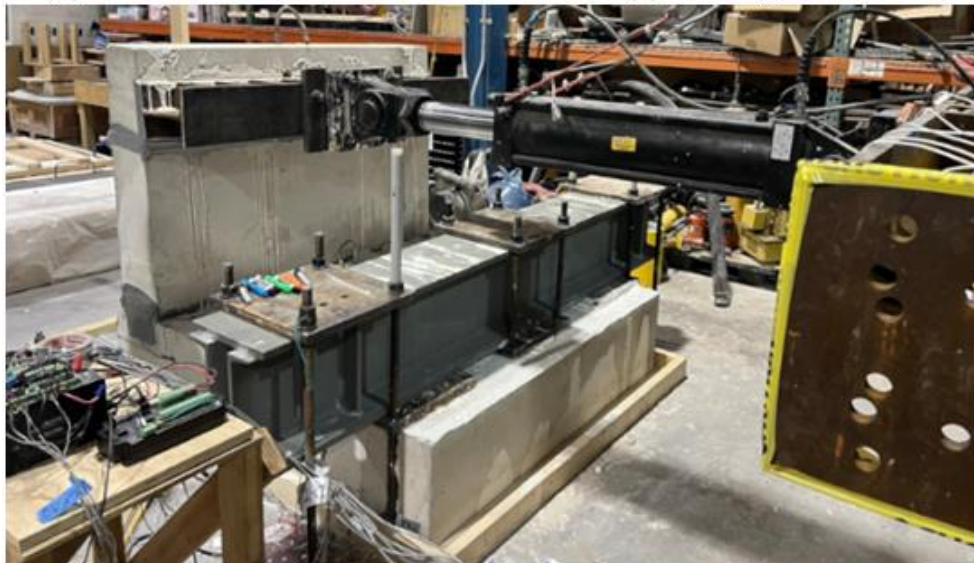
(a) Barrier and deck reinforcement

(b) Placement of the barrier

(c) Casting UHPC

(d) Constructed specimen at the testing location

the connection region. This method simplified the construction process by removing the need for formwork and temporary supports, thereby reducing the construction time.

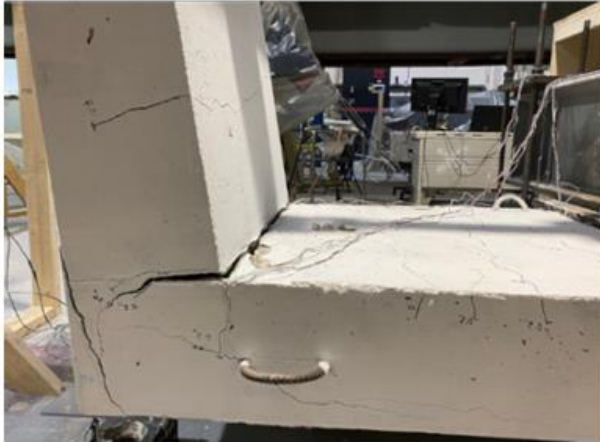
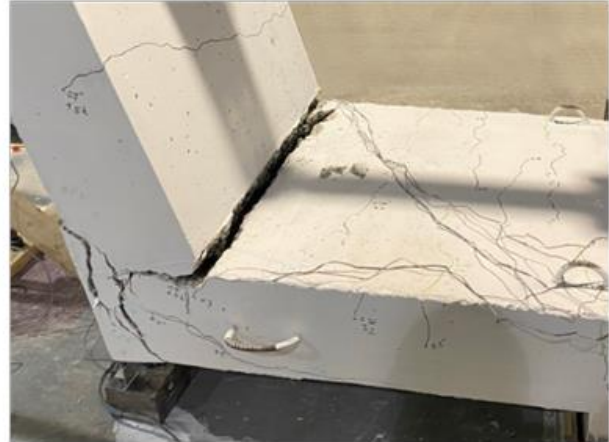
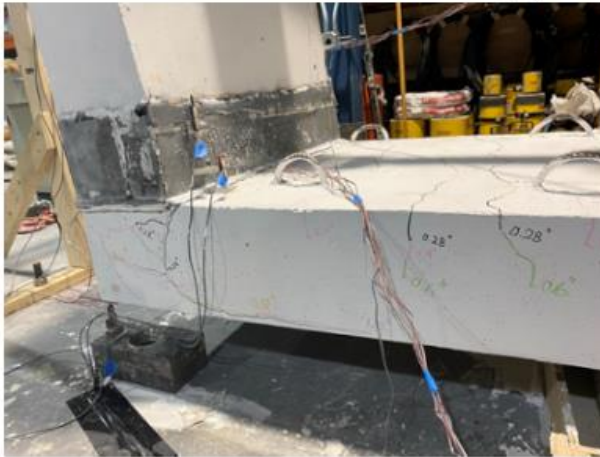
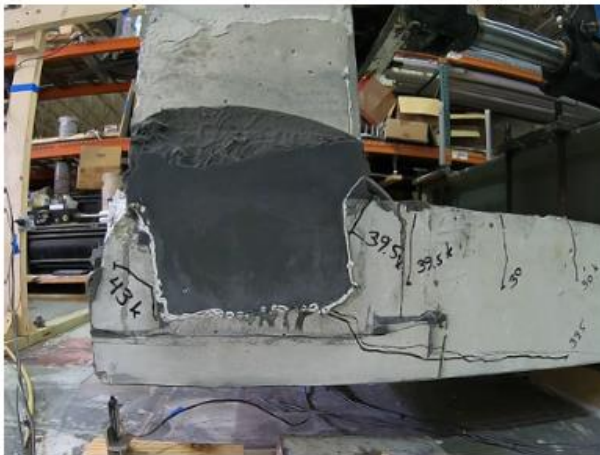
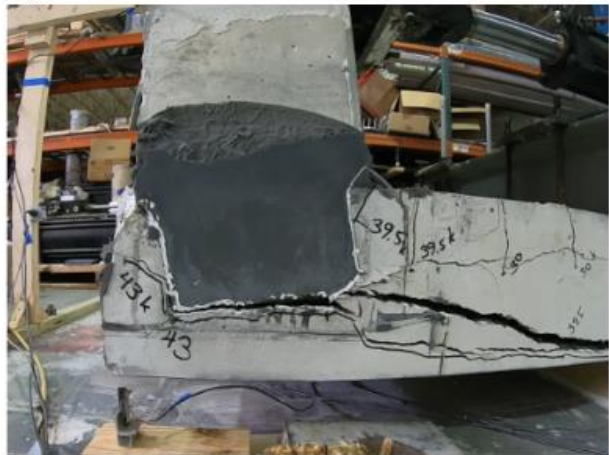
(a) CIP specimen

(b) U-Shape specimen

(c) Recessed specimen

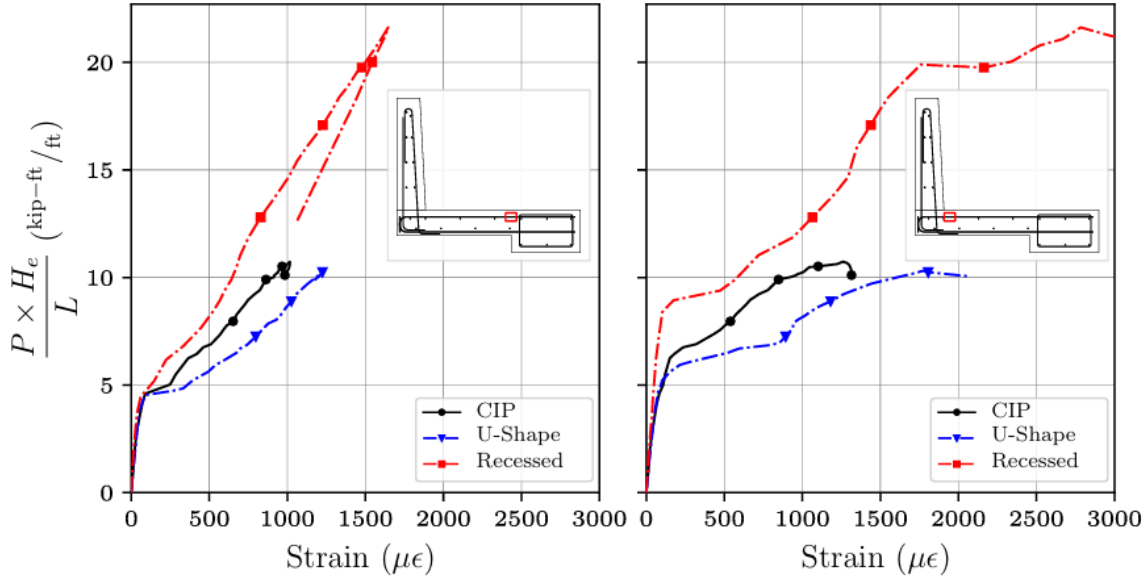
Figure 23 Moment-Strain curves for the top transverse deck reinforcements [19, 32].

Similar to the CIP specimen, the U-shape specimen showed an initial linear response with cracking occurring in the deck overhang at the support edge. As the load increased, hairline cracks and horizontal cracks at the barrier-to-deck interface were observed. The ultimate capacity of the U-shape specimen was comparable to the CIP specimen, with failure occurring at a drift ratio of about 0.02 due to punching shear in the deck overhang. The use of UHPC in the connection region did not significantly enhance the ultimate capacity because the shear failure of the deck overhang remained the limiting factor. Increasing the number of stirrups would not have substantially improved the capacity due to this failure mode.

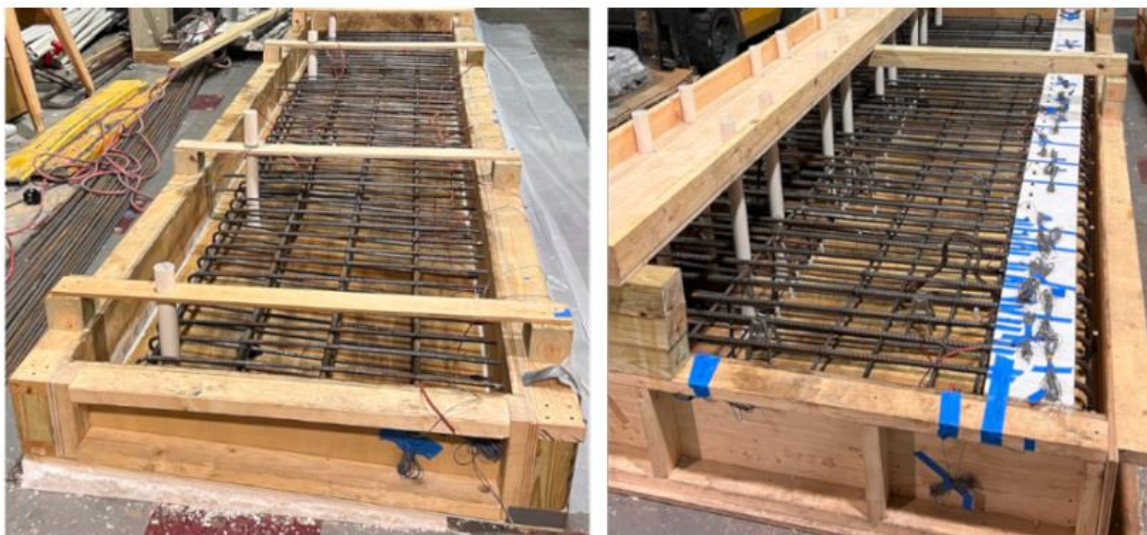
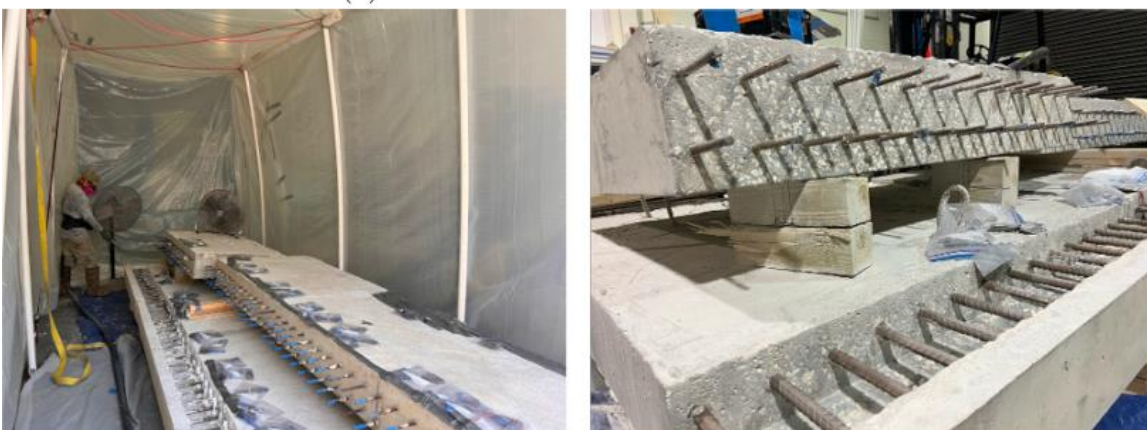
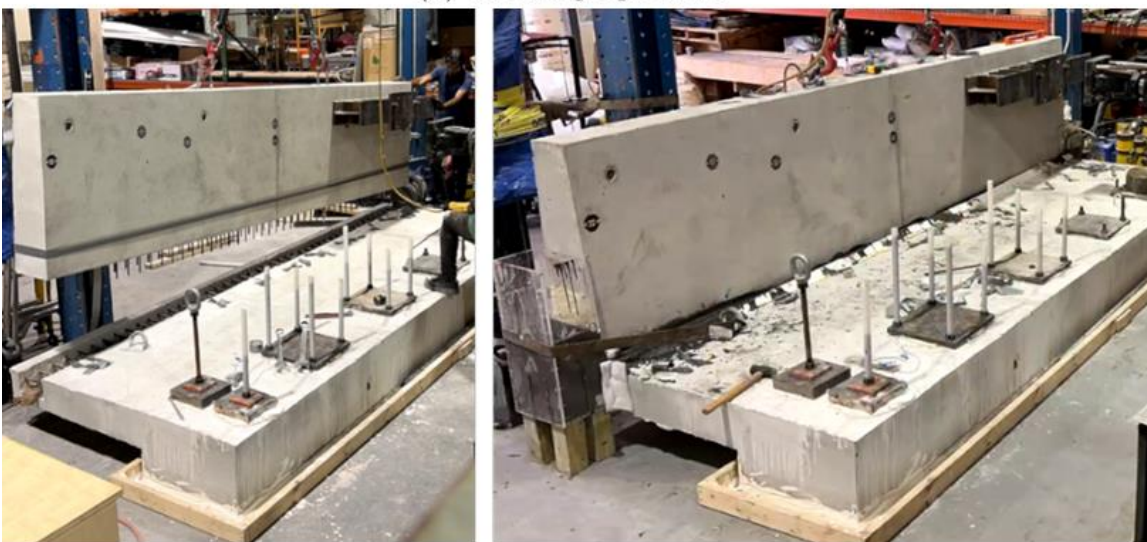
(a) Barrier and deck reinforcement

(b) Surface preparation

(c) Placement of the barrier and casting UHPC

The full-scale barrier unit and deck overhang were constructed following the same procedure as the smaller 5-foot component-level specimen, with each element built separately to closely replicate actual ABC method. Formworks were assembled for both the barrier and deck overhang, and reinforcement cages instrumented with strain gauges were placed inside. A Styrofoam mold with perpendicular holes spaced 2 inches apart was used to form the UHPC recess in the deck overhang, accommodating transverse reinforcement and dowel bars. To enhance performance and service life, the contact surfaces between the UHPC and Normal Strength Concrete (NSC) segments were sandblasted to create a rough texture. Before casting UHPC, the barrier and deck overhang were covered with wet burlap for 24 hours to reduce moisture absorption. The barrier was then installed with a 1/2-inch gap, and UHPC was poured into the recess from both ends, flowing toward the center. An additional 12-inch pressure head was applied at the pouring locations to prevent cavities or unbonded zones by displacing excess UHPC from the gap (see Figure 26). Consistency in material properties between the full-scale and component-level specimens was ensured by using the same batch of concrete for NSC components and sourcing steel reinforcements from the same heat treatment process. The short timeframe between construction phases contributed to maintaining consistent concrete properties, with compressive and splitting tensile strength tests remaining consistent with previous results.

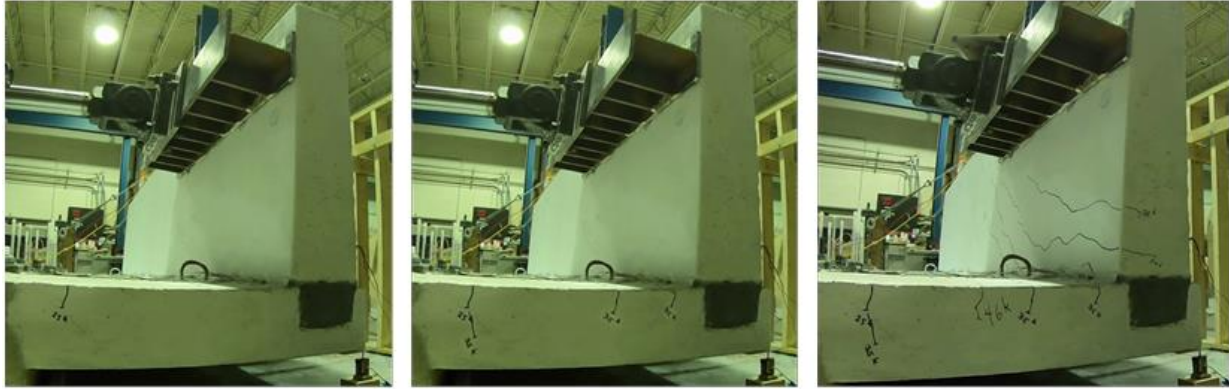
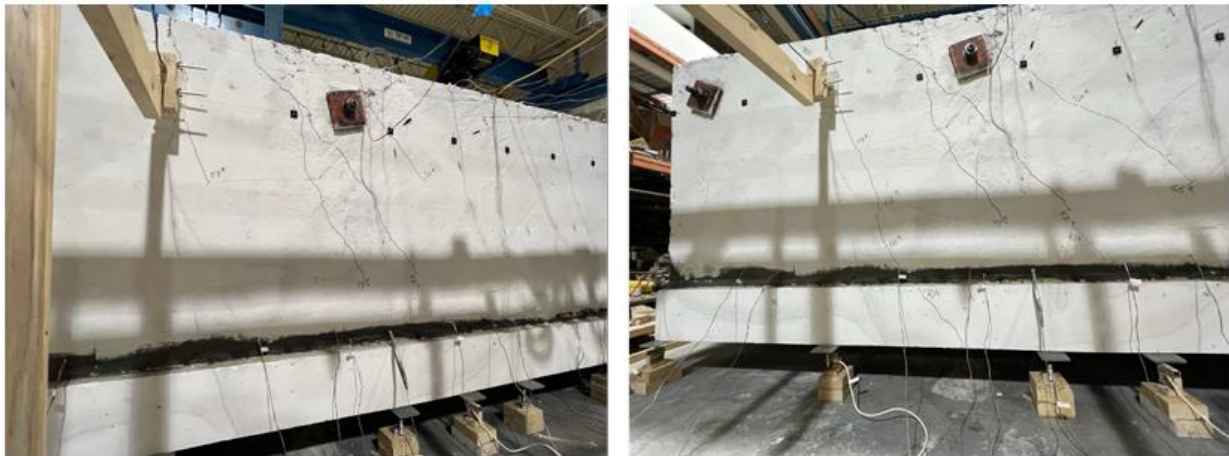
(a) Initial cracking in the deck overhang and the barrier ($P < 54$ kip)

(b) Development of diagonal cracks in the face of the barrier ($42 \text{ kip} < P < 86 \text{ kip}$)

(c) Development of cracks at the backside of the barrier ($57 \text{ kip} < P < 70 \text{ kip}$)

The barrier specimen was subjected to a quasi-static transverse load applied 30 inches above the slab, following NCHRP Project 22-20(2) recommendations for TL-4-2 barriers, using a hydraulic jack supported by a strong floor. Cracking was closely monitored at 5-kip load increments throughout the experiment. Initial cracks appeared at 25 kips in the deck overhang at the support, leading to a reduction in system stiffness (see Figure 27-a). As the load increased, hairline flexural cracks developed in the deck overhang, and at 42 kips, horizontal cracks formed in the barrier, extending diagonally and reaching the top surface—confined to the loaded half of the barrier (see Figure 27-b). At 54 kips, additional horizontal flexural cracks appeared at the unloaded end, with more dispersed diagonal cracks. Vertical flexural cracks emerged on the back face at 57 kips, and at 61 kips, a prominent diagonal crack developed above the loading beam due to shear effects (see Figure 27-c). By 70 kips, more diagonal cracks and flexural cracks extended toward the bottom of the barrier, and a wide shear crack was observed at the bottom of the UHPC region, indicating significant shear forces but the specimen continued to withstand additional load. Ultimately, the specimen failed at 92.1 kips due to punching shear in the barrier, accompanied by spalling of the concrete cover at the bottom of the deck overhang and delamination on both faces of the barrier caused by doweling action in the reinforcement during the final loading stages.

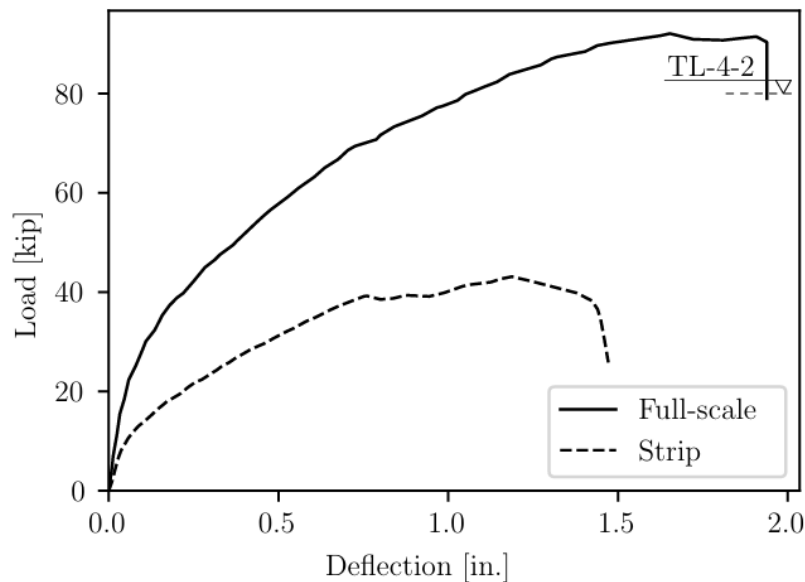
Figure 28 Comparison of the load-deflection responses for full-scale and component-level specimens [32].

The full-scale experimental testing confirmed that the developed barrier system meets the TL-4-2 design load requirements recommended by NCHRP Project 22-20(2), as the specimen withstood a transverse load of 92 kips at its end. This capacity implies that the barrier system can exceed required capacities under less demanding scenarios, eliminating the need for barrier-to-barrier connections. As shown in Figure 28, comparing load-deflection responses between the 15-foot full-scale and 5-foot strip specimens, increasing the specimen length resulted in a capacity increase by a factor of 2.13—from 43.1 kips to 92 kips—due to differences in failure modes (punching shear in the full-scale specimen versus a single yield line in the component-level specimens). Initial cracking in the deck overhang occurred at approximately 25 kips, reducing system stiffness, and stiffness decreased further with diagonal cracks in the barrier at about 42 kips. At 70 kips, a wide shear crack formed at the bottom of the UHPC region, causing sudden deflection increases without corresponding load increases and leading to system softening until ultimate failure at 92 kips with a maximum deflection of 1.93 inches.

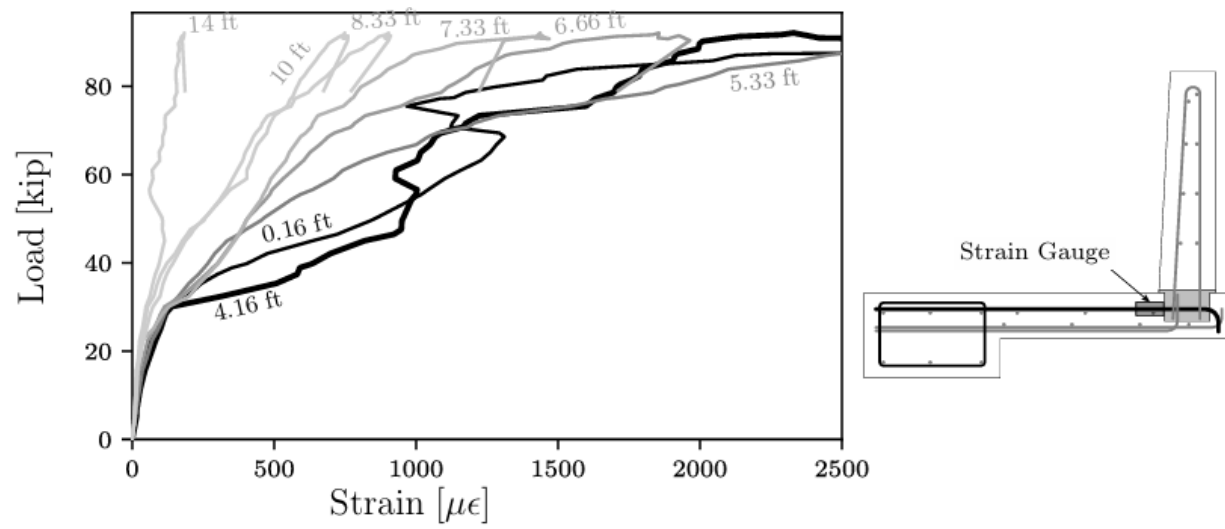
Figure 34 Load-strain responses for steel strain gauges on the top transverse reinforcements in the deck at the face of the barrier [32].

Figure 34 shows the strain responses obtained from strain gauges on the top transverse reinforcements in the deck at the face of the barrier. The load-strain responses illustrate the formation of cracks at the loaded end, which propagated rapidly along the length of the barrier before reaching a load of 40 kip. The variation in strains along the specimen at different load levels generally follows a consistent pattern throughout the test, with localized responses at the loaded end diminishing further away. The strains observed at a load of 70 kip are significantly lower than the steel's yield strain. The large transverse reinforcement ratio in the deck overhang prevented the opening of these cracks, contributing to higher shear strength in the deck overhang. The elastic behavior observed up to a load of about 80 kip is attributed to this reinforcement ratio, effectively delaying the onset of punching shear failure in the barrier.
