CDOT Rapid Response to Hydrogen Cracking in Grade 100 Steel Welds at Blue Mesa Reservoir Bridges

Colorado Department of Transportation

Michael Baker International

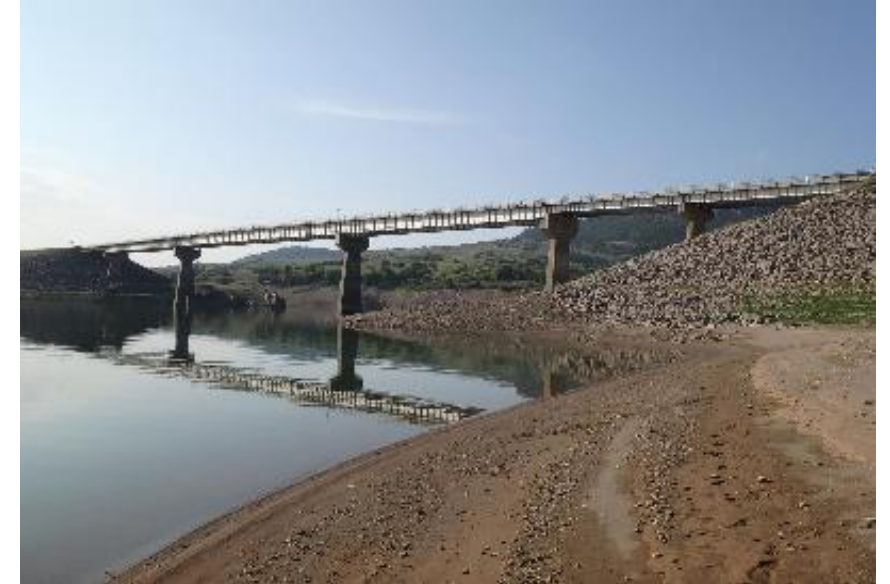
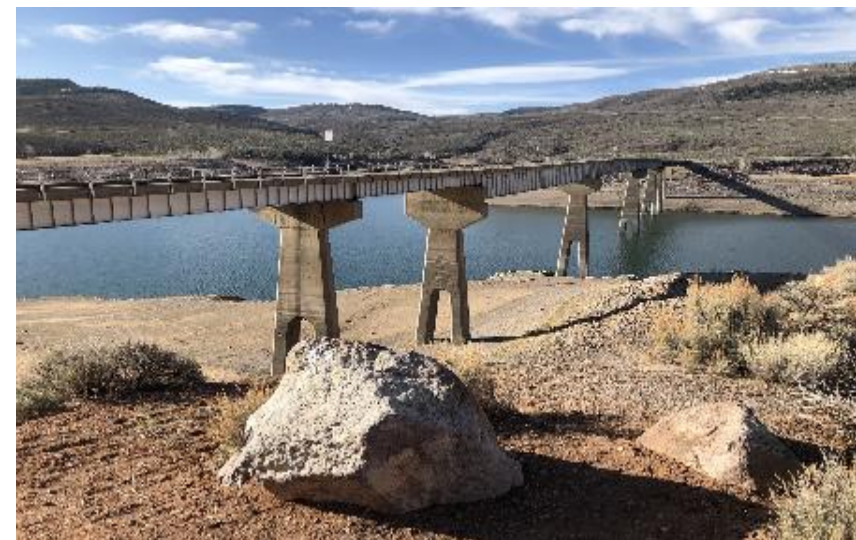
- Both bridges built 1963, FAIR condition
- K-07-A
 - US 50 over the Lake Fork at mile marker 132.69
 - Six span, continuous composite welded girder bridge. 993ft, 300ft max span
 - Spans 3, 4, and 5 are Non-Redundant Steel Tension Members (NSTM).
- K-07-B
 - US 50 over the Blue Mesa Reservoir at mile marker 136.16
 - 10 span, continuous composite welded girder bridge. 1,532ft, max span 360ft
 - Spans 5, 6, and 7 are NSTM.
- 1 lane each direction

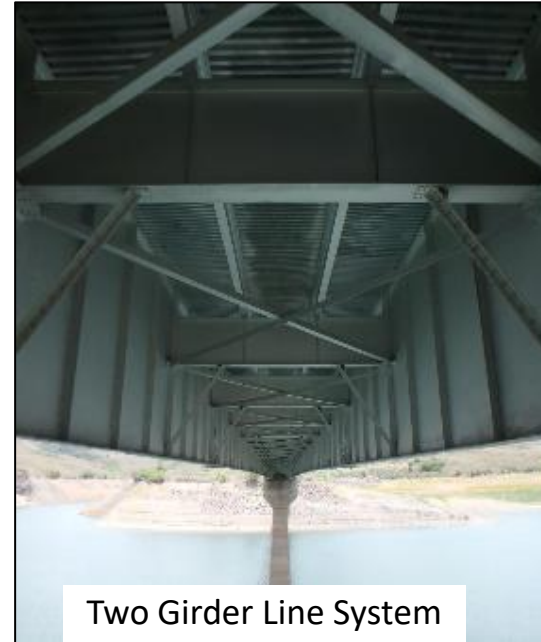
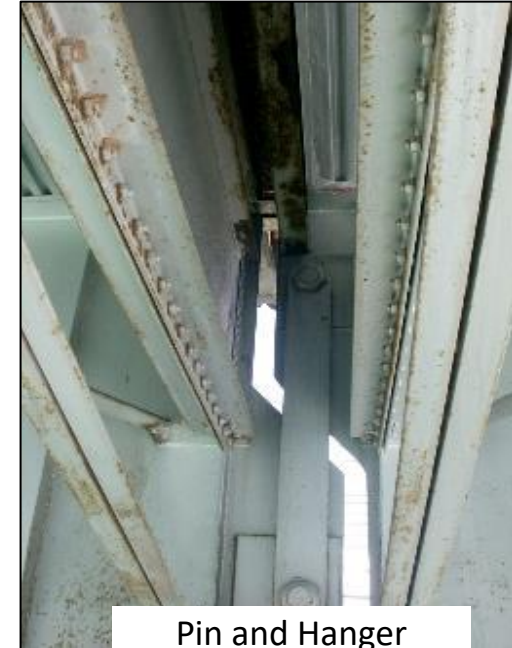
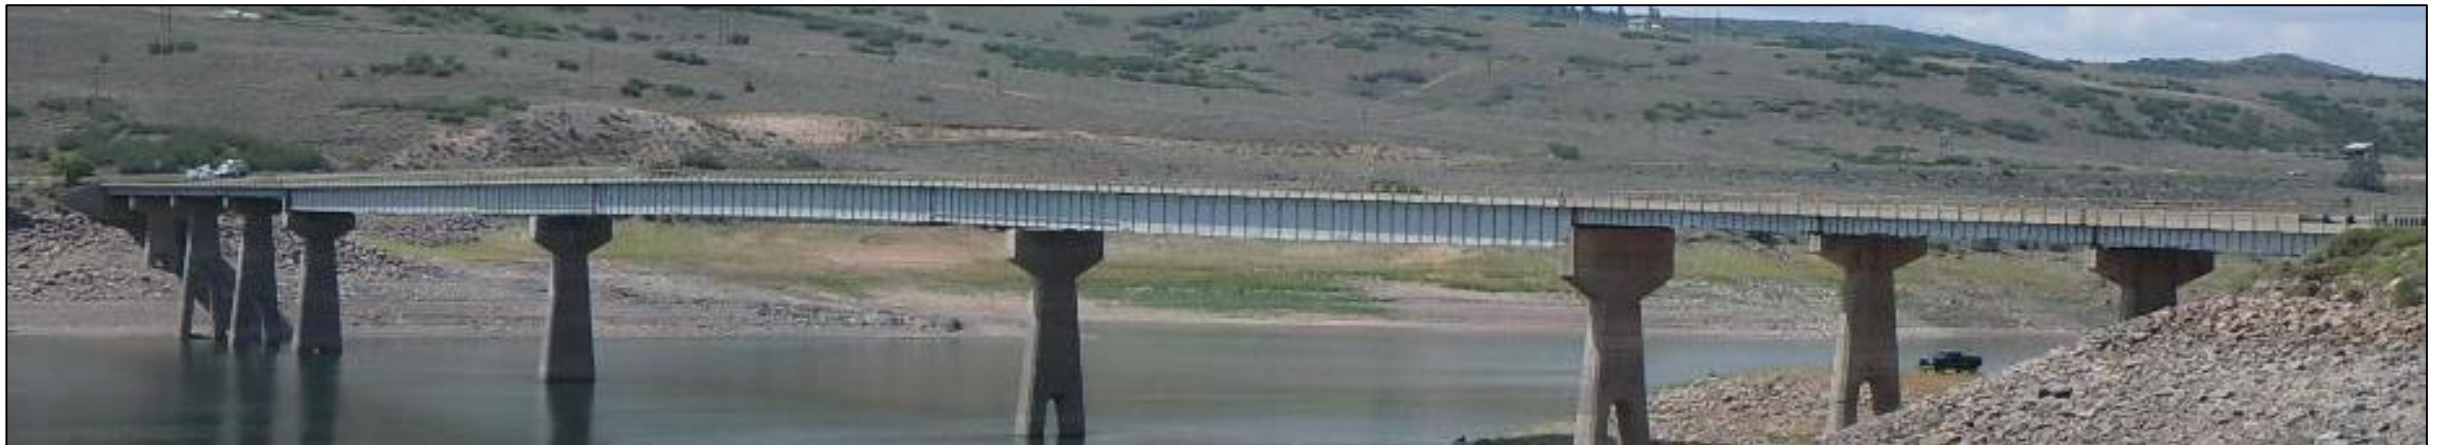
- On December 31, 2021, FHWA issued a memo requiring the identification, testing, and repair of T1 steel bridges with NSTM (Non-redundant Steel Tension Members)
- Colorado identified two Blue Mesa bridges as having main spans are composed of 100 ksi T1 Steel built-Up (welded) NSTM members

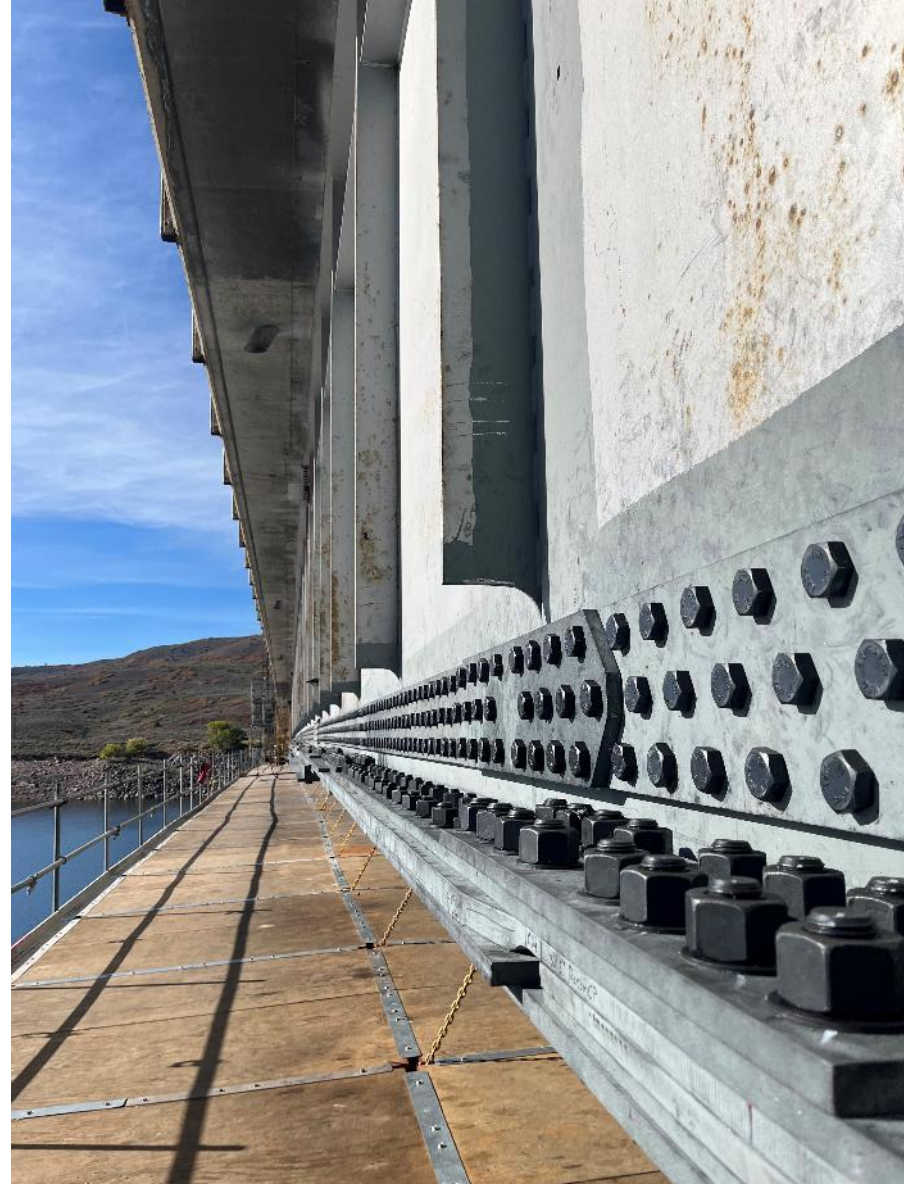
Permanent Repair Schematic

- Prevalence of fillet weld cracks
- Availability 100 ksi material
- Substructure capacity
- Schedule risk
- Historic bridge

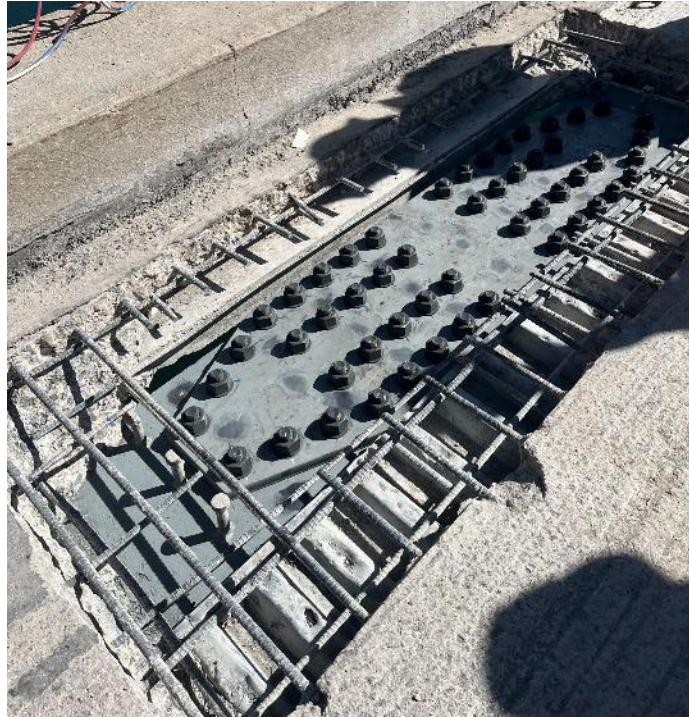
Top Flange Repairs

- Local splice
- Minimize deck removal
- Minimize duration
- Grade 50 for speed

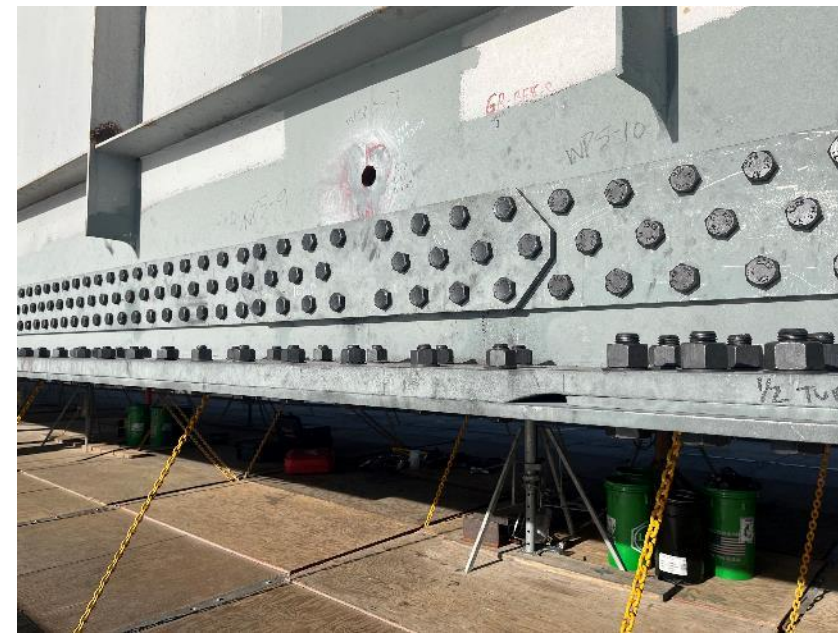
- T1 steel with weld embrittlement issues
- Widespread defect indications in web-to-flange welds
- The extent of the indications made traditional repairs (grinding/coring) infeasible
- Nonredundant Steel Tension Member (NSTM, old FCM)
- The high number of defects also raised the likelihood of undetected cracks
- These conditions required a continuous retrofit, effective regardless of crack location, rather than localized repairs at each indication

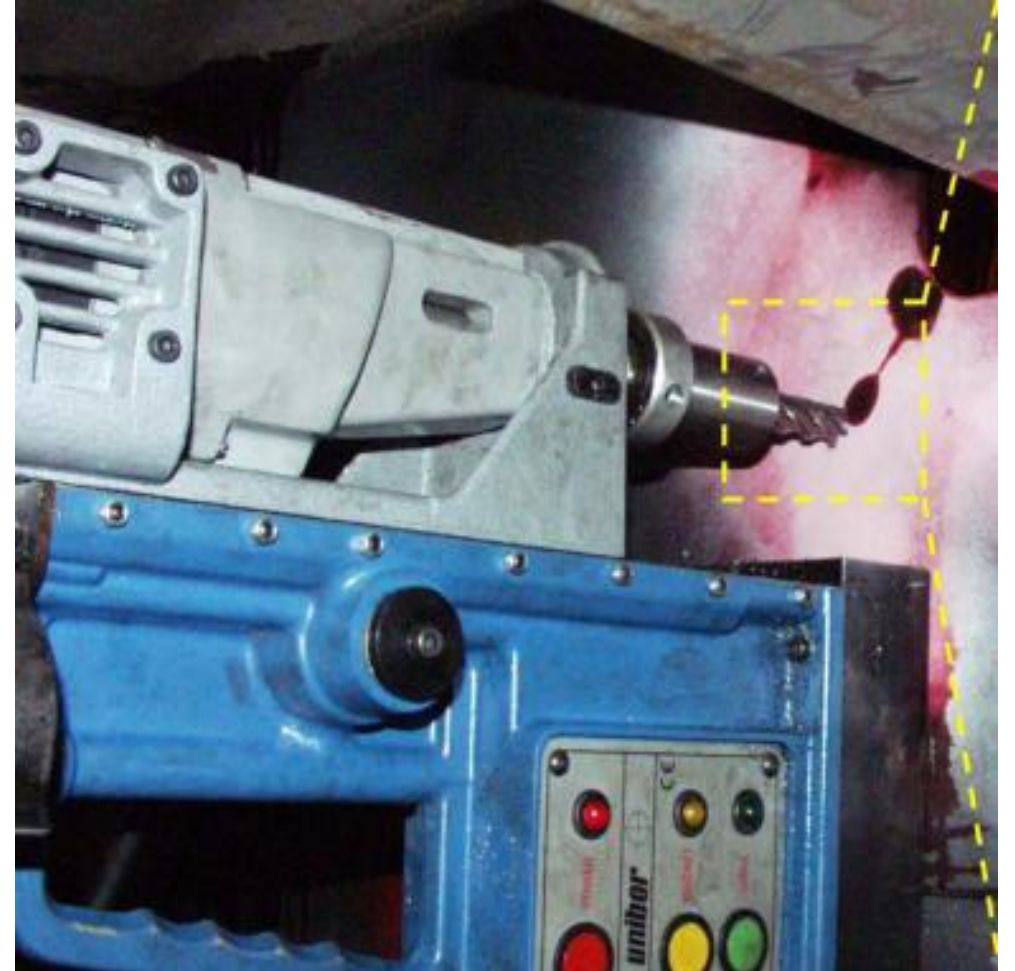
- Common retrofit methods: coring and dogbone details
 - Dogbones were impractical due to extensive overlap and risk of flange-web separation
- Web-splicing (plates on both sides + angle connections) was unsuitable because:
 - Excessive added weight,
 - Fabrication and fit-up with other repairs
- Widespread cracking meant localized strategies would be ineffective
- Inspection uncertainty required a location-independent crack-arrest mechanism

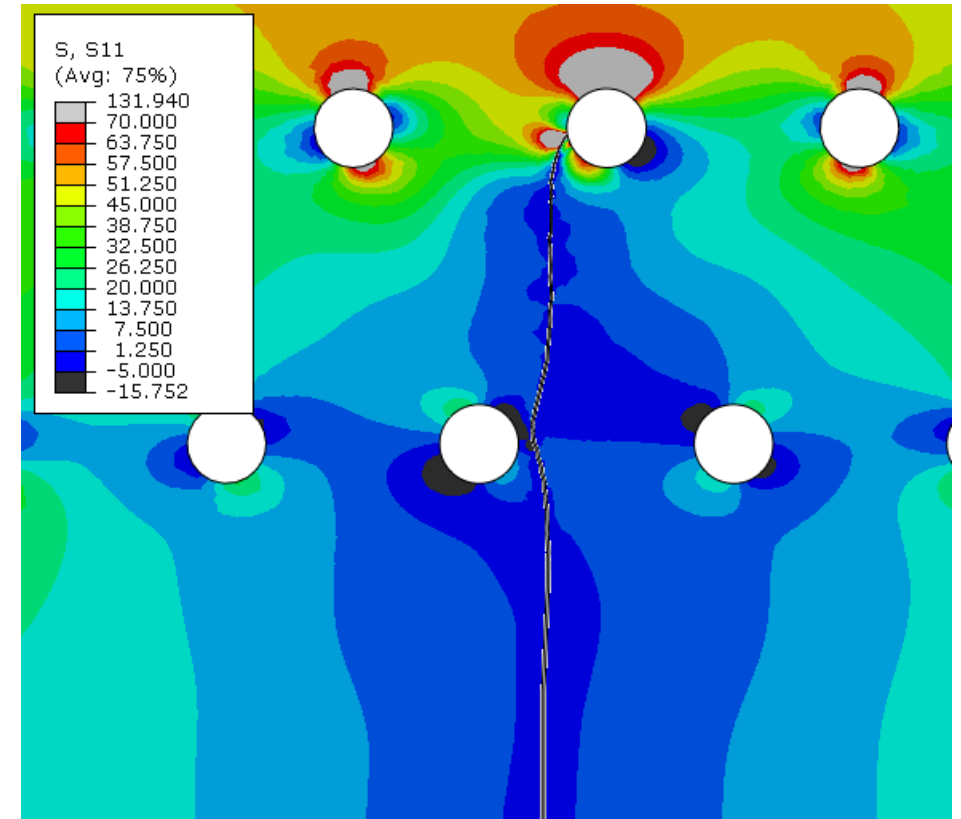
- Validation performed at Purdue University by Dr. Korkmaz and Dr. Connor using Abaqus FEA
- Crack behavior modeled using Extended Finite Element Method (XFEM)
- XFEM employs enrichment functions enabling:
 - Heaviside discontinuity modeling,
 - Accurate crack-tip stress fields through stress-intensity functions
- XFEM's key benefit: no remeshing required as cracks grow
- Bolt-pattern performance tested using cracks initiated at various distances and directions from bolt holes
- Multiple crack-propagation criteria evaluated (energy-release rate, mode mixity, etc.)
- All simulations showed cracks arresting in the first or second bolt row, with no propagation beyond row two

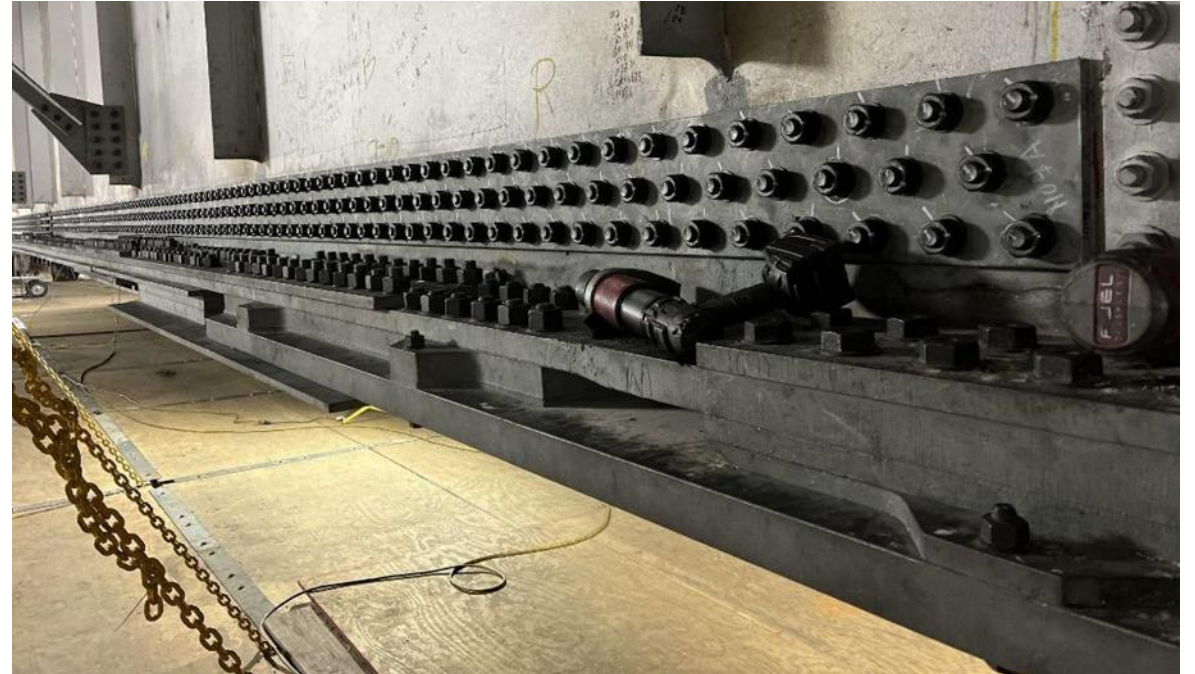
- Final retrofit: three bolt rows with defined minimum and maximum spacing limits
- Web reinforcement plates placed on both sides to maintain capacity if cracks arrested at bolt holes
- Retrofit required compatibility with other repairs, including:
 - Cored web-crack locations,
 - Existing flange splice retrofits
- Where bolt spacing conflicted with prior repairs, dogbone crack-arrest details were used instead of altering spacing
- These adjustments preserved consistent crack-arrest performance across the structure
