Introduction to the Milton-Madison Bridge Project

Anne Rearick, PE INDOT Bridge Director
Kevin Hetrick, PE INDOT Project Manager

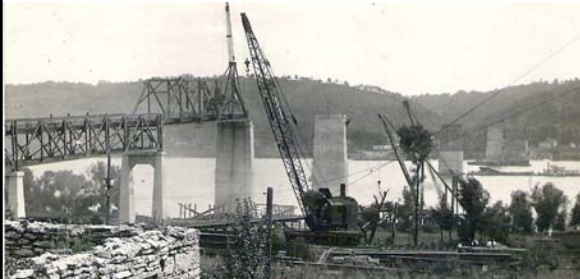
- 3,181-foot long truss structure with two 10-foot wide travel lanes
- Built in 1929 by J. G. White through National Toll Bridge Company
 - Tolled until 1949: 5¢ for pedestrians, 45¢ for vehicles
- Purchased by Kentucky in 1939; half interest sold to Indiana in 1970s

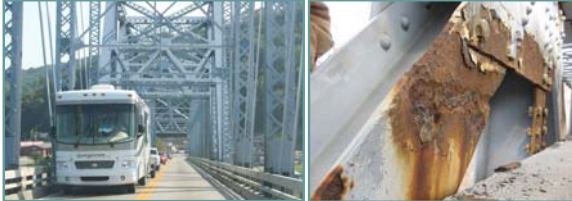
- Sufficiency Rating of 6.5 out of 100
- 15 ton load limit in 2009, 3 ton by 2011
- Two ten foot wide lanes couldn't handle traffic

Functionally Obsolete Structurally Deficient

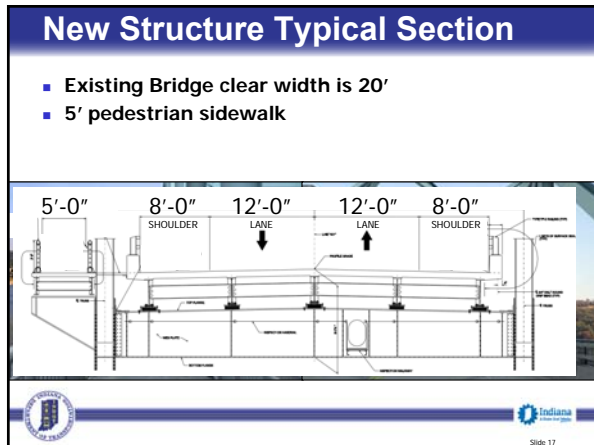
Superstructure Replacement with Minimal

- Milton Approach re-construction
- STR 1 replace KY Approaches
- STR 2 Truss replacement
- STR 3 Replace IN Approach
- STR 4 Pedestrian Access to Park

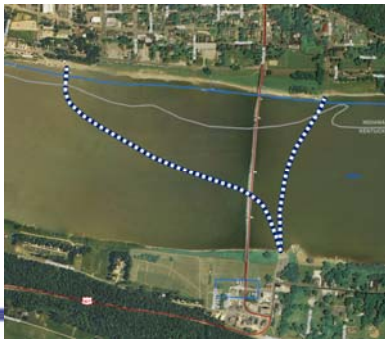
Ferry Service during Construction

- 52 Mile Detour
- No Cost to Users
- Ferries would accommodate vehicles, up to 240 per hour
- Ferries would not be able to operate during high water, extreme fog, etc
- Special provisions for medical emergencies

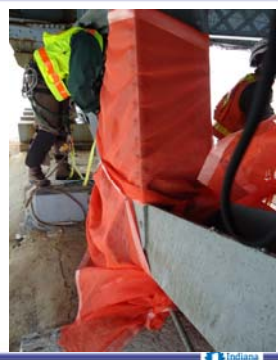
Coordination for Peregrine Falcon

- Special Provision Requirements
 - KDFWR Coordination
 - Relocation of Nesting Box
 - KDFWR Access to Box
 - Potential Nesting Sites
 - Cover February 1 – June 30
 - No Work w/n 300' of Nest
