# PERFORMANCE EVALUATION OF UHPC FIELD CAST CONNECTIONS FOR HOOPER ROAD BRIDGE PROJECT

## ABSTRACT

A project overview and a performance evaluation of the field cast UHPC connections for the Hooper Road Bridge after four years of service are presented. The original intent and observed performance of the link-slab, pier to column, transverse deck panel, and hidden composite field cast UHPC connections are illustrated, assessed, and discussed. The fundamentals of the technology, materials properties, original project design criteria, ABC requirements, and benefits for using UHPC as a field cast connection material are included.

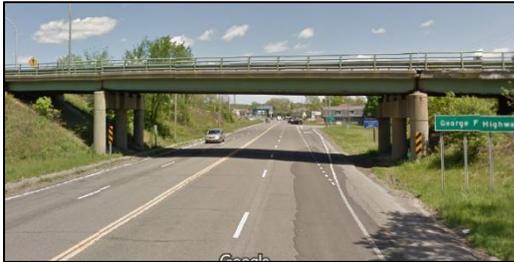
Fig.1: Hooper Rd. Bridge Prior Rehabilitation

With a total length of 150', the 3-span, 2 lane Hooper Road bridge over NYS Route 17C in Union, NY was originally constructed in 1964 (Fig.1). Hooper Road is an urban, arterial road that accommodates large traffic volumes (ADT 10,000) and is a critical link between the local community and the City of Binghamton, NY. Years of continuous impact loading from vehicles and continuous exposure to deicing salts resulted in severe deterioration of the bridge.

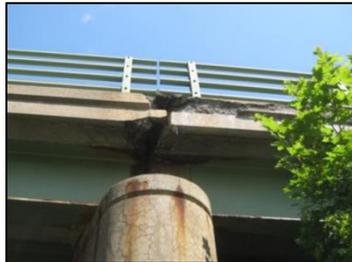
Fig.2: Leaky Joints (7)

Leaky and failed joints (Fig.2) resulted in a widespread deterioration of the bearing pedestals (Fig.3) and piers (7). The pier concrete was also cracked and delaminated; whereas areas of the deck showed additional deterioration. In 2013, the condition of the bridge structure was assessed at a rating of 4.45 and an FSR of 68.3 determining that rehabilitation of the bridge is required (7).

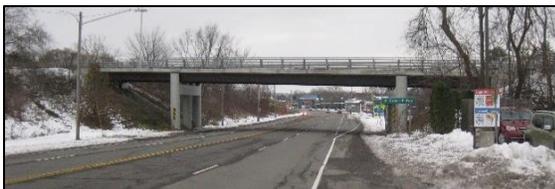
Fig. 4: Hooper Road Bridge Inspection

In November 2018, a second round of a total of 20 New York State bridges with field cast UHPC connections including the Hooper Road bridge (Fig. 4) were visited and visually inspected. The weather conditions were cold, snowy and changeable between wet and dry for several days leading up to the field visits with temperatures around the freezing point. Even though these conditions seem not favorable for the inspectors, the continuous wetting of the bridge deck for several days provided favorable inspection conditions for leakage and crack detection. Several of the recently inspected bridges, each with varying types of typical field cast UHPC connections have been recently published (9).

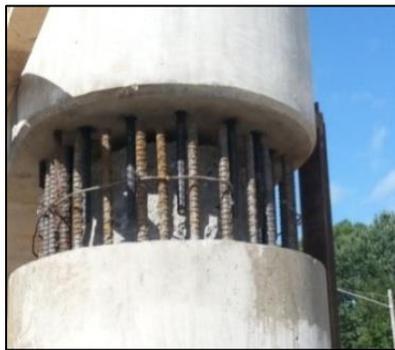
Fig. 6: Rebar Connection

Since UHPC was already specified for other portions of this project, the contractor saw an opportunity to propose a field cast UHPC connection for the precast pier caps to existing columns. Rebars from the existing columns were exposed to create continuity with new rebars extending from the underside of the new precast pier caps (Fig. 6). Due to the short development length of #9 (nominal area 1 in<sup>2</sup> or 654 mm<sup>2</sup>) dowels in UHPC, it was determined that an 11 in (280 mm) development length was sufficient to achieve the required load transfer.

The existing rebars on the outer edge of the existing columns were exposed and cut to allow the 11 in (280 mm) splice. By leaving a concrete pedestal at the center of the existing columns, steel shims were used for final height adjustments and to provide spacing for the UHPC material flowing down the central placement duct. The precast cap had rebars extending downward the same distance.

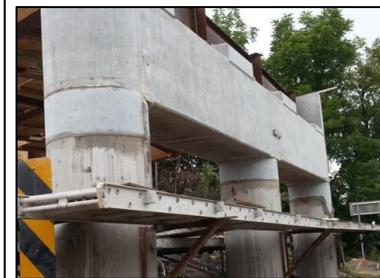
Fig.8: Completed Connection

This field cast UHPC connection (Fig. 8) saved two days on the construction schedule and allowed easy adjustments to set the elevation and place the new precast pier caps. It also eliminated the uncertainty of misalignments and the individual grouting of 84 ducts.

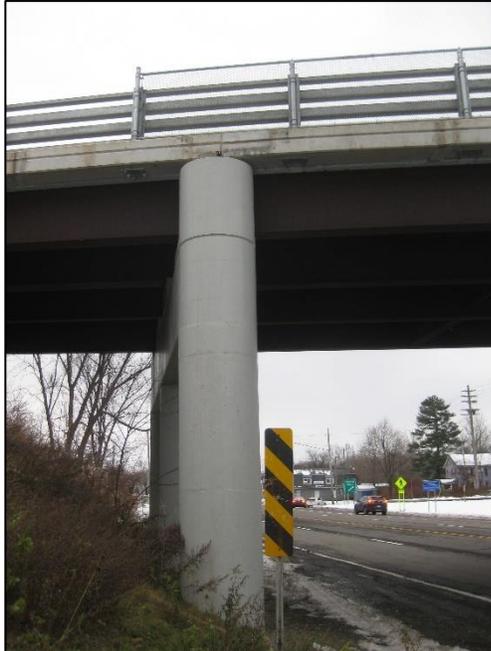
Fig. 9: Precast Pier Cap/Column Connection

A visual inspection of the precast pier cap to existing column connection showed no evidence of any reflective cracking within the UHPC for both pier caps after four years in service (Fig.9). Upon closer inspection vertical cracks were noticed in the existing concrete column and the precast pier cap but seem to disappear within the UHPC connection (Fig. 10). The authors believe that micro and non-visible to the eye cracks are present in the UHPC connection and that they are spread across multiple micro cracks which are bridged by the fibers in the UHPC matrix. This appears to be very similar when testing precast panels with UHPC connections under flexural cycling loading, where single structural cracks in conventional concrete precast panels tended to become multiple, tightly spaced cracks in the field-cast UHPC (11).

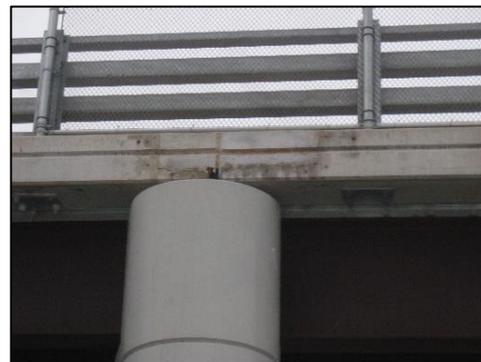
Fig.12: Installed UHPC Link Slab

Link slabs connections are located above the interior supports of multiple, simple span bridge structures and are designed to resist tensile forces due to the negative moment from live-load on the structure. The intent of the connection is to eliminate the need for strip seals or other traditional joint systems by creating a durable structural element spanning between the adjacent bridge decks (12). This prevents ingress of water and maintenance of the joint is eliminated (13). The Hooper Bridge was designed (Fig.11) and installed with two link slabs (Fig. 12).

The visual inspection showed no evidence of reflective cracking in field cast UHPC link slabs above both piers (Fig. 13). No leakage through the UHPC link slab was noticed. Water draining down the side of the deck at the piers was seen causing some surface rust staining of the steel fibers. Only one longitudinal crack parallel to the link slab connection was noticed in the precast deck panel above the South Pier (Fig. 14) which may have been caused due to the negative moment over the pier of the bridge structure. This

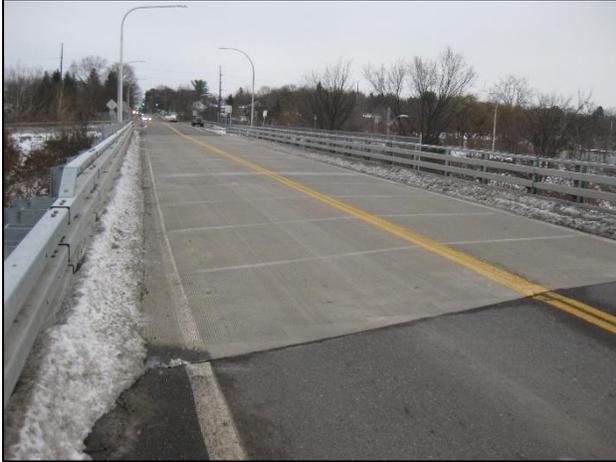
Fig. 17: Bridge Deck Surface

The visual inspection on top of the bridge deck (Fig. 17) showed no cracking within the transverse field cast UHPC connections. The precast deck panels revealed multiple random cracking beside (Fig. 18), parallel (Fig. 19) and perpendicular to the UHPC connections throughout the entire structure. No leakage below the deck along the UHPC connections was observed. All galvanized channels originally used for forming the UHPC connections showed no rust stains, therefore no leakage is evident (Fig. 20). Water draining down the side of the deck panels were seen causing some surface rust staining of the steel fibers (Fig. 21). Any of the observed deteriorations are not related to field cast UHPC connections.
