Missouri DOT's 2018 Poplar Street Bridge Lateral Slide

Gregory Kuntz & Dennis Heckman

Monthly Webinar
July 18, 2019

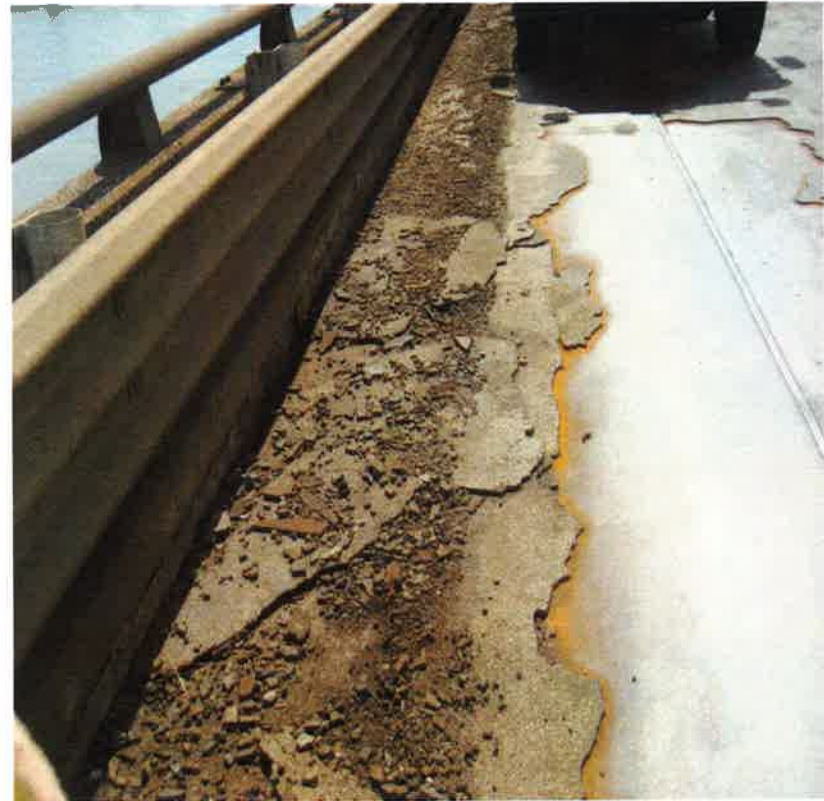
- 1. Riding Surface
 - Failure = Unsafe driving conditions
- 2. Contributes to stiffness of deck system
 - Failure = Deck plate cracking
- Provide solution to continuing problems
- Minimize future maintenance and repairs

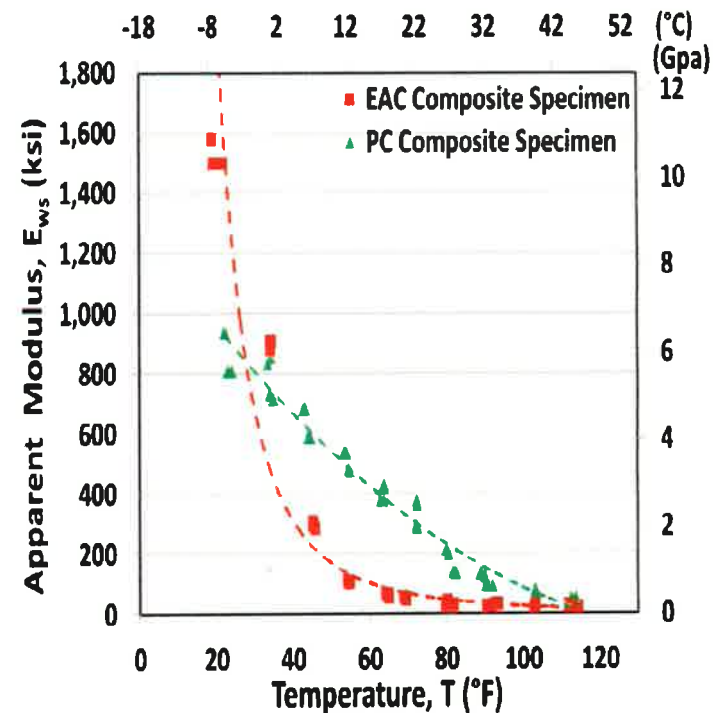
- Tests show material stiffness (E) is reduced significantly with high temperatures (see plot)
- $E < 200$ ksi for Polyester Concrete with Temperature > 80 degrees; Epoxy asphalt even worse
- Minimal overlay stiffness = flexible deck = Deck Plate susceptible to cracking

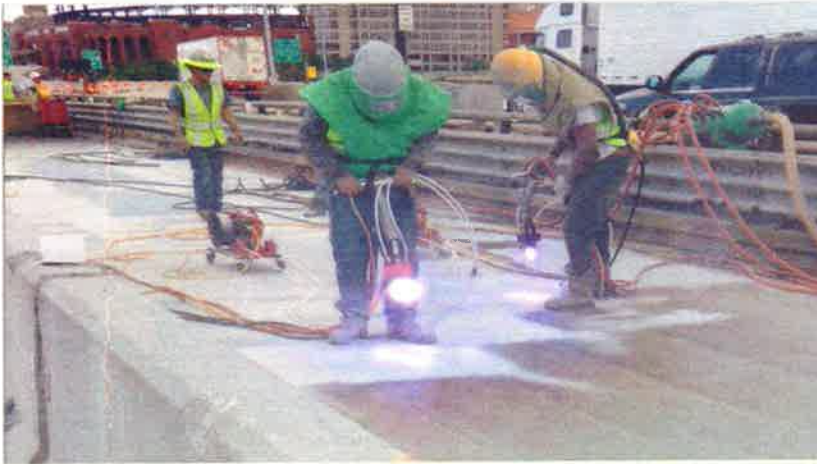
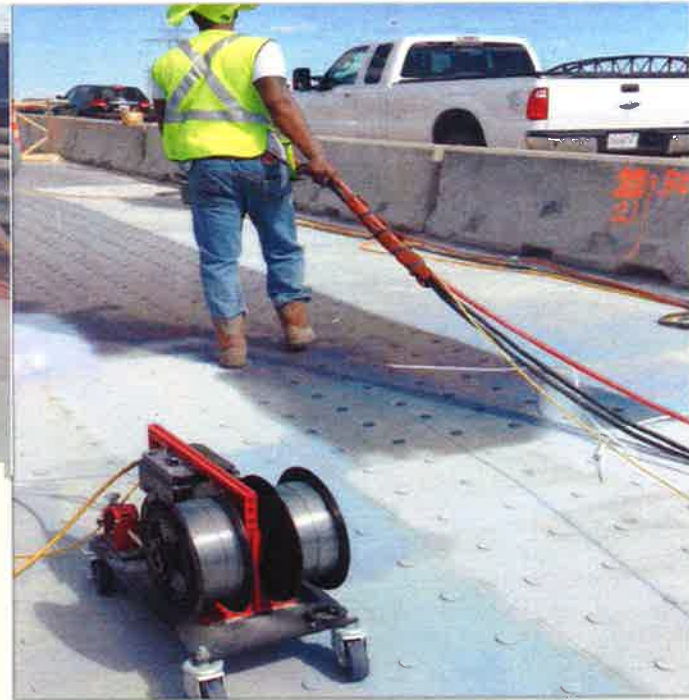
Zinc Coating Application

Thermal coating
99.9% Zinc

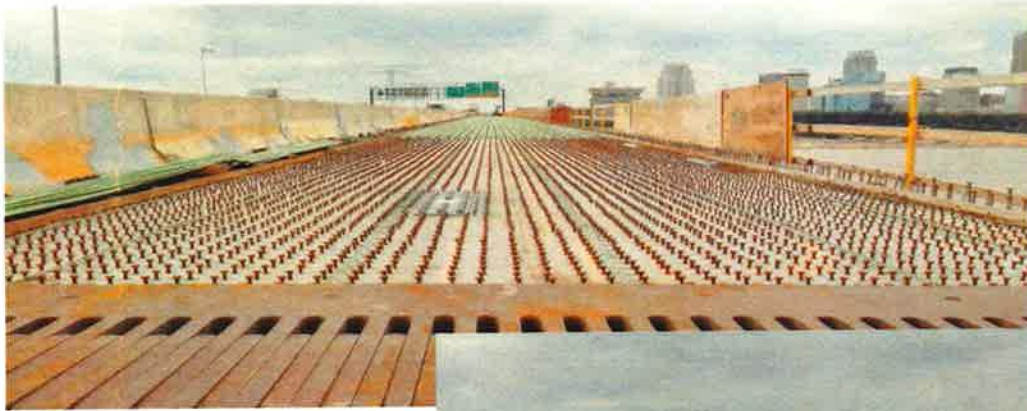
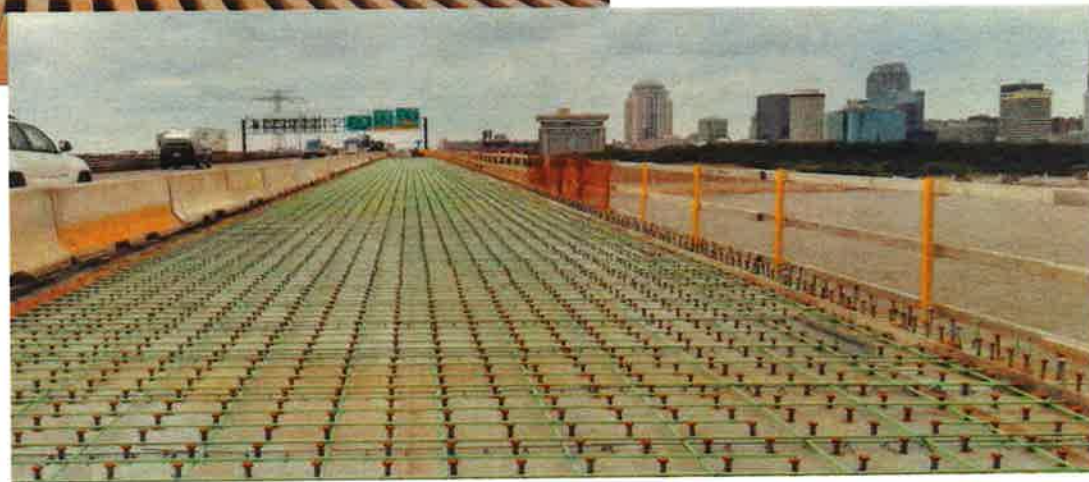
Shear Studs

> 1,000,000
studs on
deck

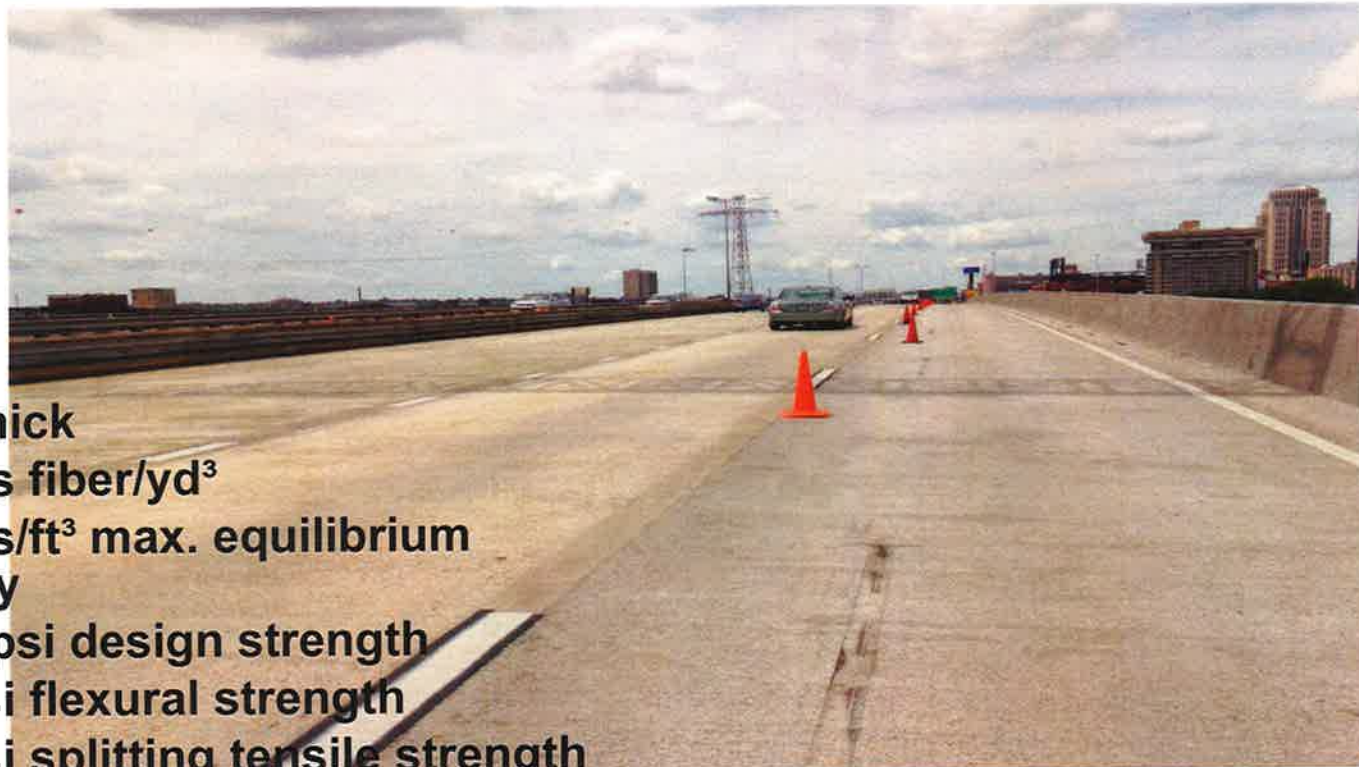
Finished Overlay

- **4-in. thick**
- **196 lbs fiber/yd³**
- **120 lbs/ft³ max. equilibrium density**
- **6,000 psi design strength**
- **800 psi flexural strength**
- **425 psi splitting tensile strength**

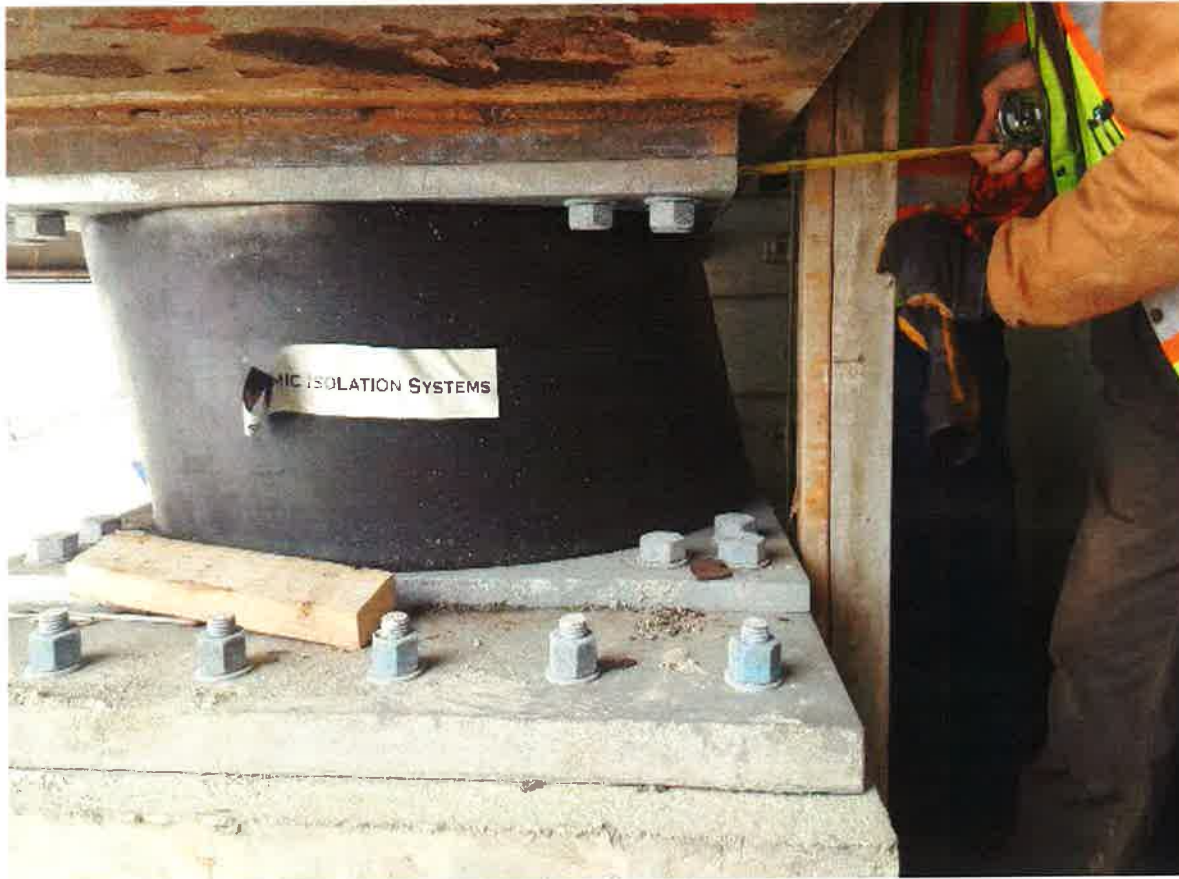
Bearing Replacement

- Evidence existing bearings not performing as intended (no thermal movement)
- Shock transmission units (STU) previously installed as part of seismic retrofit
- Concern of poor performance, sent 4 STU's to lab for testing

- Confirmed 1 of the 4 STU's fluid had leaked out and did not pass verification testing
- Potential for lack of response under seismic loading
- Remove existing STU's & replace existing bearings with lead core seismic isolation bearings
