## ACCELERATED AND RESILIENT REPAIR OF BRIDGE COLUMNS

Shamim A. Sheikh, Ph.D., FCAE, University of Toronto, (416) 978-3671, [sheikh@ecf.utoronto.ca](mailto:sheikh@ecf.utoronto.ca)

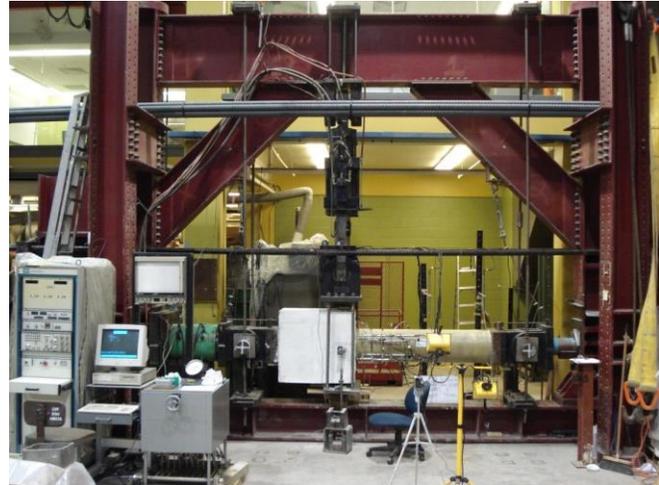
Fig. 6. Column tested under simulated loads

The specimens in this second research program were designed to evaluate the effects of FRP retrofitting on the performance of columns under simulated earthquake loads (4). Each of the twelve columns in one test series of this program was 356 mm in diameter, 1.47 m long and cast integrally with a stub of dimensions 510x760x810 mm. All columns contained six 25M longitudinal bars uniformly distributed around the core. Clear concrete cover was 20 mm. The spirals consisted of US # 3 bars. Figure 6 shows a specimen in the Column Test Frame especially designed to test columns under axial load and lateral displacement excursions.
