# **Alaska Department of Transportation & Public Facilities**

## **Using ABC to Address Climate Change in Alaska's Arctic**

ABC-UTC Monthly Webinar  
October 20<sup>th</sup>, 2022

Elmer Marx, PE & Nicholas Murray, PE, SE

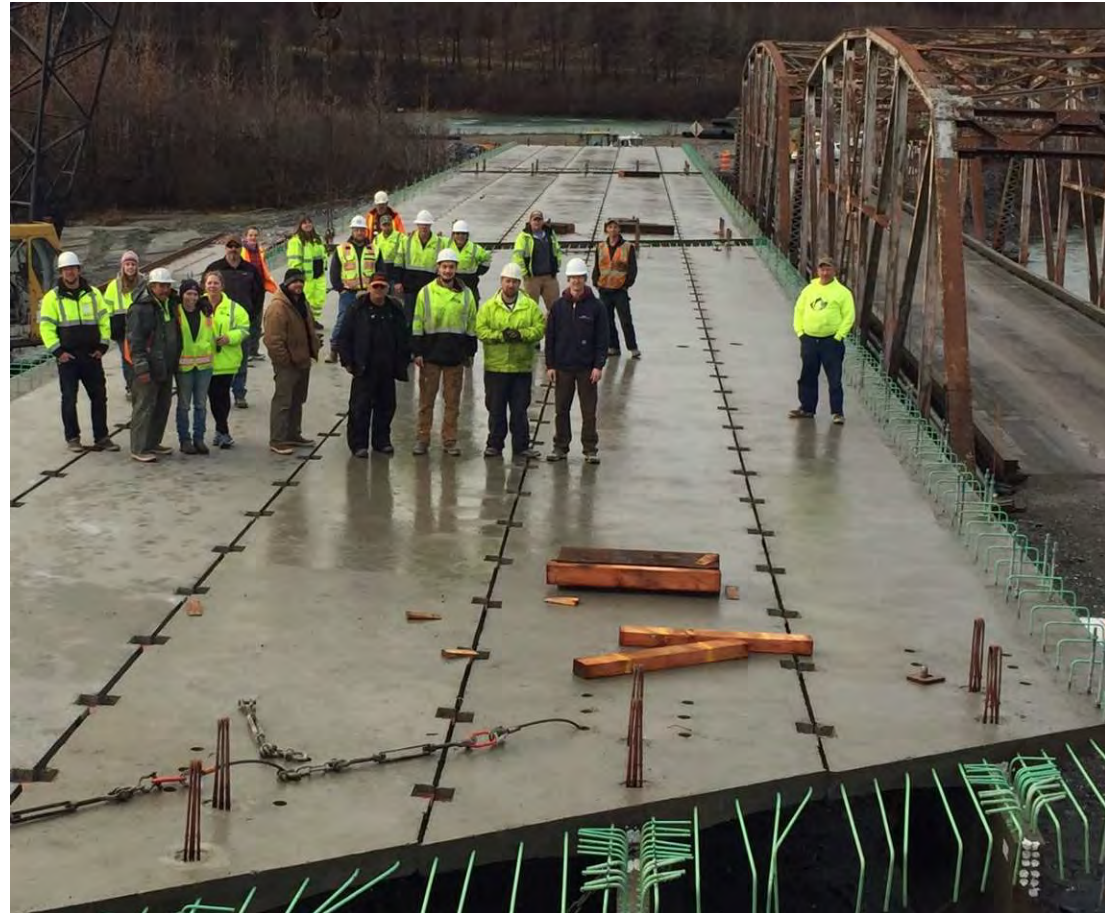
# Preferred Details

- Preferred structure type is a 'decked bulb-tee' that requires no CIP deck or formwork. Asphalt is placed directly on precast girders
- Used successfully since mid 1970's

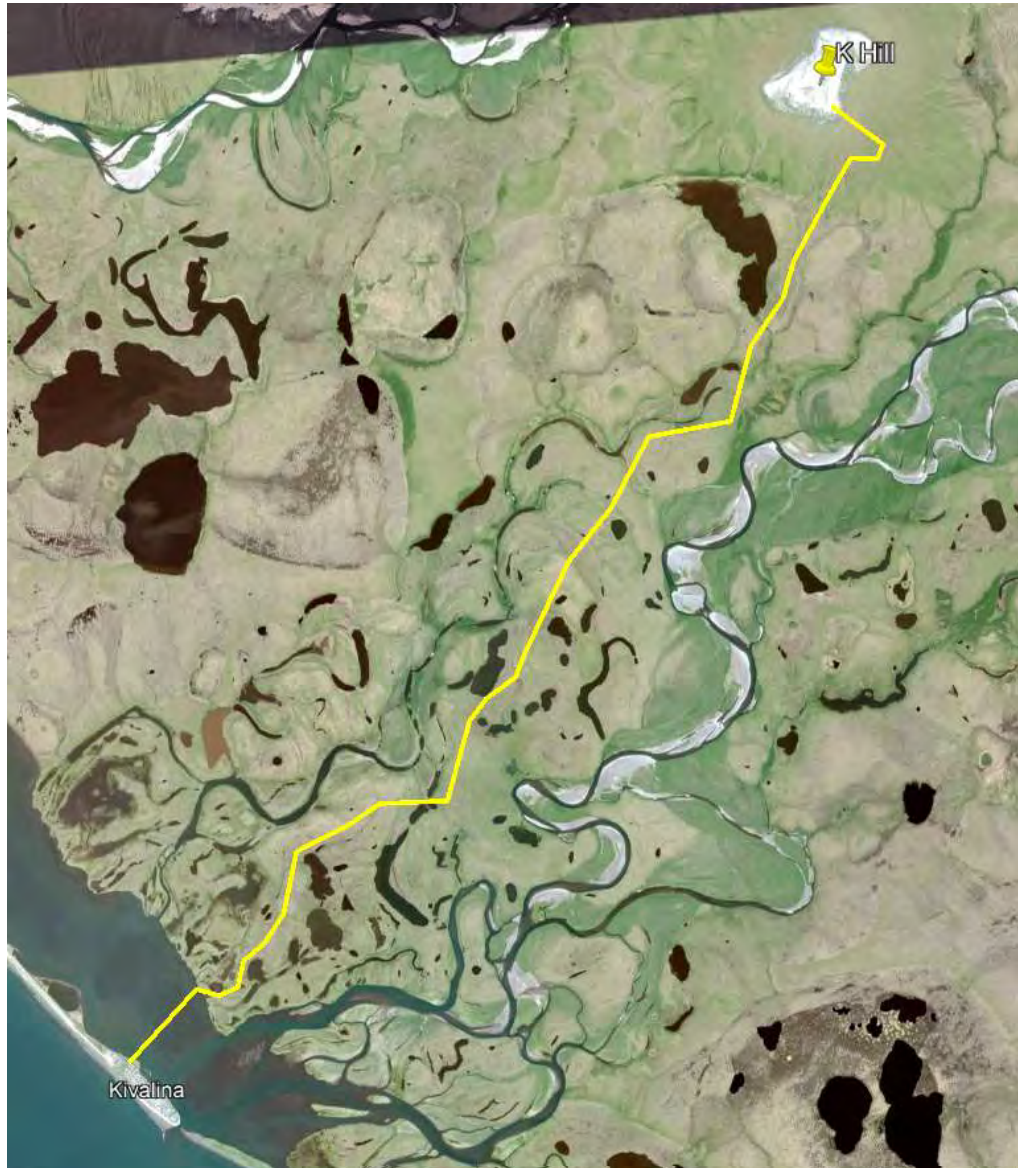
# Project Scope

- ~8 miles of new gravel road needed over permafrost and tundra to Kisimigiutuk Hill (K-Hill)
- 3,200ft causeway across lagoon with a ~190ft single span bridge

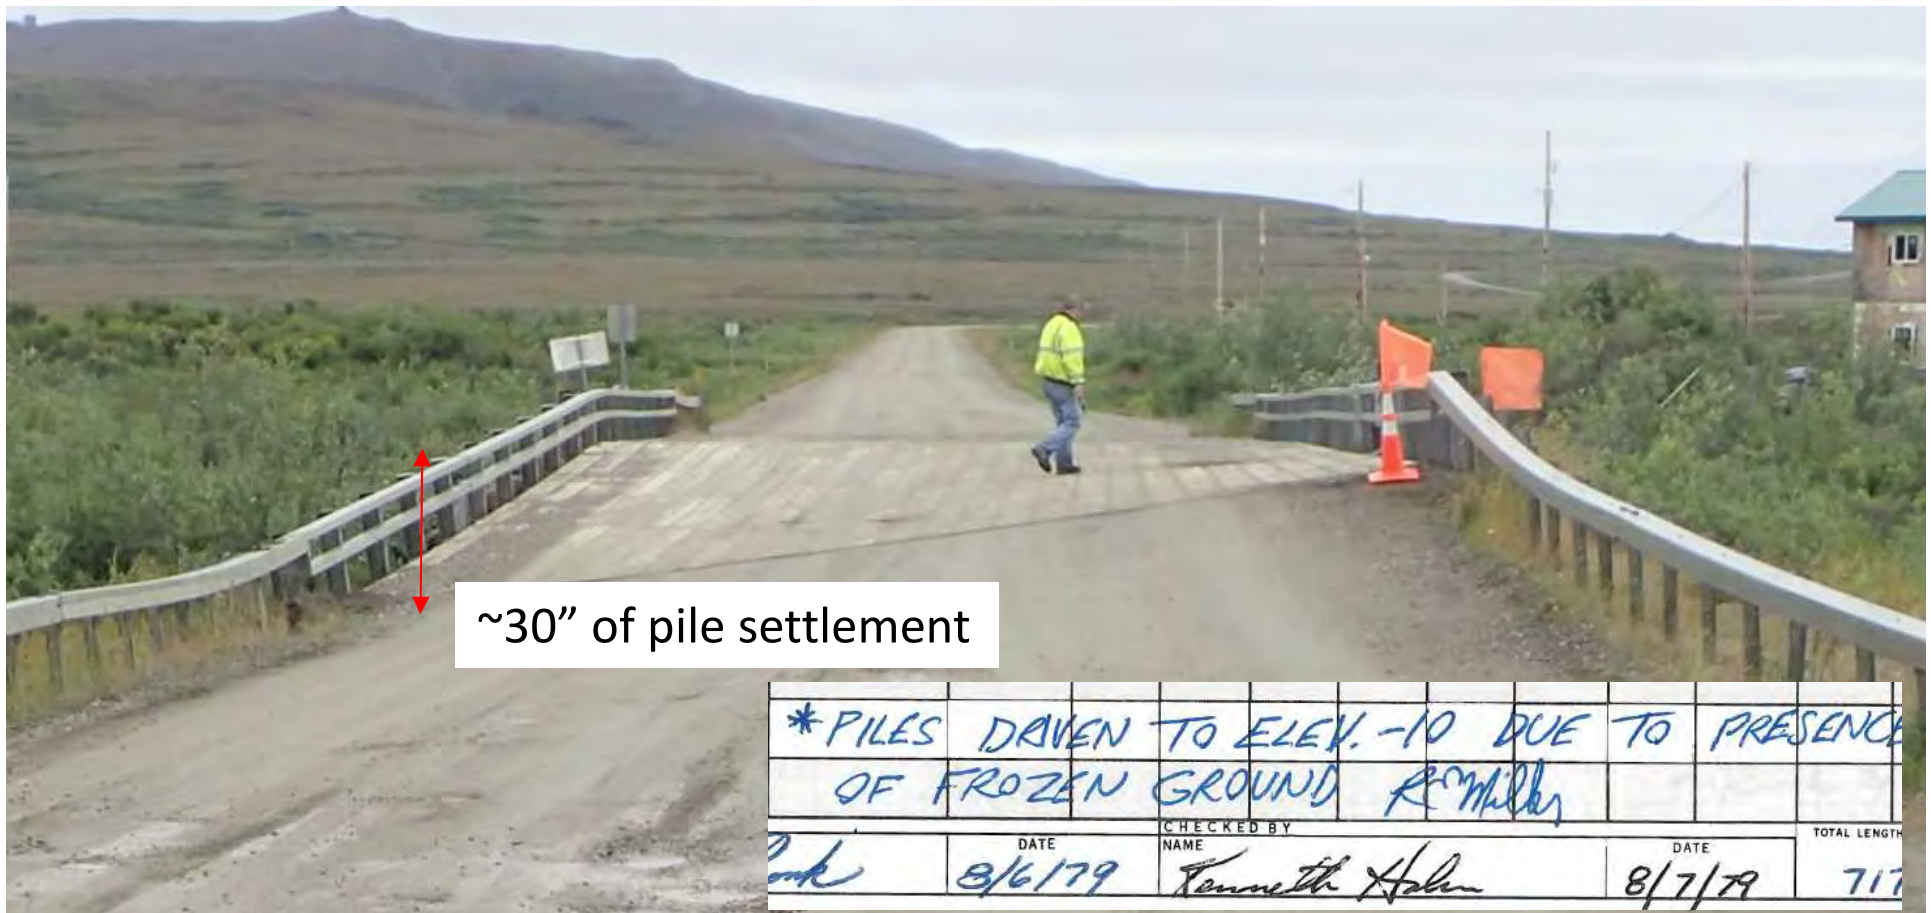
# Consequences of Thawing Ground

- As the arctic warms, previous strategies of supporting structures are becoming less reliable

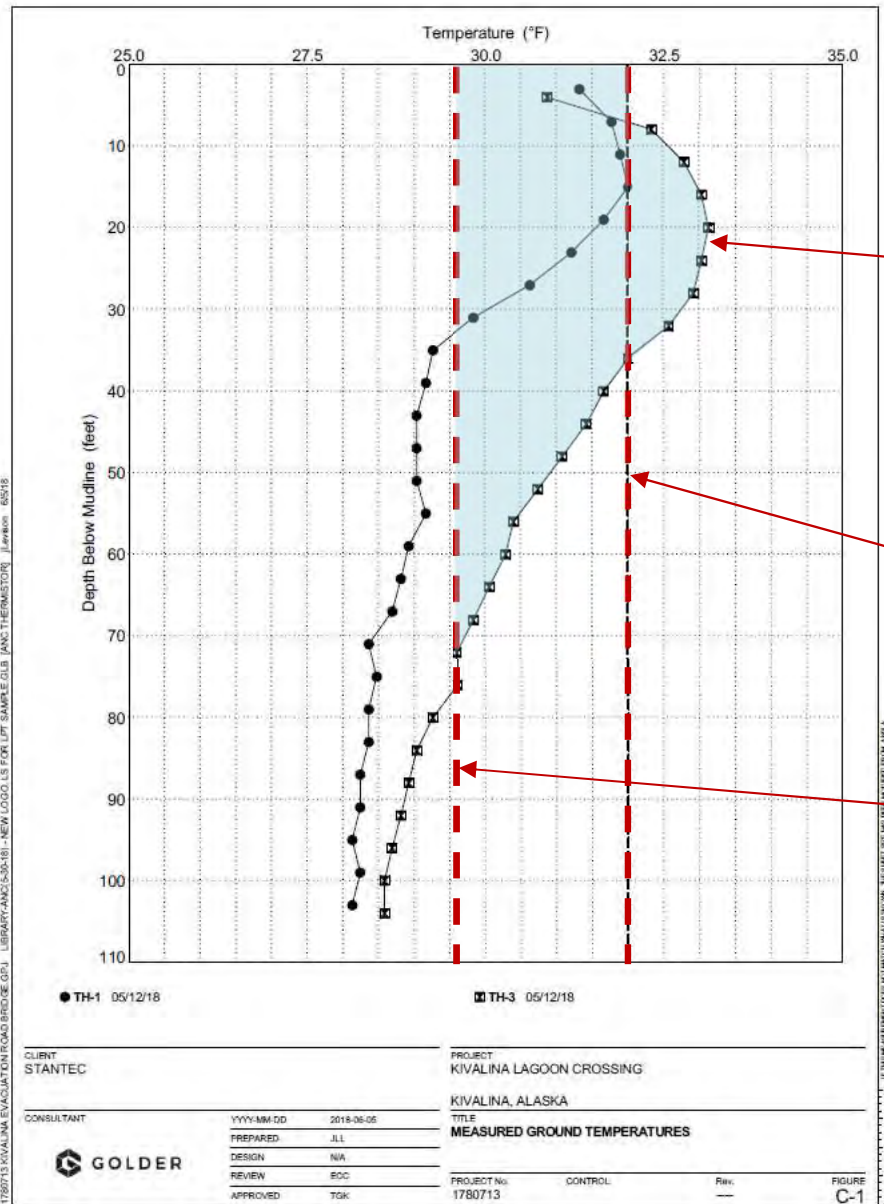
# Measured Ground Temperatures

Thawed region

Freezing Point of freshwater

Freezing Point of saltwater

- SPT testing not particularly useful in frozen soils.
- Pile bearing capacity based on future thawed conditions
- But pile installation needs to occur during current frozen conditions

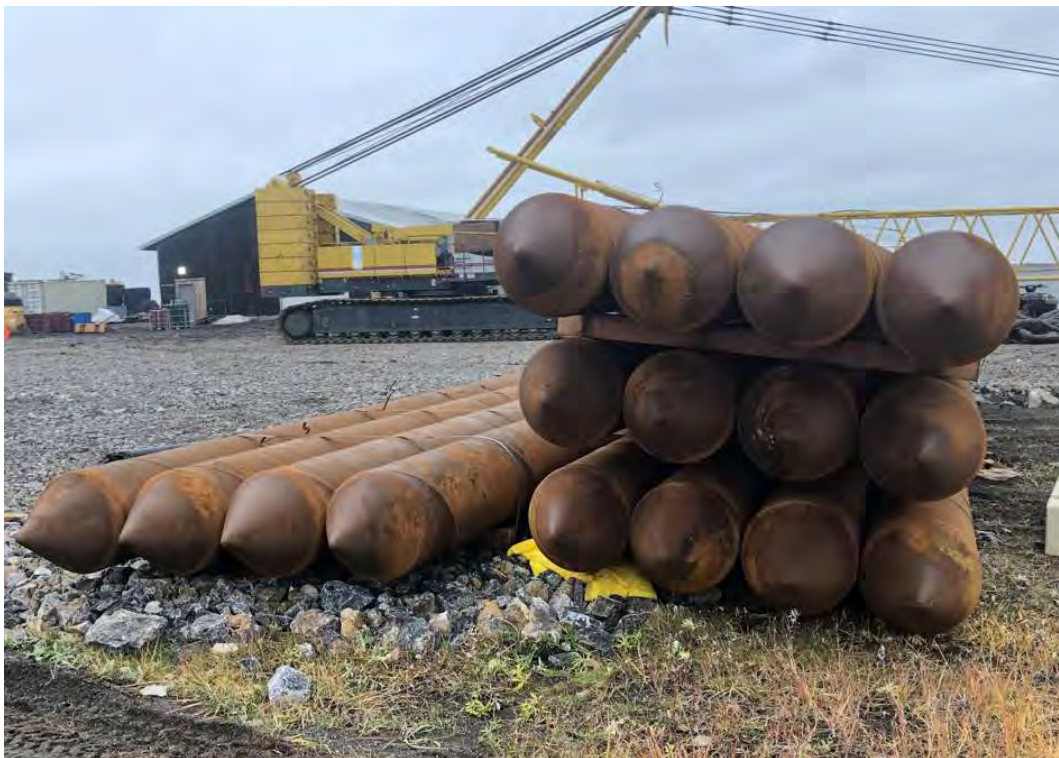
# Foundations

- Close ended helically welded steel pipe piles
  - 2'-0"  $\emptyset$  x 1/2" x 80ft deep (A709 Gr50T3 or API 5L-PSL2)
  - Concrete filled with a gap in shell at the top to force the plastic hinge location during design seismic event.

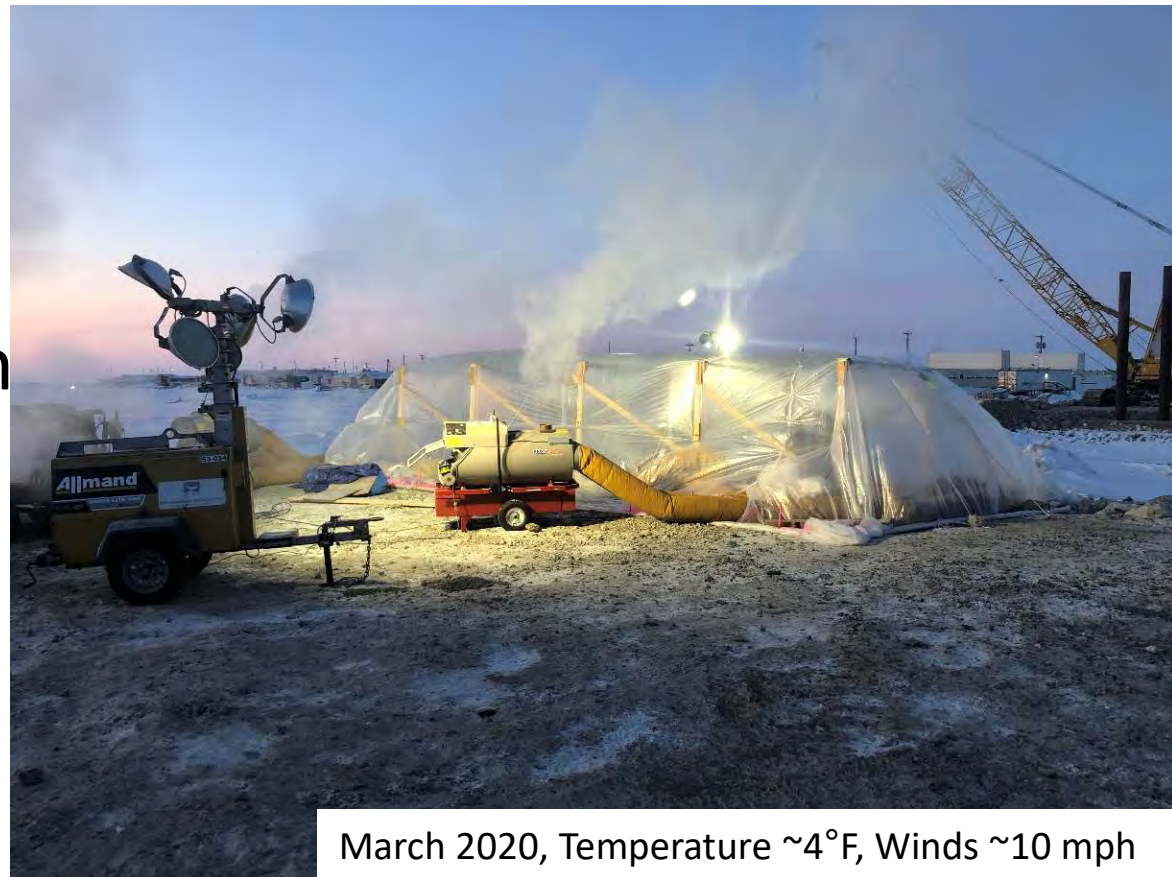
# Abutment Cap Beams

- Contractor chose to use CIP cap beams instead for field flexibility.
- Cold weather protection required when air temp  $< 40^{\circ}\text{F}$ . Max temp of  $90^{\circ}\text{F}$

March 2020, Temperature  $\sim 4^{\circ}\text{F}$ , Winds  $\sim 10$  mph

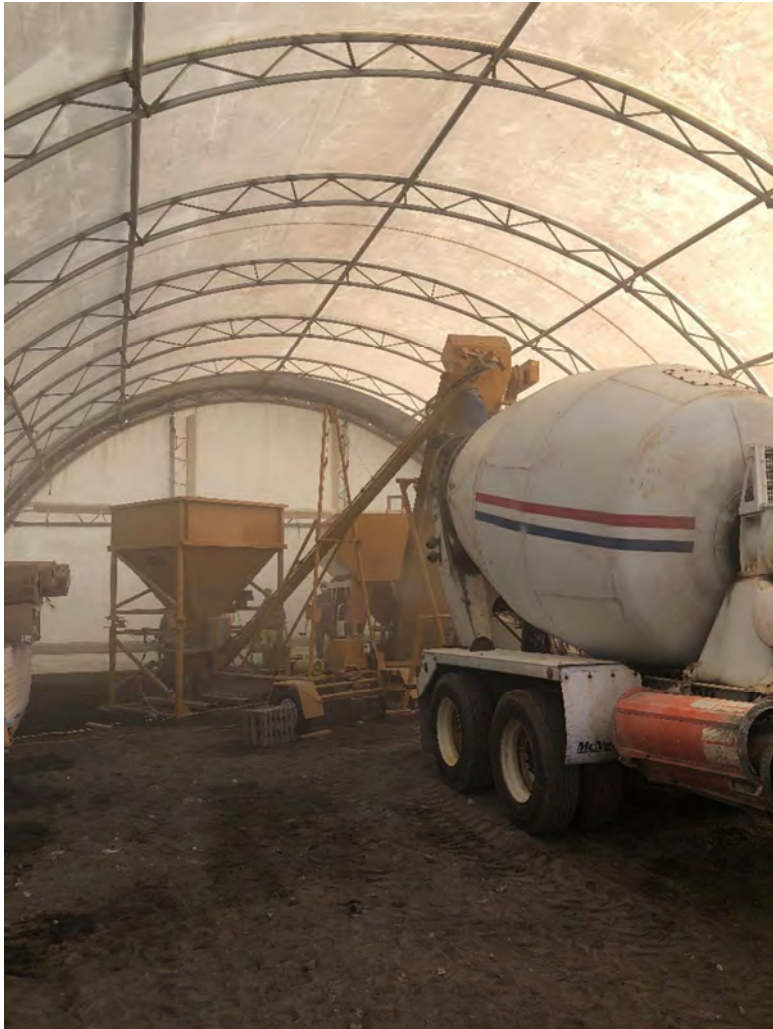
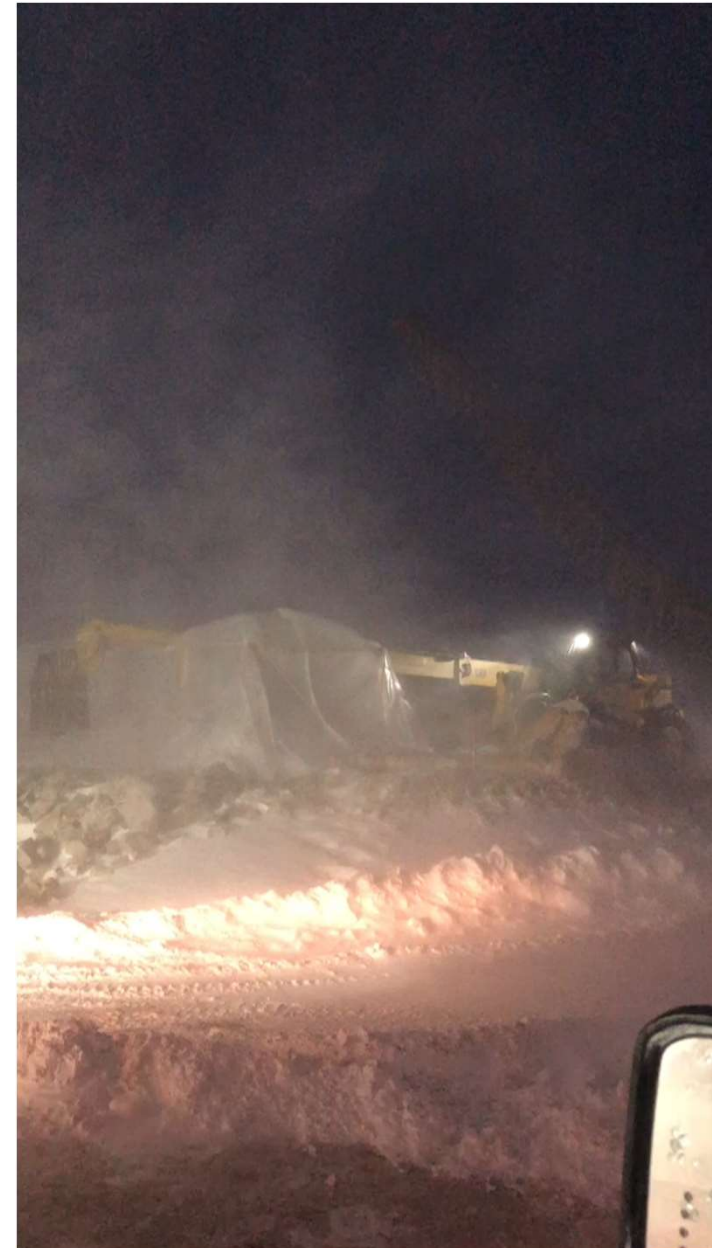
# Cast-in-Place Concrete

- Pre-measured supersack components mixed on site

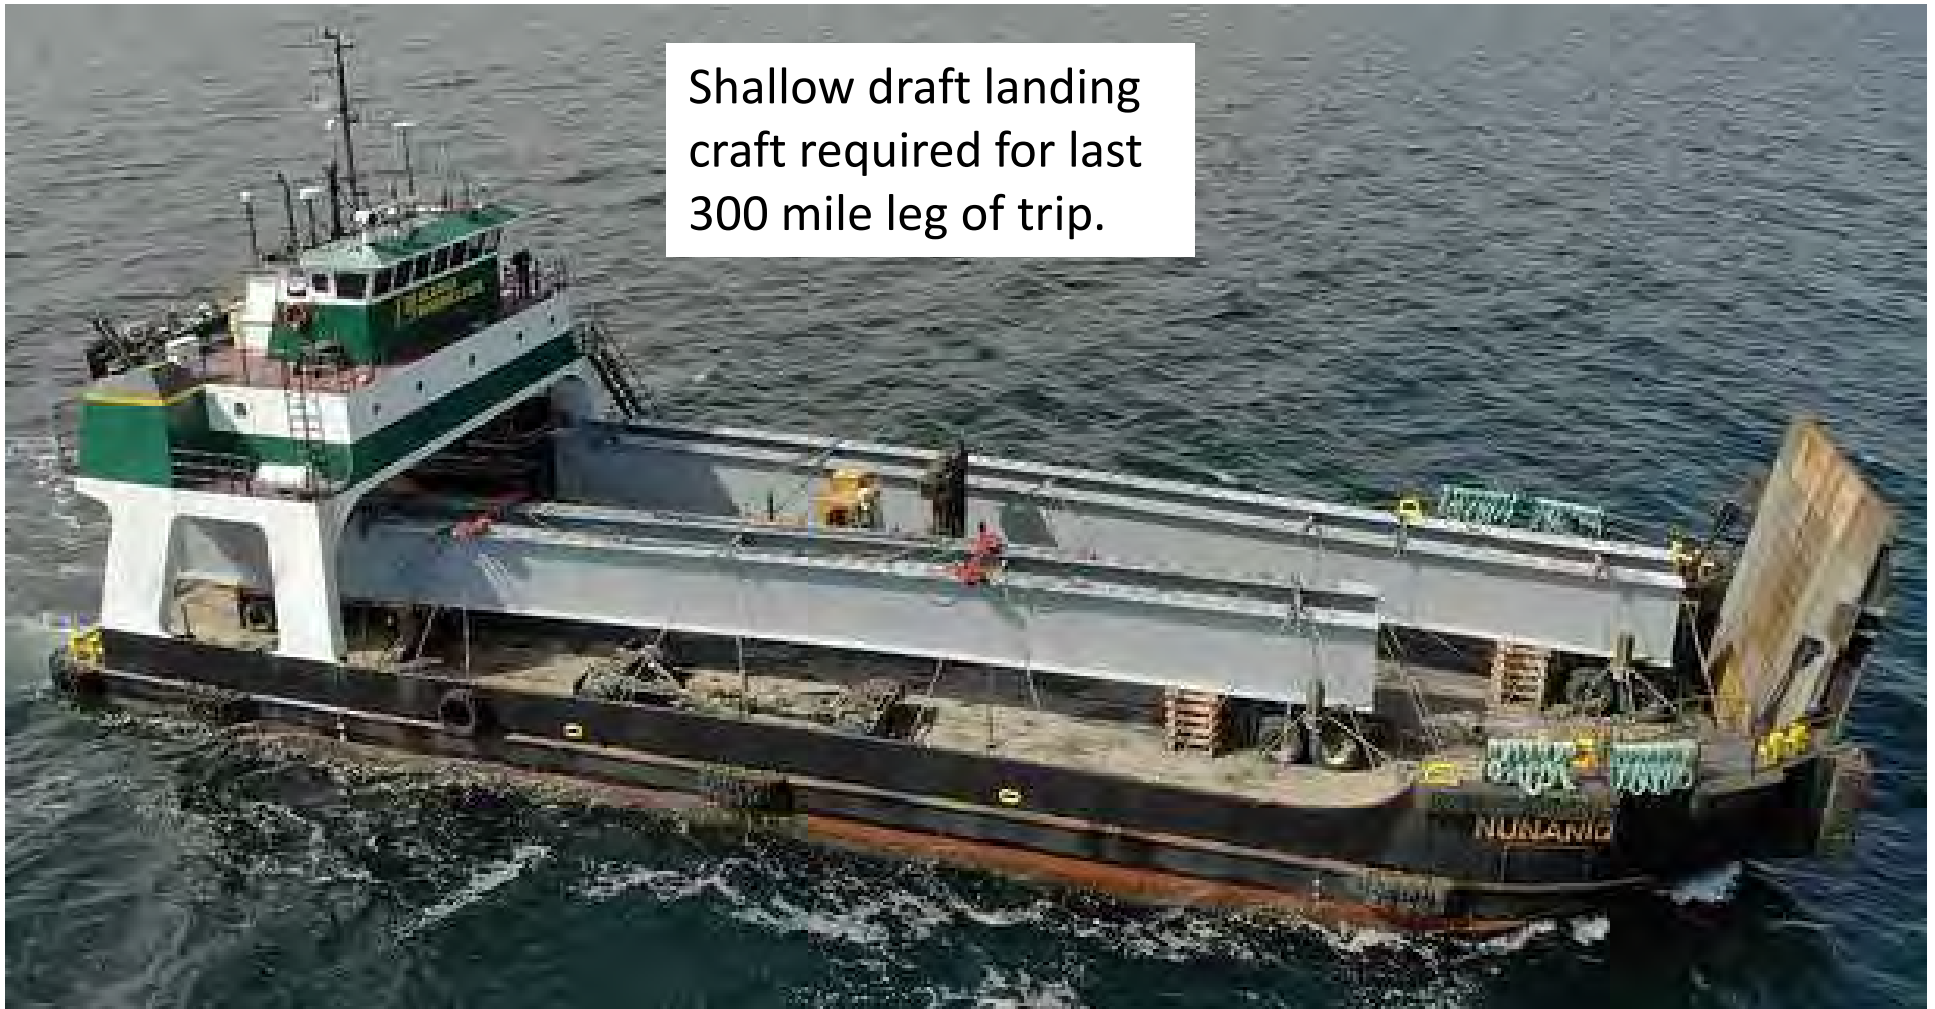
# Girder Transport

Shallow draft landing craft required for last 300 mile leg of trip.

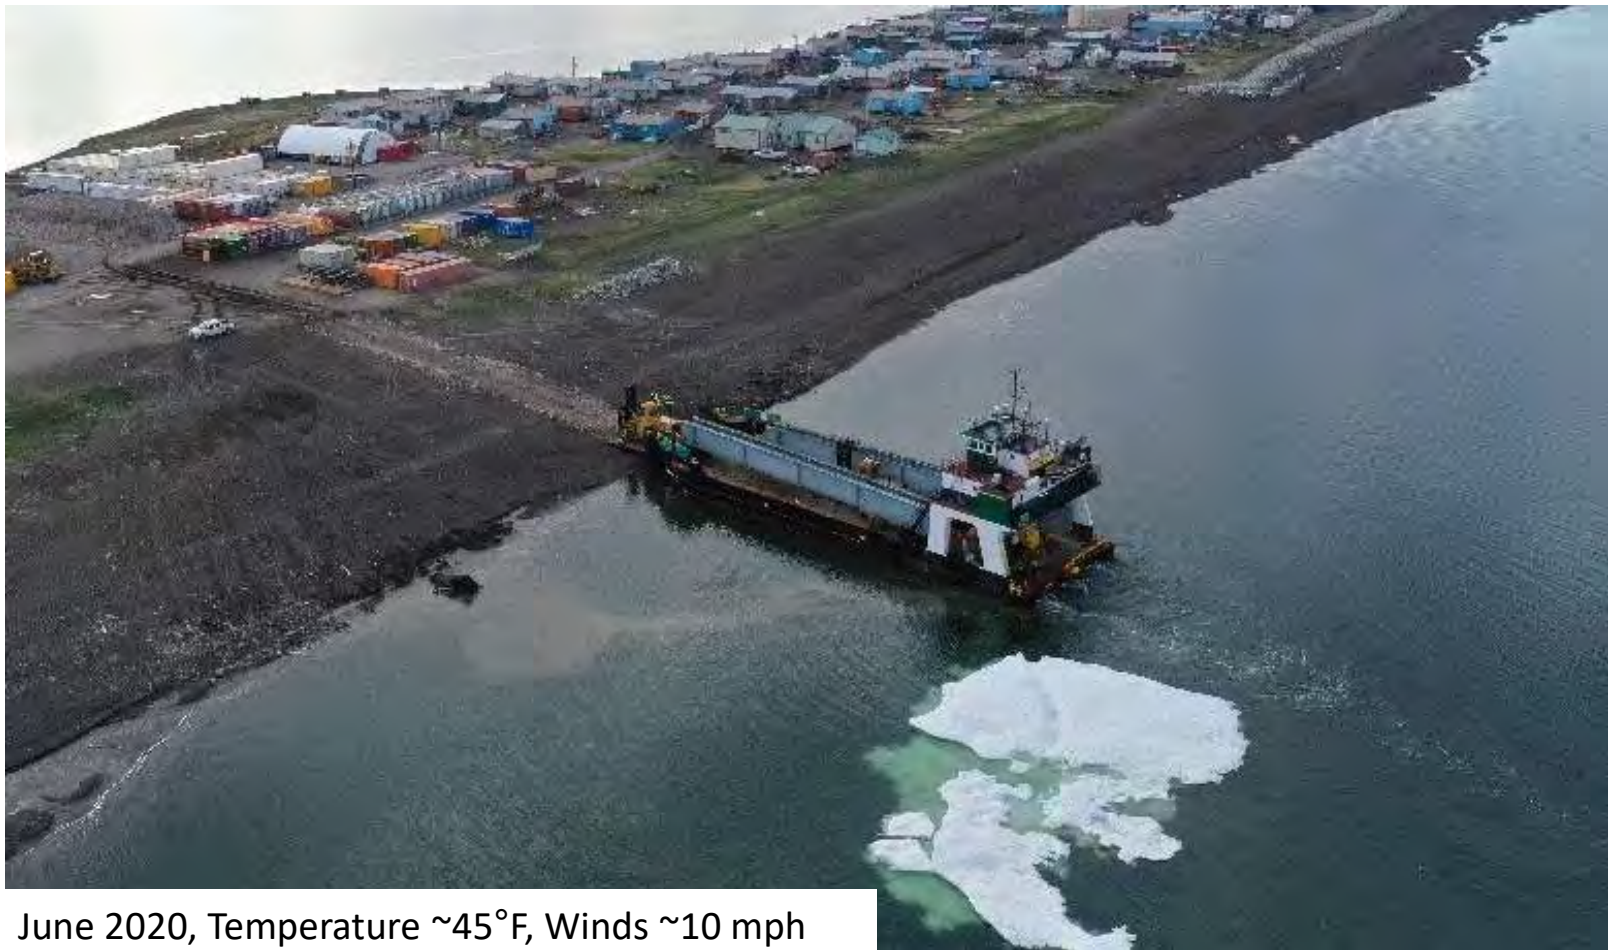
# Girder Transport

- No port facilities in Kivalina so landing craft unloaded girders directly onto beach.

June 2020, Temperature ~45°F, Winds ~10 mph

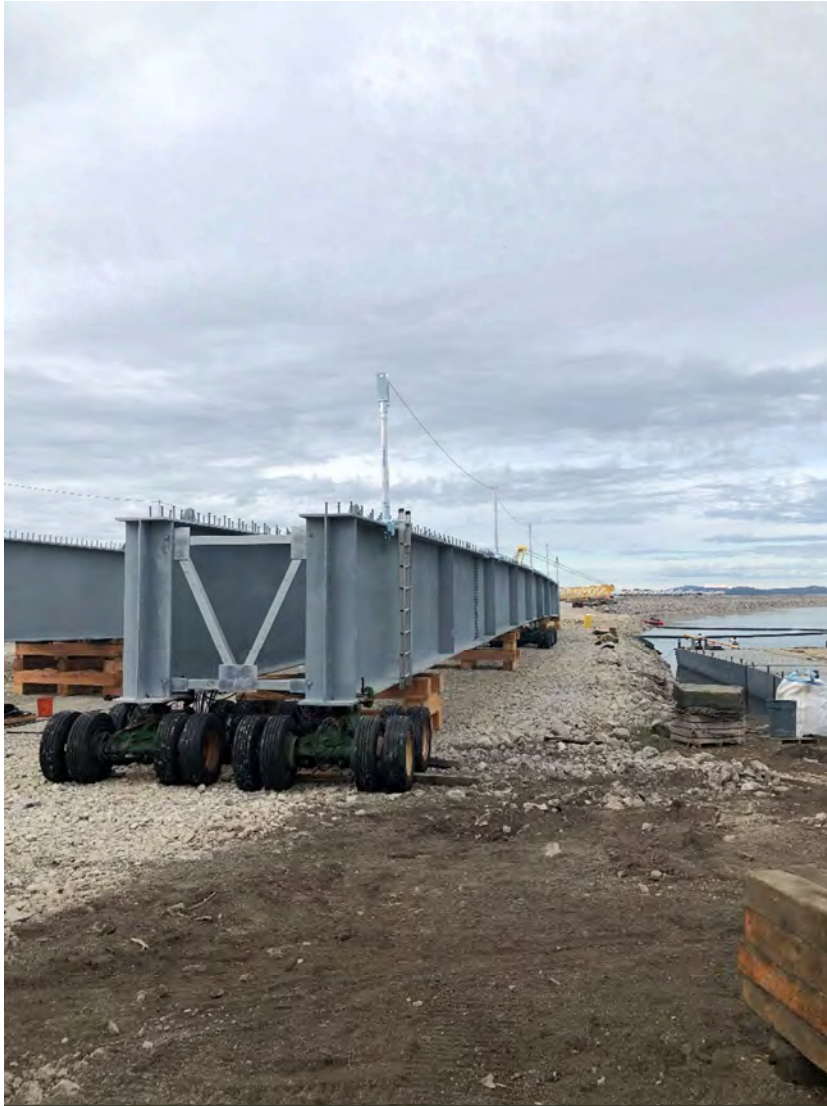
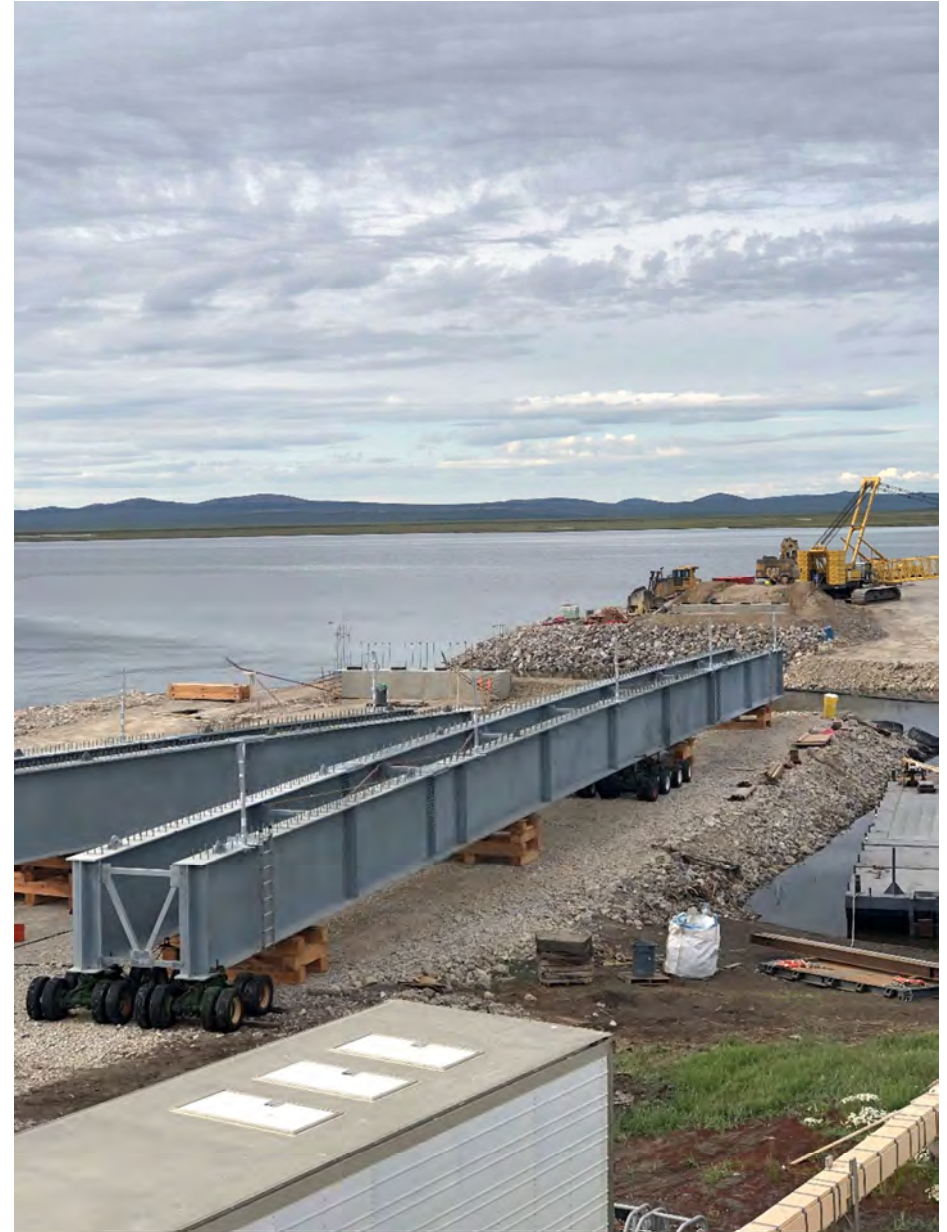
# Girder Launching

- Crane assisted launch

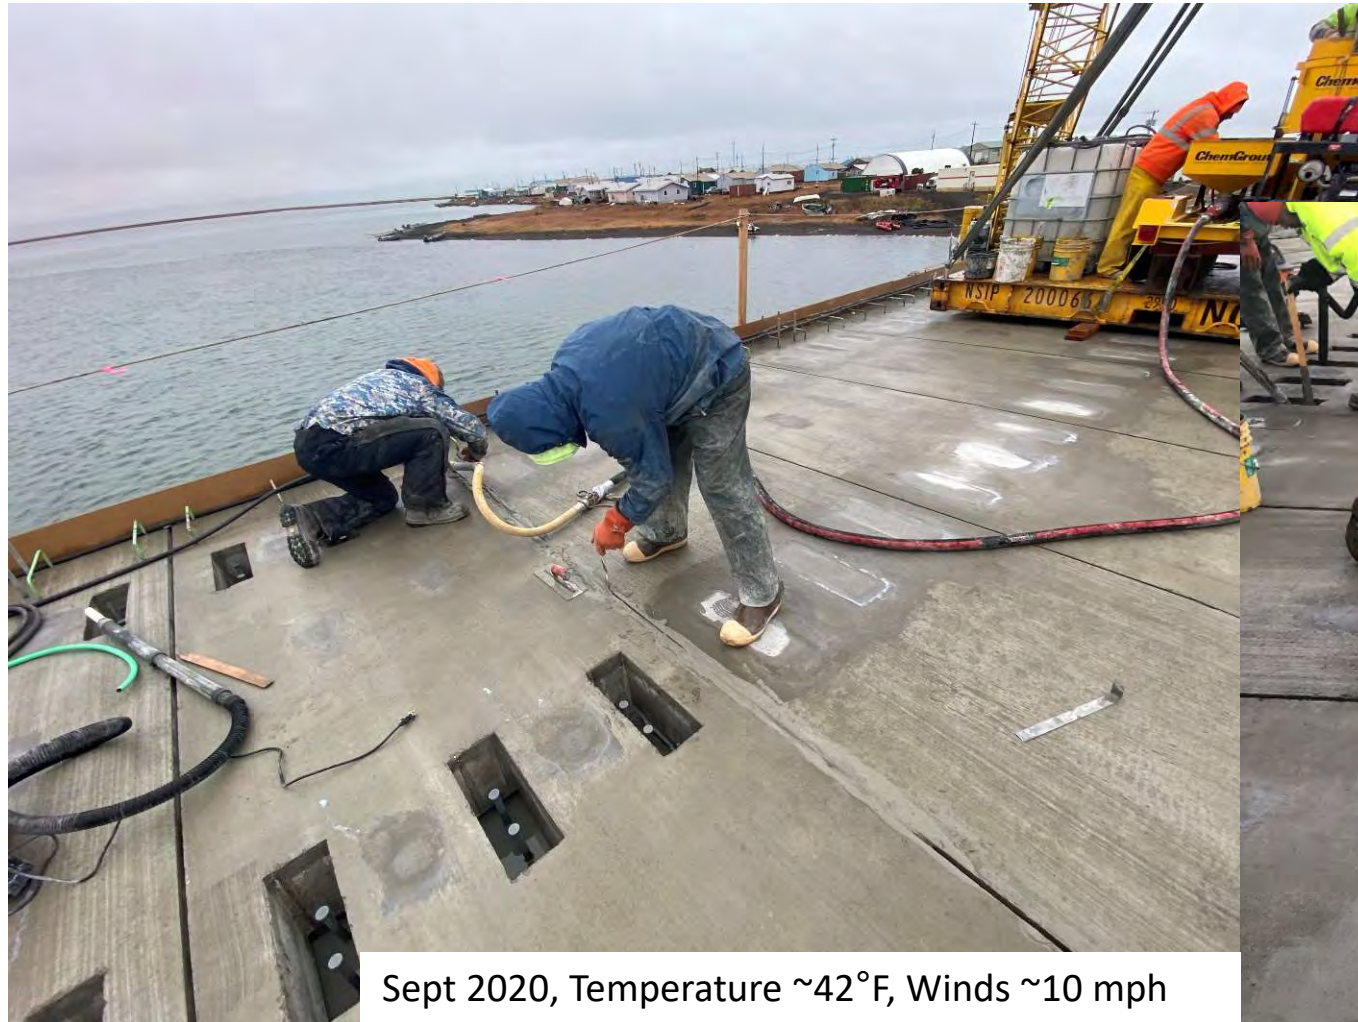
# Grout Placement

Sept 2020, Temperature ~42°F, Winds ~10 mph

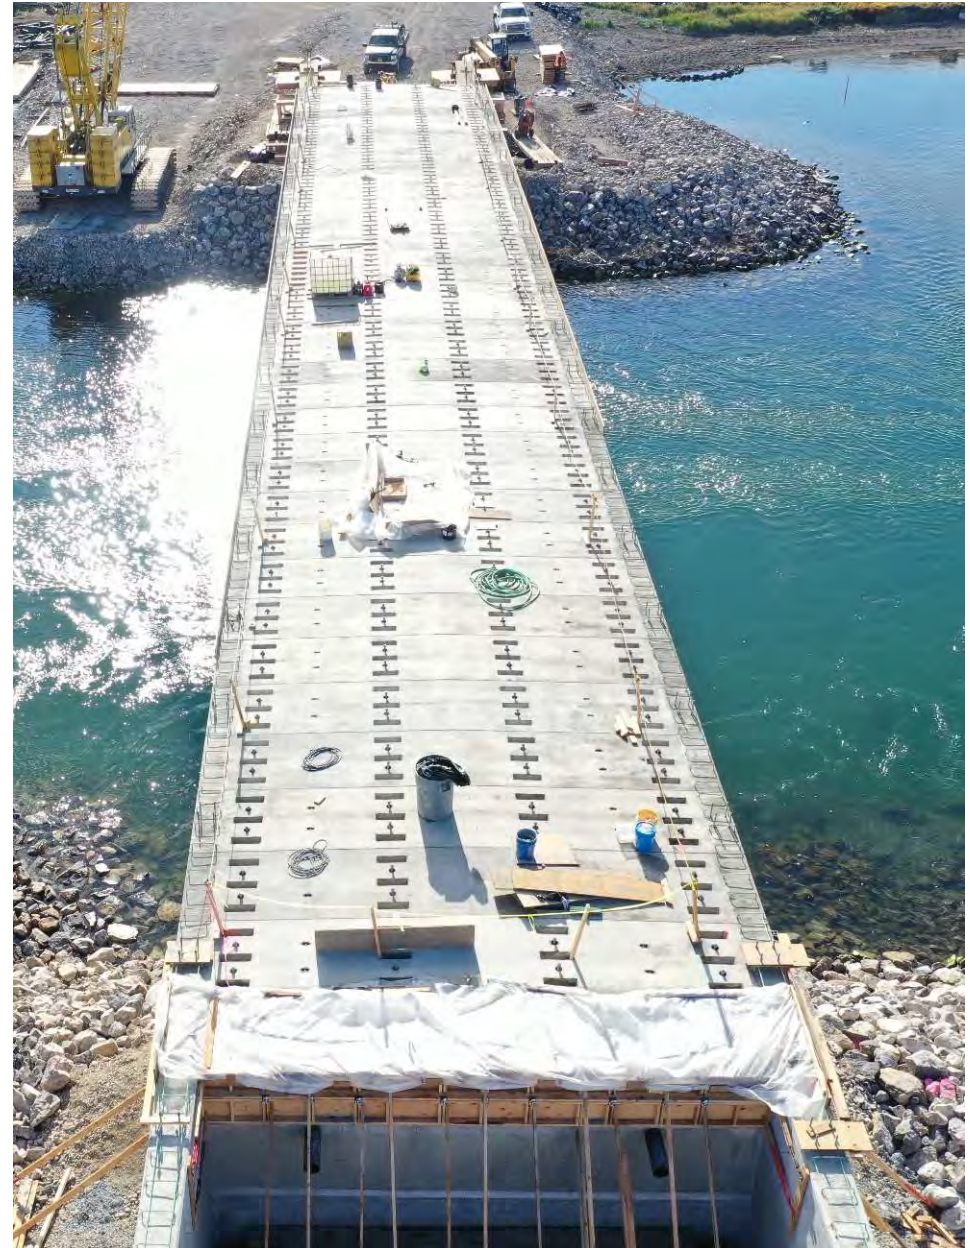
# Deck Panel Installation

- Rapid installation, usually 1-2 days to set and level panels
- Factory controlled production (made in WA)
- While they are heavy, they are still readily shipped
- Easily adjustable in the field for varying camber
- No access from below required
