# RIDOT - Glenbridge Avenue Bridge Replacement

Presented by: John W. Preiss, PE, PMP State Bridge Engineer Rhode Island DOT

FIU ABC UTC Webinar April 20, 2023

### **Glenbridge Avenue Project**

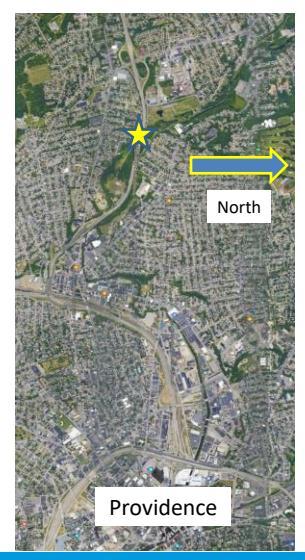
- Located in Providence, RI
- Carries Glenbridge Avenue over US Route 6
- Two-span bridge
- Full replacement with the exception of the abutment foundation
- Traffic Volumes (AADT)
  - Glenbridge Avenue: 14,200
  - Route 6: 67,800

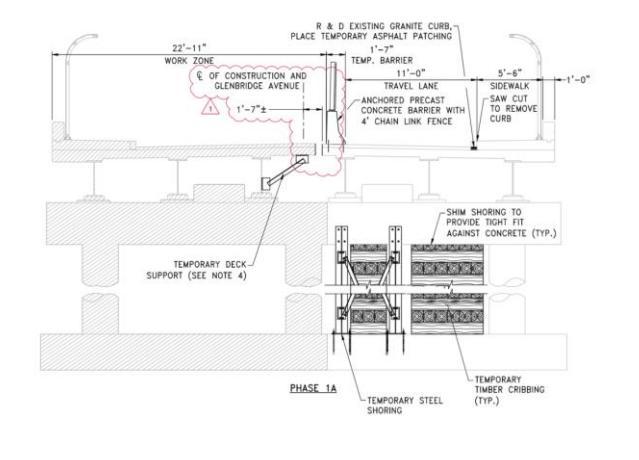
#### Phase 1A

- Cut deck
- Remove half of the bridge
- Maintain one lane of traffic and one sidewalk on existing half

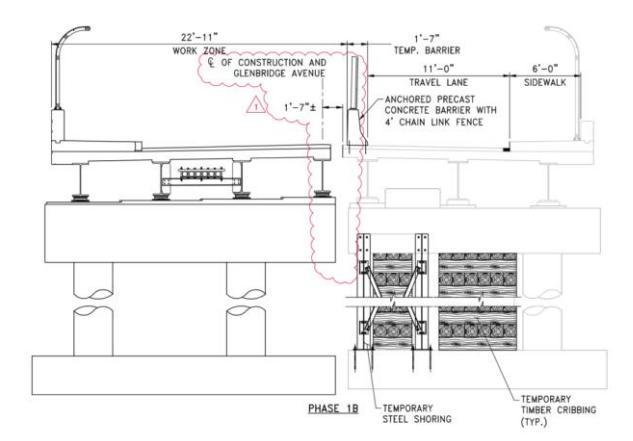
- Phase 1B
  - Construct half of the new bridge
  - Maintain one lane of traffic and one sidewalk on the existing half

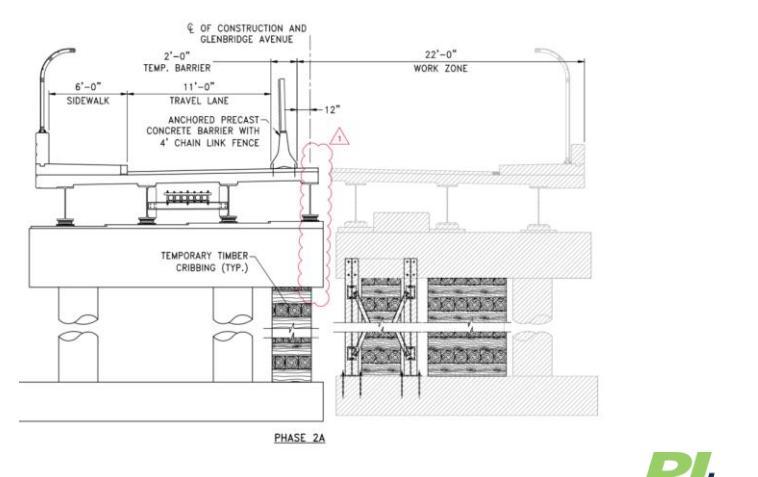
#### Phase 2A

- Demolish the second half of the bridge
- Maintain one lane of traffic and one sidewalk on the new half

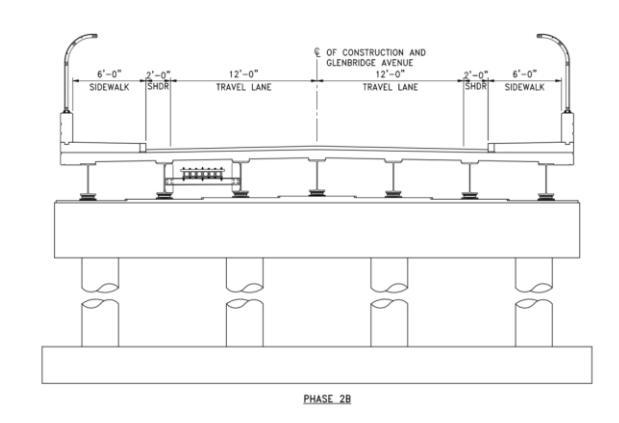
- Phase 2B
  - Construct the second half of the new bridge
  - Re-open to full traffic

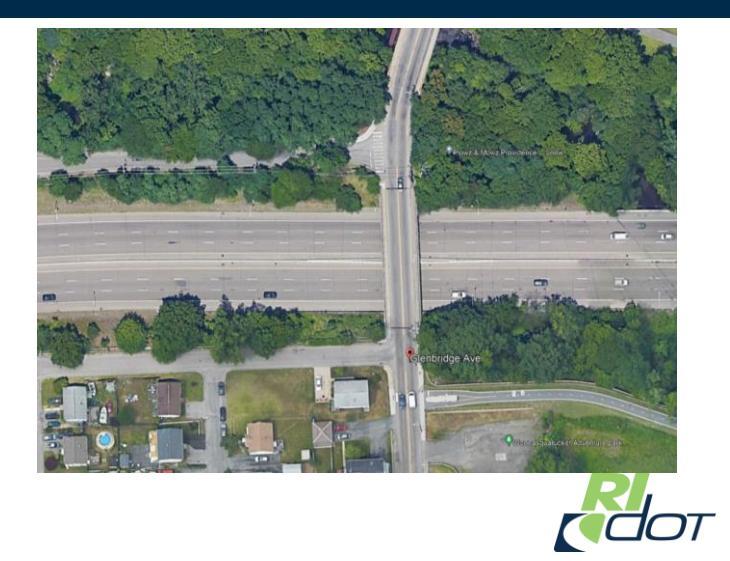
- Option 1:
  - SPMT?
  - No reasonable staging area nearby
    - Slopes along Route 6
    - Wetlands
    - Multi-use paths
    - Local roads

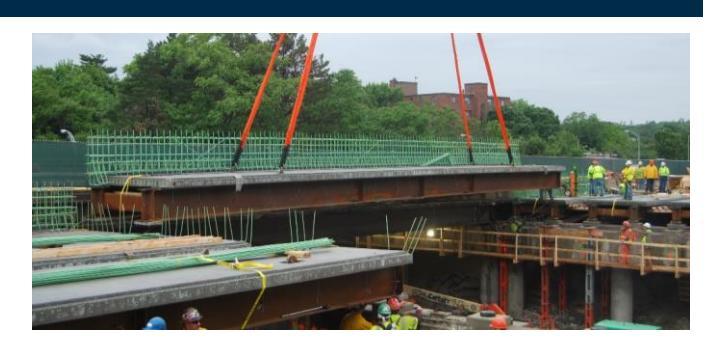
### Option 2

- Modular Deck Beams?
  - Beams, piers, and abutments were already designed
  - This would require a complete redesign of the project

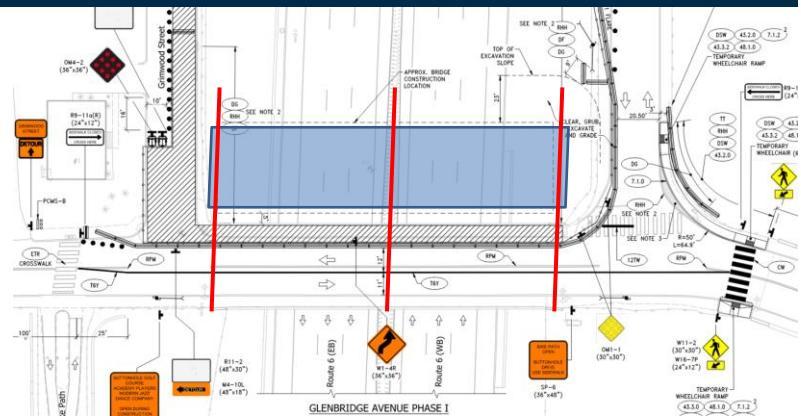
#### • Option 3

- Lateral Slide
  - Construction over Route 6 was reasonable.
  - Ample room to build temporary pier and temporary abutments
  - Maintain 2 lanes and one sidewalk at all times
  - Buttonhole Drive remains open
  - Grimwood Street is closed with a very short detour
  - Most of the original design could be salvaged
  - Short-term closures Of Glenbridge Avenue and Route 6

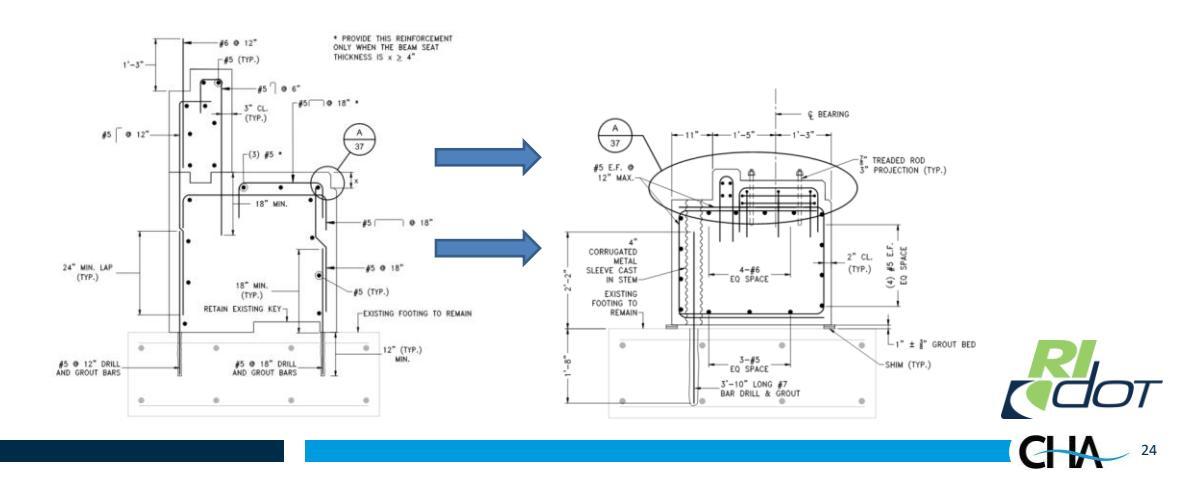
- Abutment Stem
  - Convert from CIP to Precast

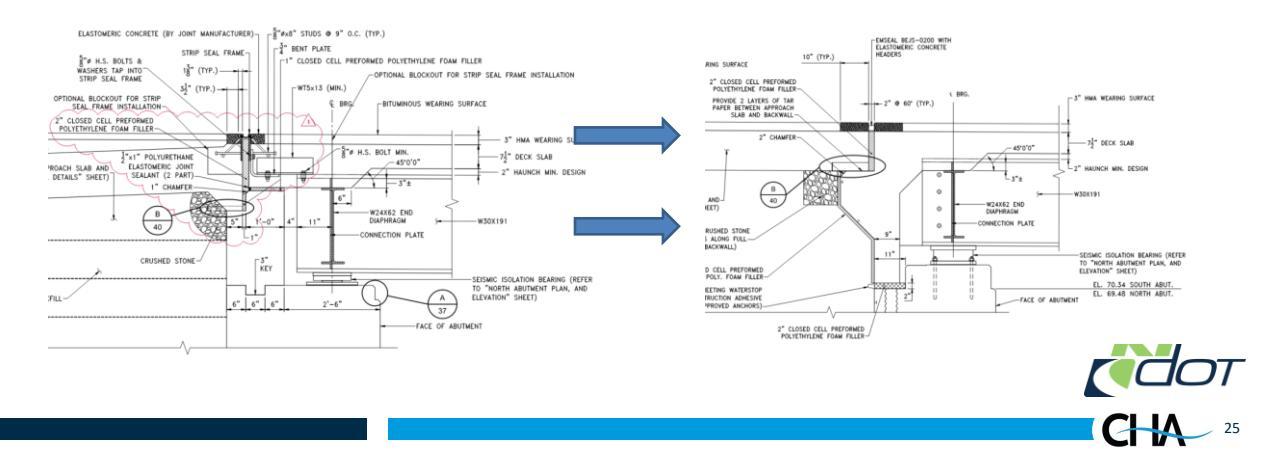
#### Abutment Backwall

#### - Convert conventional to semi-integral

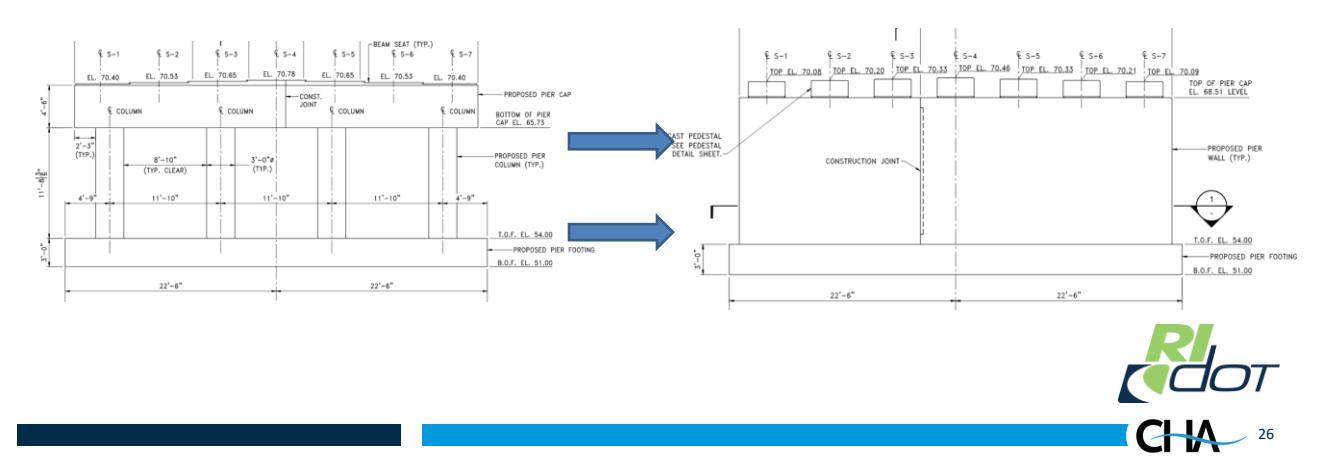
- Pier
  - Convert column bent to wall pier
    - · Accommodates moving loads better (if slide track is placed on the pier)

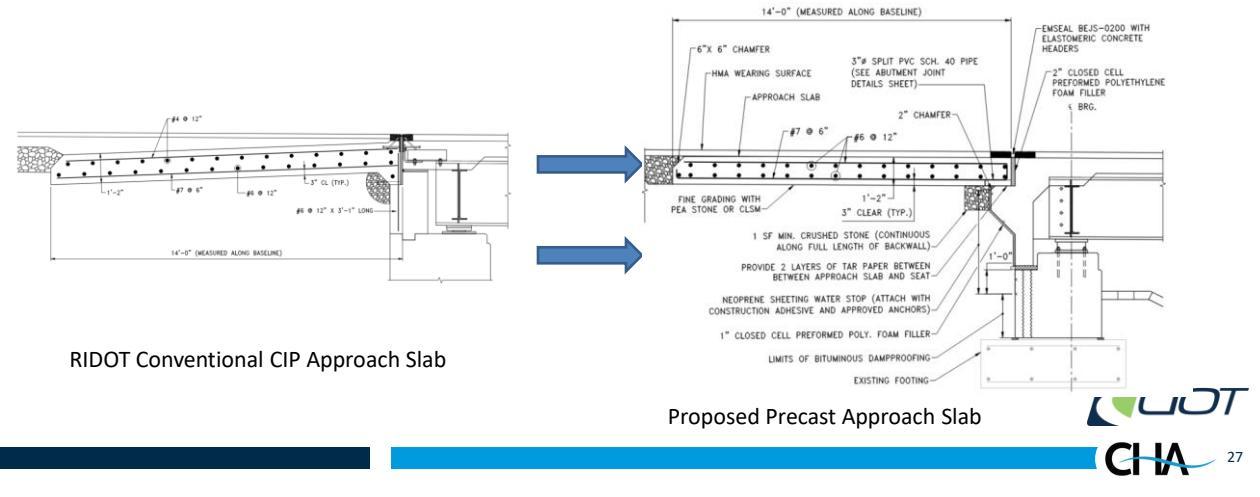
- Approach Slabs
  - Convert CIP to Precast

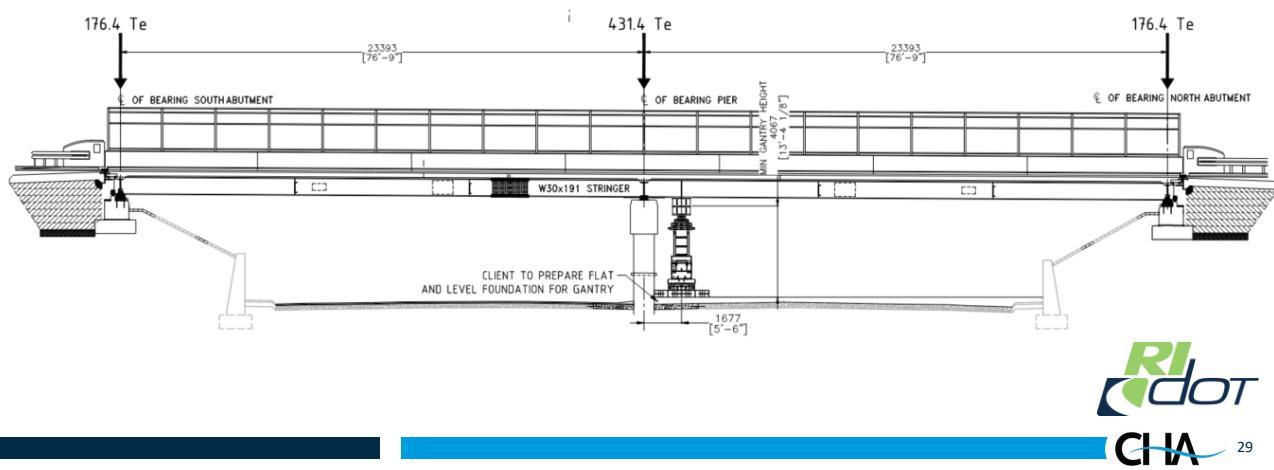
#### · Preliminary plan

- 3 slide tracks
- 2 abutment tracks and one pier track

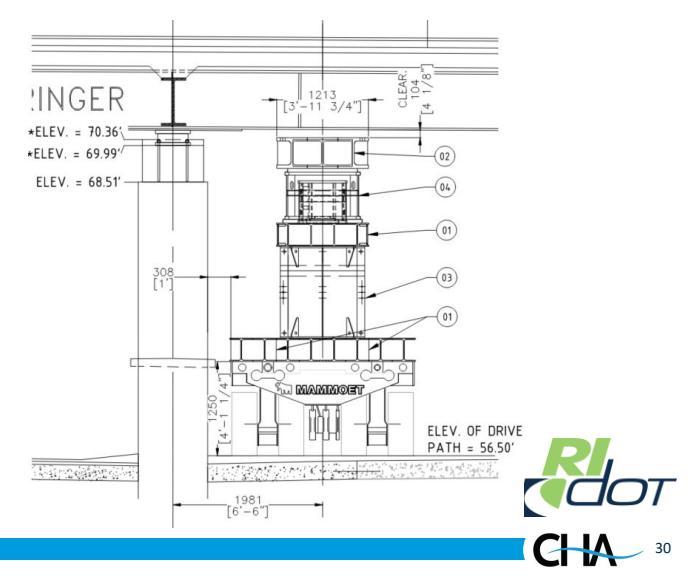
- · Revised Plan Mammoet
  - 2 abutment tracks
  - Change Pier track to SPMT
    - Eliminated a significant structure for the pier track
    - Eliminated jacking systems at abutments

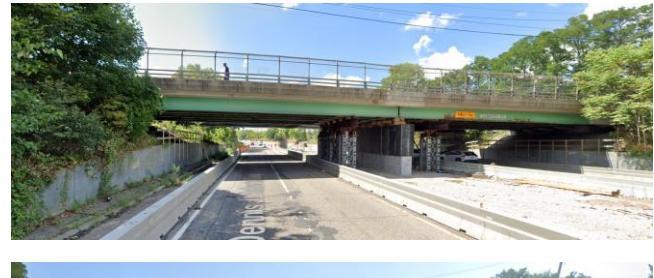
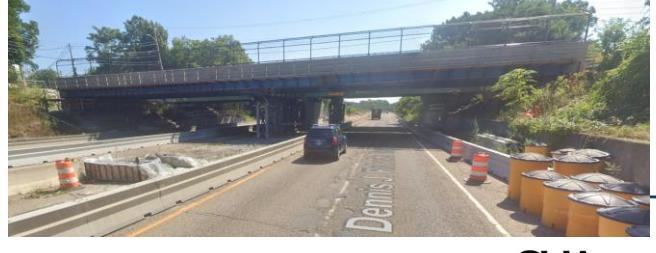
#### Pier Construction

- There was room for temporary support towers
- Contractor elected to build the new pier under the existing bridge
  - Remove work from the critical closure period
- There was ample room to build the temporary pier as well

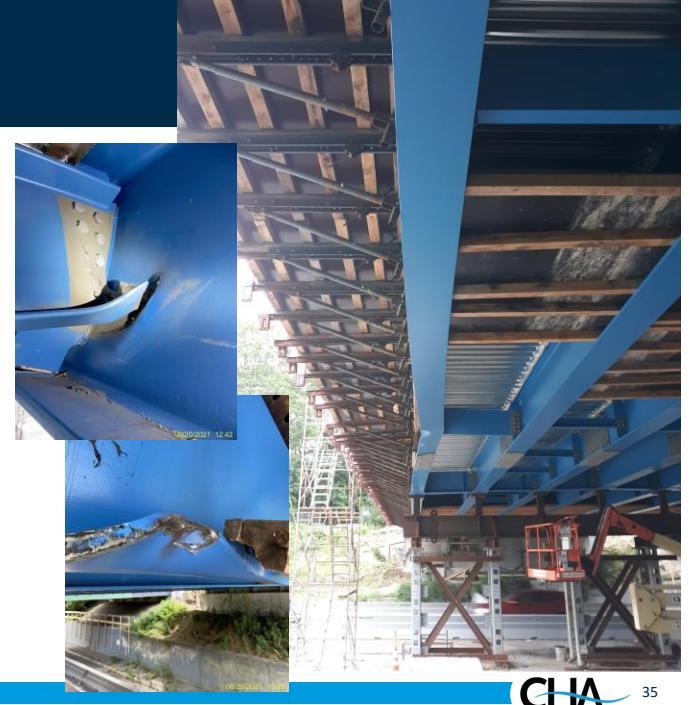
- "The new bridge was hit by an overheight truck"
- New bridge was 6" higher than the existing
- The new bridge was approximately 90% complete
- The fascia girder was heavily damaged
- The temporary supports were undamaged

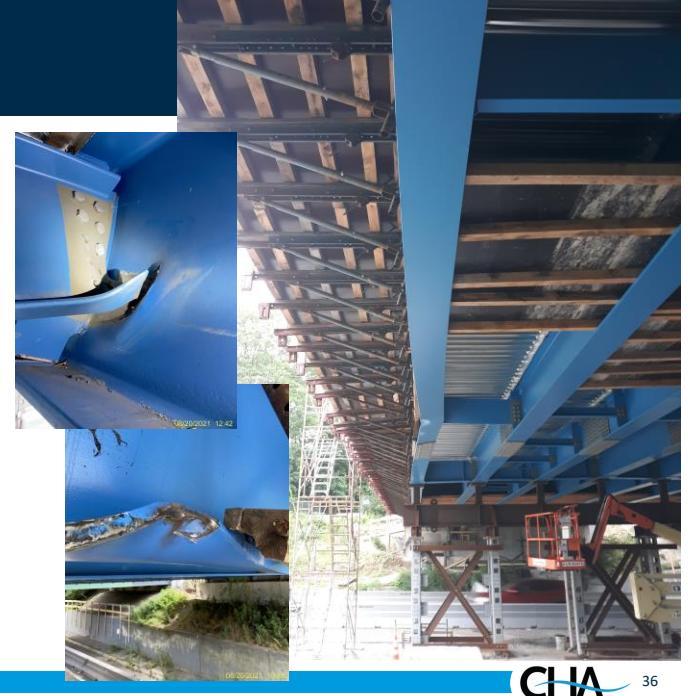
#### Repair Options Considered

- 1. Removal of a portion of the beam and heat straightening of the remainder
  - RIDOT concerned with damage to metalizing and paint system
- 2. Removal of the entire fascia beam and repair to minor damage on other beams
  - · Provided a "like new" result
  - This option was chosen

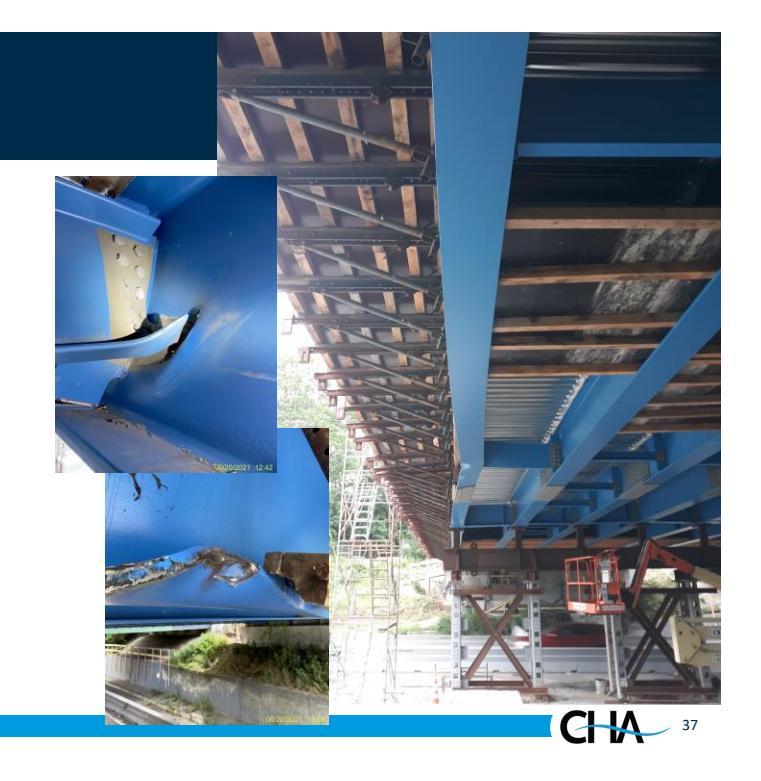
- Raise the bridge higher
  - Slows construction due to need for significant lowering during the move
- Add a sacrificial beam
  - Increases costs
- Design temporary supports for an impact load

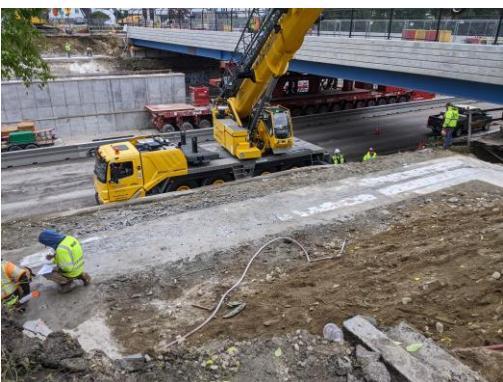
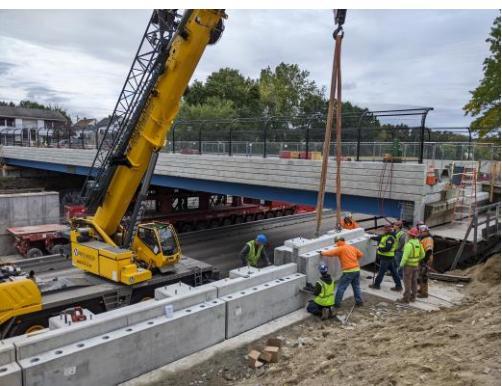
· Precast abutment stem installation

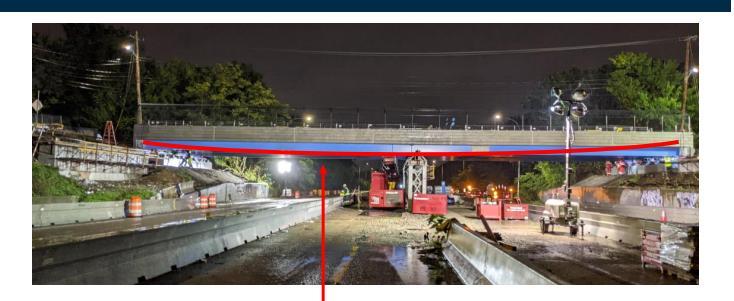
Greatly exaggerated profile

- The pier touched down
- The abutments had a 2" gap
- Elevation calculations were triple checked
- Survey shots before the move were checked
- Everything was correct
- Result: The SPMT moved lower relative to the abutments
- Solution: Set the bridge down on the abutments
- No issues with this

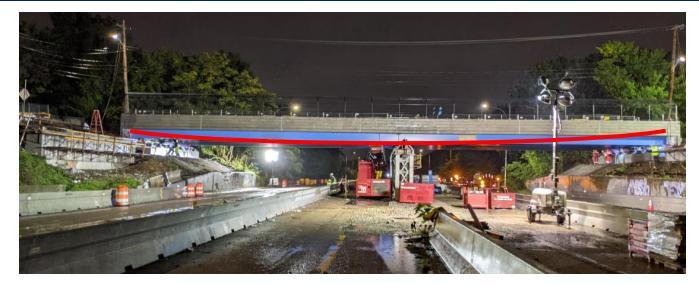
- Include deflection monitoring during the move
- Normally not required for a slide
- The adjustability of the SPMTs is cause for the need for monitoring
- If this happens, the SPMTs can easily be adjusted during the move
