# **Synthesis on the Use of Accelerated Bridge Construction Approaches for Bridge Rehabilitation**

**Final Report  
December 2015**

Federal Highway Administration  
Accelerated Bridge Construction University Transportation Center  
U.S. Department of Transportation Office of the Assistant Secretary  
for Research and Technology  
Iowa Department of Transportation  
(Part of InTrans Project 05-52)

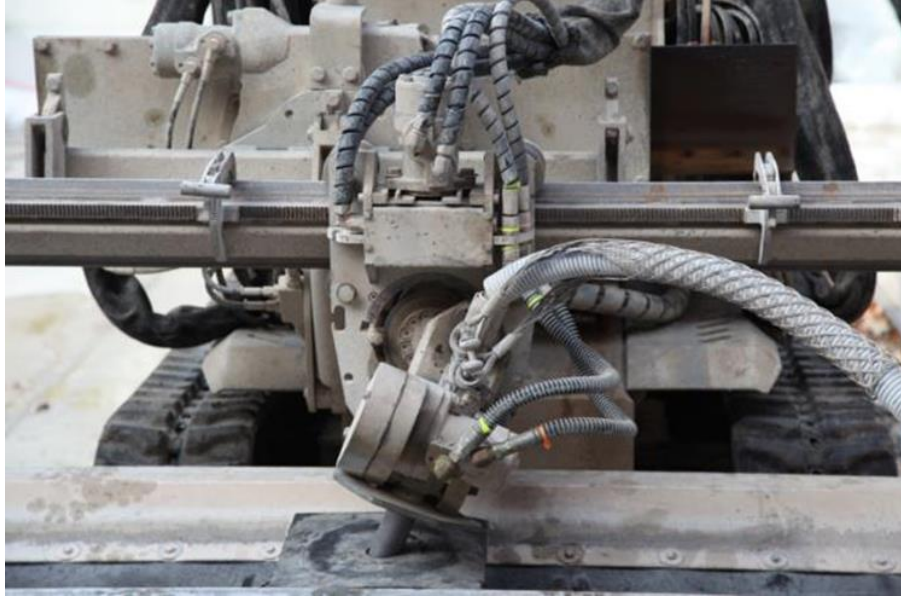
As mentioned previously, hydrodemolition is a process that makes use of a high-pressure water jet to remove damaged or deteriorated concrete. A hydrodemolition unit as well as a surface removed using hydrodemolition are shown in Figures 1 and 2, respectively.

**Figure 1. Hydrodemolition machine**

Damaged concrete can be removed with relatively high precision, allowing the designer/contractor to be much more selective in their removal process. The interface created from the water jet provides for a very rough surface, which should result in a better bond between the remaining concrete and the repair materials compared to the surface generated by jackhammers and sandblasting. Furthermore, other methods may cause microcracking of the concrete or may damage the underlying steel reinforcement or superstructure; whereas, hydrodemolition leaves these areas unharmed, making it a good option for both partial- and full-depth removal (Phares et al. 2014).

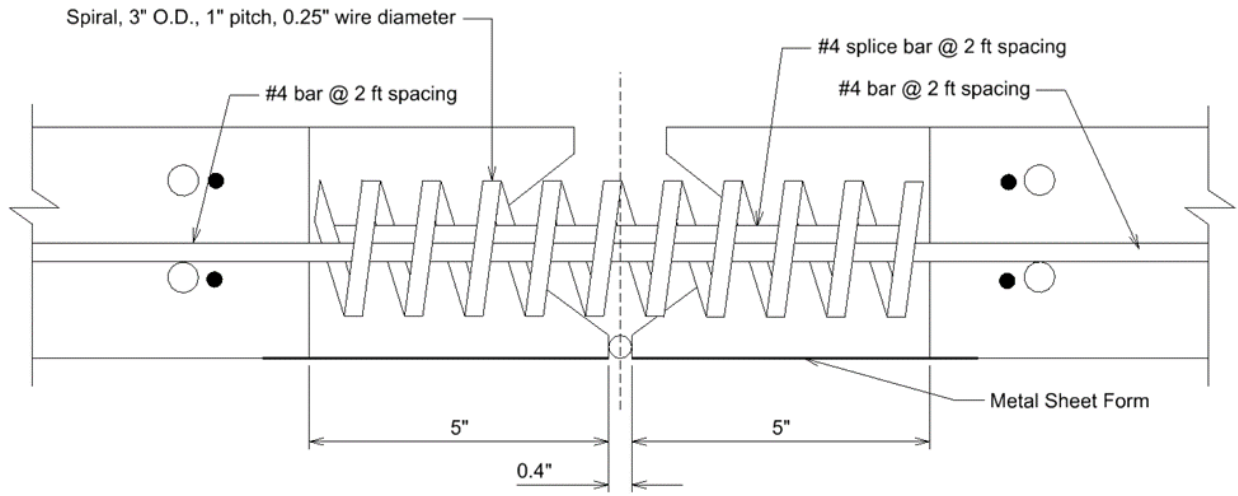
**Figure 11. NU continuous precast prestressed panel reinforced pocket detail**

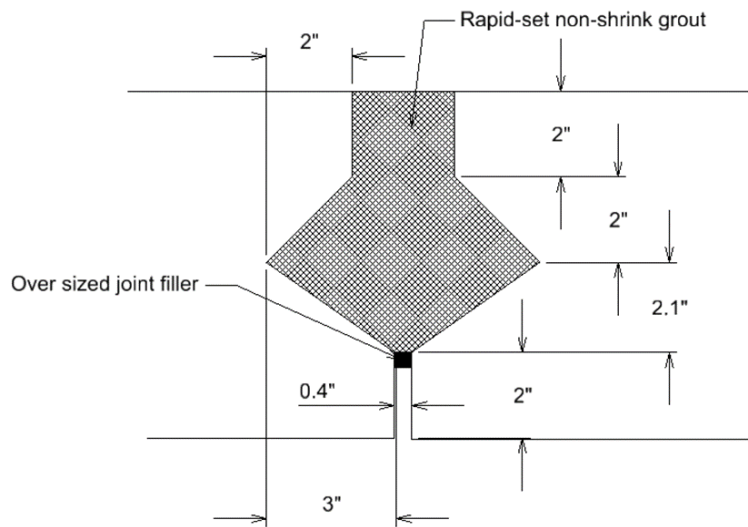
**Figure 19. Transverse shear key detail for full-depth concrete panel**

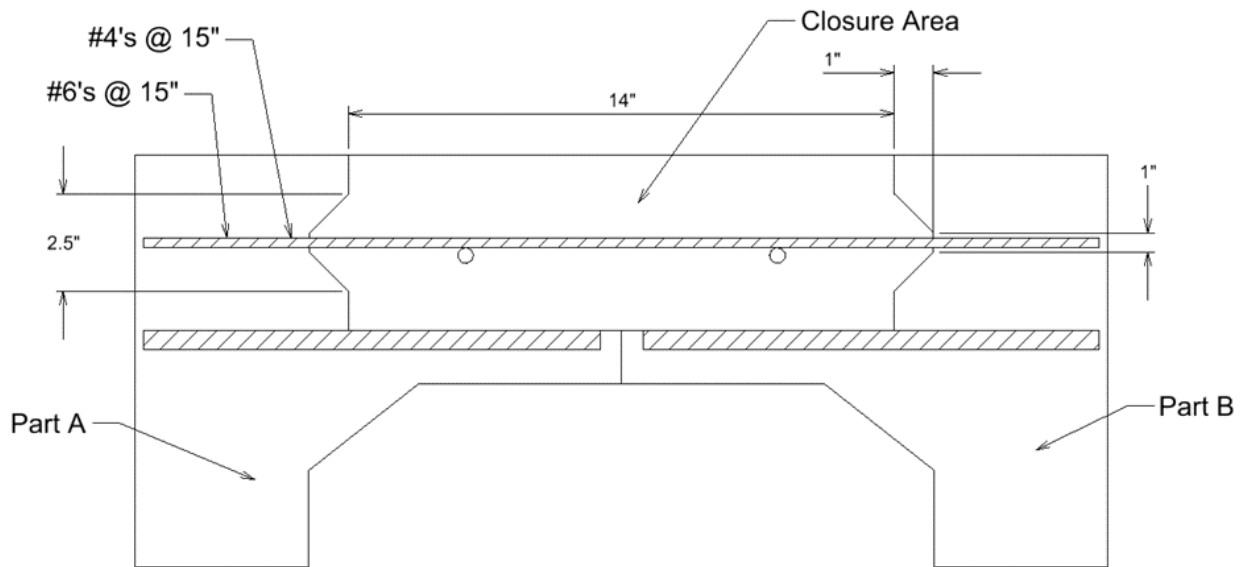
**Figure 27. Side view of panel-to-panel connection for precast modified beam-in-slab bridge system**
