NDT METHODS APPLICABLE TO HEALTH MONITORING OF ABC CLOSURE JOINTS

**Quarterly Progress Report
For the period ending May 31, 2018**

**Department of Civil and Environmental Engineering
Florida International University
Miami, FL**

**ACCELERATED BRIDGE CONSTRUCTION
UNIVERSITY TRANSPORTATION CENTER**

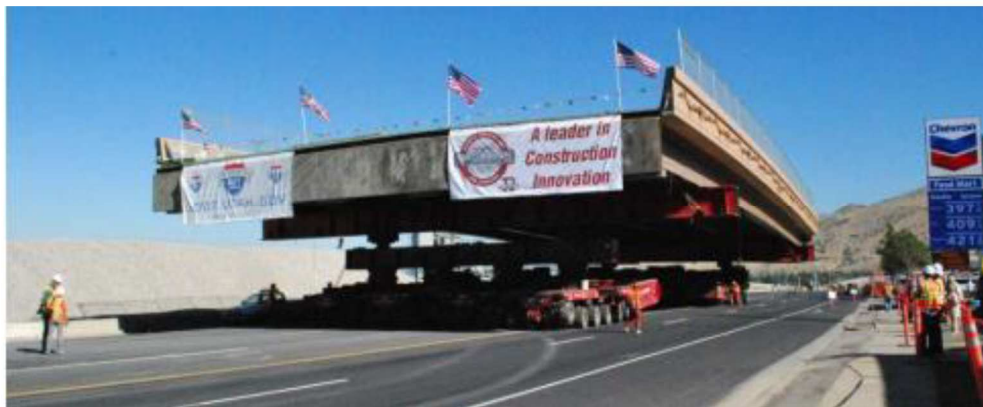
Figure 1: ABC superstructure positioning [5]

Owing to these advantages, application of ABC methods is growing across the US (Fig. 1).

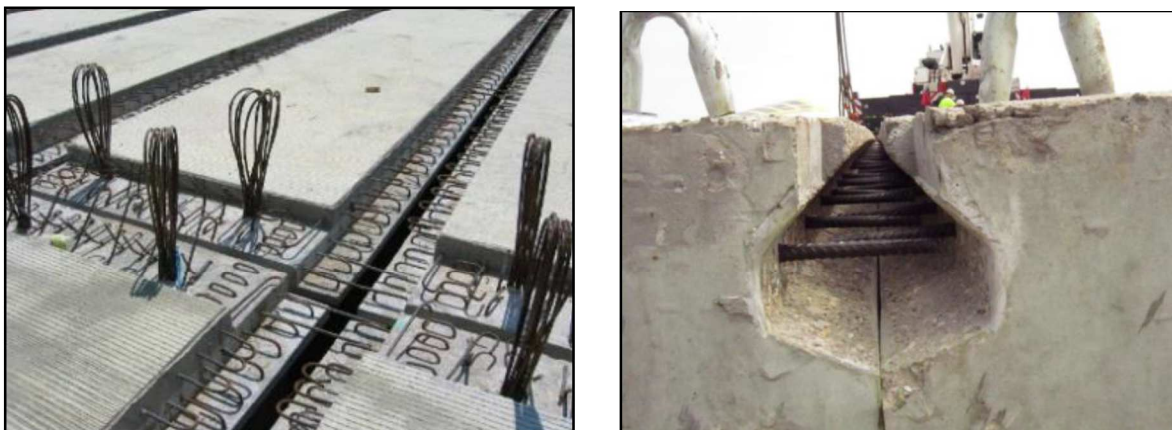
Figure 2: Examples of various types of ABC closure joints [6]–[9]

Closure joints normally refer to joints for connecting the bridge deck elements to each other and to the substructure. Other joints are used for connecting superstructure to substructure as well as substructure elements to each other (Fig. 2).

Application of the Accelerated Bridge Construction (ABC) using prefabricated elements and assemblies necessitates the use of joints for connecting and integrating the bridge structure.

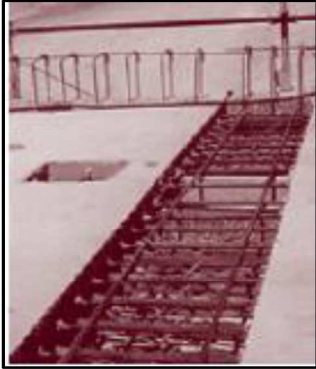
Figure 4: Type 2 Joint [7], [9]

Type 2 Joint designation refers to linear joints that normally join full-depth precast decks to each other, and precast decks to precast concrete beams (Fig. 4).

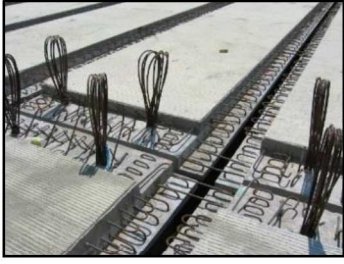
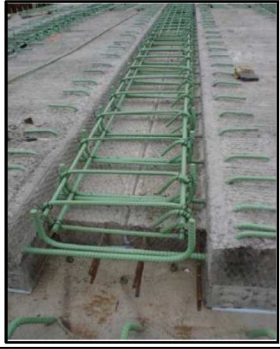
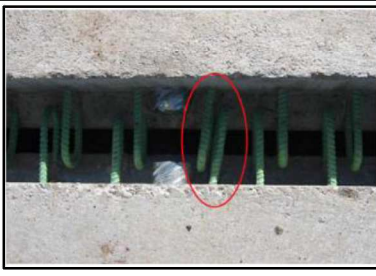
Figure 5: Type 3 Joint [7], [8], [12]

Type 3 Joint designation refers to linear joints that normally joining partial depth precast deck panels, butted decked precast girders, and in some cases P/C Slab Longitudinal connections to Steel Girder Superstructure [7] (Fig. 5).

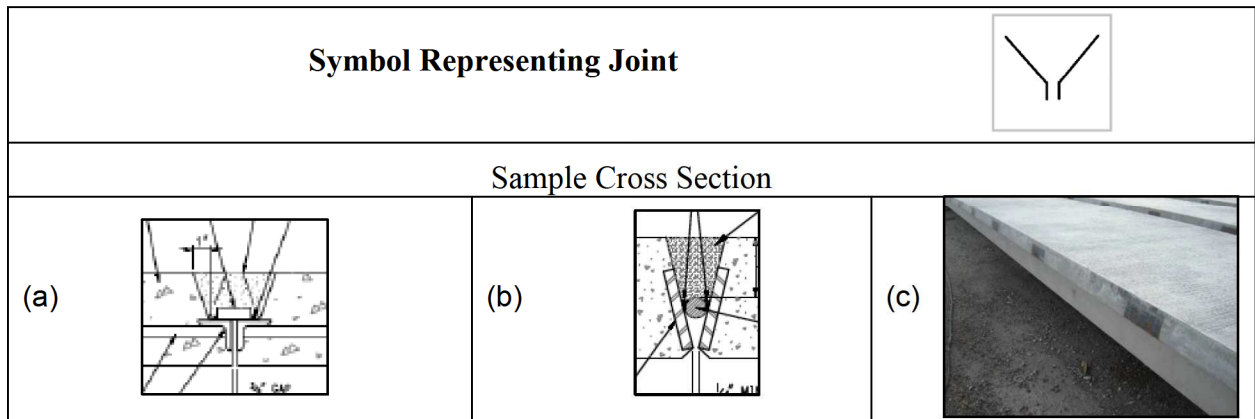
Figure 6: Type 4 Joint [7], [8], [12]

Type 4 Joint designation refers to linear joints that normally joins two prestressed tee beams or double beam, and in some cases full or partial depth deck panels. The V shaped joint is cast in the longitudinal direction (Fig. 6).

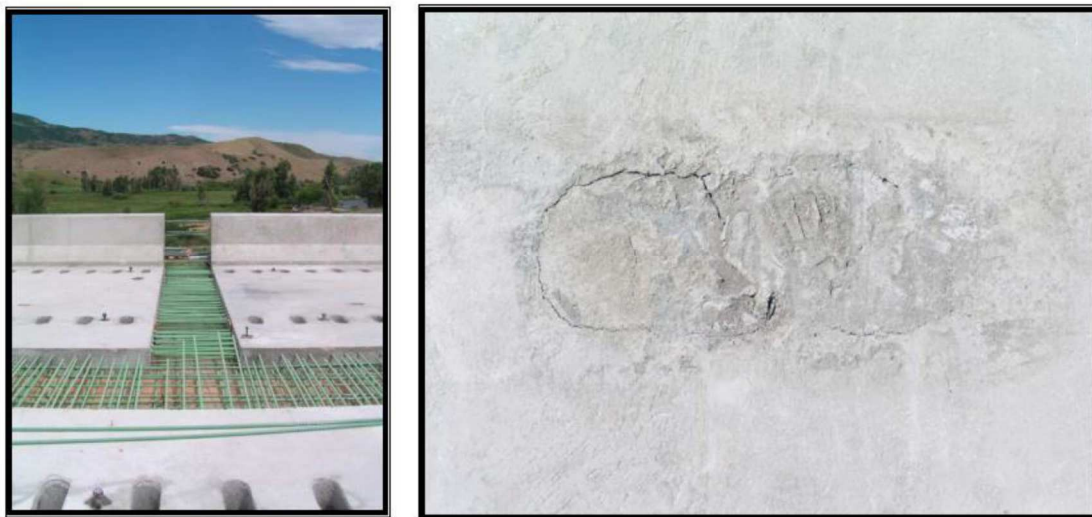
Figure 9: Shrinkage crack in the blockout type of ABC closure joint [13]

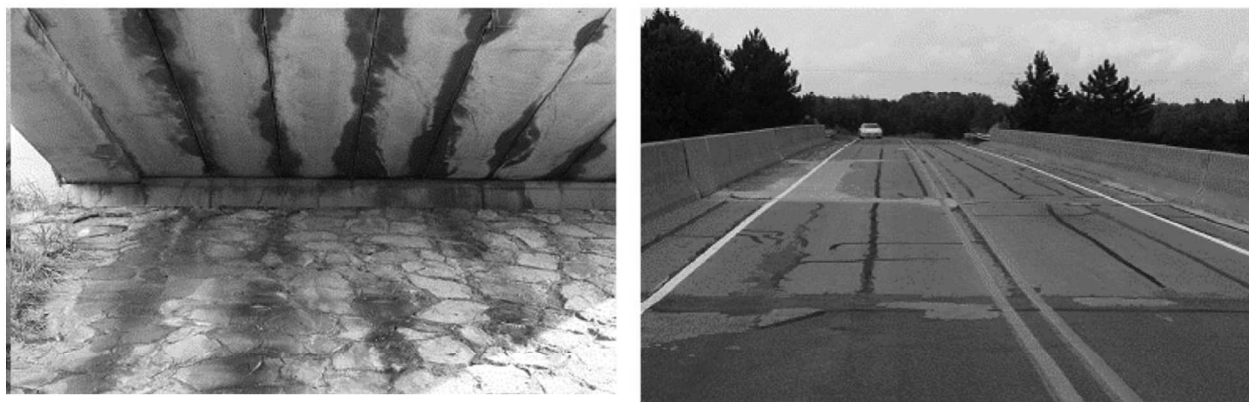
Figure 10: Longitude deck cracking of ABC closure joint [14]
