## **RAPID RECONSTRUCTION OF BNSF BR. 482.1 WEST APPROACH**

Temple Overman, P.E., HNTB Corporation, (816) 527-2726, [toverman@hntb.com](mailto:toverman@hntb.com)  
Cory Duerr, P.E., Kraemer North America, (715) 834-3514, [cduerr@kraemerna.com](mailto:cduerr@kraemerna.com)

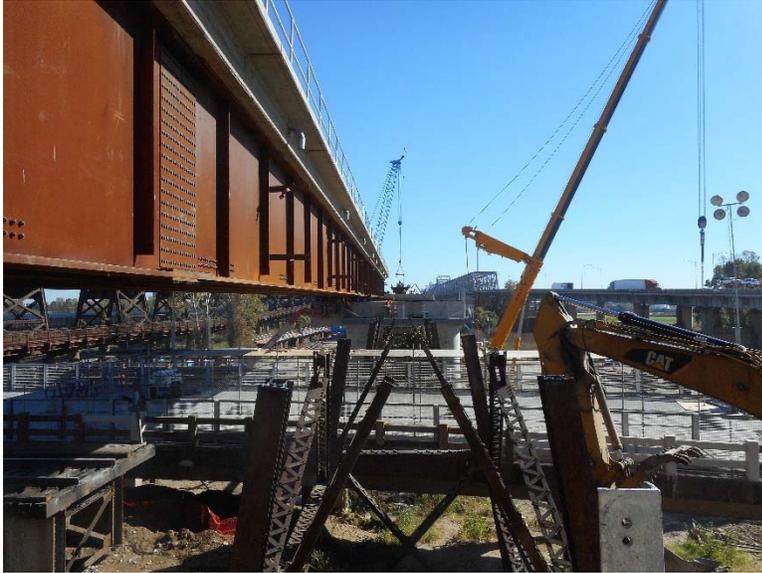
Figure 1: Preparing to roll a 176'-6" steel span into final position during the Phase 1 changeout

The Phase I changeout took place in November 2016 and replaced 748' of bridge in 40 hours. Rollers were utilized to transversely roll the two 176'-6" steel spans 17'-6" during the changeout. The project team learned a few valuable lessons while rolling the two long spans in this phase that would be transferred to the final two spans of the project which allowed those spans to roll in more smoothly.

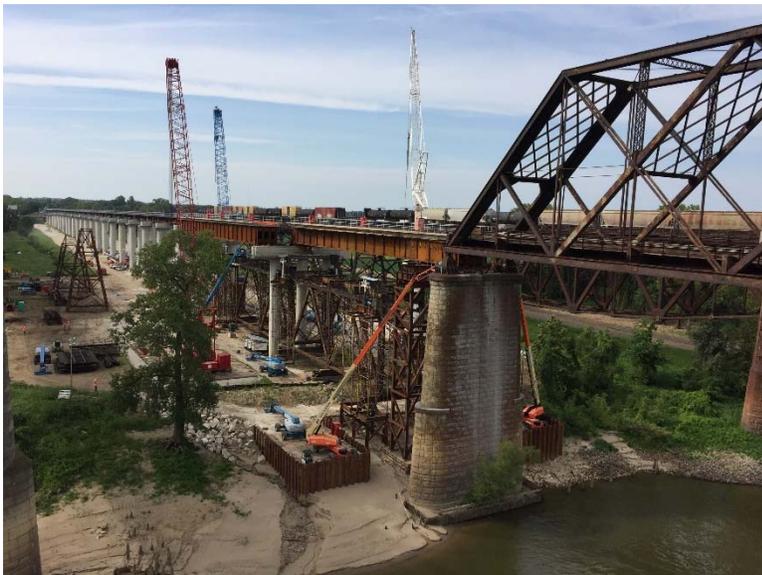
Figure 2: After lowering the 339' deck truss using strand jacks. Crews prepare to roll two steel spans during the Phase IV changeout.

The final changeout occurred in August 2017 and replaced the remaining 548' of approach. Prep work required prior to the changeout included constructing a pier through a 339' deck truss, strengthening the truss in preparation to be lowered, erecting extensive falsework towers to support the strand jacks, and erecting 178' and 191' spans onto extended pier caps. During the changeout, the ends and middle sections of the 339' deck truss were removed prior to lowering the span with strand jacks. Some sections of the deck truss had thick multiple layers of steel which would reweld back together. This greatly lengthened the time for removal. As soon as the deck truss was lowered below the new girder spans, the 178' span was rolled 23'-8" transversely and 3'-8" longitudinally to align with the existing river pier, and then the 191' span was rolled transversely by 23'-5" into alignment.
