RAPID REPAIR AND RETROFIT OF TIMBER PILES USING UHPC

Quarterly Progress Report For the period ending August 31, 2020

**ACCELERATED BRIDGE CONSTRUCTION
UNIVERSITY TRANSPORTATION CENTER**

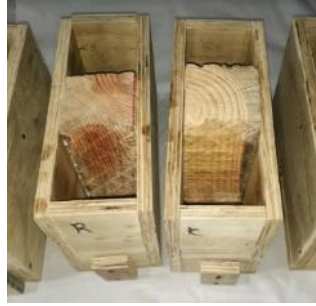
Figure 4. Formwork for pull-off specimens prior to casting UHPC.

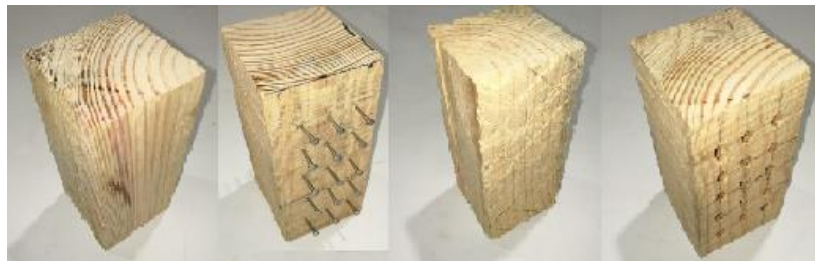
Figure 6. Different surface preparation for timber prisms

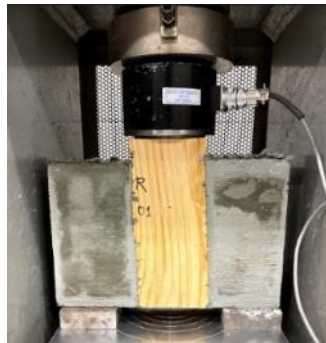
Figure 7. Push-off test setup.

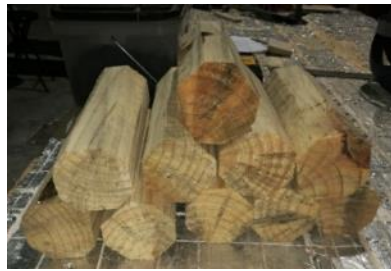
Figure 8. Timber cylinders. (a) hexagons as cut form large timber pile, (b) cylindrical shape using wood turning.

For load-carrying capacity, timber cylinders were cut by woodturning as shown in Figure 8, some of them were cast with an outer UHPC shell and other specimens were just UHPC shells molded by the use of cylindrical inner cylindrical styrofoams, as shown in Figure 9. Two diameter-to-thickness ratios between the inner timber cylinder and outer UHPC shell (d/t) of 6 and 2.57 were selected in this test as shown in Figure 9. All the specimens required cylindrical plastic molds for forming UHPC, as shown in Figure 10. Same surface preparations as bond strength specimens were replicated in the load-carrying capacity test as shown in Figures 11 and 12. Figure 13 shows the compression test setup and Figure 14 shows the final damage of one specimen. It should be noticed that two timber moisture preparations were conducted by (1) soaking timber in a water tank prior to casting UHPC (2) by spraying timber with water prior to casting UHPC. Tables 3 and 4 lists all specimen notations, failure load, and average failure load for each group. New specimens were cast as shown in Figure 15

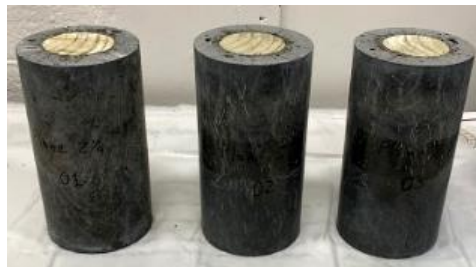
Figure 10. Sample for final timber cylinders with UHPC encasement.

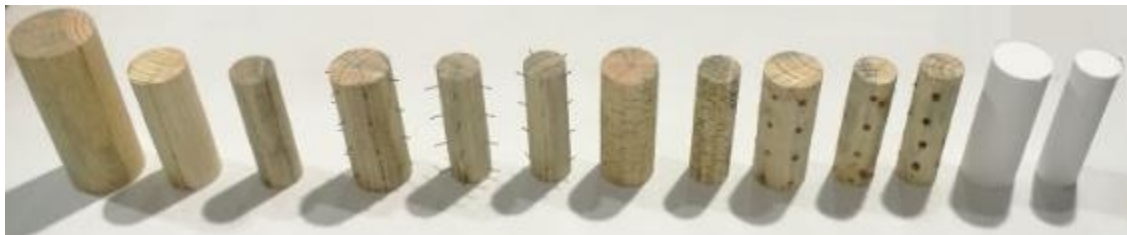
Figure 12. Different surface preparation for timber prisms

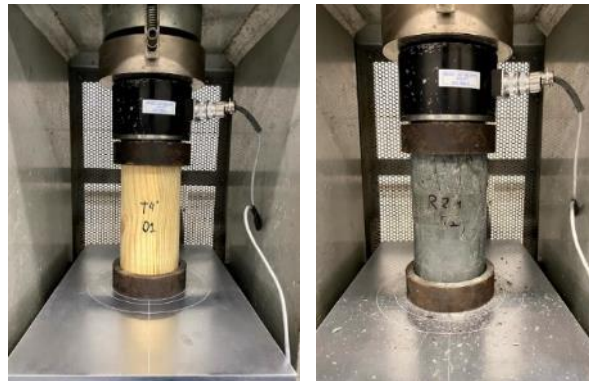
Figure 13. Test setup for load-carrying capacity. (a) timber specimen, (b) timber cylinder with UHPC encasement.

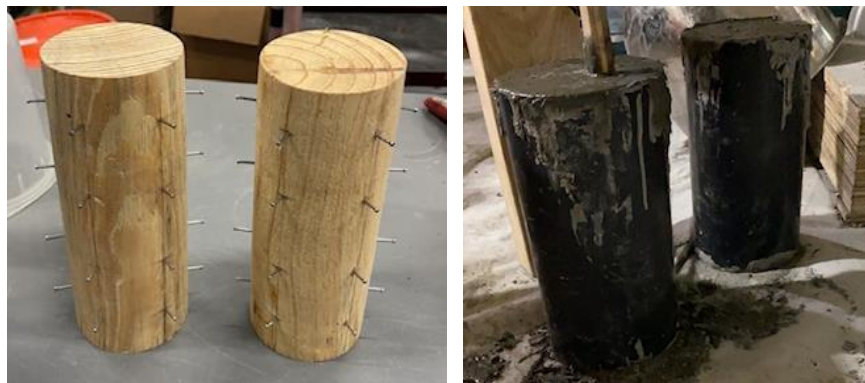
Figure 15. New specimens to replace the ones that turned out deficient.
