**DESIGN GUIDELINES FOR ABC COLUMN-TO-DRILLED-SHAFT  
FOUNDATION CONNECTIONS IN HIGH SEISMIC ZONES**

**Quarterly Progress Report  
For the period ending May 31, 2021**

**Affiliation: Department of Civil and Environmental Engineering  
University of Washington**

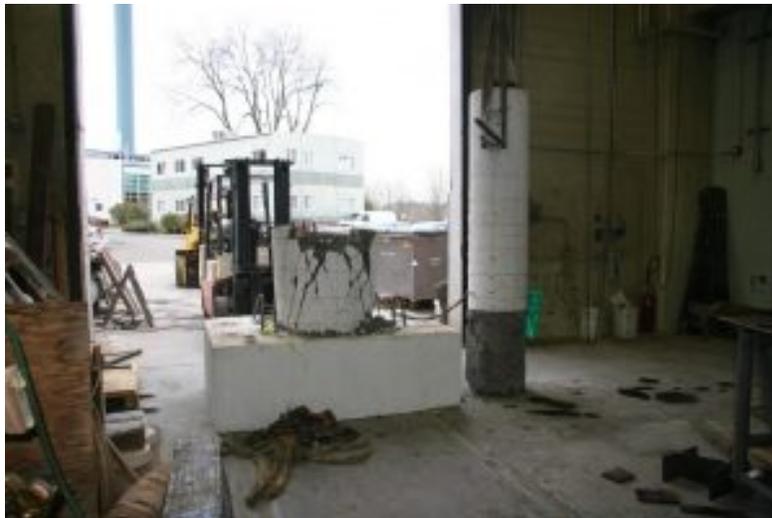
*Figure 1. Tran Tests of Connection Between Precast Column and Enlarged Drilled Shaft*

The current AASHTO ABC design recommendations for shafts are based on the results of cast-in-place column behavior and a single cyclic test of a column-to-shaft subassembly. This research uses experimental data from a past study (Fig. 1) and data from a PEER-funded study to calibrate strut-and-tie and/or finite-element models of connections between precast columns and cast-in-place drilled shafts. The calibrated models will be used in a parametric study, whose results will make it possible to develop design recommendations for such connections.

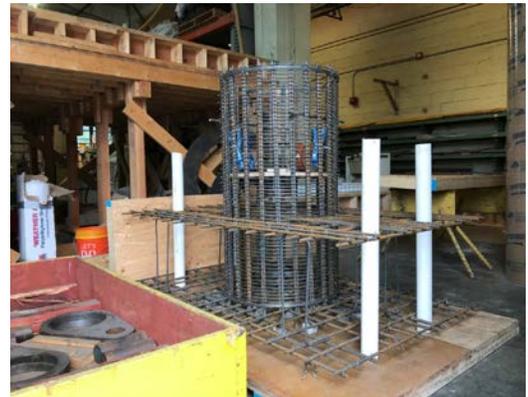
*Figure 2. Photo of Shaft and Base Reinforcement*

An additional test of a column-to-drilled shaft connection was performed with the support of the Pacific Earthquake Engineering Research center (PEER). These tests were delayed by laboratory delays due to Covid-19, but the laboratory is now open for research. During the Summer of 2020, graduate student researcher Michelle Chang constructed some of the formwork and reinforcement cages for her specimen. Figures 2, 3 and 4 shows photos of the specimen under construction.

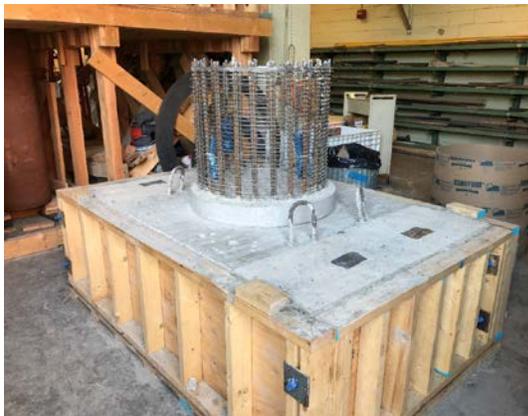
*Figure 3. Photo of Shaft Reinforcement and Cast Base*

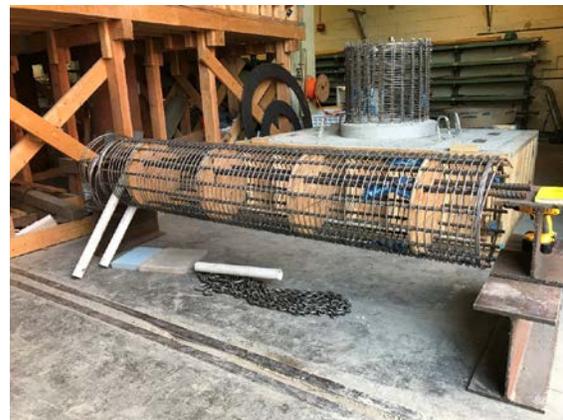
*Figure 4. Photo of Column Reinforcement Cage*

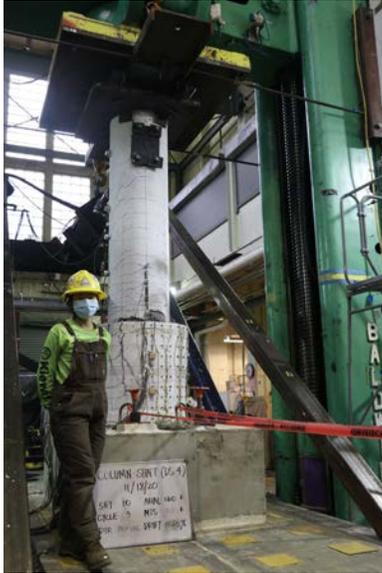
*Figure 5. Photo of Connection Specimen and End of Testing*

During Autumn of 2020, the specimen construction was completed, and the column of the test specimen was subjected to a constant axial load and cyclic, lateral displacements. Figure 5 shows Ms. Chang in front of her specimen at the end of the test. Figure 6 shows the damage to the column-to-drilled-shaft connection. The failure mode consisted of bursting of the top of the drilled shaft near the bottom of the columns.

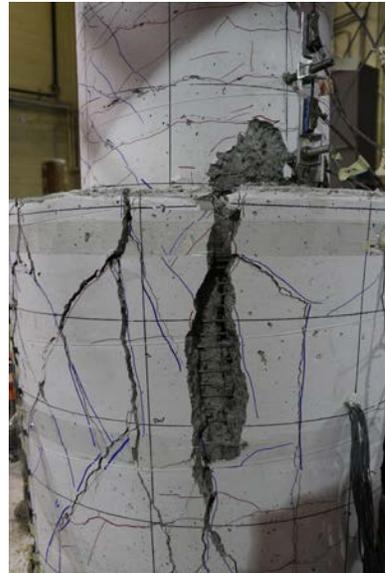
*Figure 6. Photo of Damage to Drilled-Shaft Connection*

The proportioning of the transverse reinforcement in the drilled shaft is a critical design consideration, because this reinforcement resists the splitting failure shown in Fig. 6. Figure 8 shows the vertical distribution (0 in. corresponds to column-shaft interface) of measured strains in the shaft transverse reinforcement for three levels of drift ratio (1%, 2% and 3%). Separate curves are shown for the North-Face Tension (NT), North-Face Compression (NC), South-Face Tension (ST), South-Face Compression (SC) and East-Face (E).

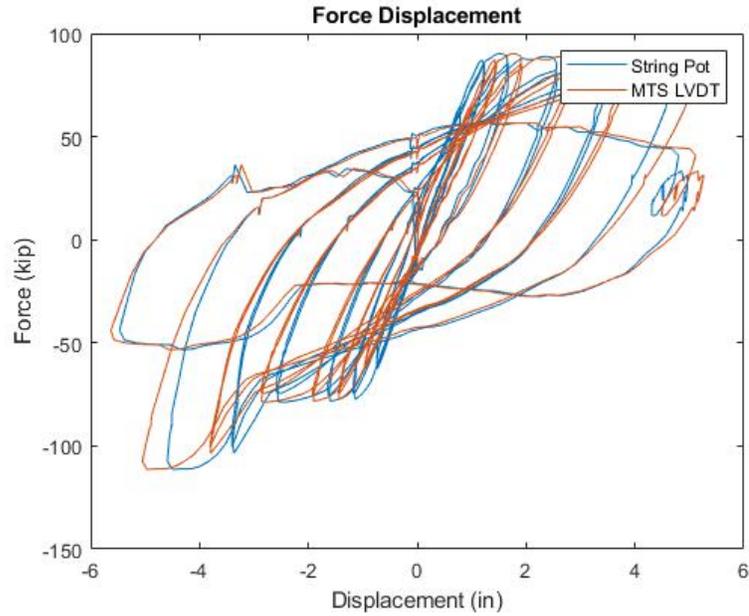
Figure 7 shows the measured overall force-displacement response for specimen DS-4. The specimen developed the full column flexural strength at a lateral displacement of about 1 inch, and it maintained its peak resistance until a top displacement of approximately 4-5 inches.

Figure 7. Overall Force-Displacement Response for Specimen DS-4.

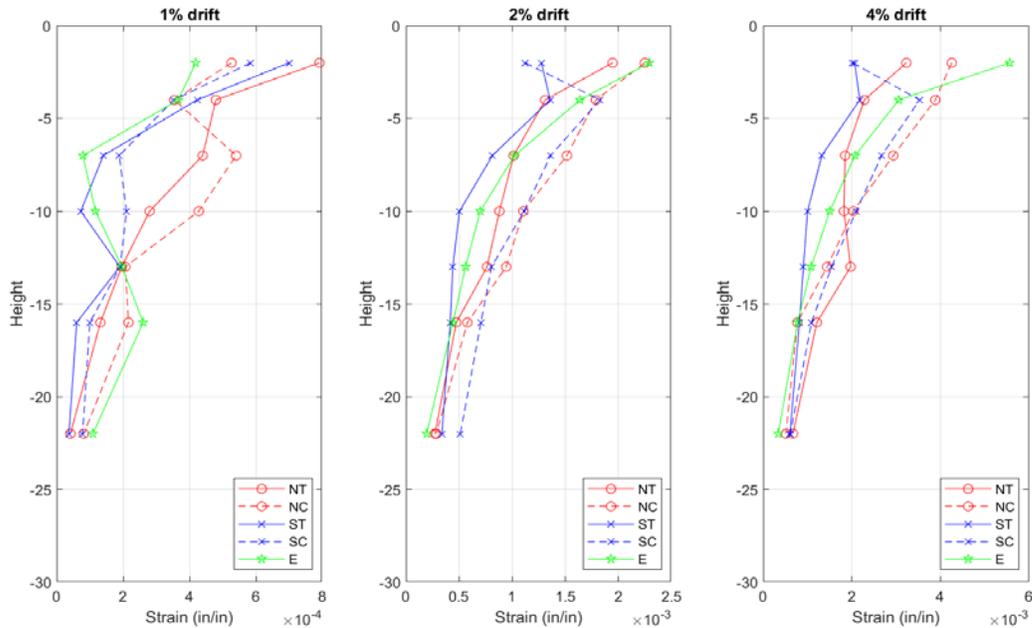
Figure 8. Vertical Distributions of Transverse Reinforcement Strains.

Figure 8 supports the following conclusions:

- The distribution of strains over the height of the drilled shaft is approximately parabolic.
- The transverse reinforcement at the top of the shaft yielded ( $\sim 0.0022$ ) at a drift ratio near 2%. The strains at a drift ratio of 4% were roughly double those at a drift ratio of 2%.
- At larger drift ratios (above 1% or so), the transverse reinforcement strains tended to be largest on the compression side, of intermediate magnitude on the “unloaded” East side, and smallest on the tension side.

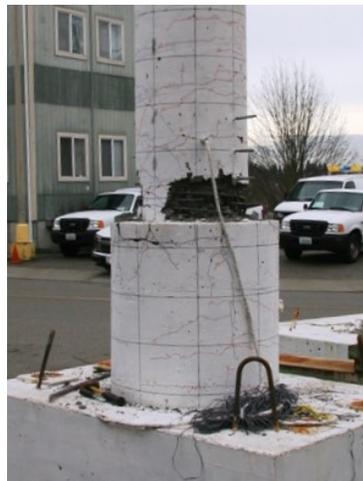
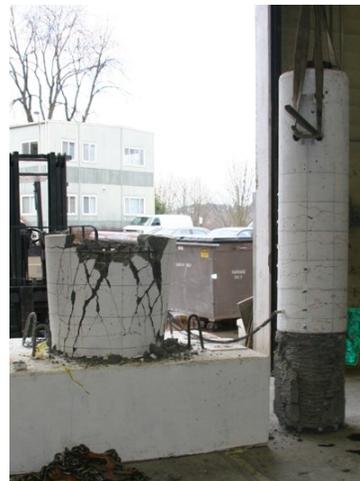
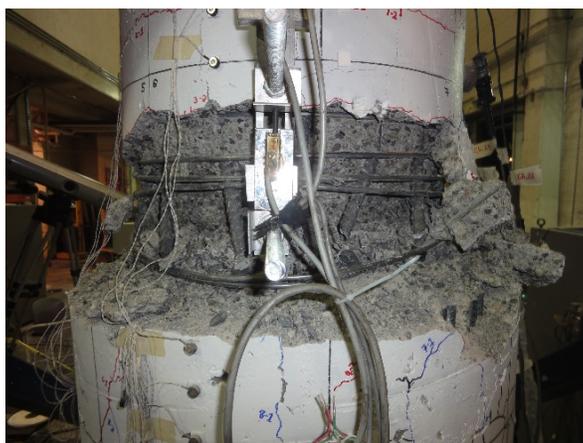
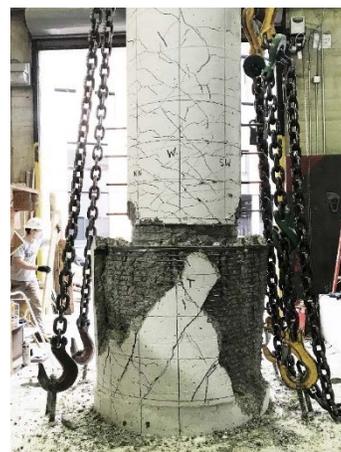
During Spring 2021, the experimental data from the recent DS-4 test was compared with the data available from previous DS-1, DS-2 and DS-3 tests (Huang 2015). Figure 8 shows photographs of the damage of the four specimens at the end of testing. The damage to specimens DS-1 and DS-3 consisted of flexural damage at the base of the column, which is the desired behavior. In contrast, DS-2 and DS-4 failed in the shaft, an undesirable failure mode.

*Figure 9. Photographs of Specimen Damage at End of Testing.*

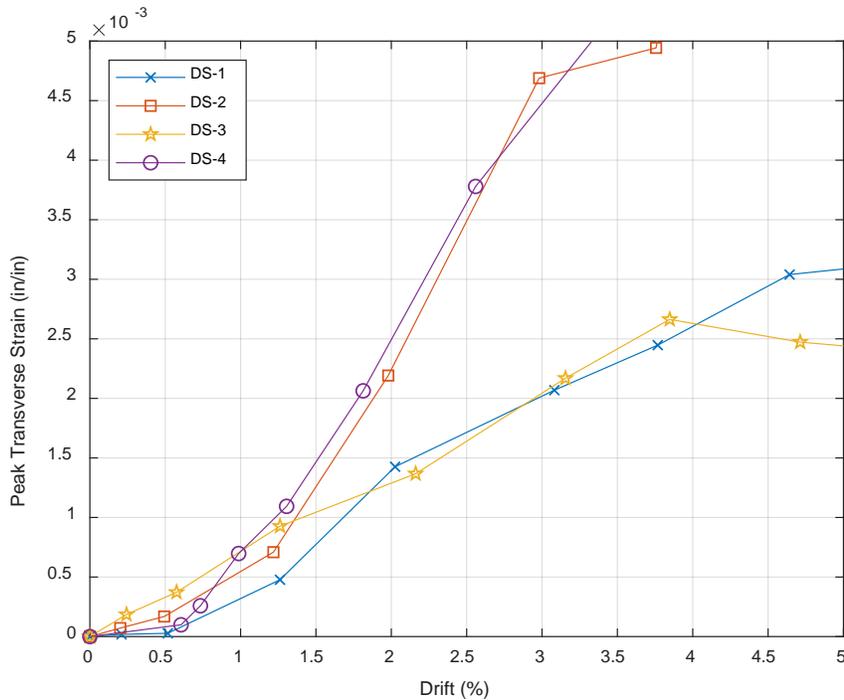
Figure 10 shows how the variation of the maximum transverse strain in the shaft reinforcement varies with the imposed drift ratio for the four DS specimens. The transverse strains increase much more rapidly in DS-2 and DS-4 than in DS-1 and DS-3. These differences in measured strains are consistent with observed damage in the four specimens.

Figure 10. Variation of Strains in Shaft Transverse Reinforcement with Drift Ratio

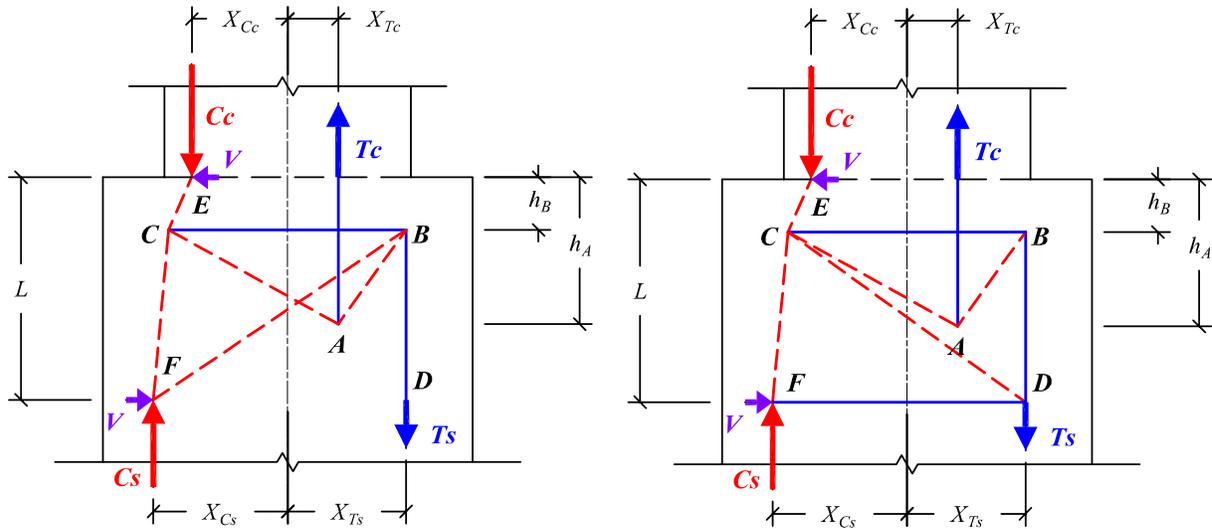
A strut-and-tie models was developed and calibrated to be consistent with the observations and data available from Tran (2015), the PEER-funded tests, and the results of four specimens tested at the University of California, San Diego, C. Figure 11 shows the final form of two strut-and-tie models that produces consistent results. The model on the left governs when shear forces are relatively high compared to the bending forces. The model of the right governs when bending forces govern the behavior.

Figure 11. Strut-and-Tie for Column-to-Shaft Connection
