# **TSUNAMI DESIGN FORCES FOR ABC RETROFIT**

**Quarterly Progress Report  
For the period ending November 30, 2021**

**ACCELERATED BRIDGE CONSTRUCTION  
UNIVERSITY TRANSPORTATION CENTER**

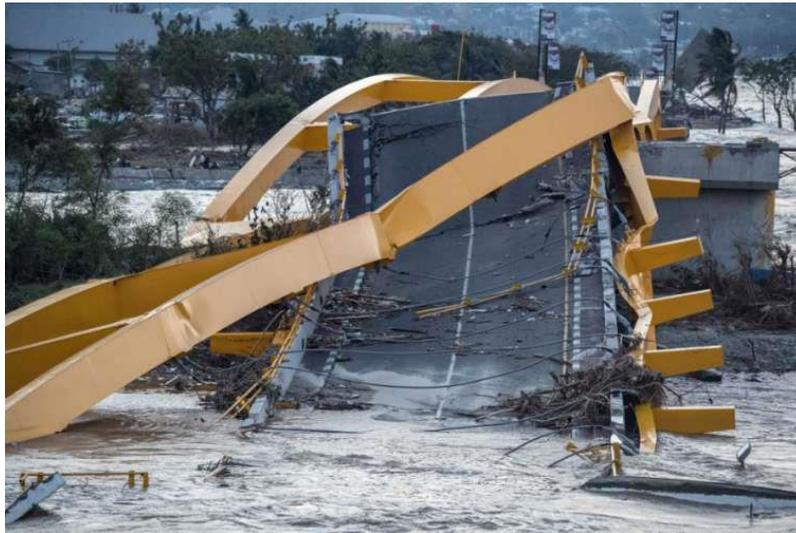
*Figure 1. Ponulele Bridge Destroyed by 2018 Tsunami*

The catastrophic damage that tsunamis cause to coastal communities is often exacerbated by the destruction of much of the transportation infrastructure (Fig. 1). This destruction delays critical rescue efforts and economic recovery.

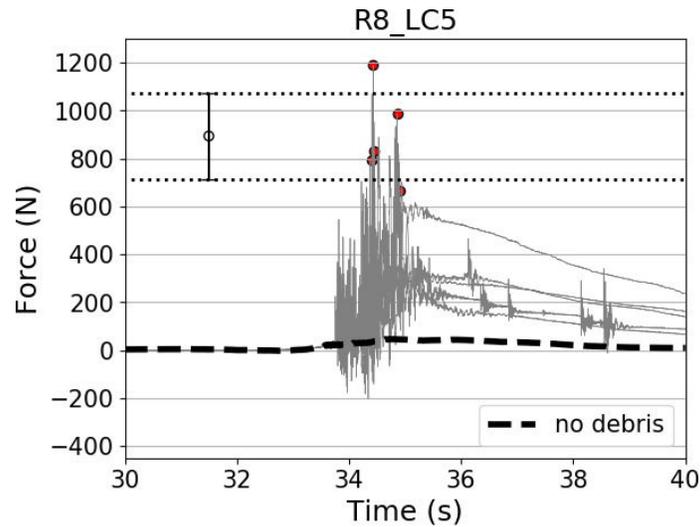
UW and OSU researchers generated an initial set of data using the OSU wave flume. As shown in Fig. 2, the force history (shown for an elevated structure) generated by debris includes multiple impacts (sharp peaks in force history) and an accumulation of force as the debris increases the hydraulic area of the bridge. The forces decrease rapidly with time, because the transient wave lasted only a short time.

Figure 2. Measured Forces on Elevated Structure

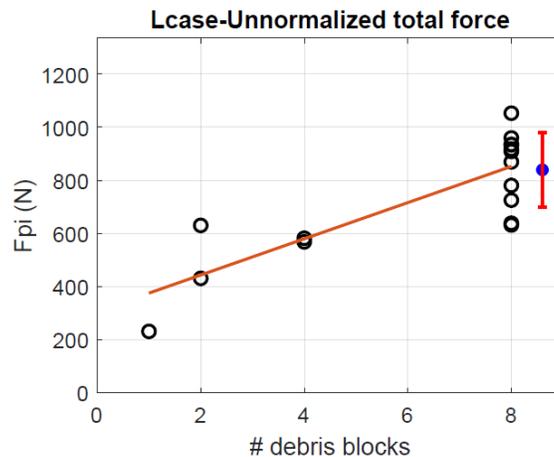
Fig. 3 shows that the total measured force increased with the number of debris in the flow. For eight blocks, this figure also shows that the total force varied greatly among the repetitions, a behavior that is consistent with the semi-chaotic nature of debris interaction with the bridge. This dataset is available from the NHERI DesignSafe data repository (PRJ-1709: NHERI Debris Impact Experiments).

Figure 3. Effects of # Debris on Measured Peak Force

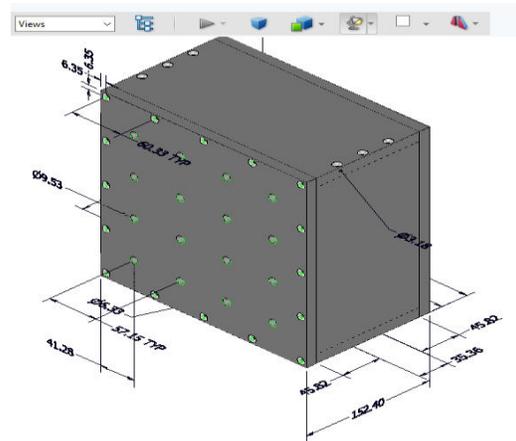
The fabrication of the test structure was completed earlier this year, and last quarter we purchased the data acquisition hardware needed to collect and store the test data. Figure 4 shows an isometric view of the test structure.

Figure 4. Drawing of Test Structure

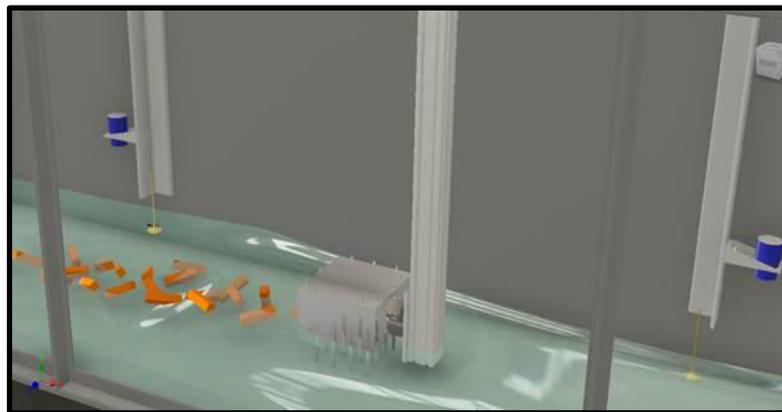
Figure 5 shows a 3D rendering of the test setup, in which the current flows from left to right. The

structure (shown in grey in middle of image) consists of a waterproof box (fabricated by Mechanical Engineering Department Machine shop), which has attachments to accommodate a wide range of column numbers, locations and heights. The specimen is connected through a 6-degree-of-freedom load cell to a

Figure 5. 3D Rendering of Test Setup

supporting frame (shown as vertical I-beam downstream box). The rendering also shows (in orange) a debris field approaching the structure. The blue cylinders depict ultrasonic gauges to

measure the elevation of the water upstream and downstream of the structure. These instruments are also supported on their own frames, which attach to the walls of the flume. During the experiments, we will also use existing (and expensive) velocimeter instrumentation to measure current velocity.

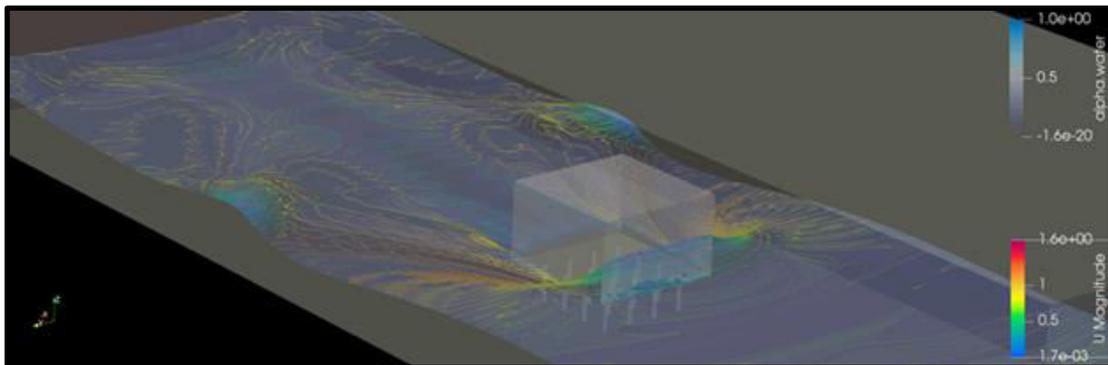
To help estimate likely the magnitudes of forces expected in the tests, the team performed 3D simulations using the OpenFoam simulation software (<https://openfoam.org>). Figure 6 shows the results of a simulation of the fluid flow around the structure for the case in which debris is not

*Figure 6. Typical Results of Simulation*

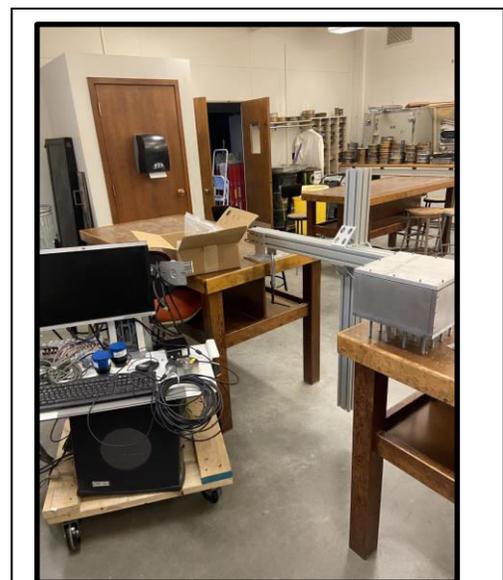
The test setup has been assembled outside of the flume (Figure 7). The next step will be to calibrate the 6-DOF load cell before testing can begin in the WASIRF facility.

*Figure 7. In-Air Installation*

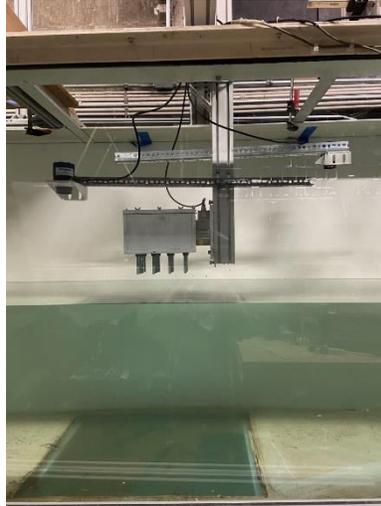
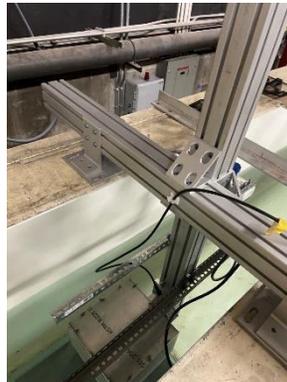
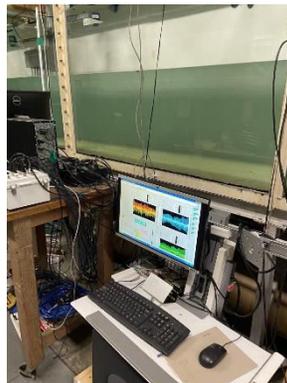
should continue until the end of the month and early September. Figure 8 shows three photographs of the test setup in the flume, including an elevation of the test setup, a top view of the test setup, and the data acquisition system.

(a) Elevation of Test Setup

(b) Top View of Test Setup

(c) Data Acquisition System

*Figure 8. Test Setup in Hydraulic Flume*
