# **TSUNAMI DESIGN FORCES FOR ABC RETROFIT**

**Quarterly Progress Report  
For the period ending February 28, 2022**

**ACCELERATED BRIDGE CONSTRUCTION  
UNIVERSITY TRANSPORTATION CENTER**

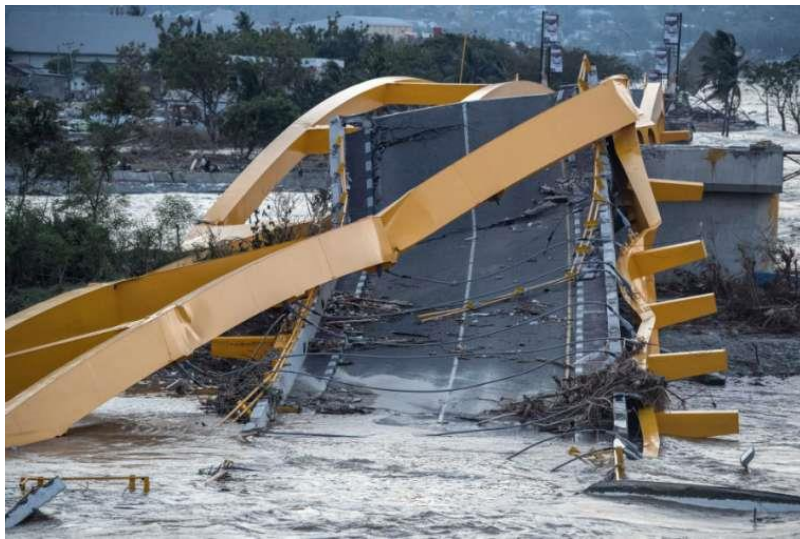
*Figure 1. Ponulele Bridge Destroyed by 2018 Tsunami*

The catastrophic damage that tsunamis cause to coastal communities is often exacerbated by the destruction of much of the transportation infrastructure (Fig. 1). This destruction delays critical rescue efforts and economic recovery.

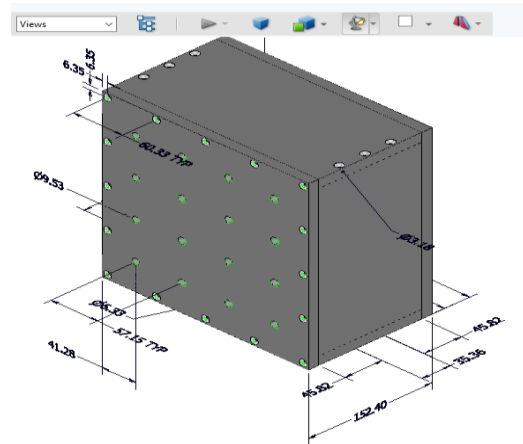
The fabrication of the test structure was completed earlier this year, and last quarter we purchased the data acquisition hardware needed to collect and store the test data. Figure 4 shows an isometric view of the test structure.

Figure 4. Drawing of Test Structure

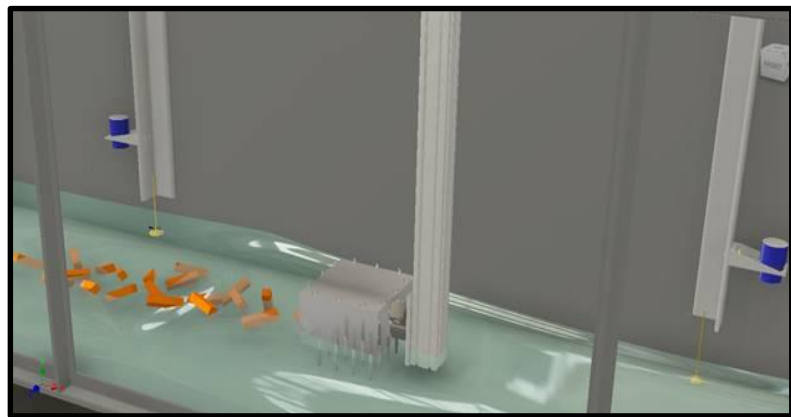
Figure 5 shows a 3D rendering of the test setup, in which the current flows from left to right. The structure (shown in grey in middle of image) consists of a waterproof box (fabricated by Mechanical Engineering Department Machine shop), which has attachments to accommodate a wide range of column numbers, locations and heights. The specimen is connected through a 6-degree-of-freedom load cell to a supporting frame (shown as vertical I-beam downstream box). The rendering also shows (in orange) a debris field approaching the structure. The blue cylinders depict ultrasonic gages to

Figure 5. 3D Rendering of Test Setup

measure the elevation of the water upstream and downstream of the structure. These instruments are also supported on their own frames, which attach to the walls of the flume. During the experiments, we will also use existing (and expensive) velocimeter instrumentation to measure current velocity.

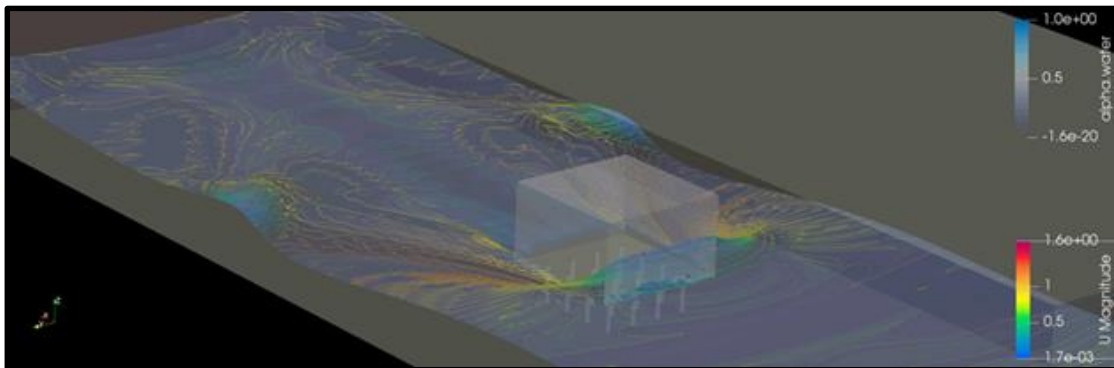
To help estimate likely the magnitudes of forces expected in the tests, the team performed 3D simulations using the OpenFoam simulation software (<https://openfoam.org>). Figure 6 shows the results of a simulation of the fluid flow around the structure for the case in which debris is not present.

*Figure 6. Typical Results of Simulation*

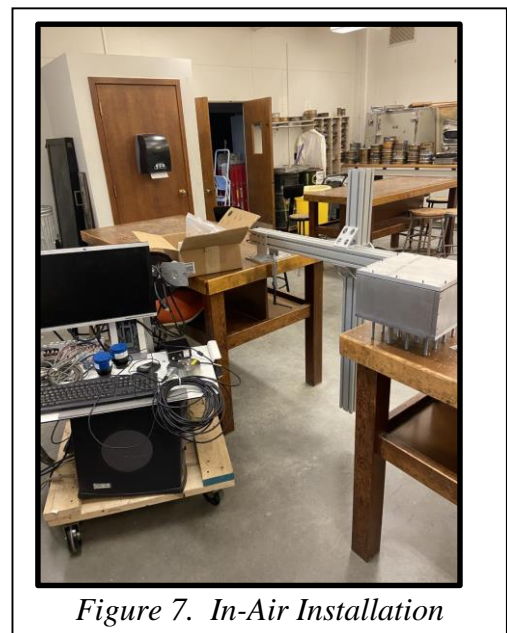
The test setup has been assembled outside of the flume (Figure 7). The next step will be to calibrate the 6-DOF load cell before testing can begin in the WASIRF facility.

*Figure 7. In-Air Installation*

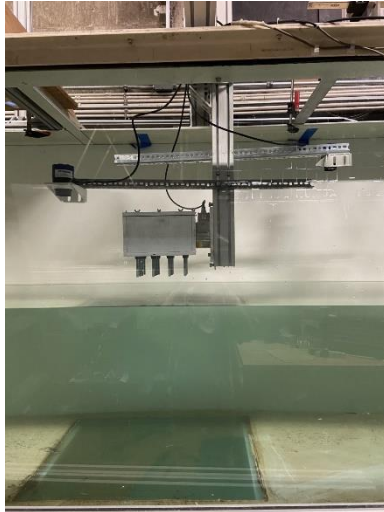
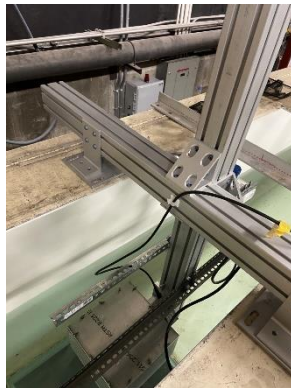
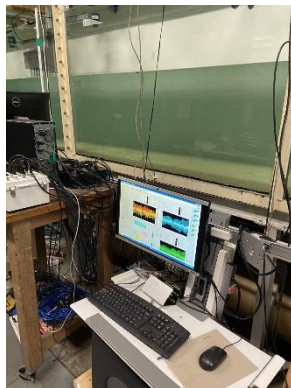
After long Covid-induced delays, the hydraulic laboratory is now available for experimental testing, and the testing began in the second week of August. It should continue until the end of the month and early September. Figure 8 shows three photographs of the test setup in the flume,

including an elevation of the test setup, a top view of the test setup, and the data acquisition system.

(a) Elevation of Test Setup

(b) Top View of Test Setup

(c) Data Acquisition System

*Figure 8. Test Setup in Hydraulic Flume*
